Document Identifier 51 - 1245880-00Title INTERIM ENGINEERING EVALUATION: ONS UNIT 2 1996 CRDM NOZZLE INSPECTION

This document contains an interim engineering evaluation of the NDE results obtained during the CRDM nozzle inspection performed at Oconee Unit 2 in April 1996. It has been determined that the indications detected are acceptable based on the NRC-approved acceptance criteria developed for CRDM nozzle flaws.

**DUKE POWER COMPANY - OCONEE UNIT 2**  
**CRDM NOZZLE EDDY CURRENT INSPECTION RESULTS**  
**APRIL 11, 1996**

**Duke Power Company - Oconee Site Unit 2  
CRDM Liquid Penetrant Examination Results**

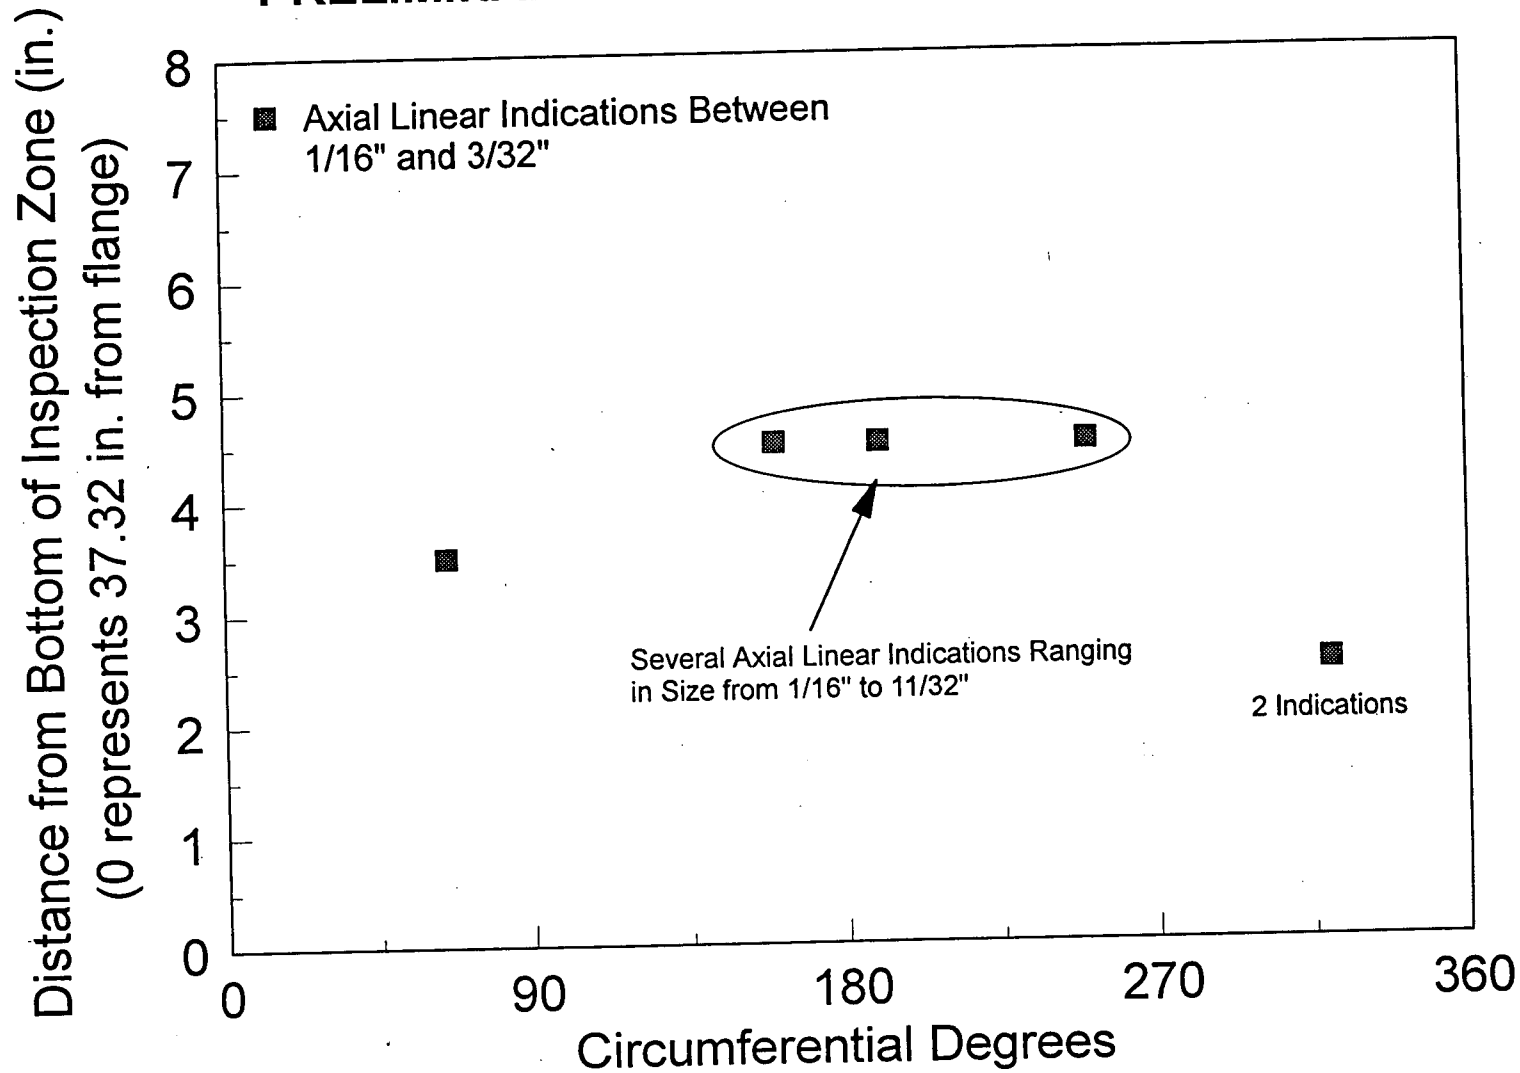
INTERIM RESULTS: LOCATION OF 1996 INDICATIONS AT ONS UNIT 2 NOZZLE 23

For nozzle 23, the PT results showed numerous axial linear indications, illustrated in Figure 1. A group of indications, ranging in length from 0.06" to 0.34", exists between approximately the 160° and 250° angular positions in the nozzle circumference (with 0° defined at the downhill side of the weld). In addition, two indications (0.06" and 0.09" in length) were identified at approximately the 320° angular position and one indication (0.06" in length) was identified at approximately the 65° angular position.

In summary, indications were identified in CRDM nozzles 23 and 63. As illustrated in Figure 1, there were numerous axial linear indications identified in nozzle 23 by ET and PT showed the lengths of the indications to be 0.06 to 0.34". Figure 2 illustrates the numerous axial linear indications identified by ET and further evaluated by PT in nozzle 63. The lengths of the indications range from 0.03" to 0.44."

## PRELIMINARY PT RESULTS FOR NOZZLE 23

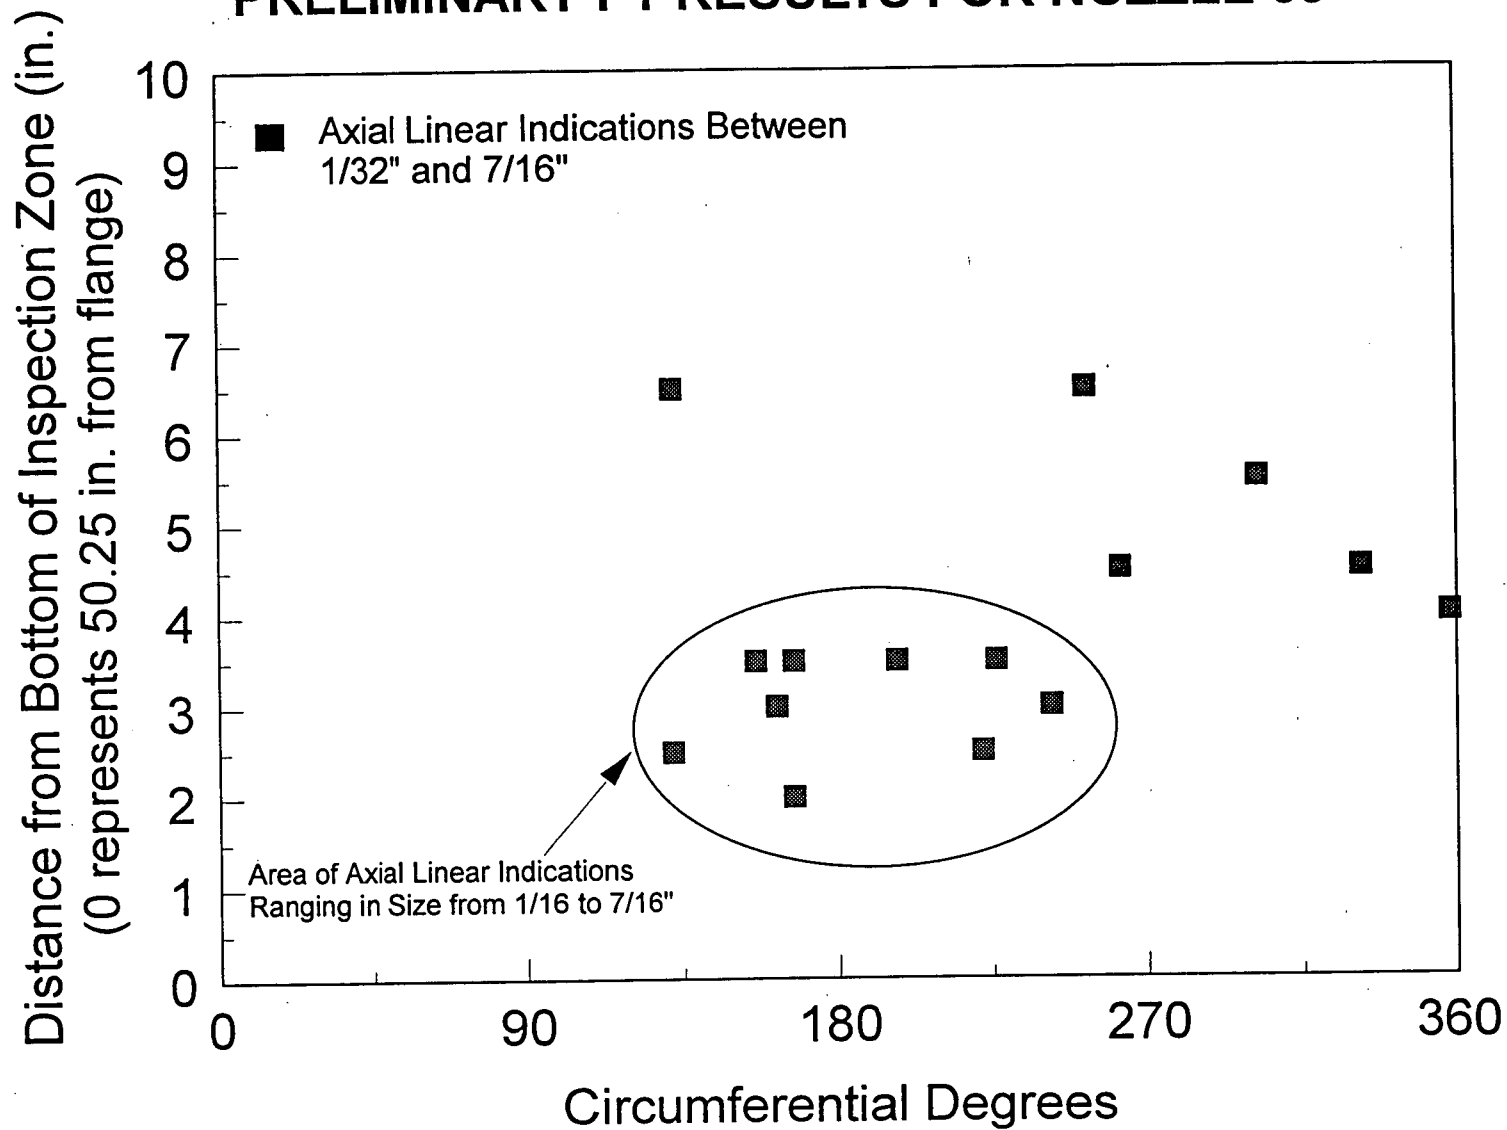
## INTERIM RESULTS: LOCATION OF 1996 INDICATIONS AT ONS UNIT 2 NOZZLE 63

For nozzle 63, the PT results showed numerous axial linear indications scattered throughout the nozzle circumference as illustrated in Figure 2. The indications range from 0.03" to 0.44" in length.

## PRELIMINARY PT RESULTS FOR NOZZLE 63

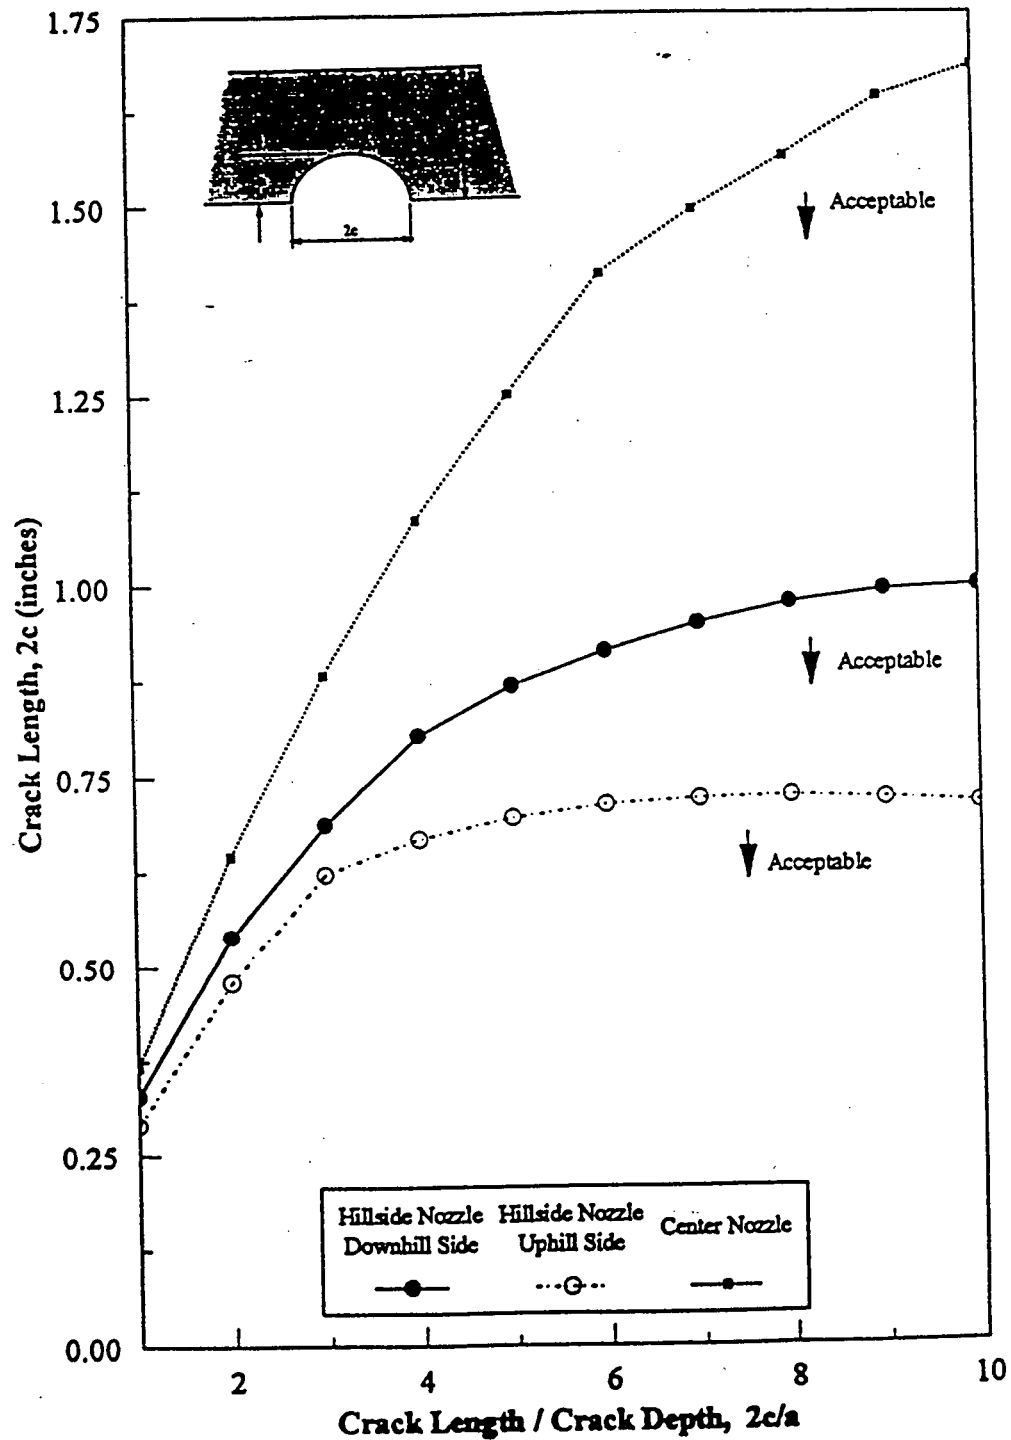
FIGURE 3

# ALLOWABLE FLAW SIZE FOR AN INTERNAL SEMI-ELLIPTICAL AXIAL FLAW

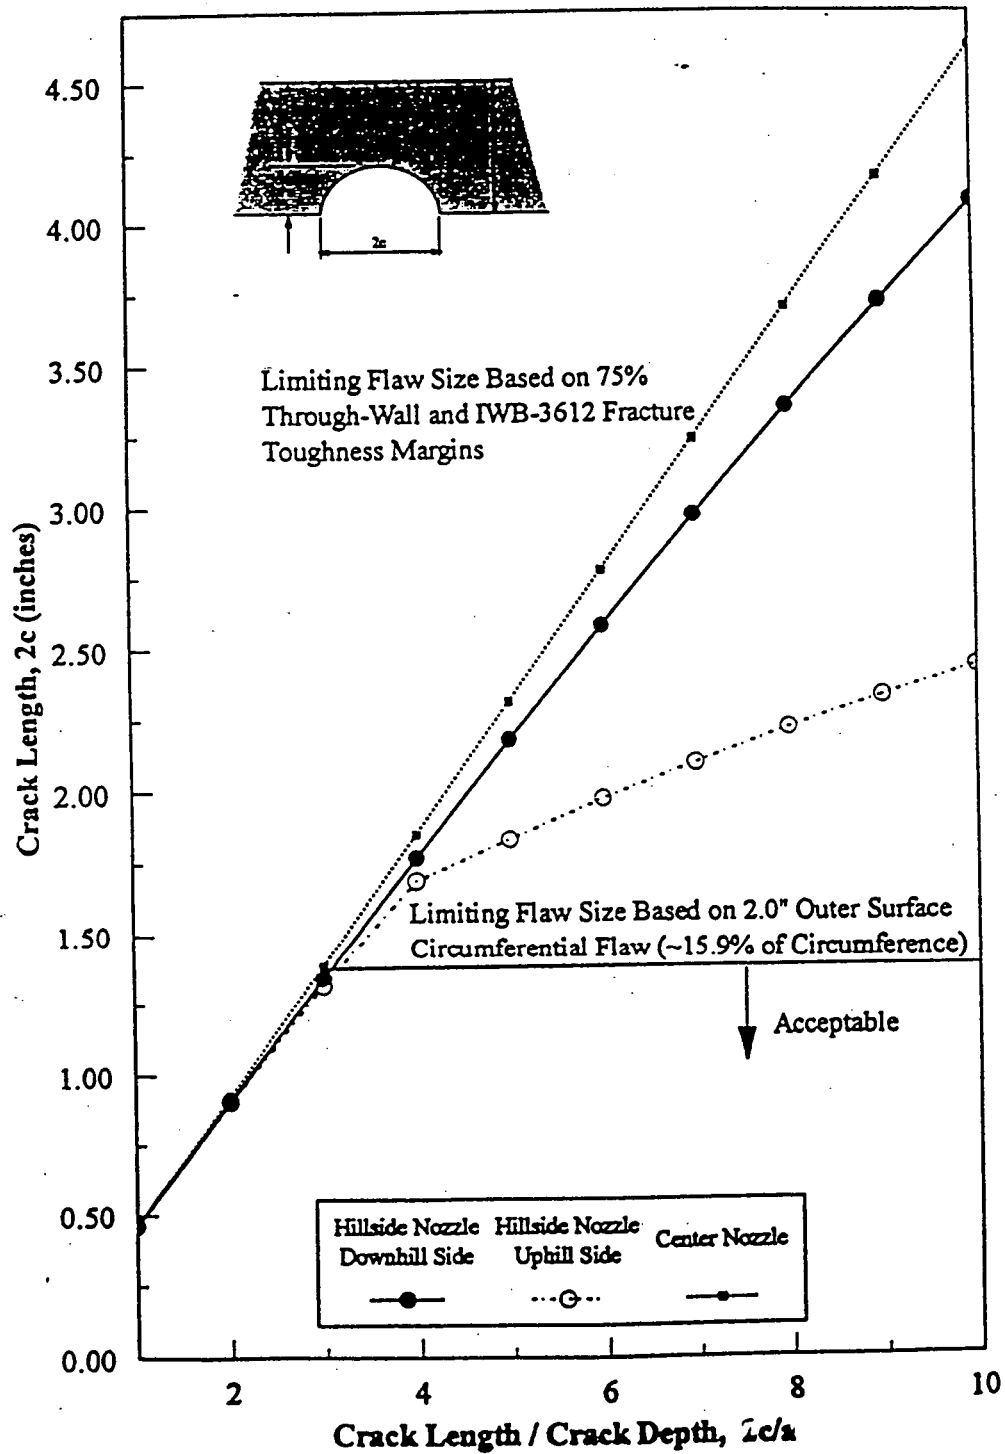
FIGURE 4

# ALLOWABLE FLAW SIZE FOR AN INTERNAL, SEMI-ELLIPTICAL CIRCUMFERENTIAL FLAW

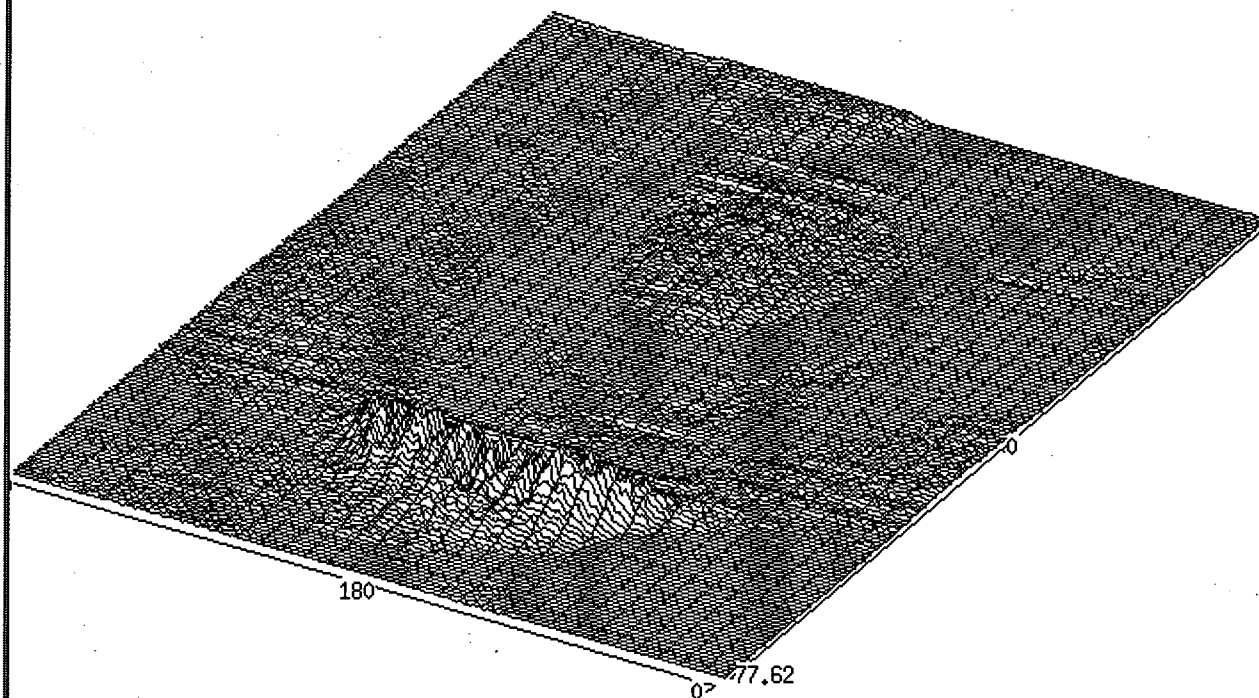
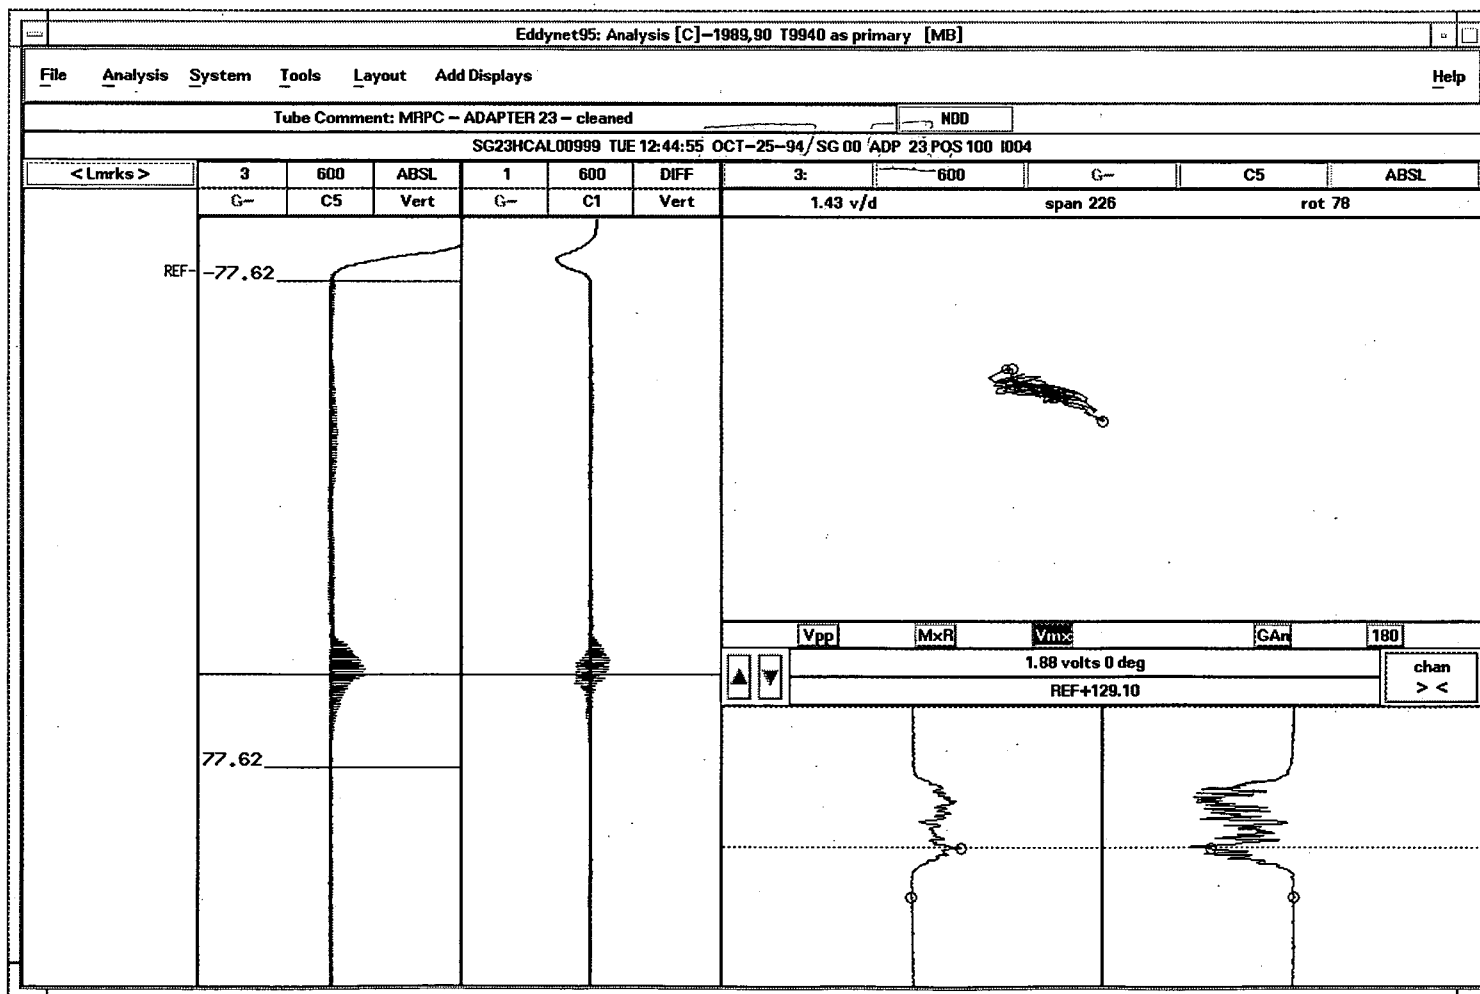
1994 Data

Nozzle #23 contained many small axial indications near the top of the weld (180 degrees) occurring along a circumferential line. A comparison between the 1994 MRPC data and the 1996 MRPC data resulted in no significant change in amplitude or phase response for the indications found.

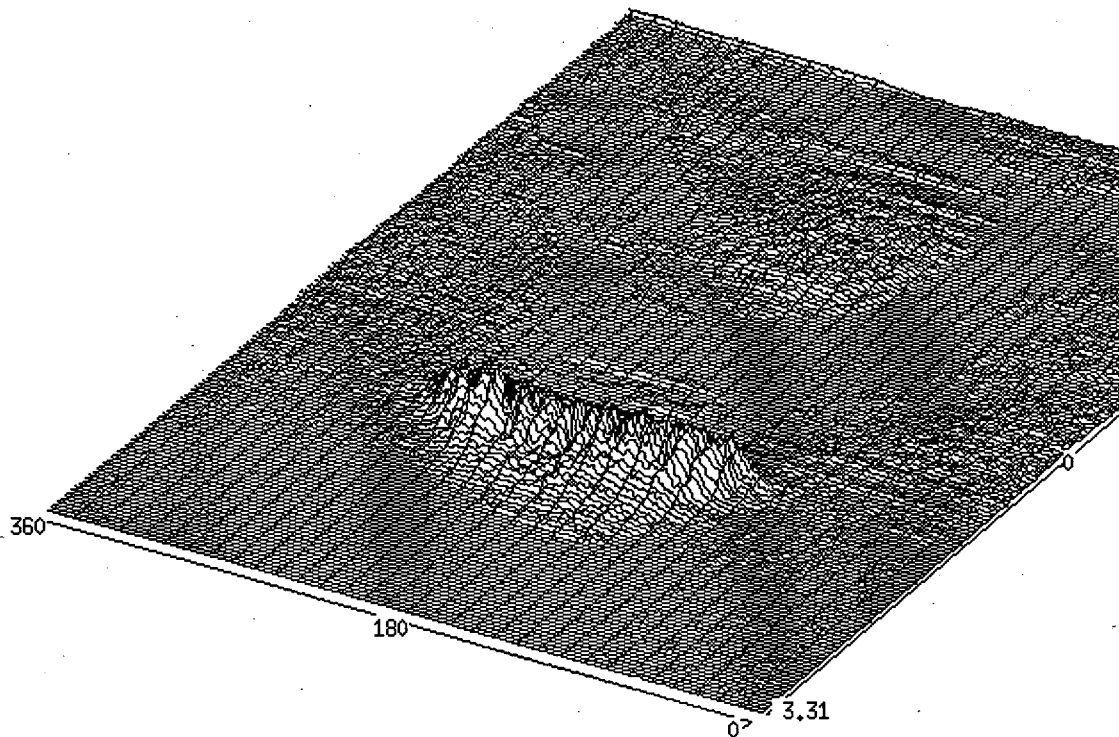
1996 Data: After Honing

Nozzle #23 was honed for two minutes and reinspected with eddy current. No significant change in signal response was noted after honing.

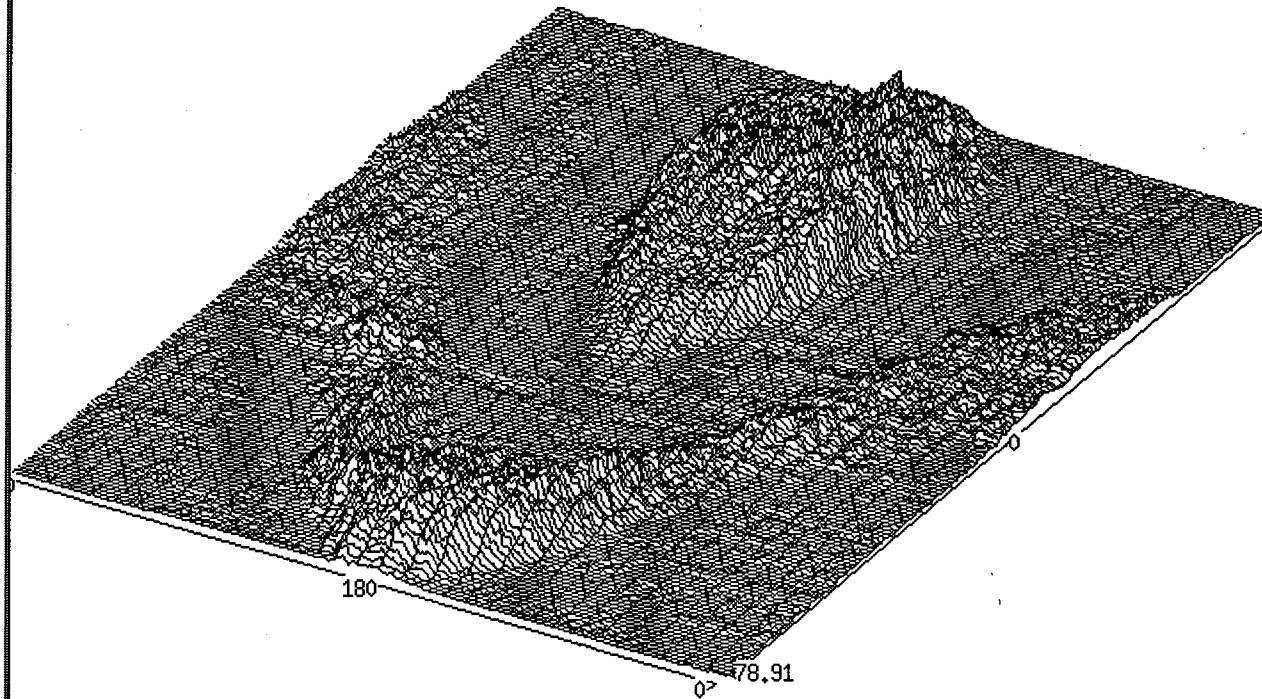
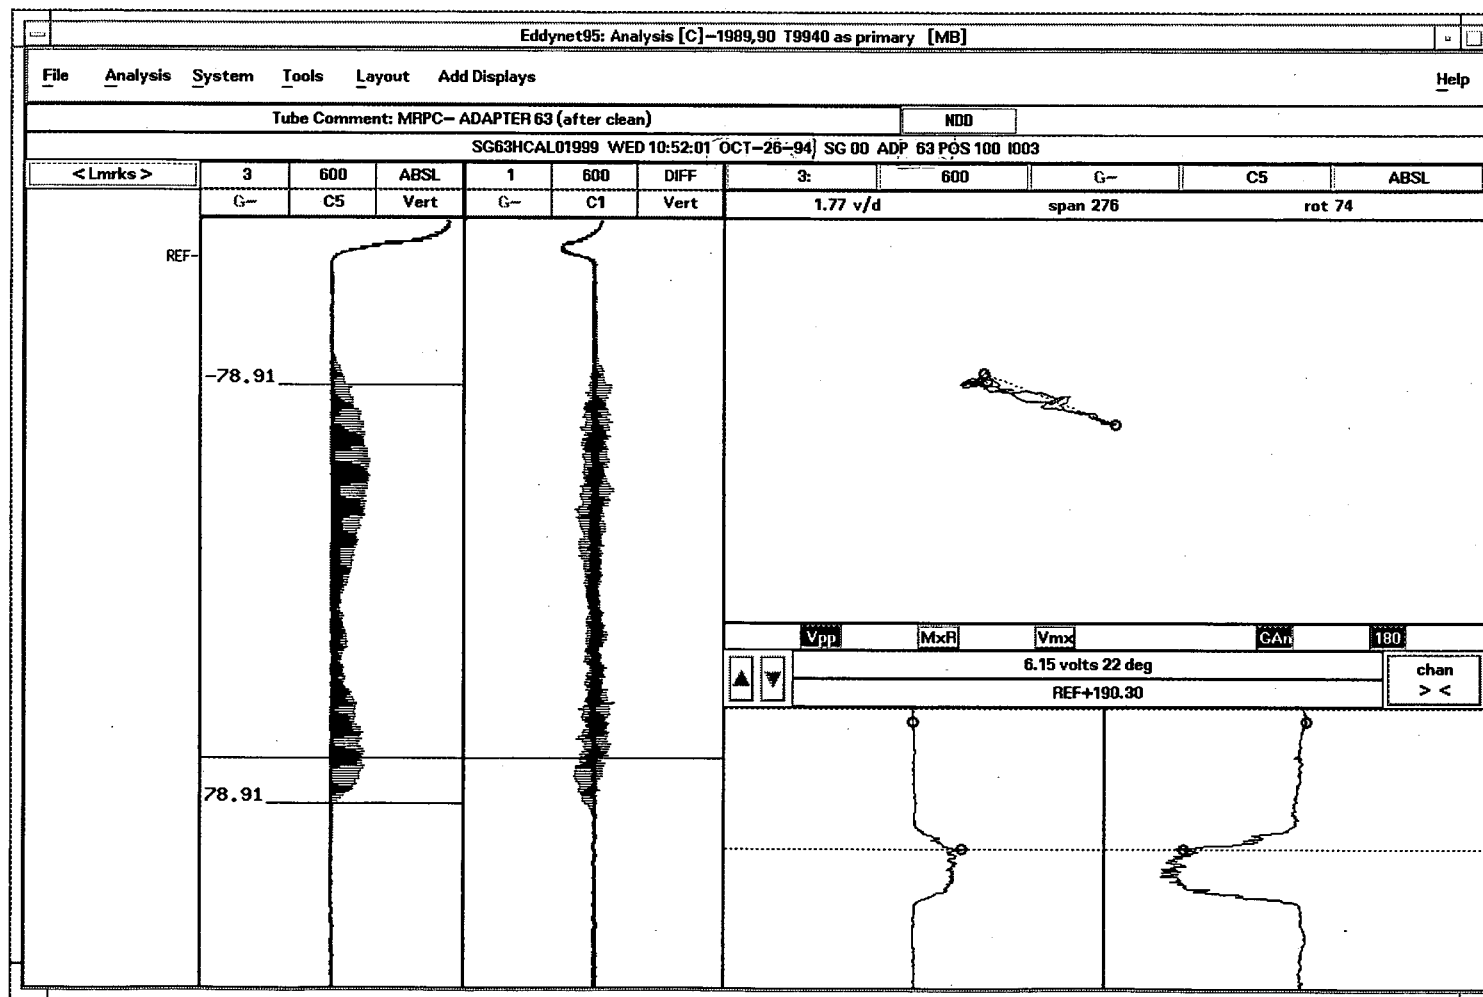
1994 Data

Nozzle #63 contained many small axial indications throughout the weld signature area. A comparison between the 1994 MRPC data and the 1996 MRPC data resulted in no significant change in amplitude or phase response for the indications found.

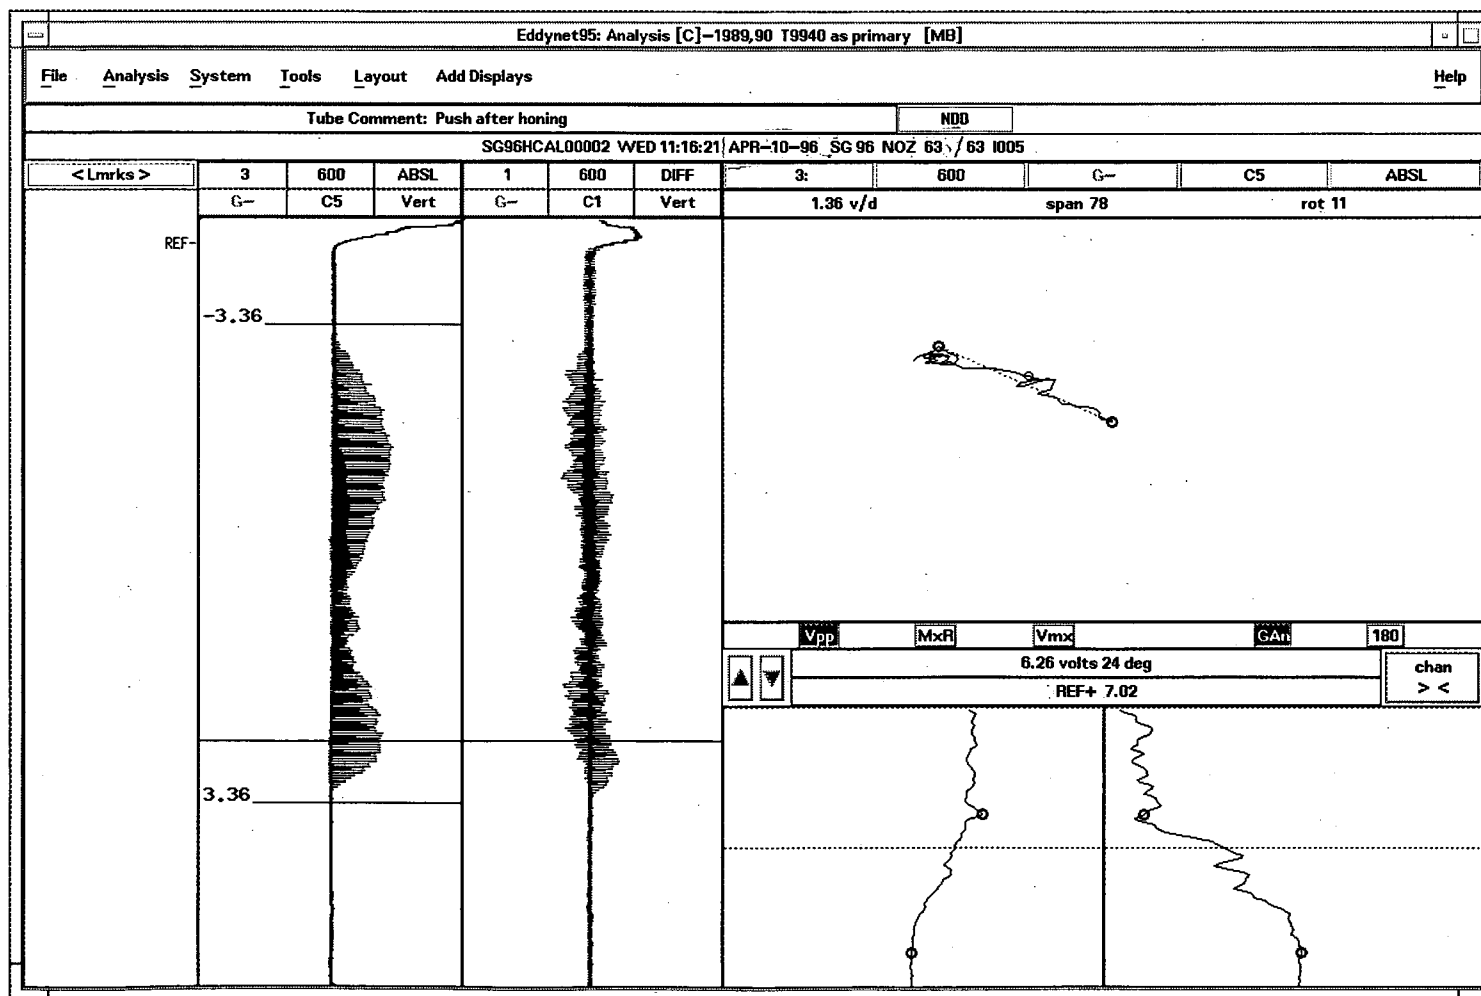
1996 Data - After Honing.

Nozzle #63 was honed for two minutes and reinspected with eddy current. No significant change in signal response was noted after honing.
