Calvert Cliffs GSI-191 Program

Chemical Effects Testing Update

Option 2b Closure Approach

August 2015

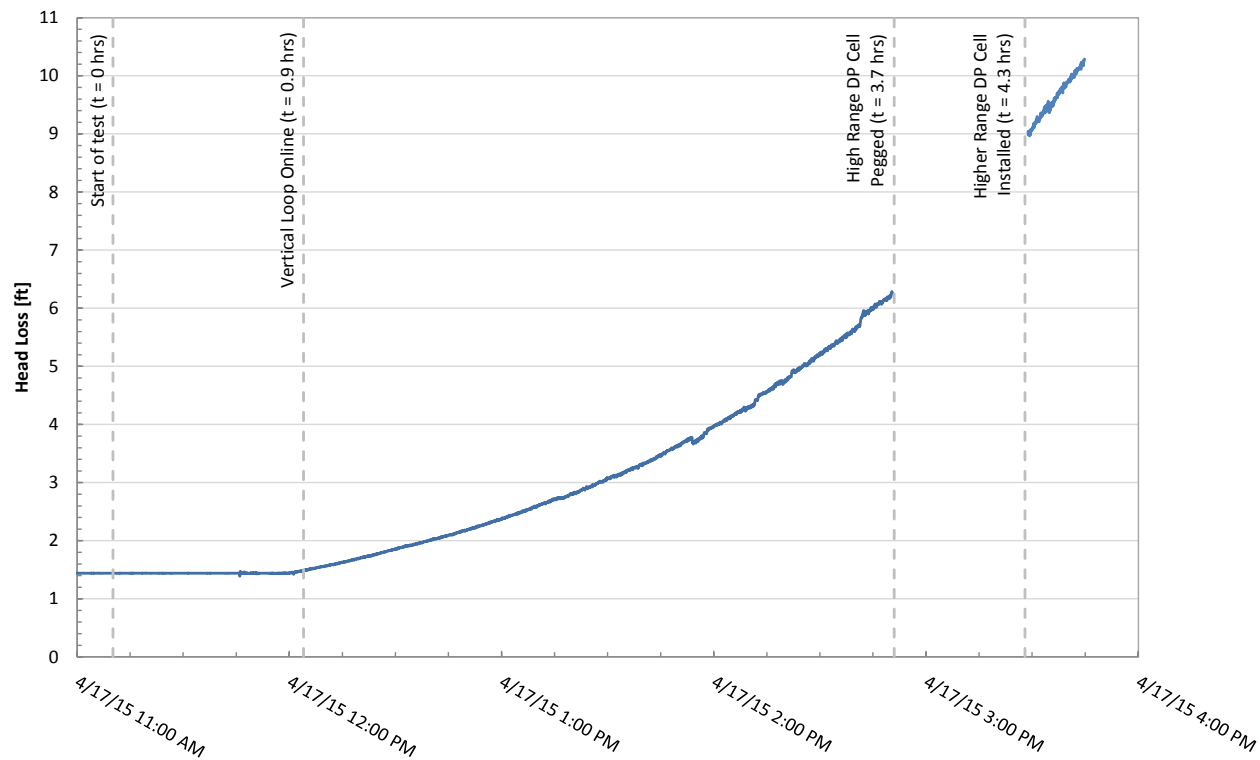
- First Integrated Test Initiated April 17, 2015
- Detector Bed Head Loss Immediately Started Increasing
- Head loss increased until the test was terminated
 - Started at 1.44 ft
 - Test terminated at 10.25 ft, and rising
- Test lasted approximately 4.6 hrs

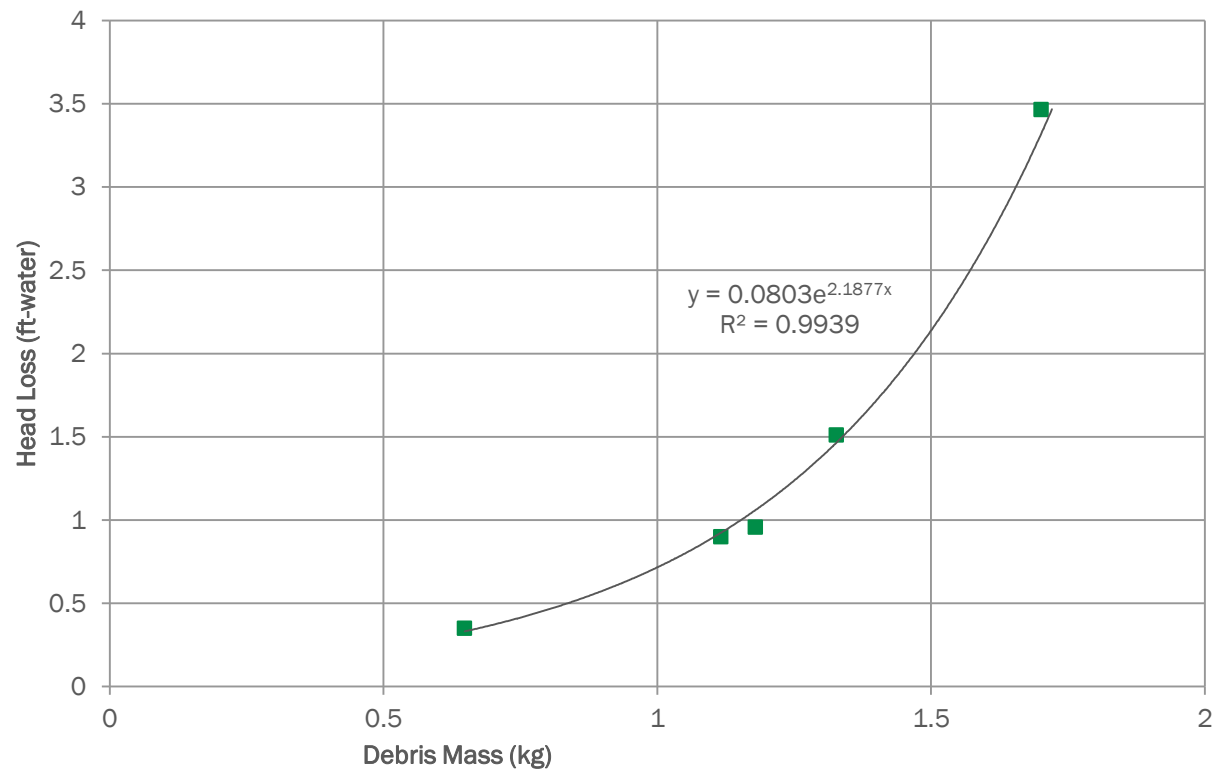
Head Loss Data - Test Data + Clean Screen

- Plot of Head Loss –vs- Fiber Mass produces well correlated curve fit
- Plot includes clean strainer head loss
