# **NRC/Industry Meeting Regarding Tube-to- Tubesheet Weld and Divider Plate Cracking Report**

Helen Cothron, Manager  
EPRI Steam Generator Management  
Program

Richard Smith, Sr. Associate  
Structural Integrity Associates

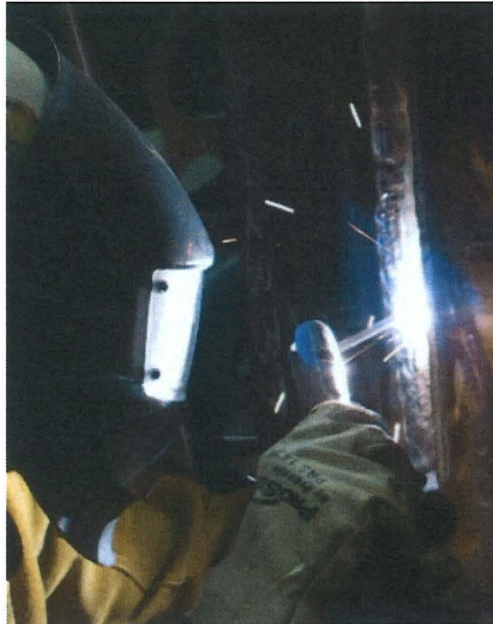
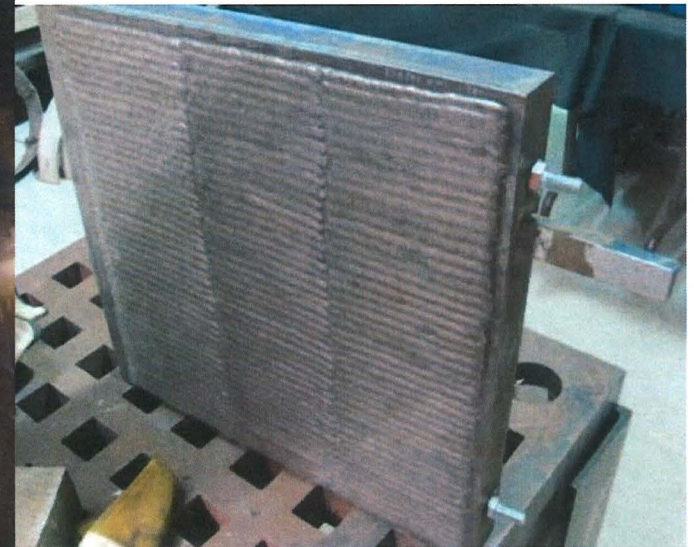
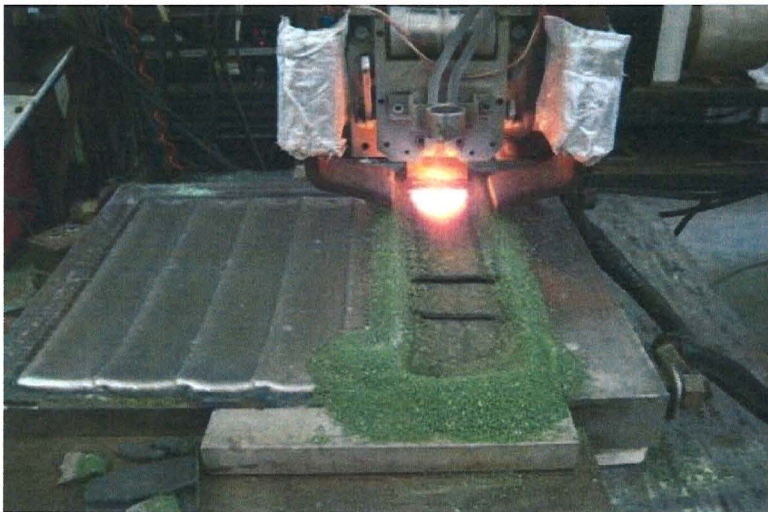
# Fabrication of the Mockup

SGMP developed prototypical tube-to-tubesheet mockups to analyze chromium levels in the tube-to-tubesheet welds

82 - Electroslag Welding (ESW)  
Strip cladding

182 Shielded Metal Arc Welding (SMAW) process

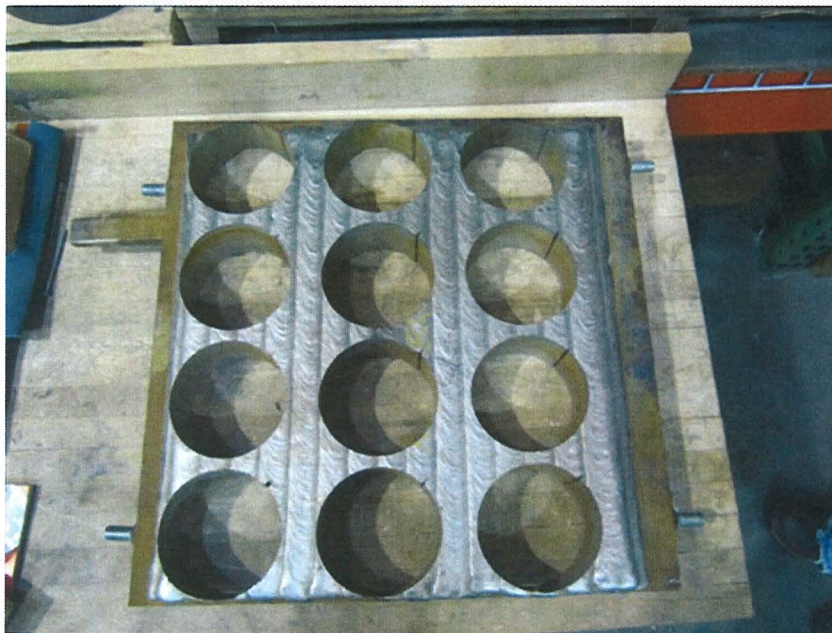
- The mockup was designed as a 3 X 4 tube-to-tubesheet matrix having 82 cladding on one side and 182 cladding on the other side
- An Alloy 690 tube was inserted into each drilled cylinder, positioned flush with each end, and welded autogenously using the Liburdi Dimetric P-Head autogenous GTAW welder (see next slide).

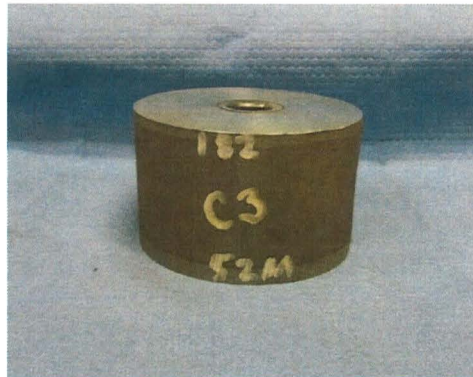
- Plugs were removed from the tubesheet, cross sectioned, and weld dilution was evaluated
- It had been estimated that the weld dilution would be 50% from the tube material and 50% from the cladding material since the weld is autogenous GTAW

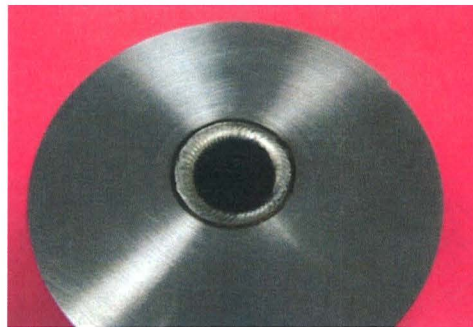
40 cross-sections  
were available for 82  
welds and 34 for 182  
welds to include in  
the tube-to-tubesheet  
weld dilution  
distributions
