SUBJECT: OBSERVATIONAL SITE VISIT AT SPOOK DISPOSAL SITE

Report: WM-00072/15-001

Facility: Spook Disposal Site

NRC Trip Report

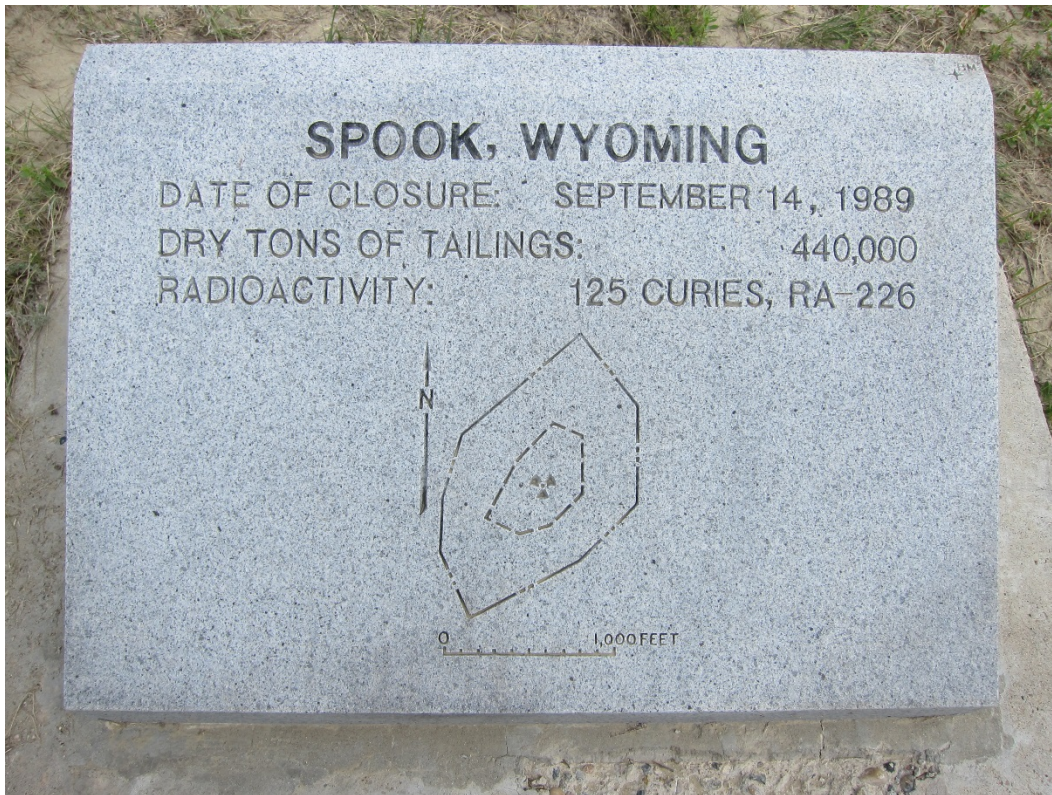
Figure 1: Spook disposal site marker

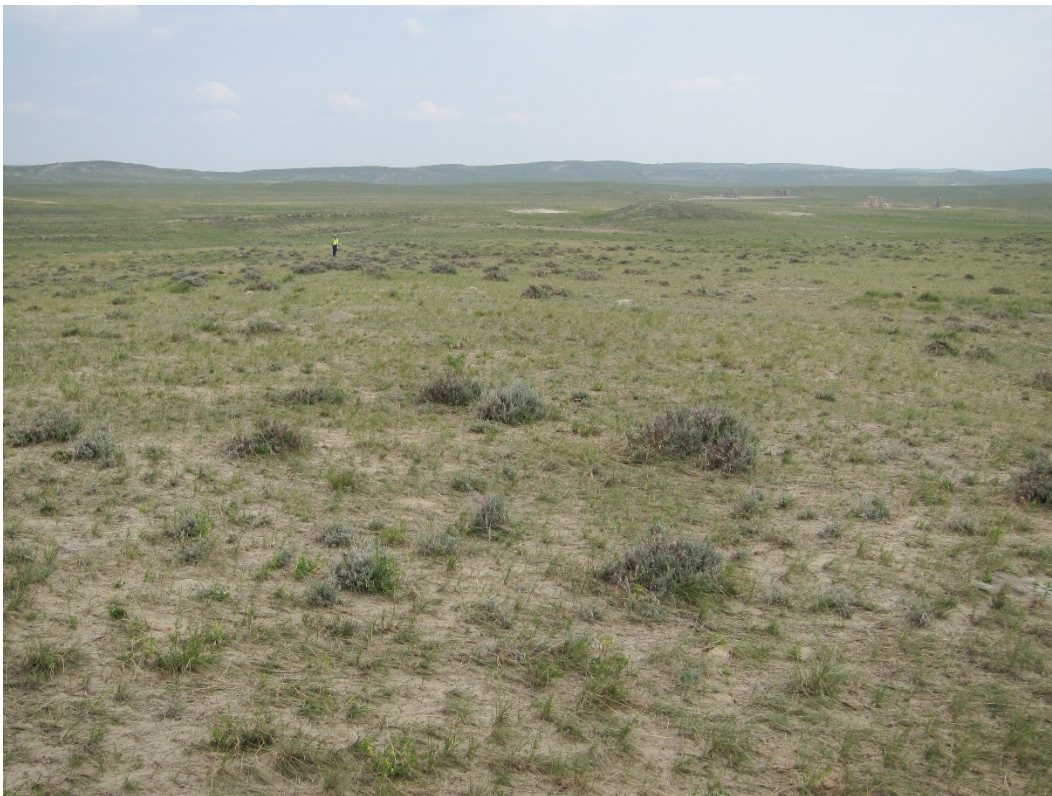
The NRC inspector observed that the surface of the disposal cell and surrounding areas appeared to be in excellent condition. No erosion or slumping was observed on or around the area of the underground cell. Vegetation appeared indistinguishable from the surrounding areas. Stable surface erosion (gullies) existed in an area northeast of the disposal site, but these features did not have an observable impact on the disposal site itself. Oil and gas development and operations continued in areas around the site, but there were no operations immediately adjacent to the site.

Figure 2: Spook disposal site, as seen from southwest corner looking northeast

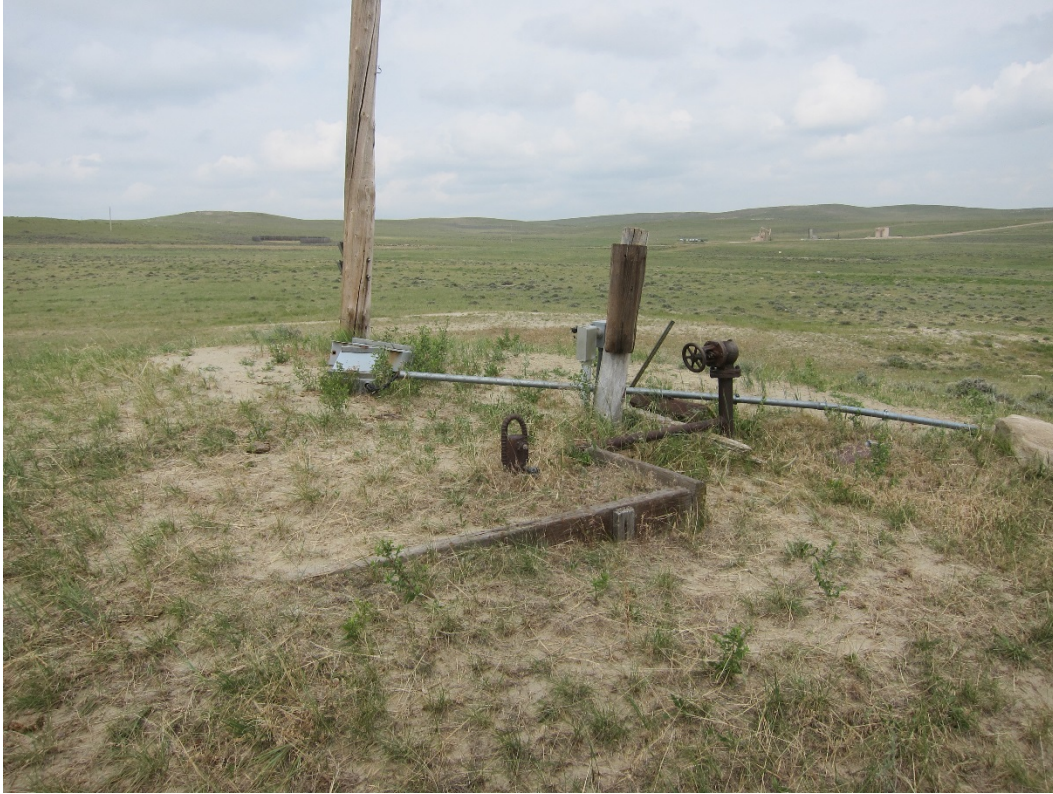
The checklist includes a requirement to review the status of a water supply well adjacent to the property. The DOE's 2014 inspection report noted that the well was not in service, and the controls for the well had been destroyed. The NRC inspector noted that the water supply well, designated as Spook #1, was not in service during the 2015 inspection and appeared to be inoperable. The power supply and controls for pump operation were not connected to the pump.

The NRC inspector also noted that the area of the water supply well, located adjacent to the disposal site, measured between 80-150 $\mu\text{R/hr}$. After discussing this finding with DOE staff, the NRC inspector concluded that the elevated measurements were most likely the result of residual naturally occurring radioactive material that was brought to the surface during the drilling of the well.

Figure 3: Abandoned well; Spook disposal cell in background (looking west-northwest)

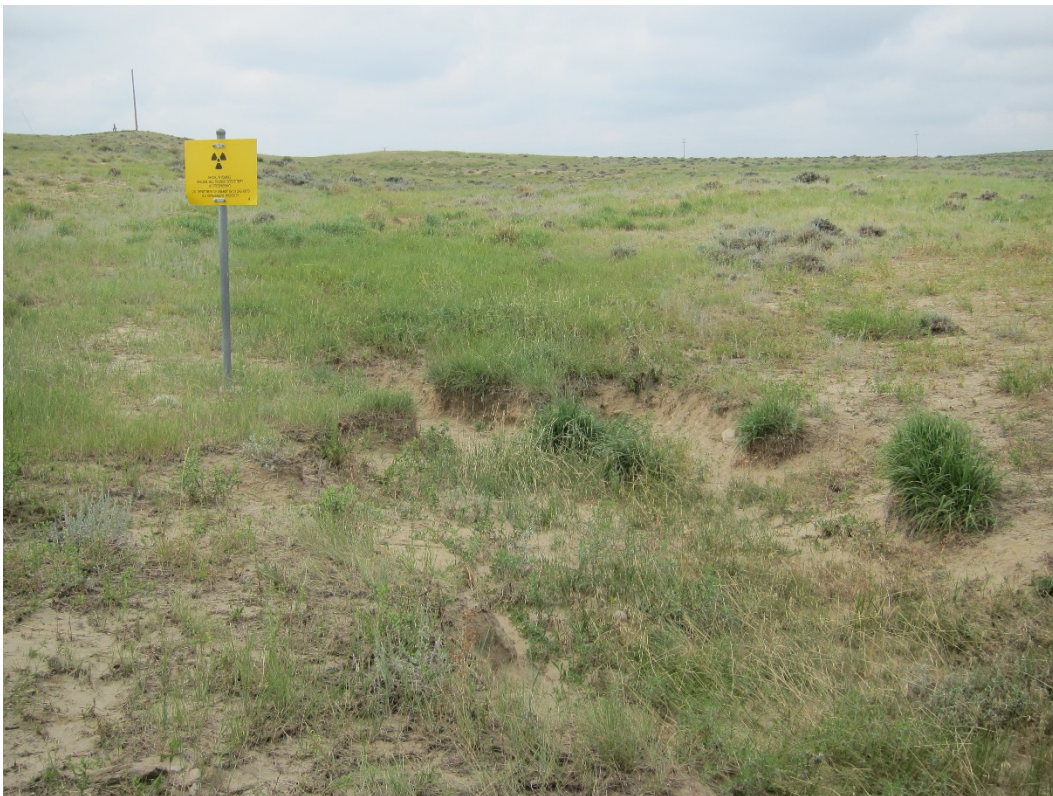
Figure 4: Perimeter sign P4 adjacent to stable erosion gully (looking southwest)
