SUBJECT: OBSERVATIONAL SITE VISIT AT GUNNISON DISPOSAL SITE

Report: WM-00061/15-001

Facility: Gunnison Disposal Site

NRC Trip Report

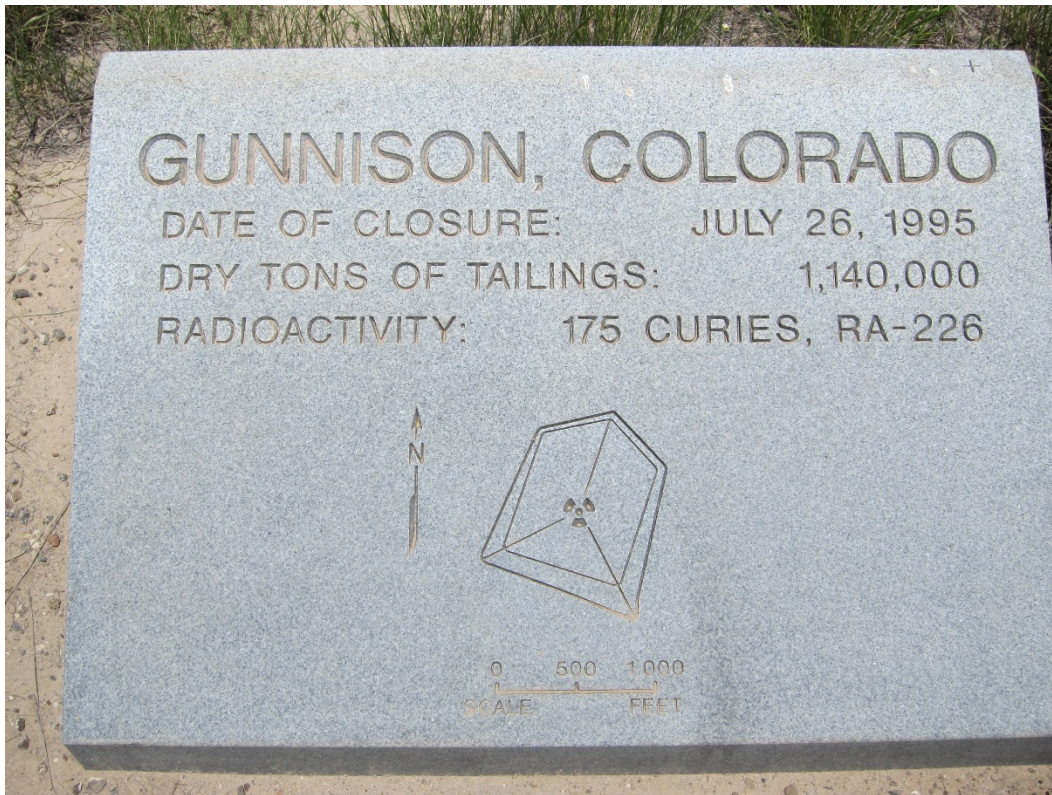
Figure 1: Gunnison disposal site marker

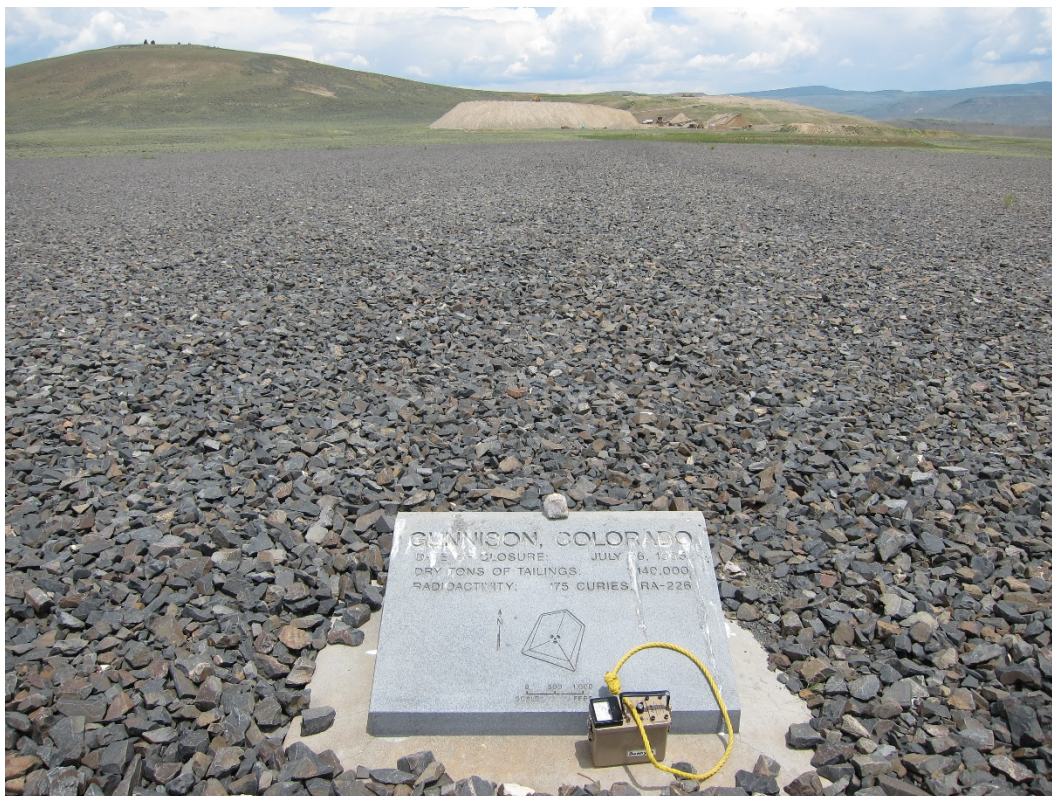
The inspector observed that the disposal cell and surrounding areas appeared to be in excellent condition. No erosion or slumping was observed on or around the cell. Although minor amounts of vegetation was observed on the cell cover and apron, there were no large trees growing on top of the cell.

Figure 2: Top of disposal cell looking north (public landfill in background)

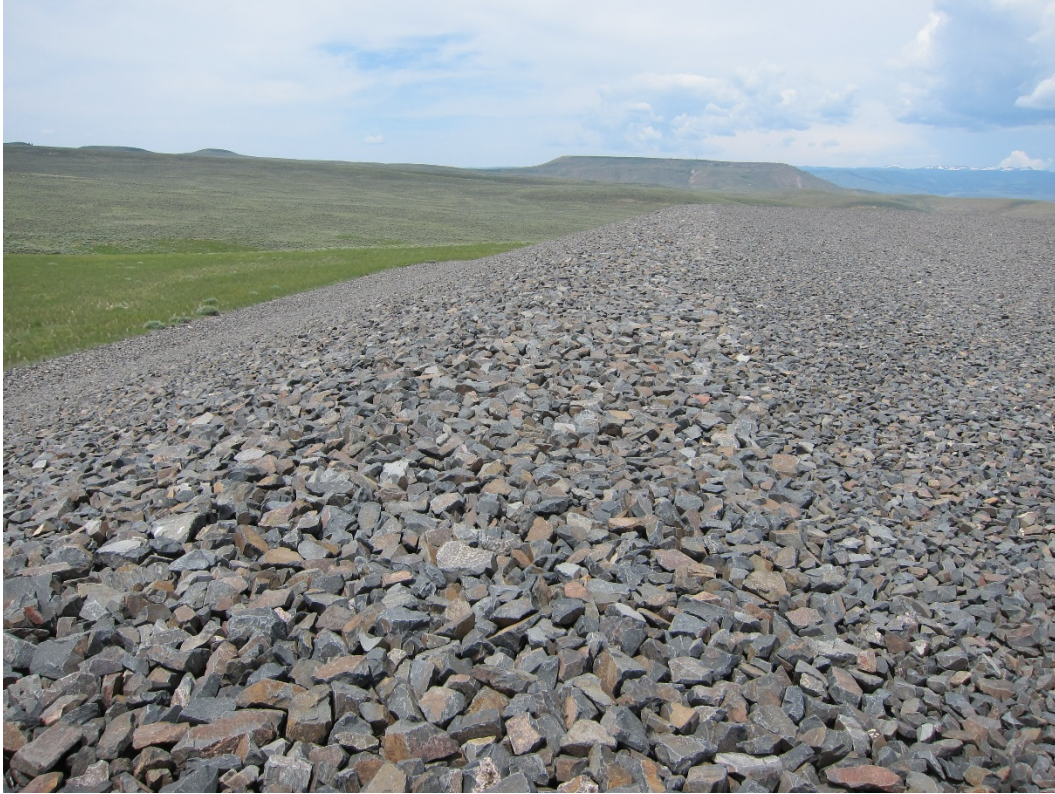
Figure 3: Southwestern edge of cell; note change in rock size from side slope to top

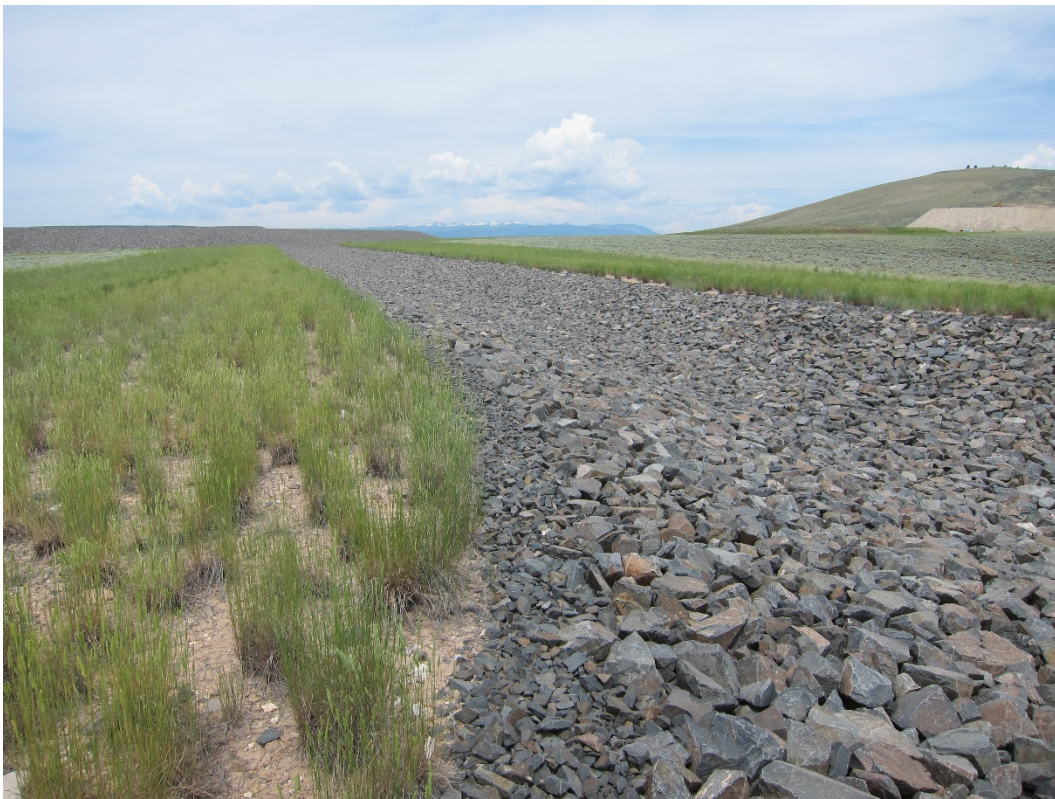
Figure 4: East diversion channel (looking northwest towards cell)

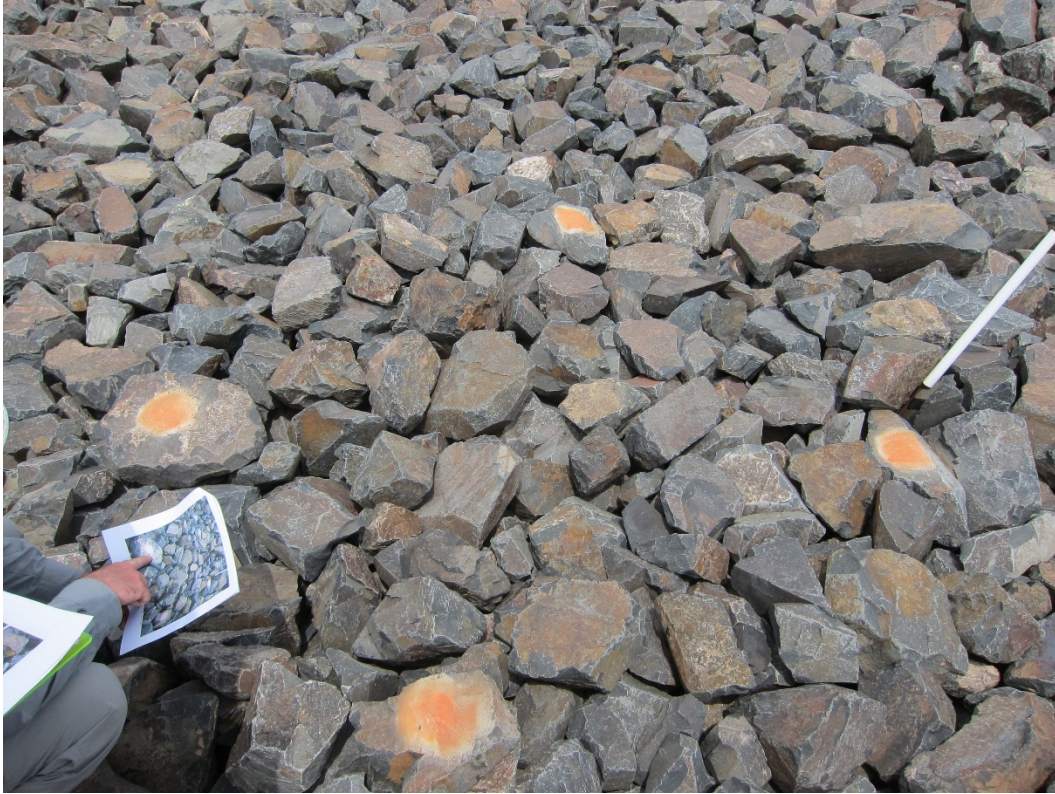
The second site-specific concern was the freeze-thaw effects on the erosion protection rock material. In response, the DOE staff created six test plots that are visually inspected on an annual basis for indications of rock degradation. The DOE inspectors compared the current status of the rock in the six 1-square meter test plots to photographs taken in 2012. During the 2014 inspection, the DOE staff did not identify any evidence that individual rocks had split or otherwise had degraded. The 2015 inspection findings did not deviate significantly from 2014 inspection findings. As discussed in Section 3.4 of the LTSP, the final set of photographs will be taken at the six test plots during the 2017 inspection. The need for special surveillances will be re-evaluated at that time.

Figure 5: DOE inspection of rip-rap Test Area 5 in east diversion channel

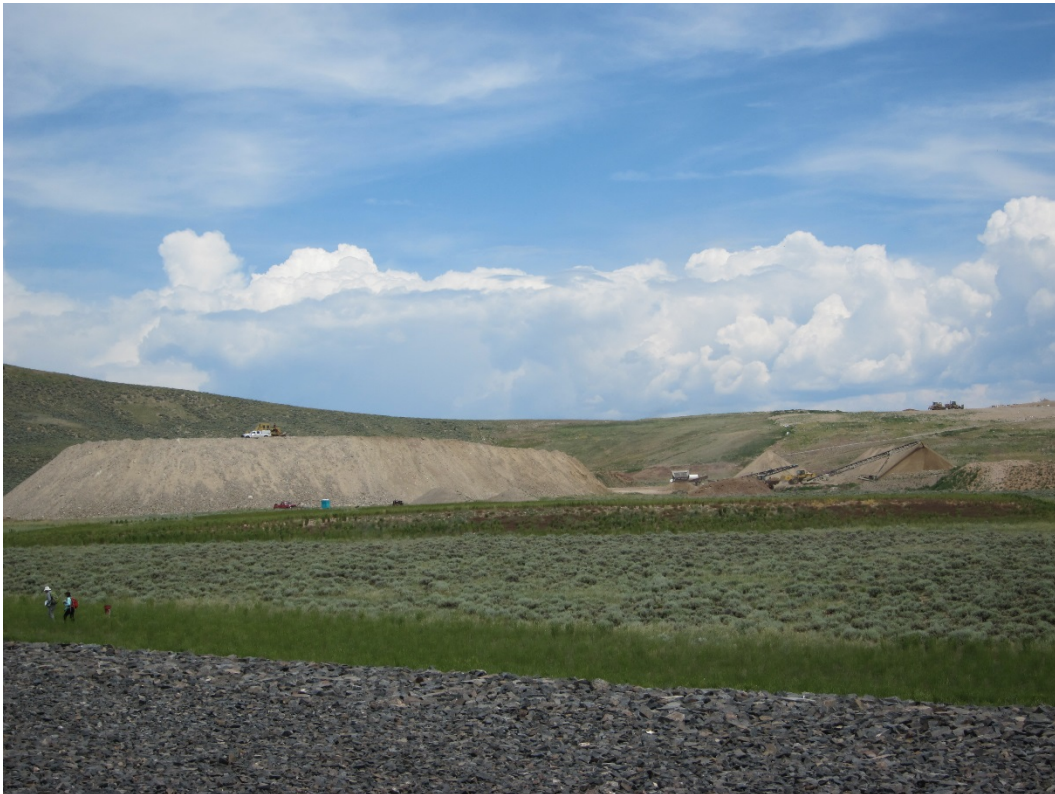
The LTSP requires the DOE inspectors to observe two site-specific concerns. The first concern is the potential for onsite impacts from the Gunnison County landfill, located about 1,200-feet north of the site. At the time of the site inspection, the landfill was in service, but landfill activities did not appear to have an impact on the disposal site.

Figure 6: County landfill north of disposal cell, as seen from the disposal cell
