# Savannah River Remediation Tank Closure Grout Assessment Final Report

Project Number: 205539

Contract Number: SRRA051386

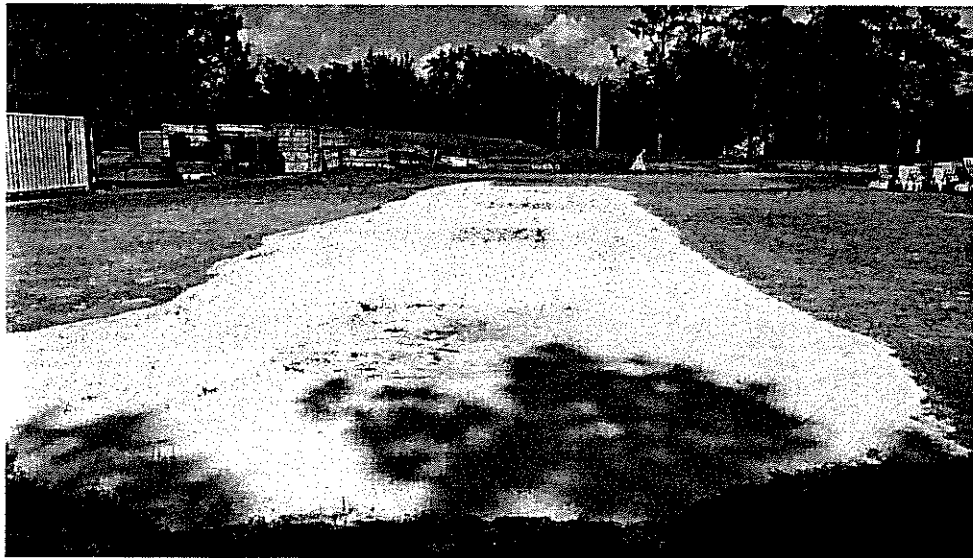
Figure 2 – Buildup of sand around impact plates

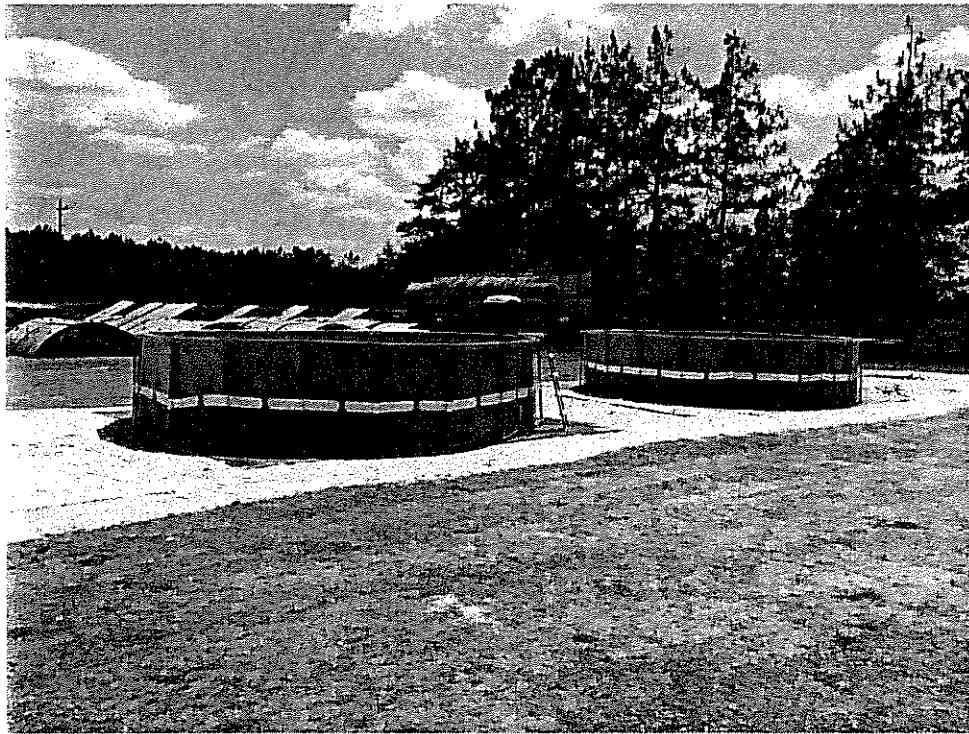
Figure 3 – Containment structures erected over impact plates

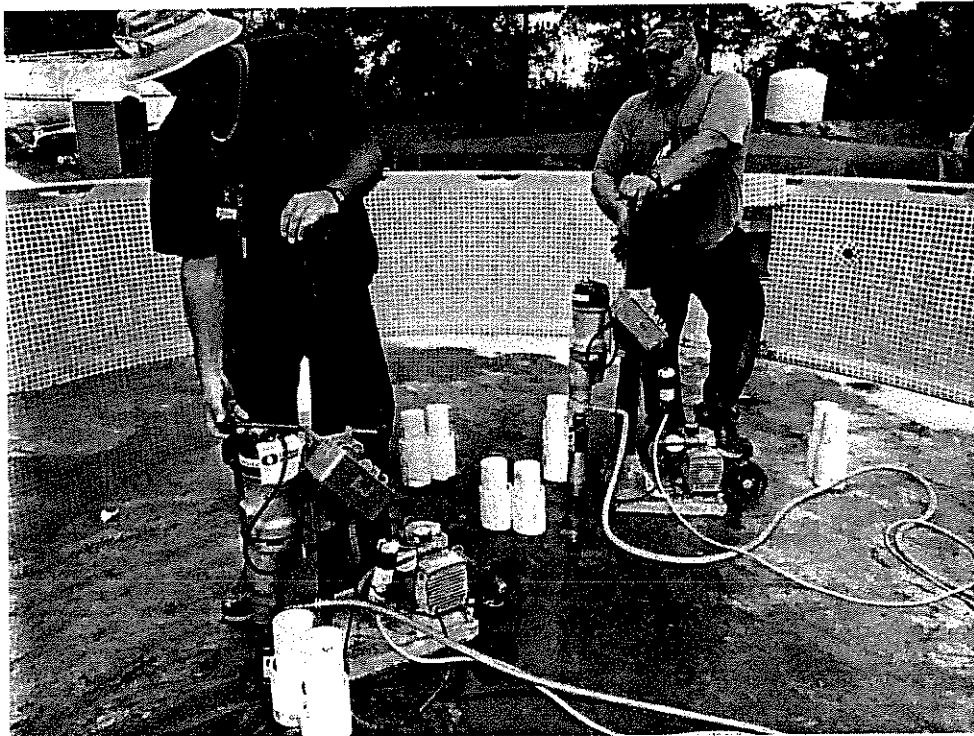
Figure 19 - Core drilling of the cured grout to collect samples

Samples from the containment areas were collected using a 3" core drilling machine. Figure 19 shows the core drilling during the collection of samples for Test 2.

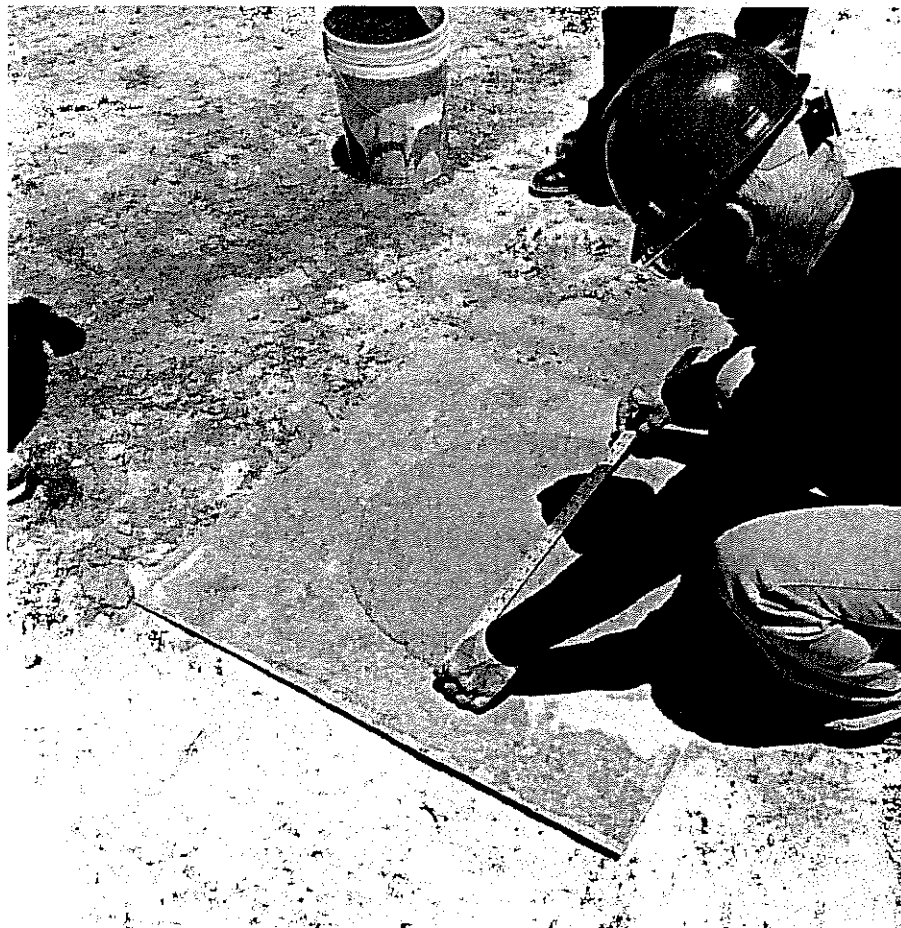
Figure 23 - Slump flow measurement being performed by ES personnel

Prior to the start of each test, the slump flow of the grout from the cement truck mixer was determined in accordance with ASTM C1611. Figure 23 shows the slump measurement being performed for one of the tests. The slump flow measurements for each test are provided in Table 6. All measurements were within the 26 – 30 inch slump as required in the grout specification [3].

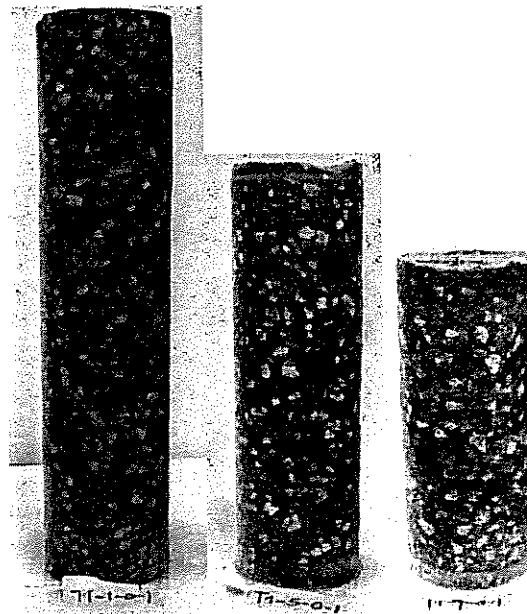
Figure 32 - Core Samples from Test 1 (1 foot radius sample at left and 9 foot radius sample on right)

Figure 32 – Figure 34 show photographs of the cylindrical samples for image analysis before being sawed into halves. The core samples from Test 1 show relatively uniform distribution of aggregate within the sample, although there appears to be a slight decrease in aggregate at the top of T1-9-O-1 (sample collected at the 9 foot radius position). Test 2 samples show clear segregation of the samples as the distance increase from the center of the containment area. Lack of aggregate in the top of samples T2-5-O-1 (5 foot radius sample) and T2-9-O-1 (9 foot radius sample) is consistent with the visual observations seen during the test. The fine material within the grout immediately mixed with the water and floated out towards the containment area walls. After the pour was completed, the fine material then settled on top of the grout resulting in the upper portion of the samples containing no aggregate. Samples from Test 3B are similar to Test 1 and show a uniform distribution of aggregate within all of the samples.

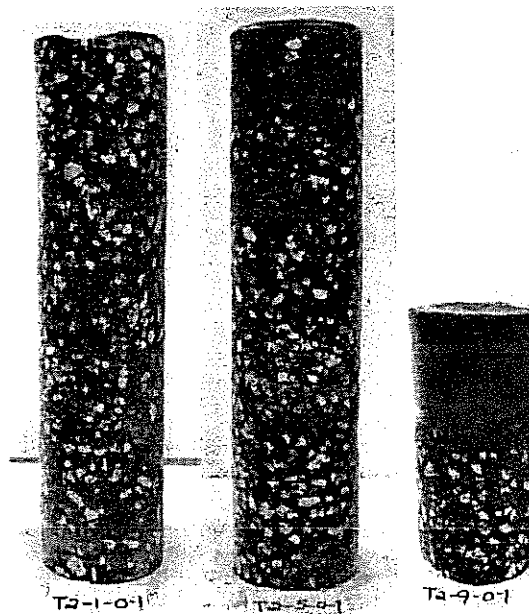
Figure 33 - Core samples from Test 2 (1 foot radius sample at left and 9 foot radius samples on right)

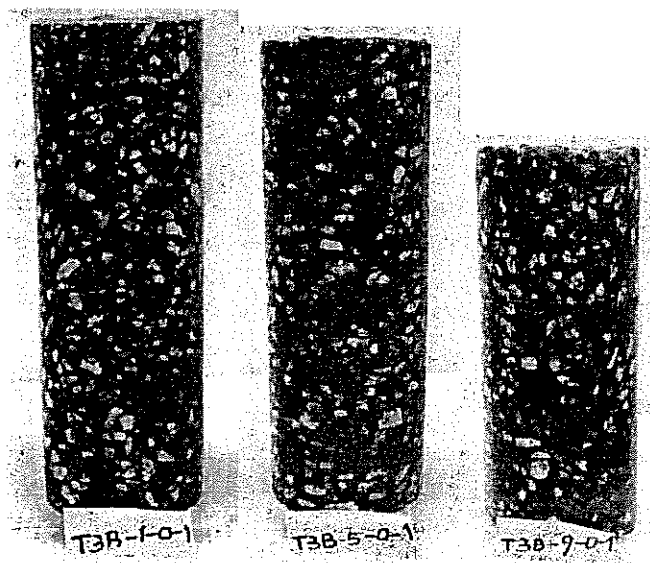
Figure 34 - Core samples from Test 3B (1 foot radius sample at left and 9 foot radius sample on right)
