STRESS CORROSION CRACKING OF A 52M WELD OVERLAY IN A PWR ENVIRONMENT^{1,2}

Bogdan Alexandreanu, Yiren Chen, Ken Natesan and Bill Shack

Argonne National Laboratory
Argonne, IL 60439 USA

June 2015

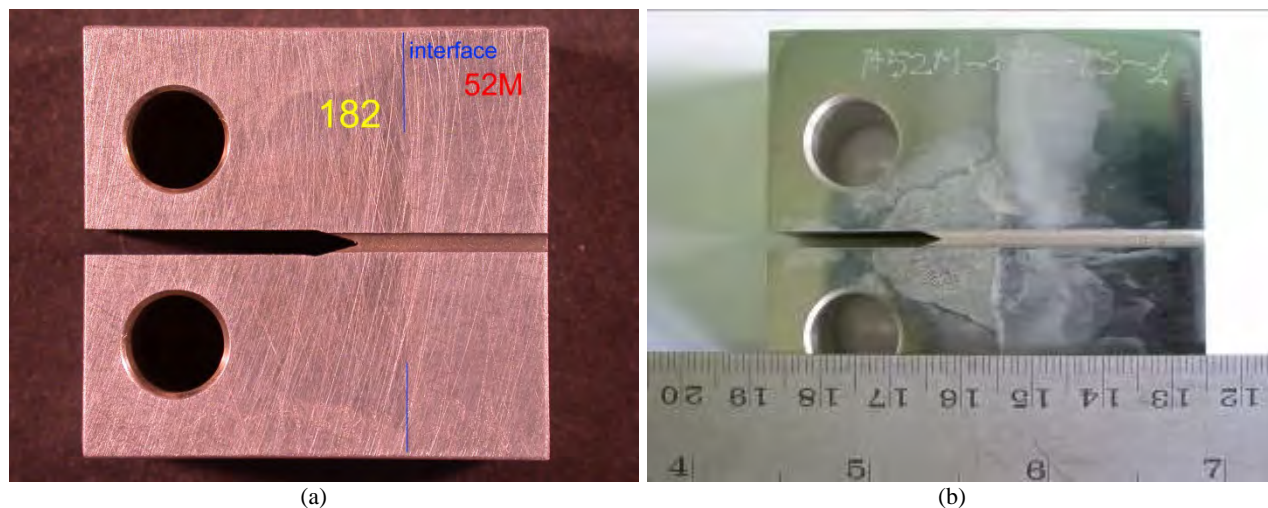
Figure 1. Photographs of the Alloy 52M-182 WOL specimens tested in the TS orientation.

Both tests in the TS orientation have shown that the SCC behavior at the Alloy 182-52M interface is complex. On the one hand, cracking along the interface, in a direction normal to the original direction of propagation (i.e., ST) was severe (Fig. 2). On the other hand, cracking was found to propagate directly (along the initial plane of propagation, TS) in a finger-like manner – consistent with SCC - into Alloy 52M. Specifically, SCC cracking was found to penetrate into Alloy 52M over 40% of interface, and in one instance, cracking was observed to extend for 2.5 mm into Alloy 52M (Fig. 3), yielding a maximum SCC CGR of 2×10^{-10} m/s (a conservative estimate for K in this case is 34 MPa m^{1/2}).

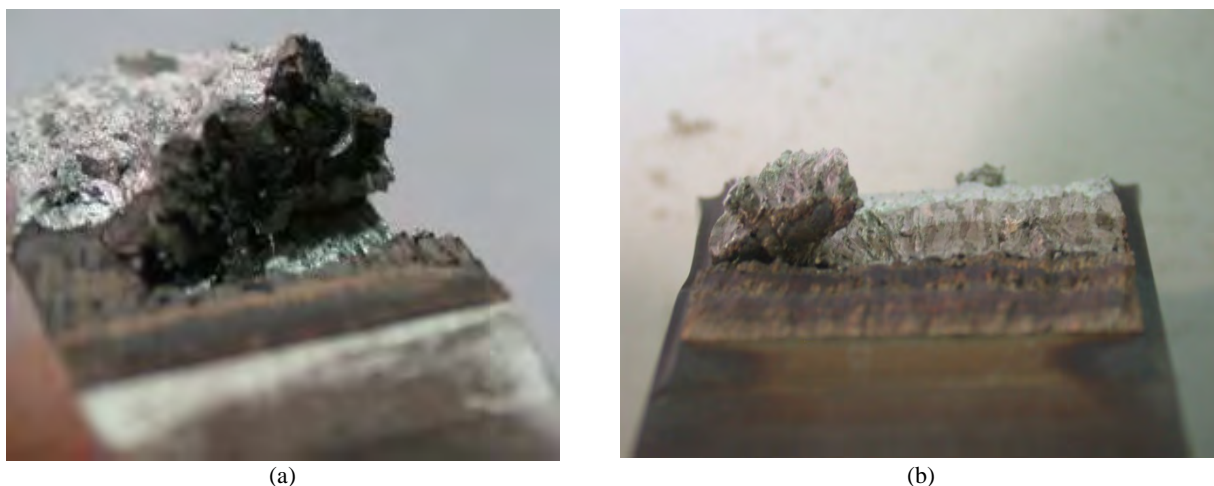
Figure 2. Fractured specimens (a) A52M-182-TS-3, and (b) A52M-182-TS-1. Note the severity of cracking along the interface and into Alloy 52M.

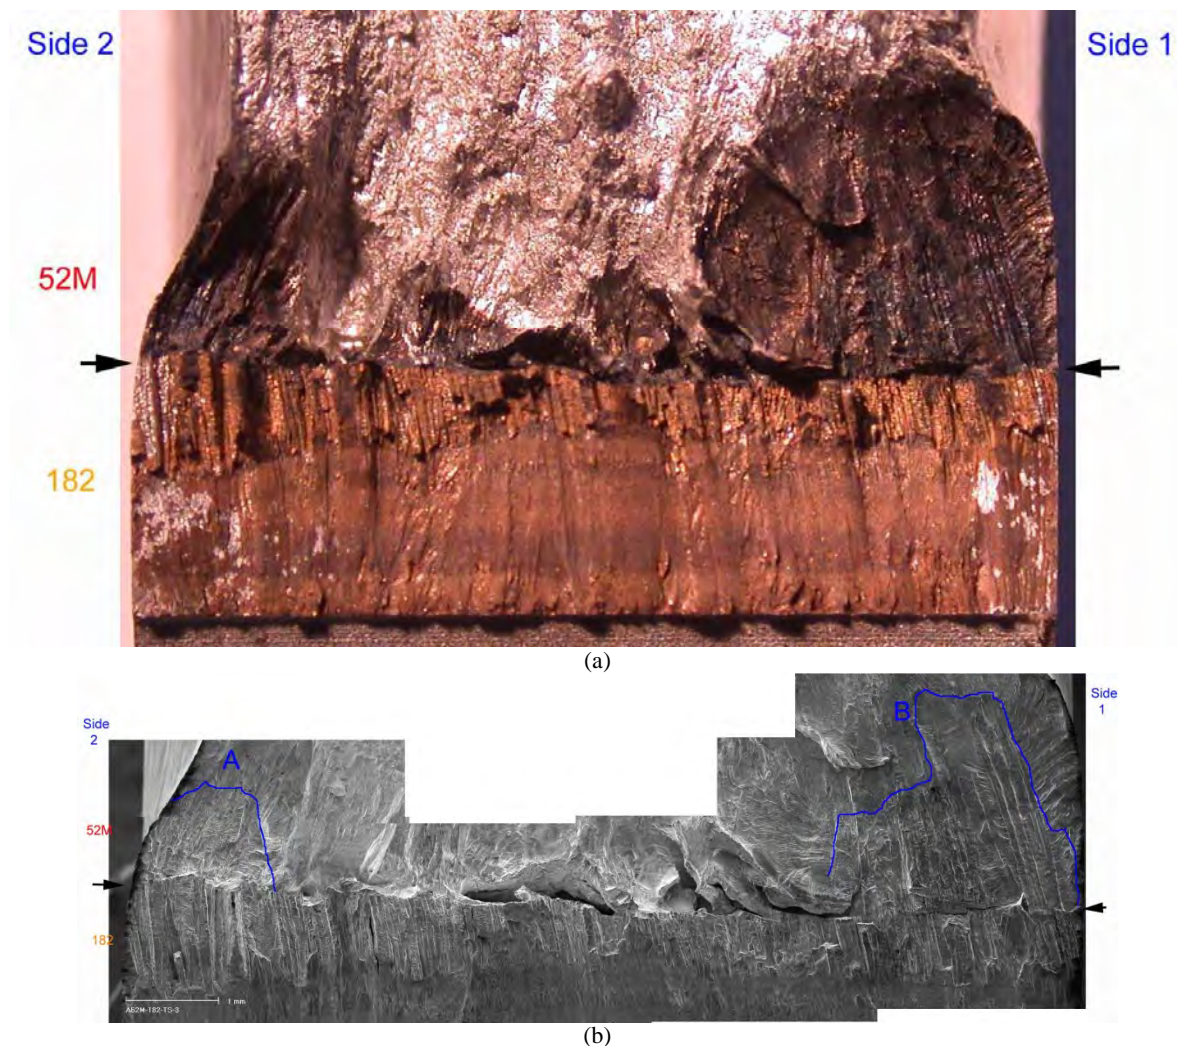
Figure 3. Fracture surface of Specimen A52M-182-TS-3: (a) photograph, and (b) SEM micrograph. The maximum crack length in area B is 2.5 mm, yielding an estimated maximum SCC CGR of 2×10^{-10} m/s. The black arrows indicate the interface between the two welds. Crack propagation is from bottom to top.

In summary, severe cracking was observed along the interface between the two welds as well as in Alloy 52M near the interface in the TS-oriented specimens. As such, SCC CGR testing was next undertaken along those planes with the objective of measuring the SCC CGRs directly. This paper presents two tests conducted on specimens in the ST orientation (Fig. 4). In both specimens, the test plane was tilted approx. 15° with respect to the Alloy 52M-182 interface. In one case, the crack is growing from Alloy 182 towards the interface with Alloy 52M. In the second case, the crack is initiated in Alloy 52M and grows towards the interface with Alloy 182.

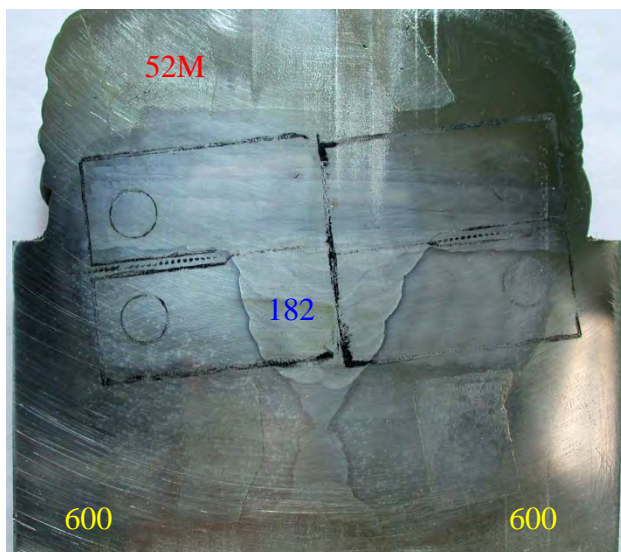
Figure 4. (a) Specimens for SCC CGR testing of Alloy 52M-182 WOL in the ST orientation.

As a result of the severe cracking observed along the interface between the two welds as well as in Alloy 52M near the interface in the TS-oriented specimens, SCC CGR testing was next undertaken along those SCC-susceptible planes. As such, two tests were conducted on specimens in the ST orientation (Fig. 4). In both ST specimens, the test plane was tilted approx. 15° with respect to the interface.

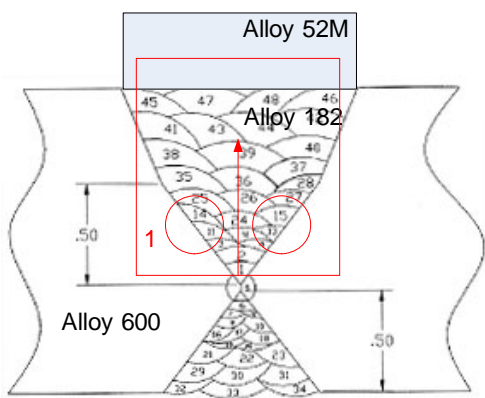
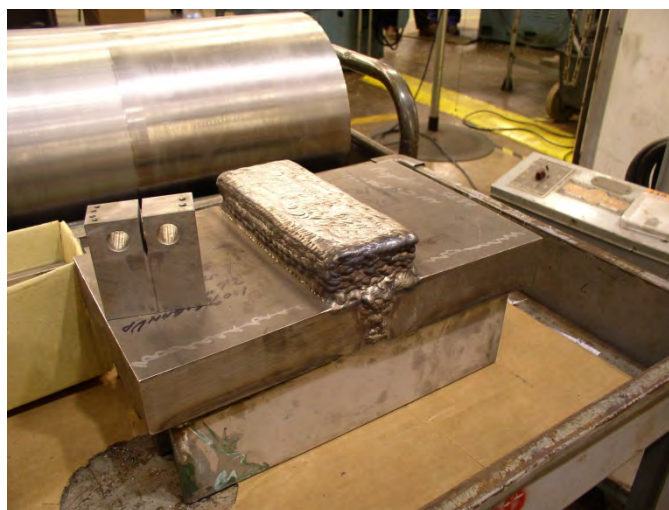
Figure 5. (a) Conceptual schematic, and (b) photograph of the resulting Alloy 52M-182 weld overlay. The continuous welded restraints used during the Alloy 52M WOL deposition are visible in the photograph.

The Alloy 52M WOL was produced at ANL Central Shops using prototypical welding parameters. The Alloy 52M deposit was made with 1/8"-dia. wire, current 158-160A, voltage 16V, travel speed 3.5-4 in./min, 99.99% Ar shield gas 22-26 CFH, oscillation approx. 1/4, weave approx. 1/4. The bead was 0.562" wide, and the crown height above base metal was 1/16".

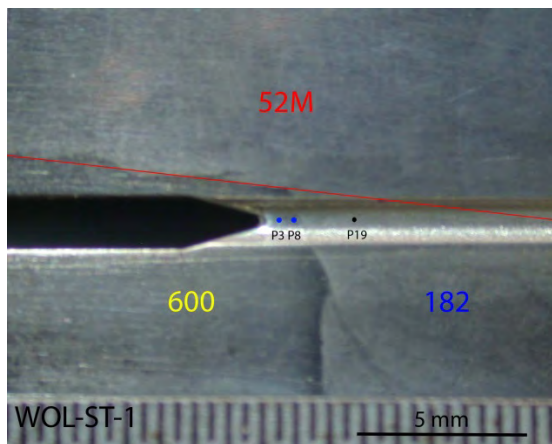
Figure 6. Notch area in specimen WOL-ST-1. The red line shows the Alloy 52M WOL interface.

The objective of this test was to measure the SCC CGR along the interface between the Alloy 52M WOL and Alloy 182. In this specimen (Fig. 6), the crack was initiated in Alloy 600, was expected to reach the Alloy 182 weld after approx. 1 mm, and then was advanced in Alloy 182 until it reached the Alloy 52M/182 interface. At that point, the specimen was set at constant load to measure the SCC CGR along the interface. The fatigue behaviors of Alloys 600 and 182 are well-known, and were used to manage the test. The testing conditions and CGR responses are given in Table 1.

The specific configuration of Specimen WOL-ST-1 (Fig. 6) also offered an opportunity to assess the cyclic and SCC behavior in Alloy 600 HAZ from the Alloy 182 weld. As such, two sets of cyclic and SCC measurements were conducted in the Alloy 600 HAZ. The SCC CGR was first evaluated in test period 3 at approx. 0.7-0.65 mm from the Alloy 182 weld interface. Next, the crack was advanced for approx. 0.45 mm, and the SCC CGR was evaluated again in a region 0.2-0.1 mm from the interface in test period 8.

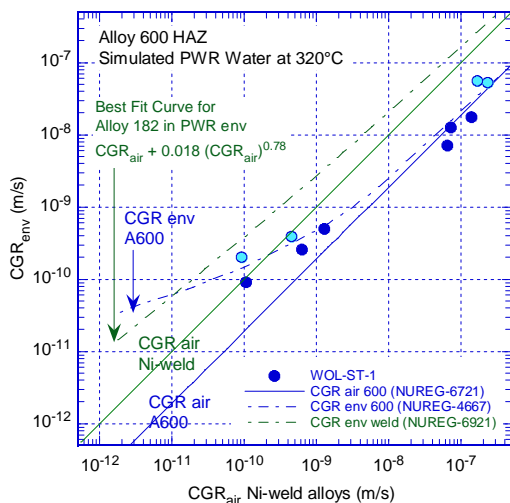
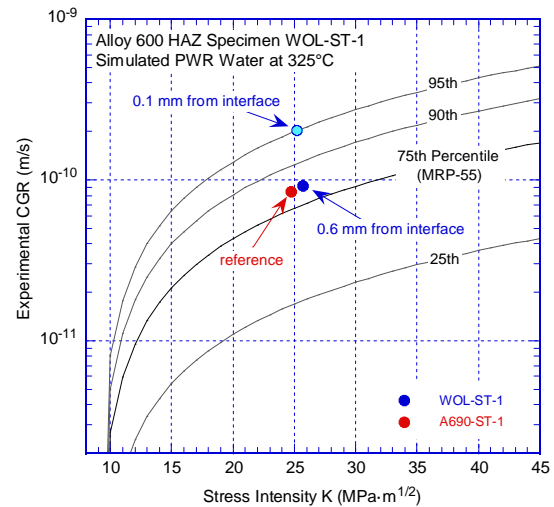
Figure 7. (a) Cyclic CGR data for the Alloy 600 (HAZ) region of specimen WOL-ST-1 in simulated PWR environment; (b) SCC CGR data for the Alloy 600 (HAZ) region of specimen WOL-ST-1 and MRP-55 disposition curve for Alloy 600.⁴

Figure 7 summarizes the cyclic and SCC CGRs measured in the Alloy 600 HAZ region of specimen WOL-ST-1. Figure 7a shows the measured cyclic CGR data vs. the expected CGRs in air under the same loading conditions, and for comparison, the expected curves in air and environment for Alloy 600 (blue) and Ni-base weld (green) are included in the figure. As expected, the cyclic CGRs measured in this stage of the test are consistent with the known response of Alloy 600. The data obtained prior to the first test period at constant load (3, dark blue symbols) seem lower than the data obtained prior to the second test period at constant load (8, light blue symbols). The comparison shown in Fig. 7a seems to suggest that the cyclic CGRs of the HAZ increase as the crack approaches the Alloy 182 weld interface. Figure 7b shows the SCC CGRs measured for Alloy 600 HAZ in test periods 3 (dark blue symbol) and 8 (light blue

symbol), and these also increase as the crack approaches the fusion line. As such, Fig. 7 suggests that both cyclic and SCC CGRs appear to increase as the crack advances towards the interface. However, Fig. 7b also includes a “reference” SCC CGR obtained from the same heat of Alloy 600 (NX 131031), tested in the same ST orientation separately. The similarity in responses between the “reference” and test period 3 (approx. 0.6 mm from the fusion line) suggests that in this case, the HAZ does not extend more than approx. 0.6 mm from the fusion line, and the effect on the SCC CGR response was approx. a factor 2.

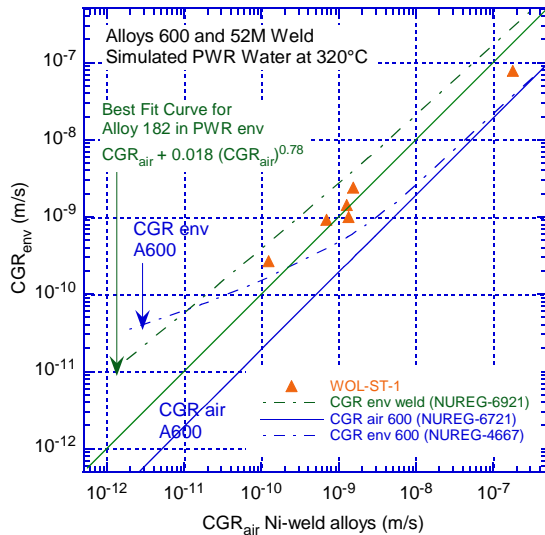
Figure 8. Cyclic CGR data for the Alloy 182 region of specimen WOL-ST-1 in simulated PWR environment.

Next, the crack was advanced in fatigue across the Alloy 600-182 interface into Alloy 182, and Fig. 8 shows the cyclic response in Alloy 182. For comparison, the expected curves in air and environment and for Alloy 600 (blue) and Ni-base weld (green) are included in the figure. The response seems lower than expected for a Ni-base weld, and this was interpreted as an off-plane advance. As such, it was assessed that the crack turned towards the interface with Alloy 52, hence, the specimen was set at constant load in what was estimated to be the vicinity of the Alloy 52M-182 interface in test period 19.

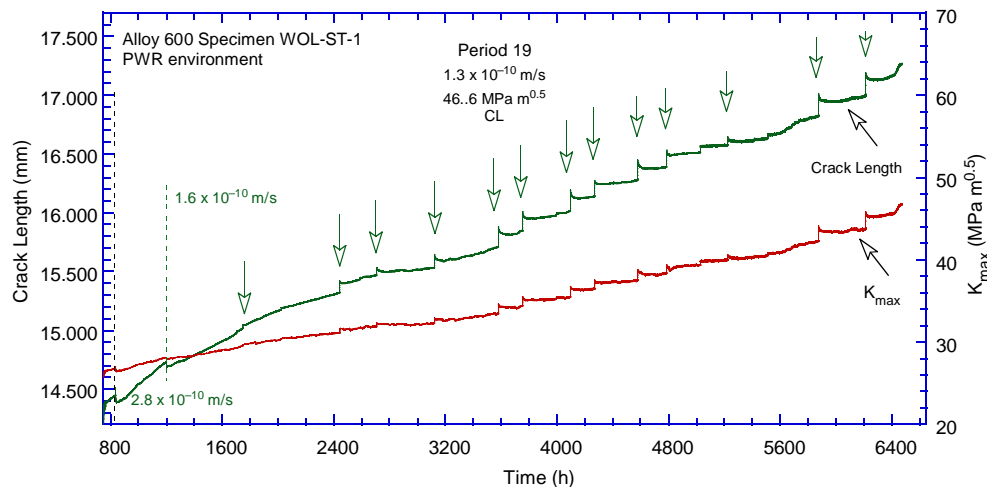
Figure 9. Crack-length-vs.-time for specimen WOL-ST-1 in simulated PWR environment during test period 19. The data were corrected by a factor 8.2 following the analysis of the fracture surface.

Figure 9 shows the SCC response of the Alloy 182-Alloy 52M interface (the data was corrected based on the fractographic information which will be presented later in this section). The initial SCC CGR of 2.8×10^{-10} m/s (up to approx. 1240h) was unexpectedly high given the orientation of the crack front with respect to the dendrites, then began to diminish and continued at the diminished rate of approx. 1.3×10^{-10} m/s for the remainder of the test. Also, small “jumps” have been observed and these are indicated by arrows in the figure. It was verified that these jumps are neither the result of some errant loading nor an electrical artifact. In fact, they are regions of fast growth (10^{-8} m/s) that occurs over short periods of time (15-20 min). The cause of the “jumps” is unknown, however, as it will be shown later in this paper, they are a signature of SCC along the interface between these two welds.

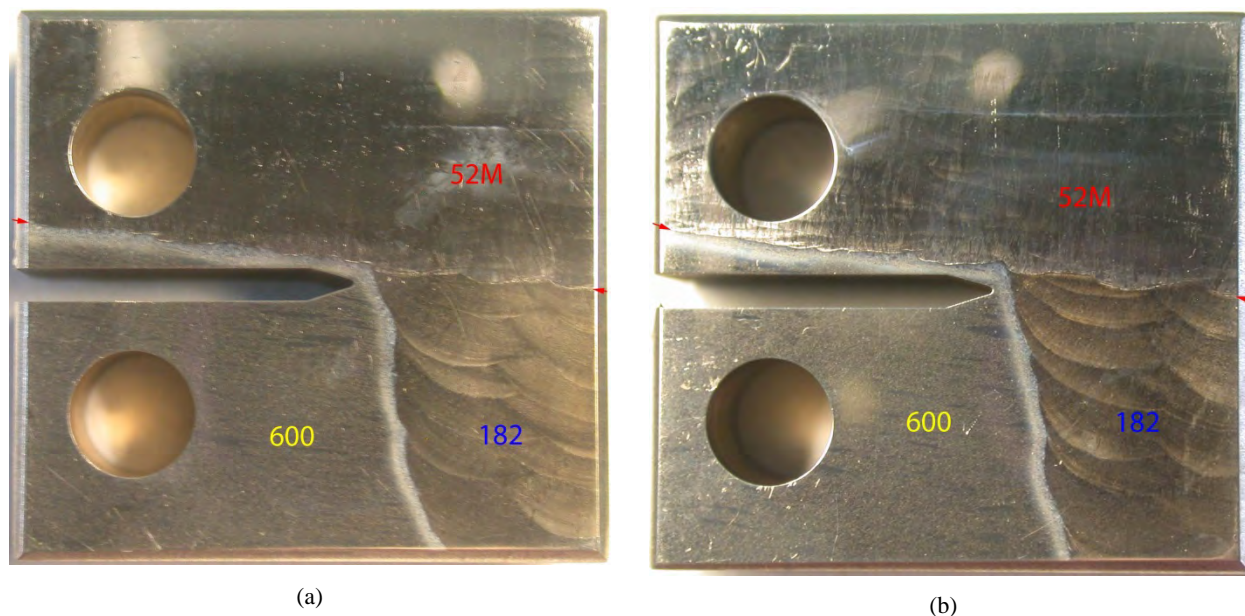
Figure 10 Post-test specimen WOL-ST-1 seen from both sides: (a) side 1, and (b) side 2. The red arrows indicate the Alloy 52M WOL interface. Crack advance is from left to right.

In order to show the side cross sections, the side surfaces were ground to eliminate the side grooves, polished and electrochemically etched in a 5% nital solution. The two side surfaces (Fig. 10) show that the test progressed largely as anticipated during the test (Fig. 6), and confirm that cracking initiated in Alloy 600, transitioned into Alloy 182 weld, and then along the Alloy 182/52M interface.

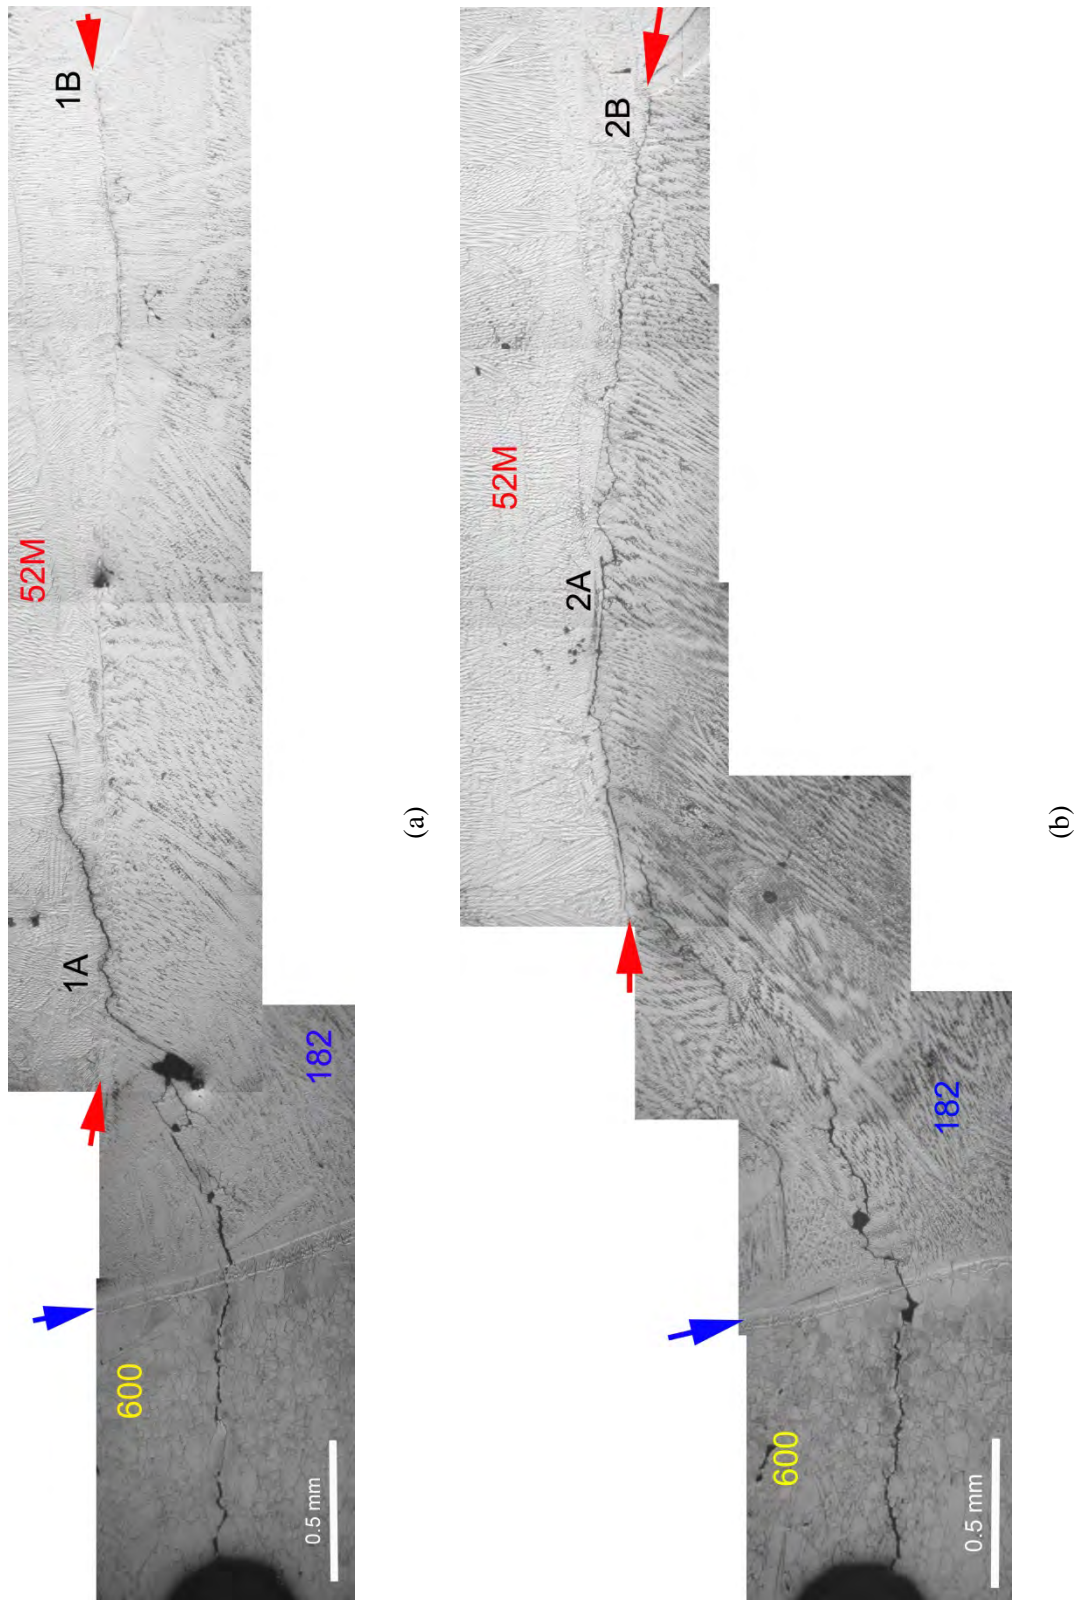
Figure 11. Cross sections of specimen WOL-ST-1: (a) side 1, and (b) side 2. Blue arrows indicate the Alloy 600/182 interface and the red arrows indicate the Alloy 182/52M interface. Crack advance is from left to right.

The two side surfaces were further examined by optical microscopy, Fig. 11. The blue arrows indicate the Alloy 600/182 interface, and the red arrows indicate the Alloy 182-52M interface. Both cross sections show that after passing through the Alloy 600-182 interface, the crack turns towards the Alloy 52M WOL interface. This off-plane cracking caused the Alloy 182 cyclic data appear less than expected, Fig. 8. The two cross sections show that the crack was driven in the vicinity of the Alloy 182-52M WOL as anticipated: on one surface (side 1), the crack under cyclic loading overshoots slightly the WOL interface, while on the second surface (side 2), the crack ends up slightly below the interface. Overall, the two images shown in Fig. 11 demonstrate that the specimen was set at constant load in the vicinity of the Alloy 182-52M WOL interface, and, hence, test period 19 represents cracking along the interface.

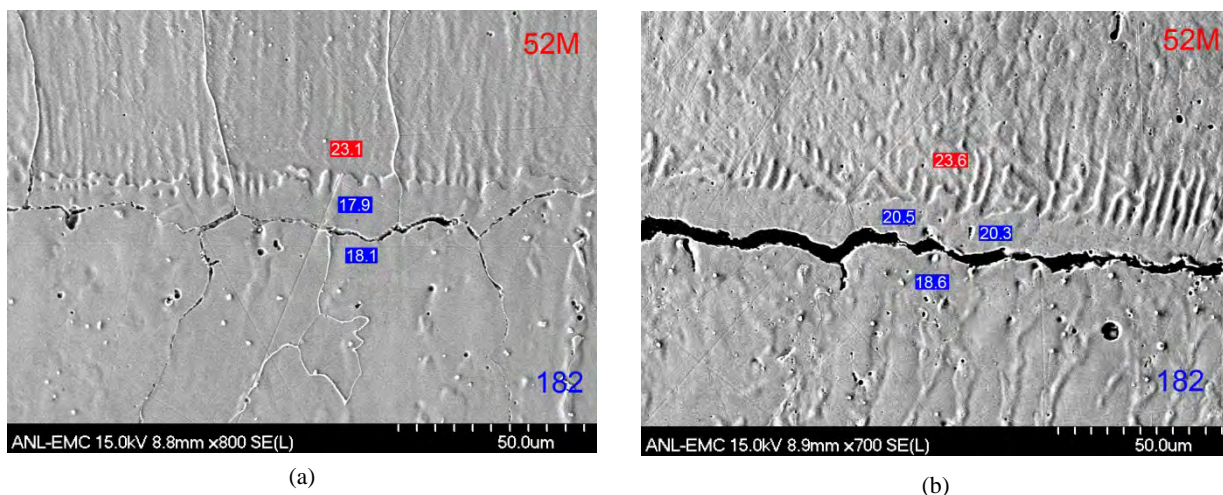
Figure 12 Micrographs on the cross section of specimen WOL-ST-1 on (a) side 1 taken at location 1B in Fig. 11a, and (b) side 2 taken at location 2B in Fig. 11b. Inserts show the local Cr concentrations (wt. %). Crack advance is from left to right.

Figure 12 provides additional detail on the crack path. Figure 12a was taken at location 1B in Fig. 11a, at the end of the test. EDS analysis shows that the preferred crack path was through a region with an average Cr concentration of 18%. Figure 12b was taken at location 2B in Fig. 11b, and the EDS analysis shows that the preferred crack path was through a region with an average Cr concentration of 18-20%. In summary, EDS analysis shows that in this test, cracking occurred preferentially along the Alloy 182-52M WOL interface with Cr concentrations of 18-20%.

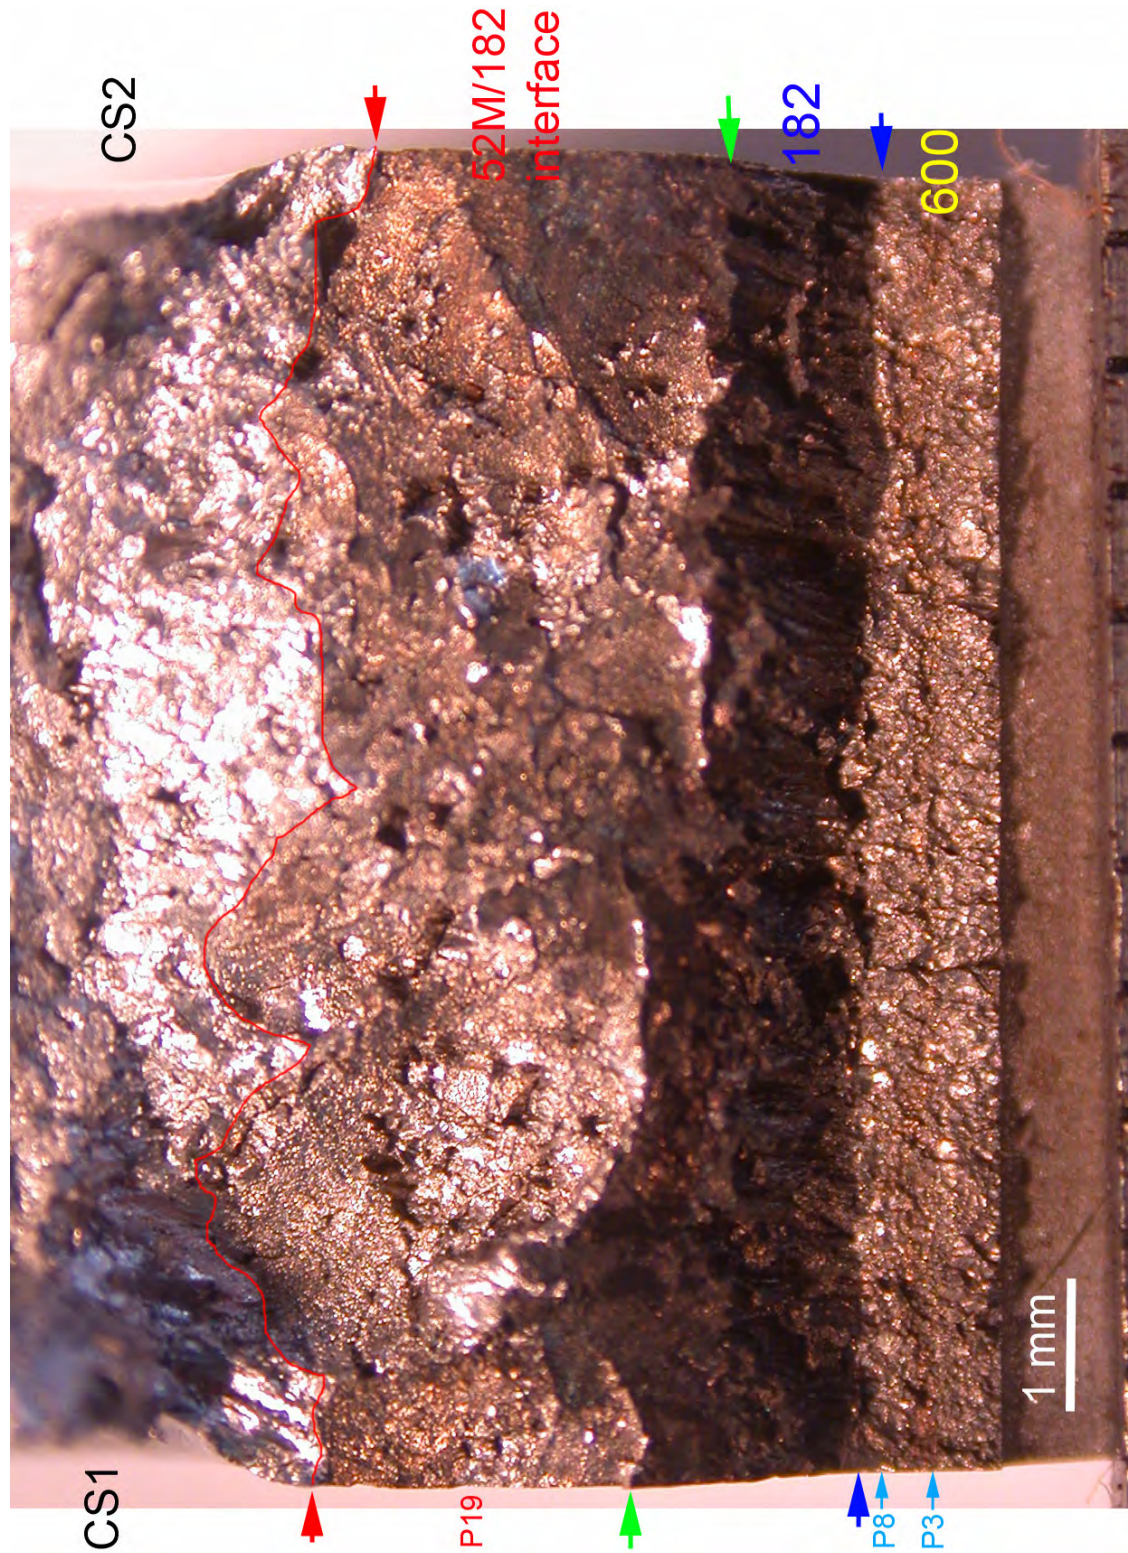
Figure 13. Fracture surface of specimen WOL-ST-1. The blue arrows indicate the Alloy 600-182 interface, the green arrows indicate the Alloy 182-52M interface, and the red arrows indicate the end of the test. The approximate locations of select test periods P3, P8 and P 19 are indicated in the figure. Crack advance is from bottom to top.

Following the examination of the side surfaces, the specimen was fatigued in air at room temperature to break some of the remaining ligaments, and was fractured after cooling in liquid nitrogen. The fracture surface was photographed (Fig. 13) and was examined in the SEM (Fig. 14).

The photograph, Fig. 13, provides a good visual contrast between the various alloys that were tested. Blue arrows indicate the Alloy 600-Alloy 182 interface, green arrows indicate the Alloy 182-Alloy 52M interface, and the red arrows and line mark the end of the test. The locations of the two test periods in Alloy 600 (P3 and P8) and along the Alloy 52M-182 interface (P19) are indicated in the figure. Measurements show that the Alloy 600-182 interface is 1.06 mm from the notch, in good agreement (5%) with expectations. The crack reaches the Alloy 52M-Alloy 182 interface after 2.61 mm, again in good agreement (2%) with the distance measured by DC potential through test period 18, Table 1, which was 2.54 mm. The end of the test is 5.50 mm from the specimen notch, hence, the crack extension under constant load in test period 19 is 2.89 mm, a factor of 8.2 higher than the 0.339 mm extension measured by DC potential. The final crack extension was re-measured on the SEM image (Fig. 14) and was found to be in very good agreement (7%) with the determination based on Fig. 13. As such, test period 19 was corrected by a factor 8.2, and the outcome is shown in Fig. 9. Table 1 already reflects the corrected rate.

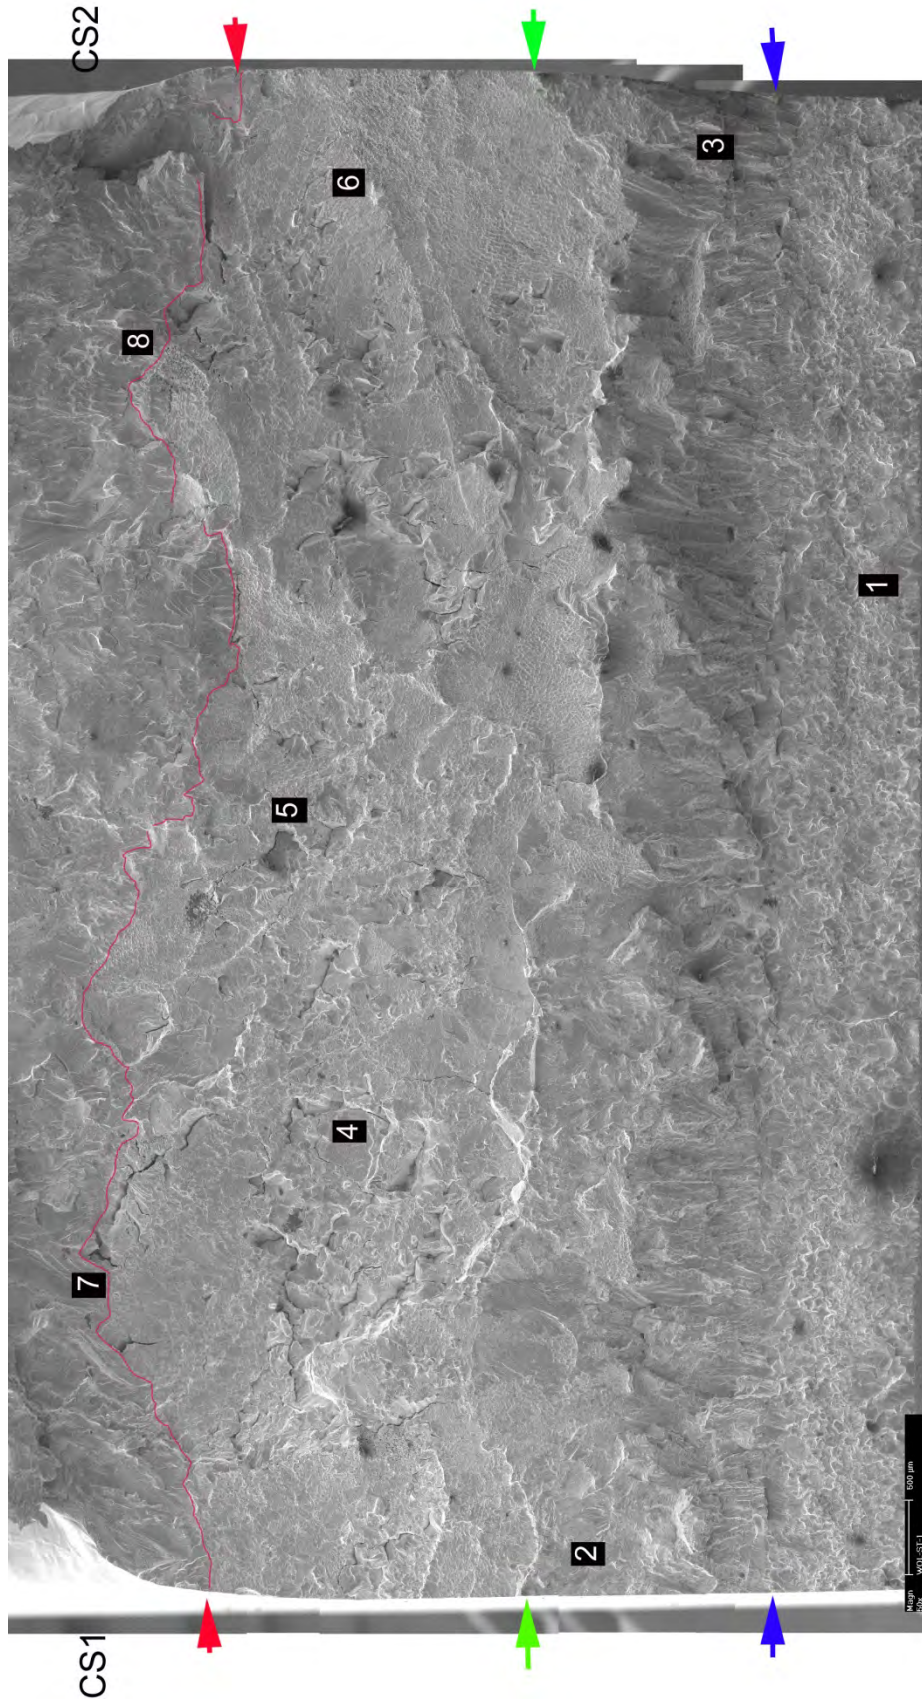
Figure 14. Fracture surface of specimen WOL-ST-1. The blue arrow indicates the Alloy 600-182 interface, the green arrow indicates the Alloy 182-52M interface, and the red arrow indicates the end of the test. Crack advance is from bottom to top.

The SEM examination also allowed for a closer inspection of the fracture features. Several areas of interest are marked in Fig. 14, and will be presented next.

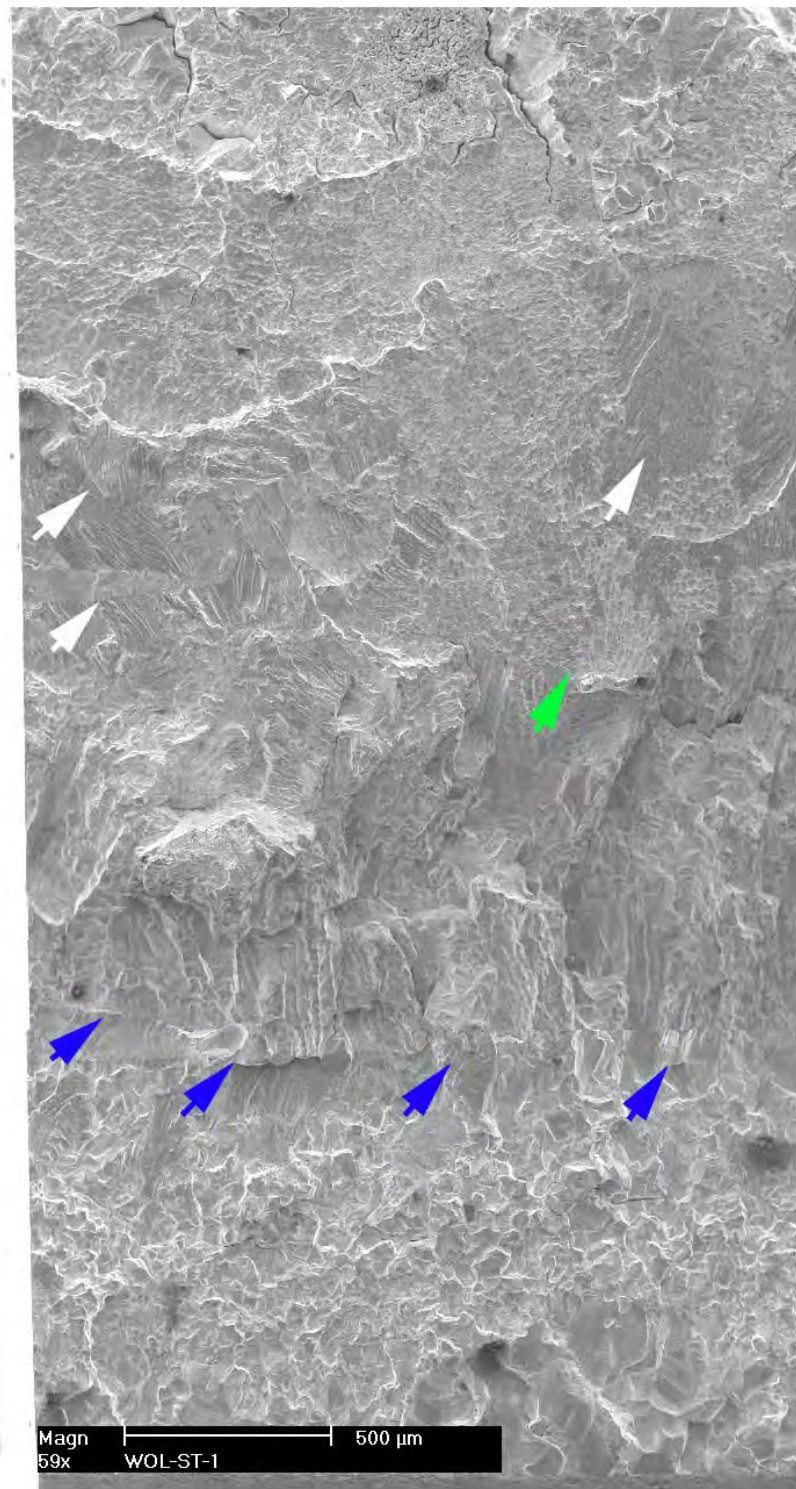
Figure 15 Fracture surface of specimen WOL-ST-1 at location 2 in Fig. 14. The blue arrows indicate the onset of cracking in Alloy 182, and white arrows indicate the occasional TG fracture that occurred prior to transitioning into Alloy 52M. These regions correspond to location 1A in Fig. 11a where the crack under fatigue loading overshot the WOL interface. The green arrow indicates a region with IG features. Crack advance is from bottom to top.

Figure 15 is an image taken at location 2 in Fig. 14, and focuses on the Alloy 182-Alloy 52M transition. The blue arrows indicate the onset of cracking in Alloy 182, and the image seems to show that occasional TG fracture (white arrows) occurred prior to transitioning into Alloy 52M. These regions correspond to location 1A in Fig. 11a where the crack under fatigue loading slightly overshot the Alloy 52M WOL interface. Nevertheless, the crack seems to have eventually transitioned to IG, and one of the early occurrences is indicated with a green arrow.

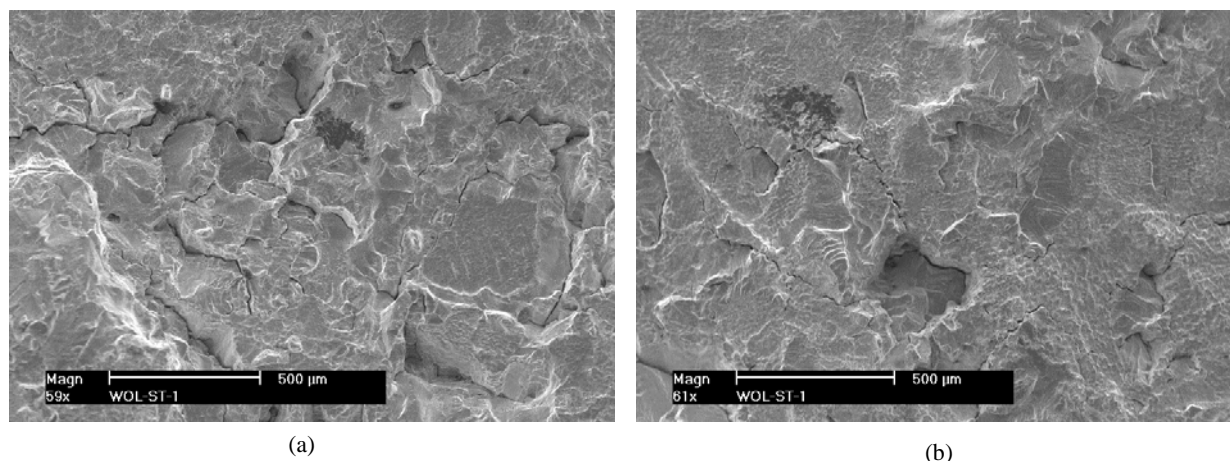
Figure 16 Fracture surface of specimen WOL-ST-1 at (a) location 4, and (b) location 5 in Fig. 14. Crack advance is from bottom to top.

Figure 16 shows images taken at locations 4, 5 in Fig. 14, and illustrate the fracture mode obtained under constant load in this specimen. Out-of-plane cracking was observed at several locations but this did not appear to be a predominant feature. The lack of out-of-plane cracking suggests that the interface was indeed the most susceptible microstructure for crack propagation. Overall, the aspect of the fracture mode was as expected, i.e., with the dendrites normal to the plane of the figure.

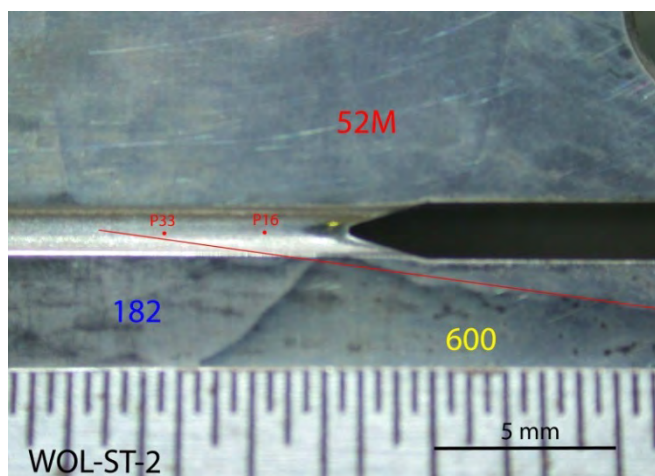
Figure 17. Notch area in specimen WOL-ST-2. The red line shows the Alloy 52M WOL interface.

The objective of the test on Specimen WOL-ST-2 was to measure the SCC CGR in Alloy 52M near the interface with Alloy 182. In this specimen the crack was initiated in Alloy 52M and was expected to reach the Alloy 182 weld after approx. 6 mm of growth, Fig. 17. Based on prior observations (Fig. 3), the expectation for this test was for the crack to find a highly SCC-susceptible region in Alloy 52M near the interface, then continue on the interface between the two welds as the prior WOL-ST-1 test showed that that is the most susceptible path; moreover, prior testing¹ showed that Alloy 182 near the WOL was relatively resistant.

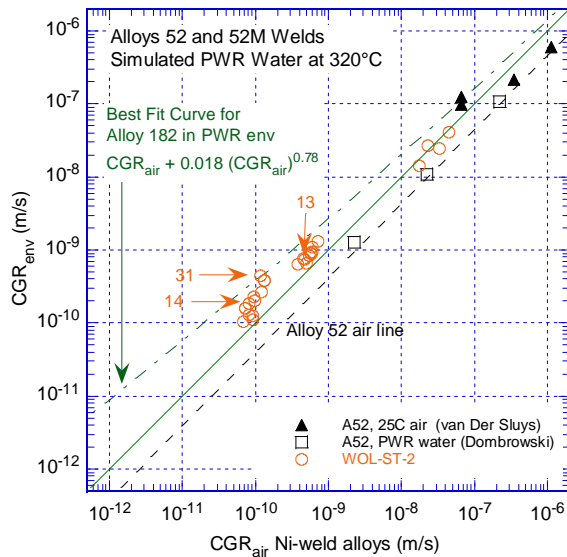
Figure 18. Cyclic CGRs for Alloy 52M specimen WOL-ST-2 in simulated PWR environment. Also included are Alloy 52 data from the literature^{5,6} obtained in air at room temperature and in PWR environment.

The testing conditions and CGR responses are given in Table 2. The test was initiated with precracking in the PWR environment (as usual), and this was followed by transitioning steps, and the known^{5,6} fatigue and corrosion fatigue behavior for the Ni-base weld were reproduced (Fig. 18). Early attempts at measuring an SCC CGR yielded very low rates (10^{-12} m/s), and it is not clear whether the unfavorable orientation with respect to the dendritic grains played a role or not. Nevertheless, regions of high SCC susceptibility were known to exist from the earlier TS tests (Fig. 3), hence it was decided to advance the crack while closely monitoring the environmental enhancement of the cyclic rates. This was accomplished in test periods 20-31. Figure 19 tracks the environmental enhancement of two loading conditions – rise 50s and rise 600s, $R = 0.5$ – vs. crack advance from the notch (propagation is from right to left to match Fig. 17). The purpose of the fast cycle is to advance the crack, and the purpose of the slow cycle is to probe for environmental enhancement. The dotted red and blue horizontal lines represent

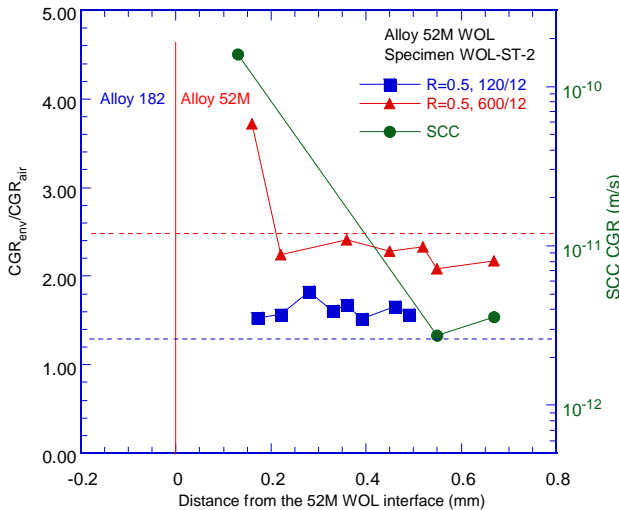
Figure 19. Environmental enhancement of two control test conditions vs. calculated distance to the interface. Crack propagation is from right to left (see also Fig. 17 for guidance)

the environmental enhancement levels of a forward advancing crack based on the Alloy 152 experience.⁷ In those tests - conducted at ANL on an Alloy 152 weld that was produced in a symmetric, double-J geometry - it was found that environmental enhancement peaks during cyclic with load ratios of $R = 0.5$, and rise time of 600s, and the resulting fracture mode is IG. Based on that experience, a similar level of environmental enhancement in the current test (period 31) was interpreted as IG SCC propagation in a forward direction that can readily be measured by DC potential, and the specimen was set at constant load (test period 33). The SCC CGR response under constant load is shown in Fig. 20.

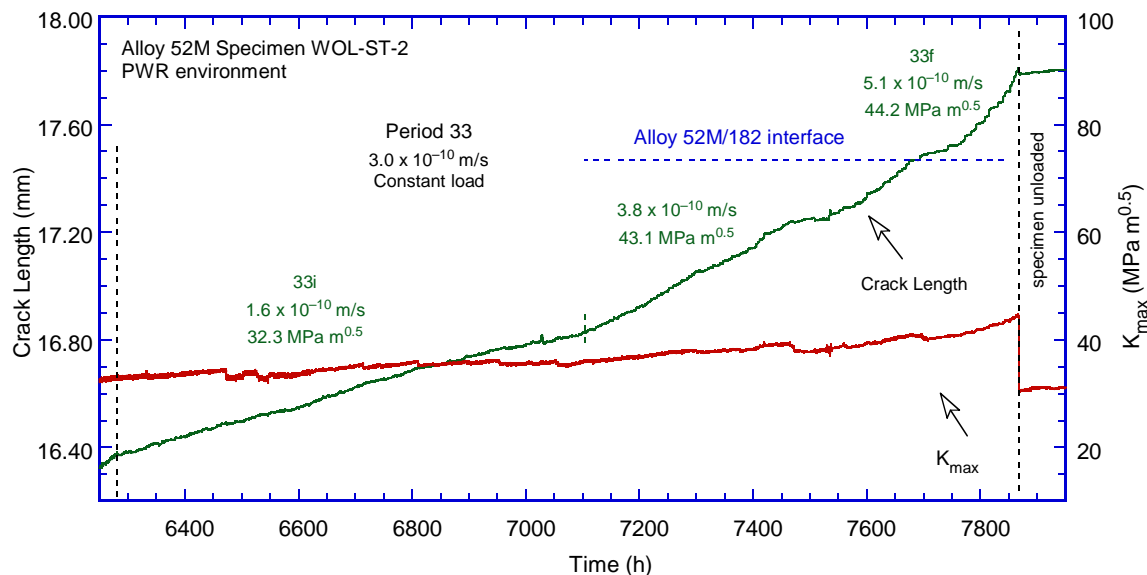
Figure 20. Crack-length-vs.-time for Alloy 52M specimen WOL-ST-2 under constant load in simulated PWR environment. The data were corrected by a factor 4.2 following the analysis of the fracture surface.

Figure 20 shows that under constant load conditions, the initial SCC CGR of 1.6×10^{-10} m/s ($K = 32.3$ MPa $m^{1/2}$) was maintained until approx. 7,100h for the first 0.46 mm of growth. Next, the rate appeared to increase, and the SCC CCR was on average approx. double, 3.8×10^{-10} m/s. It is interesting to note that in the latter part of this test period (7,700 h), 5-10 μ m “jumps” similar to those seen for some time in specimen WOL-ST-1 (Fig. 9) were observed; these features suggest that the crack reached the interface with Alloy 182. Finally, as the SCC CGR reached 1.4×10^{-9} m/s (after 7,855h), the specimen was unloaded. It is also interesting to note that although the unload at the end of test period 33 was intended to stop the growth (and effectively end the test), the crack continued to grow at a substantial rate even after the stress intensity factor was drastically decreased. Hence, this last period received its own designation, test period 34 in Table 2. Post-test measurements on three cross sections (the two sides of the specimen and one additional cross section in the middle of the specimen - details will be presented later in this section - confirmed that the SCC crack initiated in Alloy 52M, at least 0.8 mm from the interface with Alloy 182.

In summary, the examination of three cross sections revealed that the test evolved as planned: the crack was transitioned to IG in the diluted area of Alloy 52M WOL, was allowed to propagate towards the interface, and towards the end of the test it reached and propagated along the interface. SCC cracking at constant load seemed to span three regions: diluted Alloy 52M WOL in the beginning, Alloy 52M/182 interface at the end, and most likely a combination of the two in the middle. This sequence seems to describe the evolution observed during test period 33 in Fig. 20.

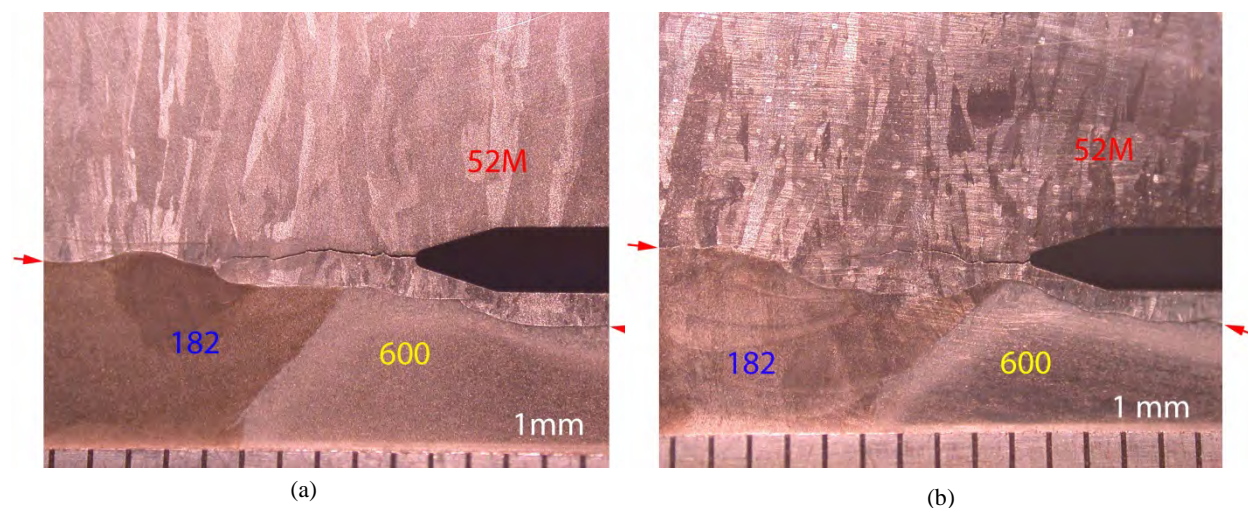
Figure 21 Notch area post-test in specimen WOL-ST-2 seen from both sides: (a) side 1, and (b) side 2. The red arrows indicate the WOL interface. Crack advance is from right to left.

For this test, the examination of the side surfaces was an essential for determining the crack path. For this purpose, the side surfaces of the specimen were ground to eliminate the side grooves, polished and electrochemically etched in a 5% nital solution. The two side surfaces (Fig. 21) show that the test progressed as anticipated, and confirm that the test took place in the Alloy 52M dilution – interface area, as was intended. The distance from the specimen notch to the Alloy 182 interface measured on the two surfaces is 6.2 mm, 1% from the value estimated prior to the test (Fig. 17).

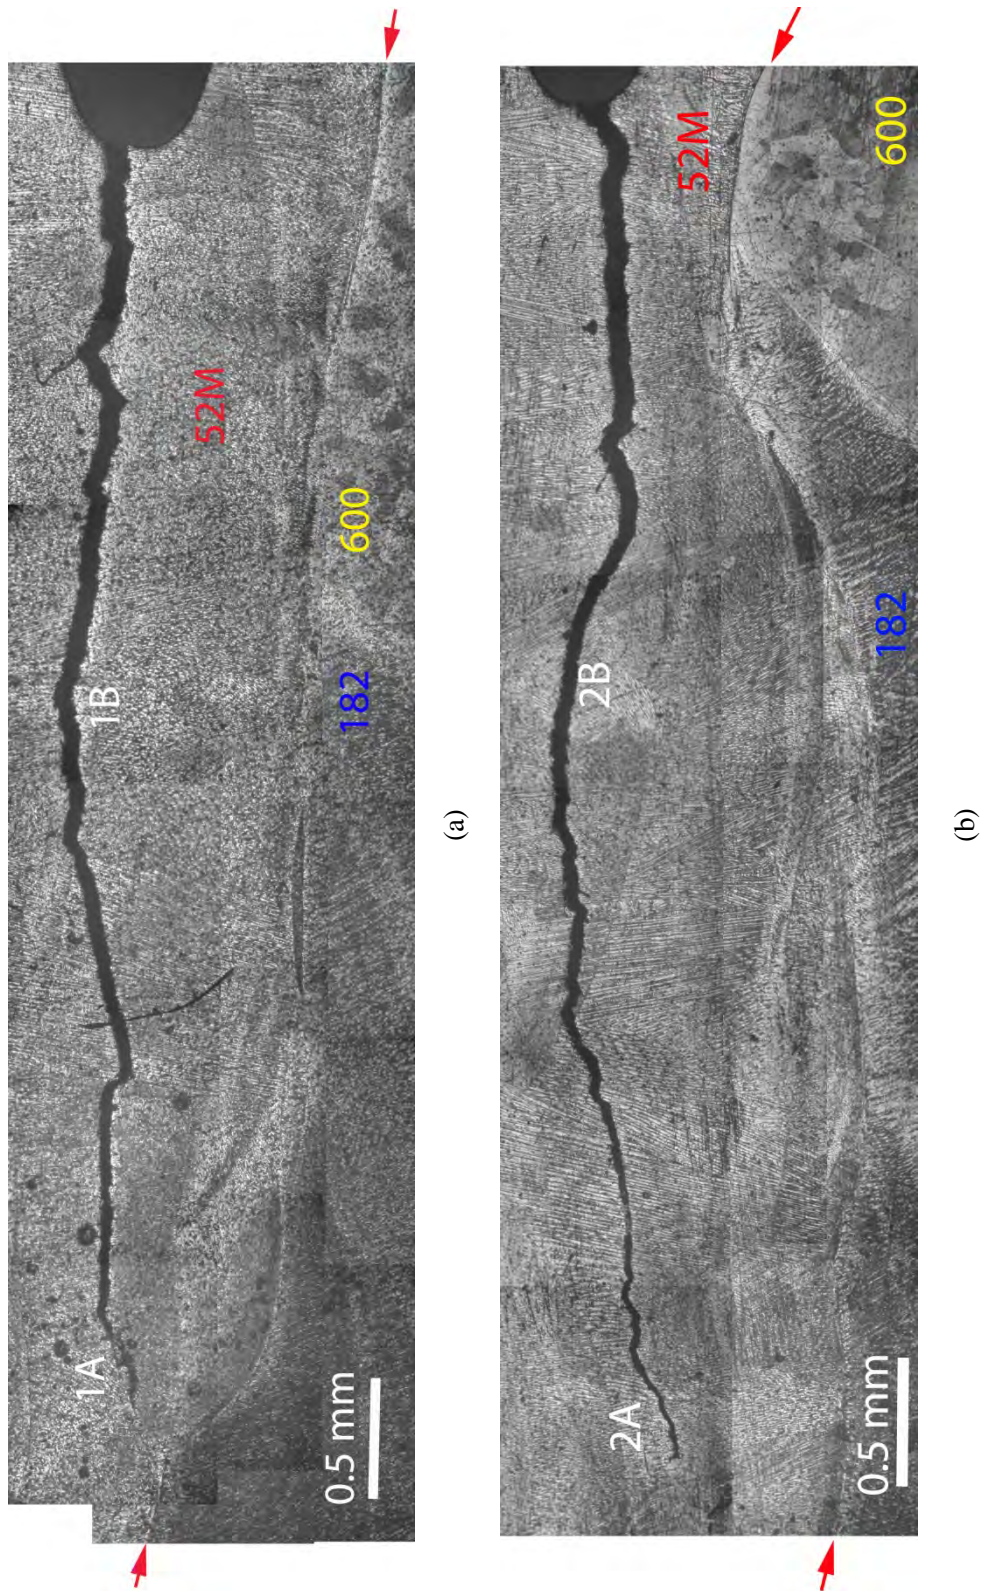
Figure 22. Cross section of specimen WOL-ST-2: (a) side 1, and (b) side 2. Crack advance is from right to left. The red arrows indicate the WOL interface.

The two side surfaces were further examined by optical microscopy, Fig. 22. The crack advance was straight, and the large opening suggests a TG fracture mode for the most part of the test. The extent of the TG advance measured on the two side surfaces is 5.01 mm, a value which corresponds to test period 31

(Table 2). This finding suggests that the onset of high environmental enhancement in test period 31 corresponds to a change in fracture mode from TG to IG.
