STRESS CORROSION CRACKING OF A 52M WELD OVERLAY IN A PWR ENVIRONMENT^{1,2}

Bogdan Alexandreanu, Yiren Chen, Ken Natesan and Bill Shack

Argonne National Laboratory
Argonne, IL 60439 USA

June 2015

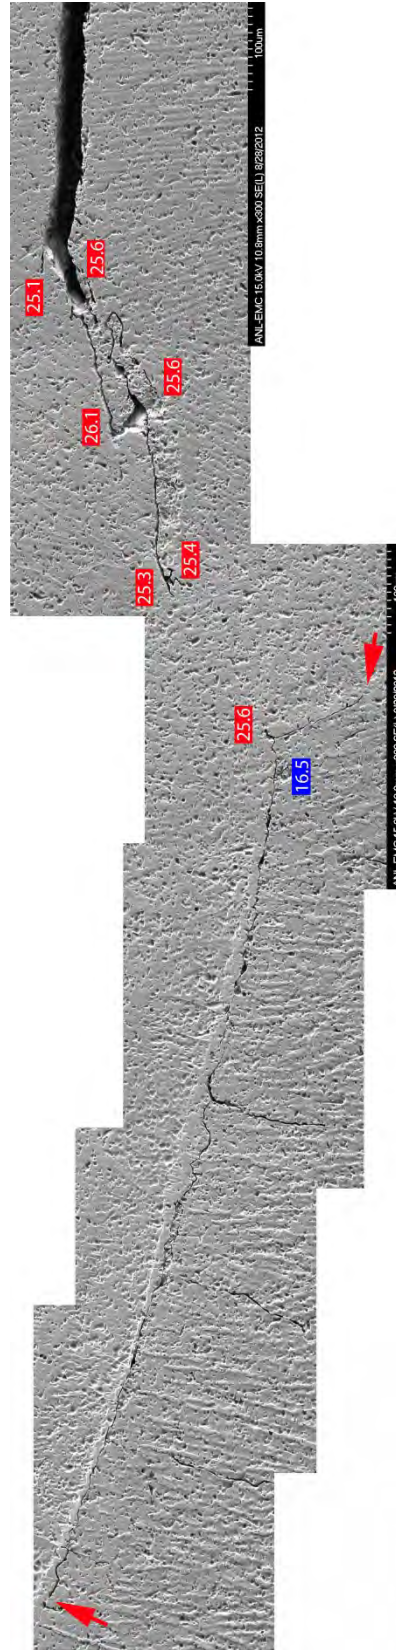
Figure 23. Crack tip region on the first side surface of specimen WOL-ST-2 (side 1, location 1A in Fig. 22a). Crack advance is from right to left. Cr concentration at select locations is indicated in the figure. The red arrows indicate the WOL interface.

The IG regions initiating in the areas marked 1A and 2A in Figs. 22a and 22b, respectively, were further examined in the SEM. Figure 23 shows the IG region on side 1 of the specimen. Chemical composition measurements show that Cr levels were on average 25.5 wt. % along the IG crack path, and no Cr gradient seems present. By contrast, Cr levels at location 1B –corresponding to test period 16 with no SCC growth – were 27.1 wt. %. The figure also reveals that the IG crack appears to have taken a more SCC-susceptible direction, i.e., along the dendritic grains, towards the interface, but the clear path seems to be obstructed by a ligament. Nevertheless, cracking along the interface seems extensive, 1.6 mm from the end of the TG region. Secondary cracking in Alloy 182 is also visible.

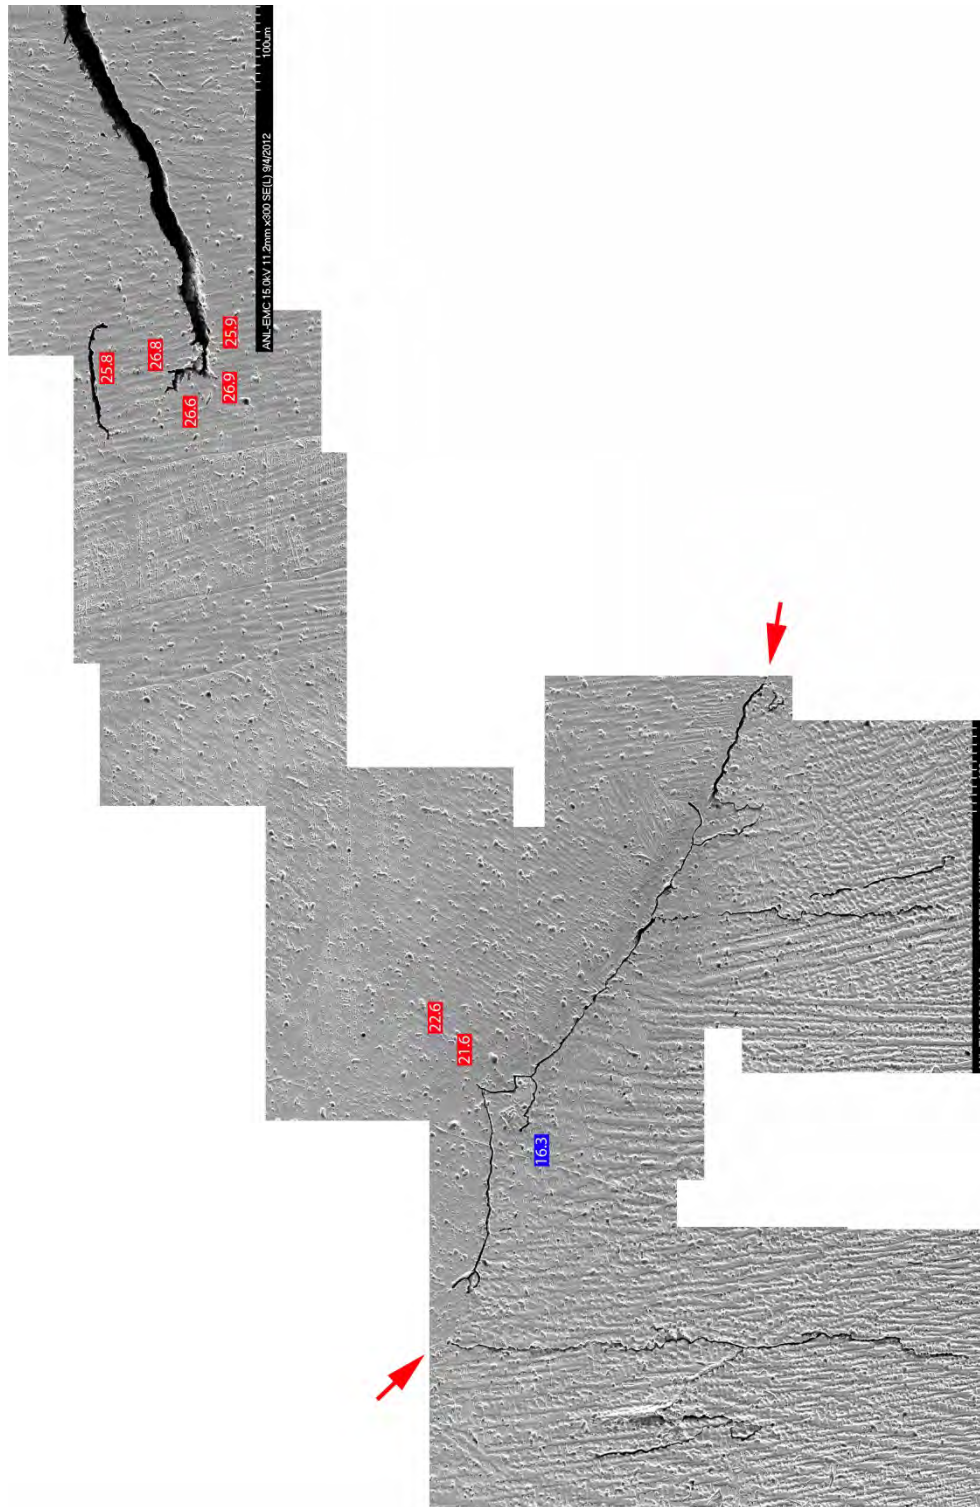
Figure 24.

Crack tip regions on the second side surface of specimen WOL-ST-2 (side 2, location 2A in Fig. 22b). Crack advance is from right to left. Cr concentration at select locations is indicated in the figure. The red arrow indicates the WOL interface.

Figure 24 shows the IG region on side 2 of the specimen (beginning at location marked 2A in Fig. 22b). Chemical composition measurements at the TG-IG transition area show that Cr levels were on average 26.6 wt. %, however, the crack did not seem to propagate much. For comparison, Cr levels at location 2B in Fig. 22b –corresponding to test period 16 with no SCC growth – were 28.1 wt. %. Nevertheless, the crack appears to have taken a more favorable direction towards the interface, and it resurfaces at the interface with Alloy 182, 0.9 mm away. As with the previous cross section, cracking along the interface seems extensive, and ends 1.2 mm from the TG region. Extensive secondary cracking in Alloy 182 is also visible.

The right hand side of Fig. 30a corresponds to the cross section shown in Fig. 24. In this particular case, the crack path was obstructed by a large ligament (Figure 24 suggested it was also off plane), but resurfaced along the weld interface. Fig. 30a provides confirmation for that initial inference, and pictures taken at location 3 provide the fracture morphology of the cracked weld interface. These images are shown in Fig. 31.

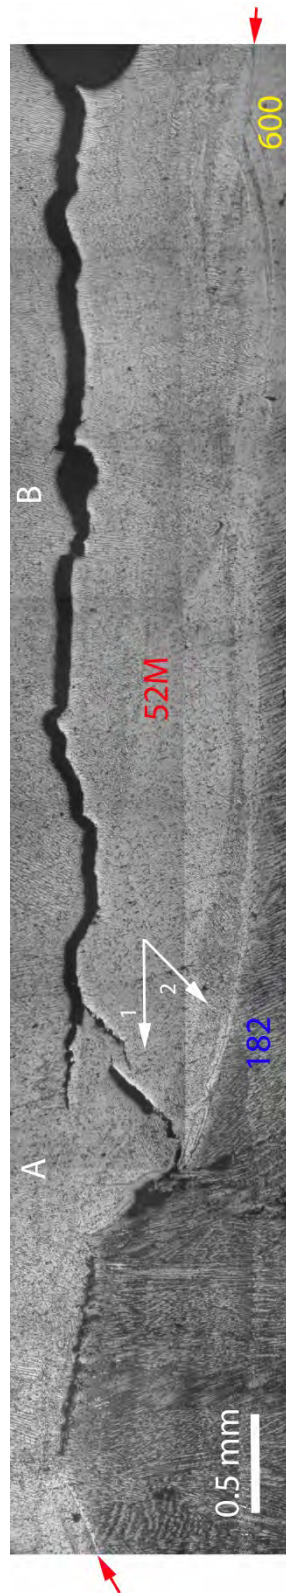
Figure 25. Cross section of specimen WOL-ST-2: taken in the middle of the specimen. Crack advance is from right to left. The red arrows indicate the WOL interface.

In order to gain additional information regarding the crack propagation in the dilution zone of Alloy 52M, an additional cross section was created by sectioning the specimen in the middle. This middle cross section is shown in Fig. 25. As with the two side surfaces, the crack advance was straight with a large opening suggesting a largely TG fracture mode. Nevertheless, Fig. 25 show that following the TG growth, the crack propagated in an IG fashion towards the interface, perhaps along a more favorable weld orientation. Figure 26 (taken at location A in Fig. 25) shows that the average Cr content along the crack path was 24.2 wt. %. By contrast, Cr levels at location B in Fig. 25 –corresponding to test period 16 with no SCC growth – were on average 27.1 wt. %. As with the previous two examples, cracking along the interface seems extensive, 2.2 mm from the end of the TG region. Extensive secondary cracking in Alloy 182 is also visible.

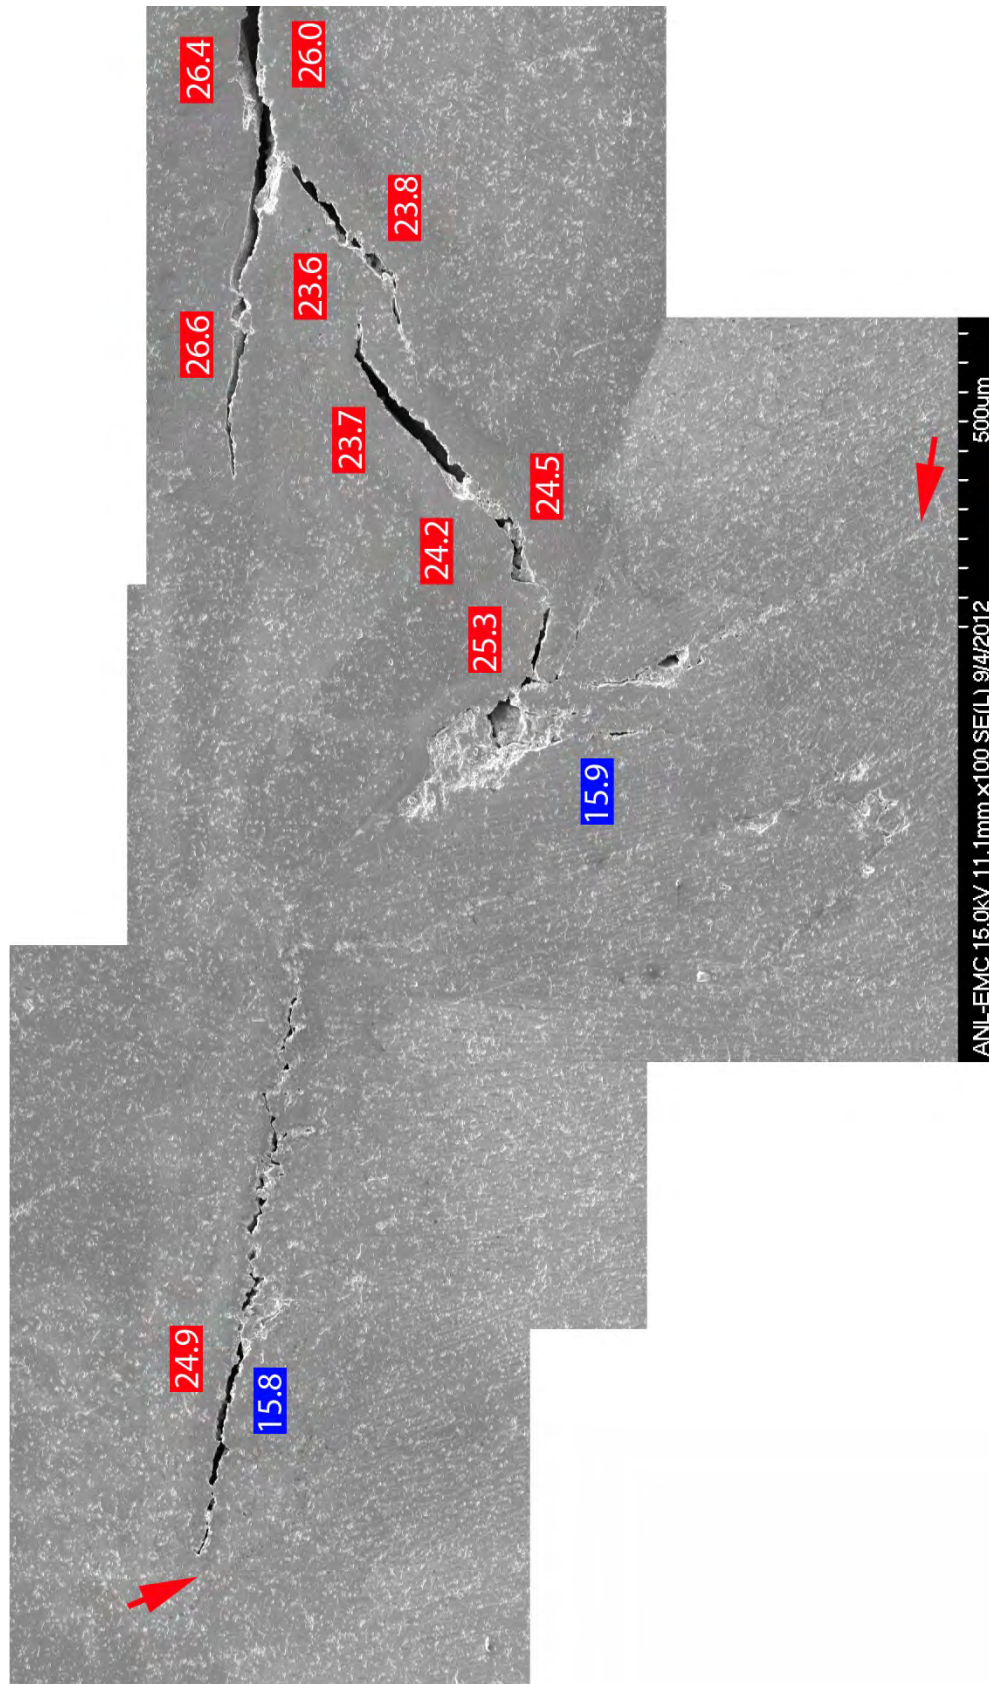
Figure 26. Crack tip regions on the second side surface of specimen WOL-ST-2 (side M, location A in Fig. 25). Crack advance is from right to left. Cr concentration at select locations is indicated in the figure. The red arrow indicates the WOL interface.

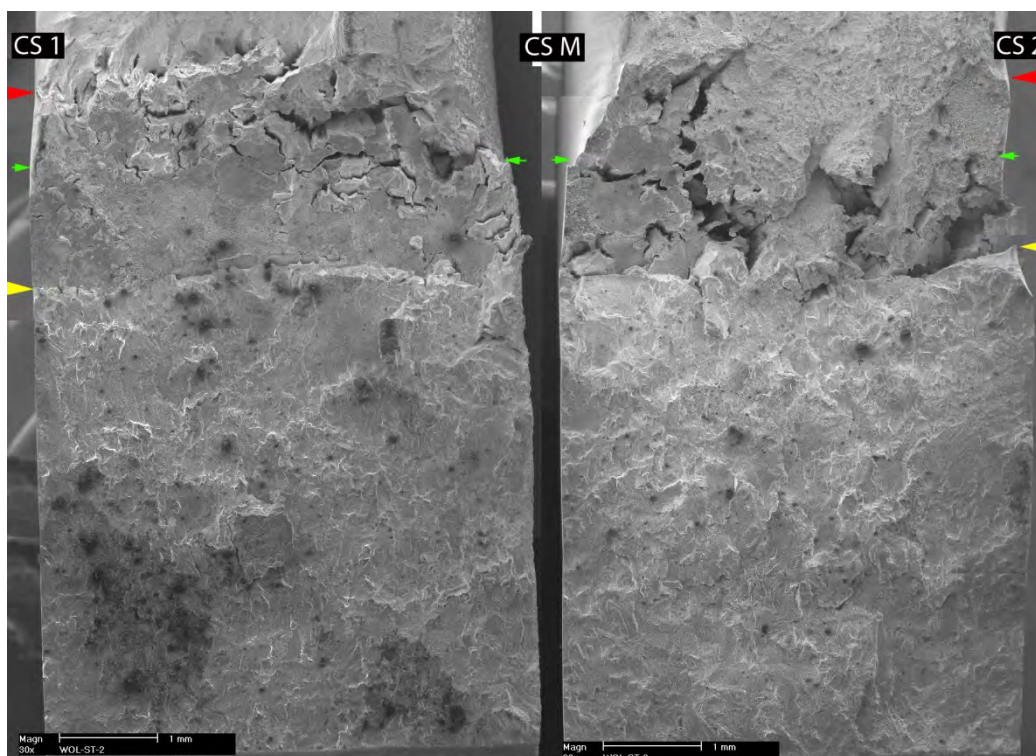
Figure 27. Fracture surface of specimen WOL-ST-2. The yellow arrows indicate the beginning of SCC growth, the red arrows show the end of the test, and the green arrows indicate the region where the crack would have intersected the interface. Crack advance is from bottom to top.

The fracture surface of specimen WOL-ST-2 is shown in Fig. 27. With respect to the CT specimen geometry, the fracture surface shown corresponds to the bottom part of the specimen as shown in Fig. 17, i.e., the Alloy 182 weld is below the plane of the crack. The yellow arrows indicate the beginning of SCC growth, the red arrows show the end of the test, and the green arrows indicate the region where the crack would have intersected the interface. The relative location of each cross section (CS) described previously is indicated in the figure. Crack advance measurements on the fracture surface and the DC potential measurements are in excellent agreement (4%) for the precracking and transitioning stage. However, the crack advance under constant load was approximately 4.2 times higher than the determination by DC potential. The disparity between the DC potential and the actual measurements is not surprising given the complicated crack pattern and the large unbroken ligaments that have been observed on the cross sections. As such, a correction factor of 4.2 was applied uniformly to test periods 32-34. Table 2 and Fig. 20 already reflect that correction.

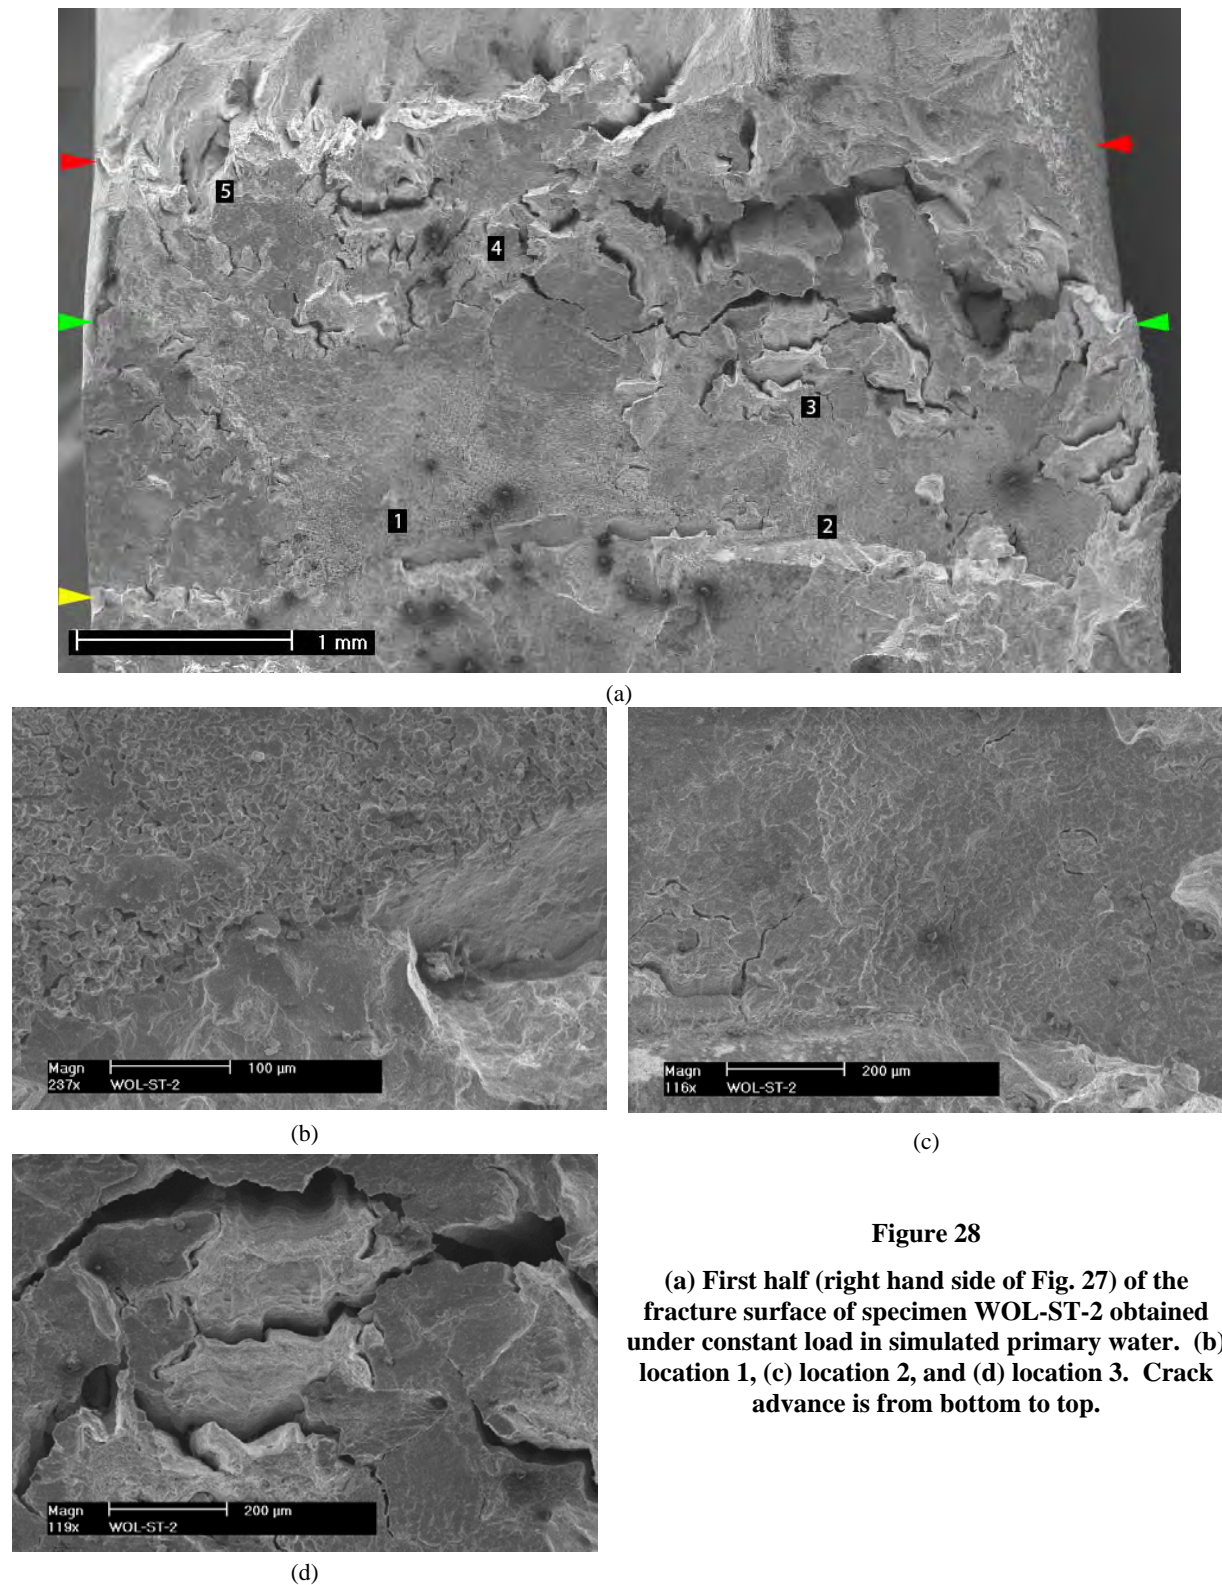
Figure 28

(a) First half (right hand side of Fig. 27) of the fracture surface of specimen WOL-ST-2 obtained under constant load in simulated primary water. (b) location 1, (c) location 2, and (d) location 3. Crack advance is from bottom to top.

Figure 28a shows half of the fracture surface, and focuses on the region at constant load. As before, the yellow arrows indicate the beginning of SCC growth, the red arrows show the end of the test, and the green arrows indicate the region where the crack would have intersected the interface. Several locations of interest are identified in the figure. For the most part, the crack transitioned readily to an IG/interdendritic fracture mode, as observed at locations 1 and 2 (Figs. 28b, c). The morphology is consistent with an ST orientation (perpendicular to the direction of dendrites, i.e., along direction 1 in Fig.

25), and several secondary cracks can be observed. Further along, more prominent secondary cracks seem to develop, most likely along direction 2 in in Fig. 25, Figs. 28d.

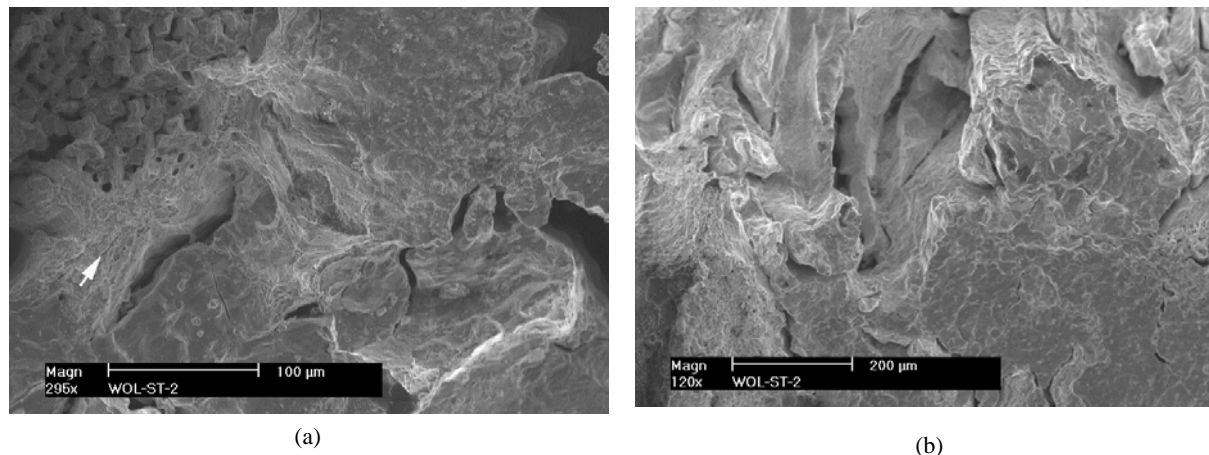
Figure 29 Fracture surface of specimen WOL-ST-2 at (a) locations 4, and (b) location 5 in Fig. 28a. Crack advance is from bottom to top.

Figure 29 focuses on the later part of the test. Figure 29a (location 4 in Figs. 28a) shows a combination of fracture modes: IG/interdendritic with secondary cracks, ductile rupture (white arrow) – most likely a ligament, and in the upper left hand corner, a fracture mode that seems consistent with that of the interface. Figure 29b (location 5 in Figs. 28a) shows the fracture surface at the end of the test. This exhibits an IG/interdendritic fracture mode as well as secondary IG cracks.

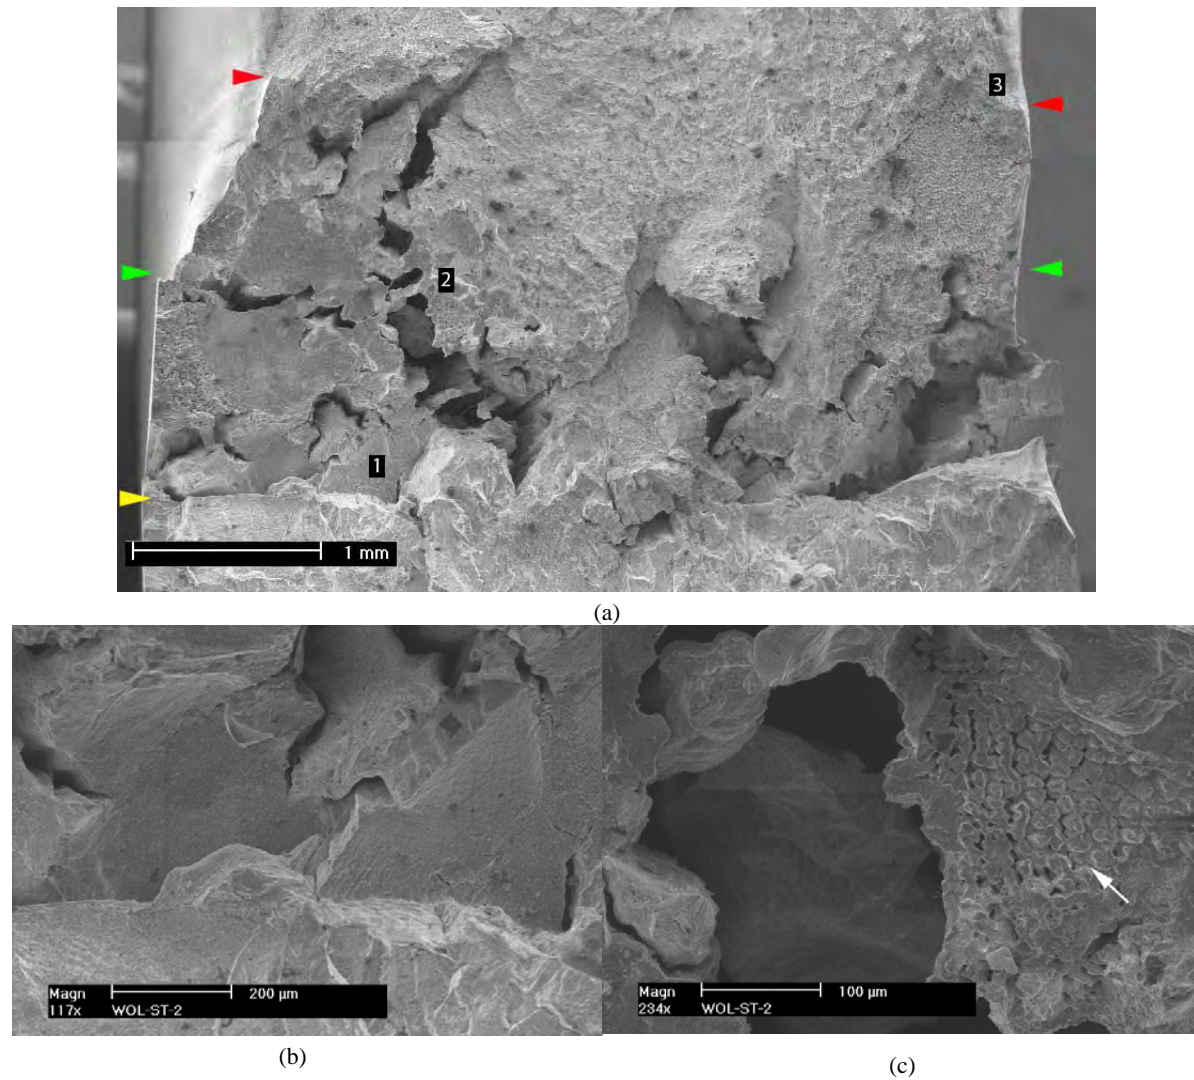
Figure 30 Second half (left hand side of Fig. 27) of the fracture surface of specimen WOL-ST-2 obtained under constant load in simulated primary water. (b) location 1, and (c) location 2. Crack advance is from bottom to top.

Figure 30a shows the second half of the fracture surface in the constant load region. The yellow arrows indicate the beginning of SCC growth, the red arrows show the end of the test, and the green arrows indicate the region where the crack would have intersected the interface. Several locations of interest are identified in the figure. For approximately 1/3 of the fracture surface, the appearance is similar to that shown in Fig. 28a. However, out of plane cracking - most likely along direction 2 (along the dendritic grains) in Fig. 25 - seems dominant. On this half of the specimen, cracking along the dendrites occurred early, Fig. 30b, and seems to have also been extensive. Figure 30c shows a region displaying what appears to be deep secondary cracking. Fracture morphology consistent with the weld interface (white arrow) also seems to be present.

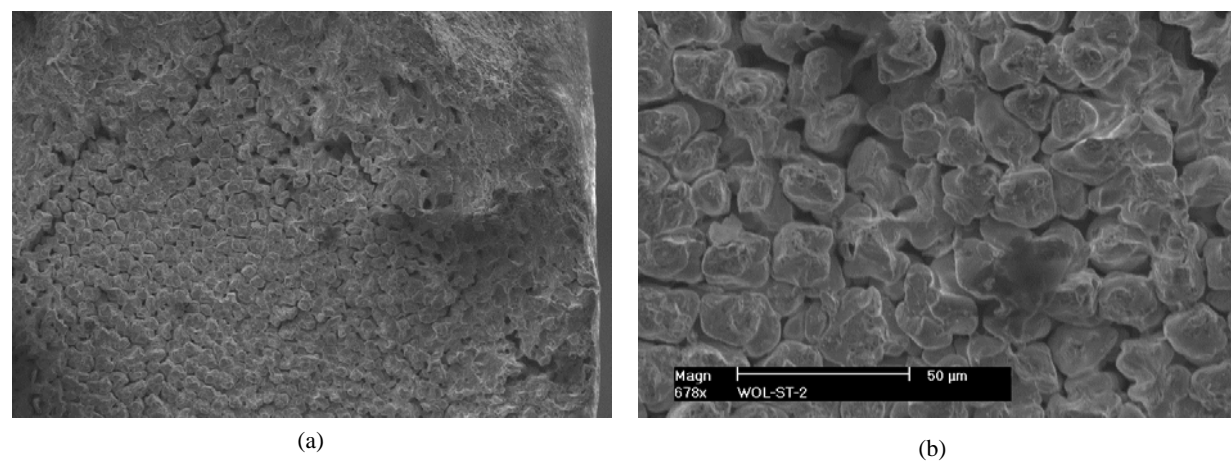
Figure 31 Fracture surface of specimen WOL-ST-2 at location 3 in Fig. 30a. Crack advance is from bottom to top.

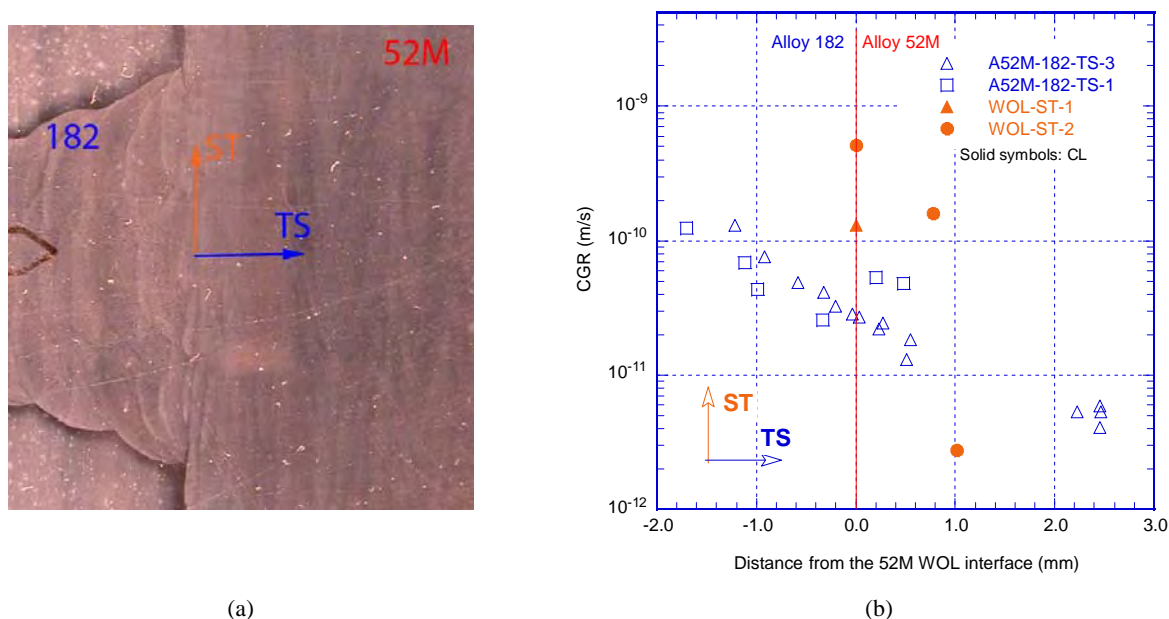
Figure 32. SCC CGRs in an Alloy 52M-182 overlay: (a) Schematic showing the test specimen orientations, and (b) SCC CGRs vs. distance to the Alloy 52M-182 interface.

SCC CGR testing on the Alloy 52M-182 WOL was conducted in two orientations: TS (earlier work⁷) and ST. Figure 32 combines the SCC CGR data obtained from these tests by illustrates these orientations and the SCC CGRs that were measured in each orientation. As described previously, the SCC CGRs in Alloy 182 are un-affected by the Alloy 52M WOL at distances larger than 1-1.5 mm from the WOL interface. However, as those cracks approached the interface in the TS orientation, the SCC CGRs in Alloy 182 were found to decrease by approx. one order of magnitude in the 1 mm leading up to the interface. The reason for the decrease is unknown, however, it may likely be due to the compressive stress exerted by the WOL. In both TS-oriented tests, significant cracking was found to develop at the interface between the two welds, and this prevented the measurement of the SCC CGR in Alloy 52M past the interface. Nevertheless, estimates based on fractography (Fig. 3) suggested that the SCC CGR in the first layer of Alloy 52M was relatively high. As such, additional testing was undertaken in the ST orientation to measure the SCC CGRs at the interface between the two welds and the first layer of Alloy 52M directly. Both the Alloy 52M-182 interface and the first layer of Alloy 52M were found to be highly susceptible. Given the long crack extensions for these measurements, and the fact that the SCC region was readily identifiable on the fracture surface, these SCC CGRs are deemed by the authors to be highly reliable.

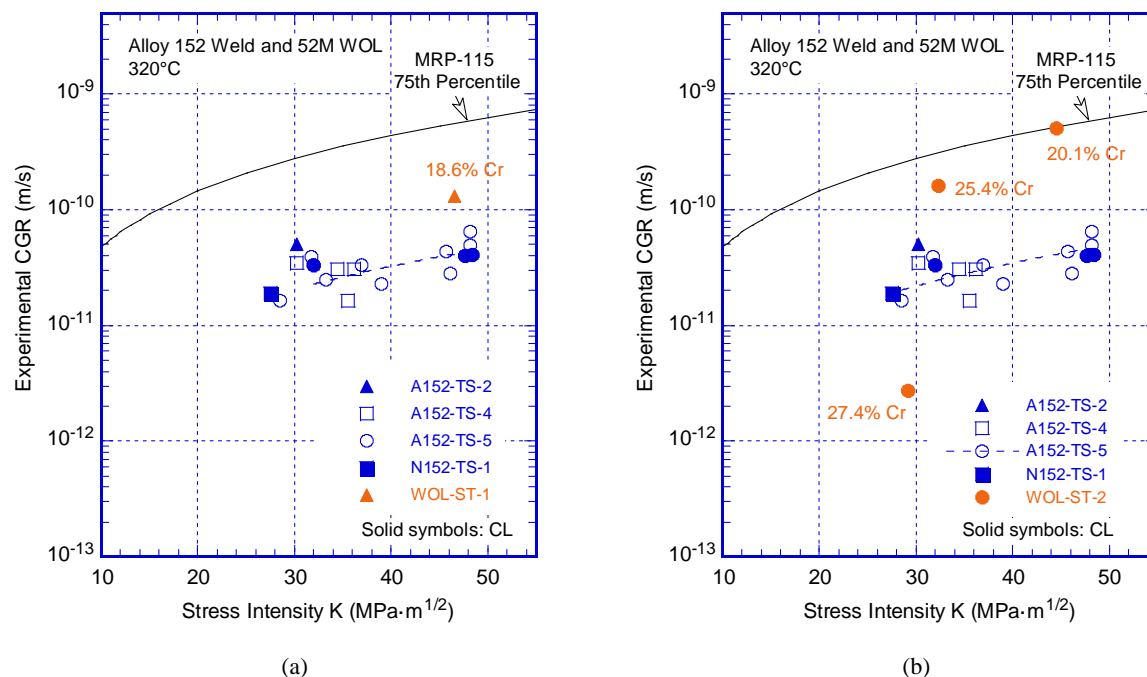
Figure 33. SCC CGRs in and Alloy 52M-182 overlay: (a) along the Alloy 52-182 interface in specimen WOL-ST-1, and (b) as a function of average Cr content in specimen WOL-ST-2. Also included are Alloy 152 data generated at ANL⁷ and the MRP-115 disposition curve for Alloys 82/182.⁸

Figure 33 suggests that the SCC CGRs along the interface between the two welds can be as high as the MRP-115 75th percentile curve.⁸ The Cr concentration for the Alloy 52M-182 interface was measured to be approx. 20 wt. %. For Alloy 52M (Fig. 33b), the Cr concentration seems to be playing a role. The SCC CGR in a region with 27.4 wt. % Cr was low, however, the unfavorable orientation of the crack vs. the dendritic grains could have played a role. However, in the first layer of Alloy 52M weld, in a region with an average Cr concentration of 25.4 wt. %, the SCC CGR was relatively high (factor 2 lower than the MRP-115 75th percentile curve⁸) despite the unfavorable orientation vs. the dendritic grains.
