## ***Stress Corrosion Cracking of Alloy 152 Weld Butter near the Low Alloy Steel Interface***

*Bogdan Alexandreanu, Yiren Chen, Ken Natesan and Bill Shack  
Argonne National Laboratory*

17<sup>th</sup> International Conference on Environmental Degradation of  
Materials in Nuclear Power Systems – Water Reactors, August 9-13,  
2015, Ottawa, Ontario, Canada

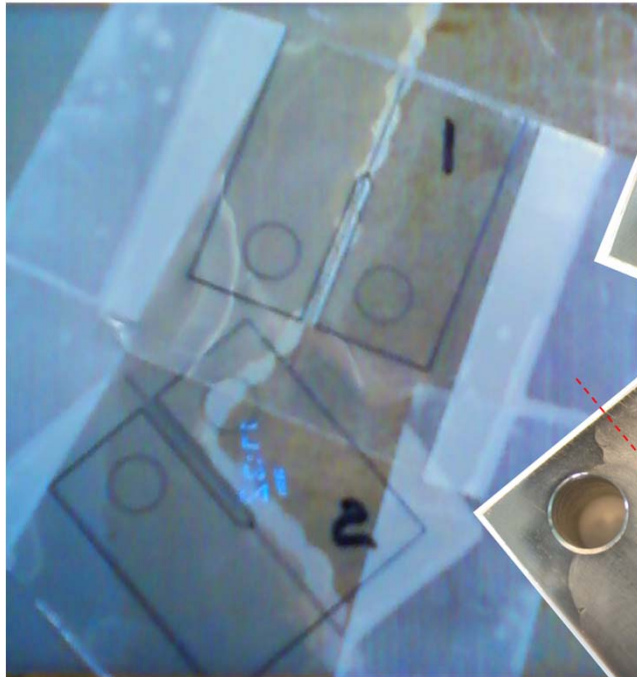
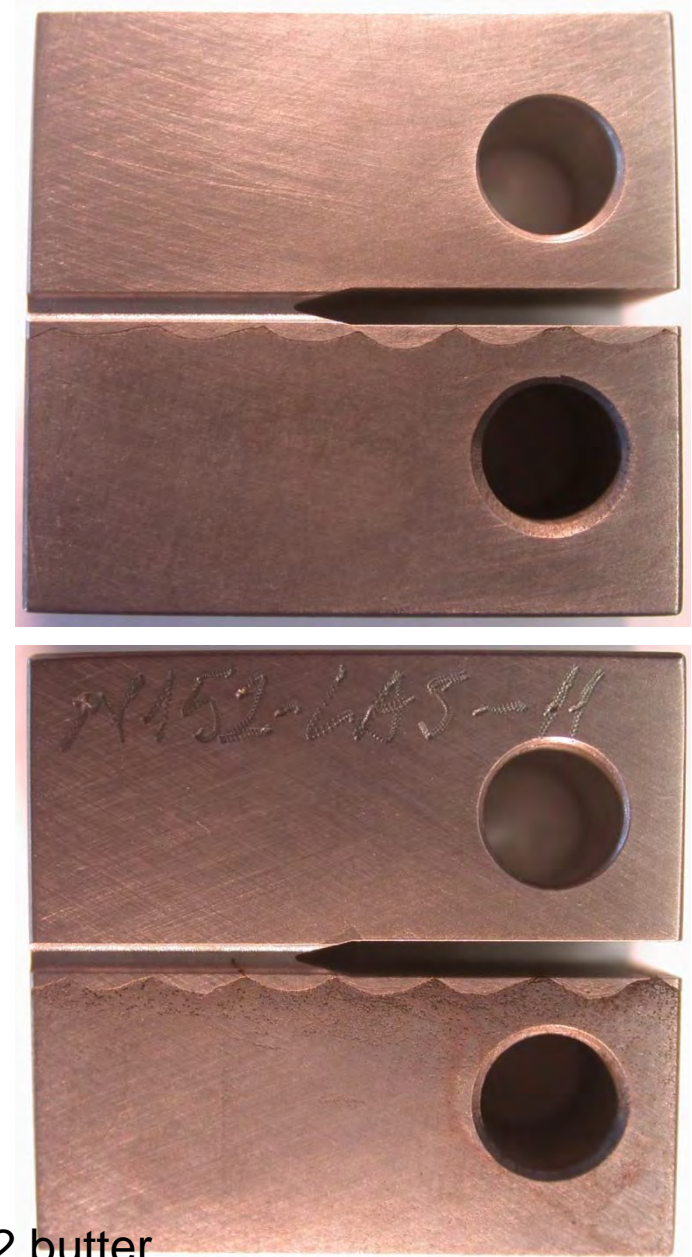
- Similar to N152-LAS-1: first layer of the Alloy 152 butter

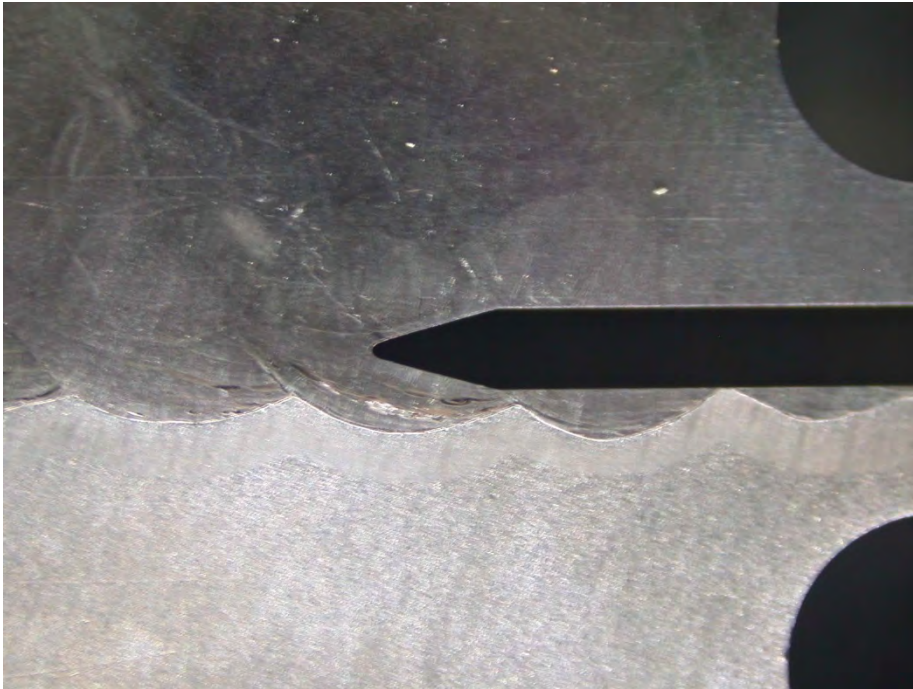
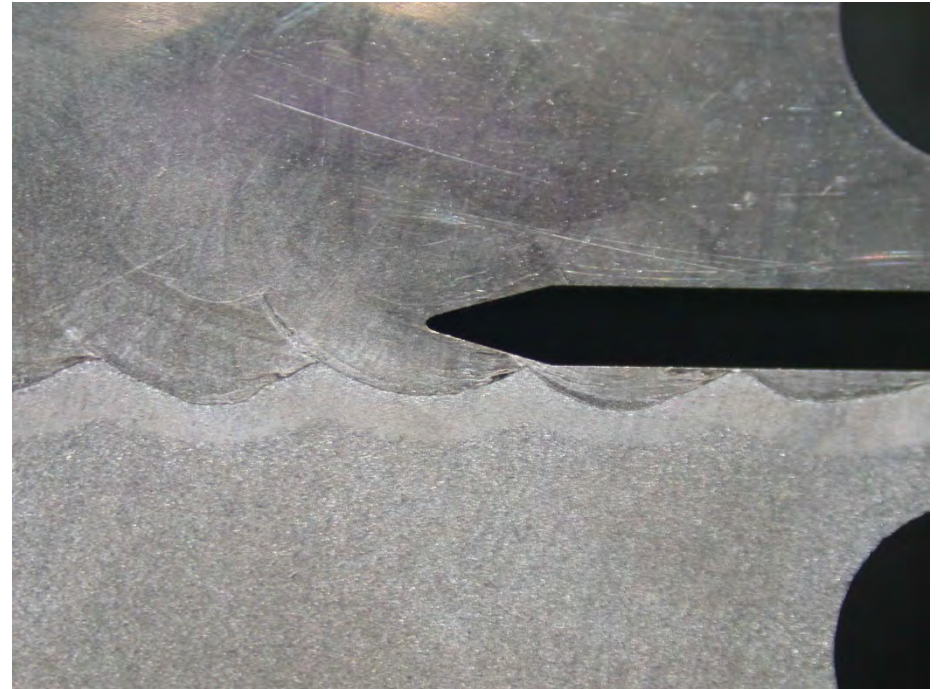
- Post-test examination confirmed alignment
- Subsequent examination confirmed that the crack was in Alloy 152
