Hematite Decommissioning Project

NUMBER: HDP-RPT-FSS-303

TITLE: Summary Report for Burial Pit Area Remediation

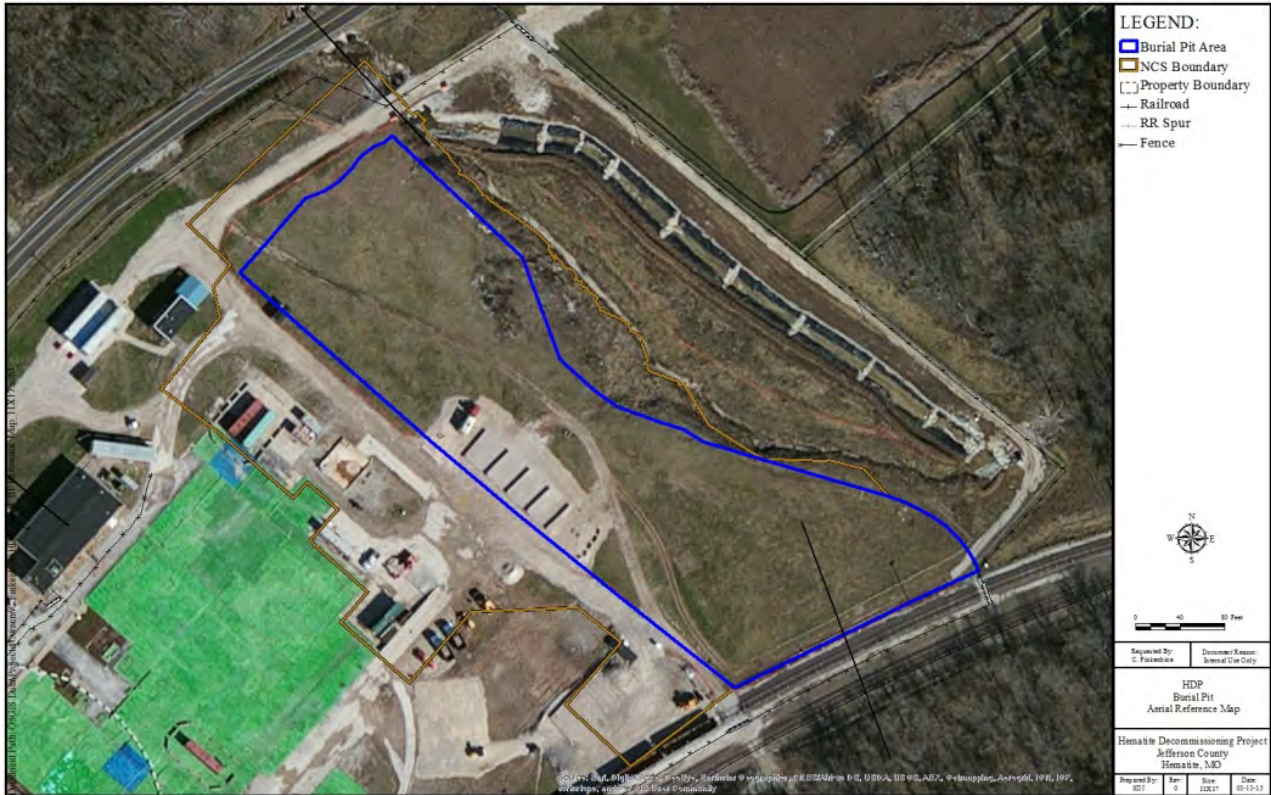
Figure 3
Burial Pit Area

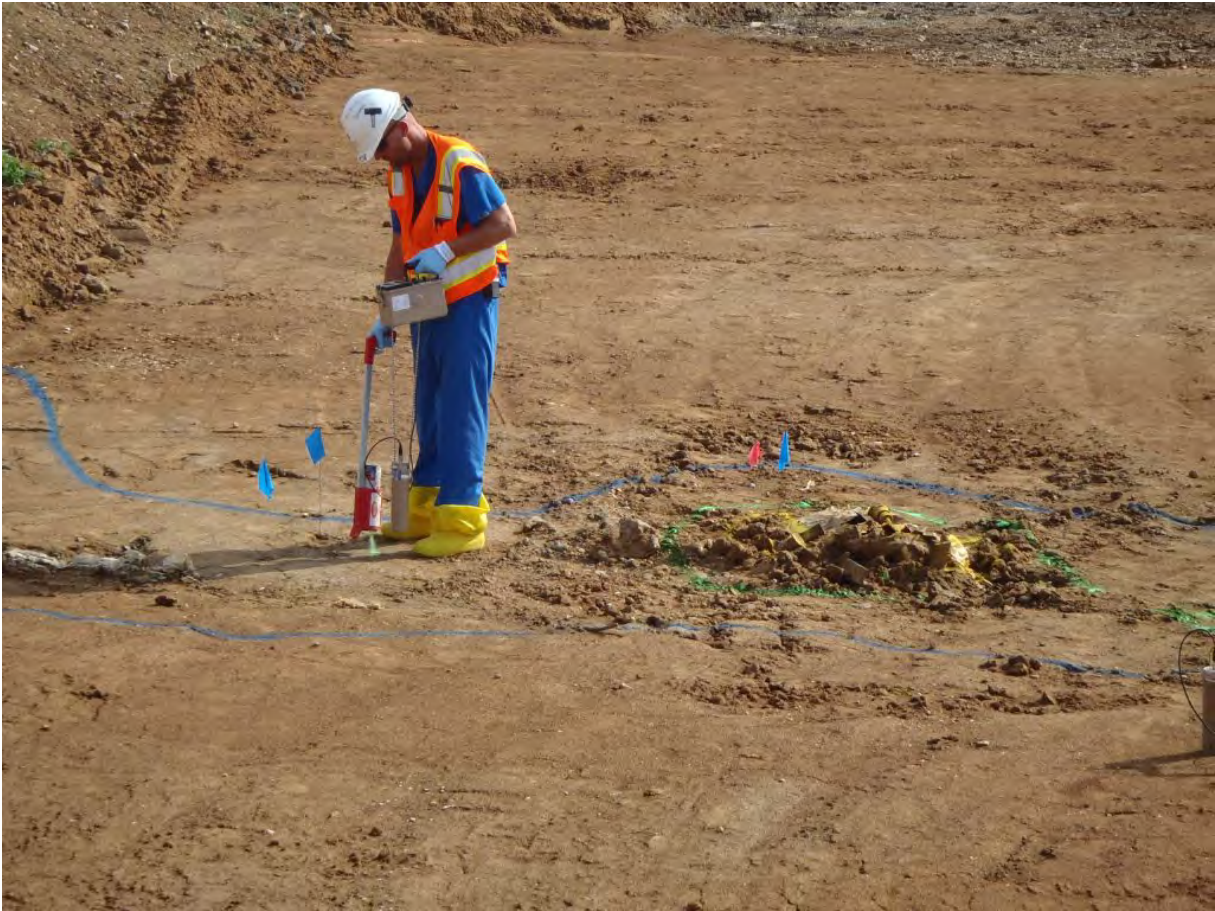
Figure 6
Example of Worker Conducting a Gamma Walkover Survey (GWS) in the Burial Pit Area with a NaI 2 x 2 Detector

Within the first few months after excavation activities began, the NRC expressed concerns whether a NaI 2x2 detector could identify lumps of U-235 via in-situ scanning through a foot of soil, therefore allowing material between 15g and 40g U-235 to be excavated prior to segregation. After further review and discussion with the NRC, HDP made the decision to take the more conservative approach and abandoned the use of 12 inch lifts, with all future NCS controlled excavations performed in 6 inch lifts. Soil/debris in areas not subject to NCS controls was still excavated in 12 inch lifts. This change was initiated in August of 2012, approximately four months after site excavation activities began. See Figure 6.

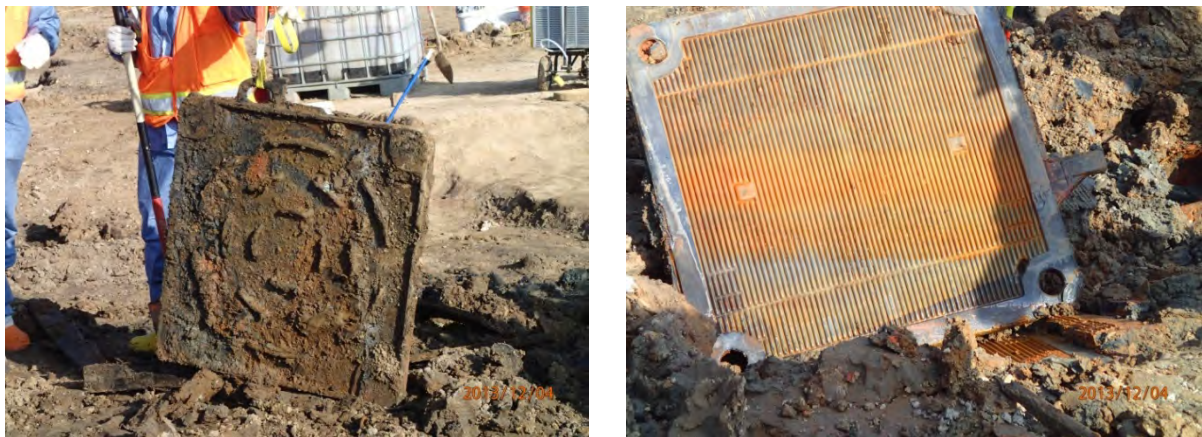
Figures 7 and 8
Examples of Radium Contaminated Filter Plates Being Unearthed While Excavating in the Burial Pit Area

the burial pits were as anticipated, 215 radium contaminated filter plates made of steel, cast iron, and plastic, about 3 feet by 3 feet in size, were unexpectedly found. See Figures 7 and 8. It was determined that these were brought to the Hematite site from an offsite entity. Figures 9 and 10 also show several examples of some of the waste from the burial pits.

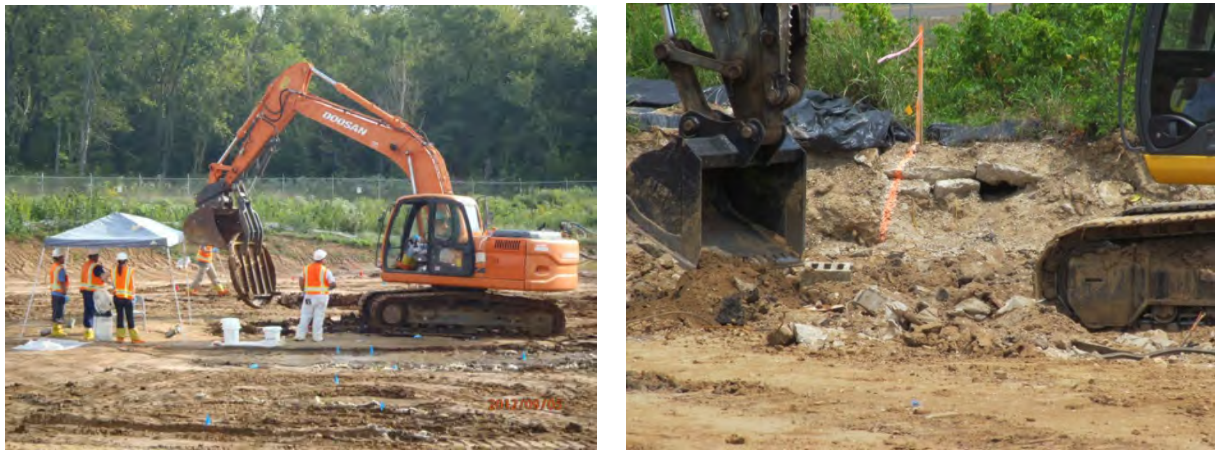
Figures 9 and 10
Examples of Debris that was Exhumed During Remediation Excavation of the Burial Pit Area

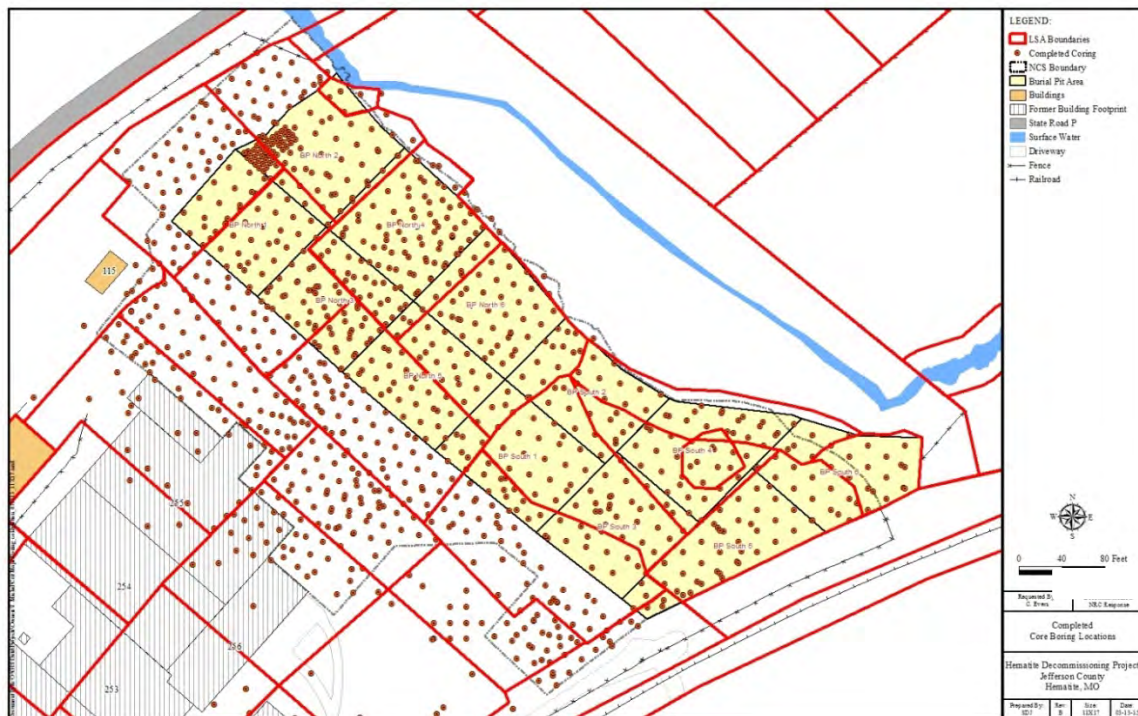
Figure 11
Core Bore Locations that were Performed for Nuclear Criticality Safety Control Purposes

These core bores were systematically placed based on a 20 foot grid, eventually covering the entire Burial Pit Area. Core cuttings and the core bore hole were surveyed to provide radiological data to make a determination whether NCS controls could be suspended for that SU. The data was evaluated against pre-determined NCS Limits. The core cuttings were evaluated against a saturated soil value of 46k net counts per minute (ncpm), and the core bore holes were evaluated against a dry soil value of 63k ncpm. If the core bore data

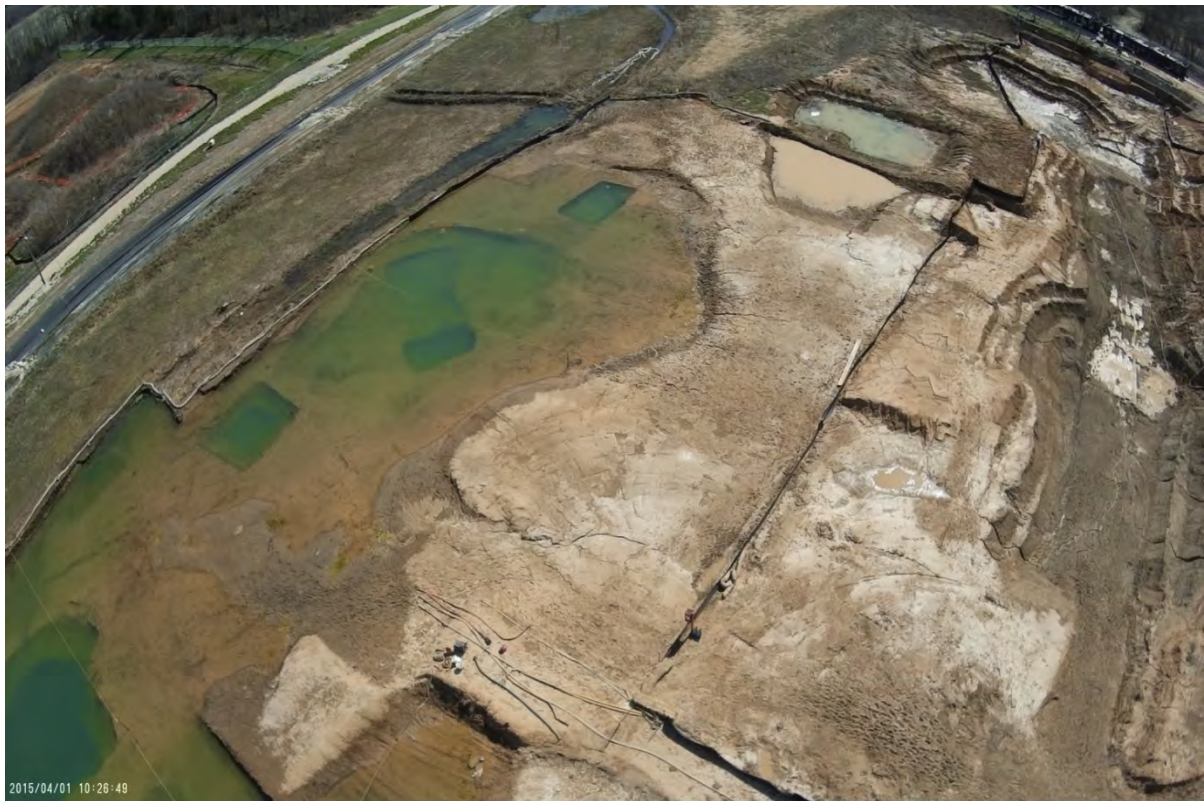
Figure 14 provides an aerial view of most of the Burial Pit Area taken on April 1, 2015. The photograph was taken after all remediation activities, both radiological and chemical, were completed. While a portion of the area had filled with water following the completion of excavation activities, the change in water color with depth helps visually identify the change in depth and extent of some of the excavated areas. The large excavation identified in the lower-left corner of Figure 14 is where a large number of burial pits were located in close proximity, and is near where the radium plates were found. The Burial Pit Area will be backfilled with clean soil from offsite and the site topography restored prior to license termination.

Figure 14
Aerial View of a Portion of the Burial Pit Area Post Remediation Looking West to East
