United States Nuclear Regulatory Commission Official Hearing Exhibit In the Matter of:	CROW BUTTE RESOURCES, INC. (License Renewal for the In Situ Leach Facility, Crawford, Nebraska)	Identified: 8/18/2015 Withdrawn: Stricken:
	ASLBP #: 08-867-02-OLA-BD01 Docket #: 04008943 Exhibit #: NRC-054G-00-BD01 Admitted: 8/18/2015 Rejected: Other:

## 25DW362 (2368-S008)

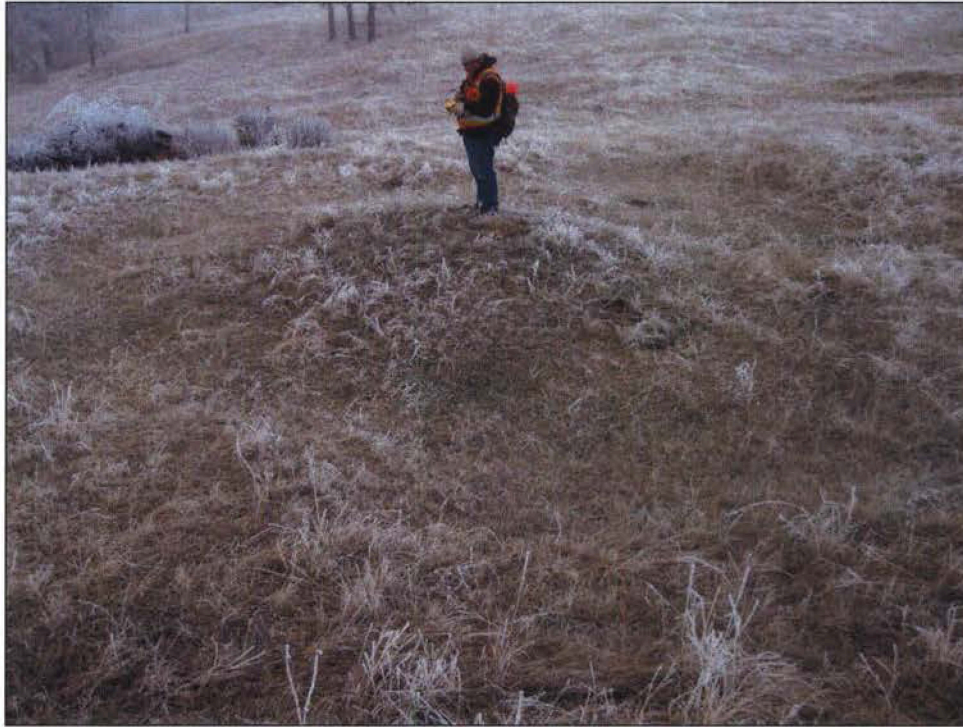
Figure 63. 25DW361 Feature F8, dirt mound, facing west. Photograph taken by Shane Rosenthal, on 11/20/2010.

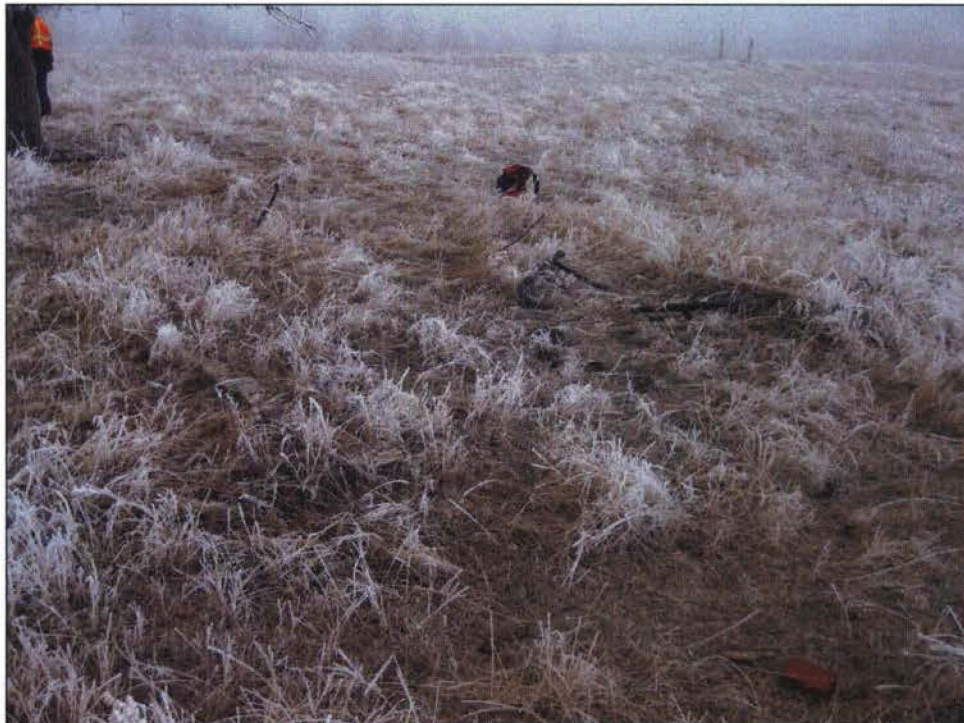
Figure 64. 25DW361 Feature F9, small foundation, facing east. Photograph taken by Shane Rosenthal, on 11/20/2010.

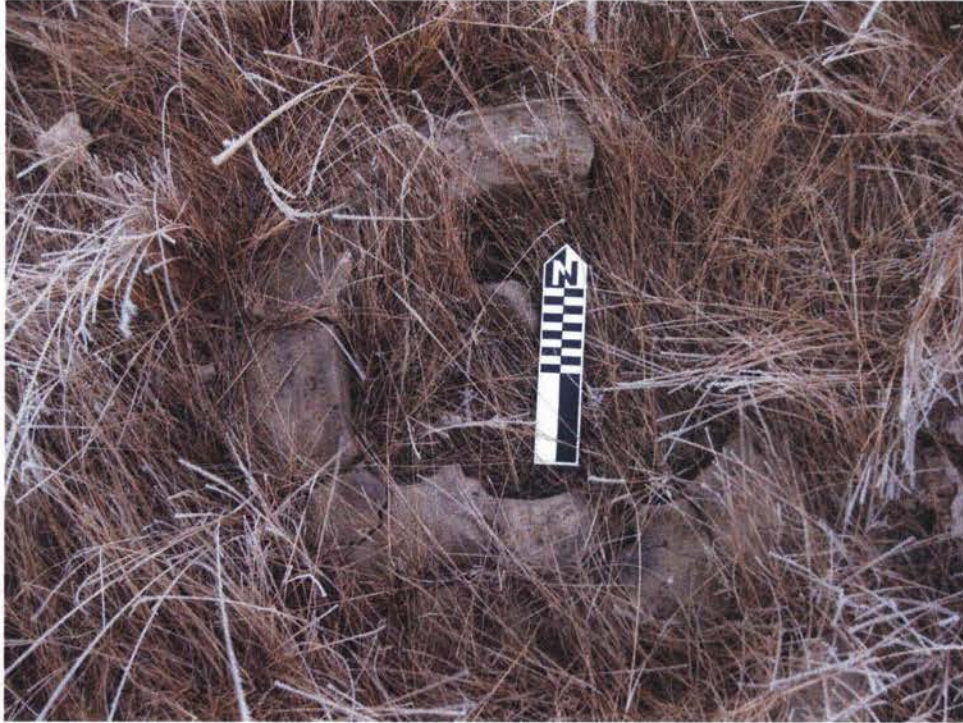
Figure 65. 25DW361 Feature F10, cement circle, facing north. Photograph taken by Shane Rosenthal, on 11/20/2010.

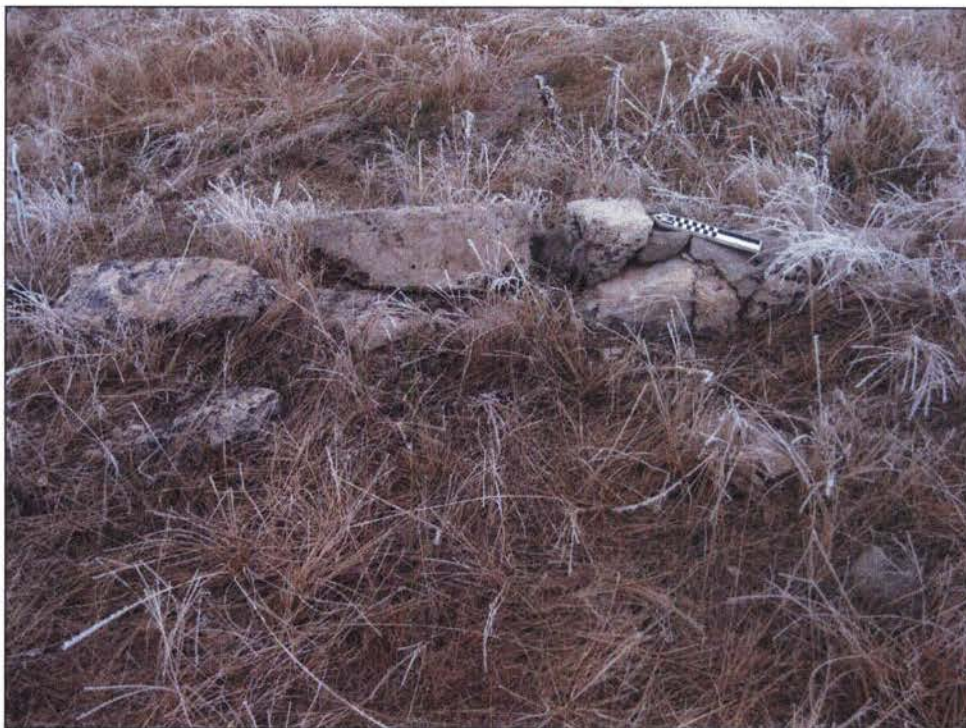
Figure 66. 25DW361 Feature F10, west wall, facing west. Photograph taken by Shane Rosenthal, on 11/20/2010.

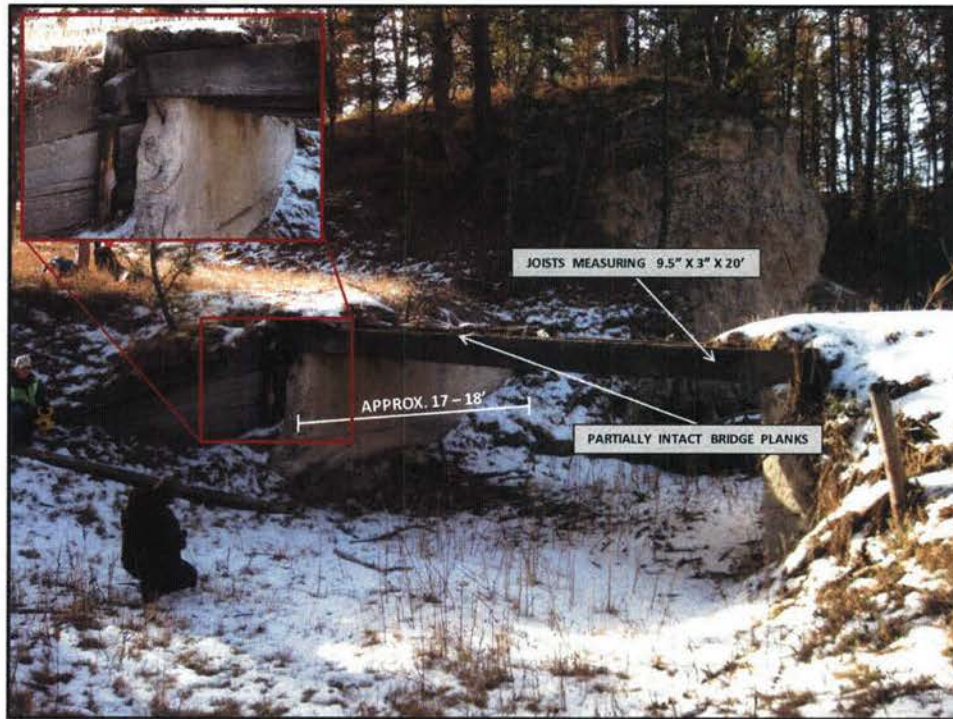
Site 25DW362 is a historic bridge located in Section 36T30N R51W, at a narrow crossing above an intermittent stream 68 feet west of Squaw Mound Road (**Figures 68 and 70**). The site measures 126 feet by 126 feet and covers an area of 12,206 square feet. Vegetation consists of ponderosa pine forest and mixed grasses affording 70 percent bare ground visibility. Impacts to the site include historic ranching and farming activities throughout the area and wind and water erosion. The site datum is a metal tag and GPS point attached to the north side of the eastern abutment of Feature 1.

Cultural materials include a 32-foot long beam bridge (Feature F1) that consists of a wooden deck and poured concrete abutments (**Figure 68 and 69**). The eastern abutment was reinforced by wooden planks extending 4 feet from the northern edge and placed against the stream bank to prevent erosion. The deck was constructed of milled joists at each end with surface planks running the span of the bridge perpendicular to the joists, of which only the northern half remains intact. No additional artifacts are associated with the structure. Several planks and other wood debris from the deck were observed down-slope in the streambed up to 50 feet north of the structure.

This historic bridge is a poorly preserved simply constructed wood plank and poured concrete structure that does not have a construction date or diagnostic artifacts associated with it or the location. National Register eligibility for any property, including historic period archeological sites, depends on integrity and significance. Integrity for a historic period archaeological site is based on the presence of features and whether or not they can tell us something about the location. Site 25DW362 does not retain enough integrity to qualify for the National Register. Lack of integrity alone, however, does not automatically exclude this site as eligible for the National Register. Significance was assessed following intensive survey and a historic records search that included a files search and architectural/structures property search conducted through the Nebraska SHPO; review of the National Register of Historic Places (NRHP) database for Dawes County, Nebraska; review of the National Historic Landmark inventory (NHL); review of General Land Office (GLO) Plats; and local literature review; that revealed sustained Euro-American historic occupation in this area occurred between 1890 to present day, and no leases or purchasers were found that can be associated with an important person or persons of "significance in history" or having an uncommon ethnic affiliation. Therefore, site 25DW362 does not possess enough significance to qualify for the National Register. ARCADIS believes this historic bridge may be the result of historic logging or ranching activities in the area as opposed to homesteading and recommends site 25DW362 **not eligible for listing on the NRHP and no further work is necessary.**

Figure 68. 25DW362, overview, facing southwest. Photograph taken by Russ Collett, on 12/02/2010.

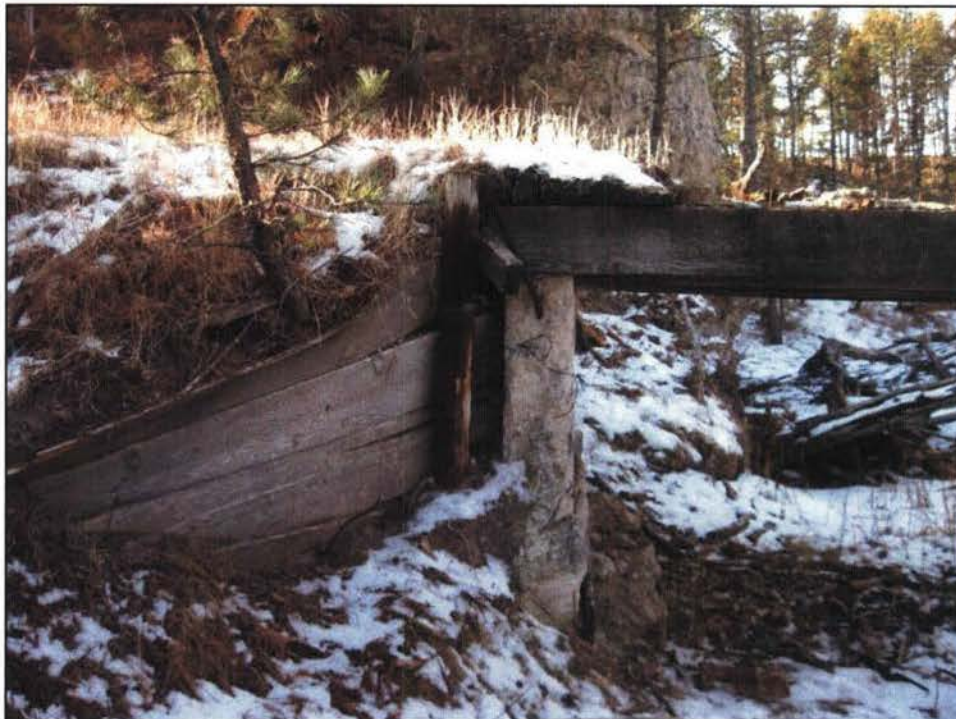
Figure 69. 25DW362, abutment construction, facing south. Photograph taken by Russ Collett, on 12/02/2010.

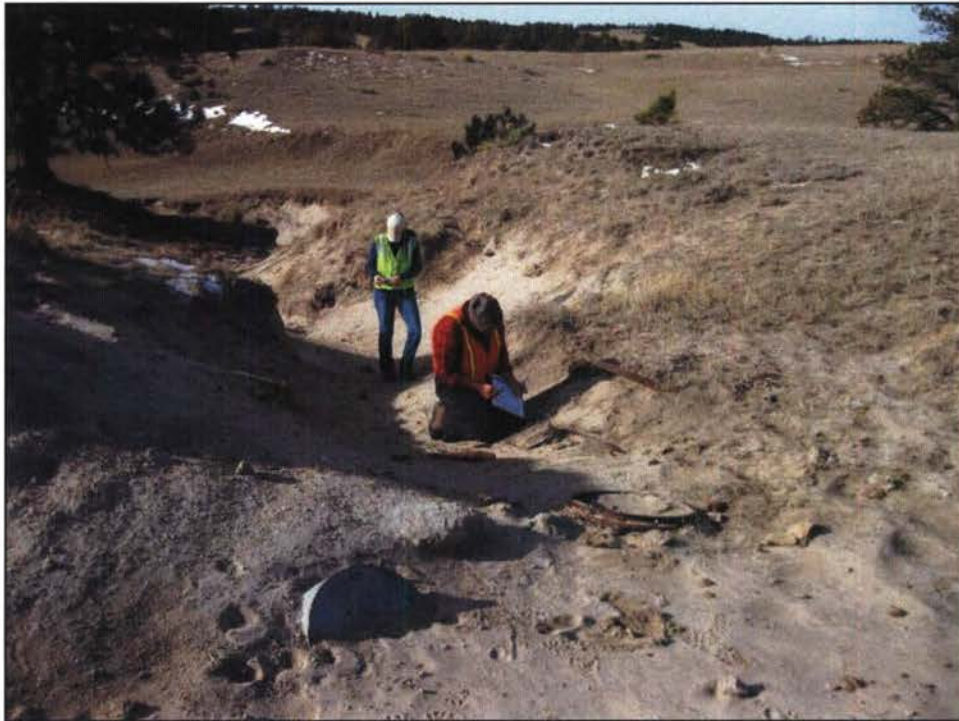
Site 25DW363 is a historic debris scatter located in Section 35 T30N R51W, in a drainage trending down-slope to the southwest and flowing into a larger south-trending drainage (**Figures 71 and 72**). The site measures 150 feet by 300 feet and covers an area of 6,564 square feet. Vegetation consists of sparse grasses and yucca above and across the drainage slopes and several ponderosa pine trees scattered along the drainage bottom affording 90 percent bare ground visibility. Sediments consist of very sandy loam intermixed with small gravels (10%) observed between zero to two meters below ground surface across the drainage cut-banks. Impacts to the site include historic ranching and farming activities throughout the area, grazing, and wind and water erosion. The site datum is a GPS point taken at the edge of the drainage along the northern site boundary.

Figure 71. 25DW363, overview, facing west. Photograph taken by Russ Collett, on 12/02/2010.

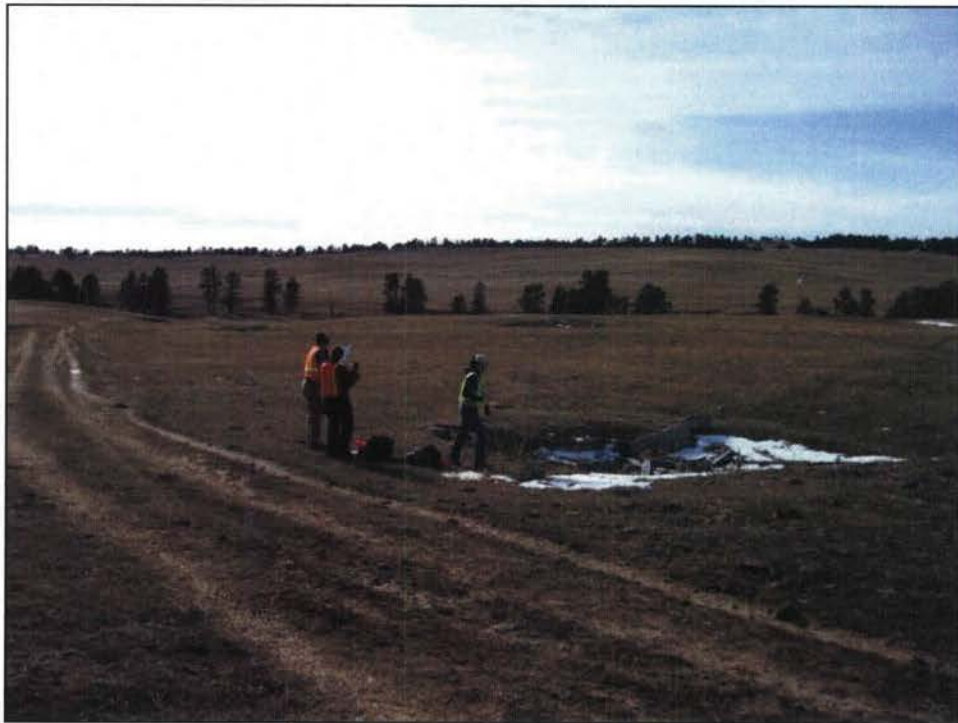
Site 25DW364 is a historic cistern and debris dump located in Section 35 T30N R51W, on a broad flat bench on the southern slope of a large northwest to southeast-trending ridge top. The cistern is located 264 feet south of a modern stock pond with an electrical water pump and is east and adjacent to a well used two track road (**Figures 73 and 76**). The site measures 78 feet by 80 feet and covers an area of 4,796 square feet. Vegetation consists of a moderate covering of grasses affording 80 percent bare ground visibility. Sediments consists of shallow sandy loam intermixed with small gravels (10%) as observed across slope and along two-track road. Impacts to the site include historic ranching and farming activities throughout the area, grazing, and wind and water erosion. The site datum is a GPS point at the southeast corner of the cistern feature.

Figure 73. 25DW364, overview, facing southwest. Photograph taken by Russ Collett, on 12/02/2010.

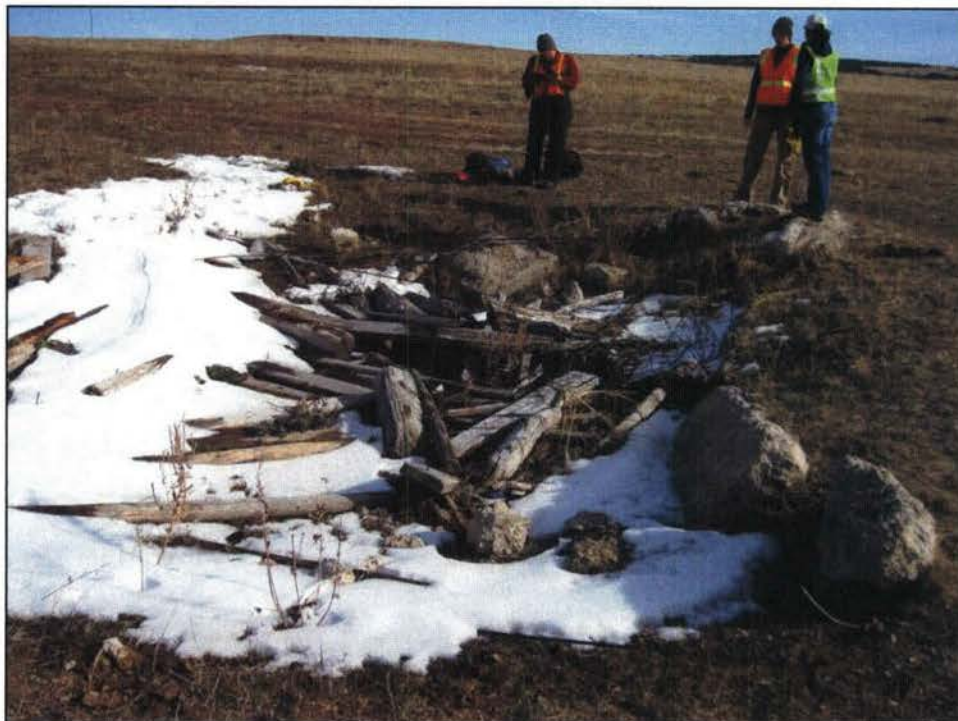
Cultural materials include one rectangular cistern feature filled with historic debris (**Figure 74**). Feature F1 is approximately 21 feet north to south by 17 feet east to west and approximately two feet deep. F1 is composed of poured concrete support walls (**Figure 75**) and a metal pipe set into a small round concrete block (3 feet diameter). All support walls have partially collapsed and F1 has been filled with miscellaneous ranching debris that includes wooden planks, wooden fence posts, metal wind mill parts, and barbed wire.

Figure 74. 25DW364 Feature F1, cistern, facing east. Photograph taken by Russ Collett, on 12/02/2010.

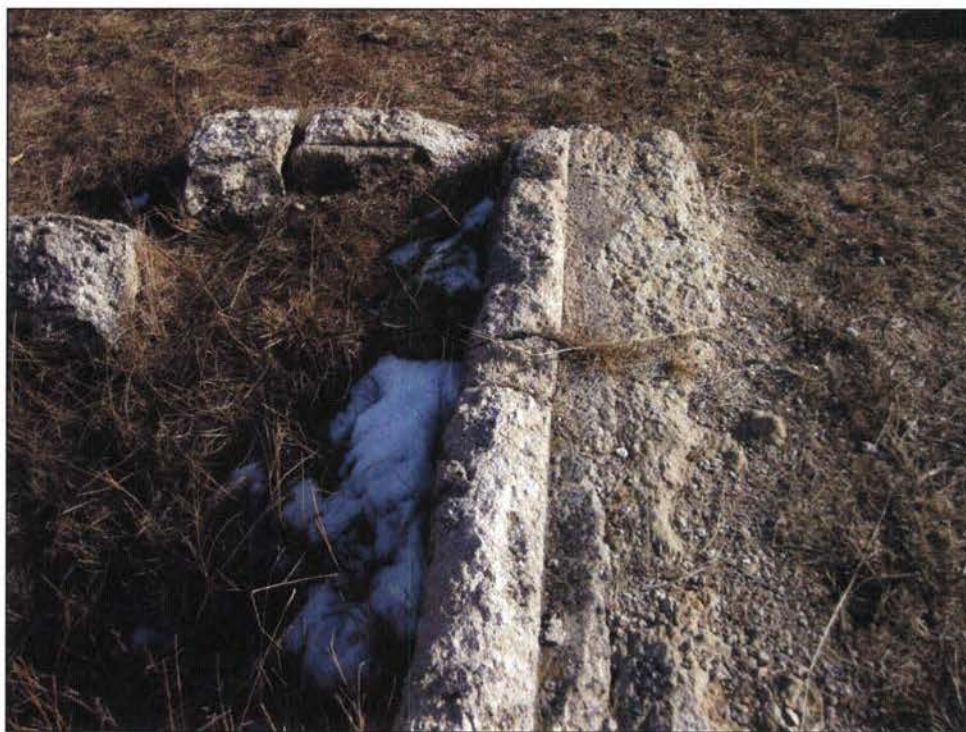
Figure 75. 25DW364 Feature F1, southeast corner of cistern support walls, facing east. Photograph taken by Russ Collett, on 12/02/2010.
