Fermi 3
Updated Final Safety Analysis Report

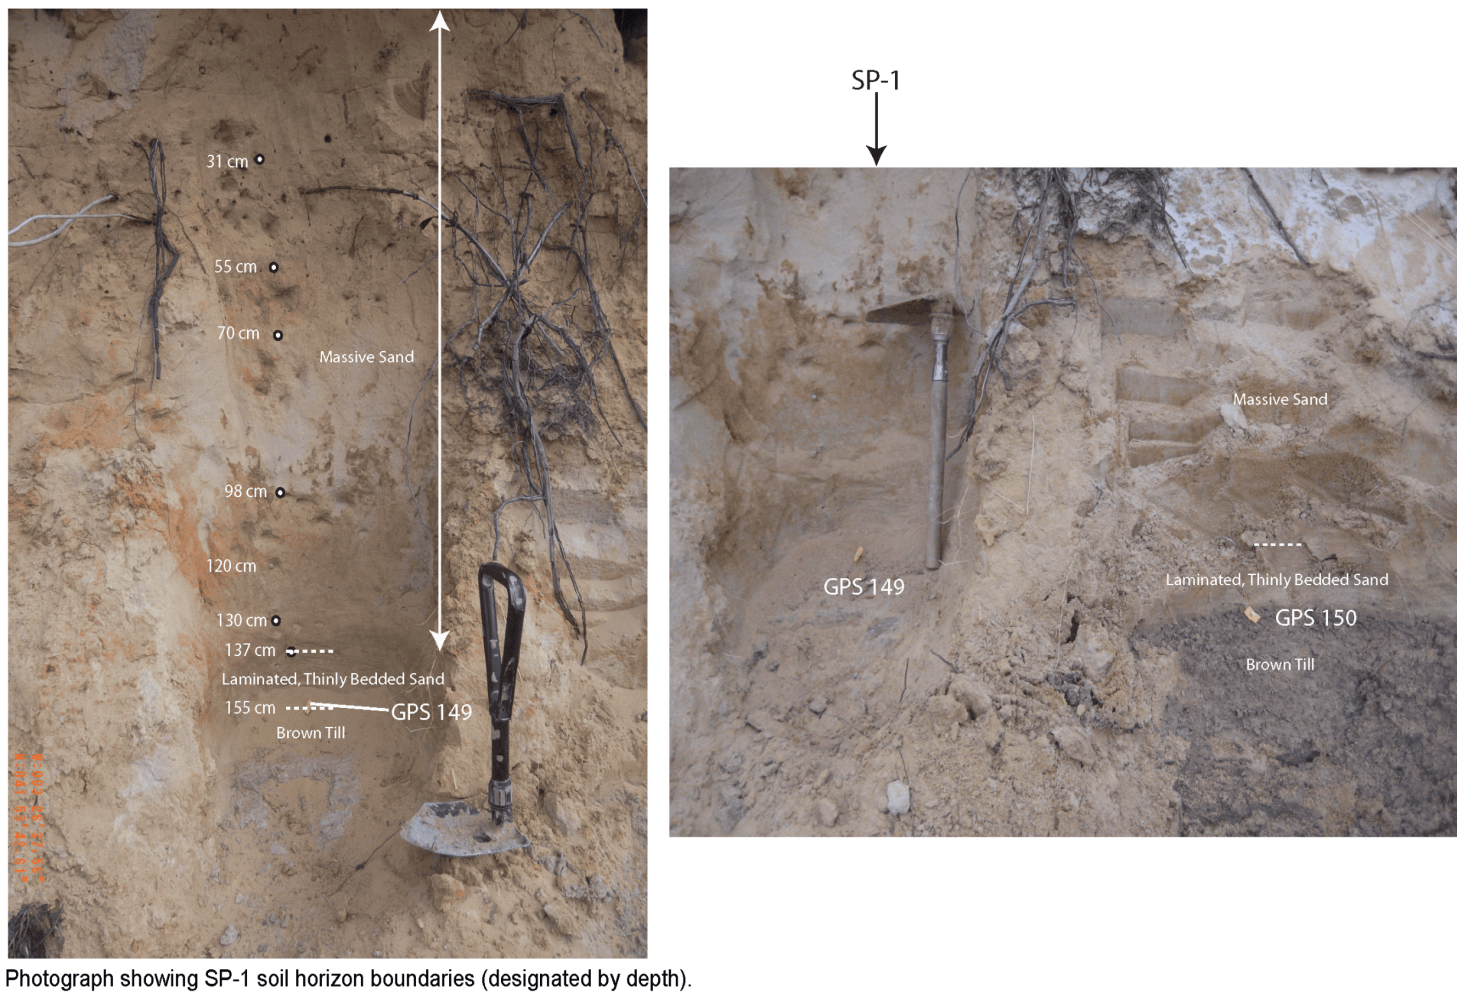
Figure 2.5.1-259 Denniston Quarry: Soil Profile SP-1 in Quaternary Excavation QE-1

Photograph showing SP-1 soil horizon boundaries (designated by depth).
