SUBJECT: TRIP REPORT

**BEATTY, NEVADA SITE VISIT
NOVEMBER 4-5, 2015
TRIP REPORT**

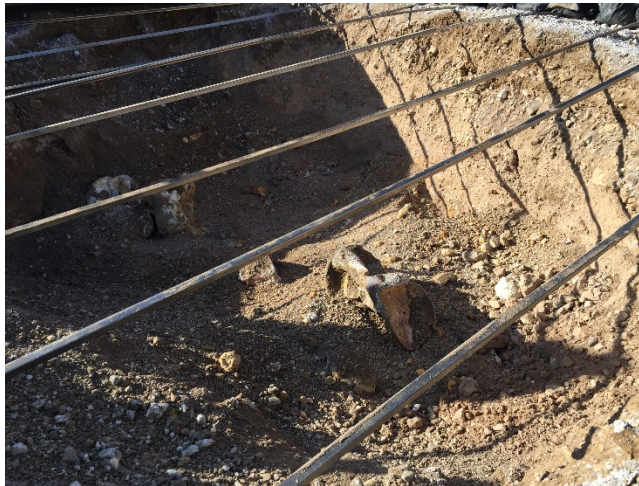
NRC staff spent the days of November 4th and 5th making observations at the site and damage to the Beatty site cover. The crater in Trench 14 was visible near the boundary of the site and, although no measurements were taken by NRC staff, was approximately 20 ft in diameter and several feet deep. It was created in the shallower portion of the trench and eleven drums were ejected from the crater. Some drums were ripped apart while others were crushed, but intact. The crater was created by a sequence of events on October 18th the consisted of white smoke, flames, violent expelling of material, material collapsing back into the crater, and subsequent cycle beginning again. The results of several surveys and samples taken at the site indicated that no radioactive material was exposed in or around the crater.

Crater in Trench 14 with remains of drums

At the close-out meeting, participants discussed various types of engineered surface covers that should replace the current one. NRC staff recommended that the State of Nevada should consider temporary repairs to the existing cracks, subsidence areas, and crater. These areas could be backfilled with soil and graded to promote runoff and minimize the potential for water to penetrate the existing cover. NRC staff had observed that the polyethylene sheets had been spread over the crater and the larger subsidence depressions in and near Trenches 14 and 20 to shield them from the weather and potential new rainfall. NRC staff recommended incorporating the polyethylene sheets with a temporary cover, i.e., backfilling the depressions and holes and leaving the sheets in place to provide additional protection from water intrusion if another significant rainfall event were to occur and minimizing the potential of additional precipitation from reaching inside trenches. In addition, NRC staff recommended that the sodium hydroxide be removed from the surface of Trench 14 as soon as possible. Dissolution of sodium hydroxide is highly exothermic, and the resulting heat may cause heat burns or ignite flammables. Removal would reduce the chance of exposure at the ground surface and also avert sodium from seeping back down into the trench with waste.

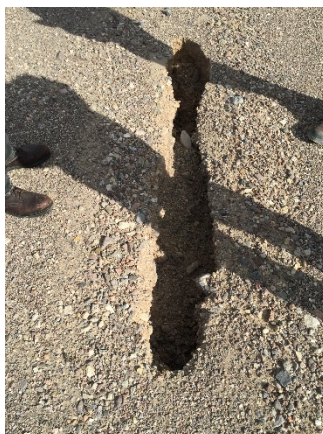
Aside from the crater at the end of Trench 14, NRC staff observed several other issues related to the earthen barrier covering the trenches at the Beatty site including linear cracks near the edge of trenches, sinkhole-type openings, and areas of subsidence. Long linear cracks were observed along what appeared to be the edge of Trench 22. These cracks likely originated along the interface of the trench fill and the non-trench material and then propagated toward the surface.

Various hypotheses were proposed for the existence of the linear cracks: The linear cracks could result from differential settlement between the waste within the trench and native soil adjacent to the trench. It was also hypothesized that different properties of the trench material and the material outside the trench lead to differences in expansion and contraction rates between the two material during periods of desiccation and rewetting. It was also mentioned that the Beatty area suffered from numerous smaller earthquakes with a magnitude range between 2 and 5 which could also contribute to either the cause or size of the cracks.

Linear cracks or fissures

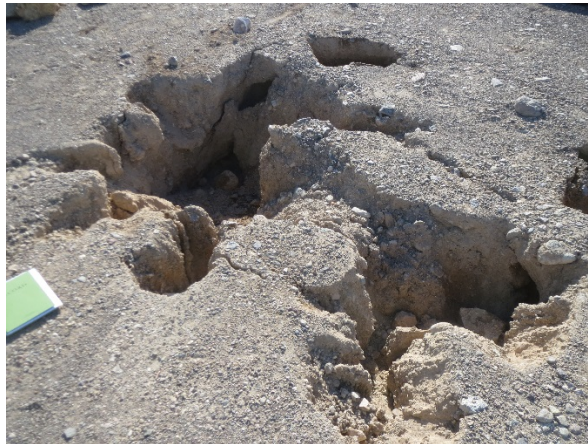
Trench 20 had evidence of subsidence, however the subsidence was more similar to that of a sinkhole-type subsidence, i.e., no visible depression except for the holes on the surface. Subsurface cavities in the trenches may have formed and increased in size so that the cavity roof lost support and cover material near the surface fell downwards into the cavity. None of the small channels that formed during the rain event seemed to flow towards the sinkhole-type subsidence. The holes were deep and the bottom was not visible.

Sinkhole-type subsidence

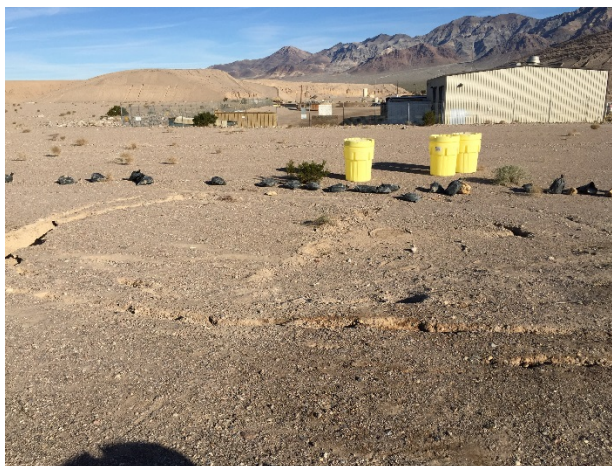
In contrast, the large subsidence depression near the middle of Trench 14 had numerous rivulets from the surrounding cover terminate in it so that much of that water may have flowed into Trench 14 through the cracks that were visible around the depression, or by ponding and infiltration. The crater was downgradient from this depression, so it would have been possible for rainwater that had entered at the depression to have moved downgradient within the trench towards the waste at the end of Trench 14 near the boundary.

Large subsidence or depression
