Oconee Nuclear Station

Technical Discussion on Cable Testing and Proposed Modifications
December 15, 2015

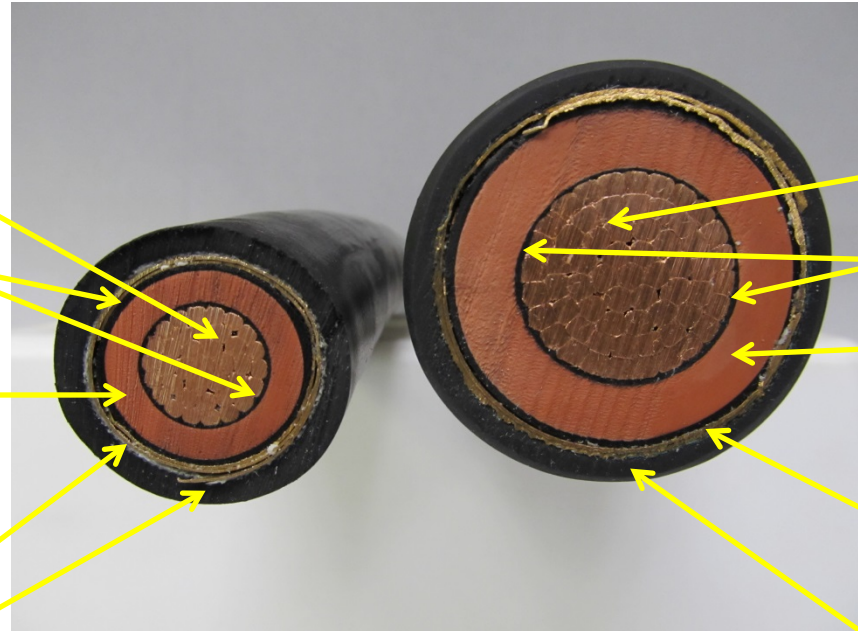
Description of Okonite Medium Voltage Single Conductor Cables

Cable nominal voltage
L-L = 4.16 kV; L-N = 2.4 kV

250 kcmil copper conductor

Semiconducting strand and
insulation shields

140 mils EPR insulation
5 kV nominal at 173% insulation
level (8 kV)

Two 10 mil layers bronze tape
shield

80 mils CSPE jacket

Cable nominal voltage
L-L = 13.8 kV; L-N = 8 kV

750 kcmil copper conductor

260 mils EPR insulation
15 kV nominal at 173%
insulation level (25 kV)

110 mils CSPE or TS-CPE jacket

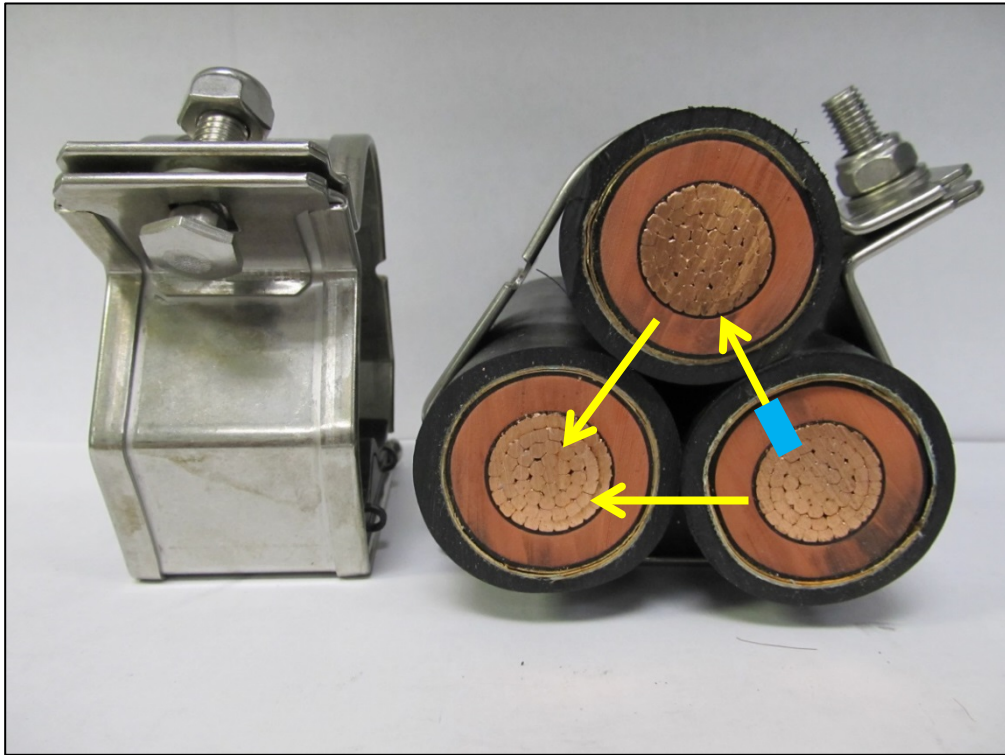
Cable Cleat With 750 kcmil Cables and Diagram of Postulated Fault Paths

■ L-N Fault Path

■ L-L Fault Paths

Initial fault path created by cutting and folding back jacket, drilling hole through bronze tapes and insulation. Copper wire was inserted to create bolted L-N fault and jacket taped back into place. Cable cleats and fault orientation ensure worst-case for direct impingement of fault on adjacent cables.

Sequence of Events for Three-Phase L-L Fault:

1. Purposely induced L-N fault penetrates cable jackets.
2. Fault penetrates both layers of grounded bronze tapes on adjacent cables.
3. Fault penetrates insulation to conductor on adjacent cables.
4. Three-phase L-L fault occurs prior to protective relaying and breaker detecting and clearing the fault (0.0717 – 1.18 seconds)

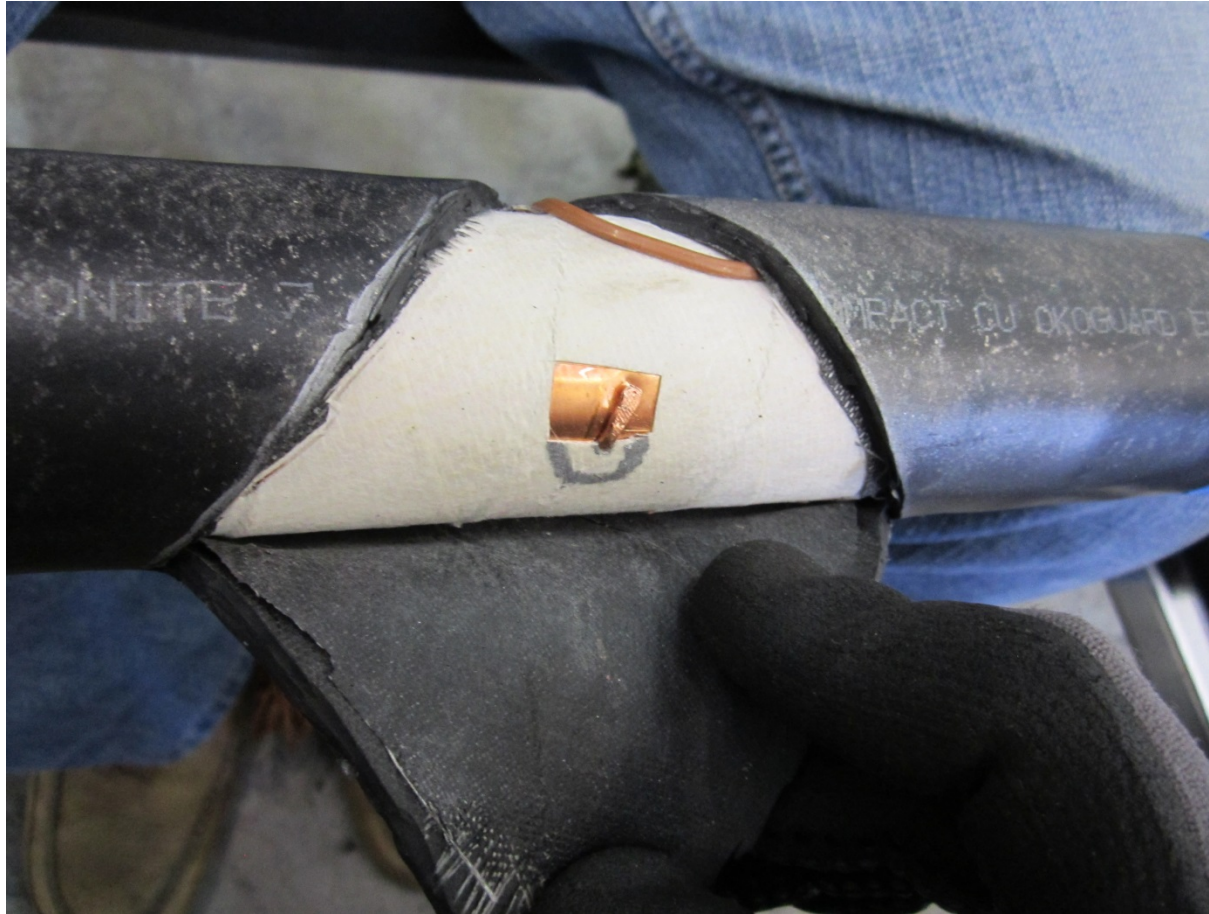
Cable Fault Testing

Fault initiation method developed with assistance from Okonite.

Cable jacket flap cut back to allow hole to be drilled through bronze tape and insulation to conductor.

Copper wire inserted through hole to create L-N fault path from conductor to bronze tape shield. #18 AWG wire used for low current L-N faults; #12 AWG wire used for high current L-N faults.

Jacket folded back and taped with Scotch 88 vinyl tape and Scotch 69 glass cloth tape.

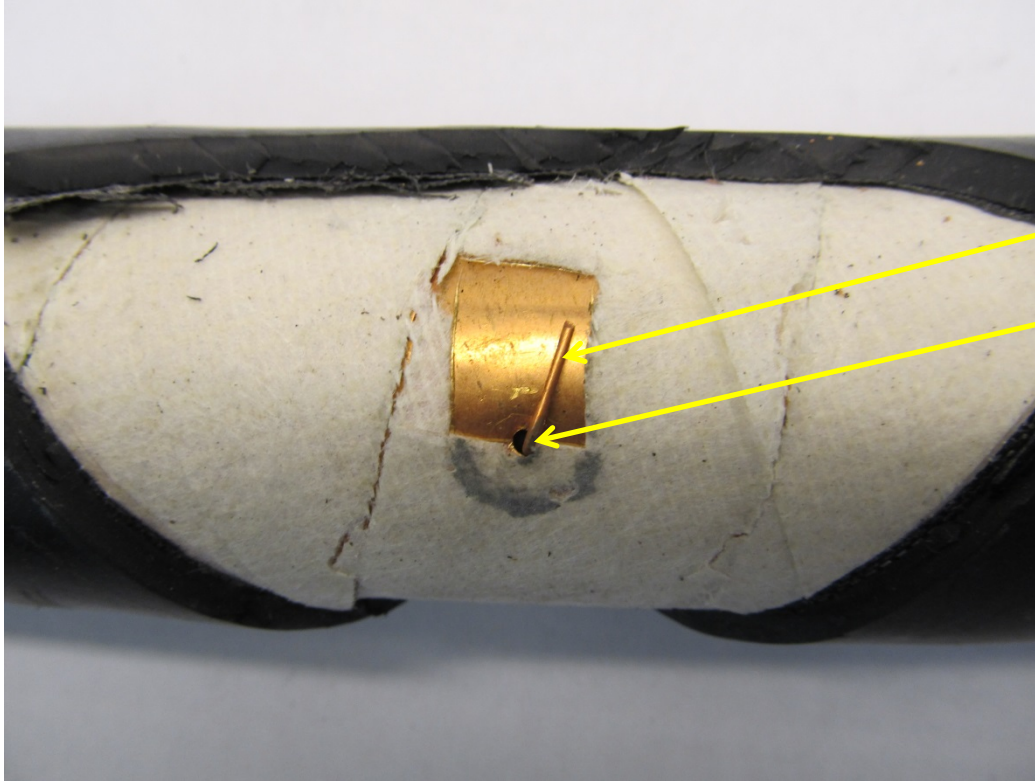
Typical Post-Fault Cable From CT4 and KPF Tests

Faulted Cable From Test 5 (CT4)

- Keowee power source parameters with neutral resistance grounding (limited L-N fault current)
- #18 AWG wire provided bolted fault path from conductor to bronze tape shield
- Hole drilled through both layers of bronze tape and insulation to conductor
- No evidence of overheating
- Conclusion: Power sources with neutral grounding resistors limit equipment damage.

- Total of 21 tests conducted
- Test configurations CT4 and KPF using electrical parameters of the Keowee-fed resistance grounded power source resulted in no visible damage or overheating to the fault area beneath the faulted cable jacket. The faulted cable jacket was not breached and there was no damage to adjacent cables.

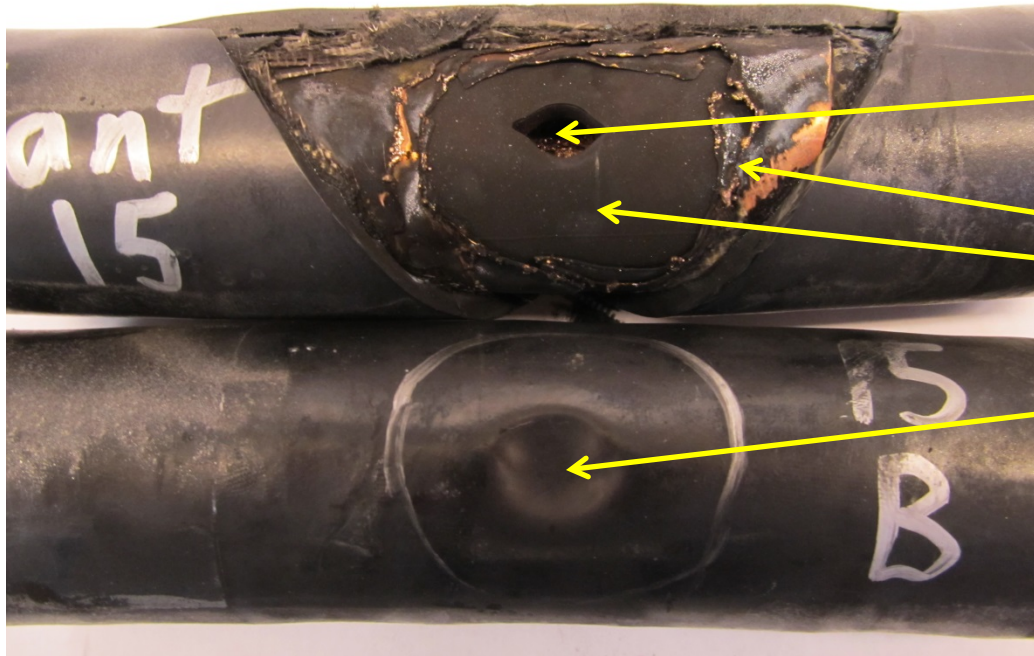
Typical Post Fault Cable From Fant Tests

Faulted Cable From Test 15 (Fant)

- Fant power source with solid grounding (large L-N fault current)
- Fault enlarged drill hole and vaporized #12 AWG wire. Partially melted 750 kcmil conductor is visible beneath hole.
- Bronze tape has been melted or vaporized
- Semiconducting layer
- Adjacent cable directly over fault has been dented. The jacket was not breached.
- L-N faults on solidly grounded power systems result in greater damage compared to resistance grounded systems.

- Test configurations Fant and CX using electrical parameters for solidly-grounded power sources resulted in significant damage to faulted cable. Affects on faulted and adjacent cables included:

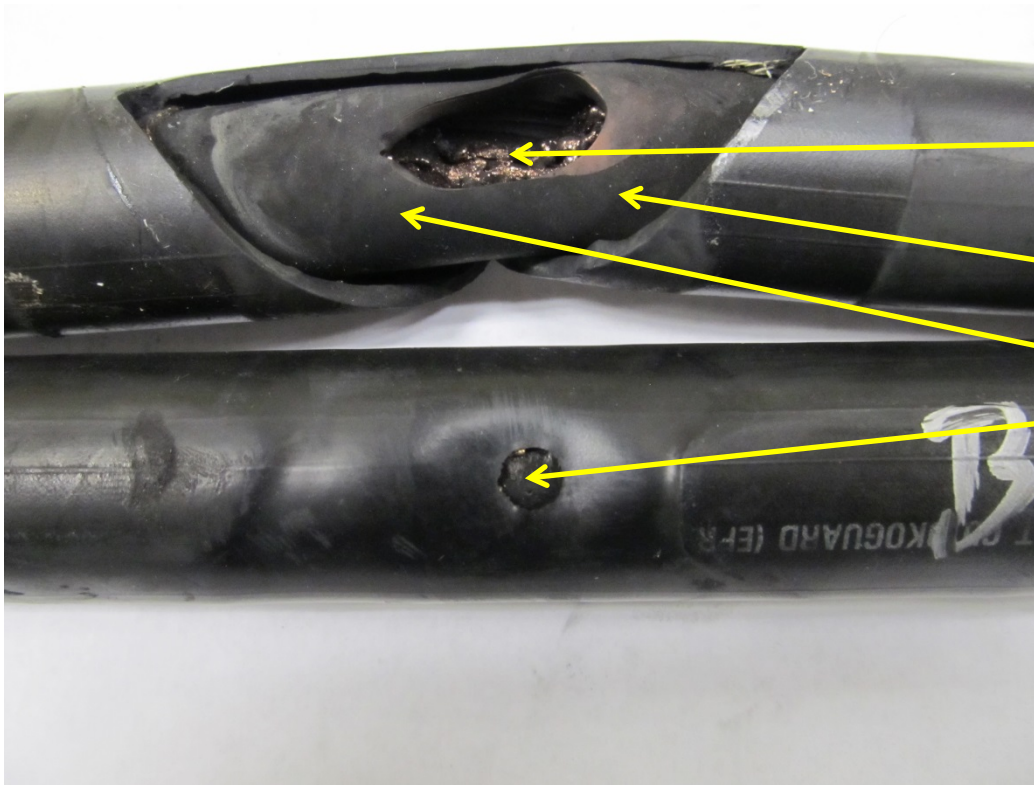
Post Fault Cable From CX Tests

Faulted Cable From Test 18 (CX)

- Switchgear 1TC power source with solid grounding (large L-N fault current)
- Fault significantly enlarged drill hole and vaporized #12 AWG wire. Partially melted 250 kcmil conductor visible beneath hole.
- Bronze tape has been melted or vaporized around entire cable circumference.
- Semiconducting layer
- Adjacent cable directly over fault has 0.25 inch hole through jacket and bronze tapes.
- Most significant damage to adjacent cable of all 21 tests, but did not result in a L-L fault.
- Adjacent cable passed a post-test VLF/Tan Delta withstand of 7.0 kV for 30 minutes.
- CX test parameters had largest L-N fault current for longest duration compared to the other three tests configurations.

- Soot deposits on faulted and adjacent cables,
 - Some adjacent cable jackets were indented but the jacket was not breached, except for one test,
 - For Test 18 (CX), one adjacent cable had a 0.25 inch circular hole through the jacket and both layers of bronze tape. Despite the damage, this cable successfully passed a 7.0 kV VLF withstand test for 30 minutes, demonstrating significant margin in Duke cable design.

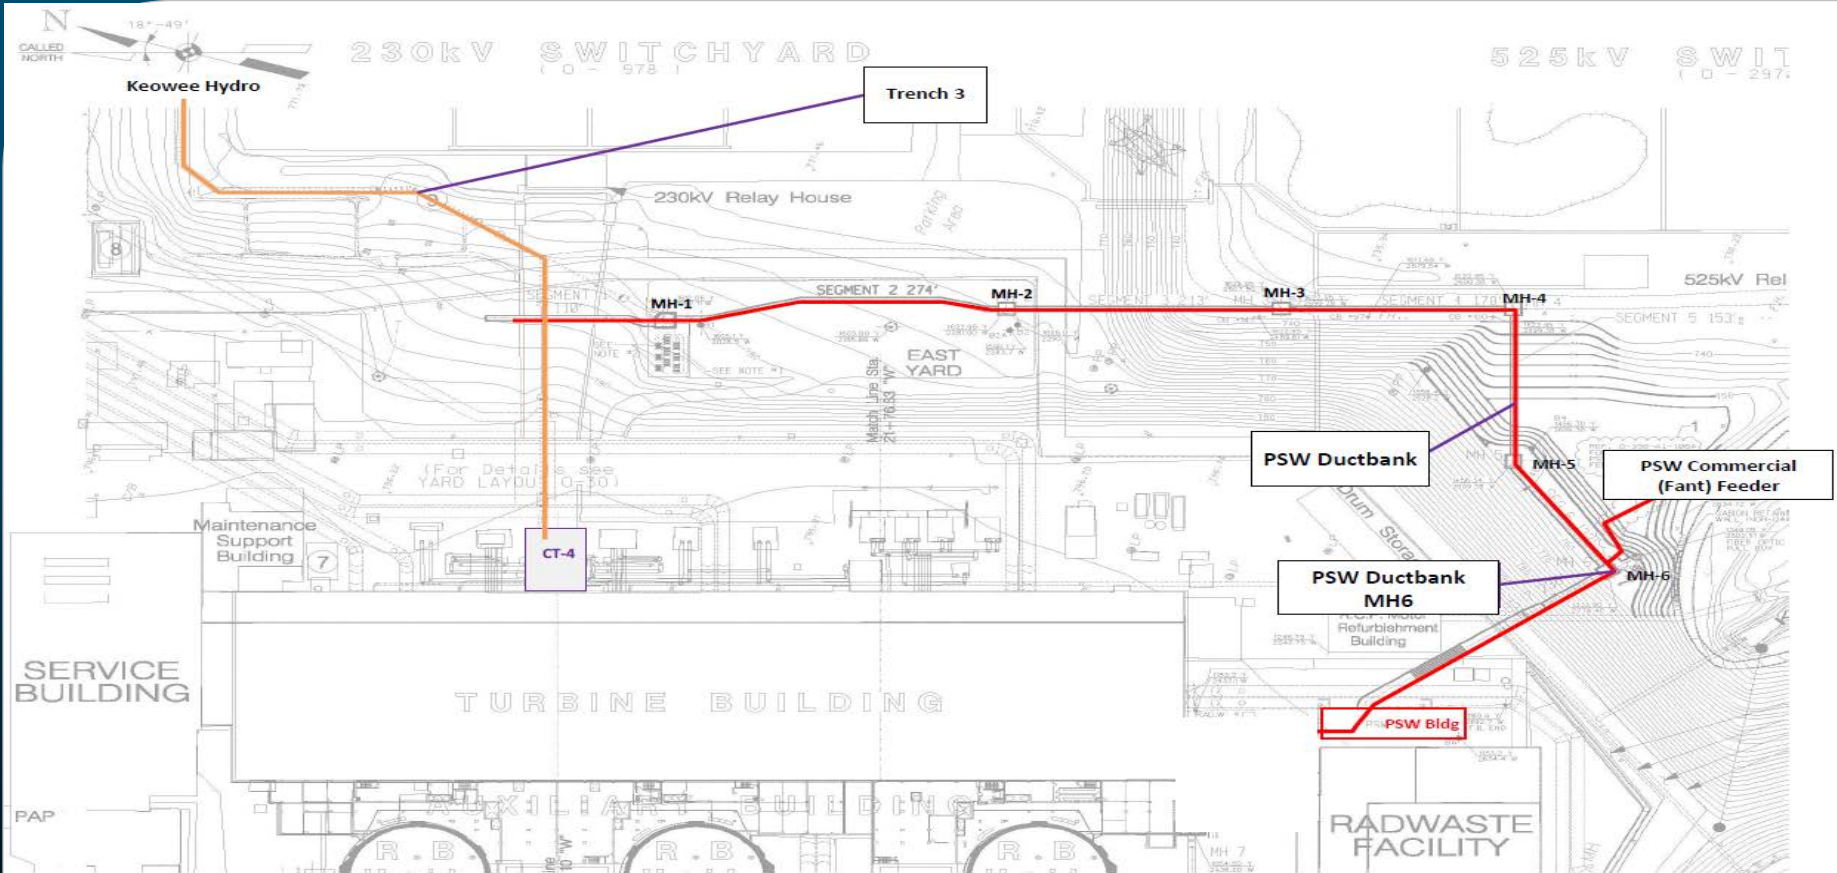
Trench 3 and PSW Ductbank Layout

Keowee Underground Power Path (Trench 3)

- Removing all low voltage control cables' circuits from Trench 3
- Functions and circuits returned to original direct buried trench cables
- Medium voltage cables remain in Trench 3

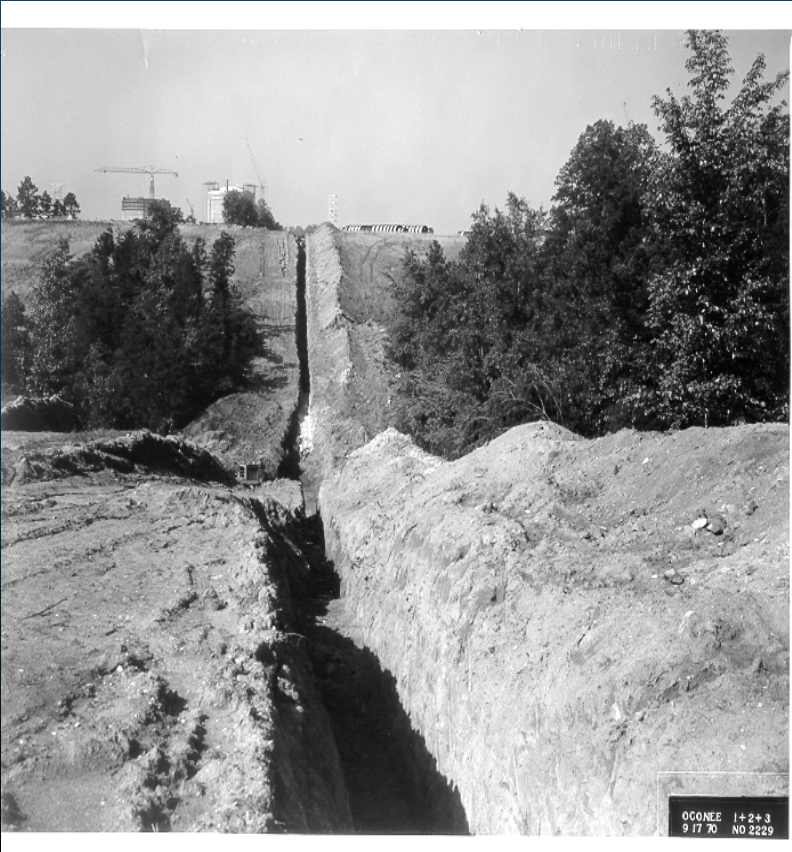
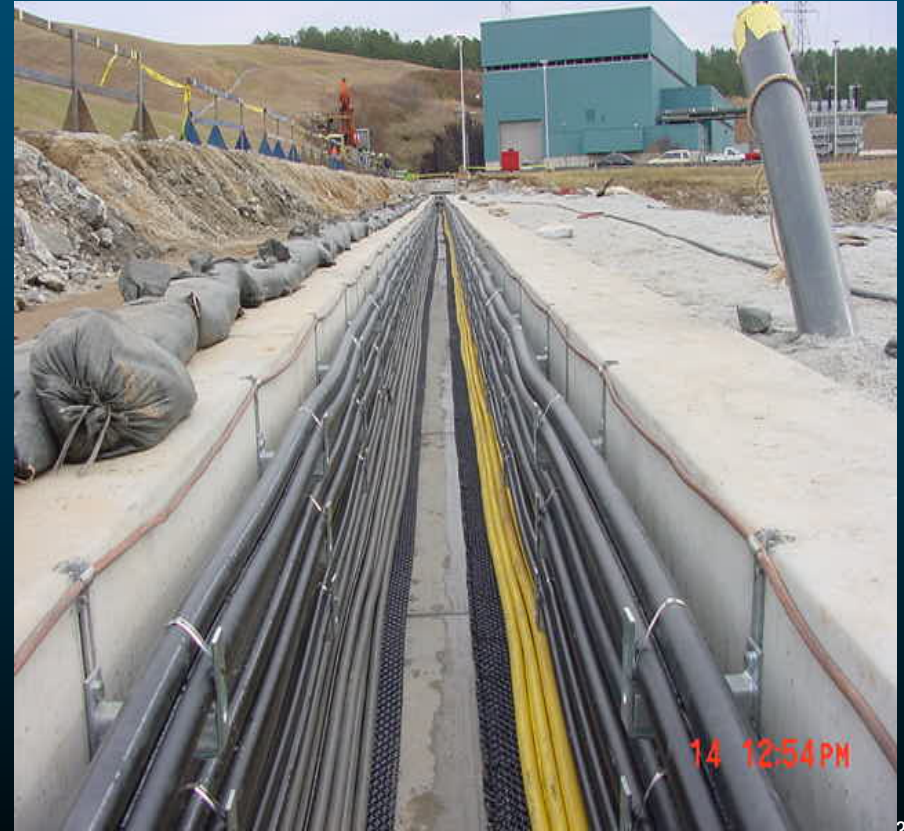
Underground Trenches

Trench 1 (2)
Original Sand Filled

Trench 3
Gray & Yellow Control Cable
Functions Eliminated

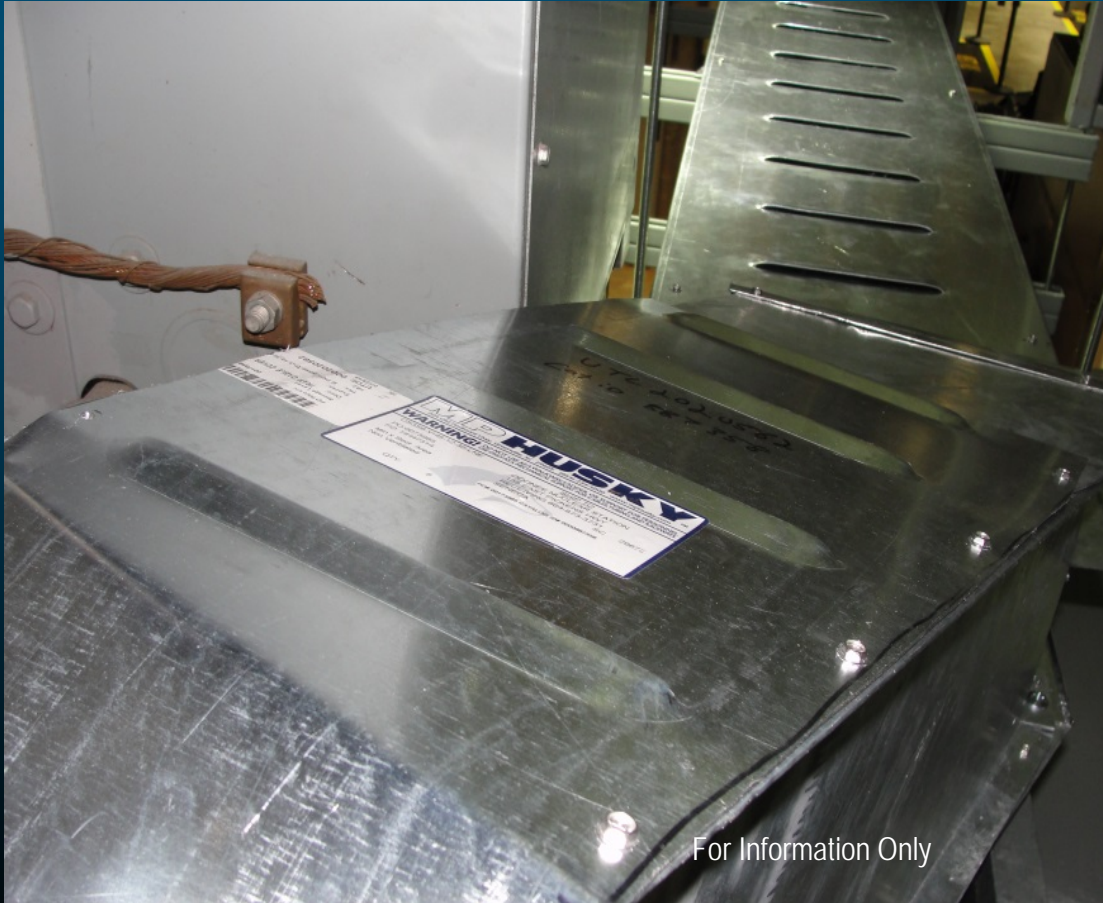
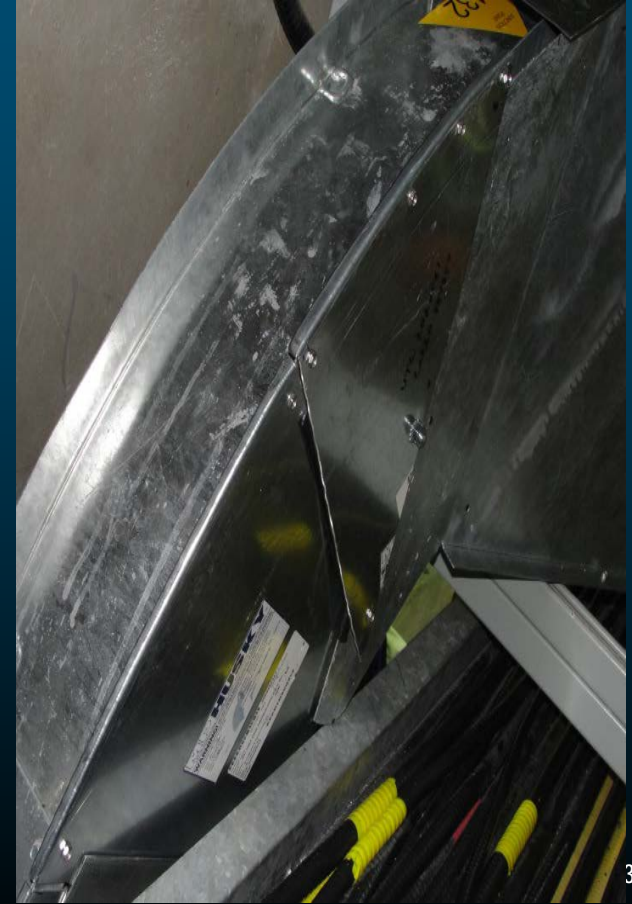
Enclosed Raceway

New covers will not be louvered.

New cable enclosures will have solid top and bottom covers.

- Proposed modifications designed to meet the separation requirements for a Limited Hazard Area as noted by IEEE 384-1992, Paragraph 6.1.4
- IEEE 384-1992 is endorsed by NRC RG 1.75, Criteria for Independence of Electrical Systems
“Conformance with the requirements of IEEE Std. 384-1992, “Standard Criteria for Independence of Class 1E Equipment and Circuits,” provides a method that the NRC staff considers acceptable for satisfying the agency’s regulatory requirements concerning physical independence of the circuits and electrical equipment that comprise or are associated with safety systems...”
- Limited Hazard Area – hazards limited to failures or faults internal to the electrical equipment or cables.
- Enclosed to enclosed configuration – identifiable housing such as enclosed raceway used for cables.

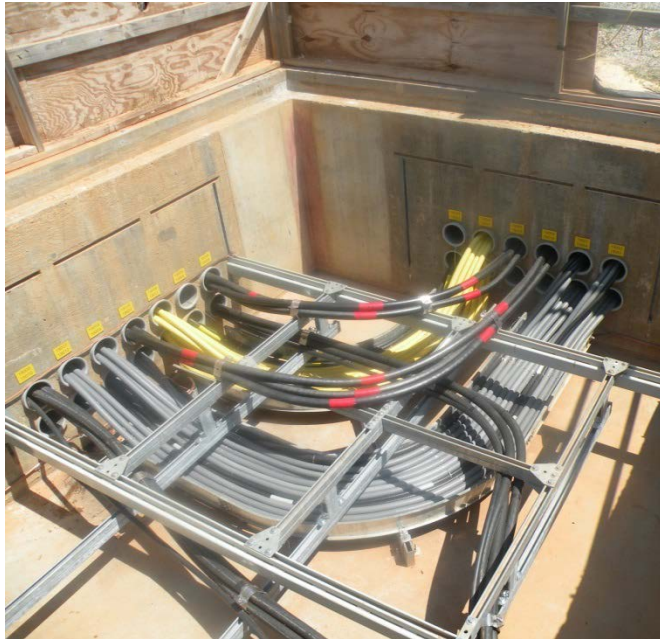
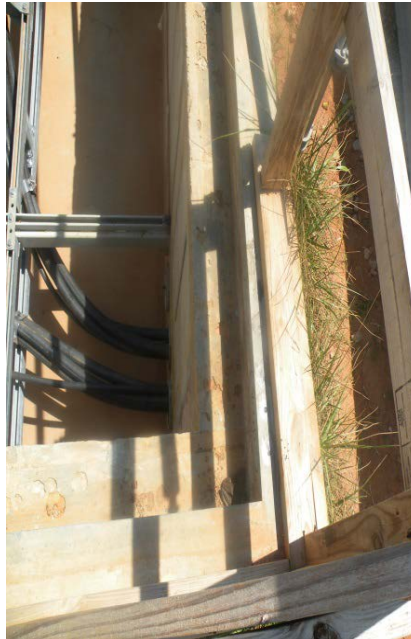
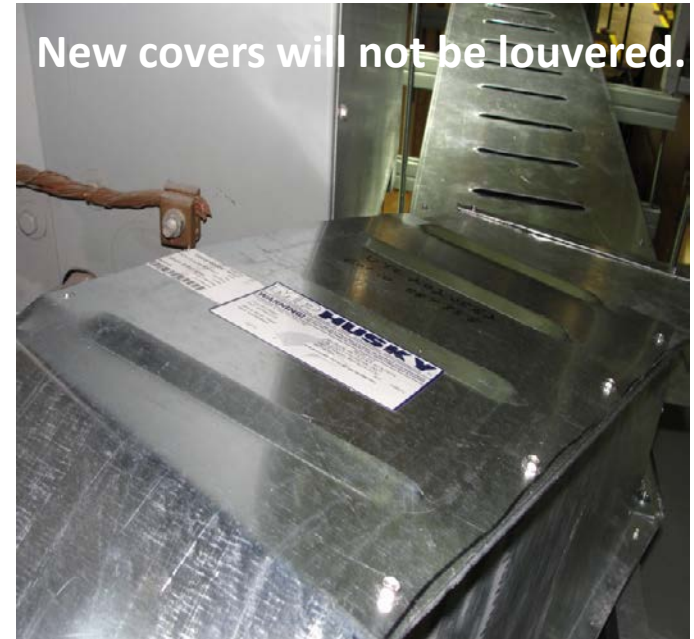
PSW Ductbank Manhole 6 (MH-6) & PSW Cable Spreading Area

- Enclosed to enclosed raceway for the gray control cables, yellow control cables and Fant Line cables
