Docket: NRC-2016-0074
 Sequoyah State-of-the-Art Reactor Consequence Analyses

**Comments on the NRC's draft technical report titled
"State-of-the-Art Reactor Consequences (SOARCA) Project:
Sequoyah Integrated Deterministic and Uncertainty Analyses"
(March 2016) for the NRC public meeting in Soddy-Daisy, TN**

**David Lochbaum
Director, Nuclear Safety Project**

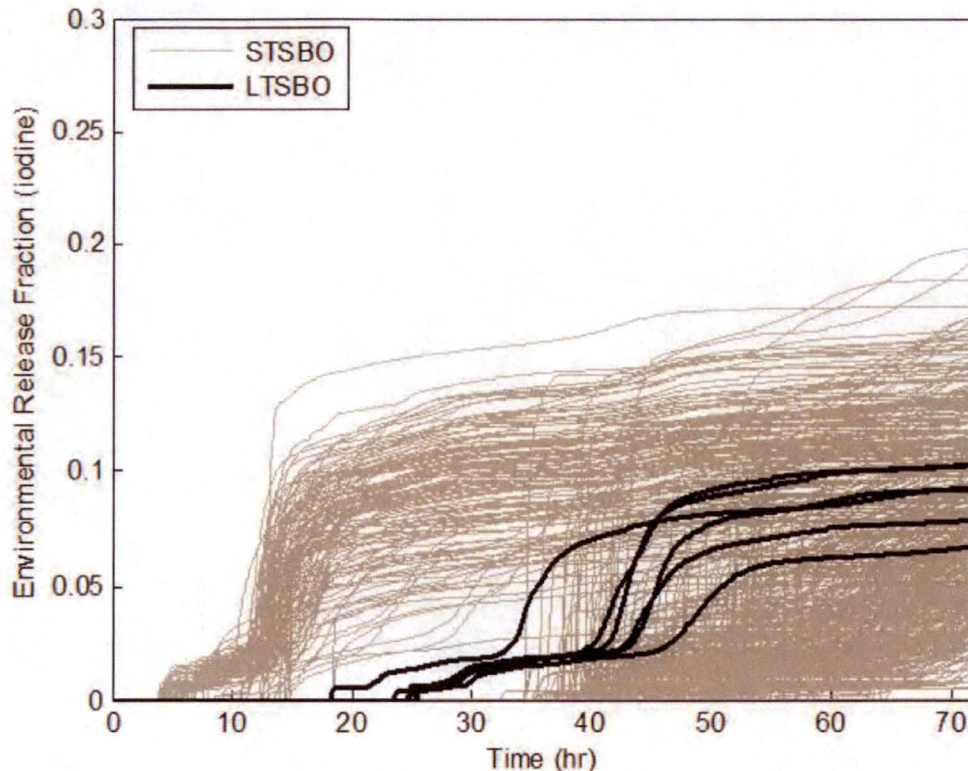
Figure ES-2 Iodine release to the environment for variations of unmitigated STSBO and LTSBO

The draft report considered that a beyond design basis earthquake caused the loss of all alternating current electricity at Sequoyah, an event termed a Station Blackout (SBO). The draft report considered two SBO cases: a long term station blackout (LTSBO) where the turbine-driven auxiliary feedwater pumps provide makeup cooling water for the reactor cores until the batteries powering their control systems deplete, and a short term station blackout (STSBO) where the turbine-driven auxiliary feedwater pumps are not available due to failure of their associated water storage tanks. Each of these two cases is further divided into two parts: a mitigated part where workers are able to successfully deploy portable equipment and take other manual actions so as to prevent overheating damage to the reactor cores, and an unmitigated part where intervention is unsuccessful and damage to the reactor cores occurs with release of radioactivity to the environment.

The draft report concludes that even in the worst case among the scenarios considered (the STSBO with releases occurring in as little as about four hours after the earthquake), there will be very little radiation exposure by members of the public, and therefore minimal harm. The postulated releases of radiation are so high that if people do not evacuate in time, considerable harm can result.

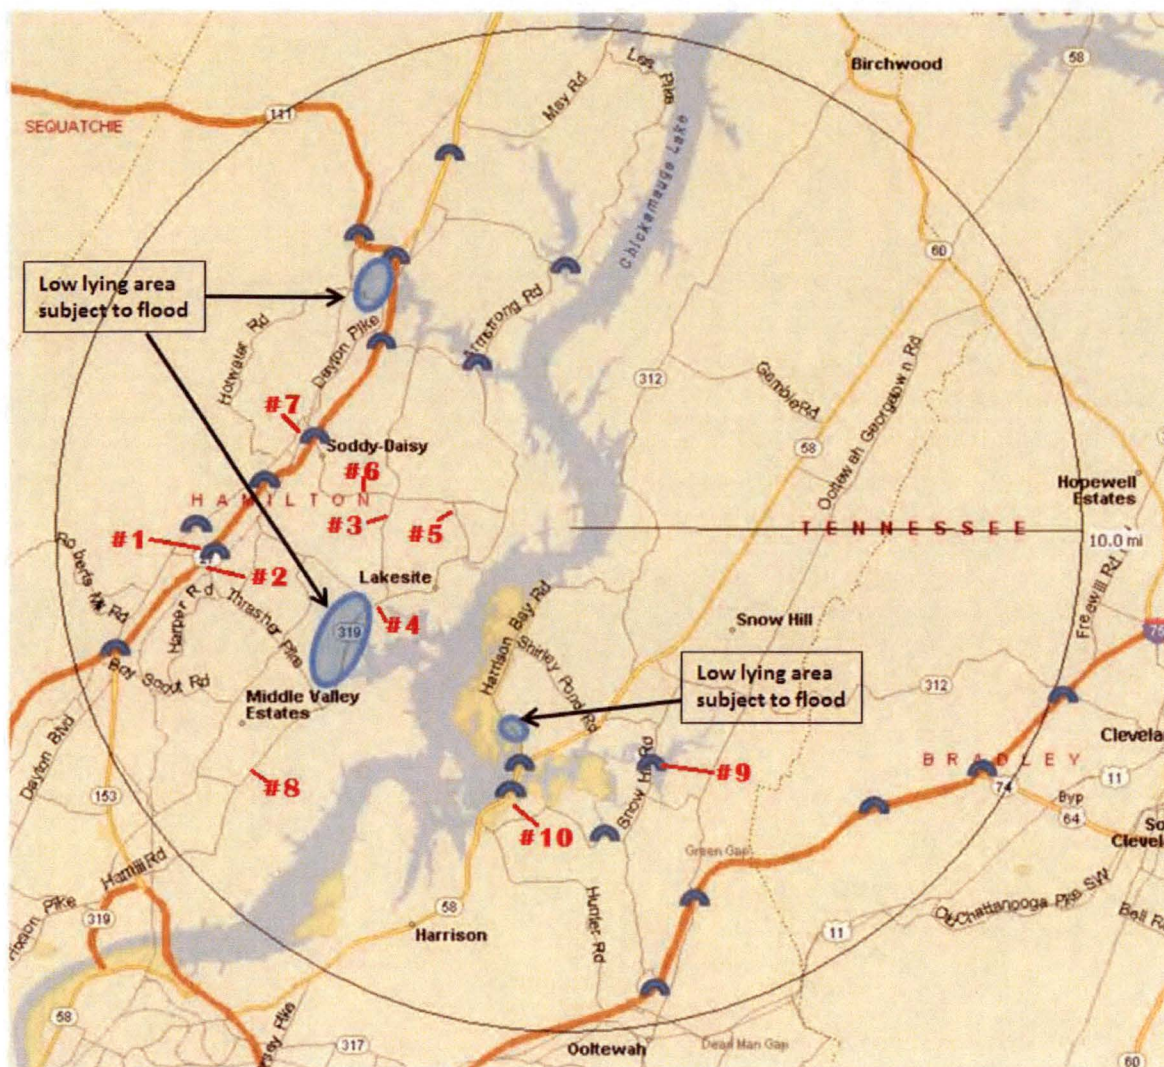
Figure C-1 Assumed bridge failures and low lying areas within the EPZ

NRC Draft Report page C-3: "All bridges within the EPZ were assumed to fail due to the earthquake."

UCS Comment: The draft report states that all bridges were assumed to fail, but Figure C-1 only shows a subset of all bridges within the EPZ assumed to fail. Pictures #2, #4, #5 and #8 are bridges not shown on

Figure C-1 and presumably not assumed to fail. Pictures #4 and #8 show bridges on Hixson Pike (Highway 319), a four-lane major artery in the EPZ. If the draft report does not consider the failure of these bridges (which appear similar in age and construction to other bridges like #9 and #10 that are assumed to fail), failure of either bridge during a real event could significantly delay evacuations.

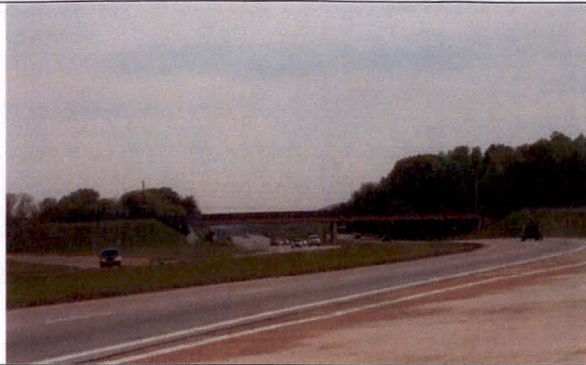
#1 – Thrasher Pike bridge over Highway 27 (shown on Figure C-1 as assumed to fail)

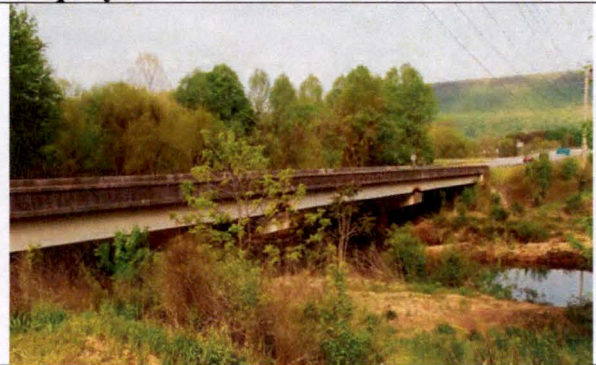
#2 – Bridge where Thrasher Pike crosses rail line east of the Highway 27 intersection (not shown on Figure C-1 as assumed to fail)

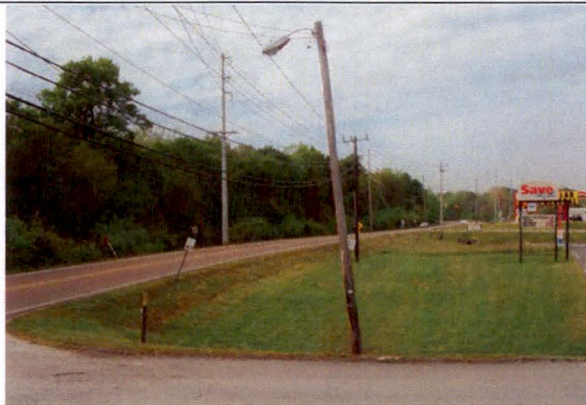
#3 – Metal and wood poles on either side of Middle Valley Road (not assumed by the NRC to fail)

UCS Comment: The draft report considered that the postulated earthquake could damage bridges. But the draft report did not seem to consider other consequences from the postulated earthquake that could equally impact the infrastructure. As many of the pictures clearly show, poles often line one, if not both, sides of roadways. Downed power lines and/or fallen poles could impede evacuation pathways. But the draft report provided neither reasons why the poles/lines would withstand the earthquake's force nor evaluations of potential adverse consequences from downed lines and/or poles.

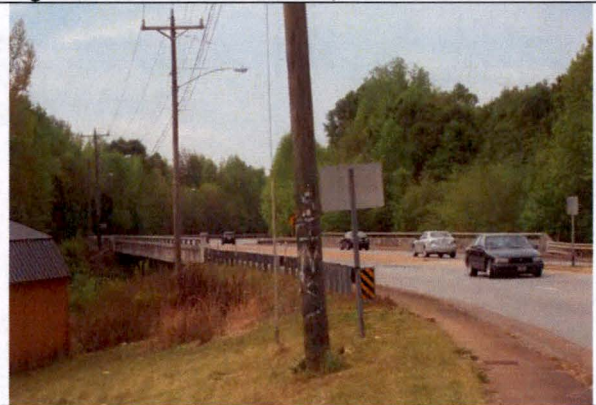
#4 – Bridge on Hixson Pike (Highway 319) just southwest of intersection with Middle Valley Road near Hixson High School (not shown on Figure C-1 as assumed to fail)

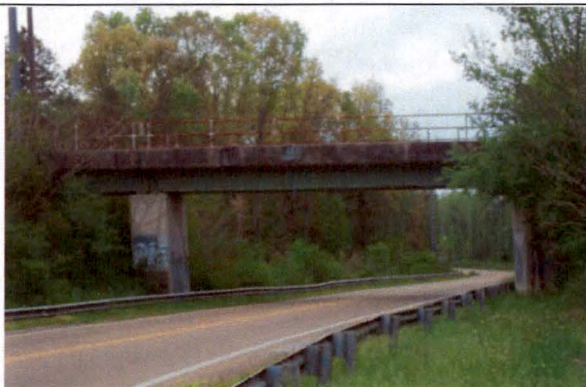
#5 – Railroad bridge spanning Dallas Hollow Road south of the Sequoyah Access Road intersection (not shown on Figure C-1 as assumed to fail)

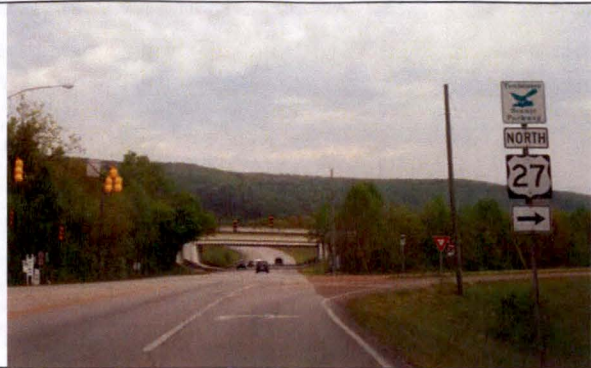
#7 – Span where Highway 27 crosses the Sequoyah Access Road (shown on Figure C-1 as assumed to fail)

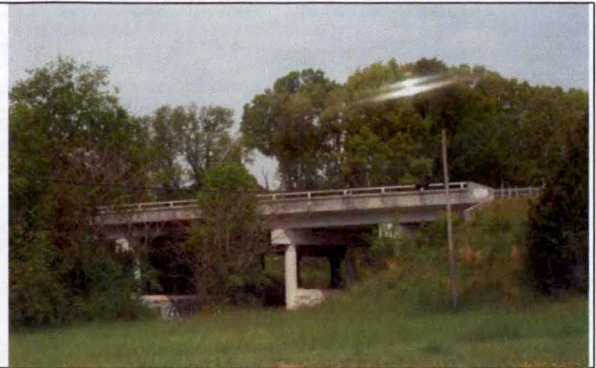
#8 – Bridge where Hixson Pike (Highway 319) crosses rail line (not shown on Figure C-1 as assumed to fail)

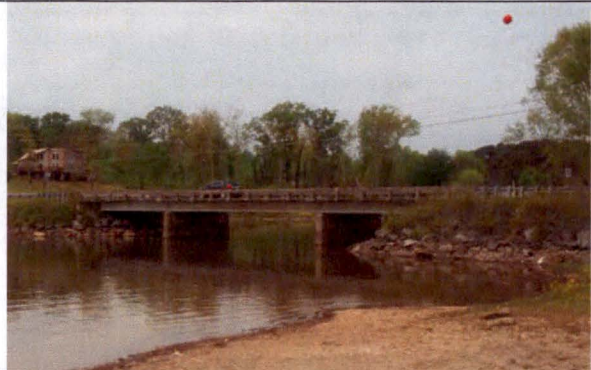
#9 – Bridge where Snow Hill Road spans inlet of Chickamauga Lake (shown on Figure C-1 as assumed to fail)

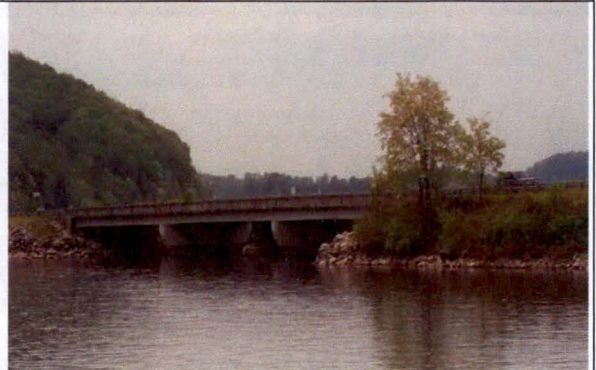
#10 – Bridge where Highway 58 spans inlet of Chickamauga Lake (shown on Figure C-1 as assumed to fail)
