WILLIAM STATES LEE III
NUCLEAR STATION UNITS 1 & 2

FIGURE 2.4.4-203 Rev 7

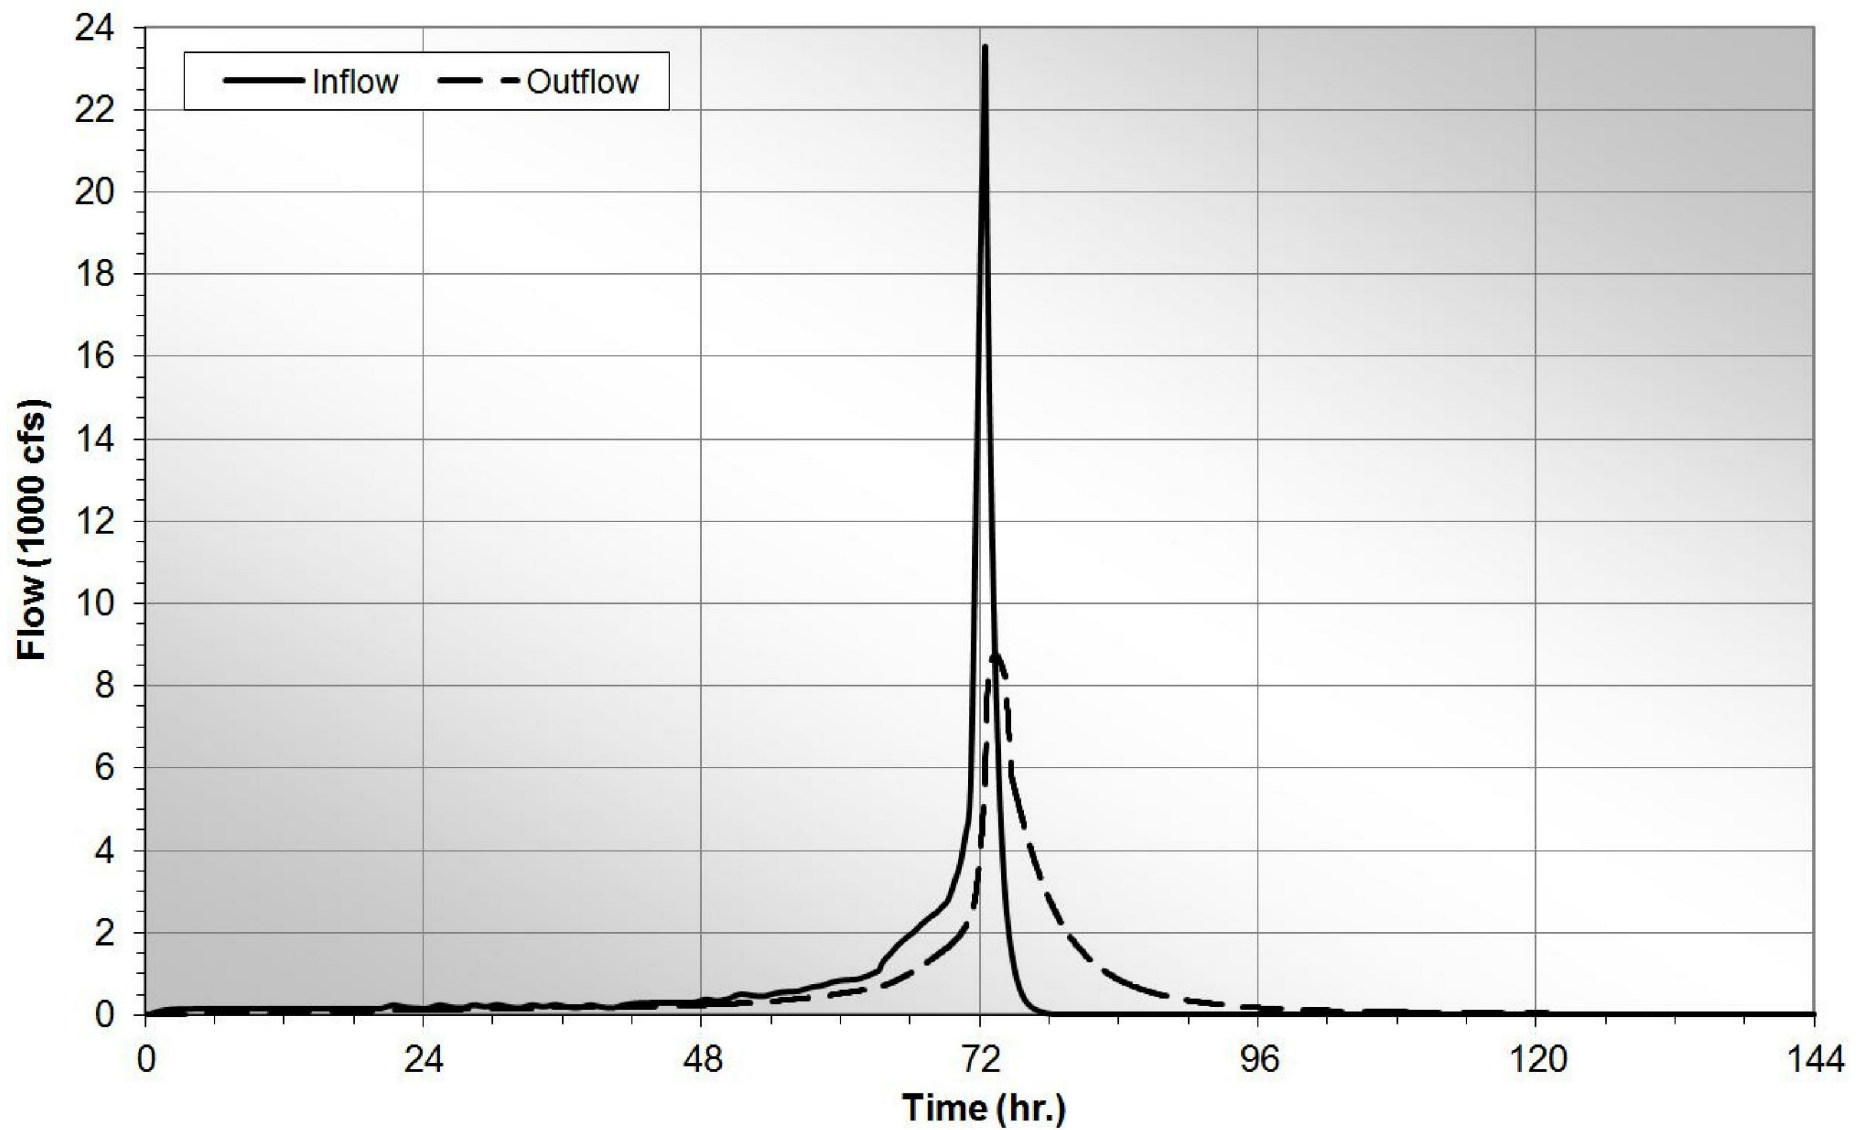
PMF Hydrograph With Upper Arm Dam
Failure, Make-Up Pond B
