Part 21 (PAR)

PART 21 - ANOMALY RELATED TO MICRO SWITCHES

Also included is Rotork
engineering report ER857.

Subject: Rotork Controls Inc. Part 21 Notification, concerning V12 [Pt No N69-921] and K5 [N69-838 & N69-926] safety related micro switches

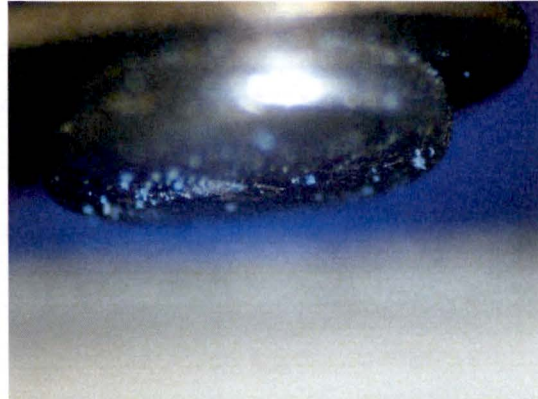
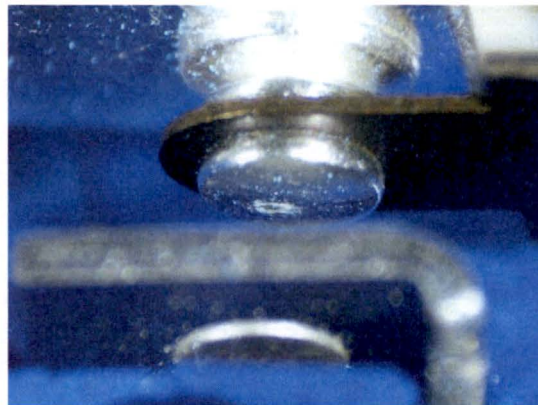
Switch F was opened for examination of the contacts (Figure 6 - Figure 9). Blue plastic particles were formed only as a result of breaking the switch apart. A pale yellow layer appears to have formed on the surface of the NC and NO contact rivets, Figure 6 and Figure 8. At the very centre of the NC and NO rivet, i.e. the point of contact, the layer has broken away and the normal silver appearance of the rivet is visible. The white powder on the moving contact, Figure 7 and Figure 9, indicates that there was transfer of the broken layer from the stationary contacts to the moving contact.

Figure 6: Switch F, NC contact rivet

Figure 7: Switch F, NC side of moving contact

Figure 8: Switch F, NO contact rivet

Figure 9: Switch F, NO side of moving contact

SEM photographs of the NO and moving contact rivets of an unaged 2015 switch, an aged 2015 switch and an aged 2007 switch are shown in Table 3. The SEM photographs show clear contamination on both the NO and moving contact rivets of aged switches. The pattern was consistently different between the NO and moving rivets and suggests the contamination deposited on the NO contact is then transferred to the moving contact during operation. This observation is in line with the results observed from in-house tests (Figure 6 to Figure 9).

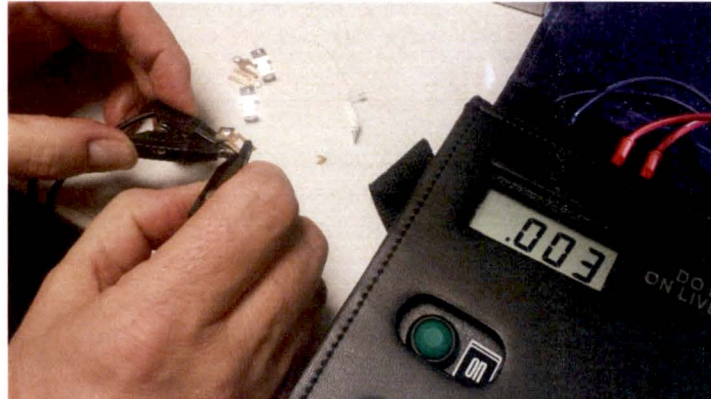
Figure 12: Resistance checks of contacts removed from switches

3 switches N69-921, date code 3613K, had their NO, NC and moving contacts removed to be aged in isolation inside a metal container. The contacts were resistance checked (Figure 12) pre and post-aging. Thermal aging time was 144 hrs (6 days).

Thermal aging the contacts in isolation did not influence their ability to conduct current. Pre and post-aging contact resistances were 3 to 4m Ω .

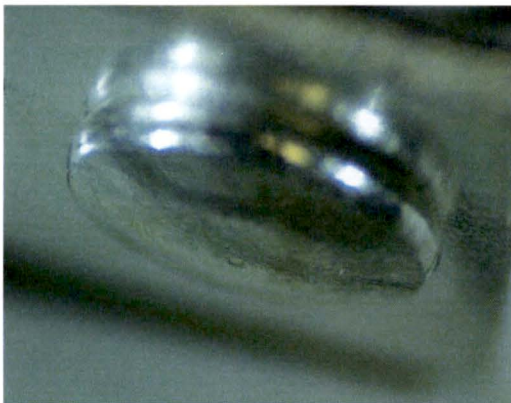
The contacts were also observed under an optical microscope but there were no signs of contamination. The rivets were similar in appearance pre-aging (Figure 13) and post-aging (Figure 14).

Figure 13: Contact rivet pre-aging

Figure 14: Contact rivet post-aging
