CDI Technical Note, 16-03NP

Nine Mile Point Steam Dryer Inspection Recommendations Based on Flow-Induced Vibratory Stresses

Exelon Nine Mile Point Nuclear Station

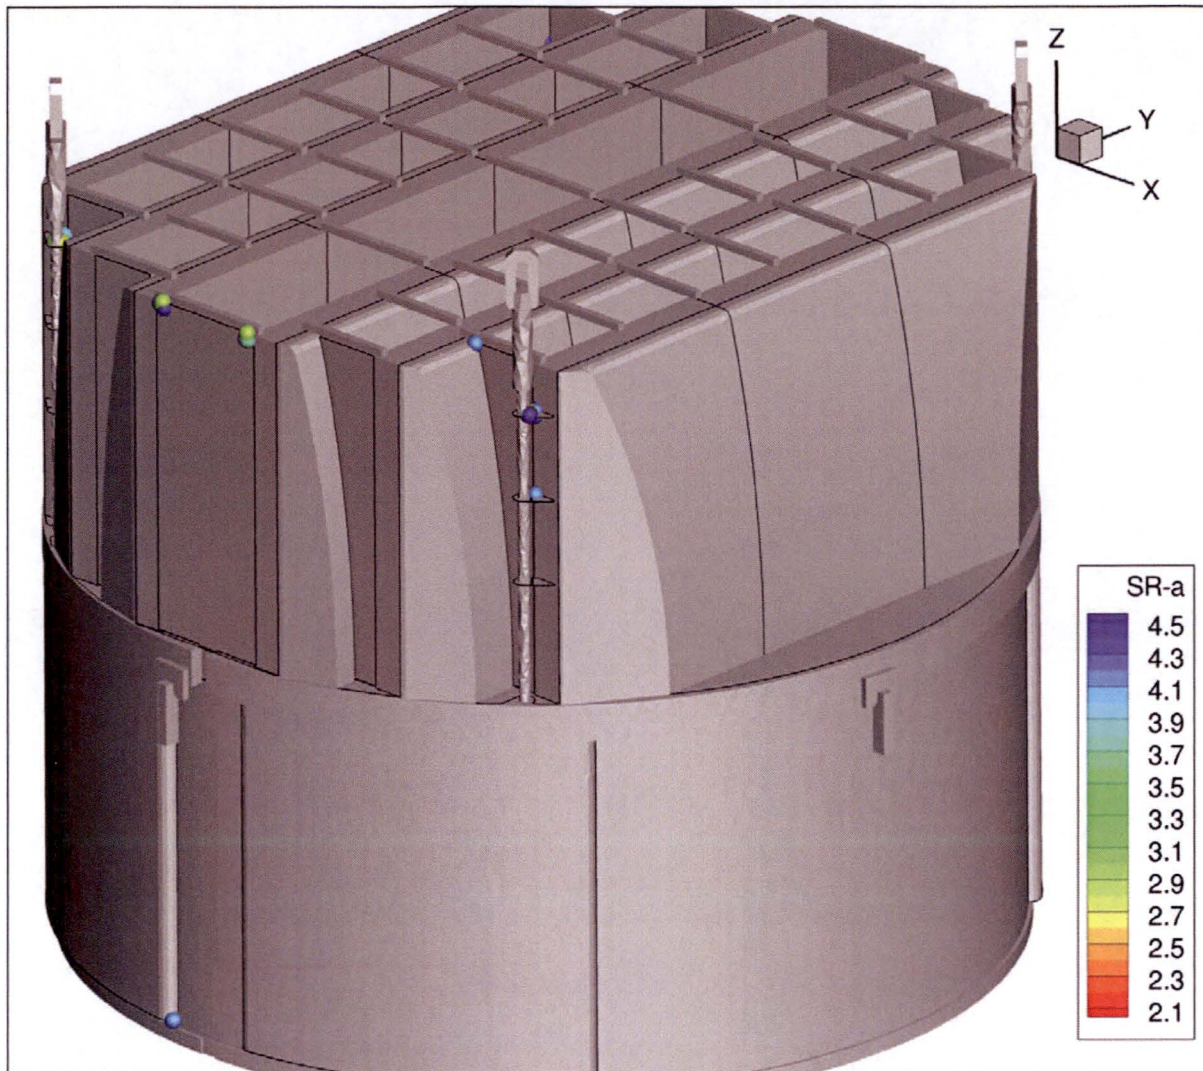
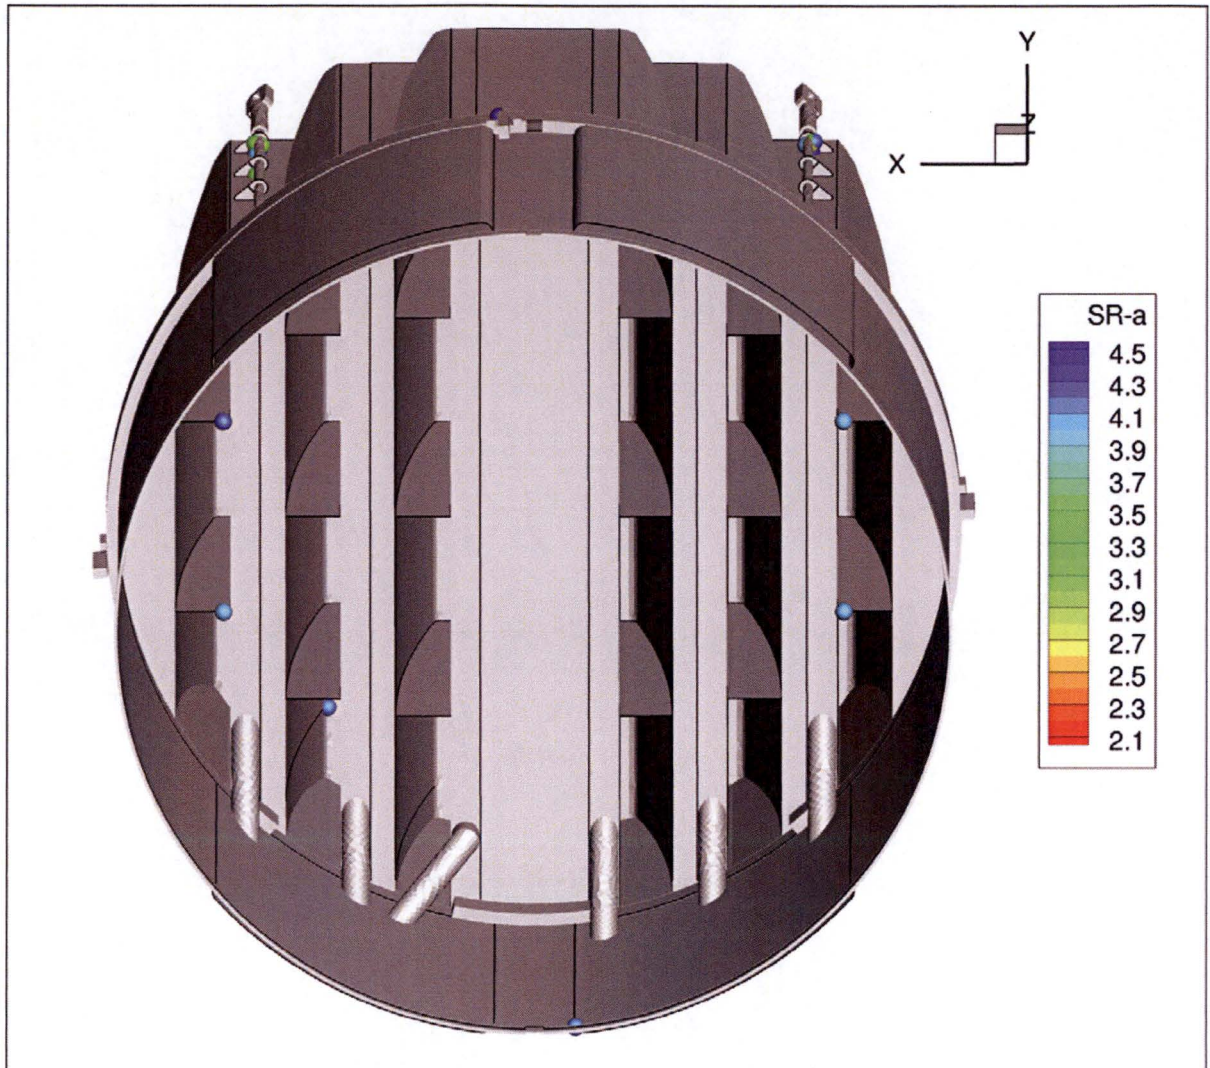
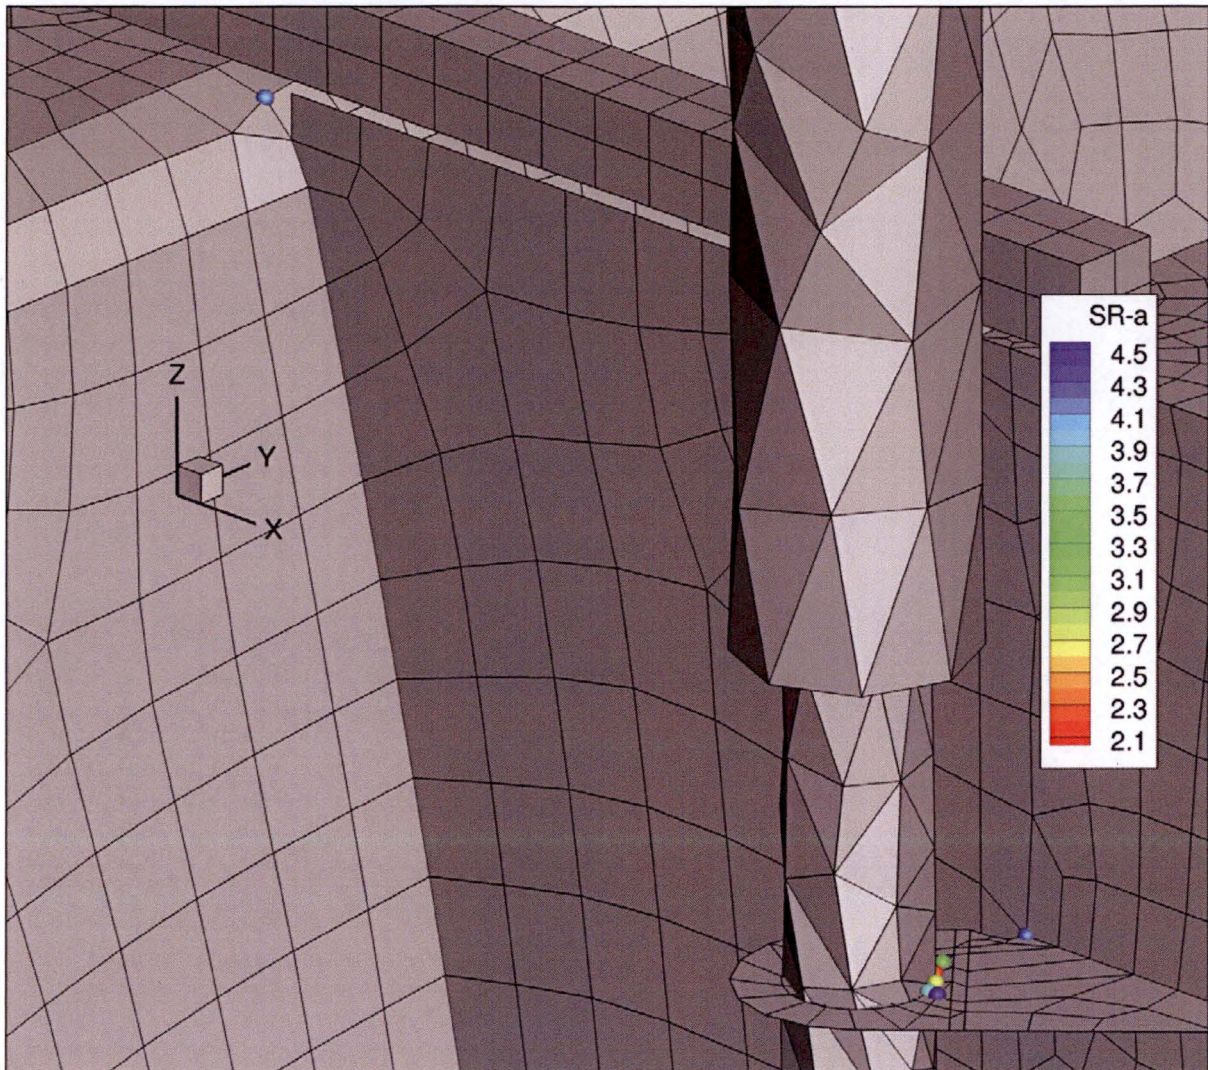
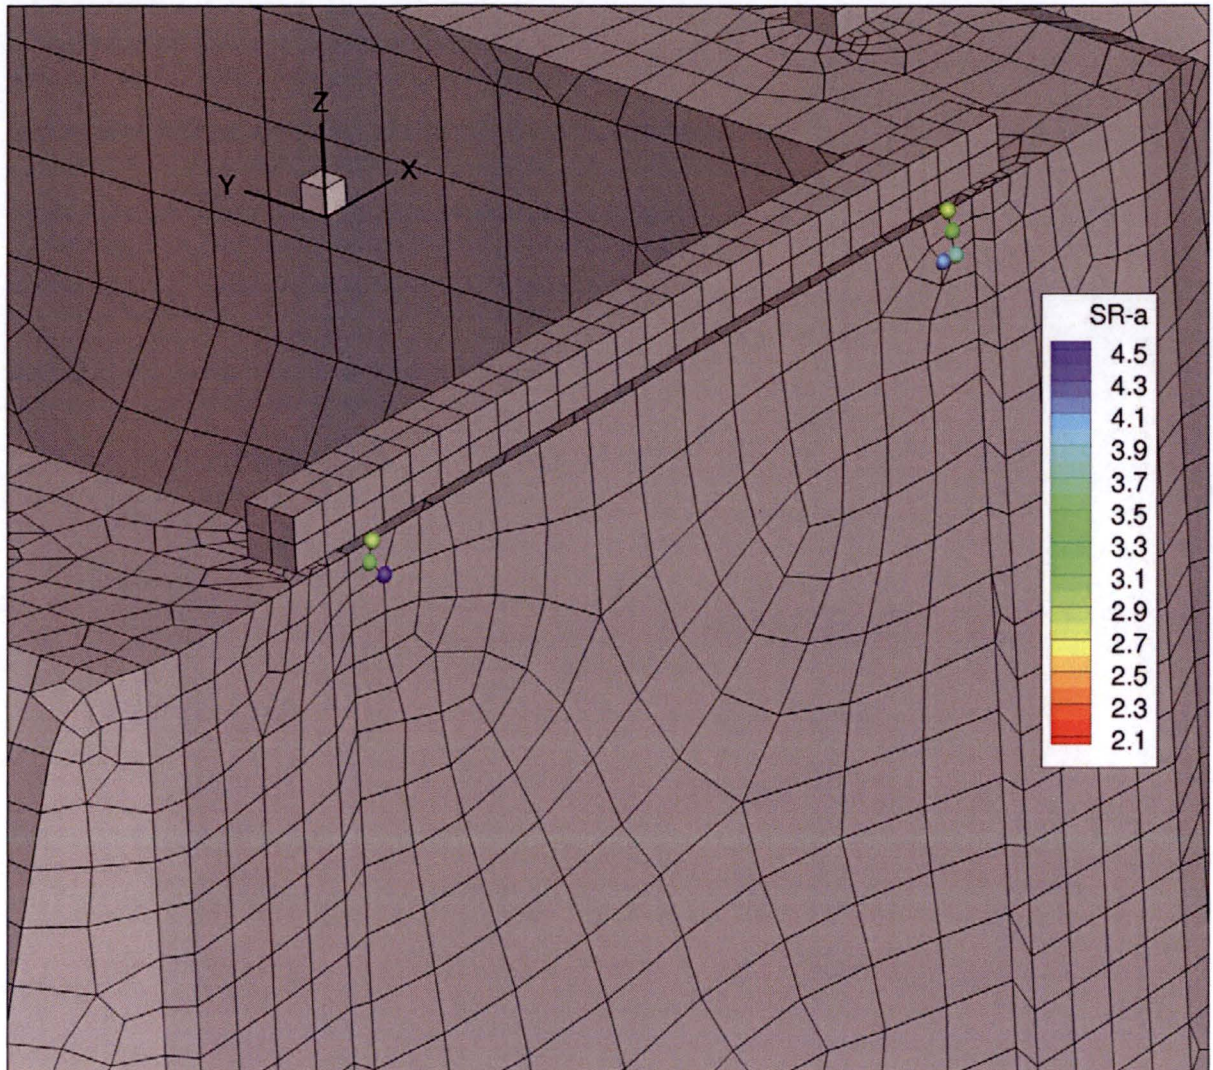
Figure 1a. Non-weld locations with alternating stress ratios below 4.5 on the NMP2 steam dryer [(3)]. View 1 from side.

Figure 1b. Non-weld locations with alternating stress ratios below 4.5 on the NMP2 steam dryer [(3)]. View 2 from underneath the dryer.

Figure 1c. Non-weld locations with alternating stress ratios below 4.5 on the NMP2 steam dryer [(<sup>3</sup>)]. Close-up view 3 showing nodes involved in lifting rod and middle hood.

Figure 1d. Non-weld locations with alternating stress ratios below 4.5 on the NMP2 steam dryer [(<sup>3</sup>)]. Close-up view 4 of inner plate.

Plots of these nodes are shown in Figure 1 (off weld) and Figure 2 (on a weld). Note that in all of the results herein the spatial coordinates used to describe the geometry and identify limiting stress locations are expressed in a reference frame whose origin is located at the intersection of the steam dryer centerline and the plane containing the base plates (this plane also contains the top of the upper support ring and the bottom edges of the hoods). The y-axis is parallel to the hoods, the x-axis is normal to the hoods pointing from MSL C/D to MSL A/B, and the z-axis is vertical, positive up. Equivalently, the x-axis points from 270° to 90° and the y axis points from 180° to 0°. Vane banks are labeled A-F in the negative x direction (i.e., from the 90° point to the 270° location) so that bank F lies nearest the manway plate at 270°. There are a total of 57 off-weld nodes with  $SR-a \leq 4.5$  [[

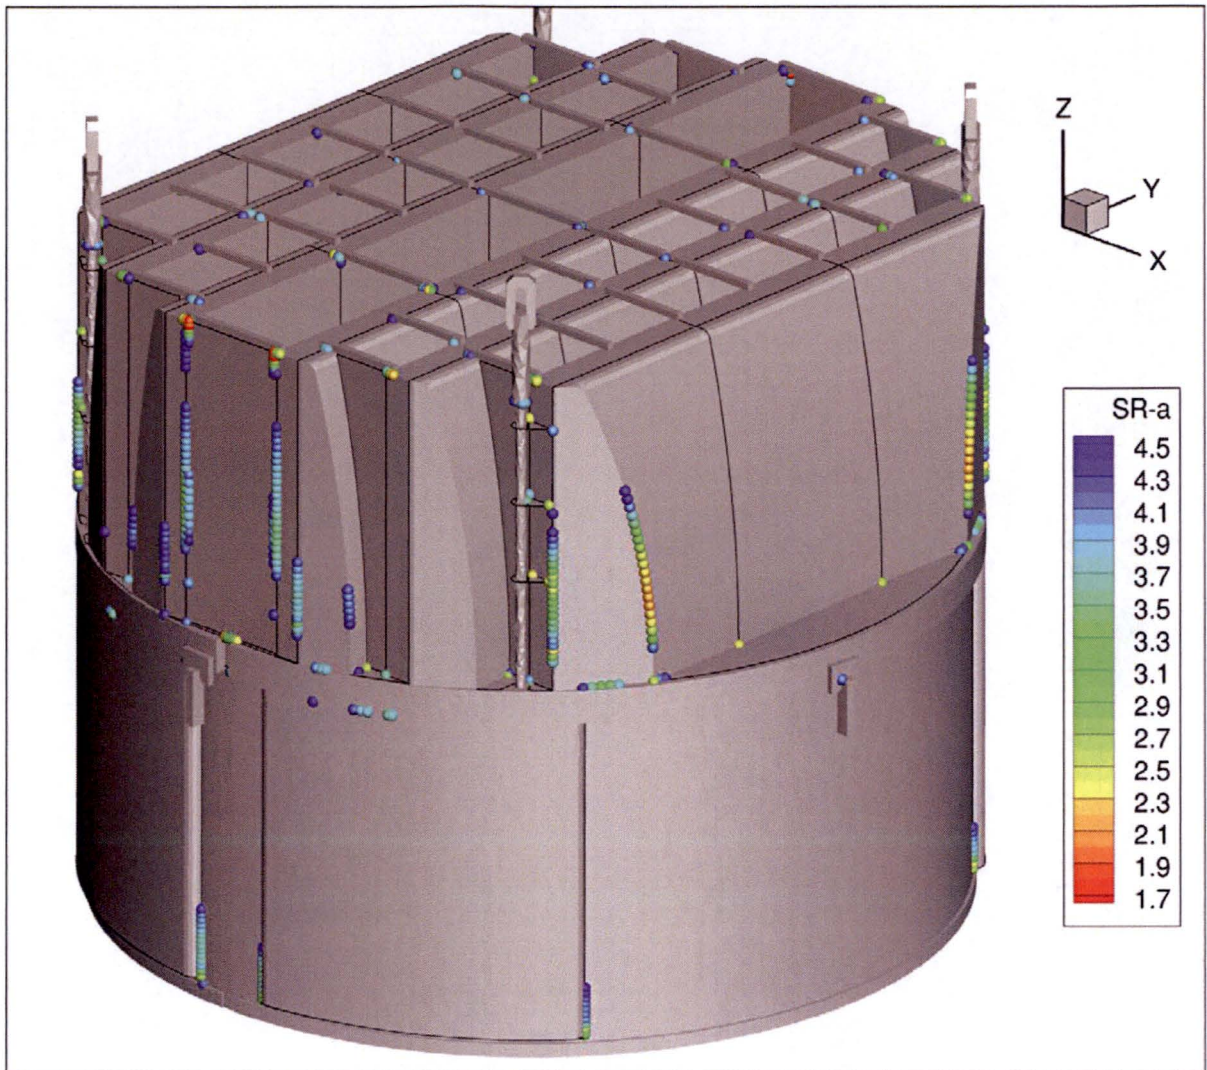
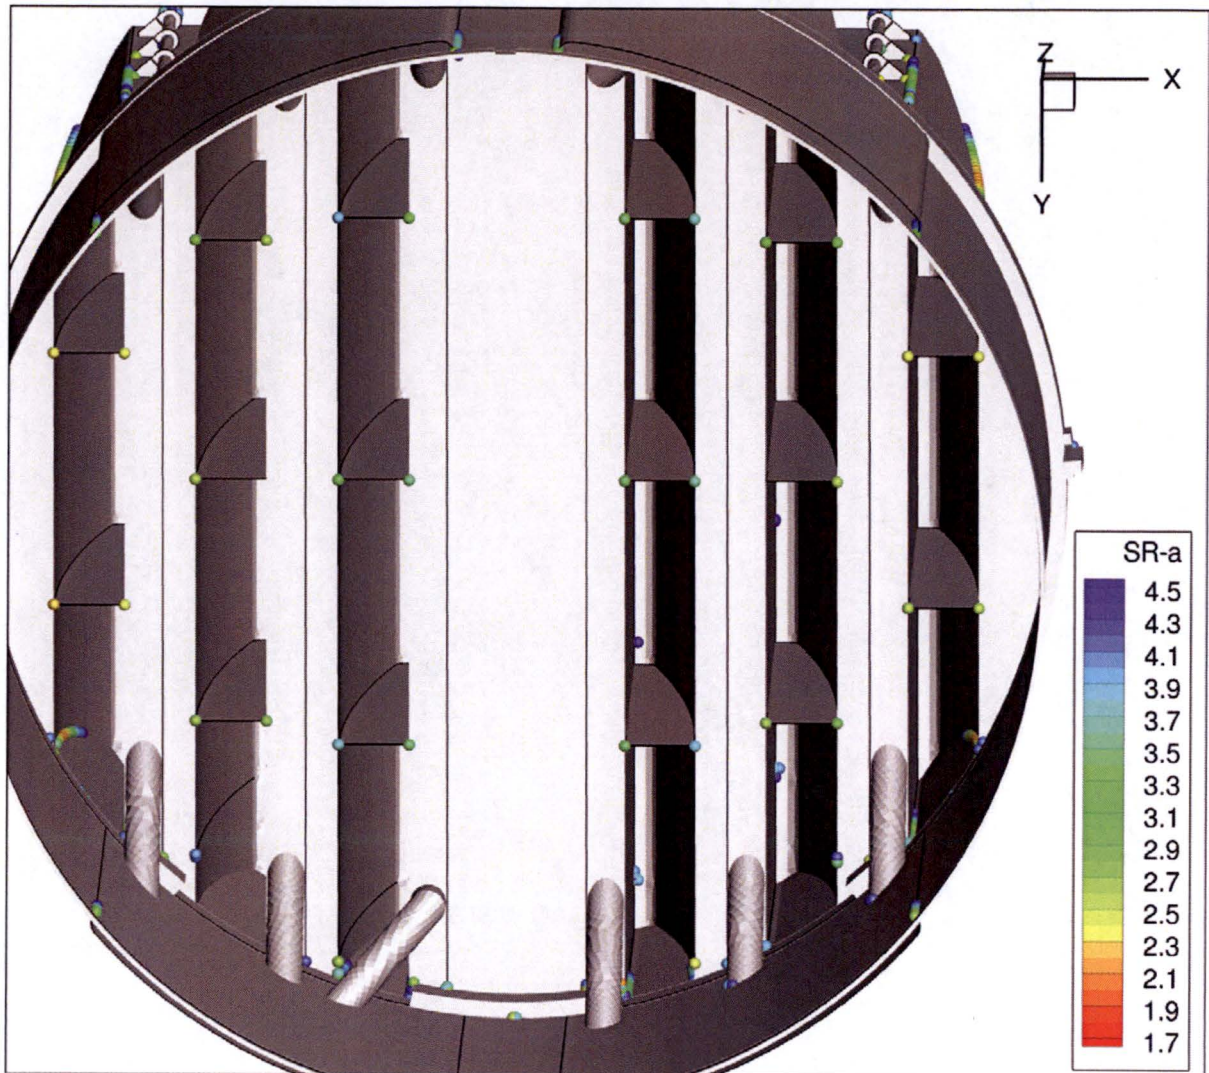
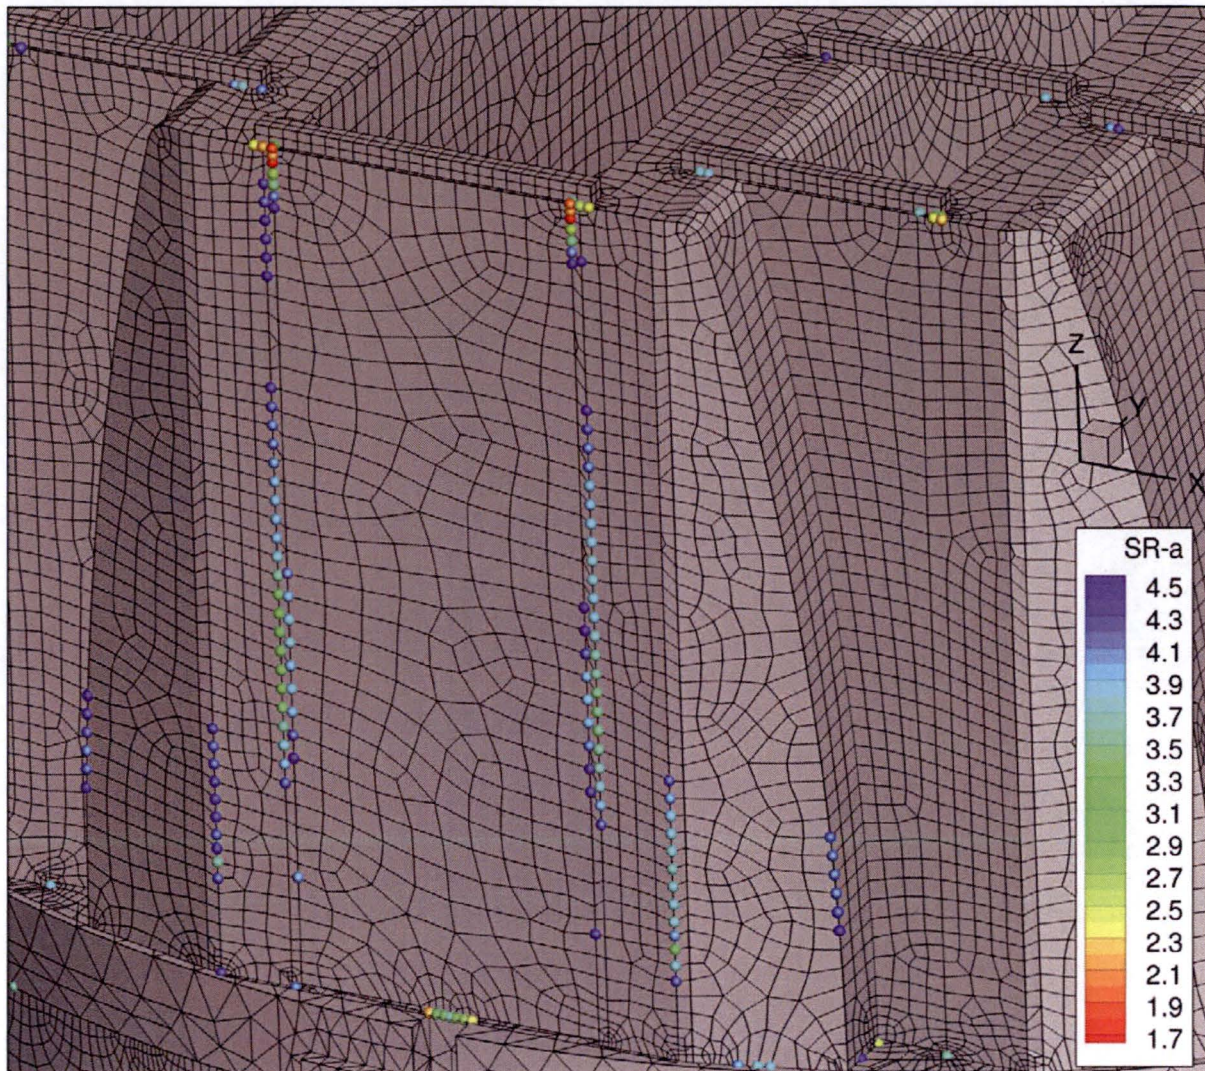
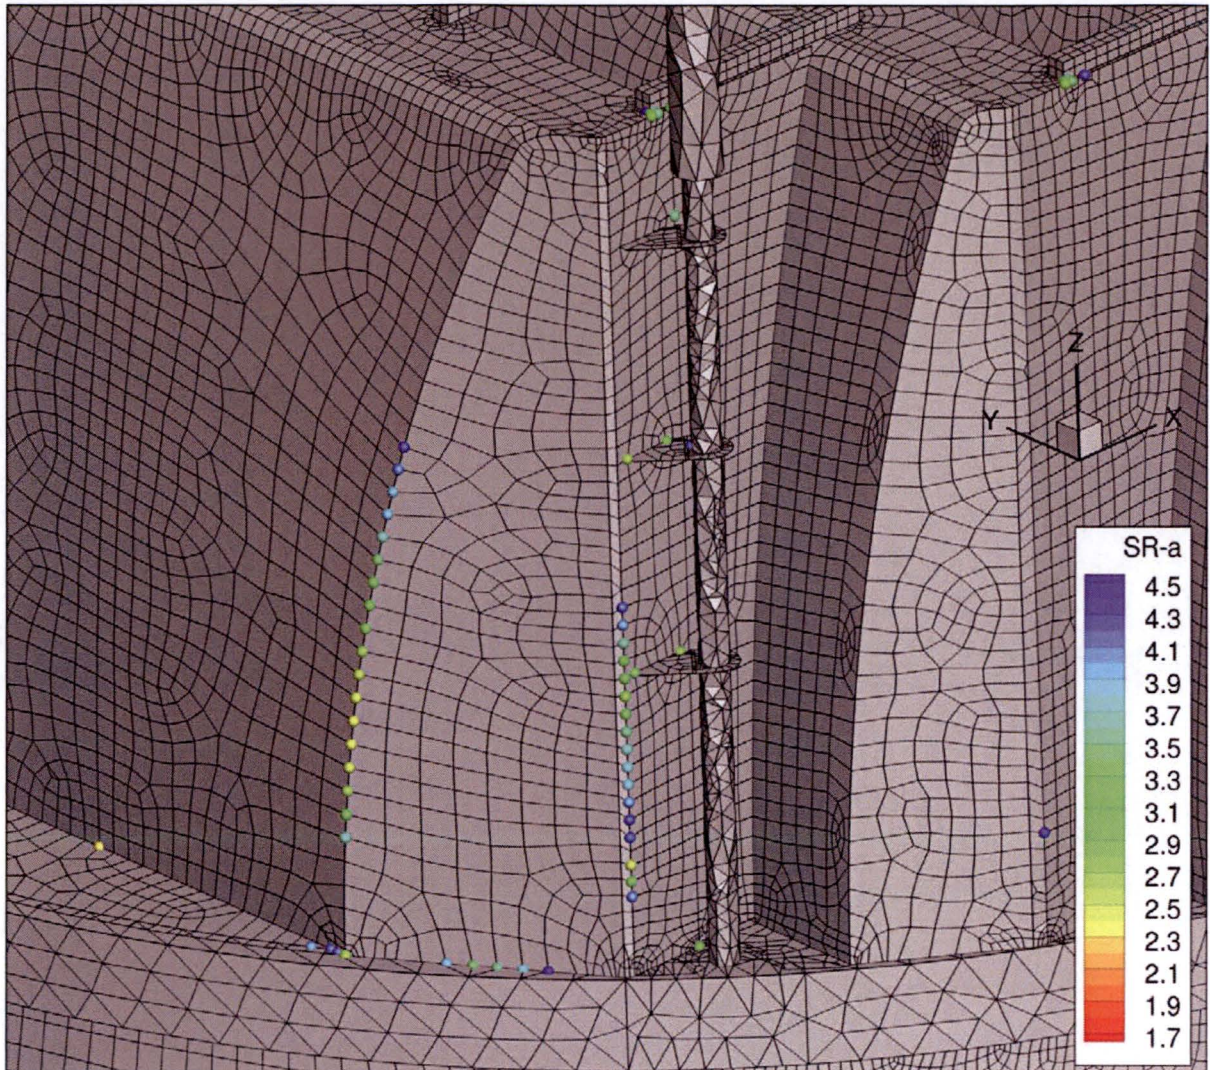
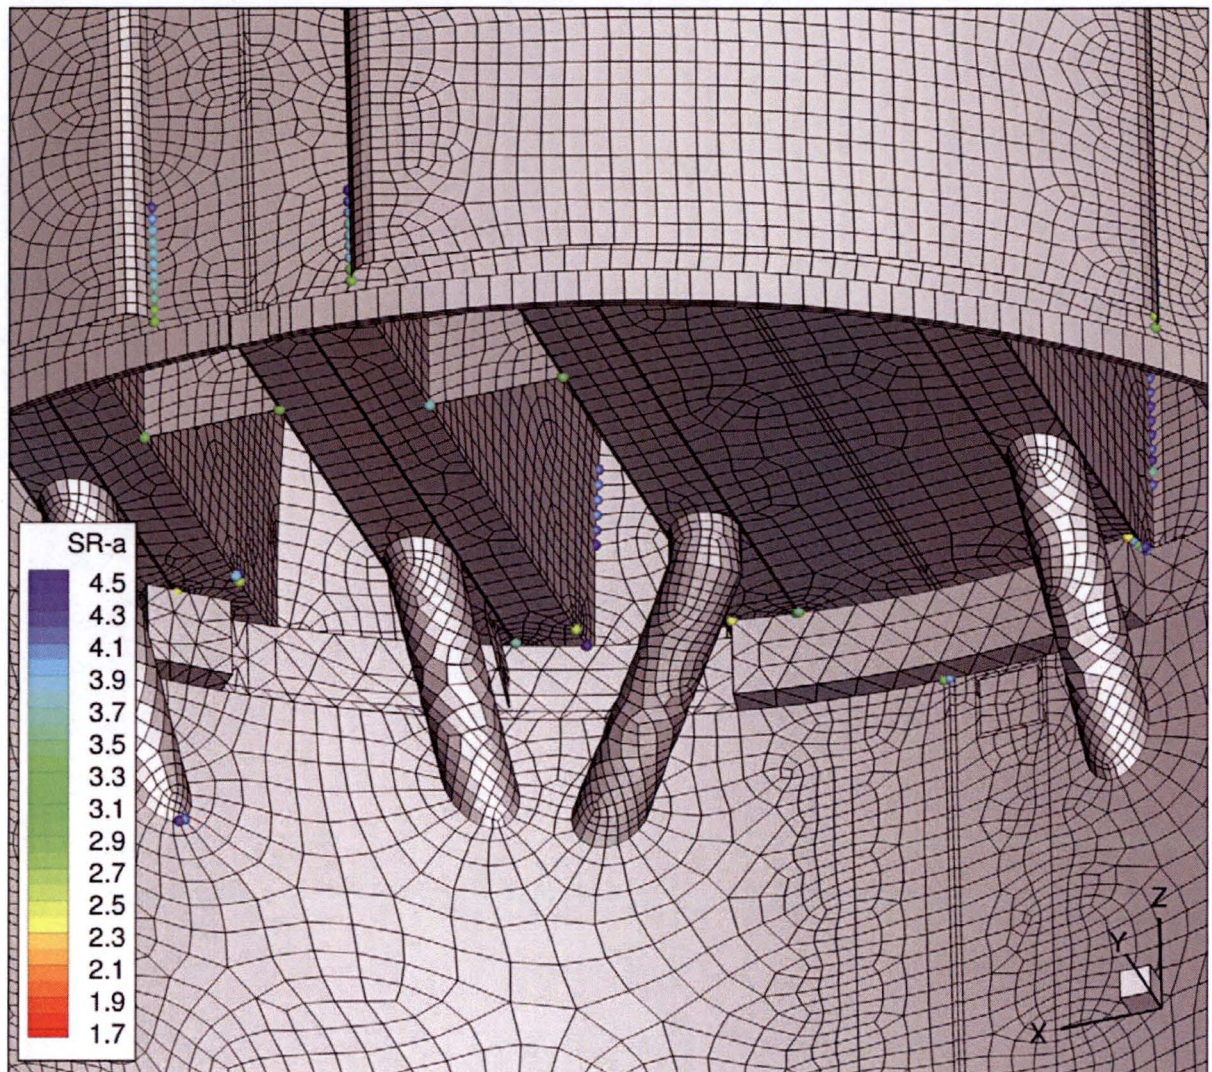
Figure 2a. Nodes on welds with alternating stress ratios below 4.5 on the NMP2 steam dryer with [(3)]. View 1 from side.

Figure 2b. Nodes on welds with alternating stress ratios below 4.5 on the NMP2 steam dryer with [(3)]. View 2 from underneath the dryer.

Figure 2c. Nodes on welds with alternating stress ratios below 4.5 on the NMP2 steam dryer with  $[[$  (3)  $]]$ . Close-up view 3 of inner plate.

Figure 2d. Nodes on welds with alternating stress ratios below 4.5 on the NMP2 steam dryer with  $[[$  <sup>(3)</sup>]]. Close-up view 4 of outer hood/side plate welds.

Figure 2e. Nodes on welds with alternating stress ratios below 4.5 on the NMP2 steam dryer with  $[[$  (3)  $]]$ . Close-up view 5 of drain channel/skirt welds and various welds underneath dryer.

There are 957 nodes on welds that have  $SR-a \leq 4.5$  [[ (3)]]. Note that this list does not compensate for the addition of the U-channel stiffener since no complete (i.e., entire 0-250 Hz frequency range) set of unit solutions with the U-channel stiffener included was requested. Instead, all of the nodes identified without the U-channel stiffener are processed and, if needed, adjusted on a per-node basis at locations near the inner plate. The weld nodes in the list generally lie at one of the following locations: (i) the inner plate attachment weld (Figure 2a, c), though, as noted, the U-channel stiffener attenuates the stresses at these nodes; (ii) welds involving the outer hood side plate (Figure 2a, d); (iii) attachment welds at the ends of tie bars (Figure 2a); (iv) the bottoms of hood support/hood and hood support/vane bank welds (Figure 2b); (v) the lower portions of skirt/drain channel attachment welds

(Figure 2a, e); (vi) lifting rod brace welds (Figure 2a, d); and (vii) miscellaneous locations with stress ratios generally above 4.25. When [[

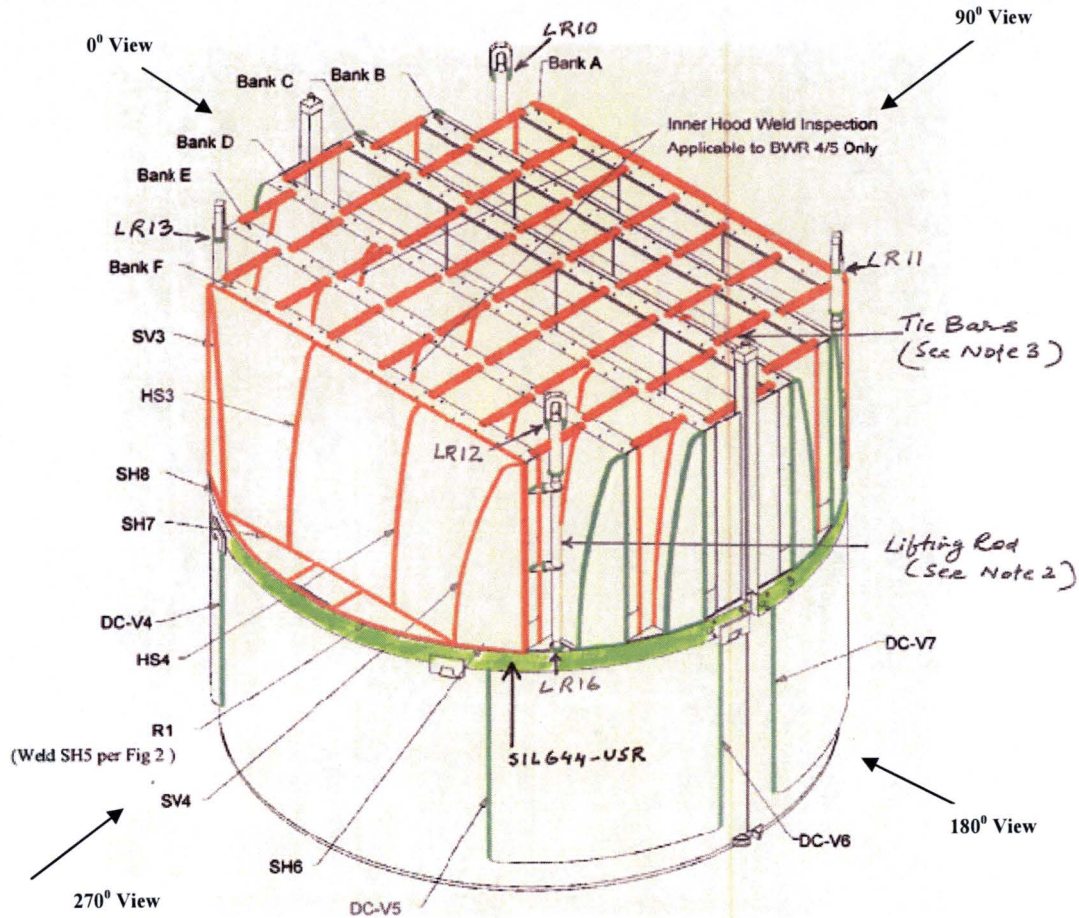
Figure 7 : Curved Steam Dryer Outer Hood Regions.

- Notes:
1. This sketch provides generic BWR 4/5 steam dryer details with respect to inspection requirements, and has been extracted from the BWRVIP Steam Dryer Inspection and Evaluation Guidelines. Supplemental details are being provided if variation exists between this generic sketch and NMP2 as-built configuration.
  2. For other lifting rod inspections see drawing OE-8.
  3. For tie bar inspections see Figure 6.
  4. For hood inspections see Figures 1 and 2. For other vertical weld inspections see Figures 4 and 5.
  5. Welds DC-V1 through DC-V3; DC-V8; LR14; LR15; and LR17 are not shown (Far Side). Reference CE drawing 795E257.
  6. Inspection areas are identified in Red and Green colors. Red colored areas depict high stress locations.

Figure 3. List of welds inspected during RFO (from E-mail: "RE: NMP2 outer hood locations" transmitted from George Inch (Exelon Corporation) at 09:24 on 02-23-2016). Note that the x-axis herein points from bank F to bank A; the y-axis is parallel to the line pointing from LR12 to LR13.

The locations with alternating stress ratios below 2.0 can be grouped as in Table 2. Where possible, connection with the welds in Figure 3 is made. The various groups are depicted in Figure 7 to indicate where inspections should be made. Note that Group 12 can be omitted from examination since its stress ratio  $SR-a=2$  and, with the various bias and uncertainties already imposed, is unlikely to be susceptible to FIV. Also, Group 14 involves a localized stress concentration that is believed fictitious. The node lies on a location where the shell elements of the skirt overlap with the solid elements of the upper support ring. Such overlap regions are prone to numerical error in the ANSYS FEA calculation due to the manner in which the connection is effected. Thus, these locations can be omitted unless the local welds are already subject to inspection.

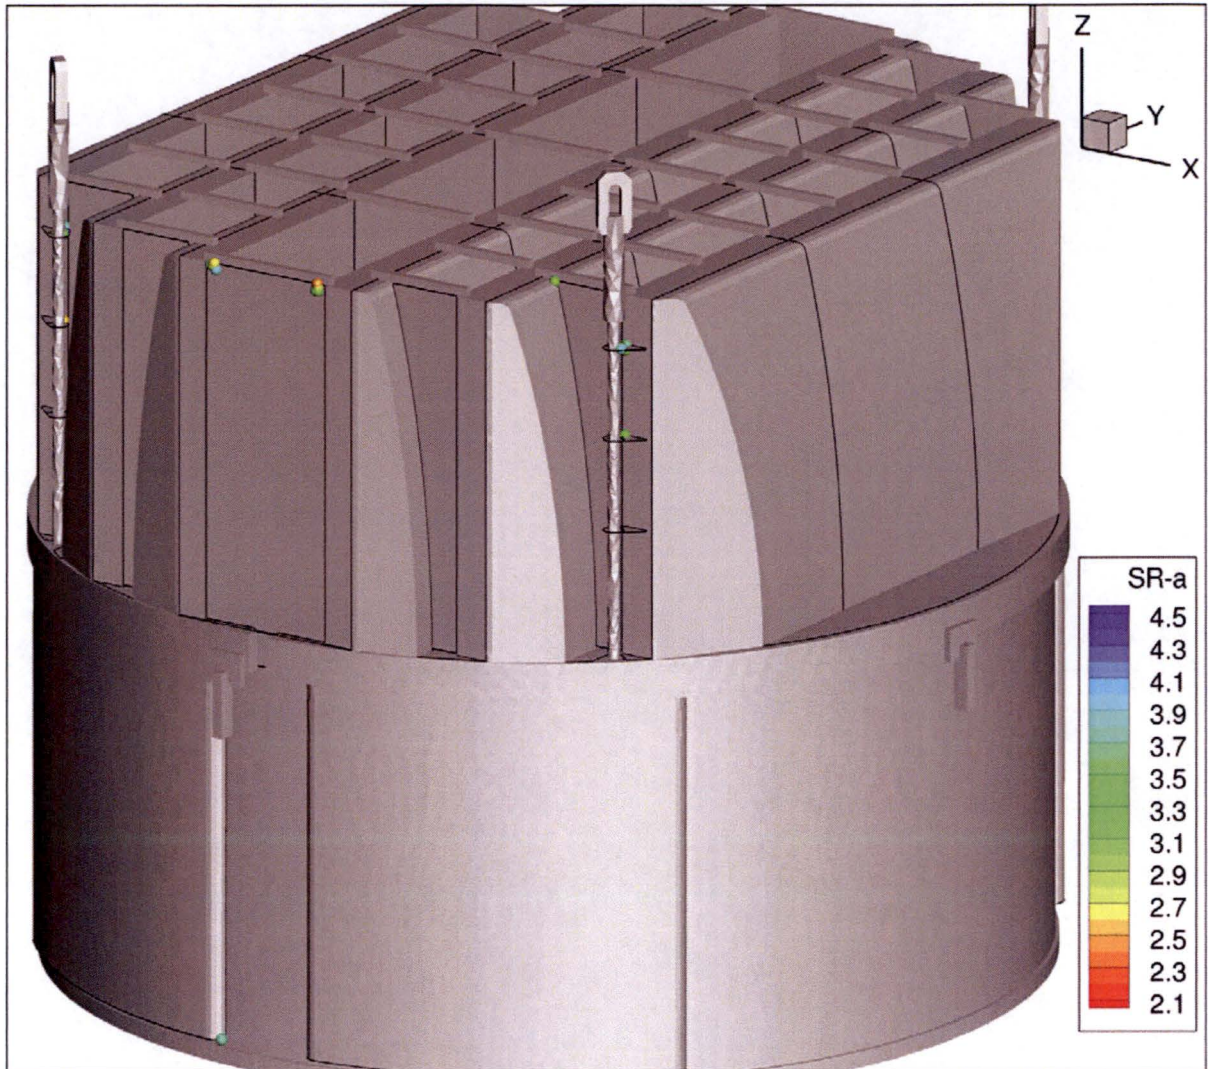
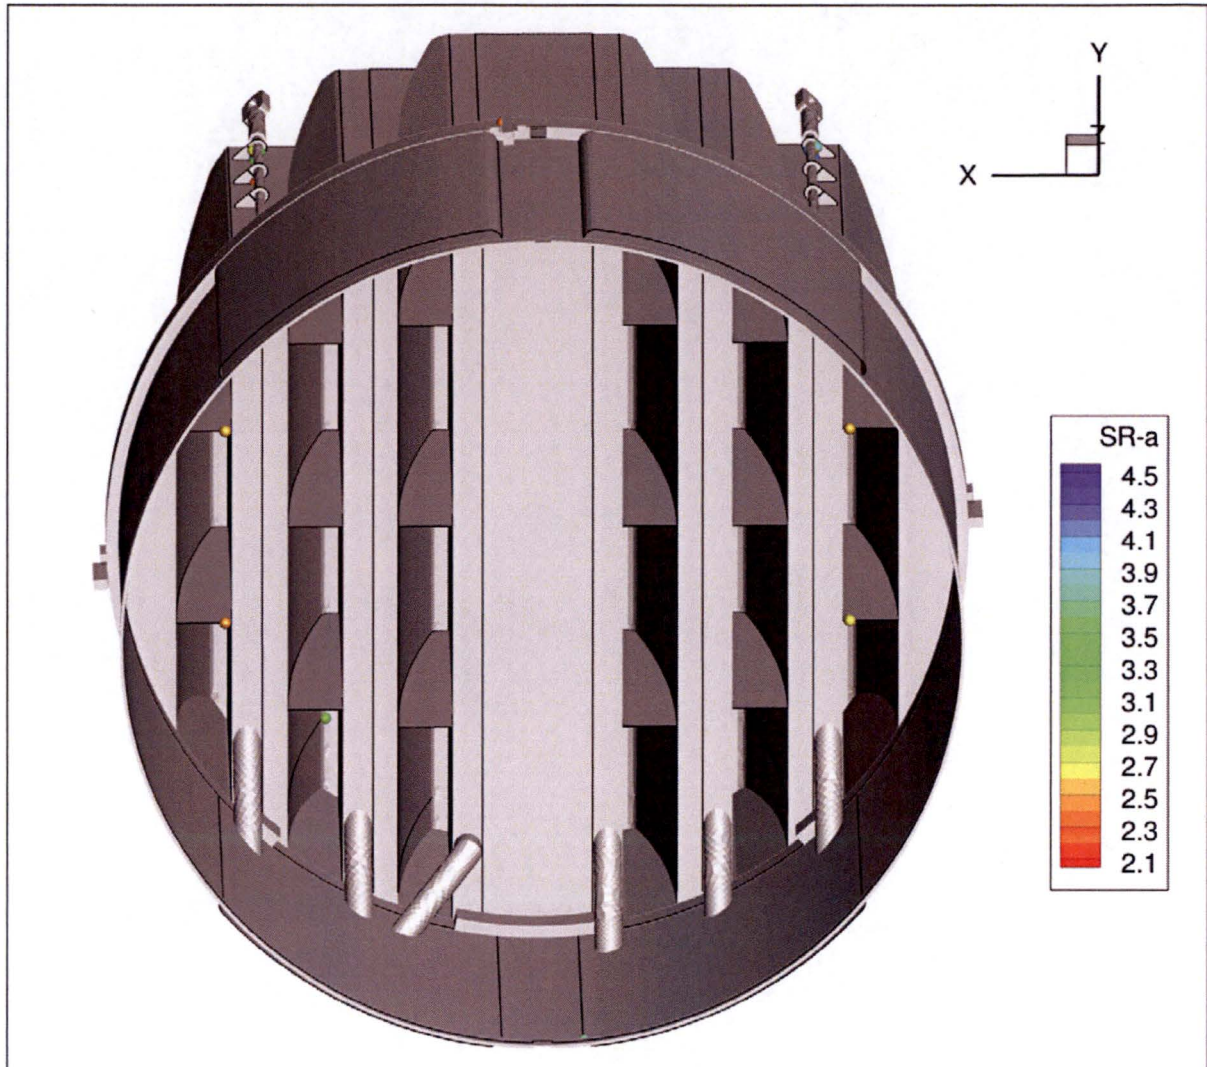
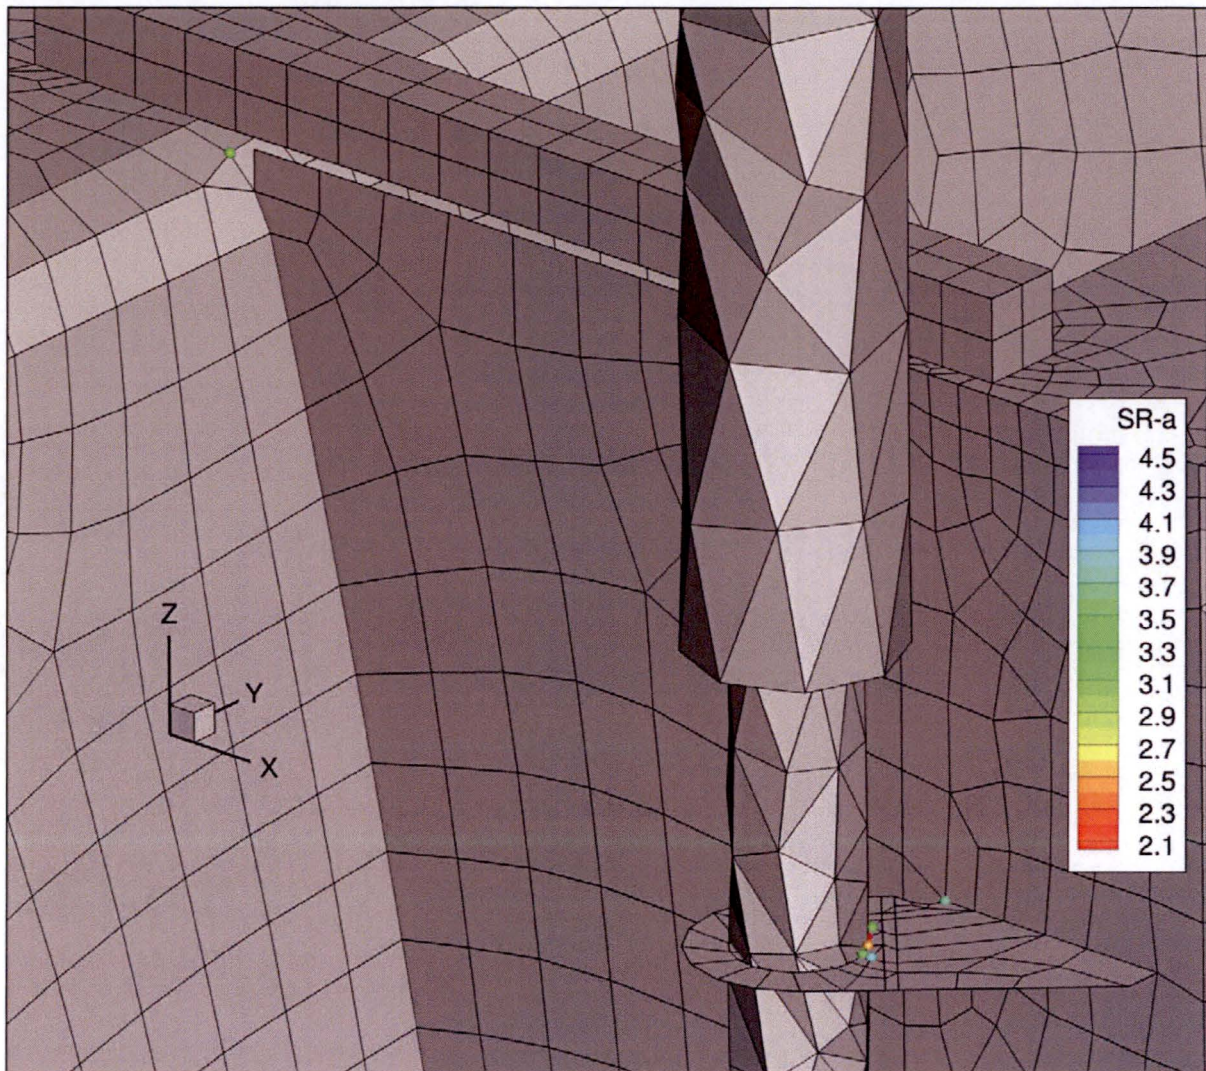
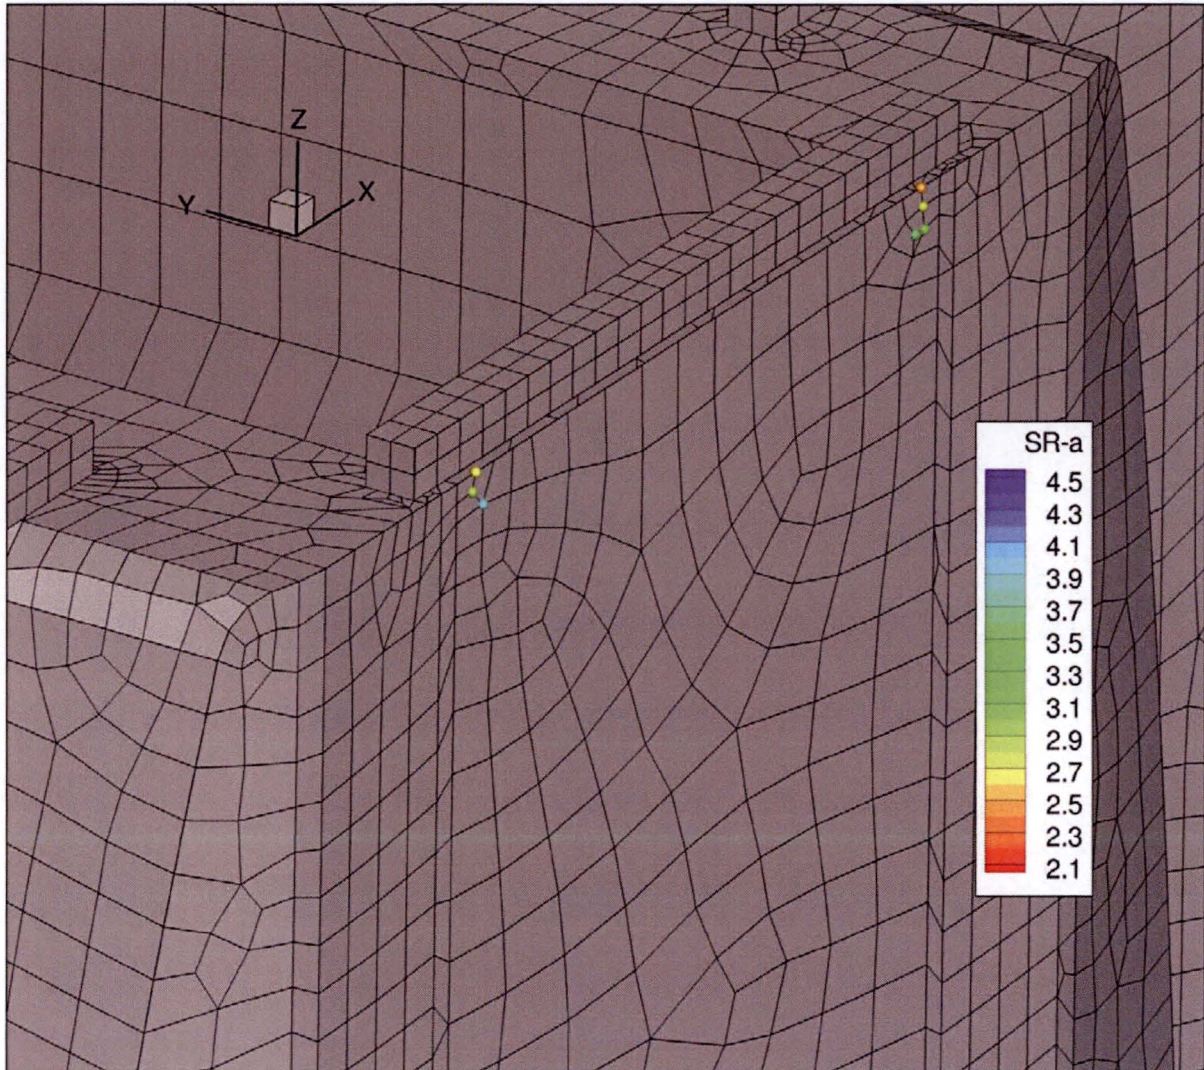
Figure 4a. Alternating stress ratios on non-weld locations [(3)]. View 1 from side.

Figure 4b. Alternating stress ratios on non-weld locations [[

Figure 4c. Alternating stress ratios on non-weld locations [[  
showing nodes involved in lifting rod and middle hood.

Figure 4d. Alternating stress ratios on non-weld locations [[

None of the non-weld node locations achieve a stress ratio below 2.0 [(3)]. Hence these nodes are not tabulated. The stress ratios for the locations are depicted in Figure 4. The limiting alternating stress ratio is  $SR-a=2.09$  (node 94911) and occurs on the lifting rod where it is restrained by the upper brace.
