CDI Technical Note, 16-03NP

Nine Mile Point Steam Dryer Inspection Recommendations Based on Flow-Induced Vibratory Stresses

Exelon Nine Mile Point Nuclear Station

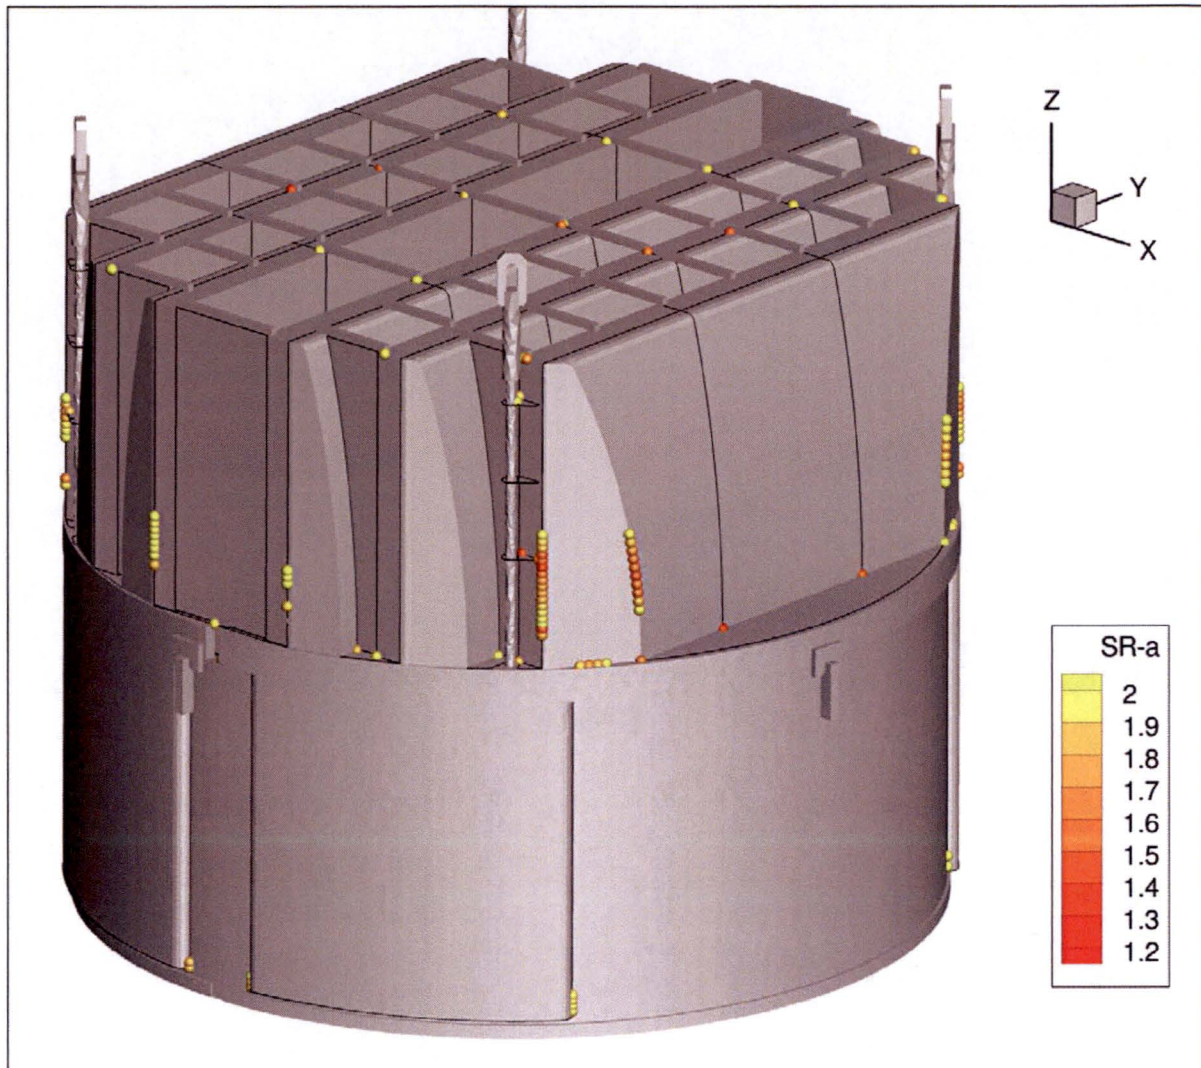
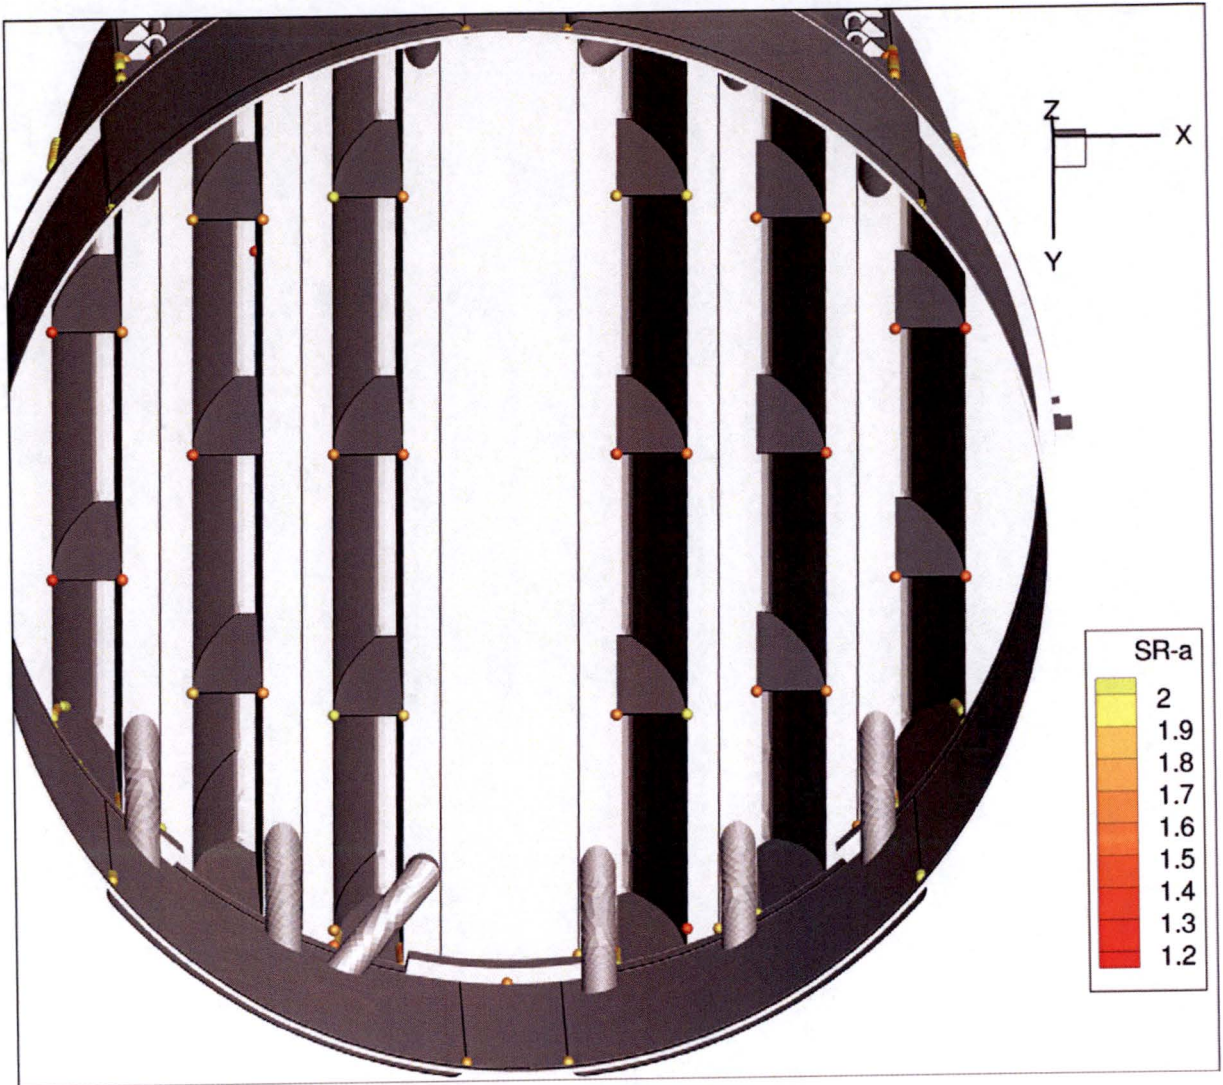
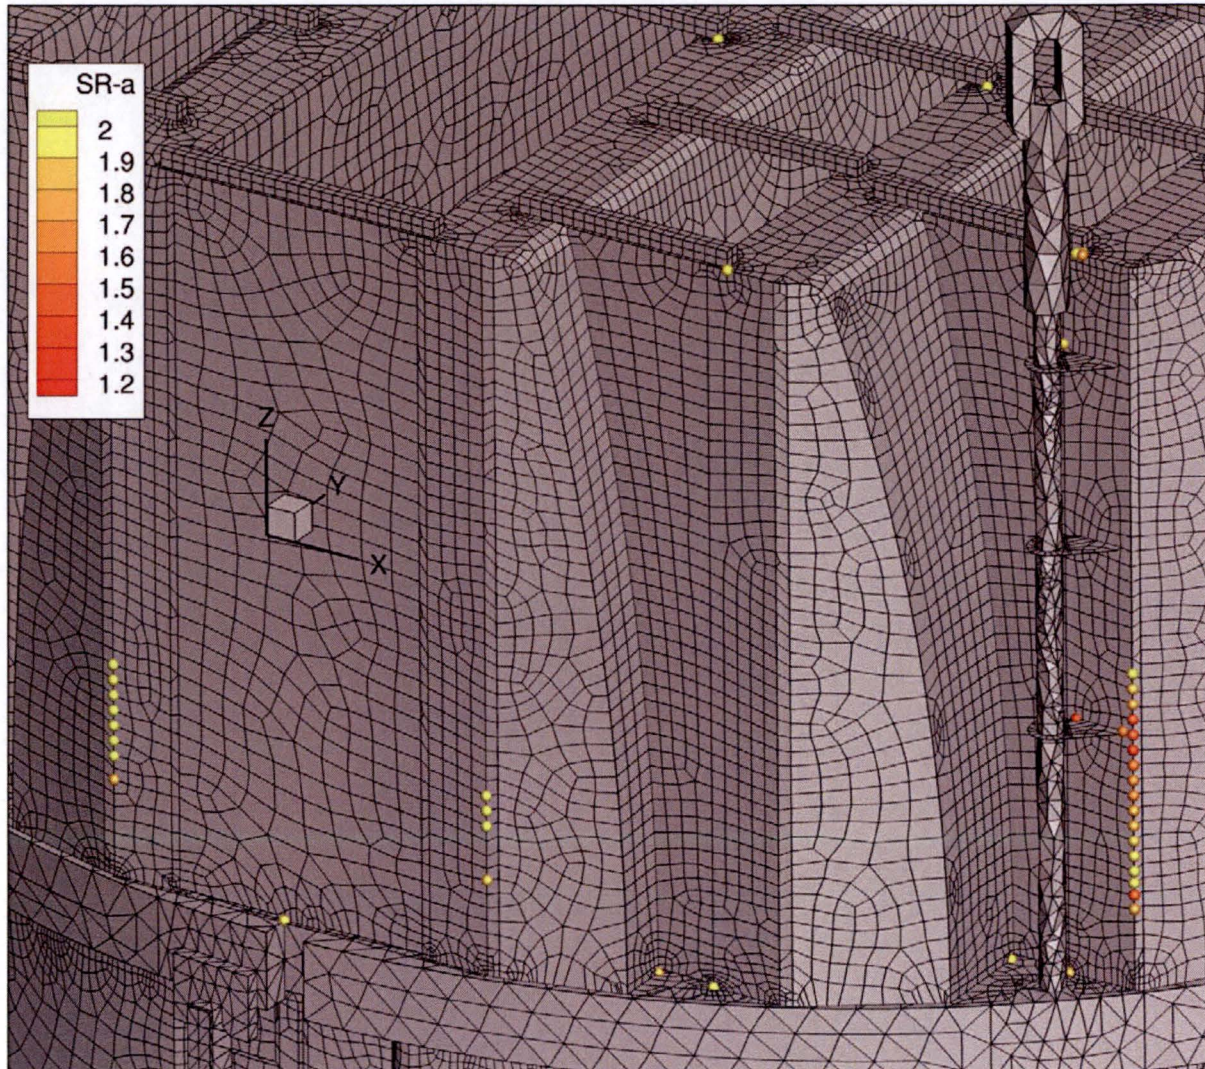
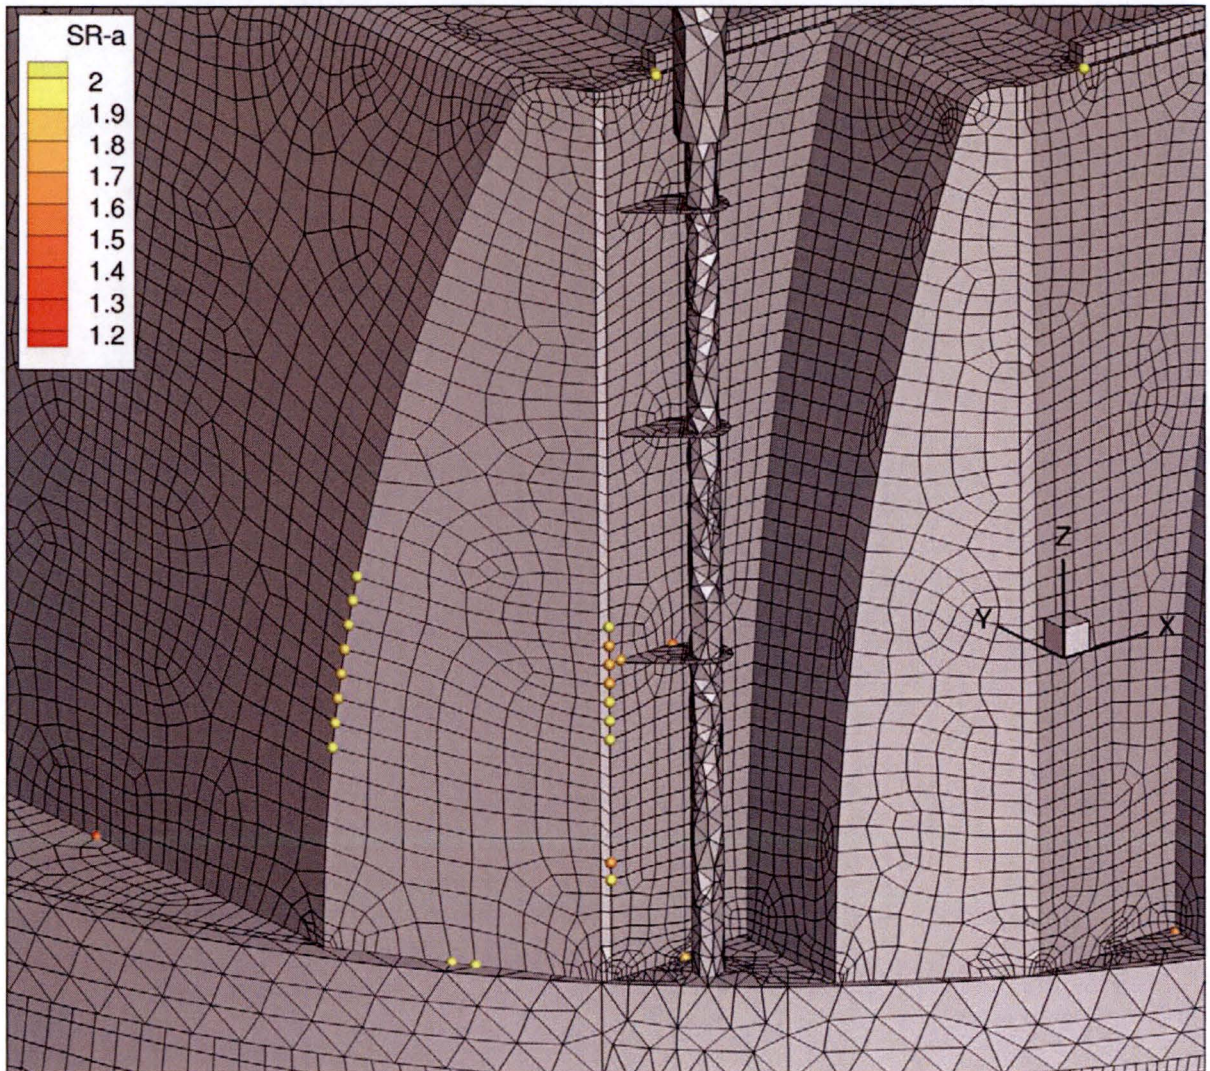
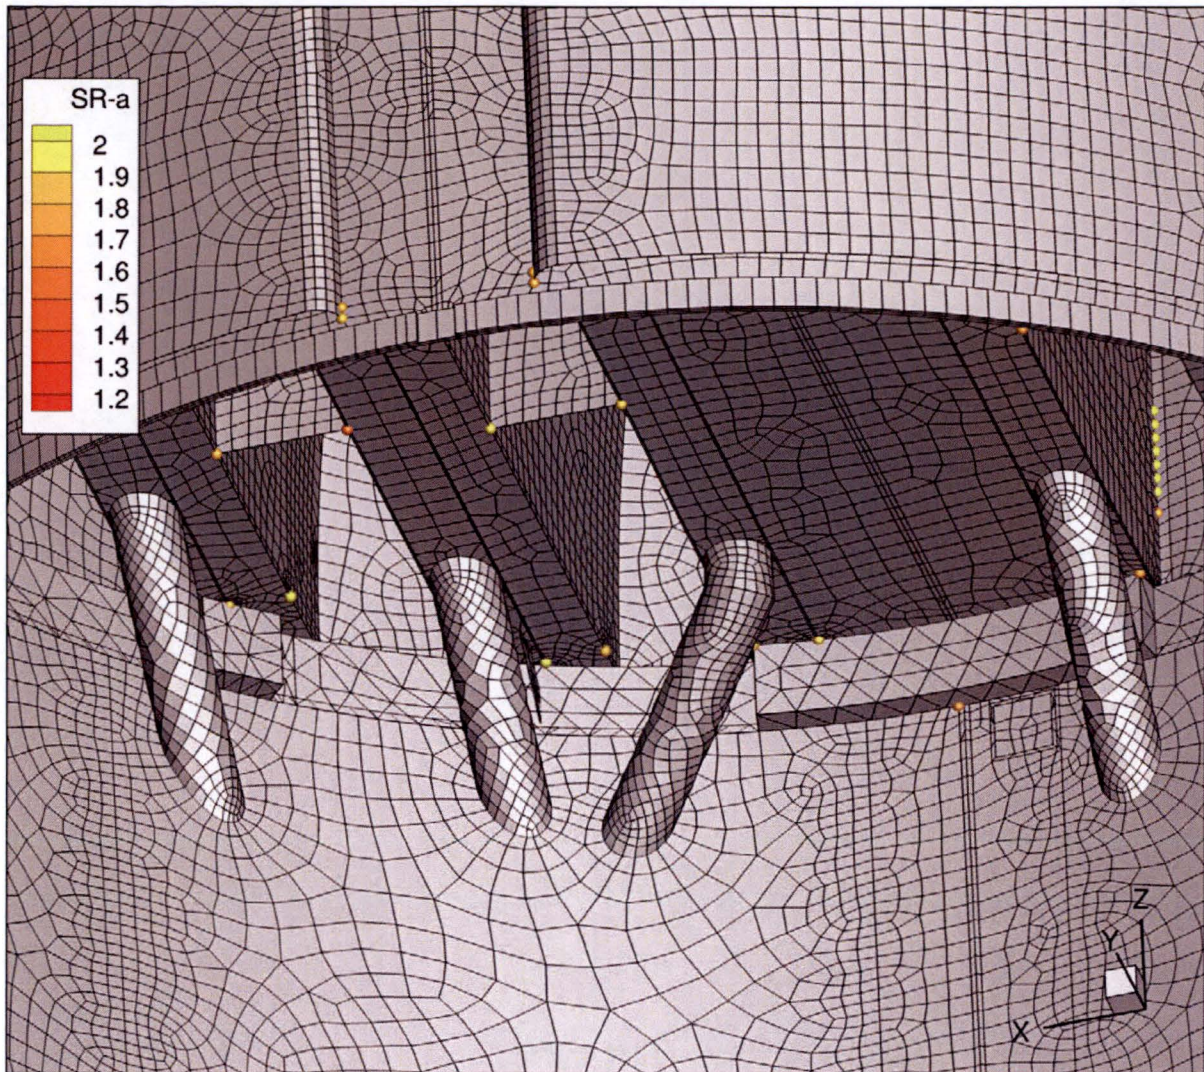
Figure 5a. Nodes on welds with alternating stress ratios below 2.1 on the NMP2 steam dryer [(3)]. View 1 from side.

Figure 5b. Nodes on welds with alternating stress ratios below 2.1 on the NMP2 steam dryer [(3)]. View 2 from underneath the dryer.

Figure 5c. Nodes on welds with alternating stress ratios below 2.1 on the NMP2 steam dryer [[<sup>(3)</sup>]]. Close-up view 3 of inner plate.

Figure 5d. Nodes on welds with alternating stress ratios below 2.1 on the NMP2 steam dryer [(<sup>3</sup>)]. Close-up view 4 of outer hood/side plate welds.

Figure 5e. Nodes on welds with alternating stress ratios below 2.1 on the NMP2 steam dryer [(<sup>3</sup>)]. Close-up view 5 of drain channel/skirt welds and various welds underneath dryer.

When [(3)]. The limiting alternating stress ratio is determined to be  $SR-a=1.22$  and occurs at the bottom of the outer hood/hood support weld. The locations are depicted in Figure 5 which shows only the locations with stress ratios  $SR-a < 2.1$  and in Figure 6 which shows the stress ratios at all locations. A reduced point set of the locations with stress ratios below 2.1 is tabulated in Table 1. The table entries are generated using the procedure described in Section 5 of [1]. Briefly, the node with the lowest alternating stress ratio is identified and recorded. Next, all nodes within 10" of this location or one of its 3 image locations obtained by reflecting across the  $x=0$  and/or  $y=0$  planes are identified and removed from the set of nodes. Of the remaining set, the node with the lowest alternating stress ratio is identified and a similar exclusion process applied. The process is repeated until all points in the original set have been processed either by retaining or excluding the node. This process produces a smaller list of representative high stress locations while ensuring that each of the tabulated entries captures the lowest stress ratio location within a 10" neighborhood.

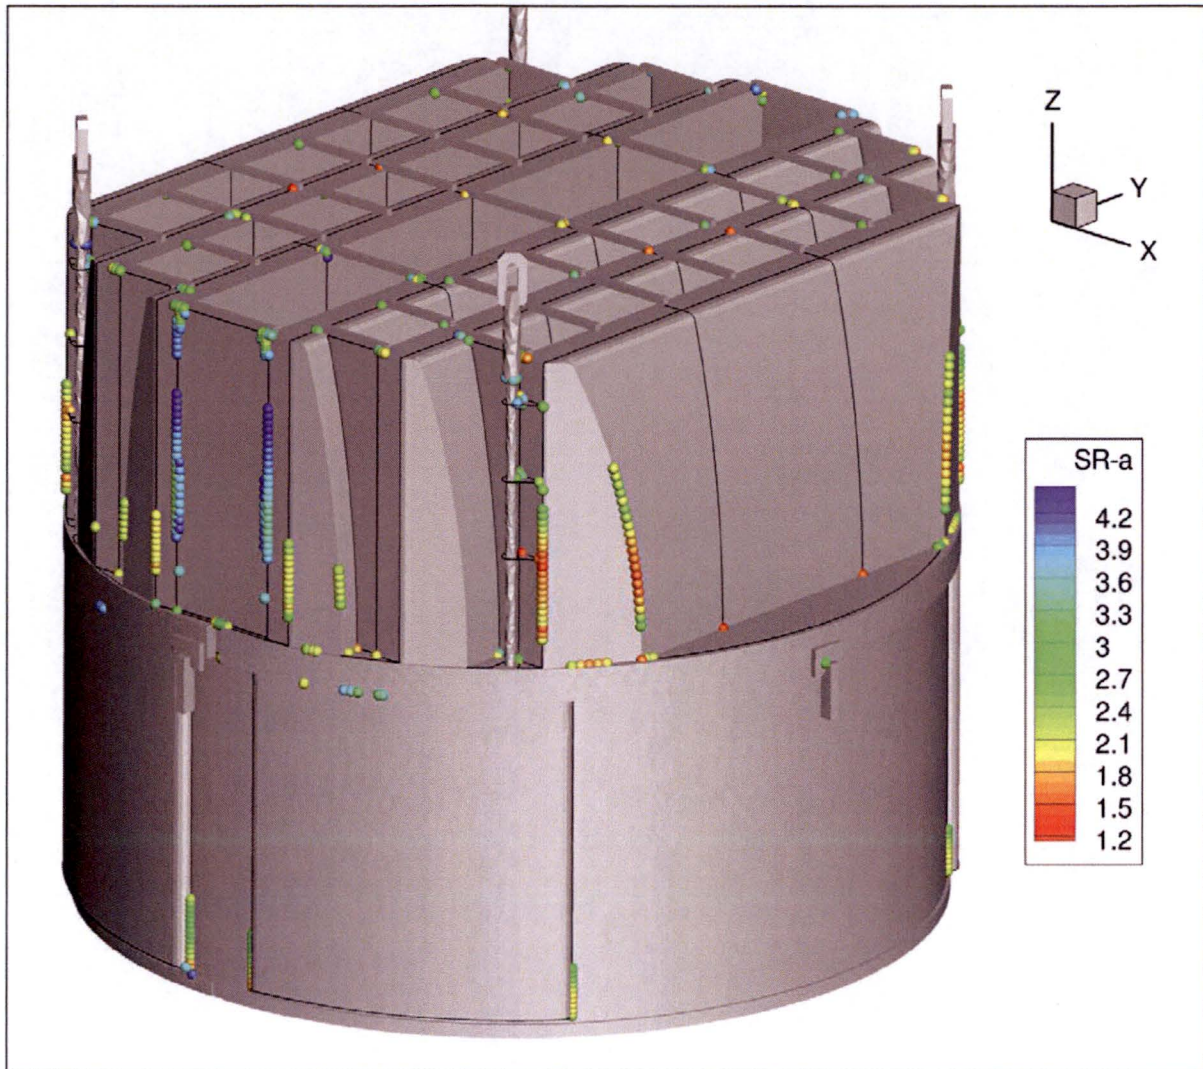
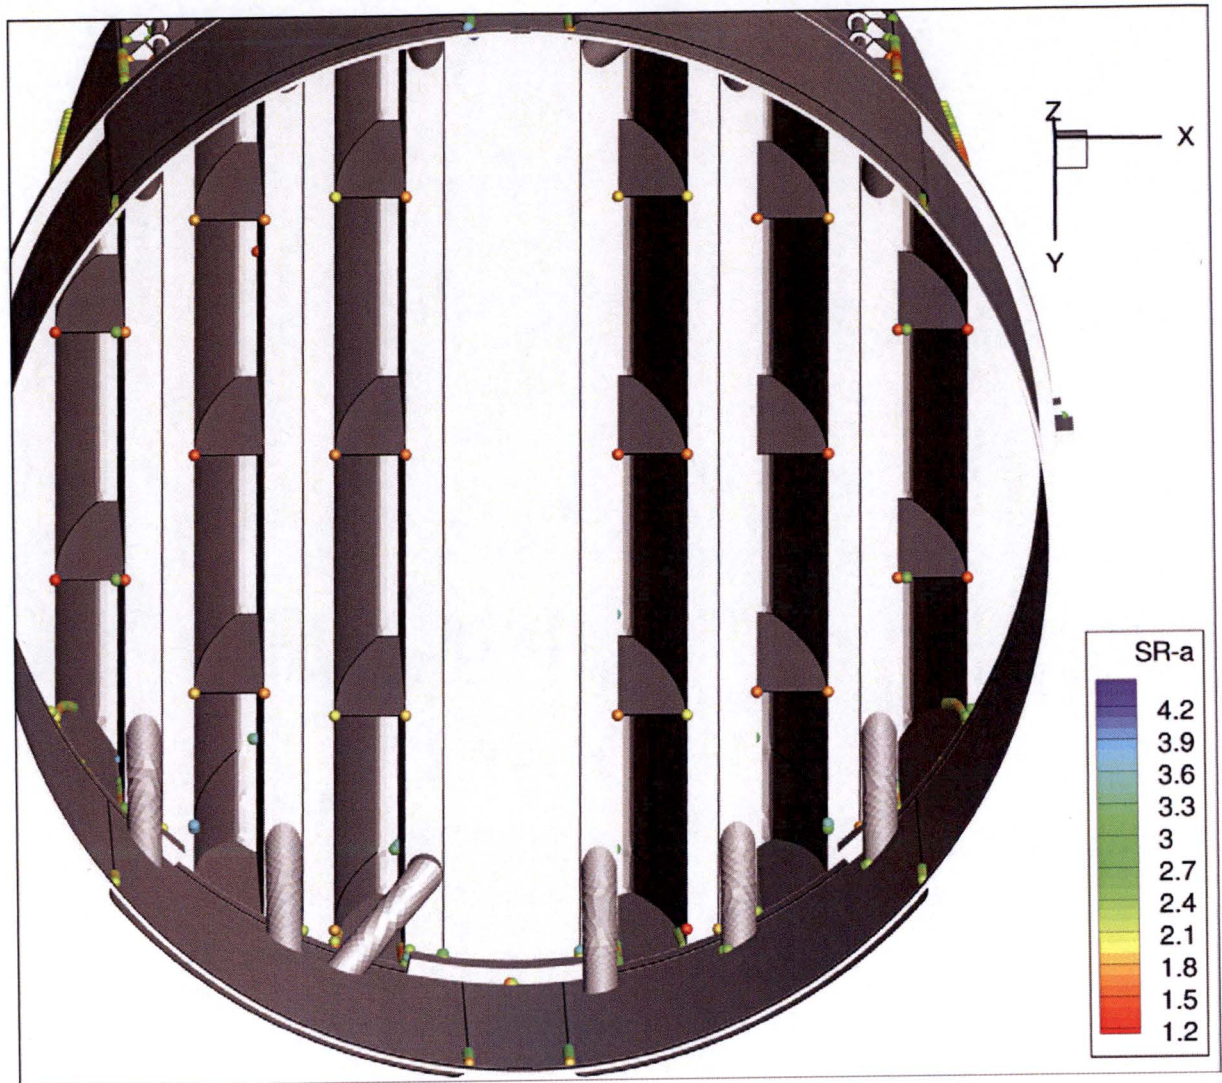
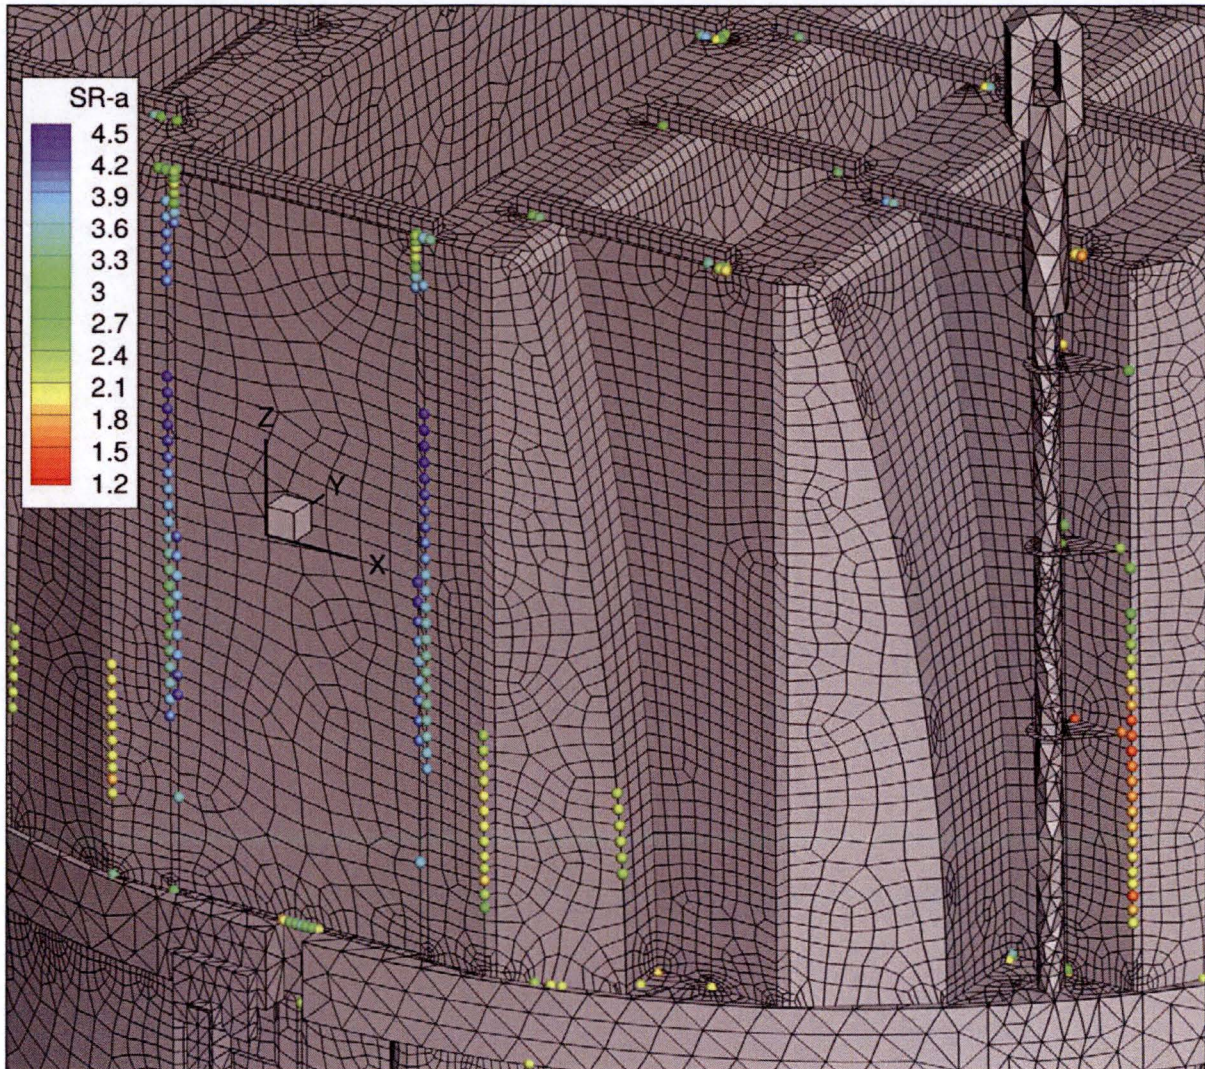
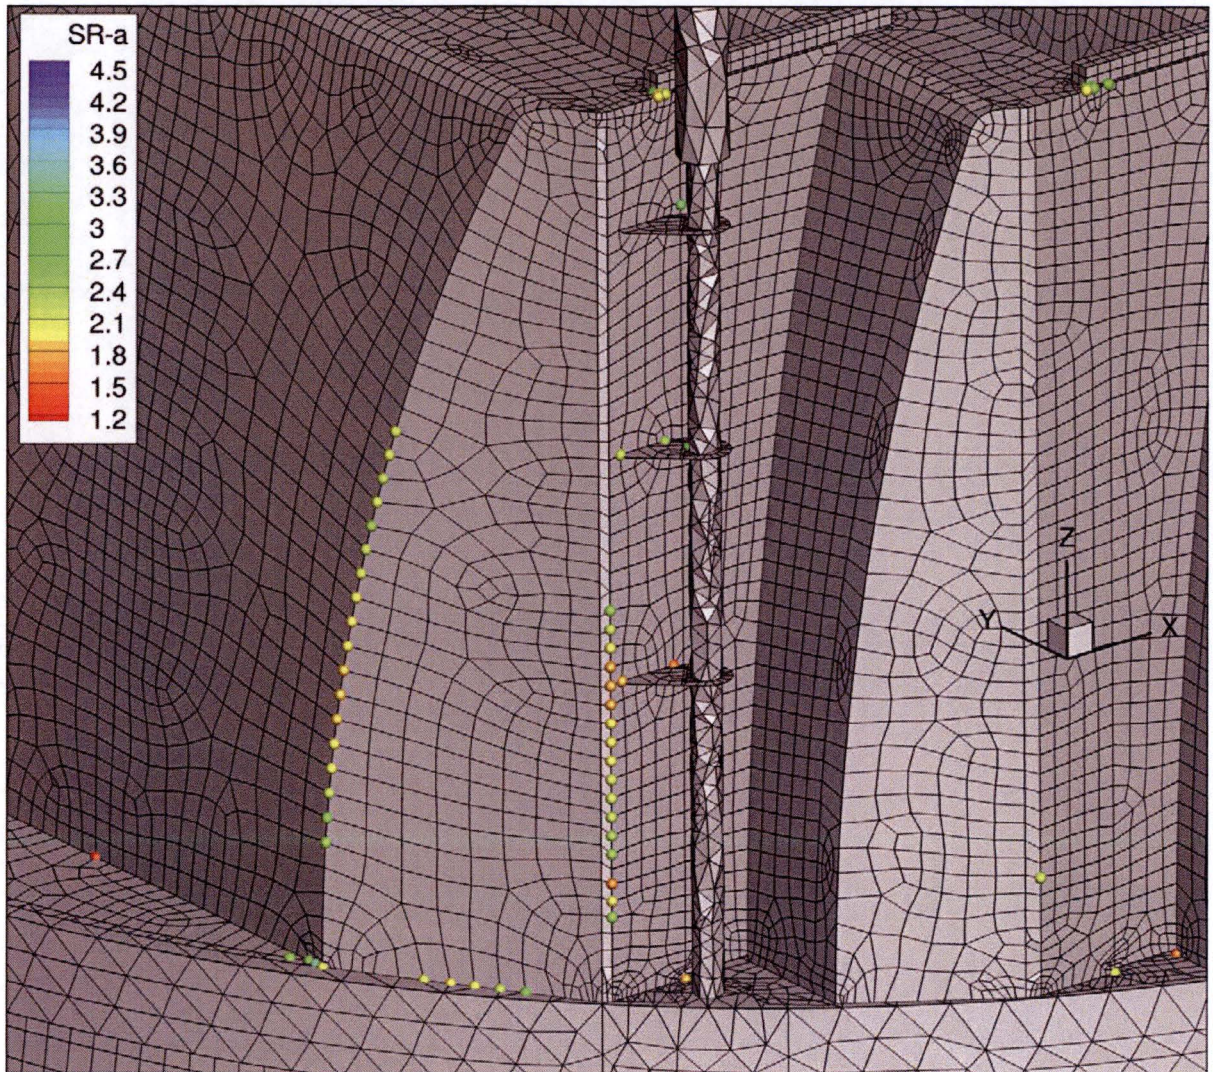
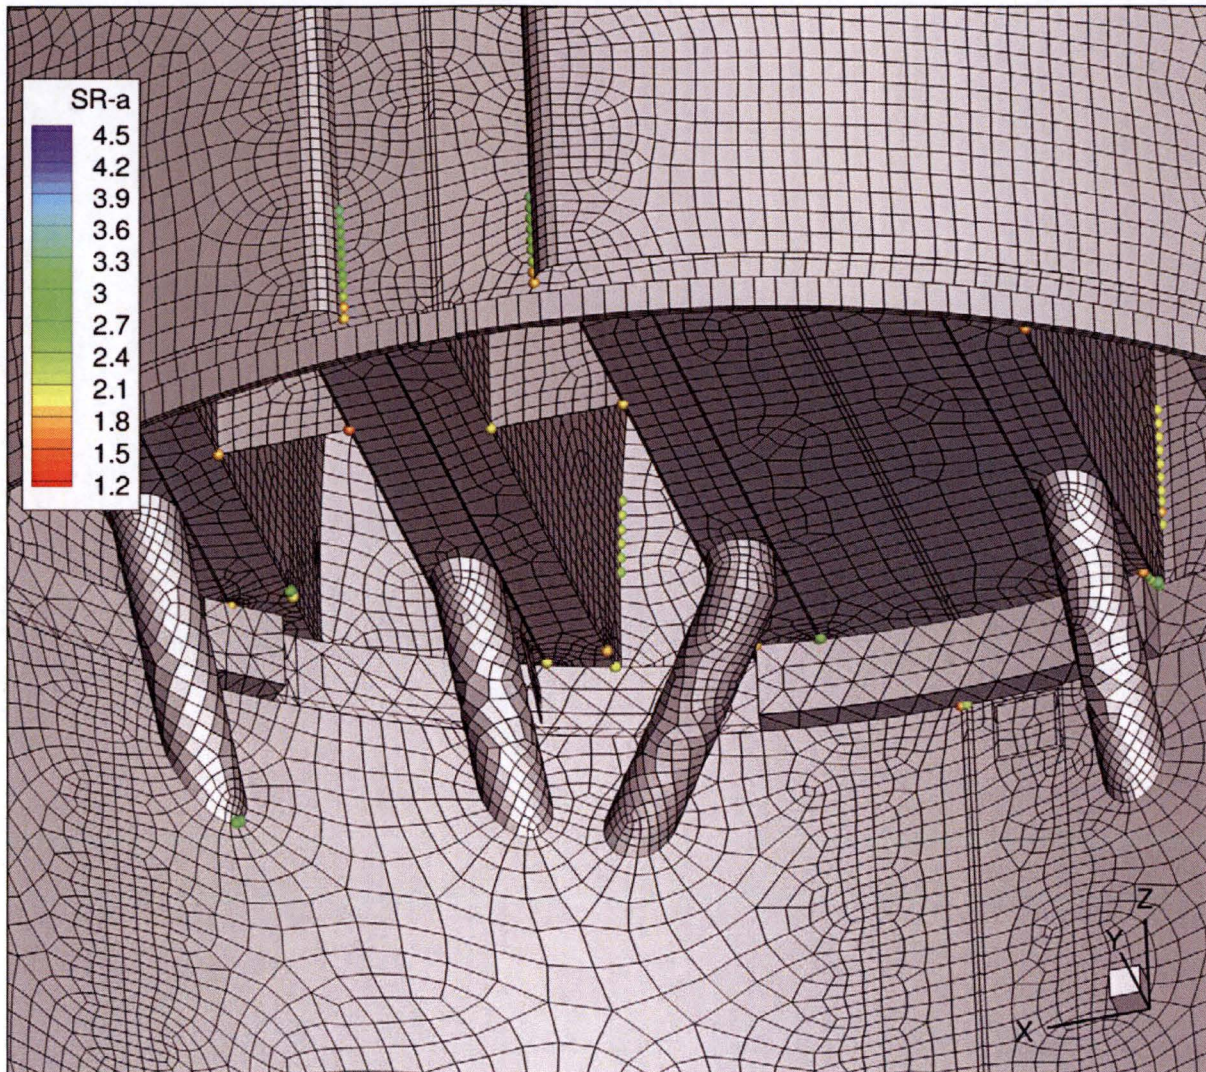
Figure 6a. Alternating stress ratios on welds [(3)]. View 1 from side.

Figure 6b. Alternating stress ratios on welds [(3)]. View 2 from underneath the dryer.

Figure 6c. Alternating stress ratios on welds [[ (3)]. Close-up view 3 of inner plate.

Figure 6d. Alternating stress ratios on welds [[

Figure 6e. Alternating stress ratios on welds [[

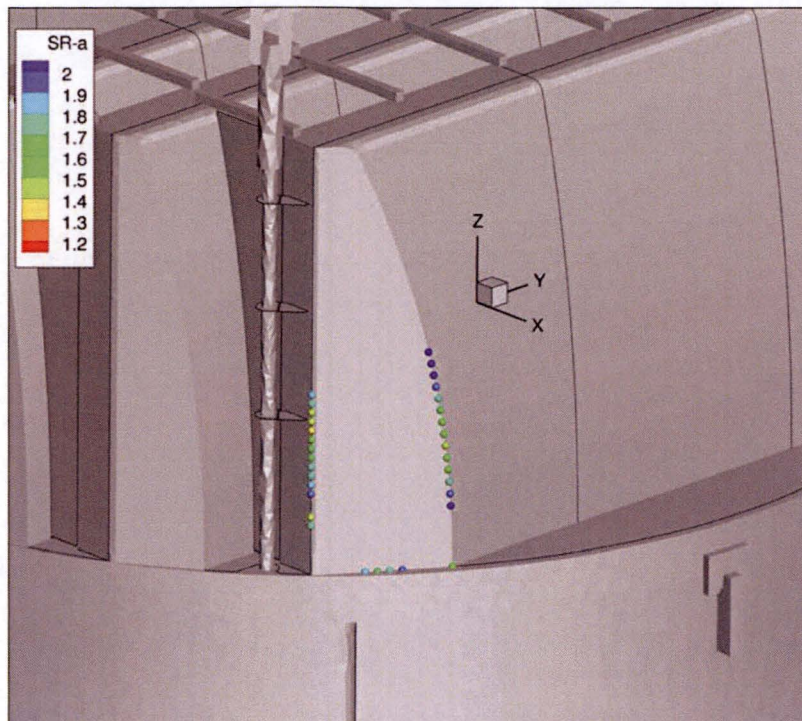
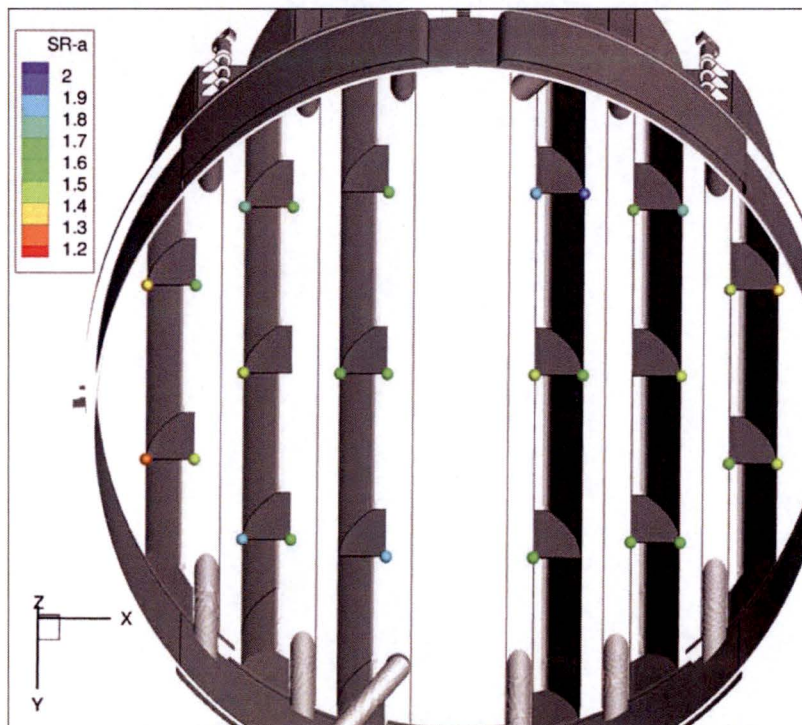
Figure 7a. Depictions of weld groups 1 and 2.

Group 1 – welds on outer end plate

Group 2 – Bottom of hood support welds

The locations with alternating stress ratios below 2.0 can be grouped as in Table 2. Where possible, connection with the welds in Figure 3 is made. The various groups are depicted in Figure 7 to indicate where inspections should be made. Note that Group 12 can be omitted from examination since its stress ratio  $SR-a=2$  and, with the various bias and uncertainties already imposed, is unlikely to be susceptible to FIV. Also, Group 14 involves a localized stress concentration that is believed fictitious. The node lies on a location where the shell elements of the skirt overlap with the solid elements of the upper support ring. Such overlap regions are prone to numerical error in the ANSYS FEA calculation due to the manner in which the connection is effected. Thus, these locations can be omitted unless the local welds are already subject to inspection.

Group	Description	No. of Nodes	Limiting SR-a	Welds in Figure 3	Comments
1	Welds involving outer end plate	78	1.39	e.g., SV4, SH6 + vertical welds	Limiting location on SV4.
2	Bottom 3 inches of hood support welds  Vane banks A & F (outer): hood support / outer hood Vane banks A & F (outer): hood support / vane bank Vane banks B & E (middle): hood support / middle hood Vane banks B & E (middle): hood support / vane bank Vane banks C & D (inner): hood support / inner hood Vane banks C & D (inner): hood support / vane bank	27	1.22  1.22 1.48 1.48 1.50 1.53 1.46		Limiting – group 2  Limiting values for individual hood support welds
3	Bottom 10 inches of drain channel attachment welds	17	1.74	e.g., DC-V5, DV-V6	
4	Tie bar attachment welds	24	1.30		
5	Bottom lifting rod brace	8	1.34	Green colored welds	
6	Attachment welds of inner vane bank end plate	34	1.48	Green colored welds	
7	Bottom of inner hood underneath or outboard of closure plate.	5	1.37	Not in Figure 3

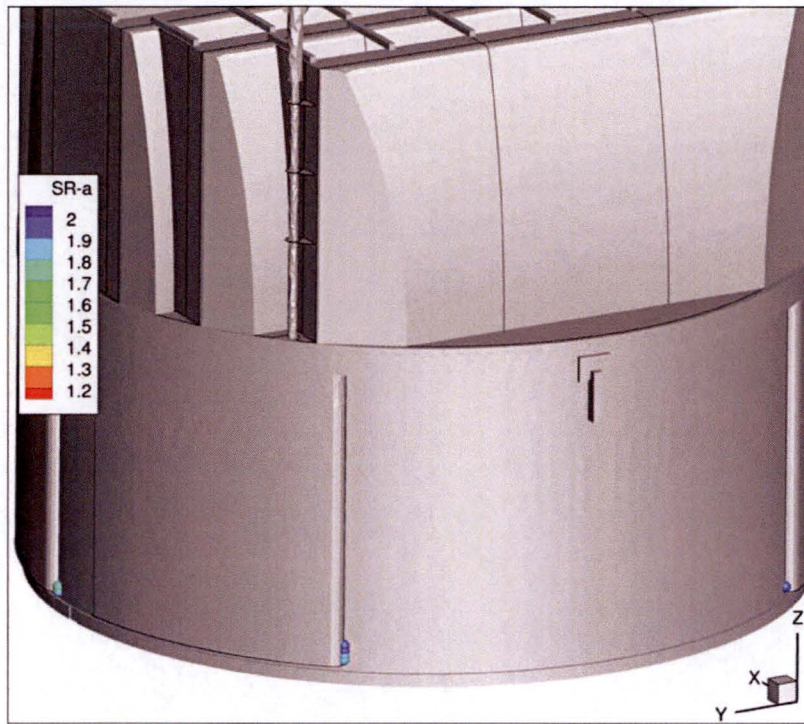
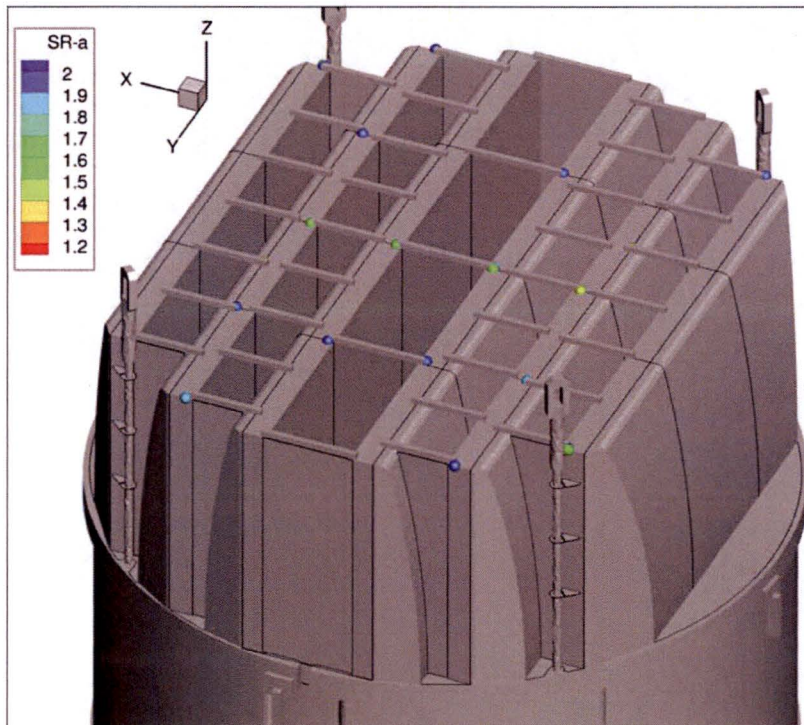
Figure 7b. Depictions of weld groups 3 and 4.

Group 3 – Bottom of drain channel welds

Group 4 – ends of tie bars

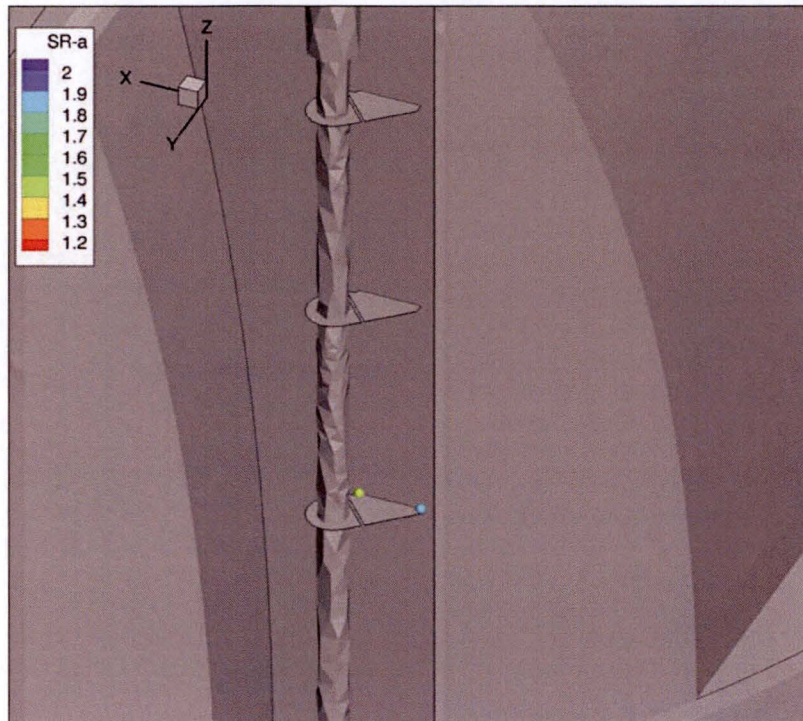
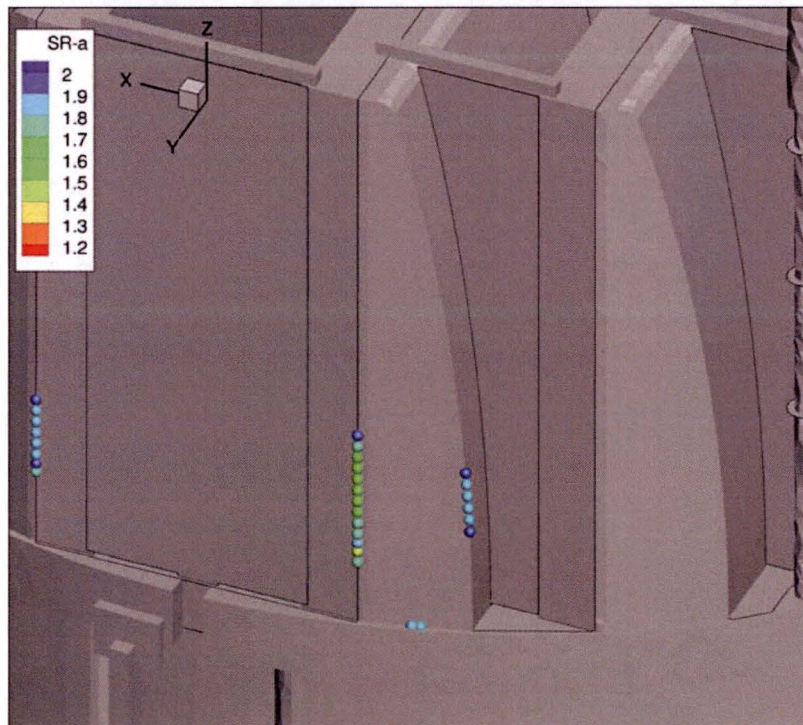
Figure 7c. Depictions of weld groups 5 and 6.

Group 5 – bottom lifting rod brace

Group 6 – inner vane bank end plate

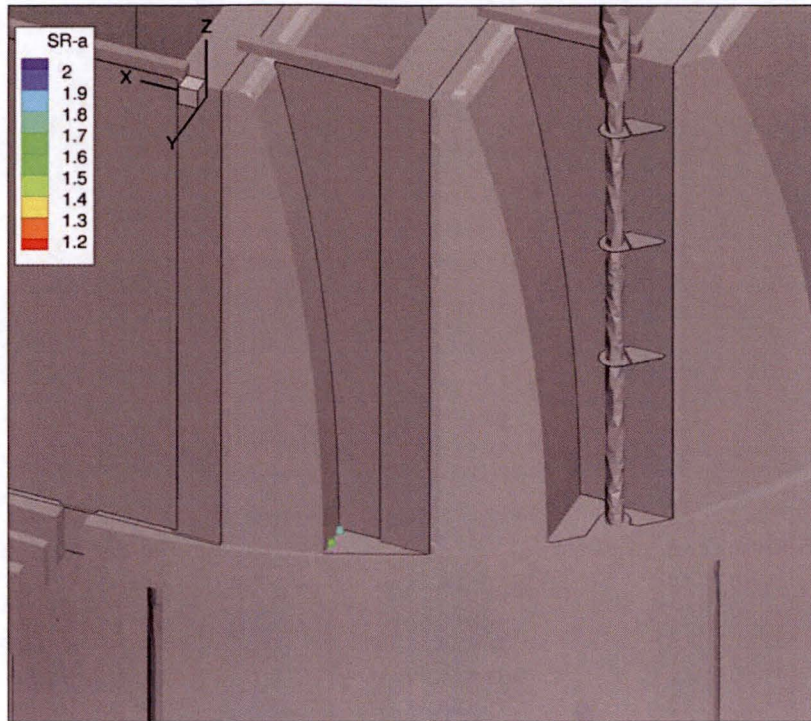
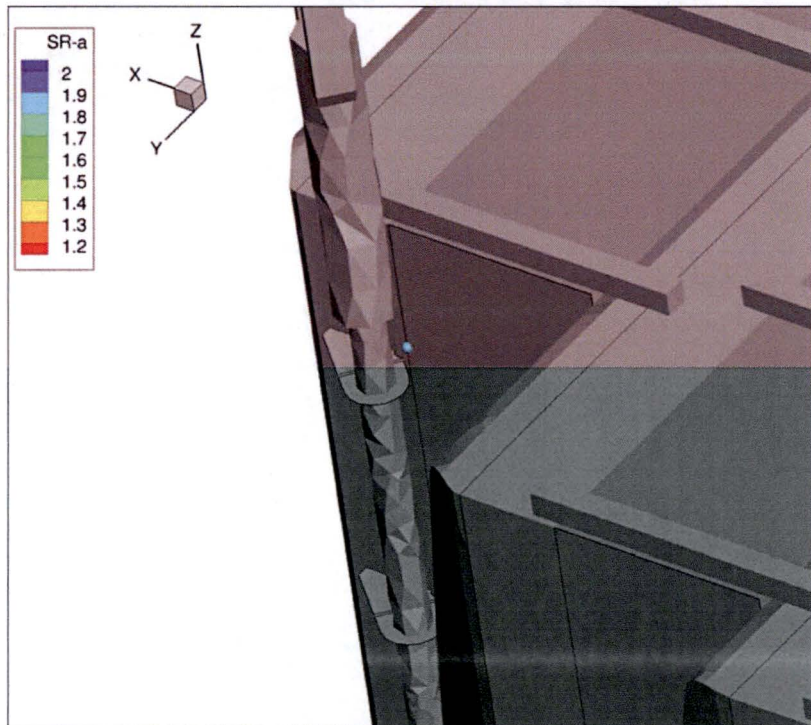
Figure 7d. Depictions of weld groups 7 and 8.

Group 7 – bottom of inner hood near closure plate

Group 8 – outer closure plate weld near upper lifting rod brace

8	Outer closure plate weld near upper lifting rod brace	2	1.85	Not in Figure 3	
9	Inner base plate/USR welds (underneath dryer)	8	1.67	Not visible in Figure 3	
10	Horizontal weld at bottom of inner side plate	1	1.97	Not visible (obscured by guide rail).	Not credited for attachment of U-channel stiffener.
11	Bottom of outer vane bank end plate (near base of lifting rod)	3	1.67	Not in Figure 3	
12	Bottom of middle hood, near closure plate	1	2.00	Not visible (obscured by lifting rod)	Limiting $SR-a=2.00$
13	Bottom horizontal weld of middle vane bank end plate.	1	1.86		
14	USR/skirt attachment weld, near support lugs.	2	1.62		Likely fictitious stress (skirt/USR overlap).
15	USR/support/earthquake block weld	1	1.87

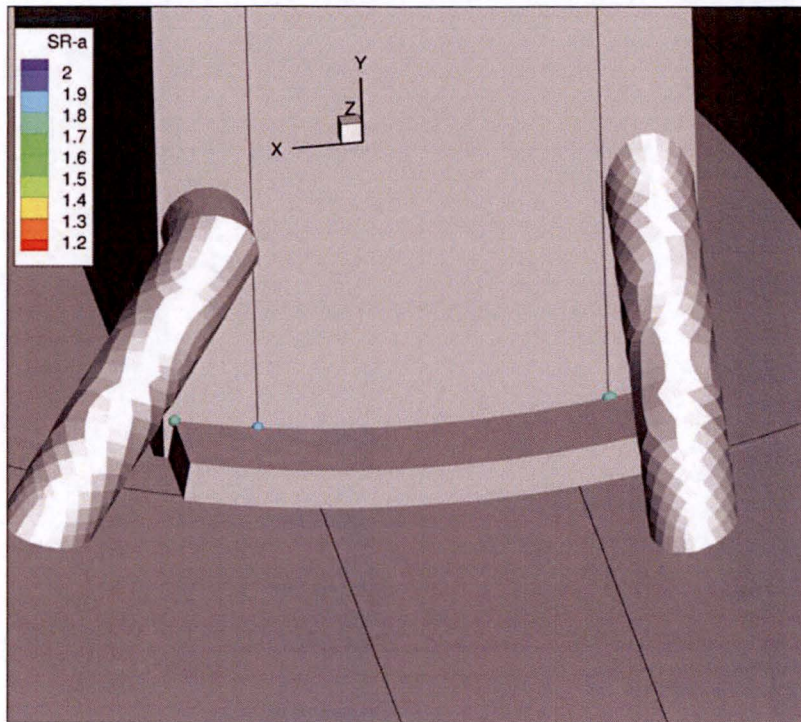
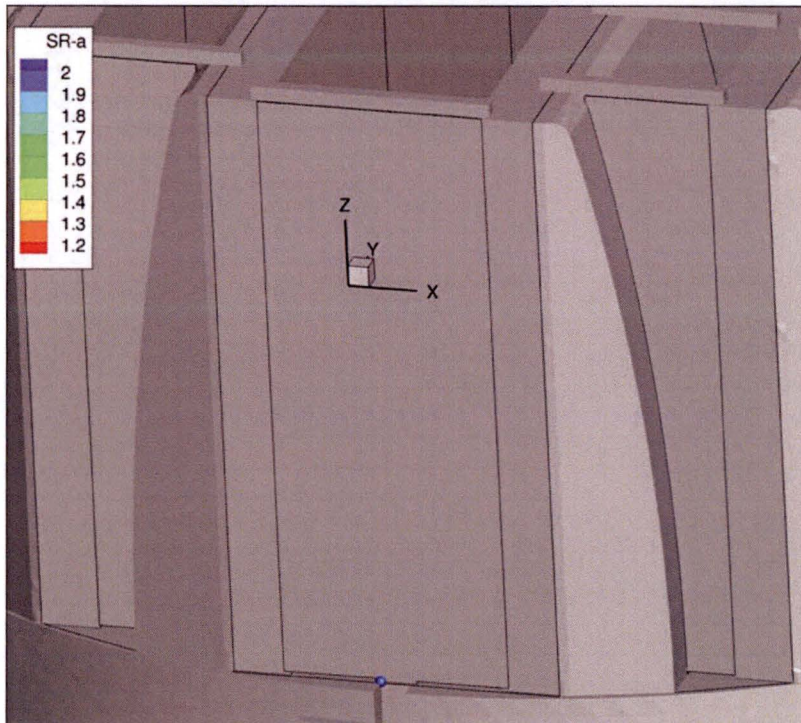
Figure 7e. Depictions of weld groups 9 and 10.

Group 9 – Inner base plates / USR

Group 10 – bottom of inner side plate

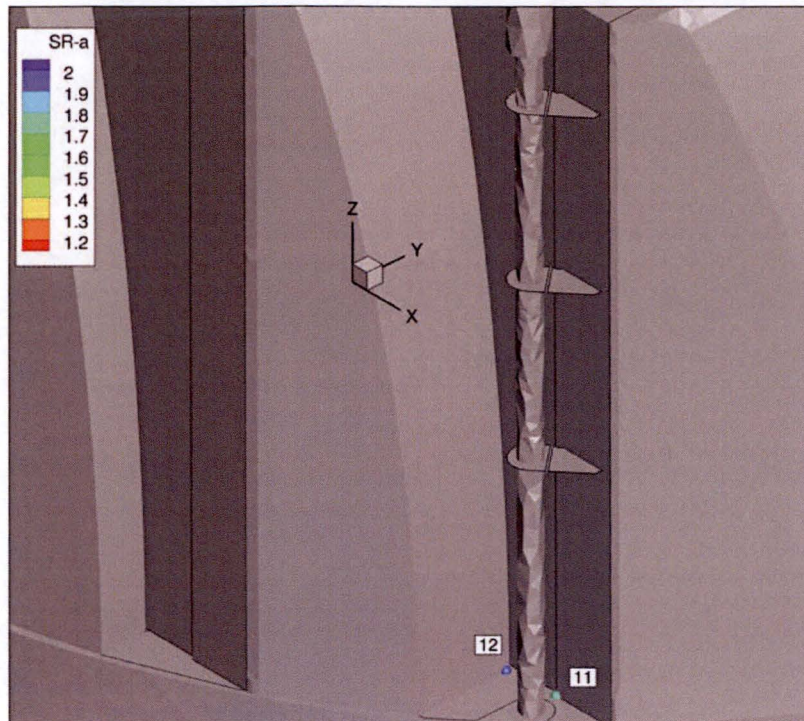
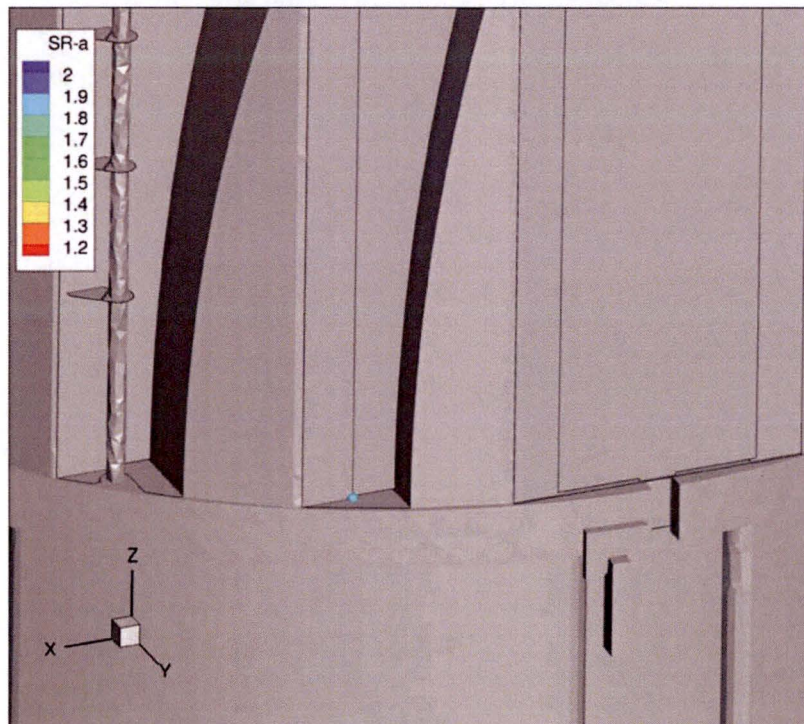
Figure 7f. Depictions of weld groups 11, 12 and 13.

Groups 11 & 12 – near base of lifting rod

Group 13 - bottom of middle vane bank end plate

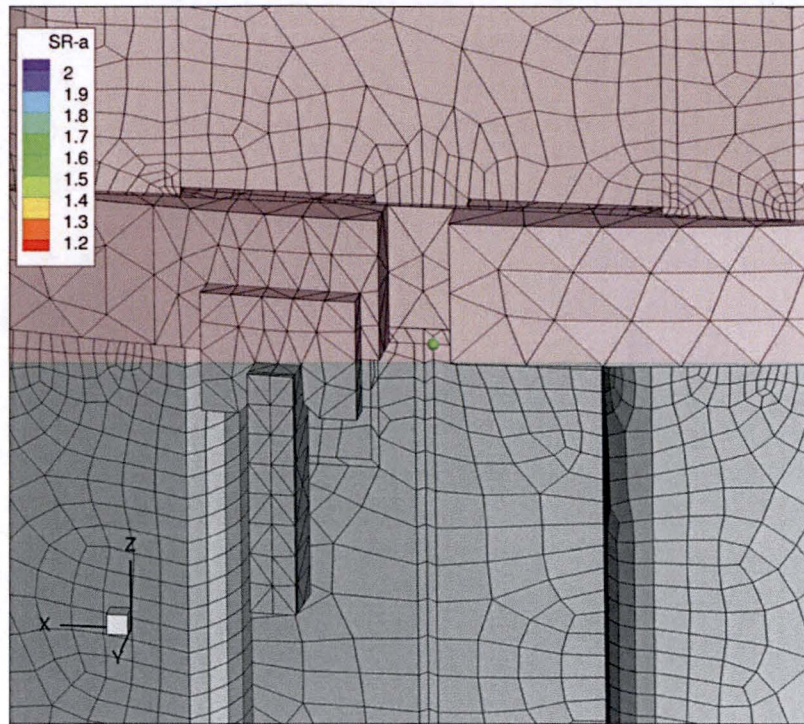
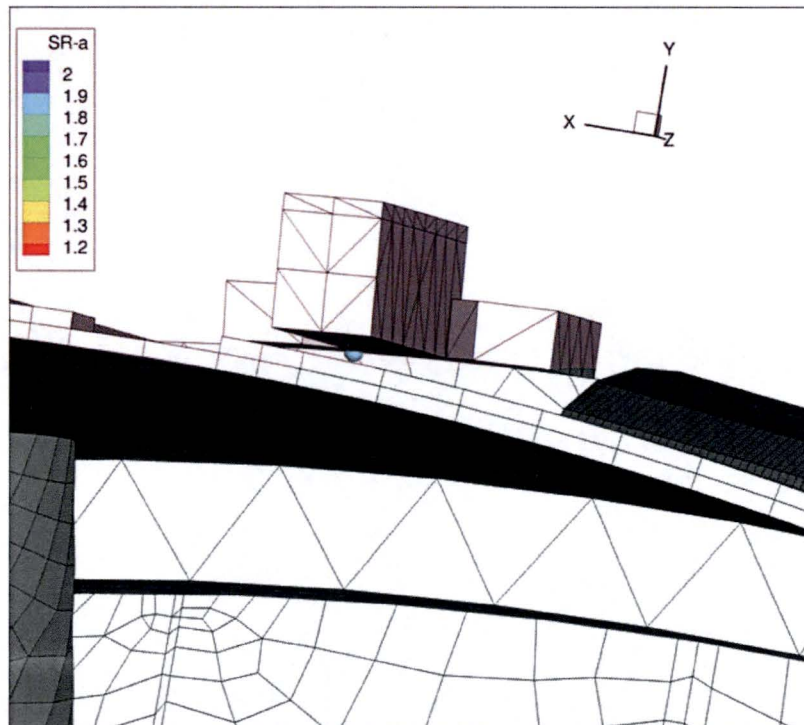
Figure 7g. Depictions of weld groups 14 and 15.

Group 14 – skirt/USR overlap (likely fictitious stress)

Group 15 – USR/support/earthquake block

(3)]] for all non-weld locations, the alternating stress ratio  $SR-a > 2$  with a limiting value of  $SR-a = 2.09$ . For all weld nodes,  $SR-a > 1$  with a limiting value of  $SR-a = 1.22$  occurring on the bottom of the outer hood/hood support weld. The weld locations with stress ratios below 2.0 are aggregated into 15 groups (Table 2) that can be compared with existing inspection schedules to determine whether an expanded inspection scope is required. Most of the groups and nodes are already confirmed within the inspection scope. Of the remaining nodes some may yet be determined to be within the existing inspection plan or else can be omitted since their stress ratios are very close to 2.0 (e.g., Groups 12 and 10) or the stresses are believed fictitious (e.g., Group 14).
