South Texas Project  
Units 1 and 2  
Docket Nos. STN 50-498, STN 50-499  
Additional Information for the  
Review of the South Texas Project, Units 1 and 2,  
License Renewal Application – Aluminum Bronze AMP (TAC Nos. ME4936 and ME4937)

1. STPNOC LRA Aluminum Bronze Basis Document
2. Intertek Report

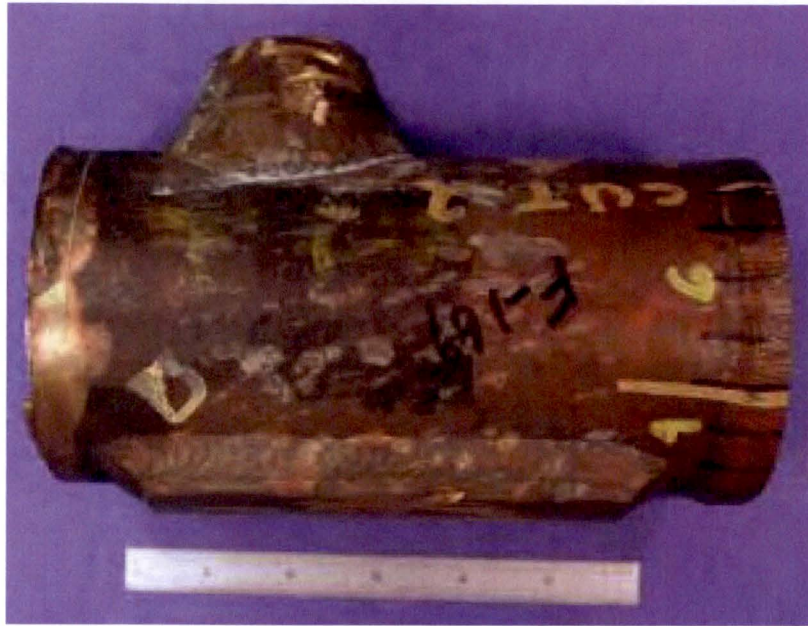
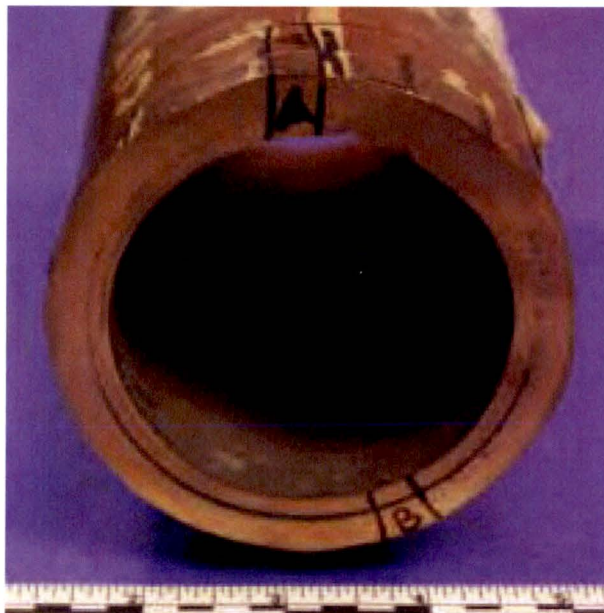
a) Pipe Segment – Long View

a) Pipe Weld Cross-section – End View

**Figure 3-4 – 3-inch Flange-to-Pipe Weld Showing Locations of Removed Sections**

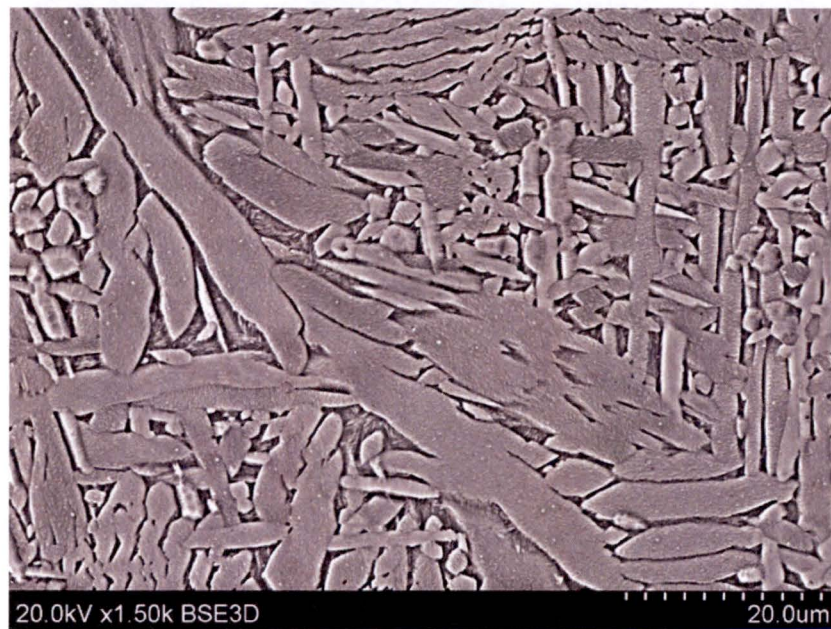
**Figure 5-12 – Representative BSE Micrographs at Progressively Higher Magnification Showing the Weld Crown Microstructure 10-Inch Pipe Field Mockup Sample. Grain Boundaries Consist of  $\alpha$  Phase Network with Interrupted Regions of Transformed Phase.**

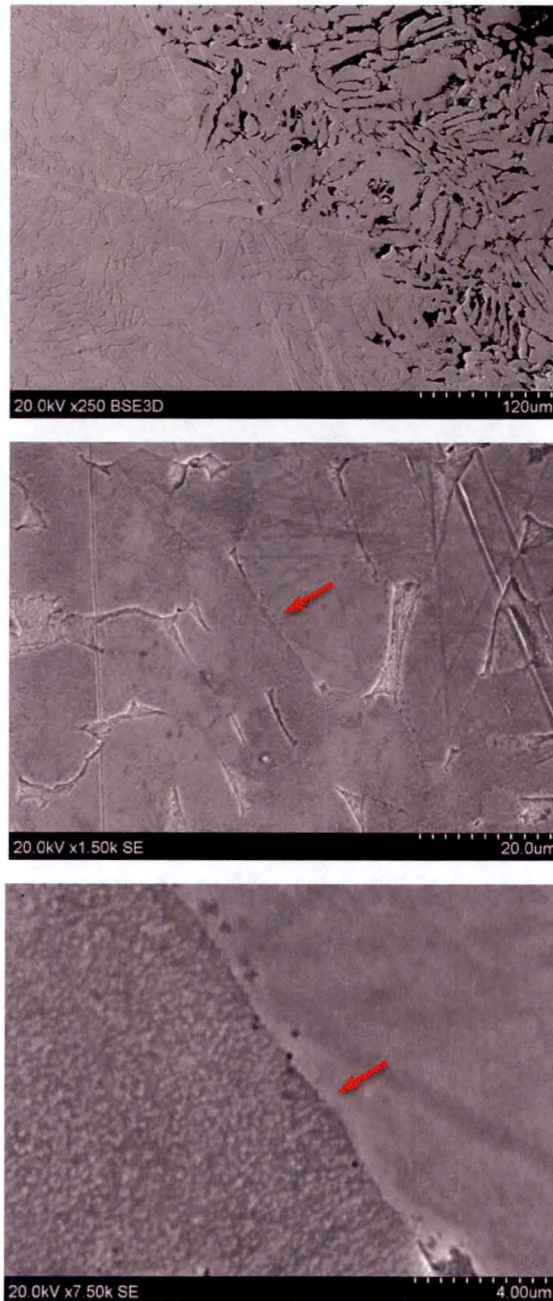
**Figure 5-17 – BSE Micrographs at Progressively Higher Magnification of Section A from The 3-Inch Flange-to-Pipe Weld. Dealloying Of Weld In Semi-Continuous Network of Transformed Phase Evident (Top). Not All Grain Boundaries Contained Transformed Phase Disrupting the Network of Susceptible Phase (Arrows).**

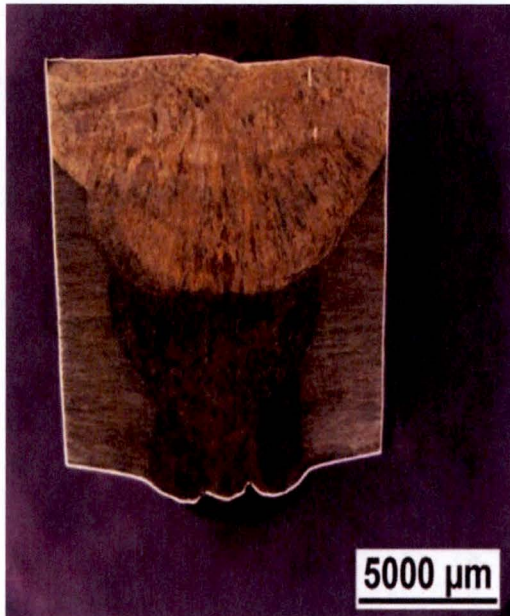
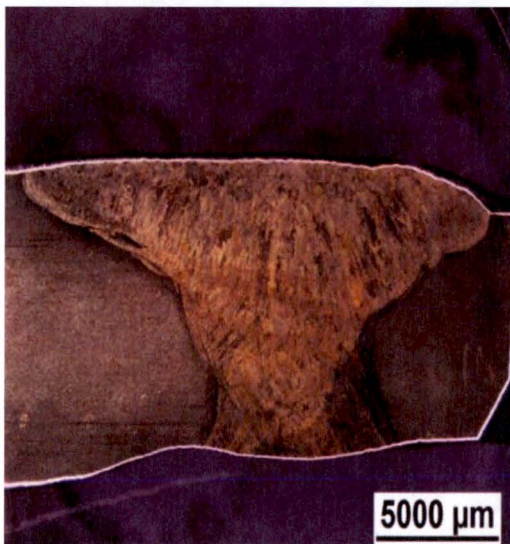
**Figure A-1 – Typical Field Mockup Weld Cross-Sections  
10-inch (Top) and 30-inch (Bottom)**
