COMANCHE PEAK S.E.S.  
FINAL SAFETY ANALYSIS REPORT  
UNITS 1 and 2

FIGURE 2.5.4-1

FIGURE 2.5.4-37

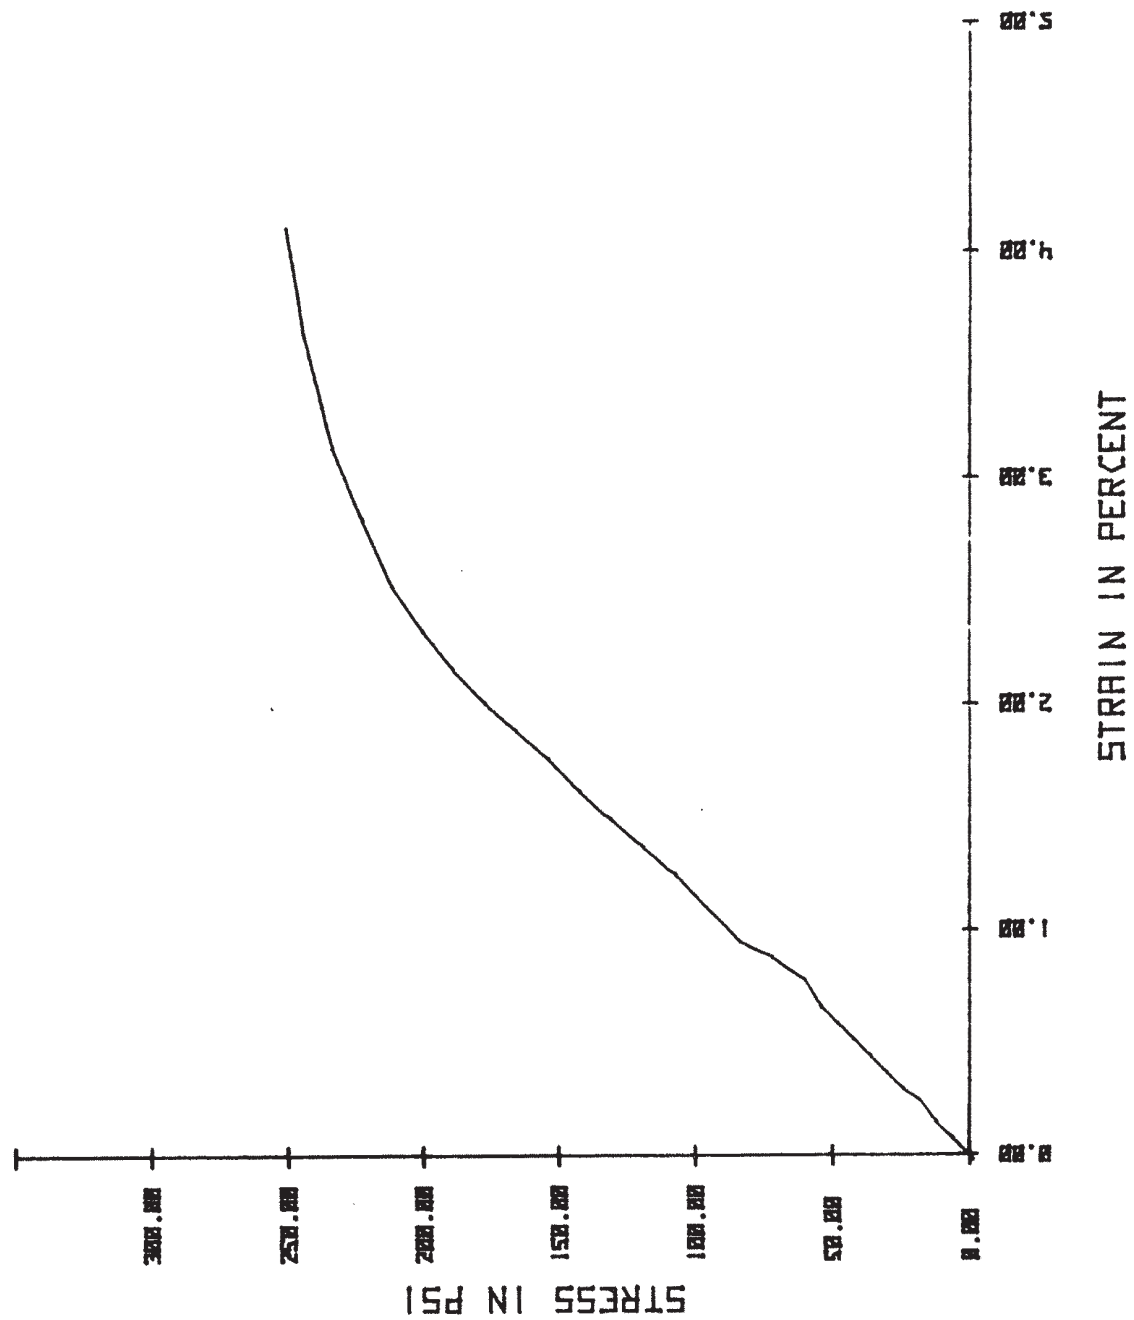
BORING NO.: P-1 DEPTH: 40.0-40.5  
 YOUNG'S MODULUS OF ELASTICITY= 9200 PSI

STRESS-STRAIN PLOT  
 Sheet 1 of 25

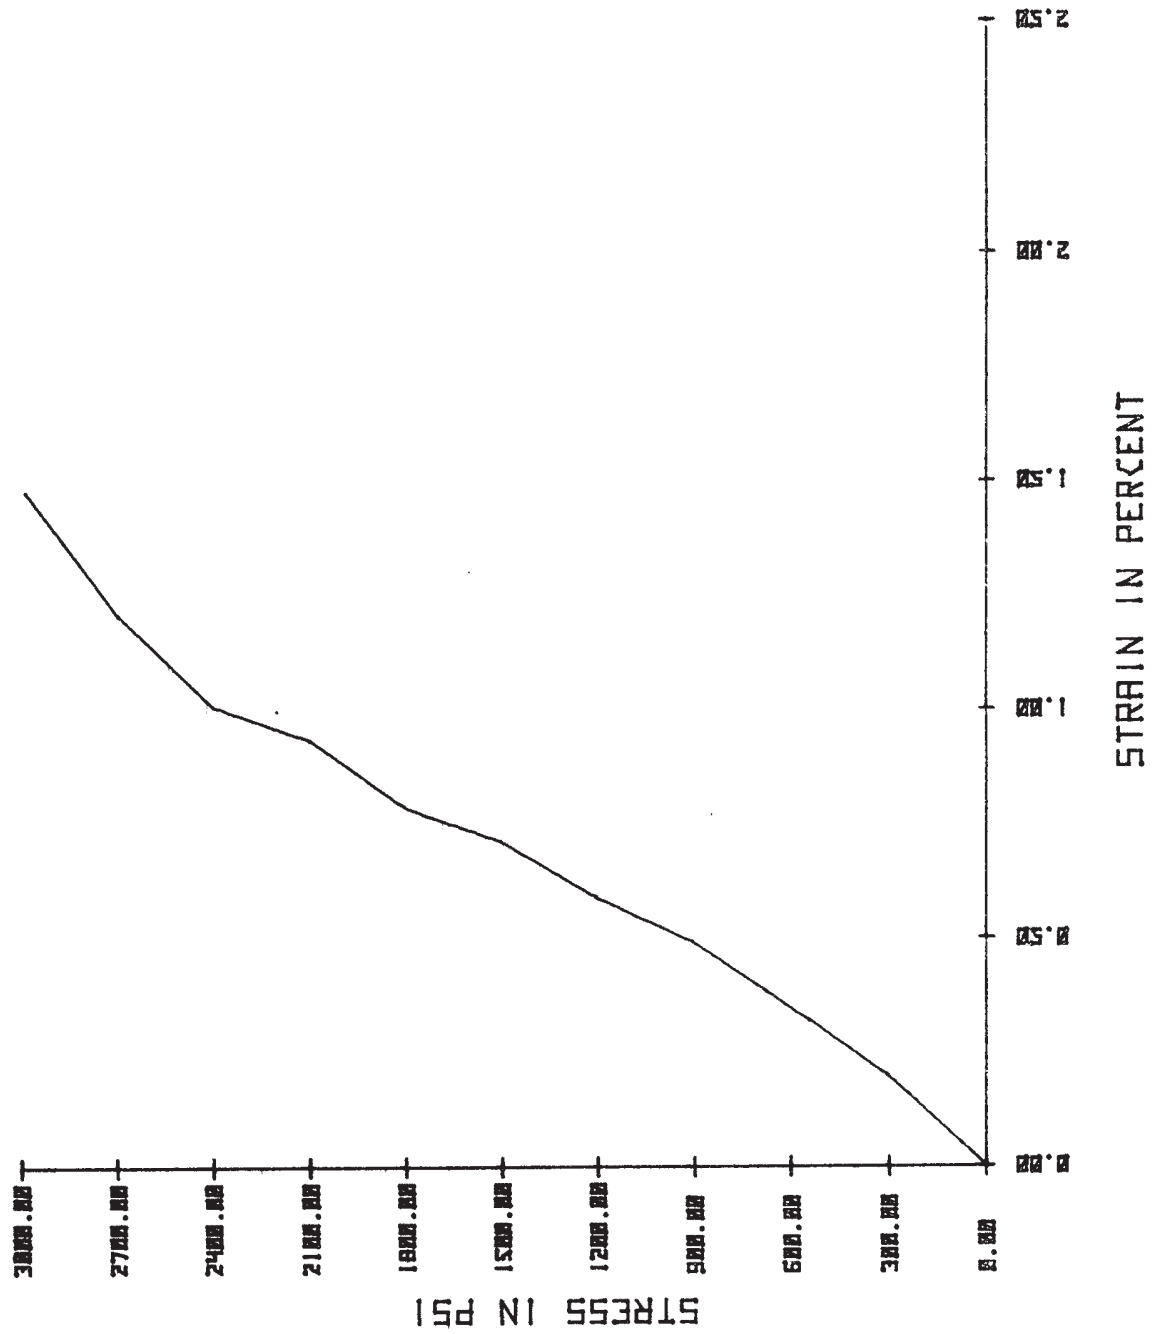
FIGURE 2.5.4-1

BORING NO.: P-1 DEPTH: 90.0-90.7  
 YOUNG'S MODULUS OF ELASTICITY= 400000 PSI

STRESS-STRAIN PLOT  
 Sheet 2 of 25

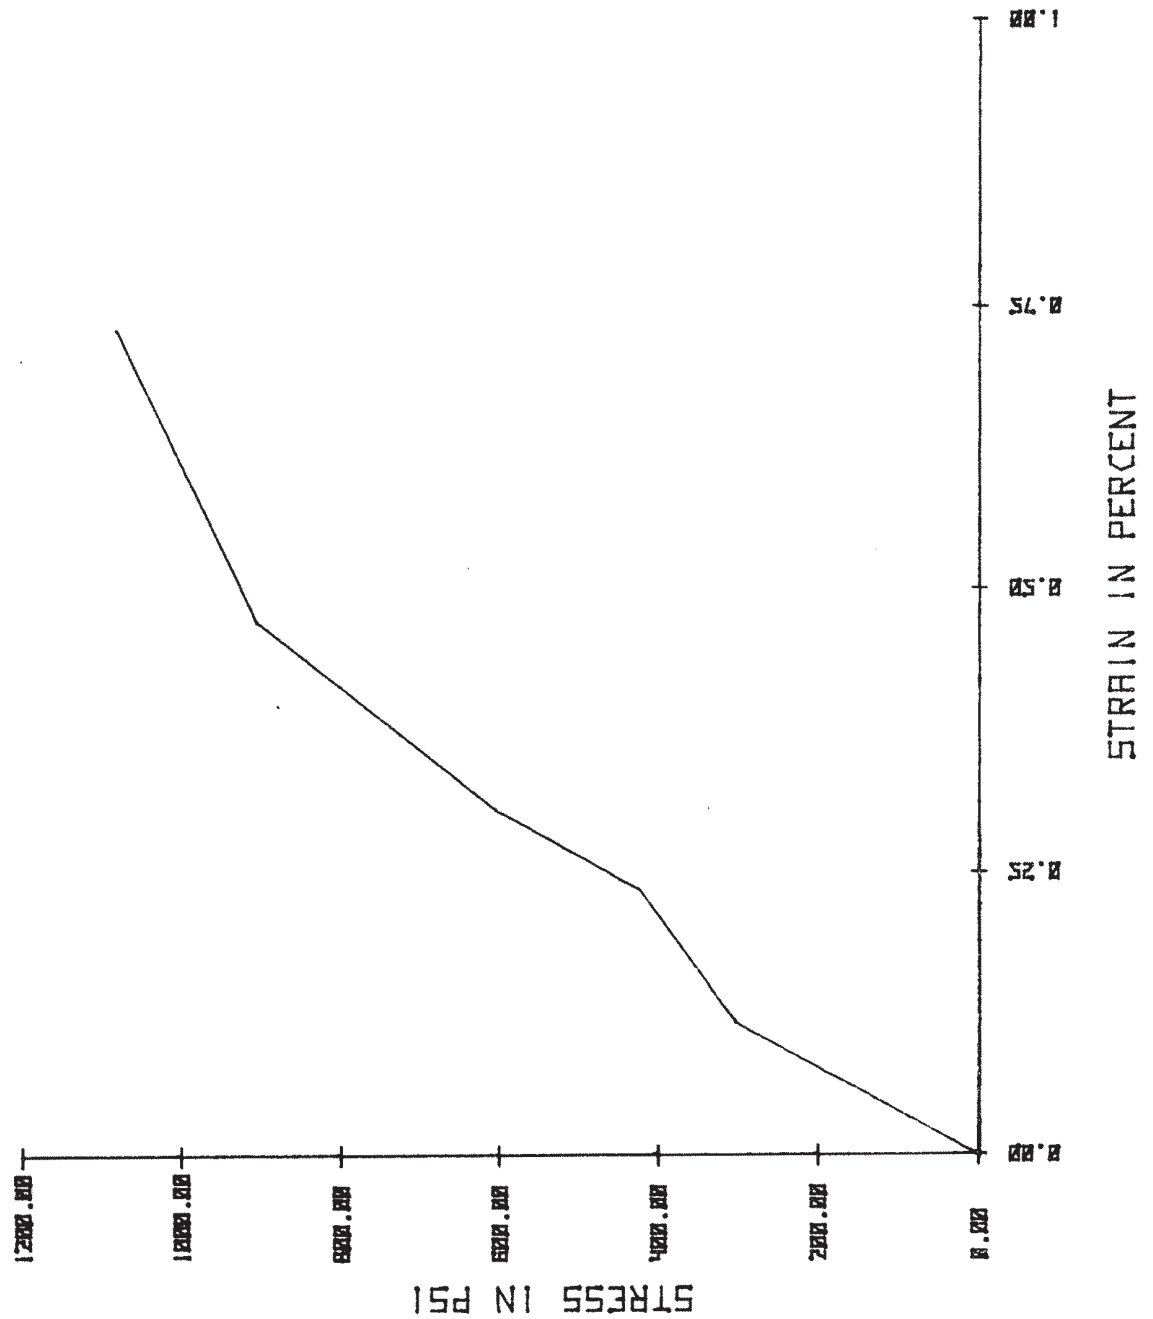
FIGURE 2.5.4-1

BORING NO.: P-4 DEPTH: 59.6-60.3  
YOUNG'S MODULUS OF ELASTICITY= 200000 PSI

STRESS-STRAIN PLOT  
Sheet 3 of 25

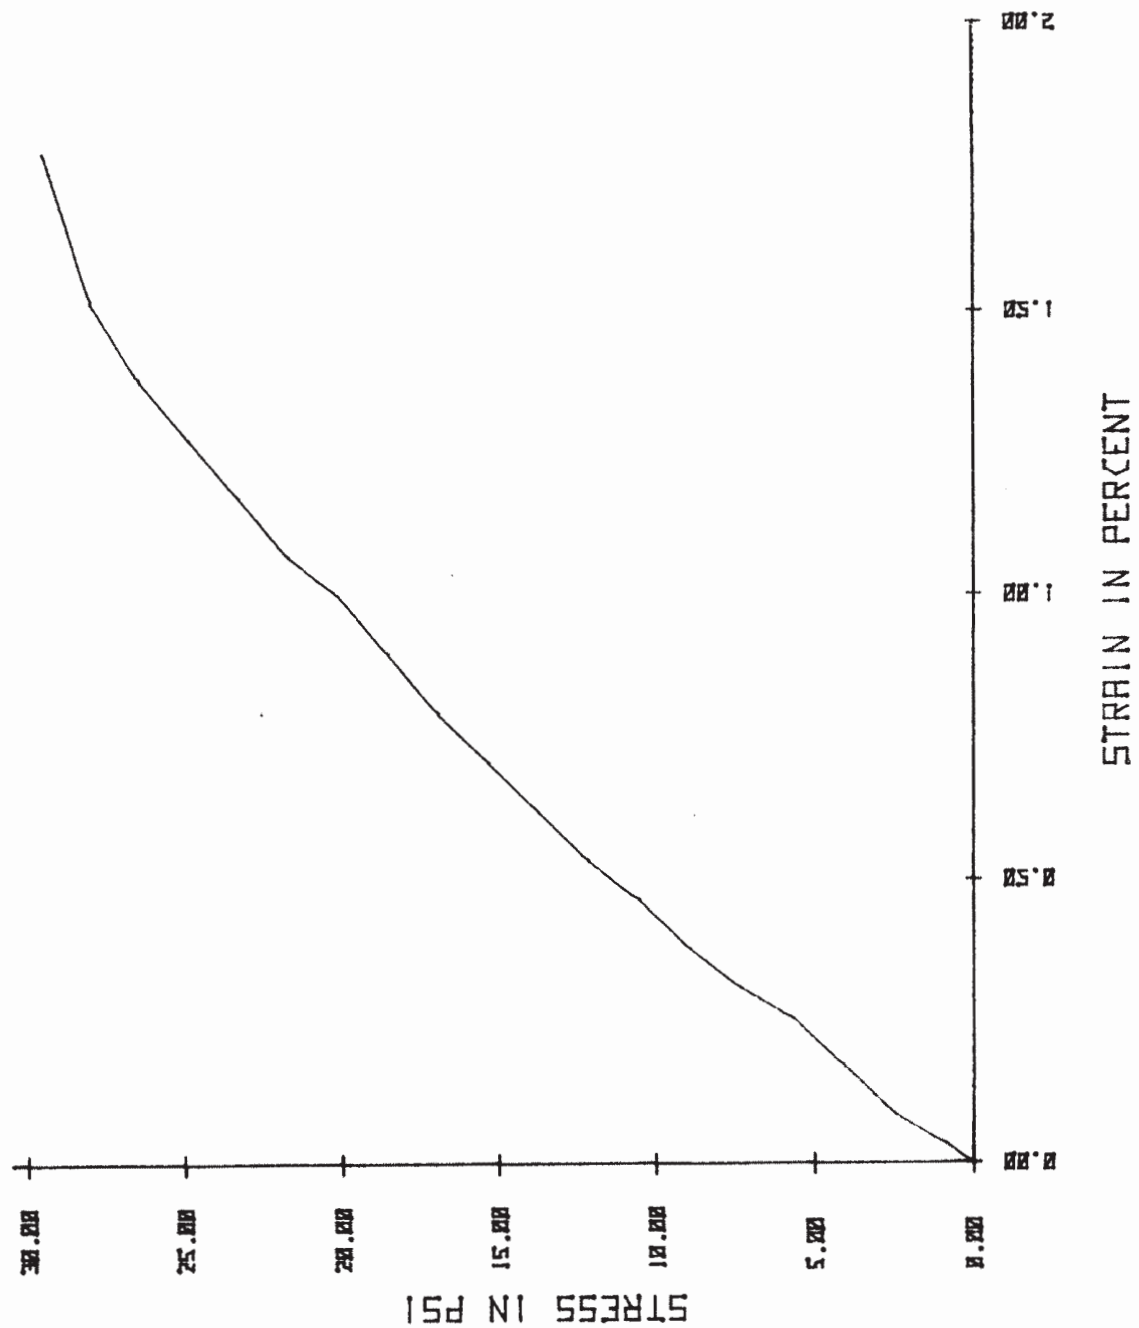
FIGURE 2.5.4-1

BORING NO.: P-9 DEPTH: 2.0-3.5  
YOUNG'S MODULUS OF ELASTICITY= 2200 PSI

STRESS-STRAIN PLOT  
Sheet 4 of 25

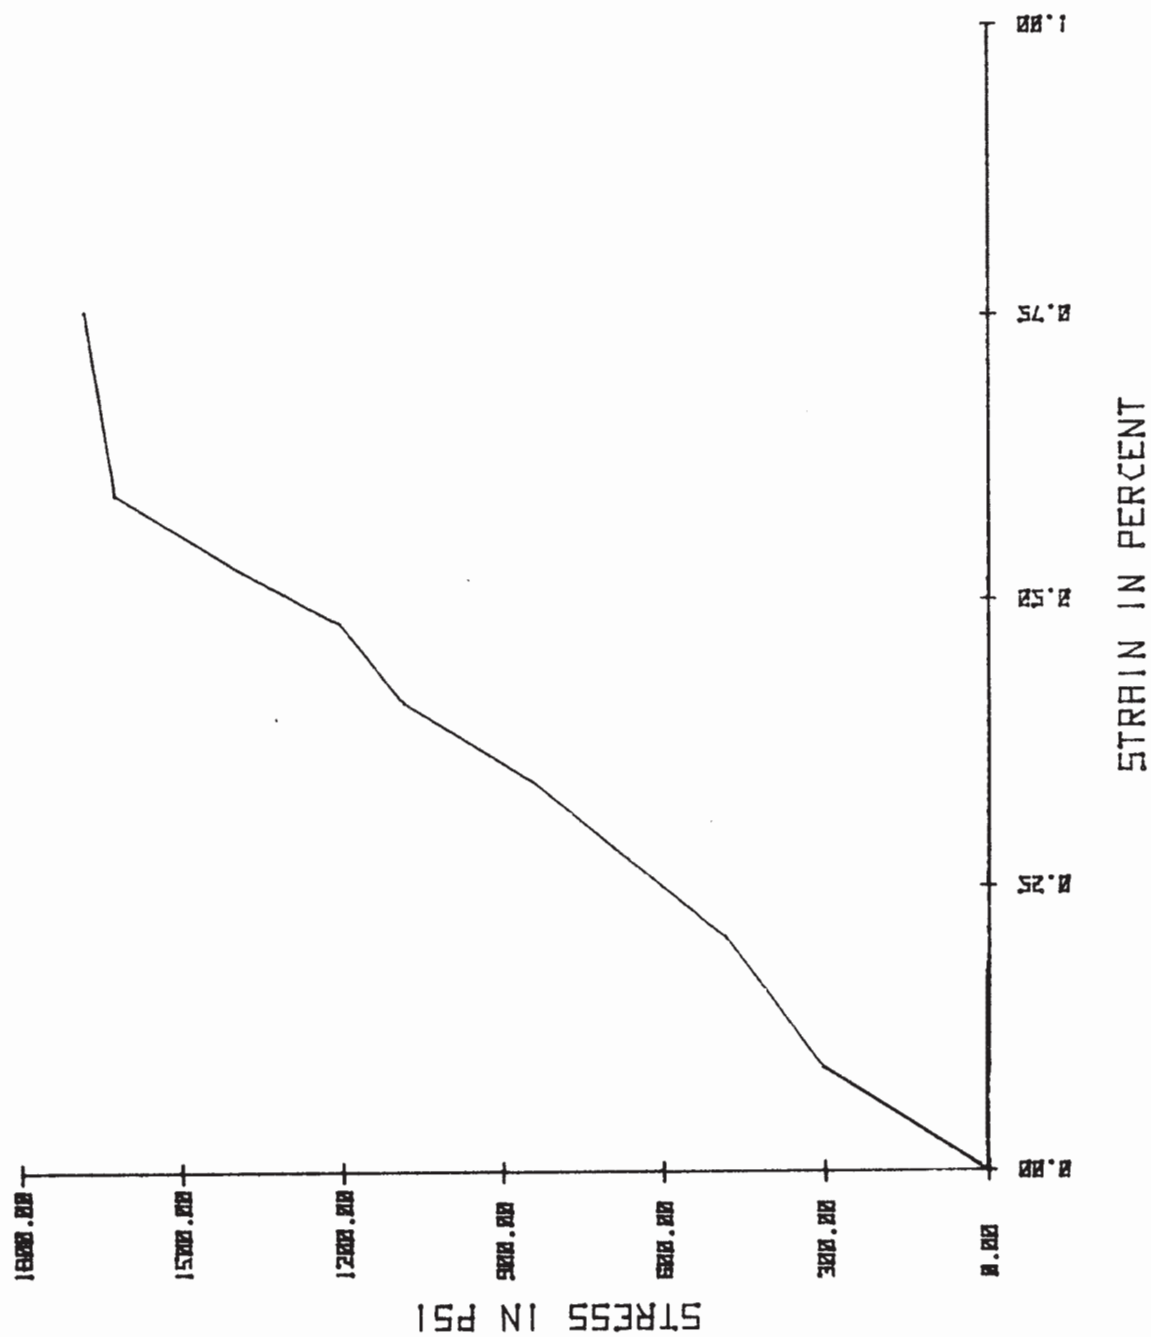
FIGURE 2.5.4-1

BORING NO.: P-9 DEPTH: 36.1-36.8  
 YOUNG'S MODULUS OF ELASTICITY= 320000 PSI

STRESS-STRAIN PLOT  
 Sheet 5 of 25

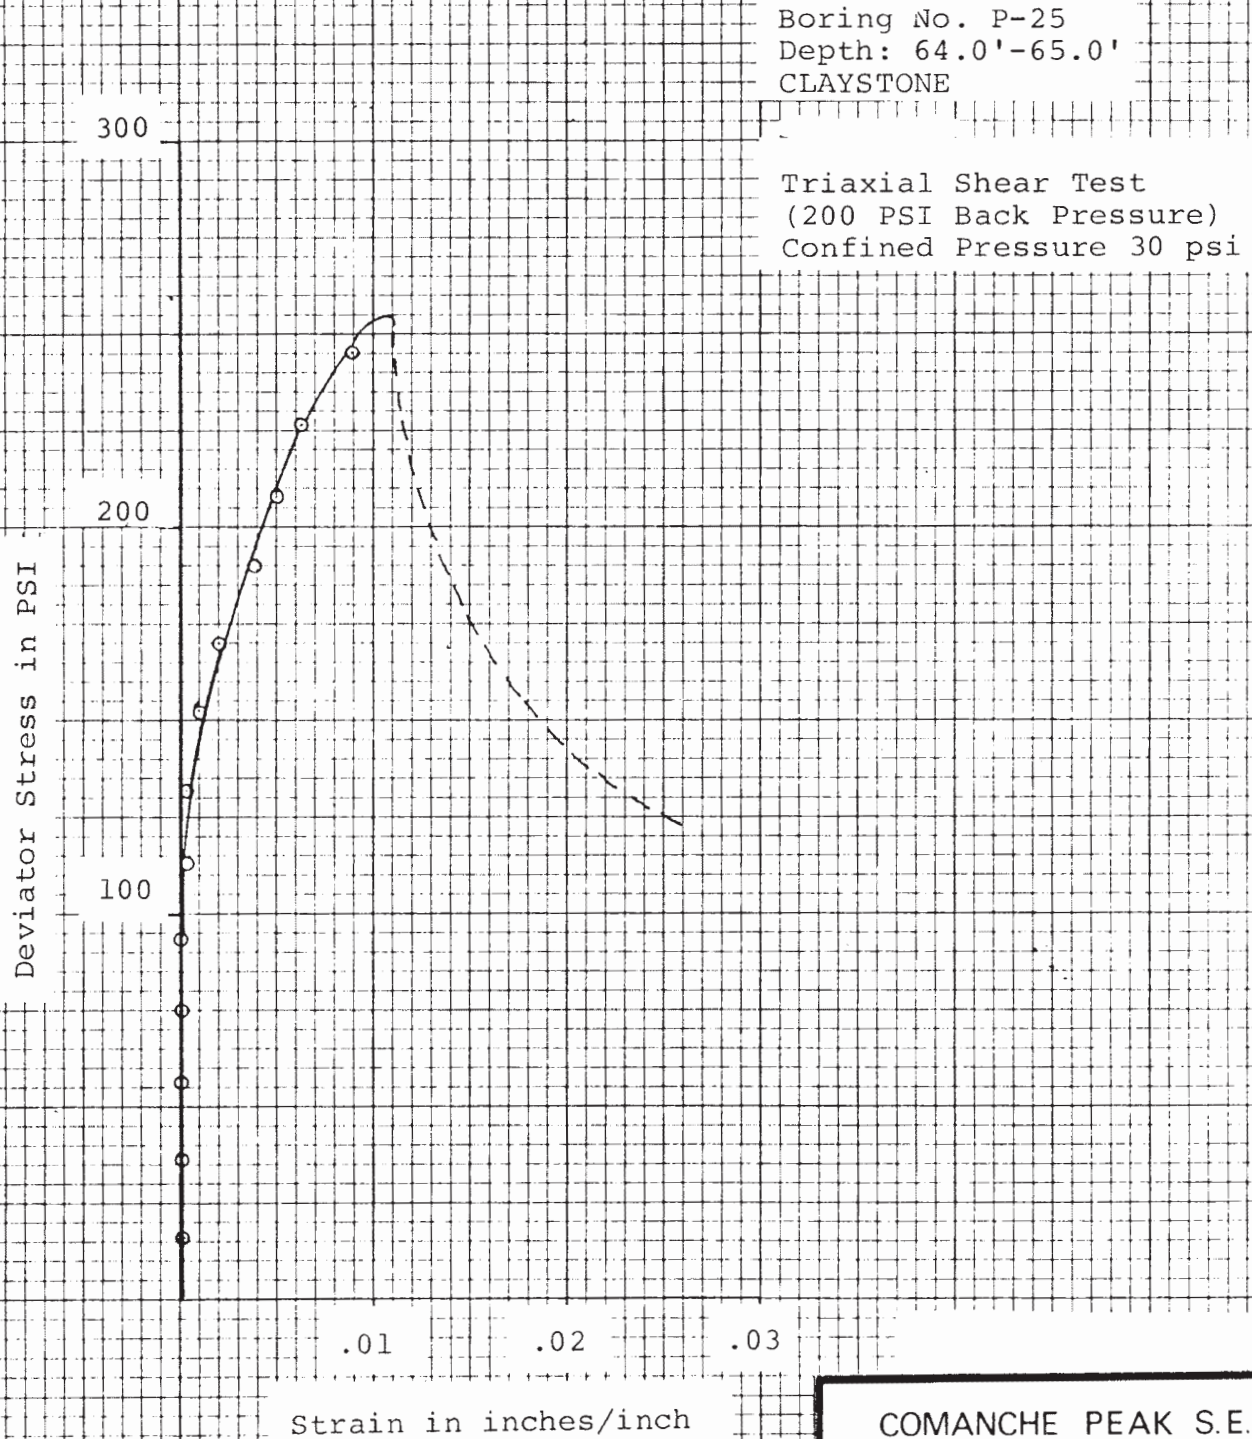
FIGURE 2.5.4-2

TYPICAL STRESS-STRAIN CURVE  
CLAYSTONE

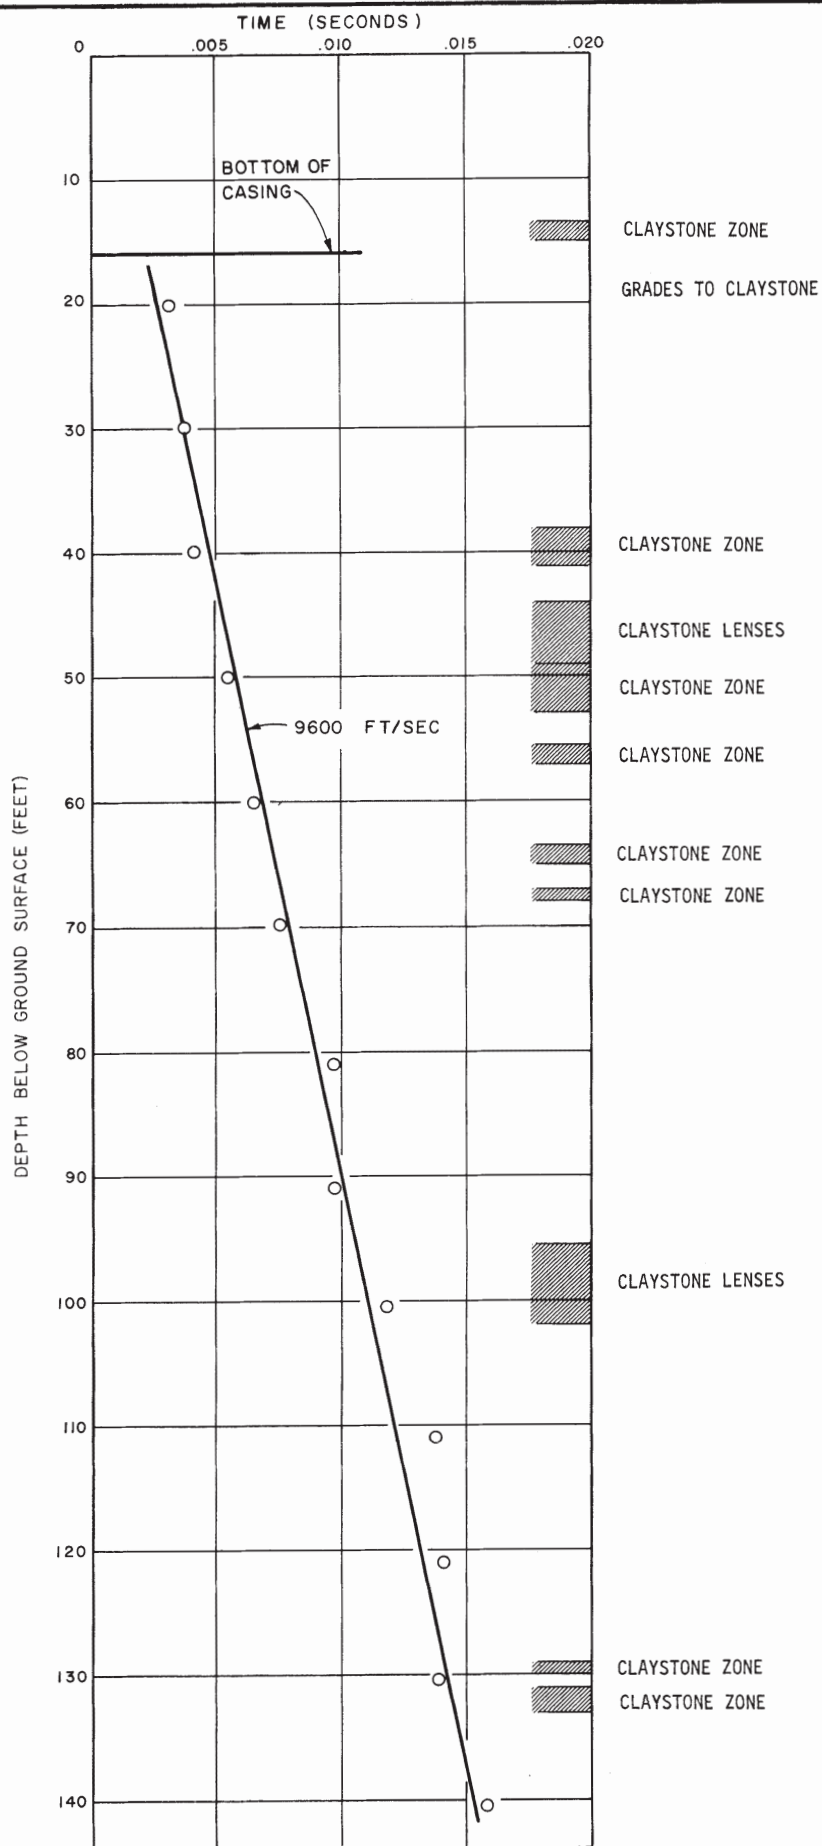
COMANCHE PEAK S.E.S.  
FINAL SAFETY ANALYSIS REPORT  
UNITS 1 and 2  
UPHOLE COMPRESSIONAL  
WAVE VELOCITY  
BORING P-1  
FIGURE 2.5.4-19

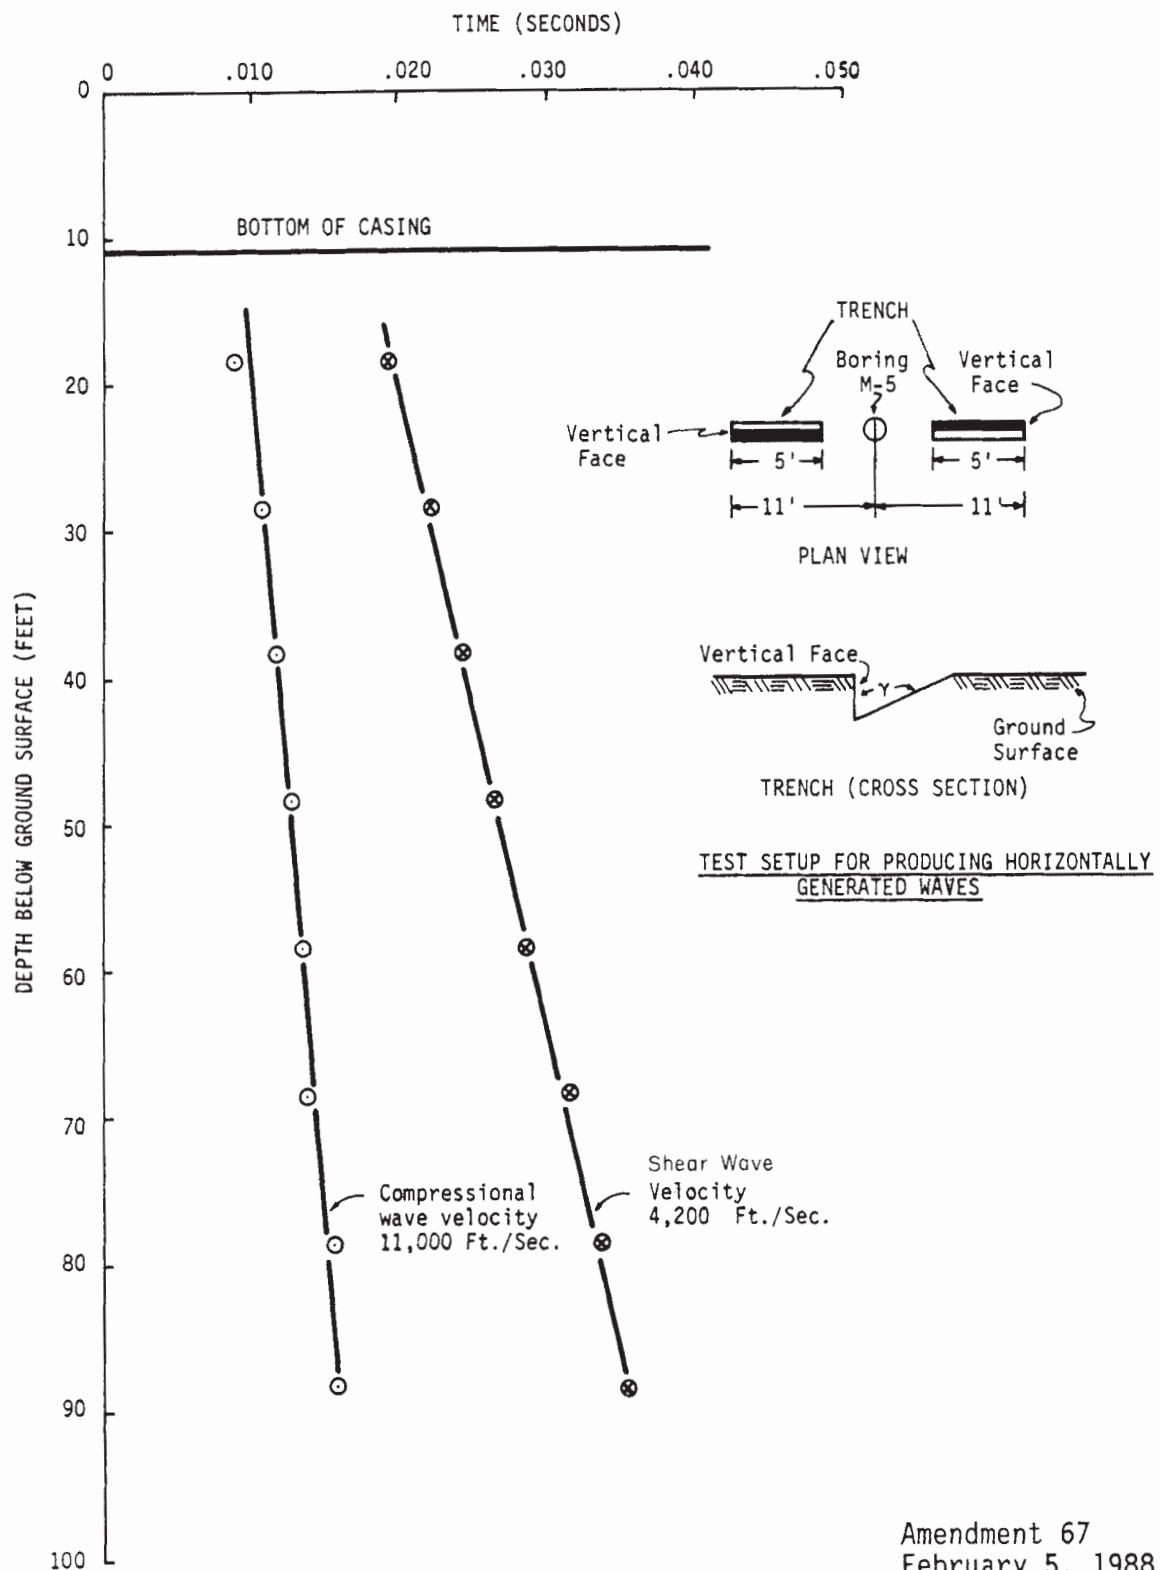
FIGURE 2.5.4-21

UPHOLE SHEAR WAVE SURVEY  
(PRIMACORD METHOD) BORING M-5

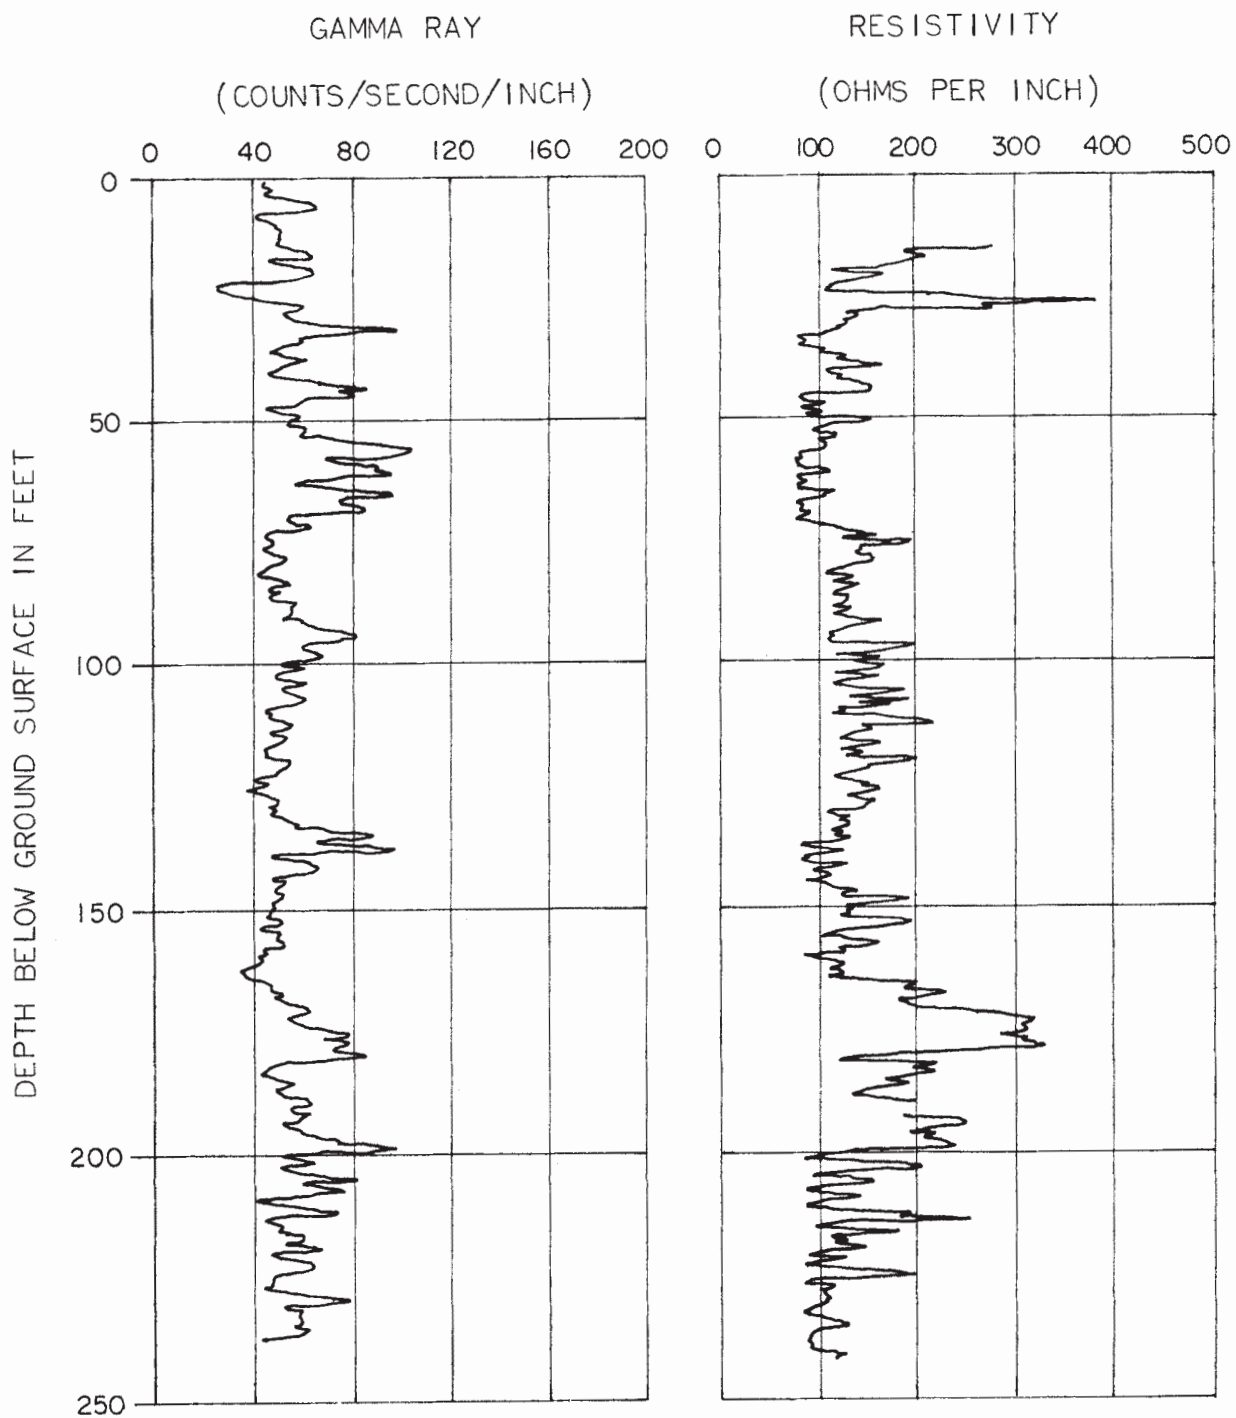
FIGURE 2.5.4-22

ELECTRICAL AND GAMMA RAY LOGS  
BORING P-10

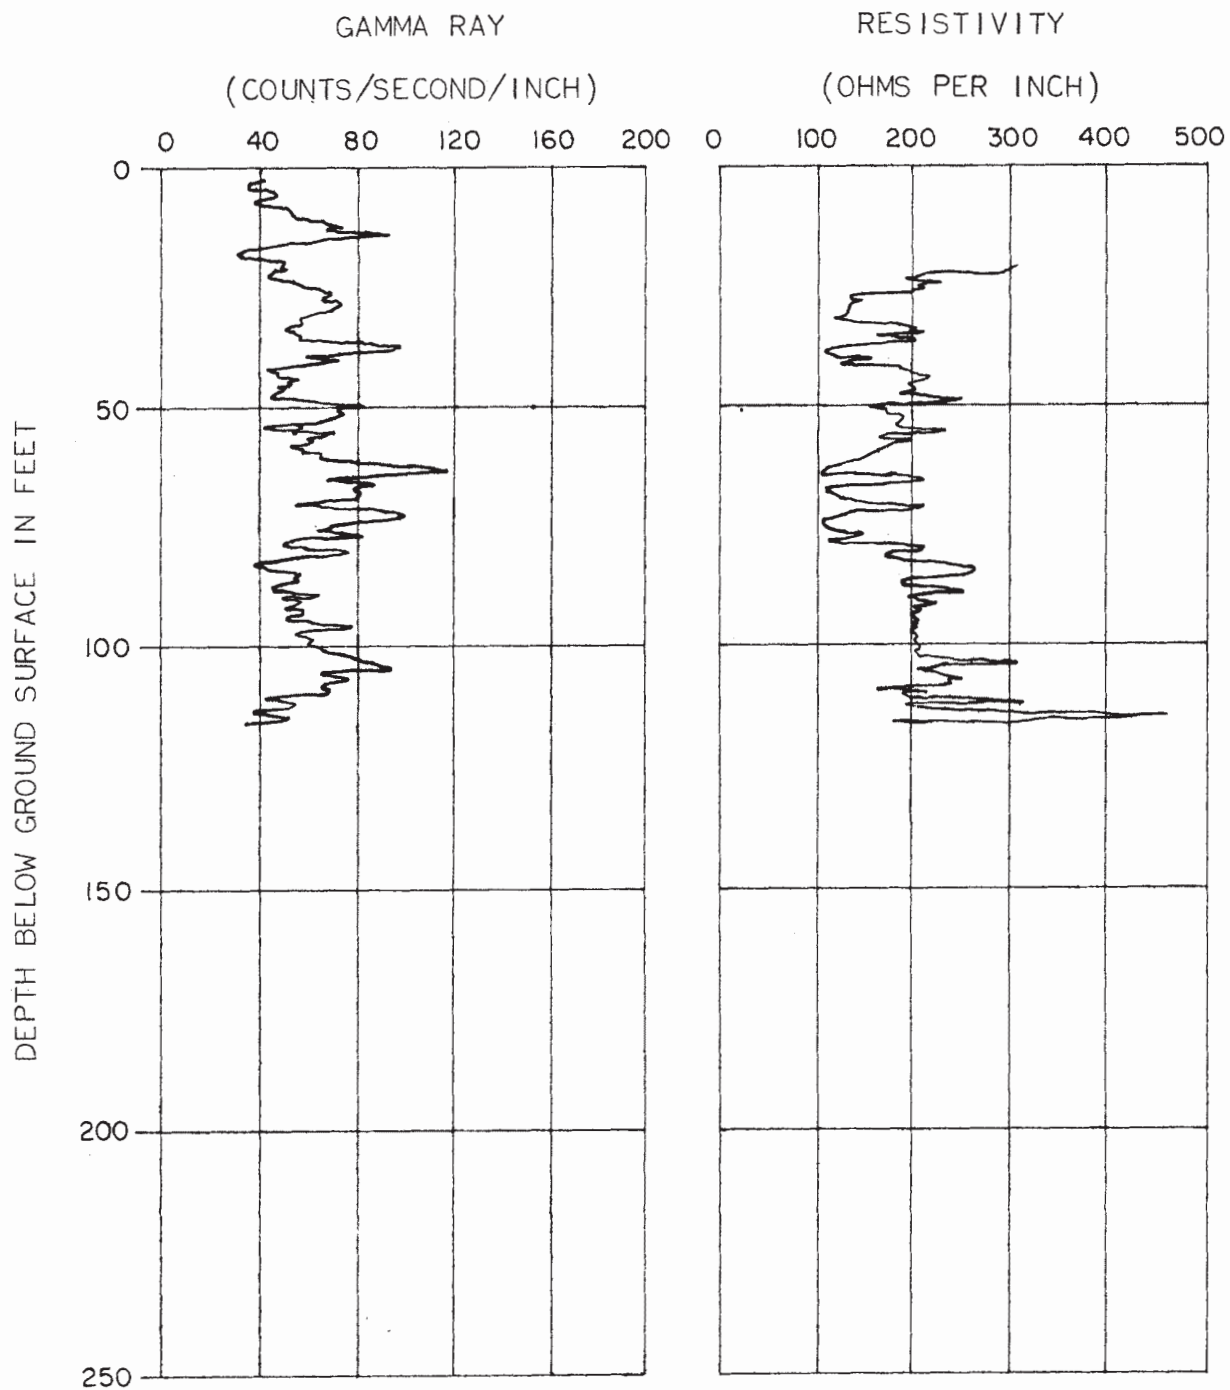
FIGURE 2.5.4-23

ELECTRICAL AND GAMMA RAY LOGS  
BORING DI-2

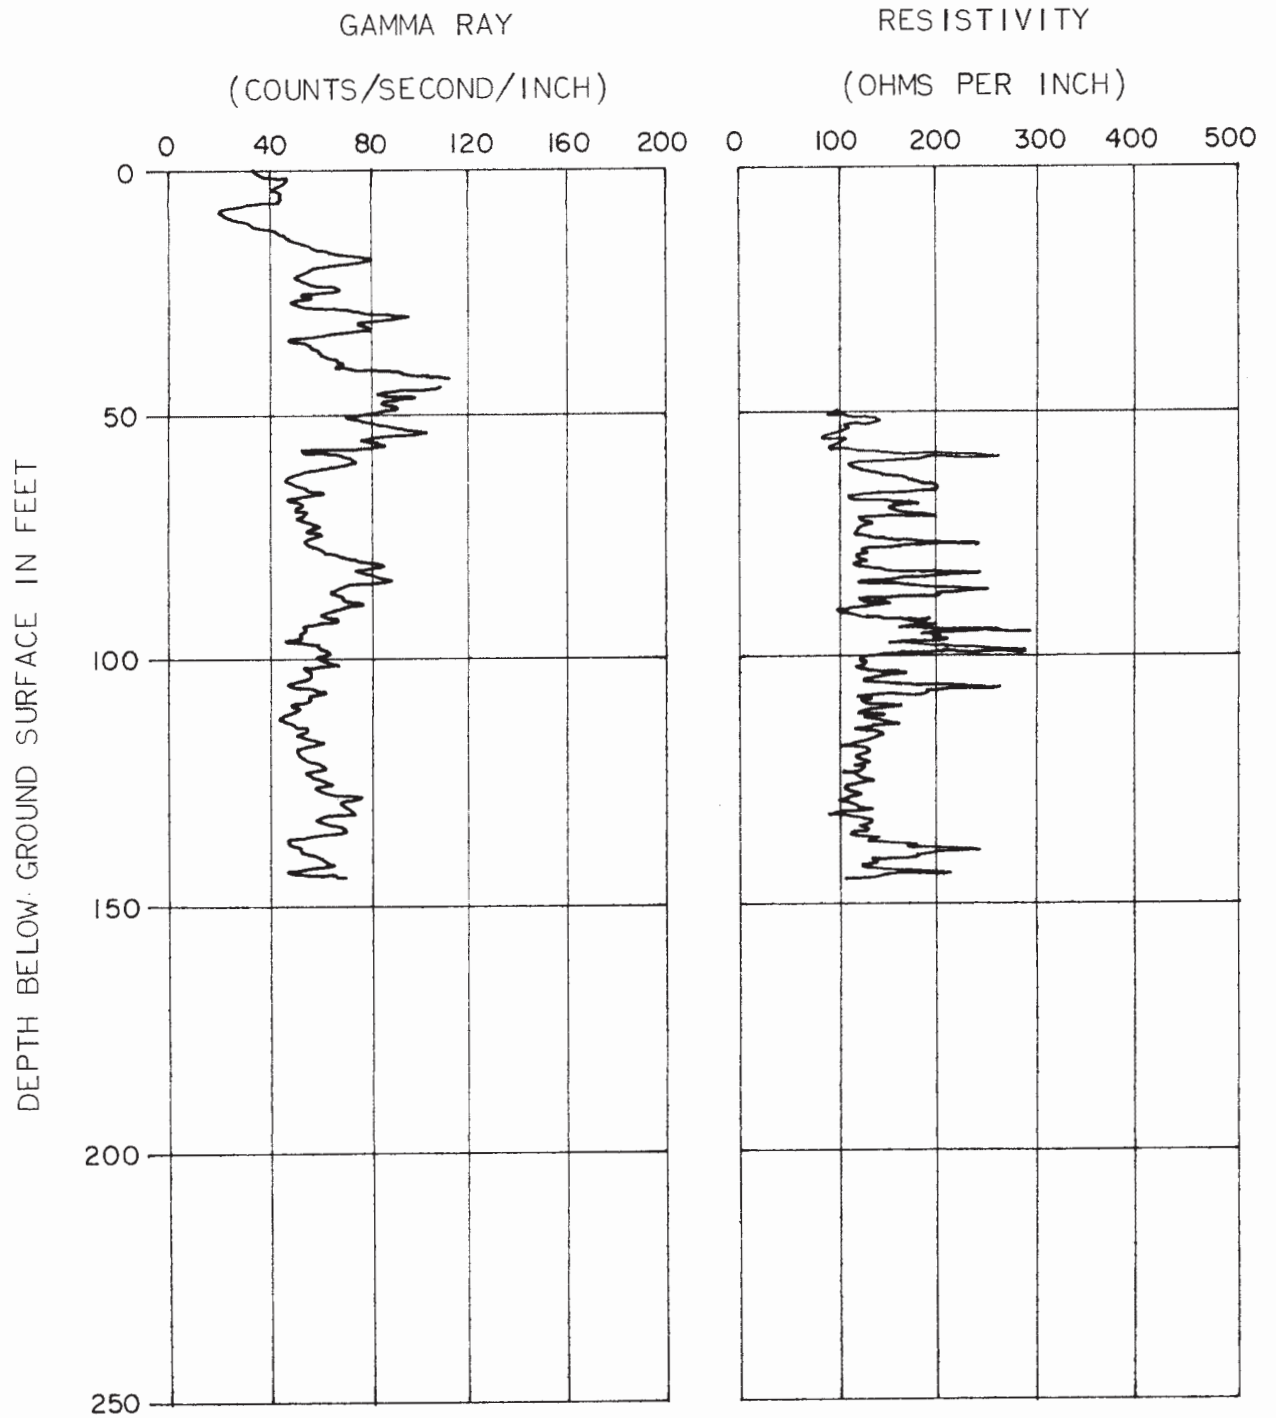
FIGURE 2.5.4-24

ELECTRICAL AND GAMMA RAY LOGS  
BORING DI-8A

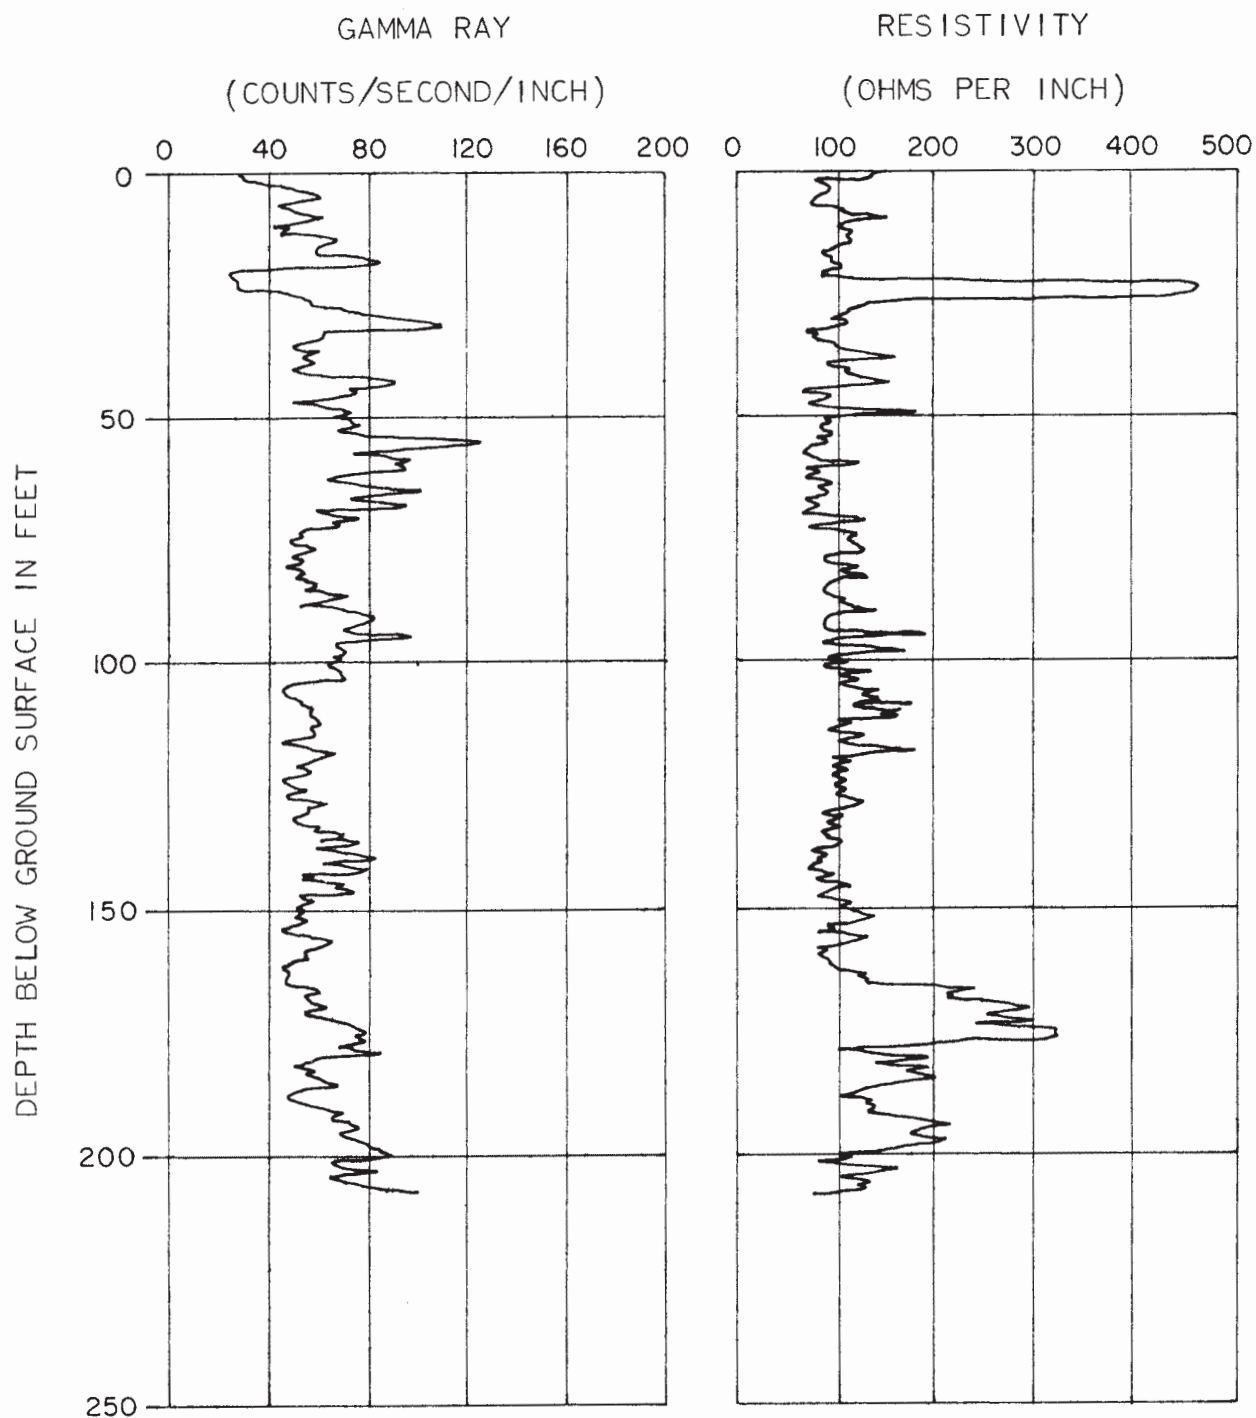
FIGURE 2.5.4-25

ELECTRICAL AND GAMMA RAY LOGS  
BORING DI-9

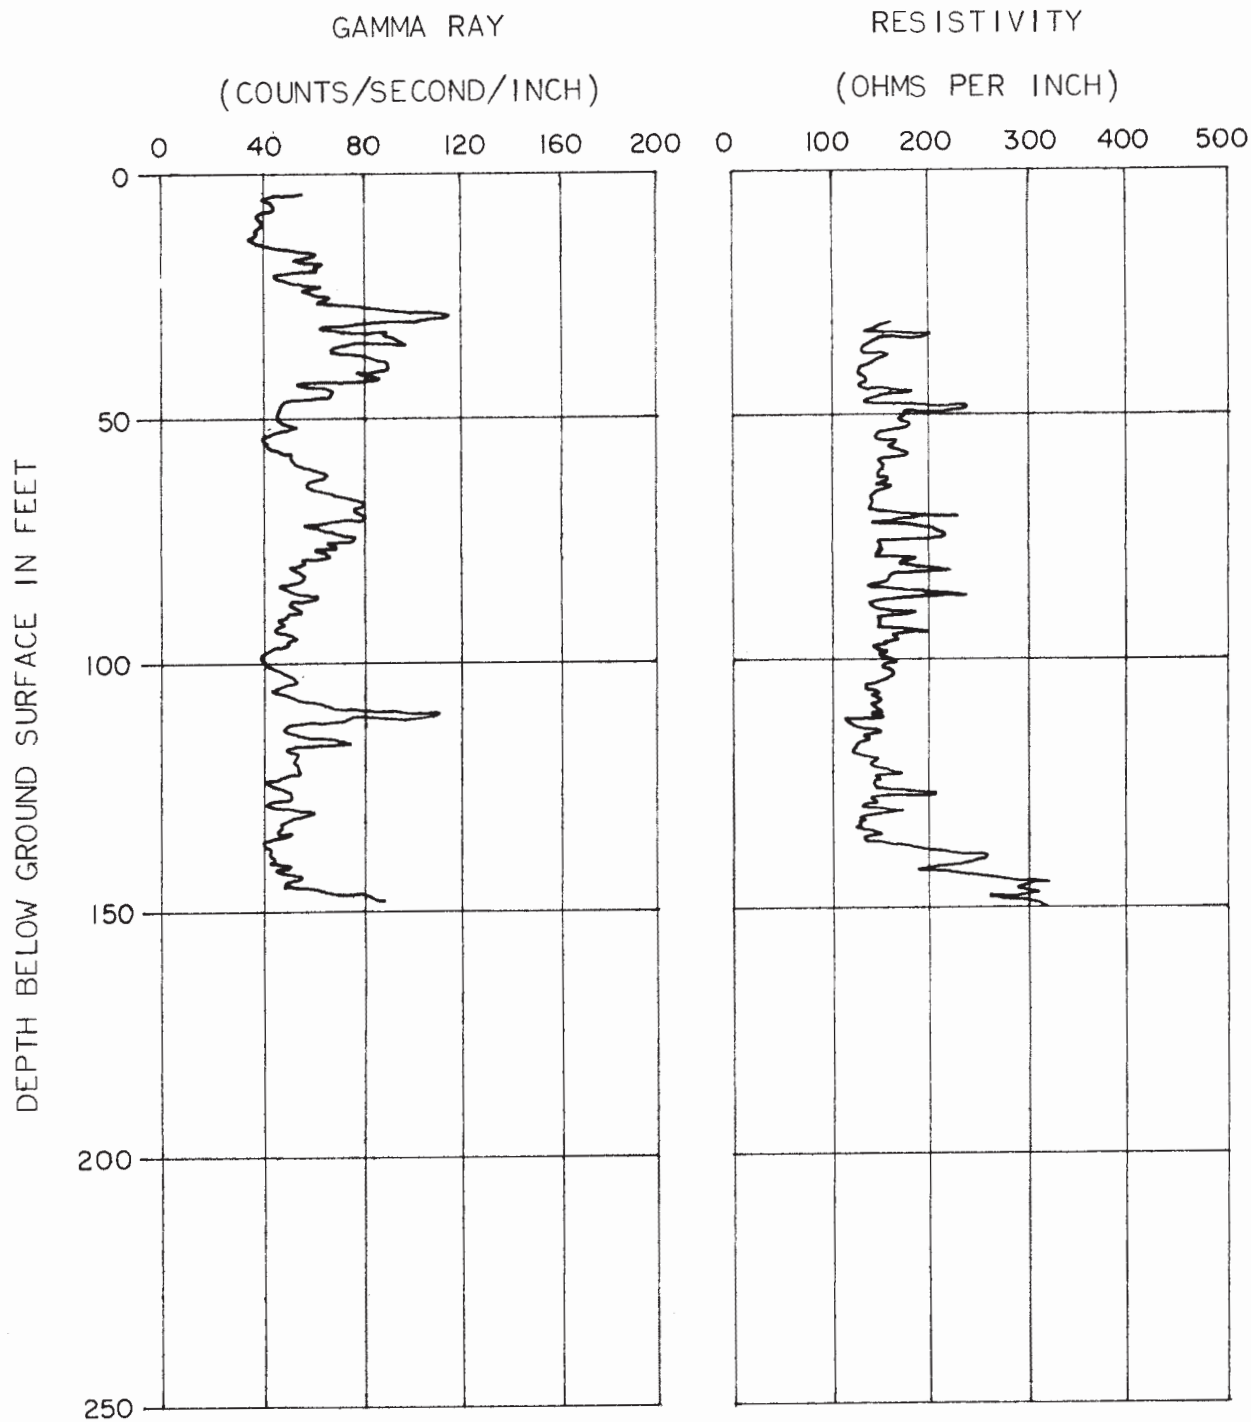
FIGURE 2.5.4-26

ELECTRICAL AND GAMMA RAY LOGS  
BORING M-1
