COMANCHE PEAK S.E.S.  
FINAL SAFETY ANALYSIS REPORT  
UNITS 1 and 2

FIGURE 2.5.4-1

FIGURE 2.5.4-37

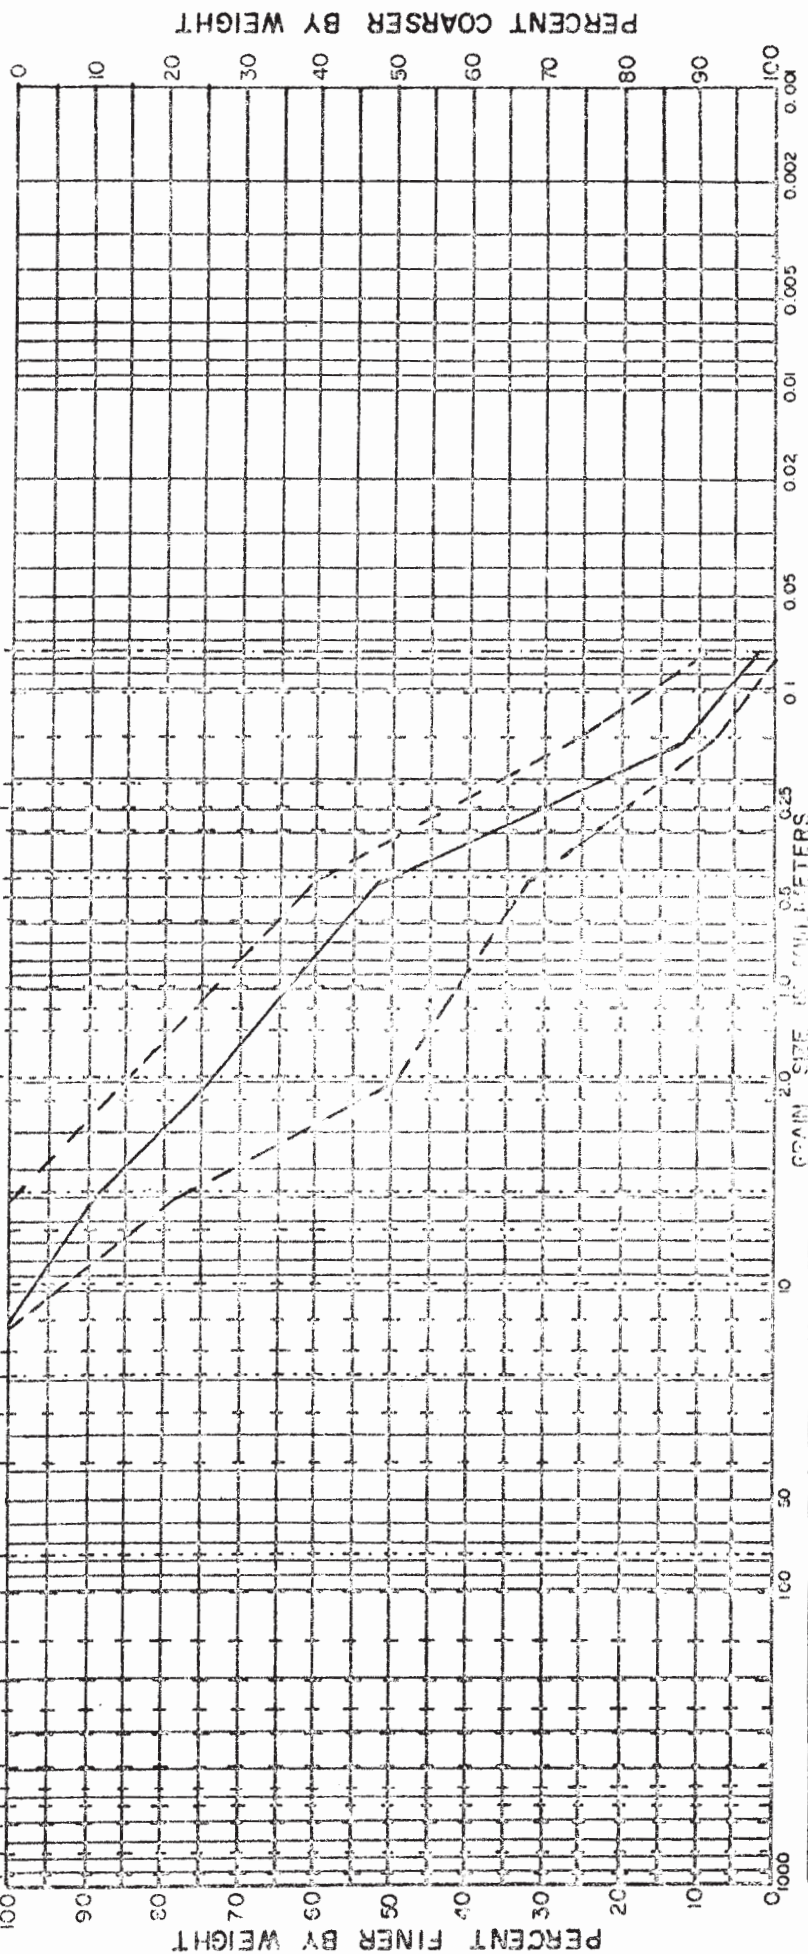
FIGURE 2.5.4-38A

CYCLIC TRIAXIAL TEST PROGRAM  
SAMPLE 1 GRADATION  
FILTER "A"

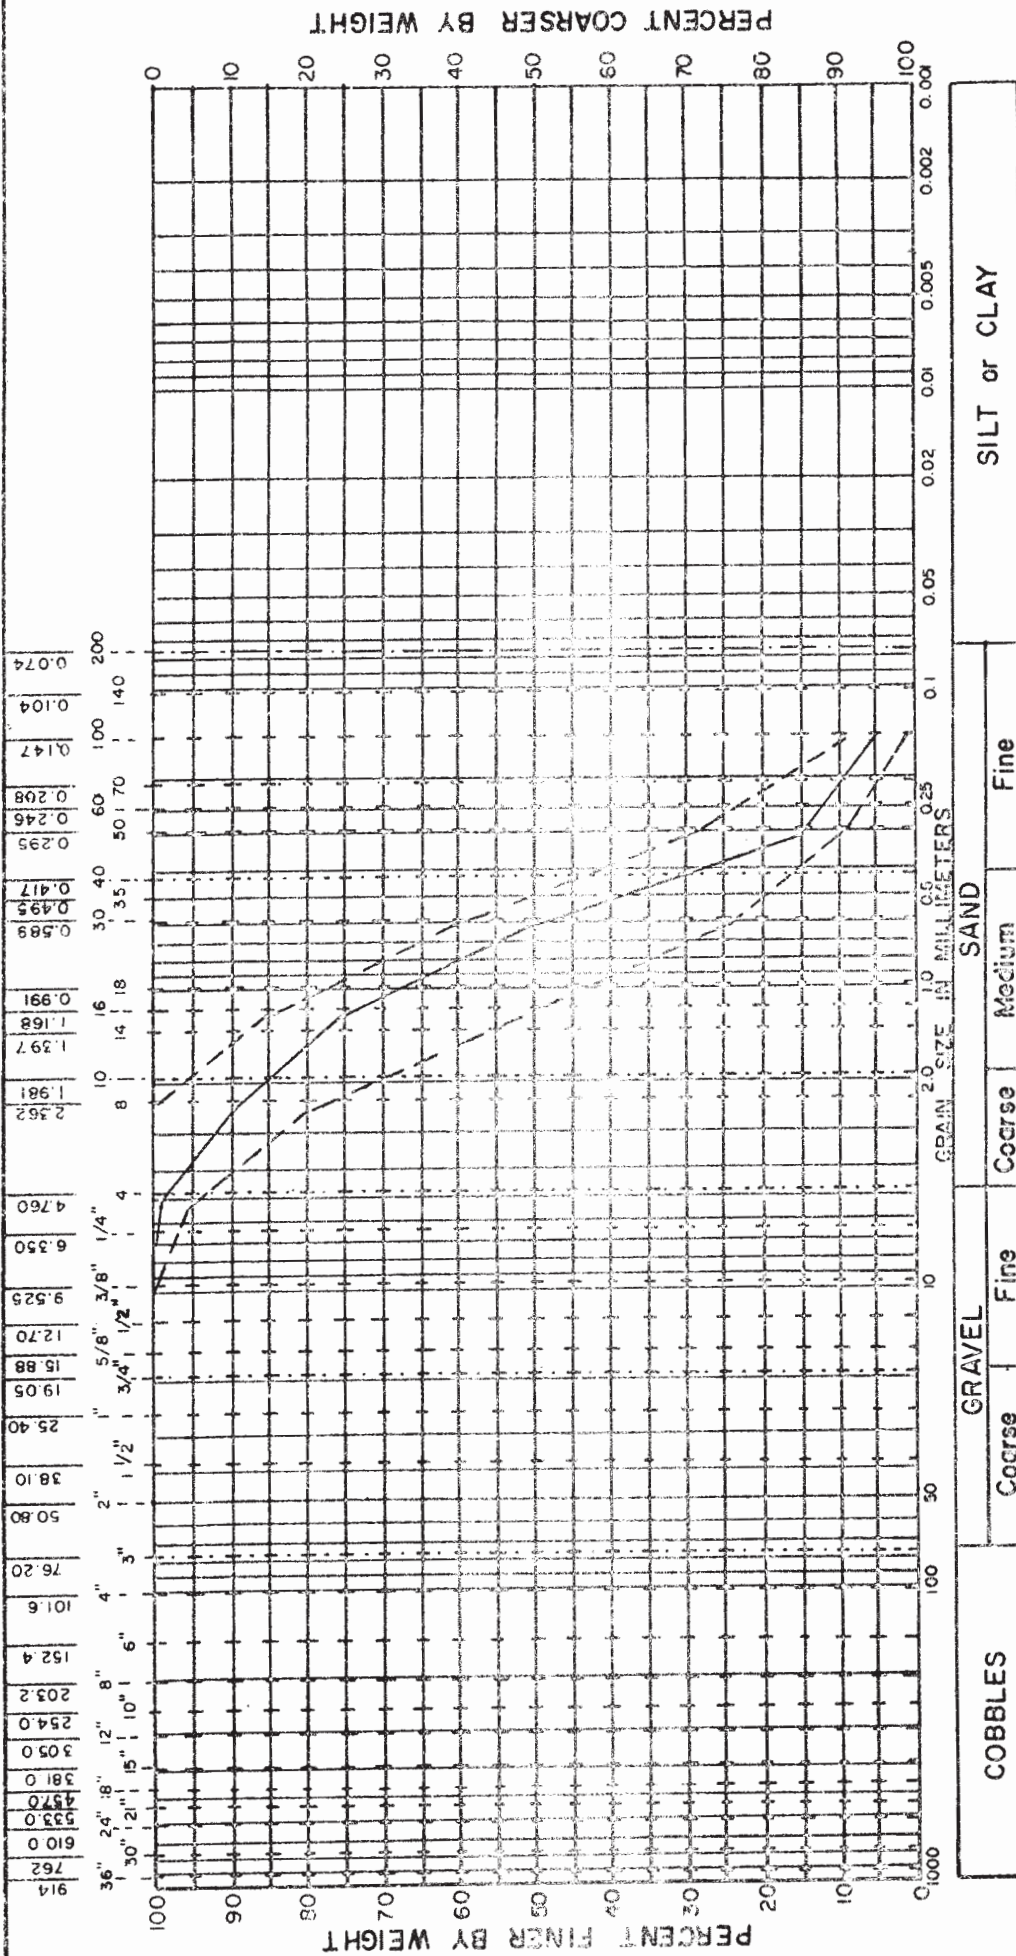
FIGURE 2.5.4-38B

CYCLIC TRIAXIAL TEST PROGRAM  
SAMPLE #2 GRADATION  
C-33 FINE AGGREGATE

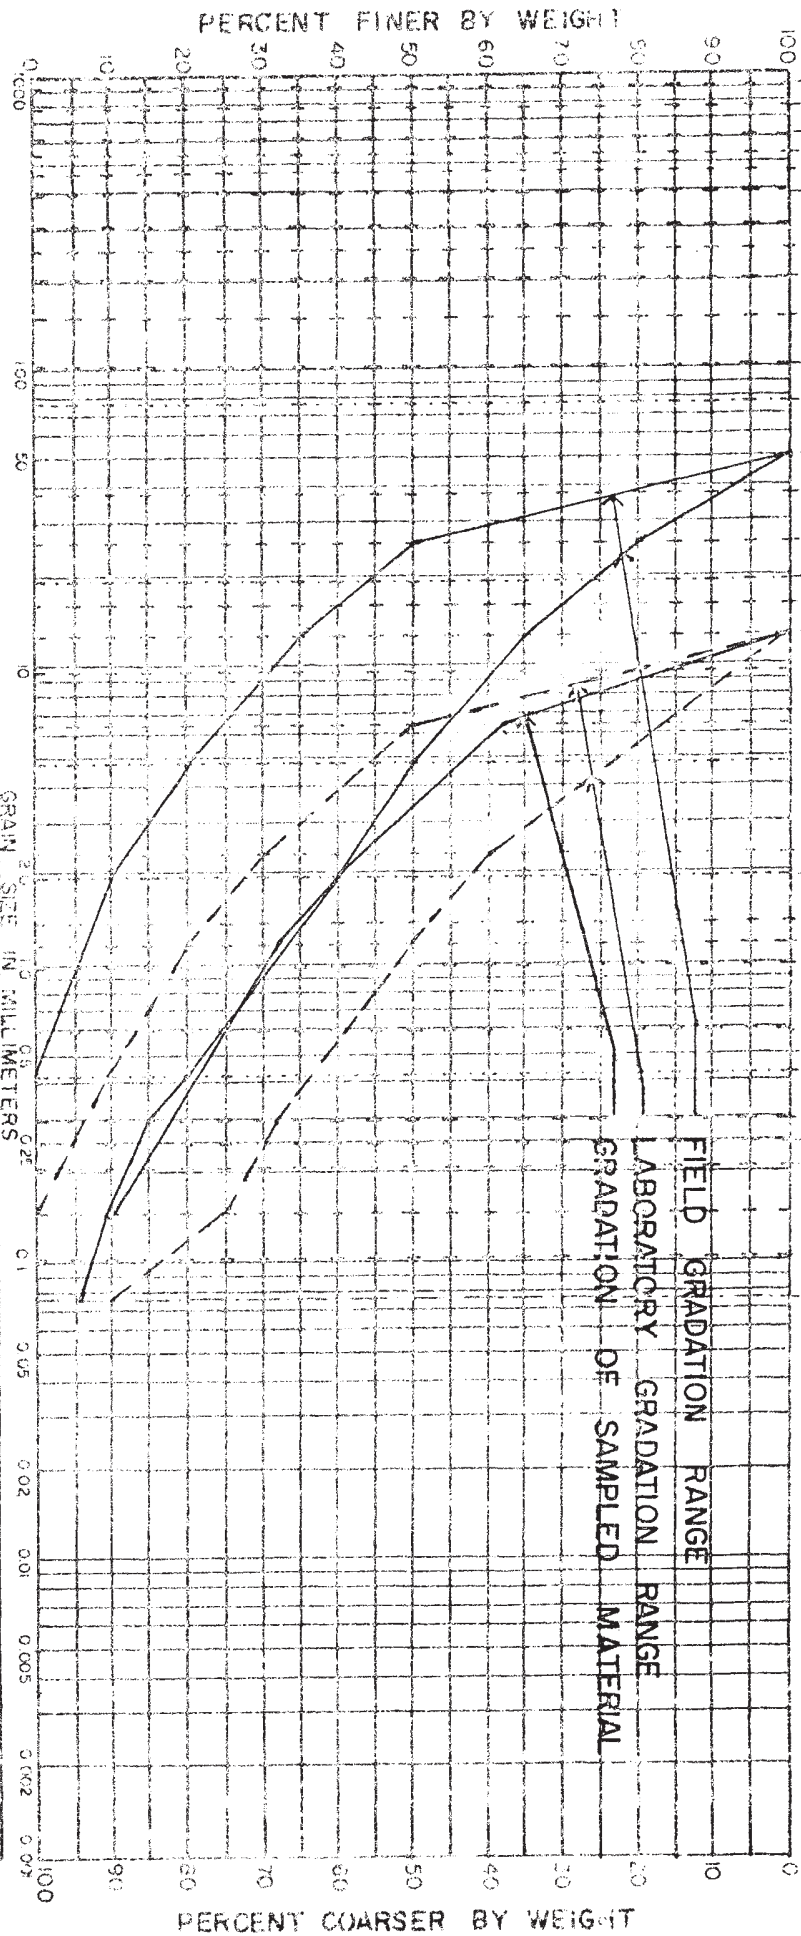
FIGURE 2.5.4-38C

CYCLIC TRIAXIAL TEST PROGRAM

SAMPLE #3 GRADATION

GLEN ROSE CRUSHED STONE

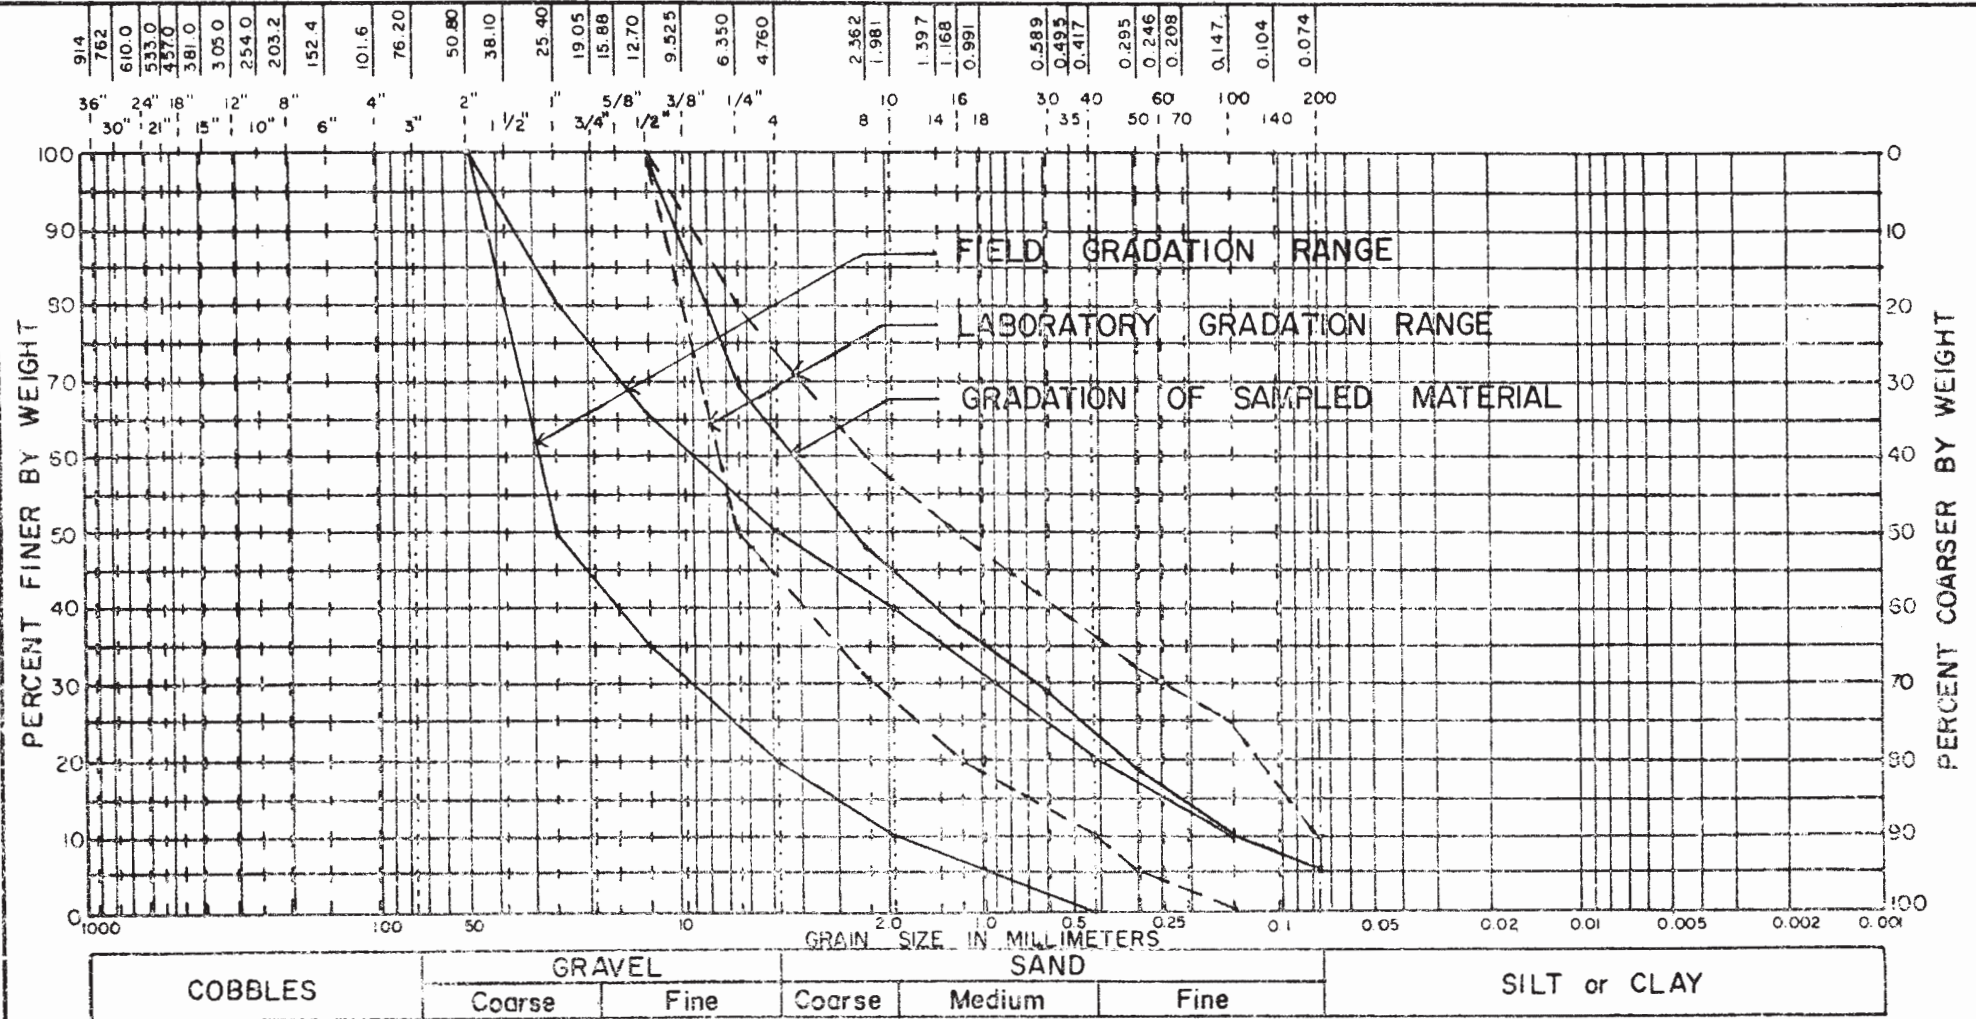
FIGURE 2.5.4- 38 D

CYCLIC TRIAXIAL TEST PROGRAM  
SAMPLE #4 GRADATION  
CROWDER QUARRY CRUSHED STONE

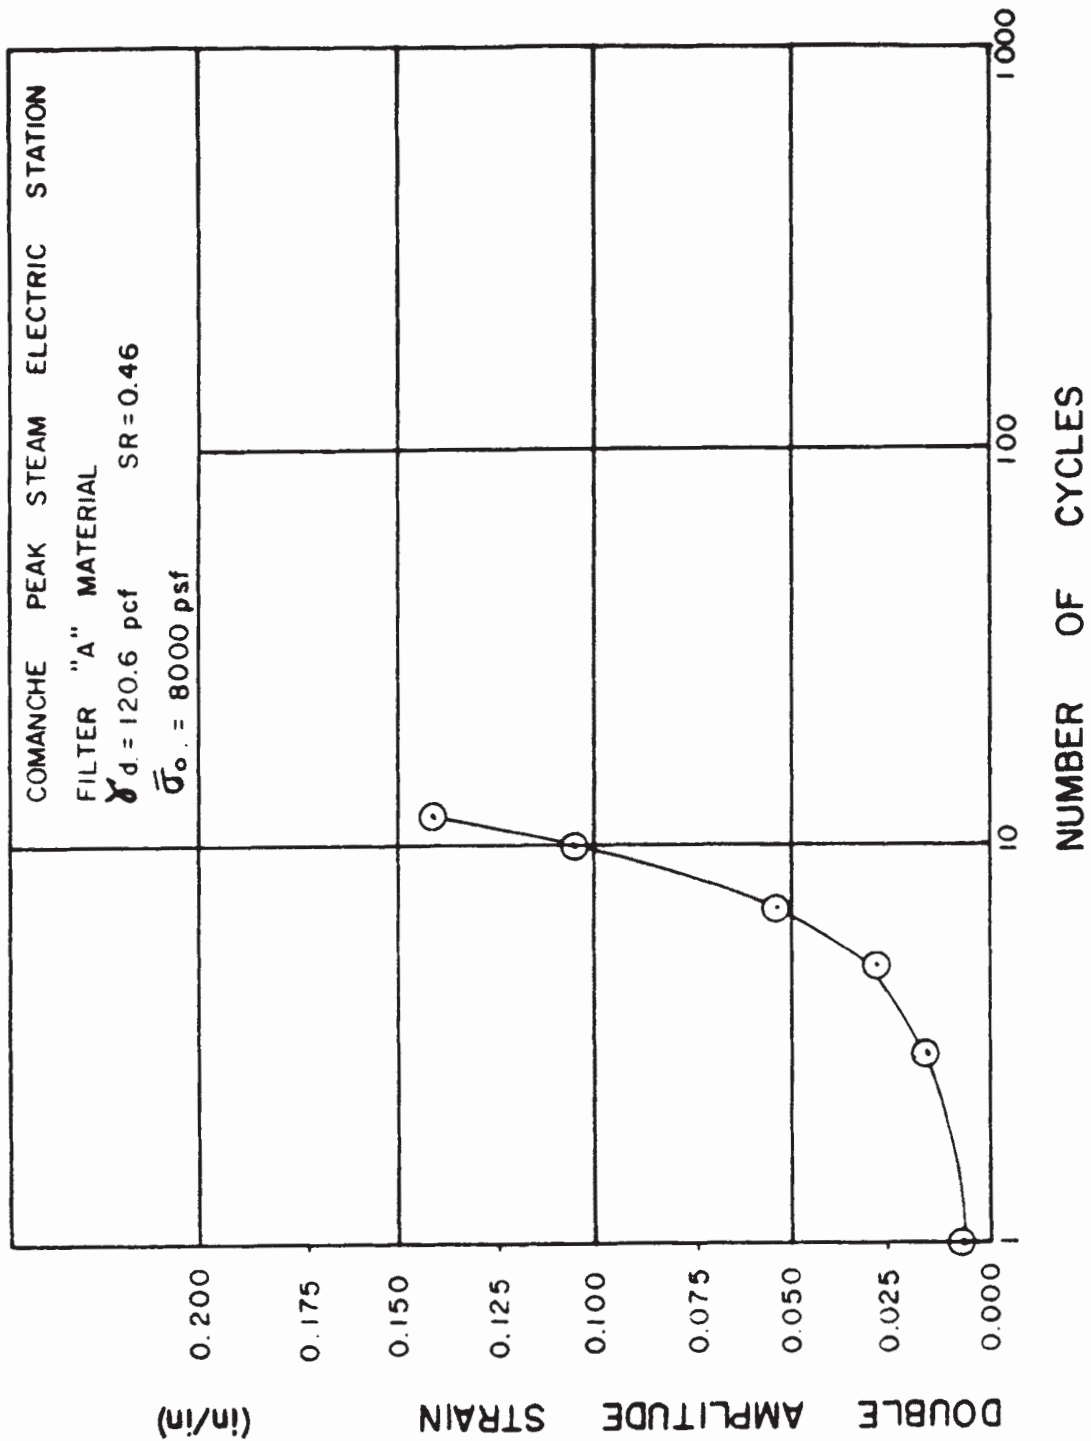
FIGURE 2.5.4-39 SHEET 1 OF 4

TYPICAL CYCLIC TRIAXIAL  
 TEST RESULTS

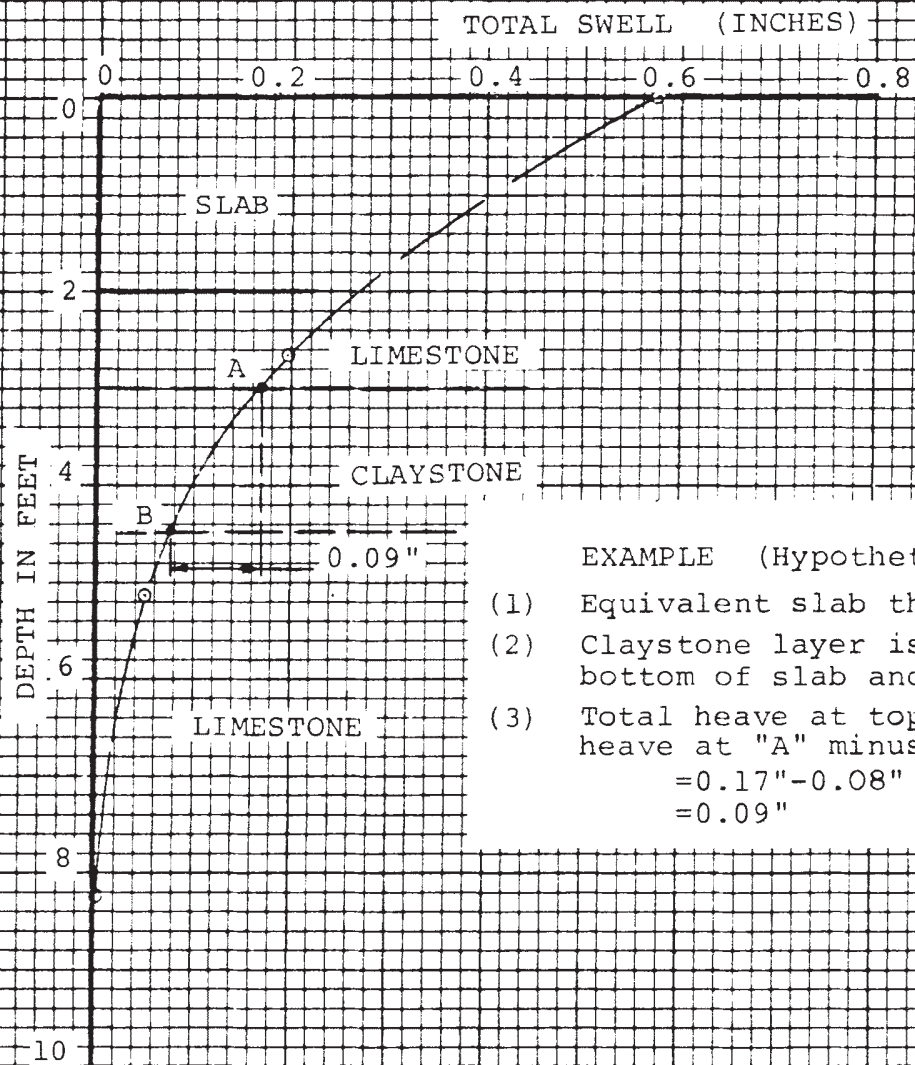
FIGURE 2.5.4-43

- (1) Equivalent slab thickness = 2'
- (2) Claystone layer is 1.0' below bottom of slab and is 1.5' thick
- (3) Total heave at top of slab =  
 heave at "A" minus heave at "B"  
 $= 0.17" - 0.08"$   
 $= 0.09"$

EFFECT OF CLAYSTONE  
ON FOUNDATION

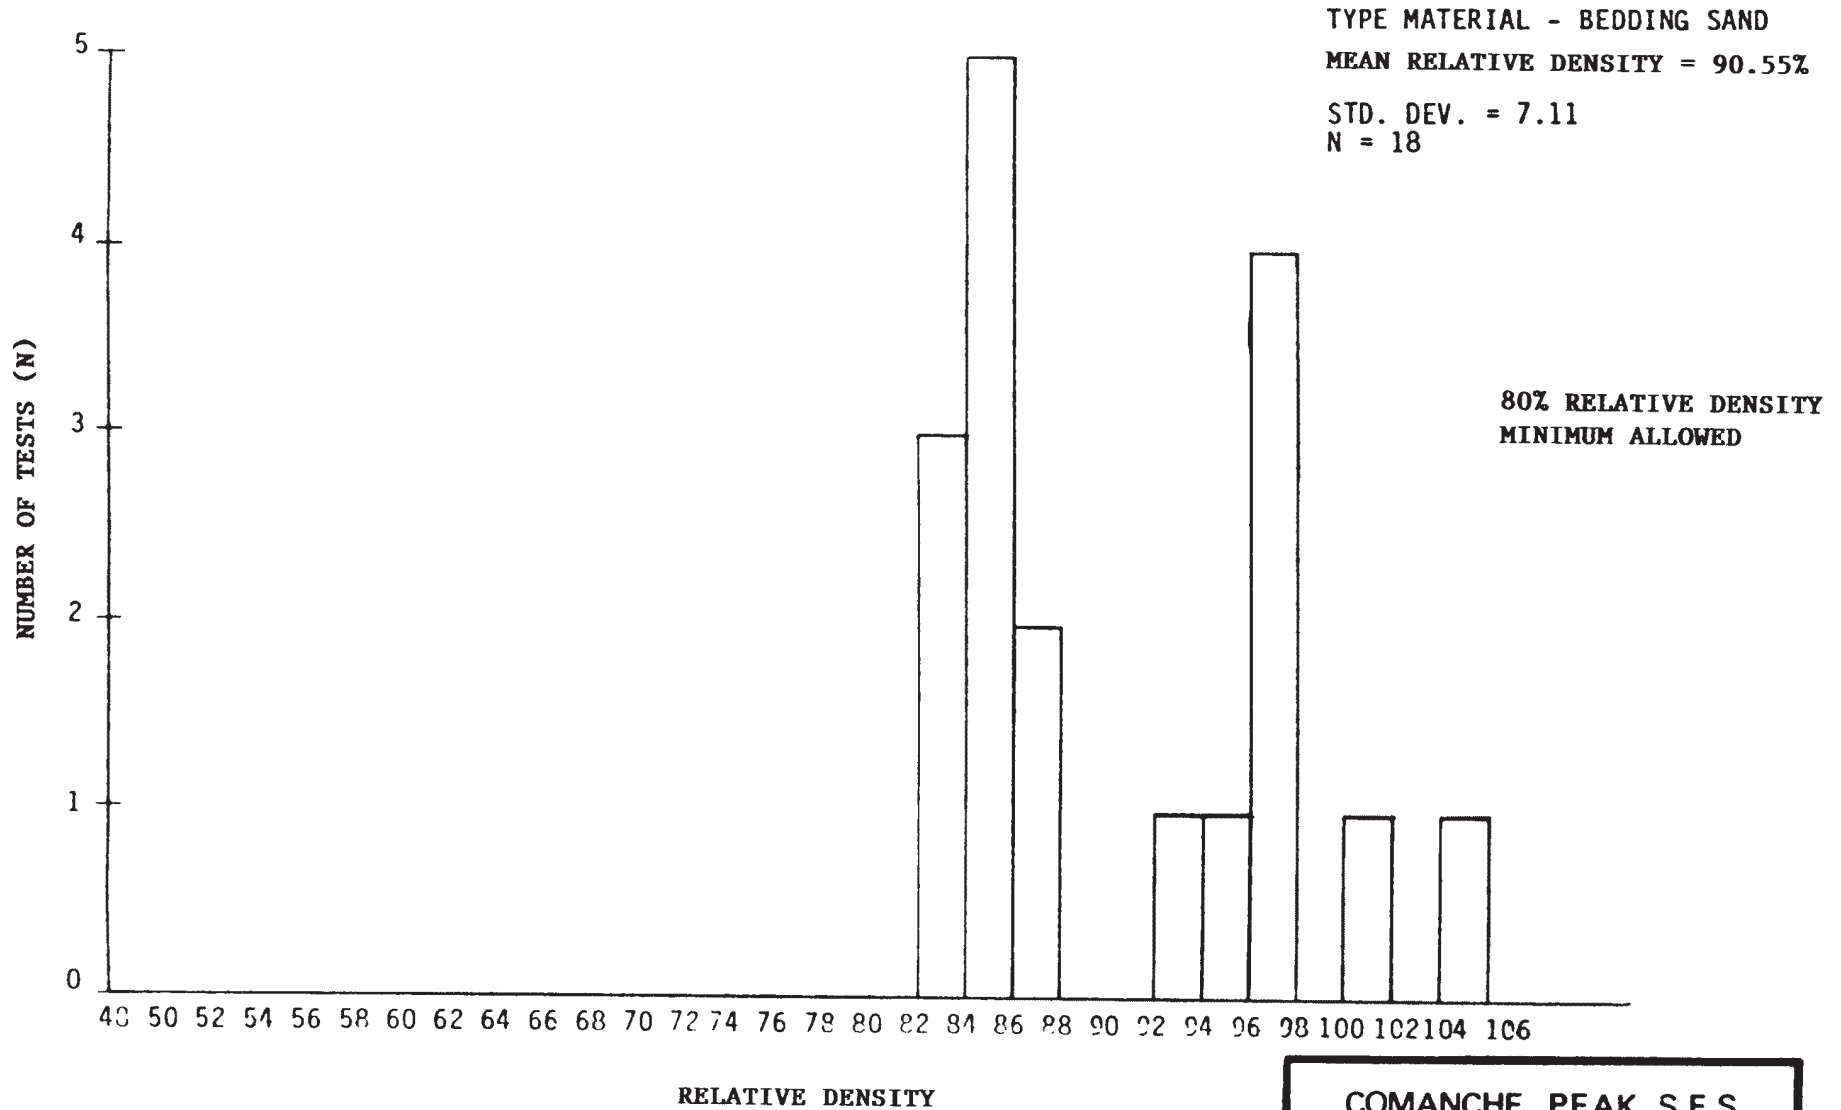
COMANCHE PEAK S.E.S. FINAL SAFETY ANALYSIS REPORT UNITS 1 and 2
RELATIVE DENSITY TEST SUMMARY FOR BACKFILL AROUND CATEGORY I ELEC. MANHOLES AND DUCT BANK
FIGURE 2.5.4-44

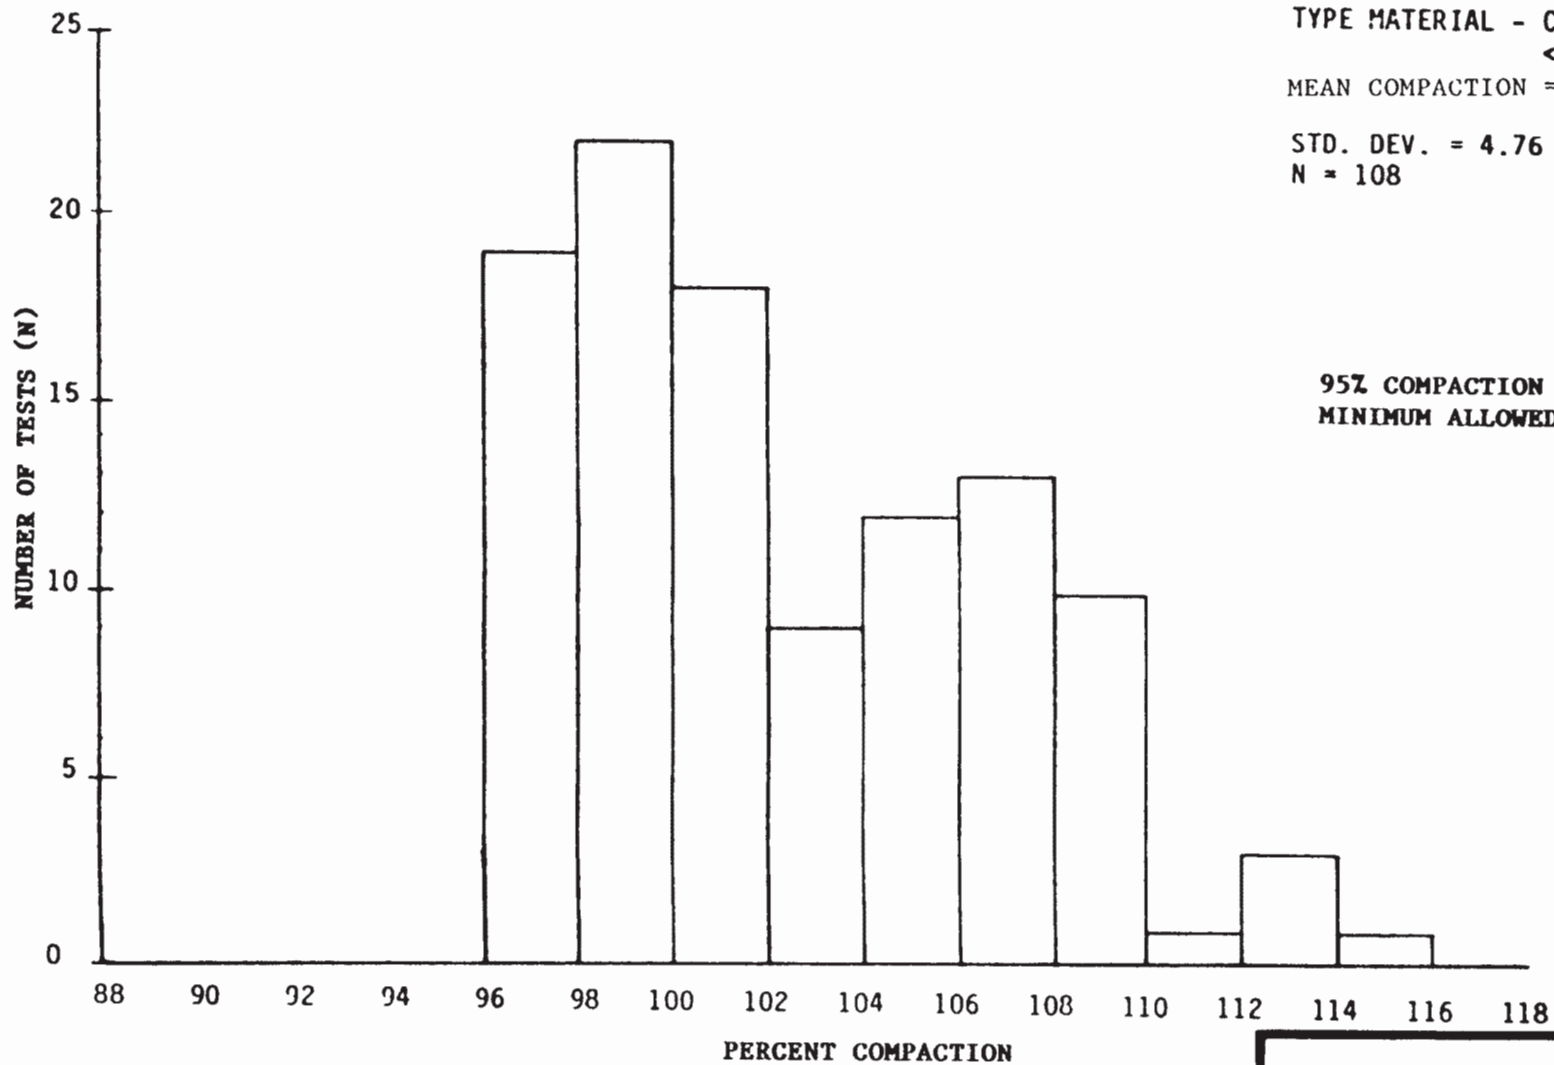
COMANCHE PEAK S.E.S. FINAL SAFETY ANALYSIS REPORT UNITS 1 and 2
PERCENT COMPACTION TEST SUMMARY FOR BACKFILL AROUND CATEGORY I CONDUIT
FIGURE 2.5.4-45

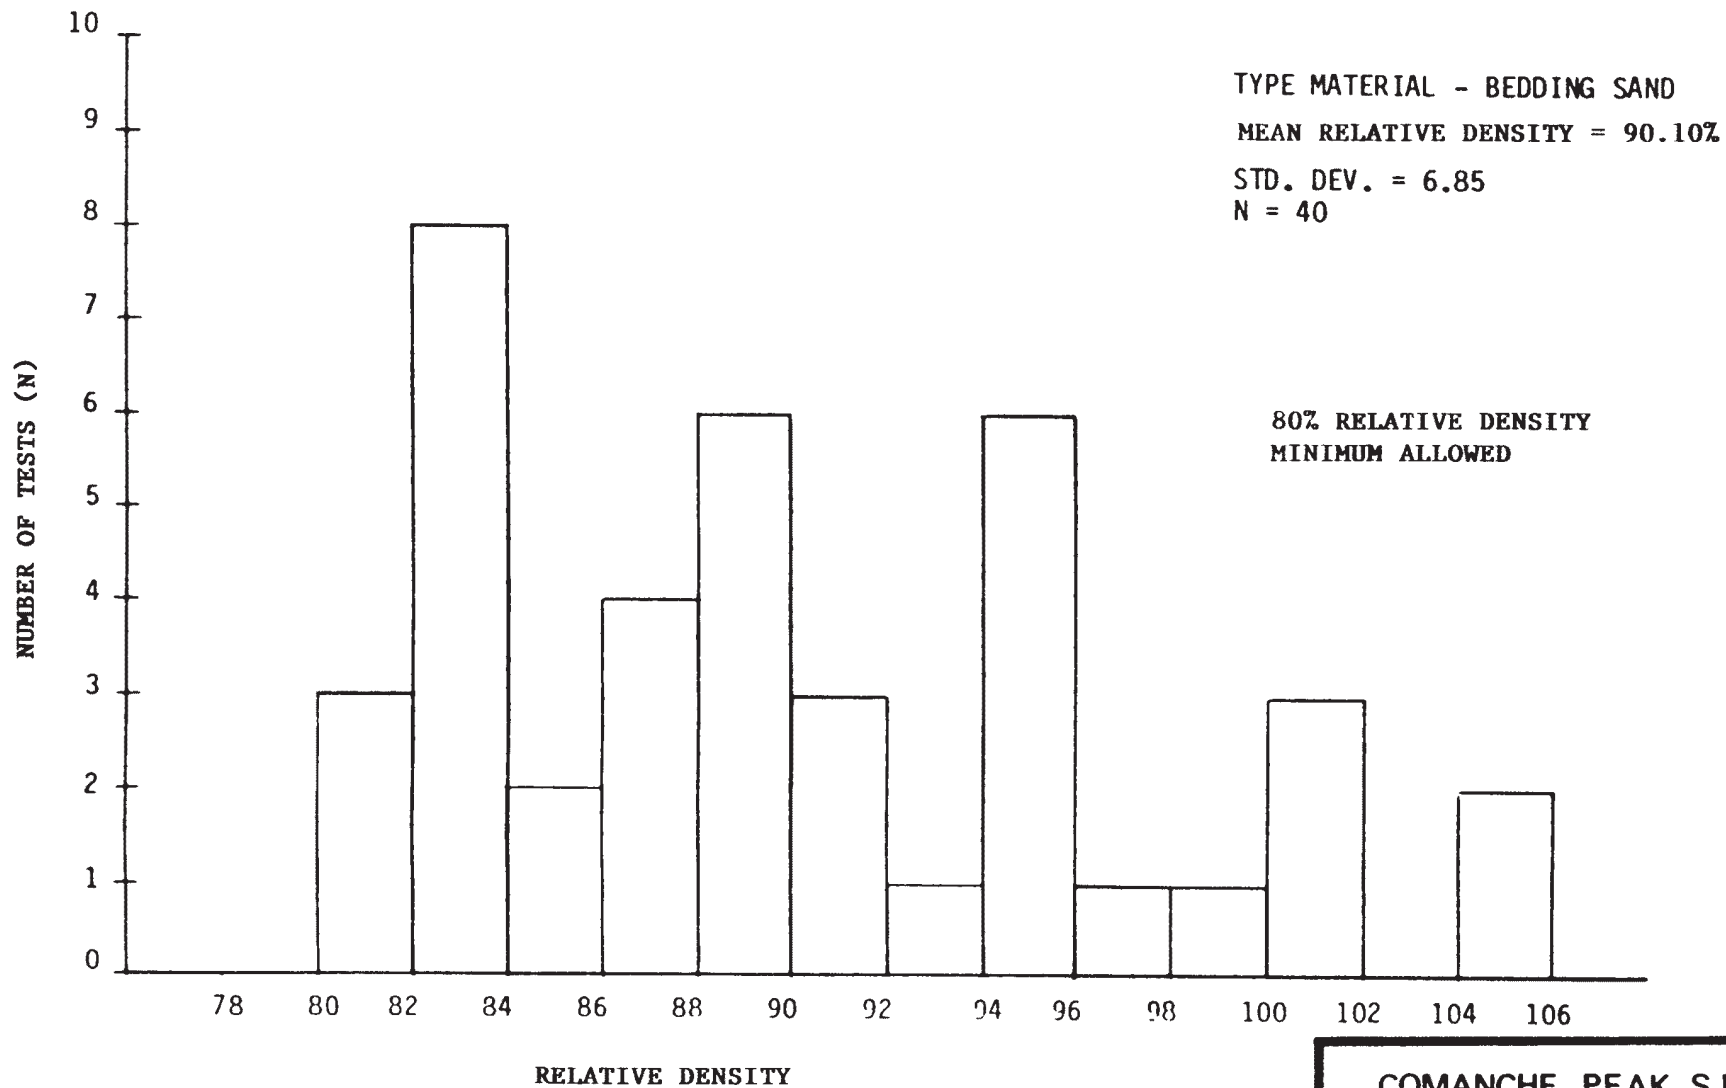
COMANCHE PEAK S.E.S. FINAL SAFETY ANALYSIS REPORT UNITS 1 and 2
RELATIVE DENSITY SUMMARY FOR BEDDING AROUND CATEGORY I PIPELINES
FIGURE 2.5.4-46

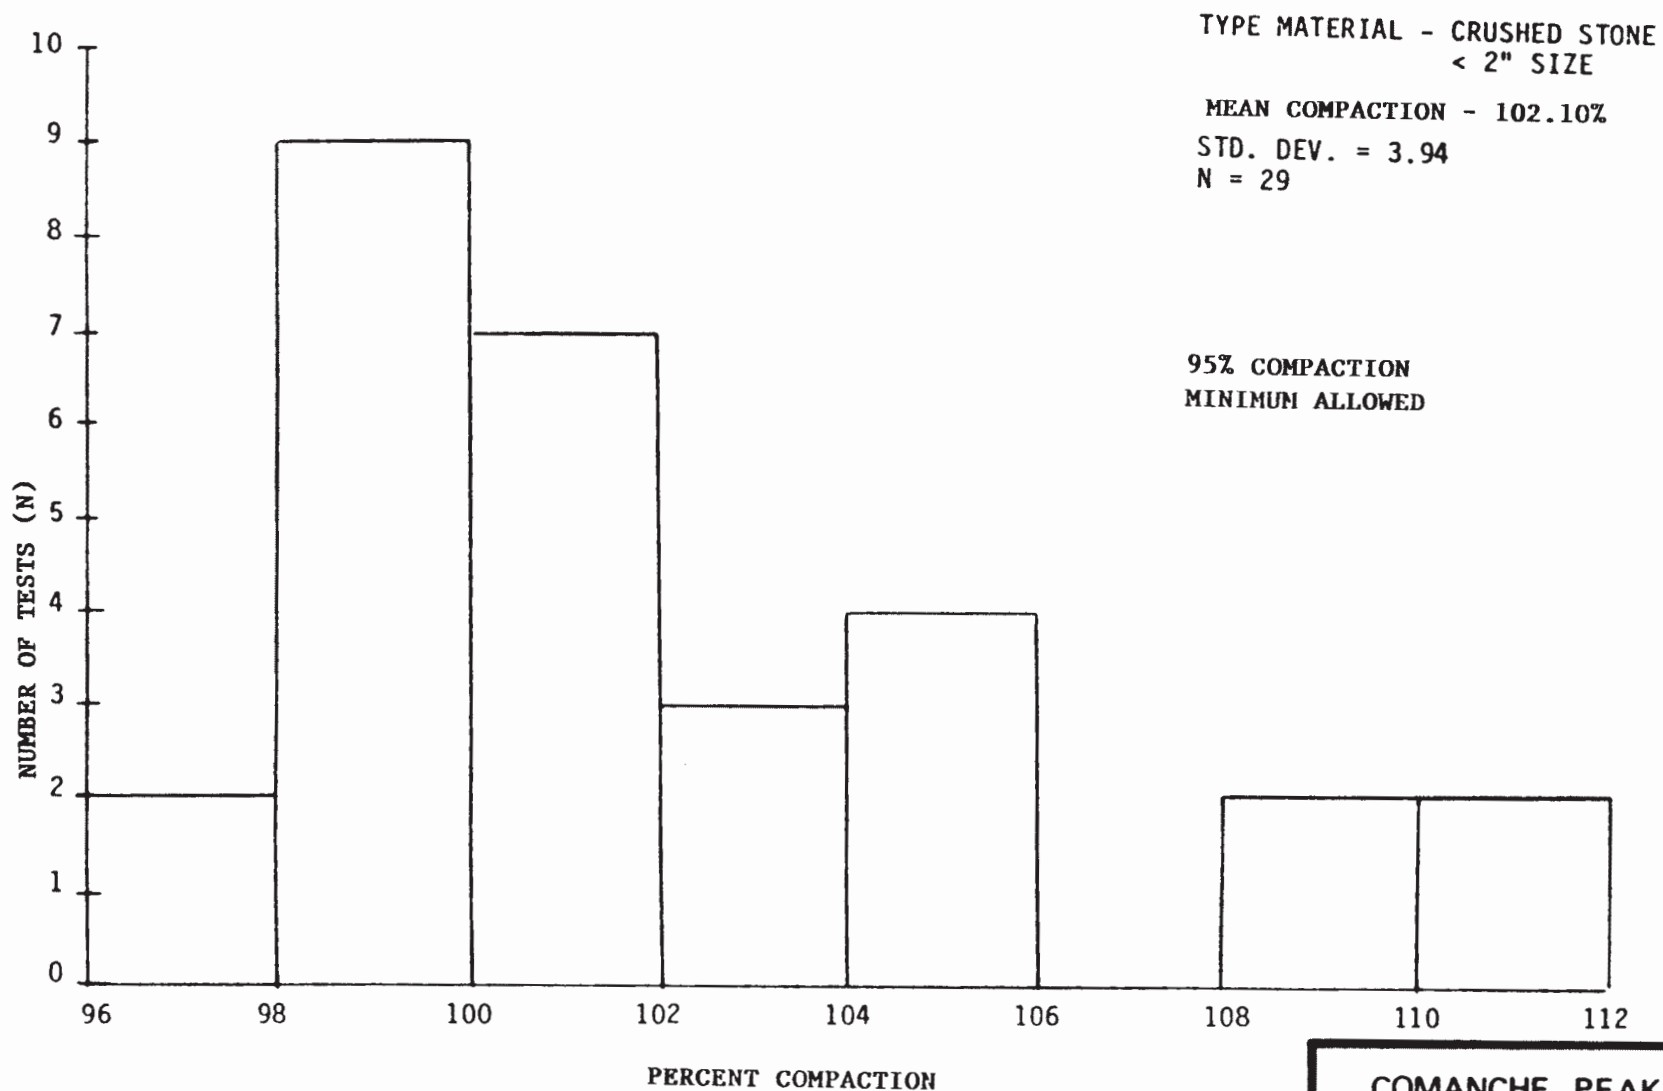
COMANCHE PEAK S.E.S. FINAL SAFETY ANALYSIS REPORT UNITS 1 and 2
PERCENT COMPACTION TEST SUMMARY FOR BACKFILL AROUND CATEGORY I PIPELINES
FIGURE 2.5.4-47

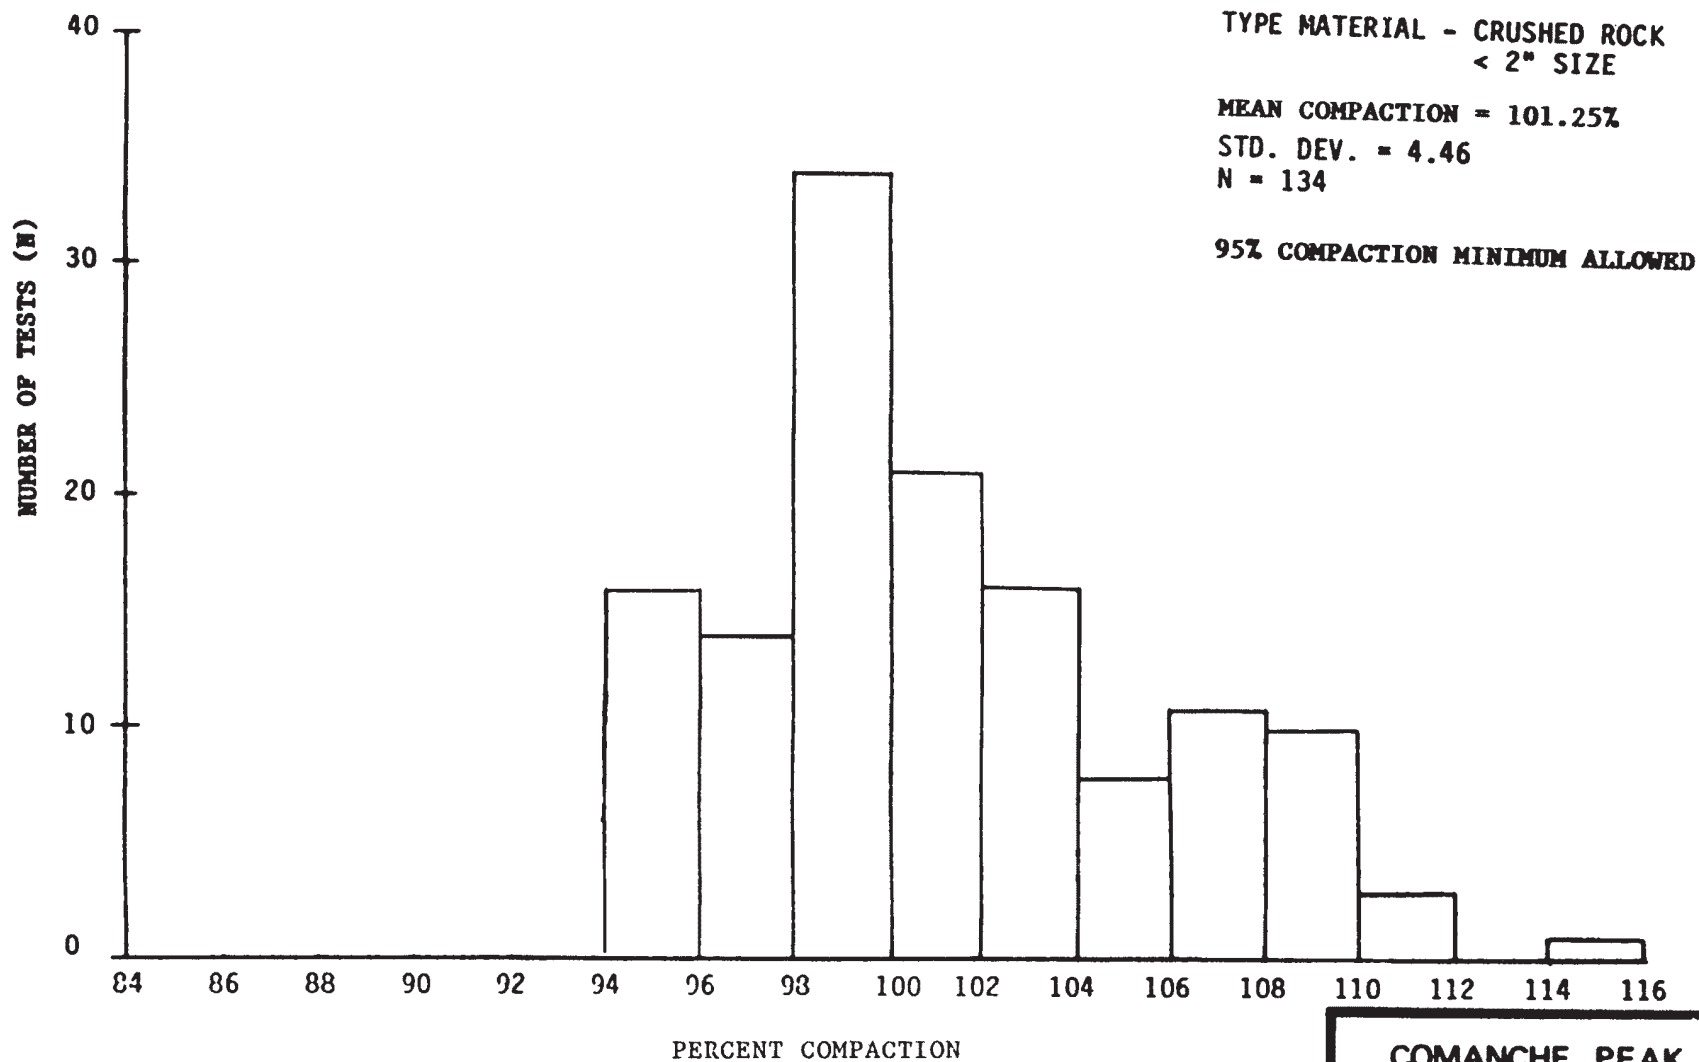
NOTE: Accepted Values Are  $\geq$  95%

COMANCHE PEAK S.E.S. FINAL SAFETY ANALYSIS REPORT UNITS 1 and 2
PERCENT COMPACTION TEST SUMMARY FOR BACKFILL AROUND THE SERVICE WATER INTAKE STRUCTURE
FIGURE 2.5.4-48
