Subject: Sand Erosion from Base of Sherwood, Washington Disposal Cell Embankment

The purpose of this letter is to inform the U.S. Nuclear Regulatory Commission (NRC) of erosion identified on the disposal cell embankment at the U.S. Department of Energy Office of Legacy Management (DOE-LM) Sherwood, Washington, Disposal Site.

Sand Washout  
Sherwood, WA, Disposal Site

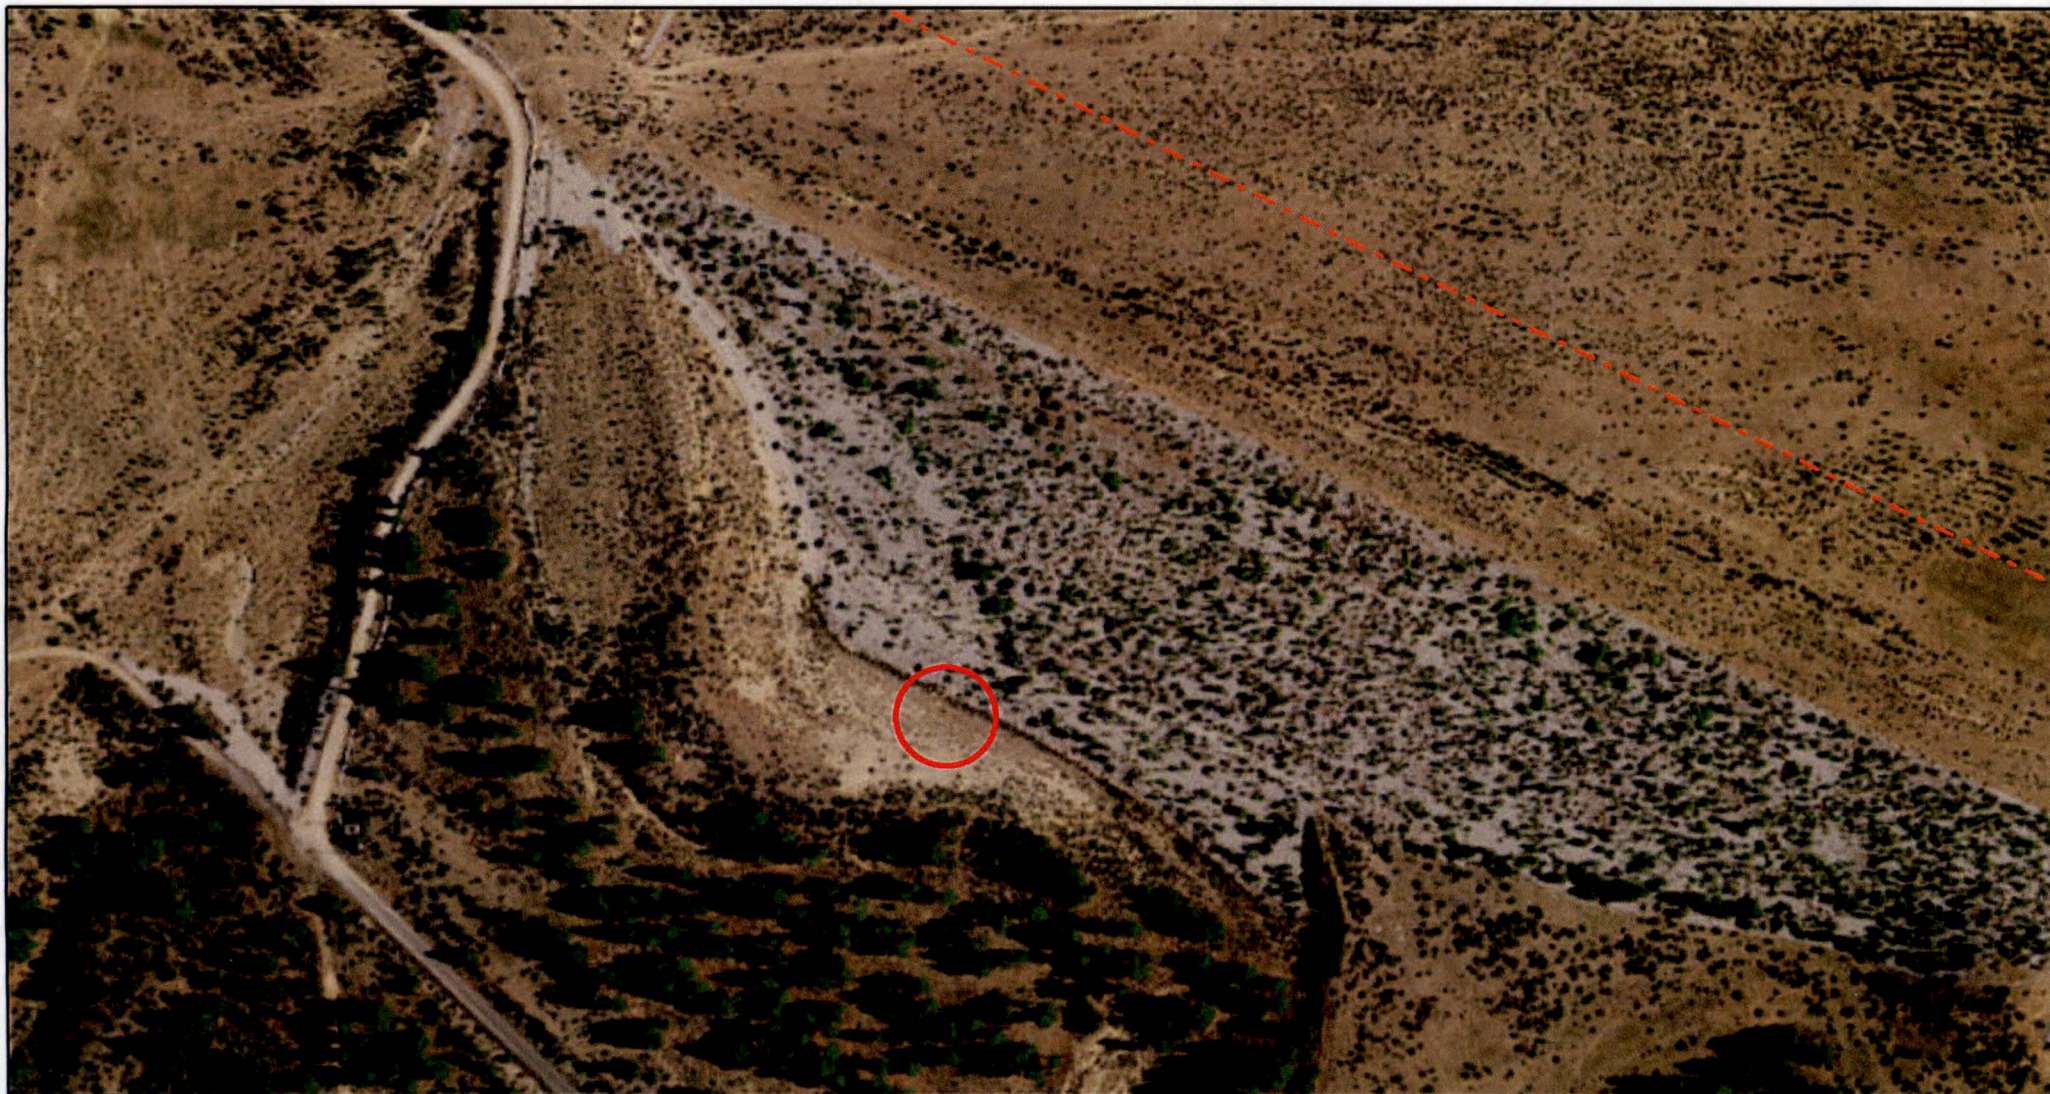
During the annual site inspection of the Sherwood disposal site on May 18, 2016, DOE-LM identified a small area where sand has been washed out from underneath the protective rock cover at the base of the disposal cell embankment. The area where the erosion was discovered is approximately 800 feet away from the actual tailings cell contained atop the embankment.

The total volume of sand washed out is estimated to be 3 to 5 cubic yards. A small gully approximately 9 to 12 inches deep and 18 to 24 inches wide can be traced 50 feet back up the embankment. This area at the base of the embankment was not designed specifically for the discharge of run-off but appears to be concentrating water flow beneath the cover rock. The enclosed photographs indicate the extent and location of the erosion.

Determining the specific site conditions that contributed to the erosion will require further assessment, in accordance with Table 3-2 in Section 3.6.3 of the *Long-Term Surveillance Plan for the DOE Sherwood Project (UMTRCA Title II) Reclamation Cell, Wellpinit, Washington, February 2001*. Based on the criteria in Table 3-2, the response for minor erosion (erosion not immediately affecting the disposal cell) requires DOE-LM to evaluate, assess the impact, and respond as appropriate to eliminate the erosion problem. Accordingly, DOE-LM is planning a site visit in early October with engineering staff and a geotechnical cover design consultant to evaluate the cause and a possible remedy, if required.
