Hematite Decommissioning Project

Technical Report

NUMBER: HDP-RPT-FSS-303

TITLE: Summary Report for Burial Pit Area Remediation

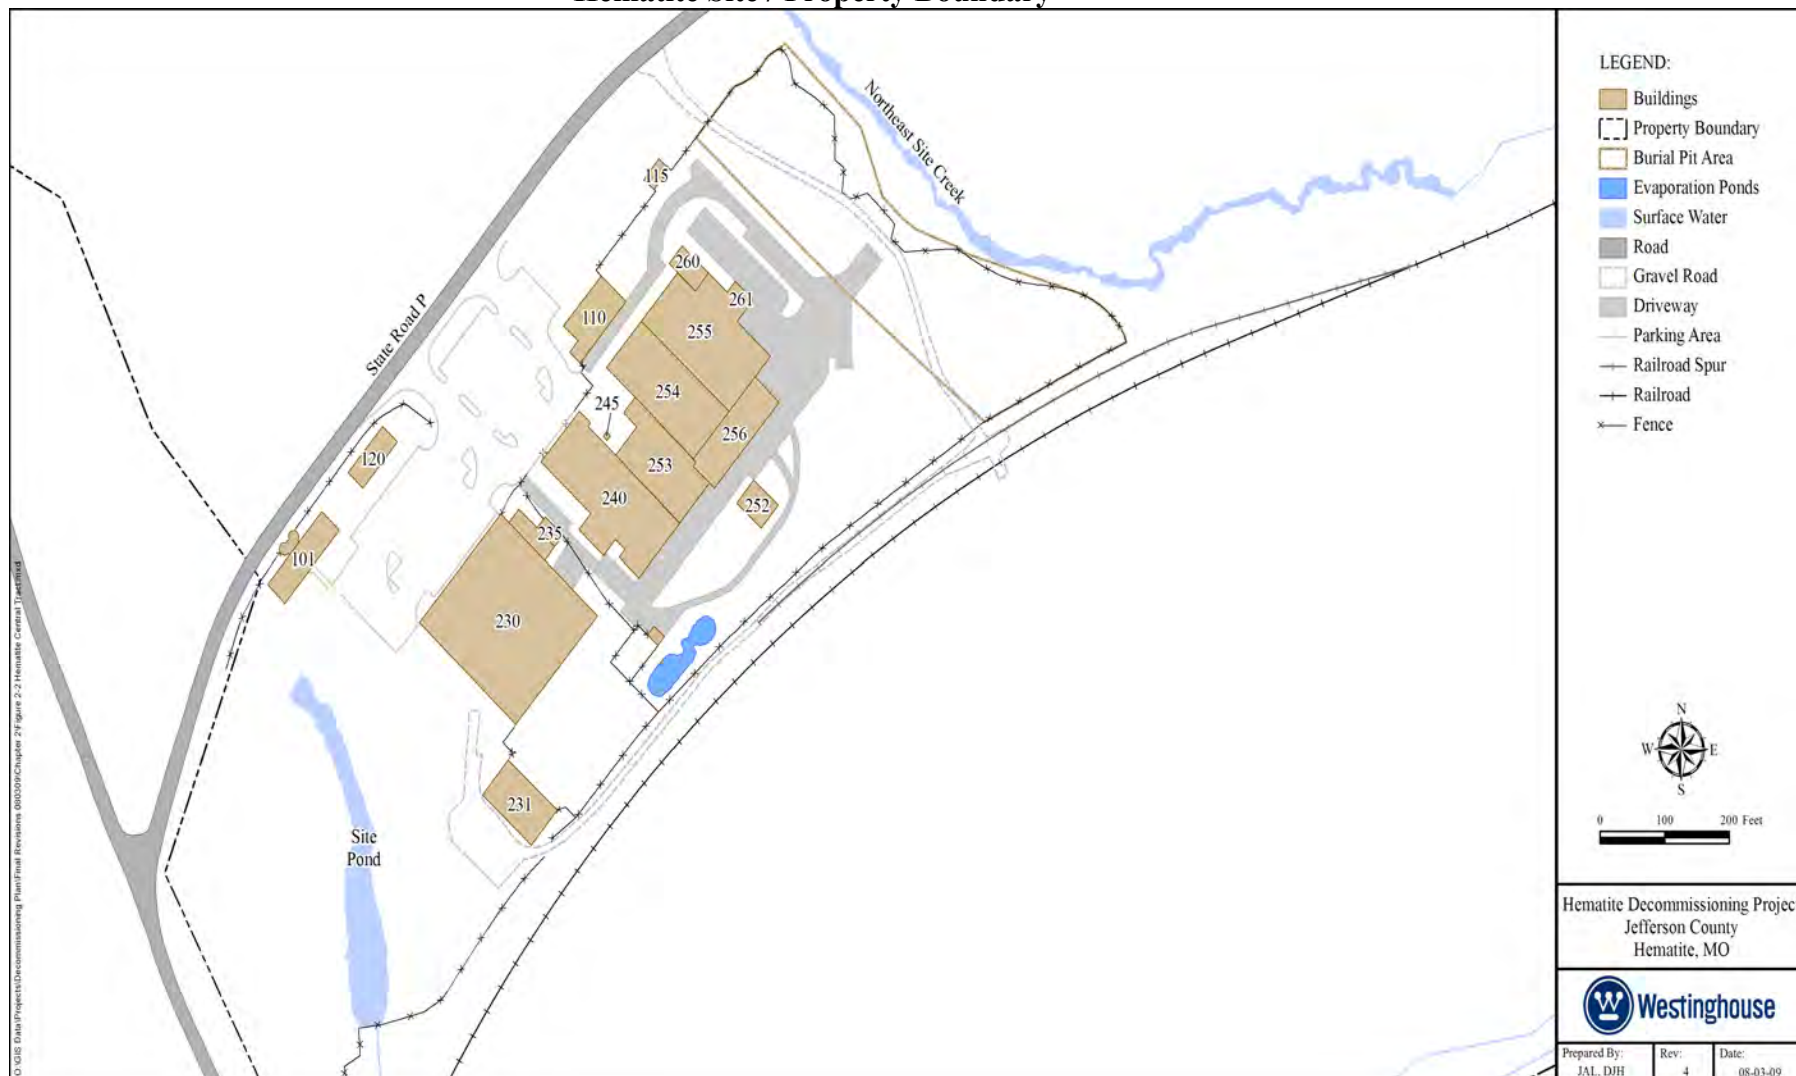
Figure 1
Hematite Site / Property Boundary

The Westinghouse Hematite Decommissioning Project (HDP) Historical Site Assessment "DO-08-005" describes the former Hematite manufacturing Site as consisting of approximately 228 acres. Figure 1 depicts the site/property boundary and specific features discussed in this section. The portion of the site where operational activities historically were conducted is referred to as the "Central Tract" and occupies an area of approximately 19 acres. The central tract area is bounded by State Road P to the north, the Northeast Site Creek to the east, the Union-Pacific railroad tracks to the south, and the Site Creek/Pond to the west. The Central Tract (Figure 2) encompassed the former manufacturing and administrative building locations, two Evaporation Ponds, the Site Pond and legacy waste burial areas. The remaining site area is predominantly pasture or woodland.

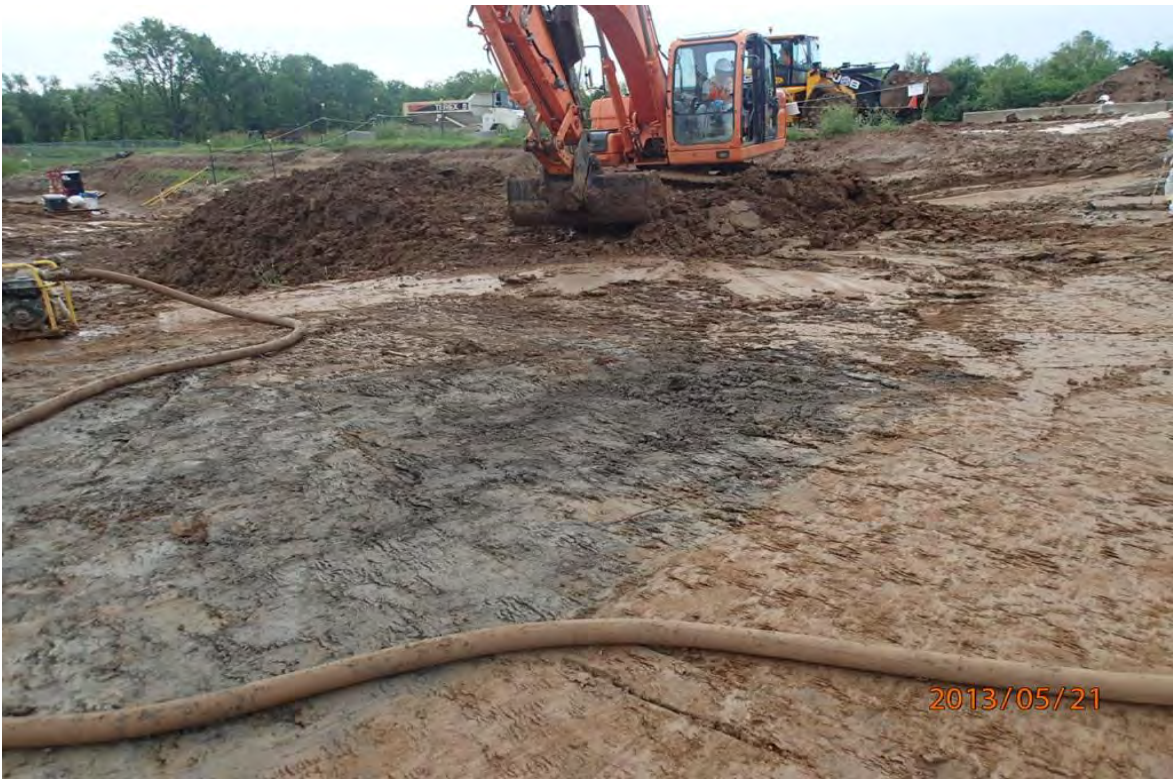
Figure 4
Example of Soil Discoloration where a Burial Pit was Located

identified by a change in soil color in spite of the fact that their size and shape was not as well defined as the documented pits. See Figures 4 and 5. Additionally, the equipment operators conducting the excavation could distinguish when they were digging in a burial pit based on the difference in the hardness of the soil. Workers could even detect the difference in the soil hardness when walking over a burial pit, which tended to be soft and spongy. Adding to the visual and soil hardness cues, the burial pit was also radiologically identifiable based on a GWS once reaching the contaminated layer.

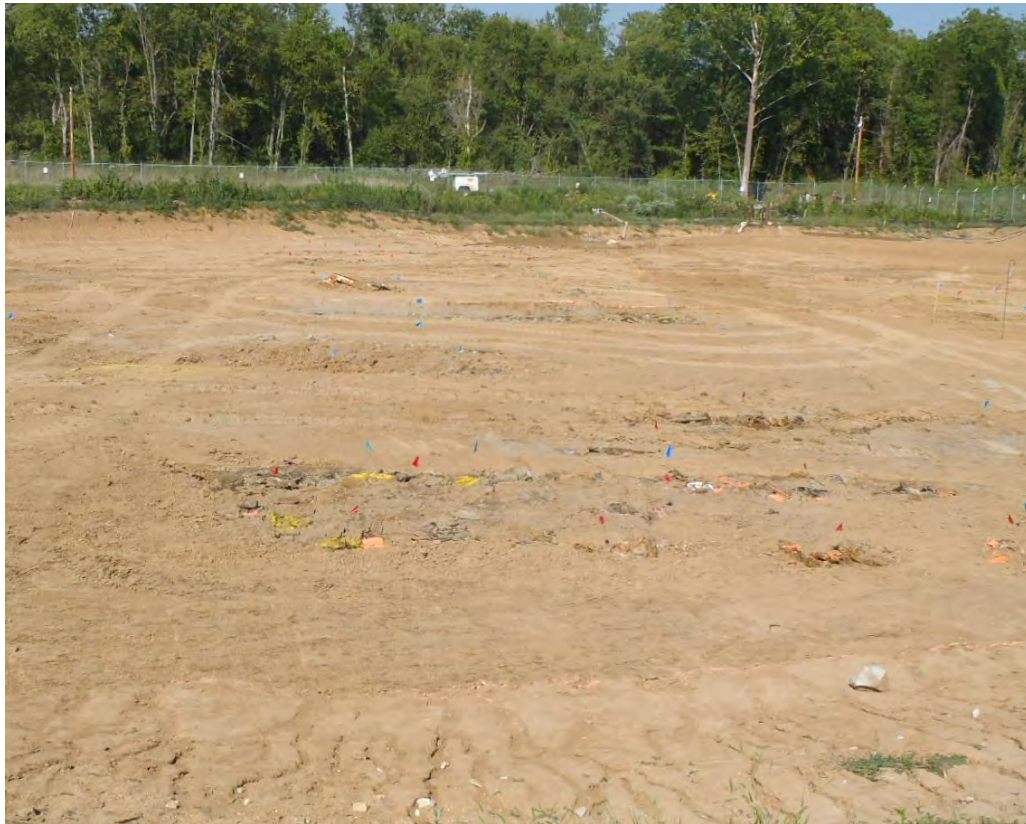
Figure 5
Example of Multiple Burial Pits Visually Identifiable by a Change in Soil Color as Well as by Uncovering Trash and Debris

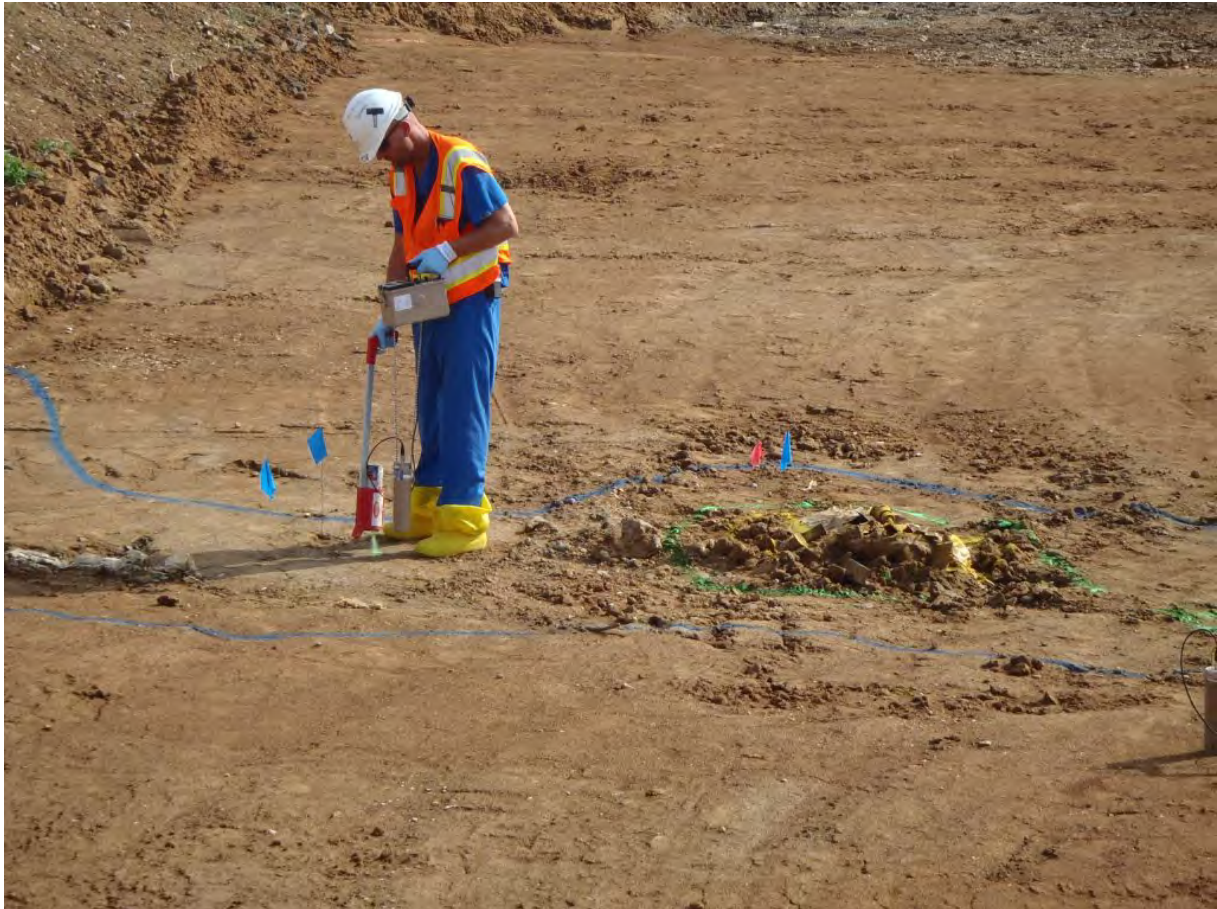
Figure 6
Example of Worker Conducting a Gamma Walkover Survey (GWS) in the Burial Pit Area with a NaI 2 x 2 Detector

Within the first few months after excavation activities began, the NRC expressed concerns whether a NaI 2x2 detector could identify lumps of U-235 via in-situ scanning through a foot of soil, therefore allowing material between 15g and 40g U-235 to be excavated prior to segregation. After further review and discussion with the NRC, HDP made the decision to take the more conservative approach and abandoned the use of 12 inch lifts, with all future NCS controlled excavations performed in 6 inch lifts. Soil/debris in areas not subject to NCS controls was still excavated in 12 inch lifts. This change was initiated in August of 2012, approximately four months after site excavation activities began. See Figure 6.

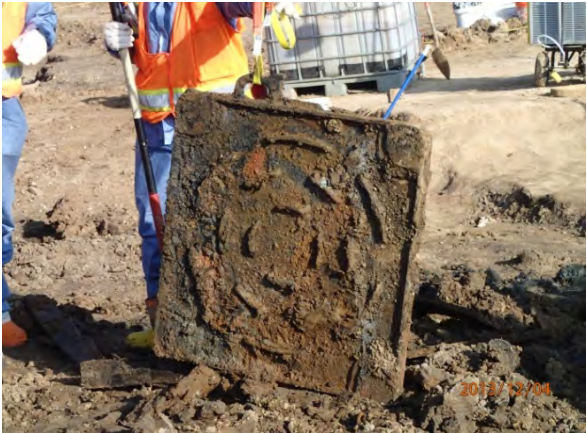
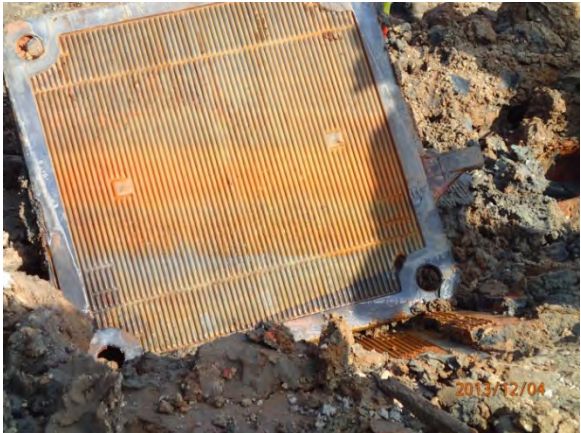
the burial pits were as anticipated, 215 radium contaminated filter plates made of steel, cast iron, and plastic, about 3 feet by 3 feet in size, were unexpectedly found. See Figures 7 and 8. It was determined that these were brought to the Hematite site from an offsite entity. Figures 9 and 10 also show several examples of some of the waste from the burial pits.

Figures 7 and 8
Examples of Radium Contaminated Filter Plates Being Unearthed While Excavating in the Burial Pit Area

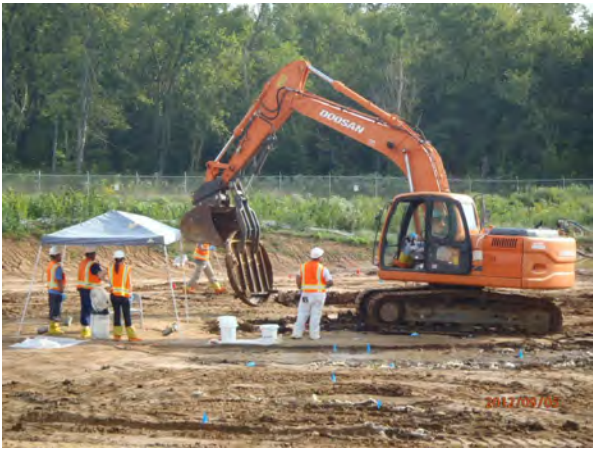
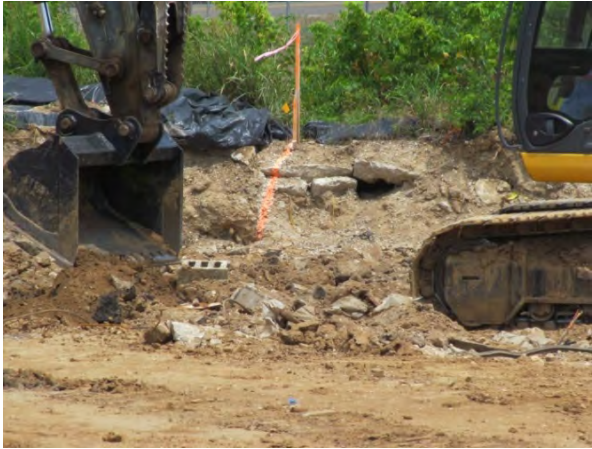
Figures 9 and 10
Examples of Debris that was Exhumed During Remediation Excavation of the Burial Pit Area

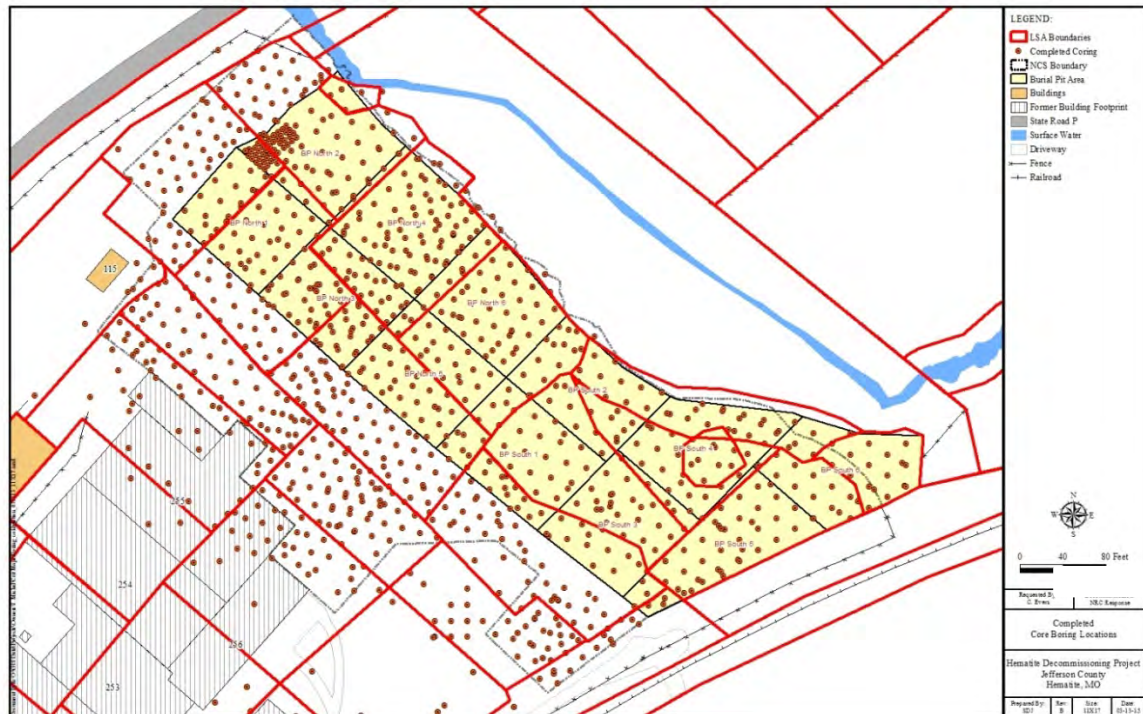
Figure 11
Core Bore Locations that were Performed for Nuclear Criticality Safety Control Purposes

These core bores were systematically placed based on a 20 foot grid, eventually covering the entire Burial Pit Area. Core cuttings and the core bore hole were surveyed to provide radiological data to make a determination whether NCS controls could be suspended for that SU. The data was evaluated against pre-determined NCS Limits. The core cuttings were evaluated against a saturated soil value of 46k net counts per minute (ncpm), and the core bore holes were evaluated against a dry soil value of 63k ncpm. If the core bore data

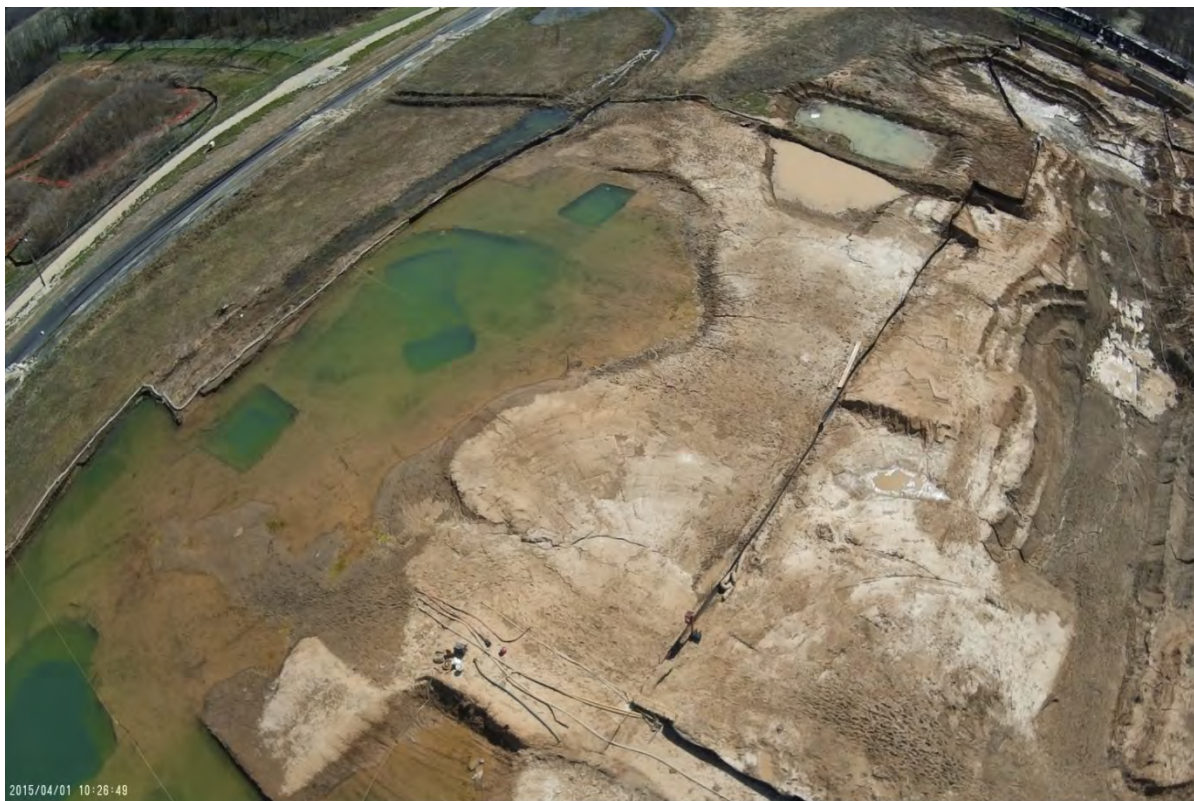
Figure 14 provides an aerial view of most of the Burial Pit Area taken on April 1, 2015. The photograph was taken after all remediation activities, both radiological and chemical, were completed. While a portion of the area had filled with water following the completion of excavation activities, the change in water color with depth helps visually identify the change in depth and extent of some of the excavated areas. The large excavation identified in the lower-left corner of Figure 14 is where a large number of burial pits were located in close proximity, and is near where the radium plates were found. The Burial Pit Area will be backfilled with clean soil from offsite and the site topography restored prior to license termination.

Figure 14
Aerial View of a Portion of the Burial Pit Area Post Remediation Looking West to East
