Trojan ISFSI

License Renewal and AMP Inspections

December 8, 2016

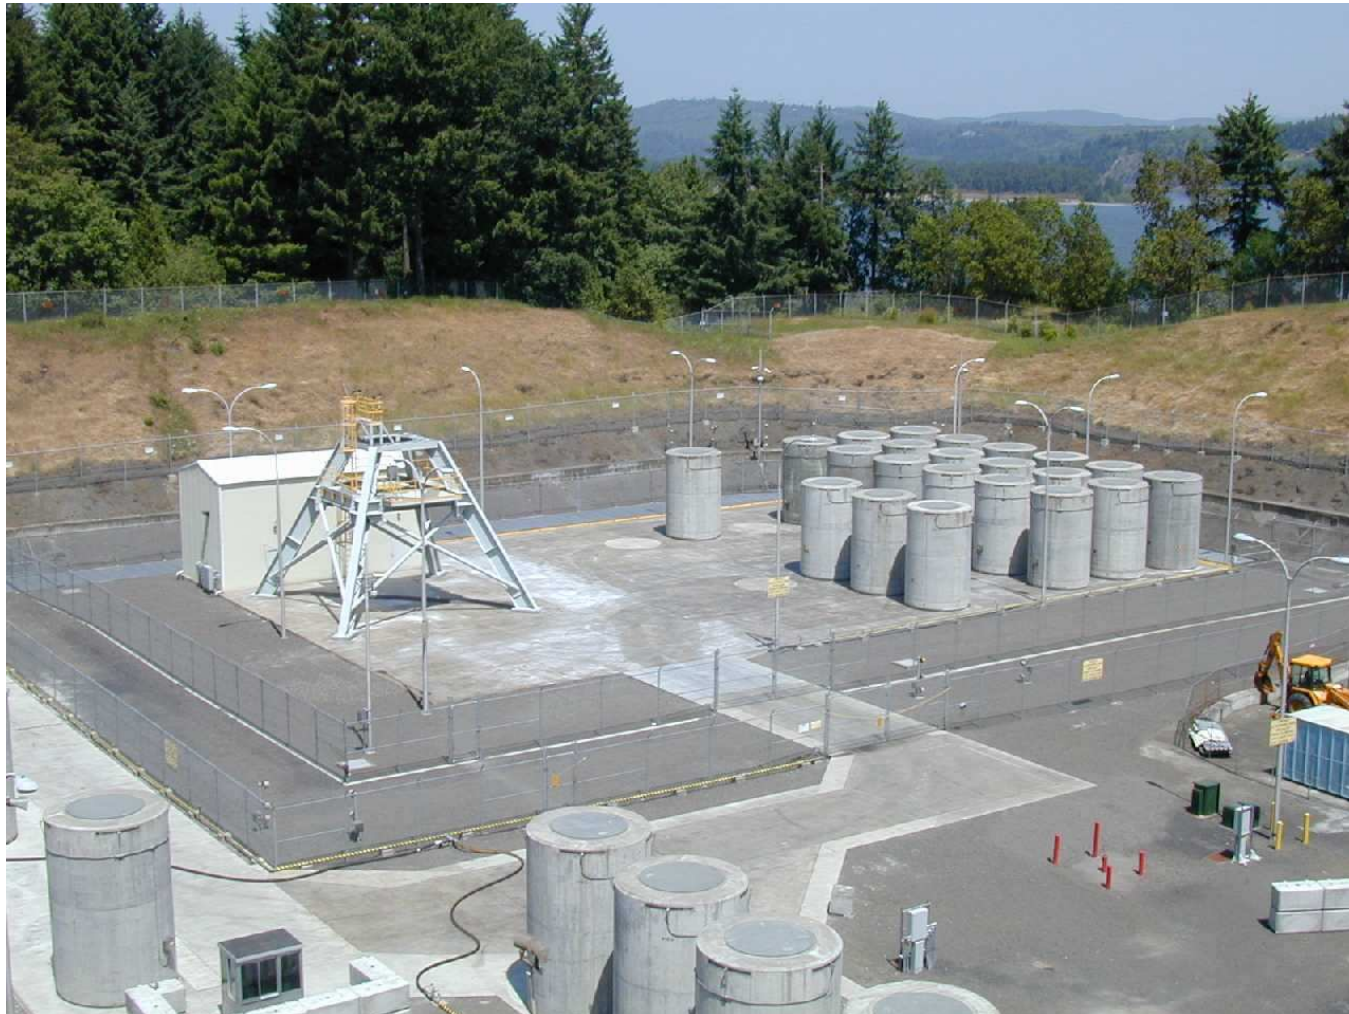
- Storage pad on engineered fill / bedrock foundation
- Sierra Nuclear ventilated Concrete Casks based on VSC-24 design
- Holtec MPC-24E and MPC-24EF fuel canisters
- Transfer Station for MPC transfers between Concrete Casks and Transportation Casks
- Impact limiter embedded in Transfer Station Pad for use during MPC transfers
- Holtec Transfer Cask, for use during MPC transfers

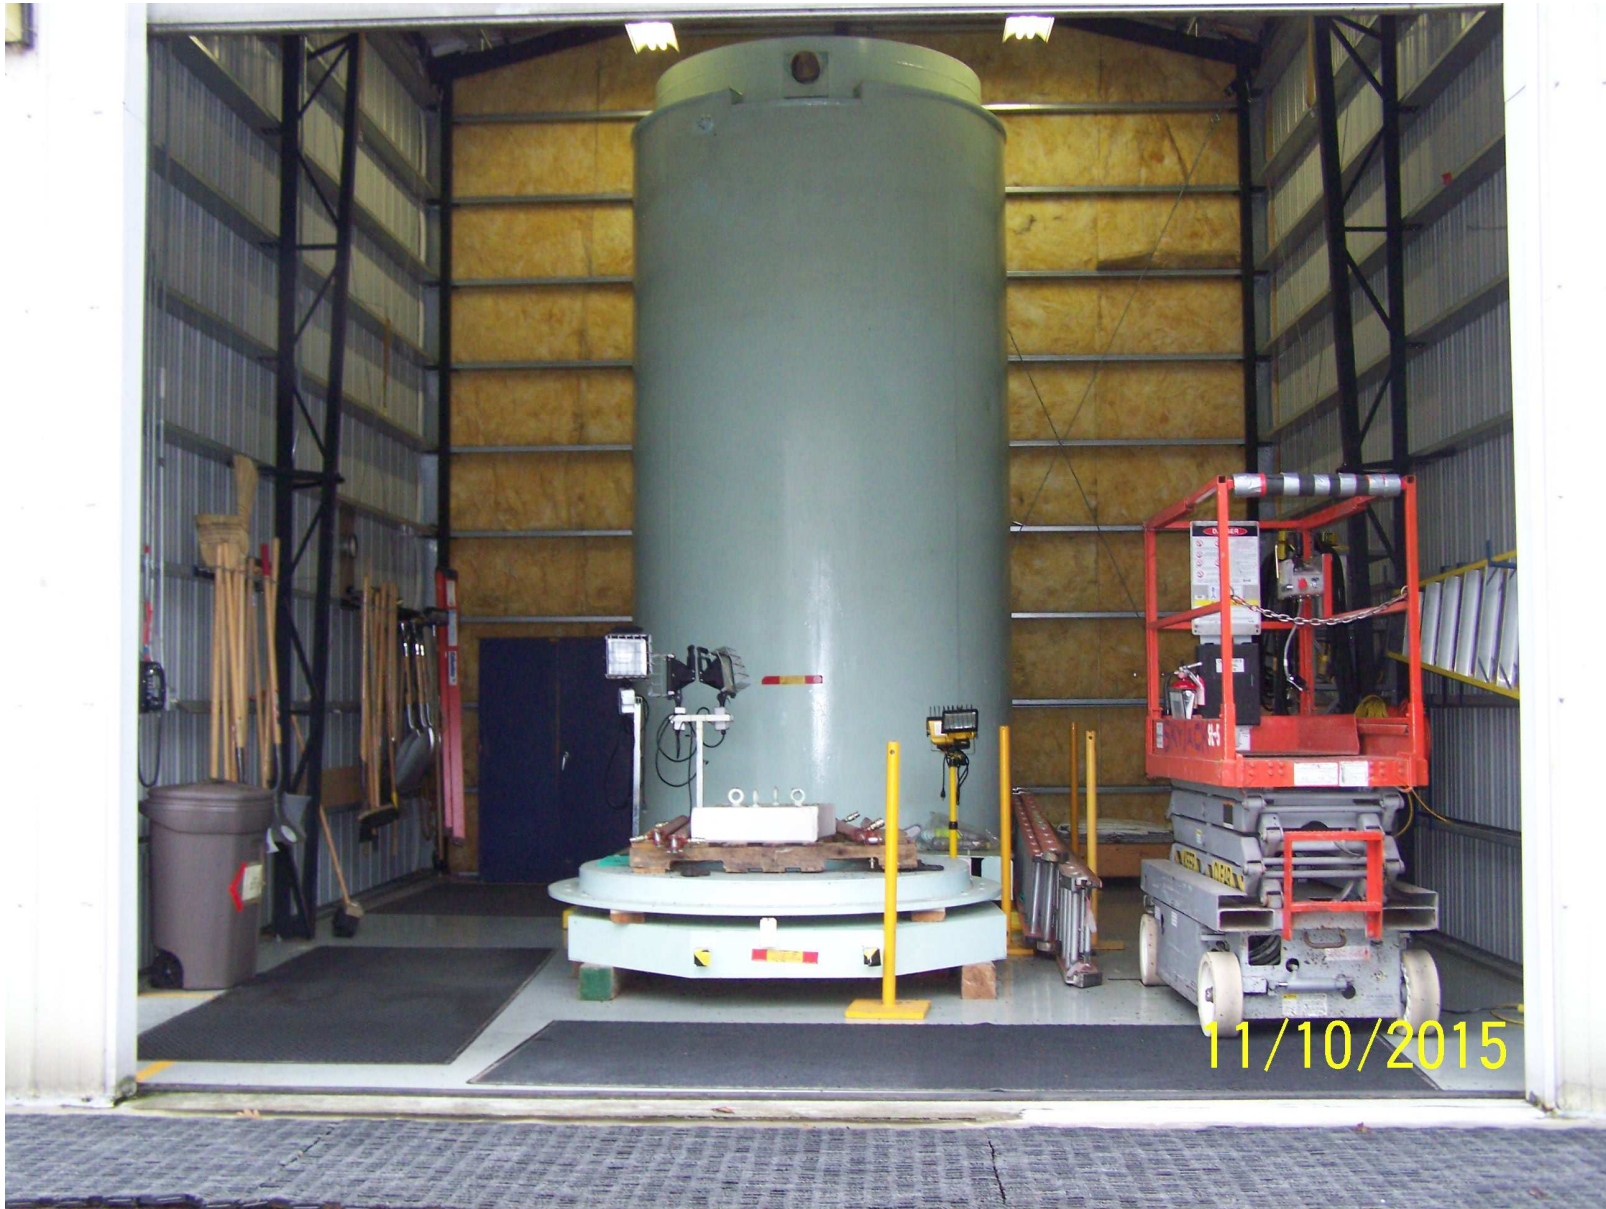
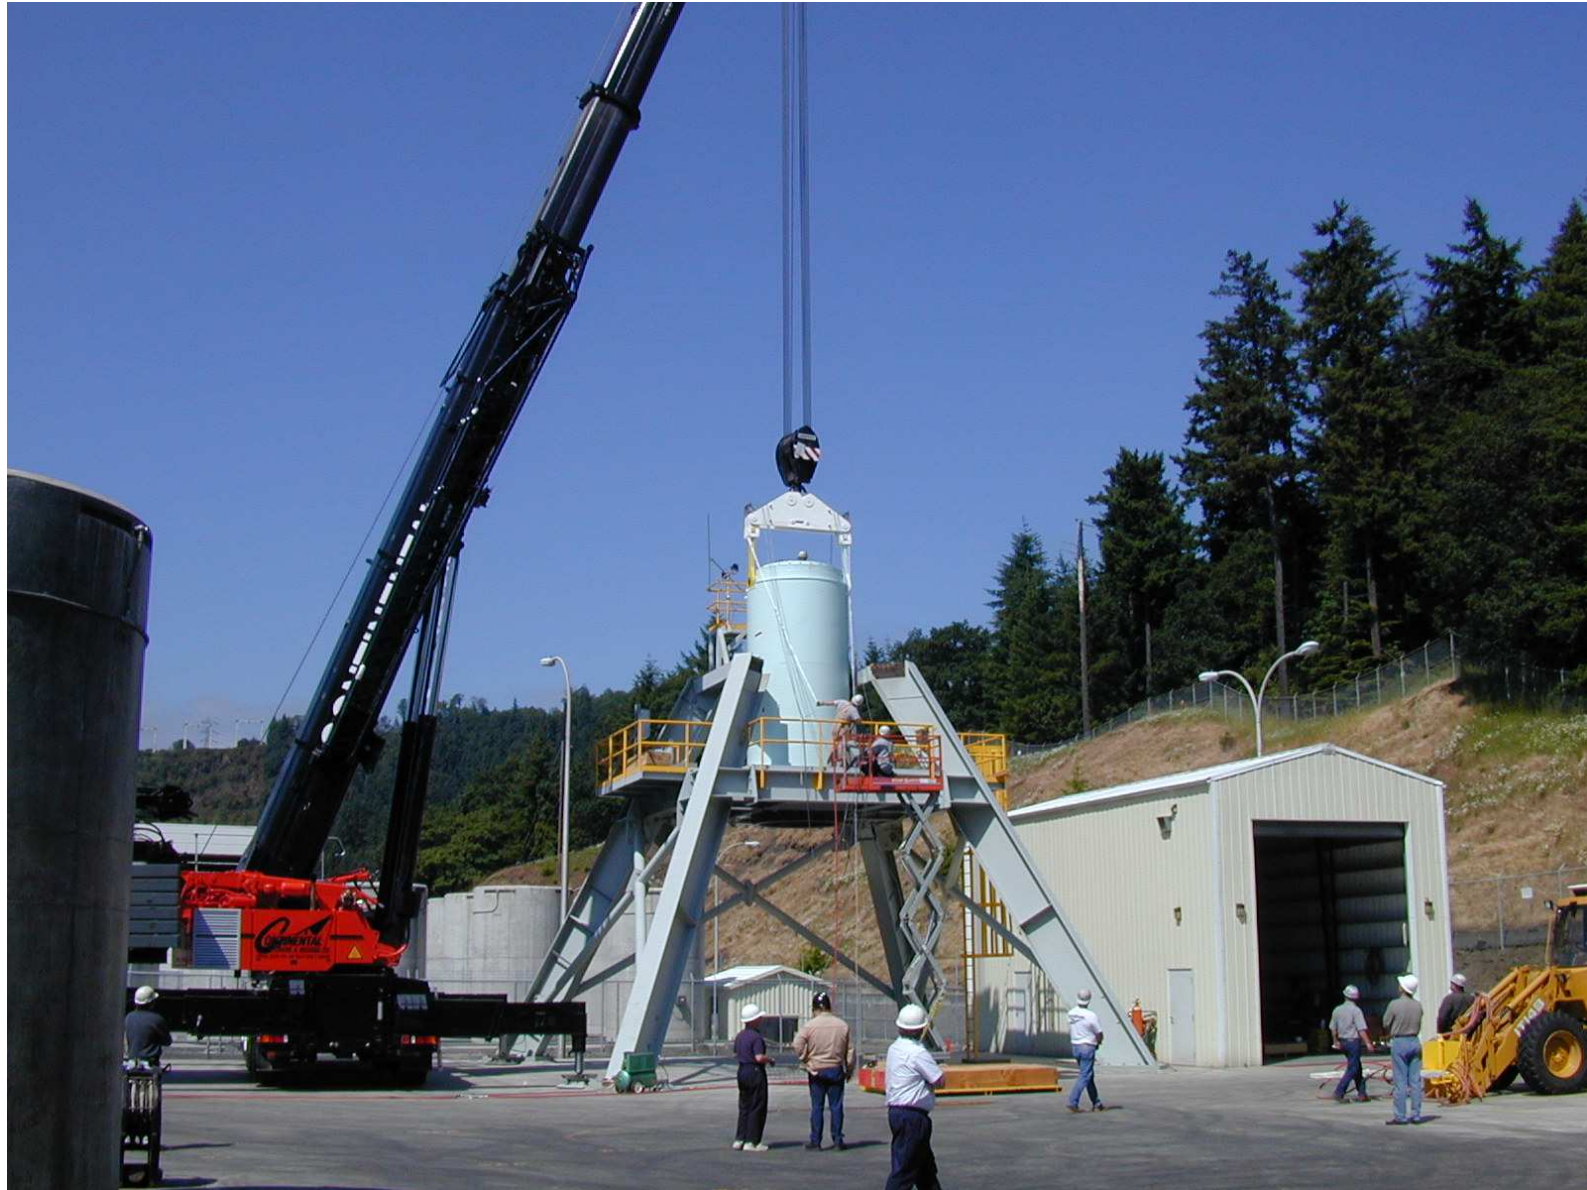
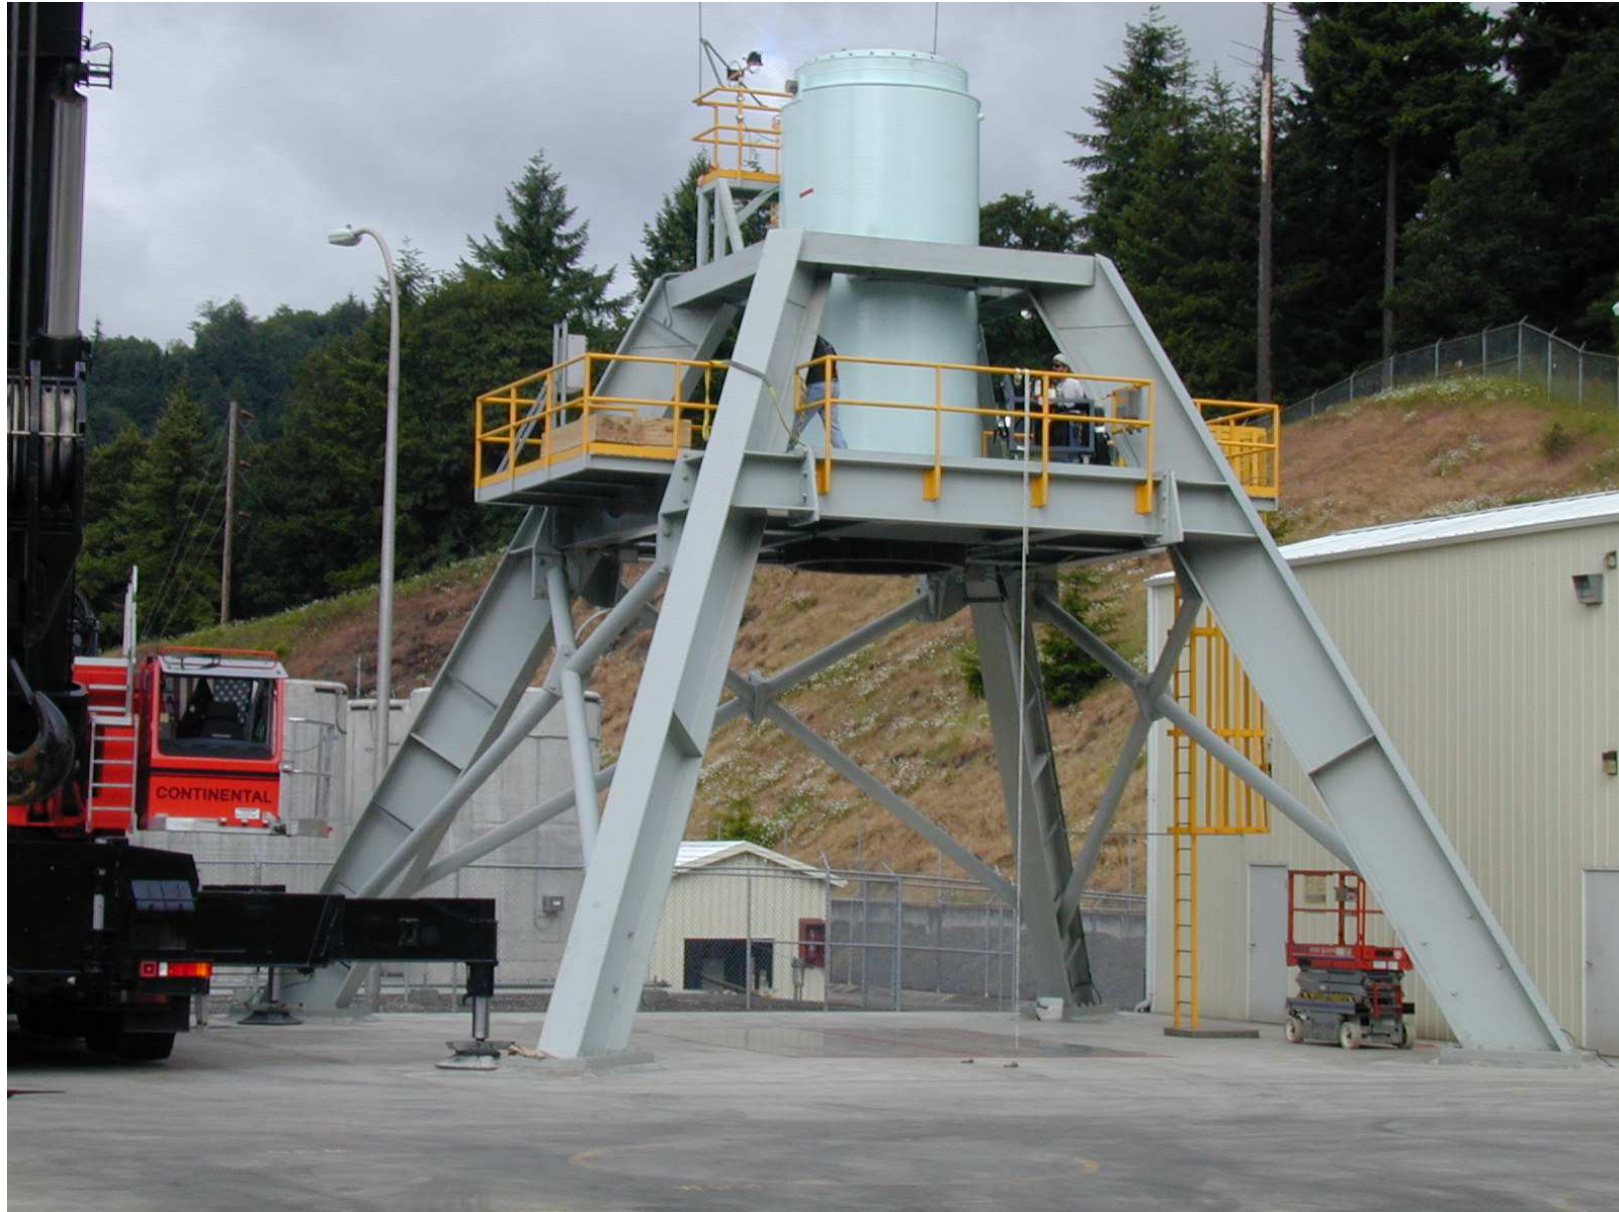
Transfer Cask AMP

- An annual visual inspection is currently performed per the Trojan Structural Inspection Program
 - Accessible surfaces
 - Excessive corrosion, pitting, loss of paint
- AMP includes inspection prior to use in the Transfer Station
 - Painted surfaces inspected for corrosion and chipped, cracked, or blistered paint
 - Lid surfaces inspected for dents, scratches, gouges, or other damage
 - Water jacket inspected for leaks
 - All other surfaces inspected for dents, scratches, gouges, or other damage

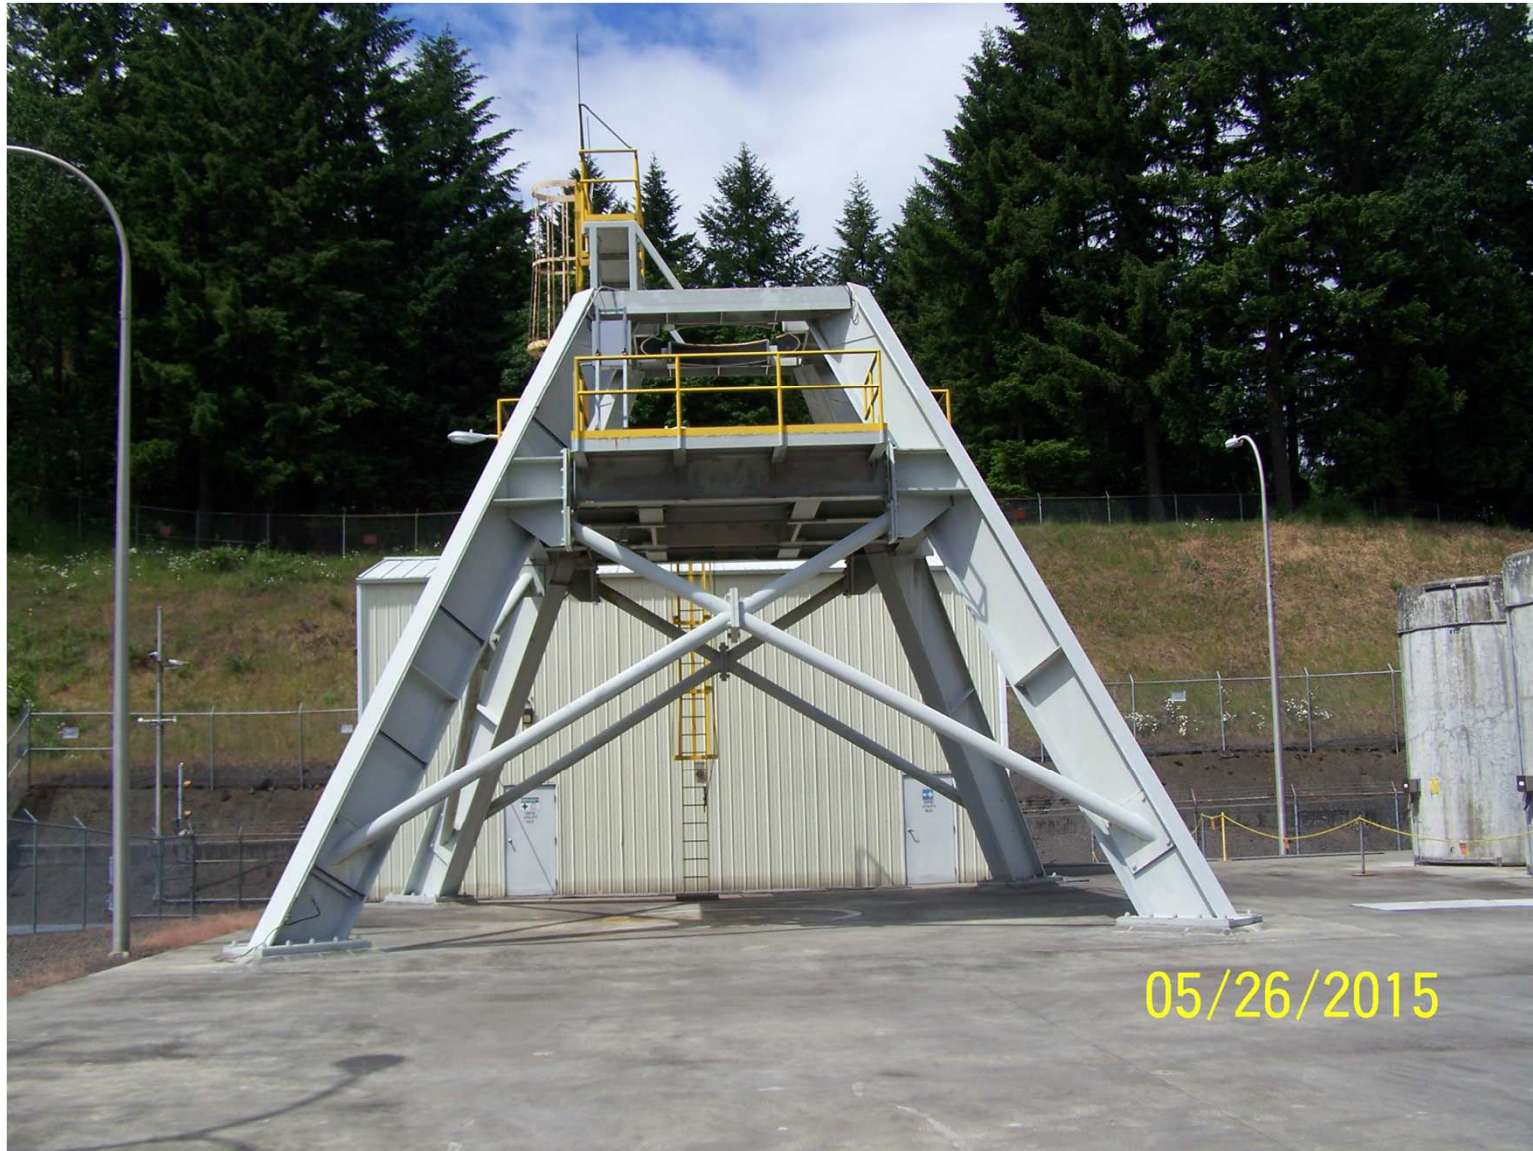
- An annual visual inspection is currently performed per the Trojan Structural Inspection Program
 - Excessive corrosion, pitting, loss of paint
- AMP includes inspection prior to use for MPC transfers
 - Painted surfaces inspected for corrosion and chipped, cracked, or blistered paint
 - All other surfaces inspected for dents, scratches, gouges, or other damage
- AMP includes inspection of Transfer Station Pad
 - Inspection and acceptance criteria similar to those for the Concrete Cask exterior (concrete) surfaces

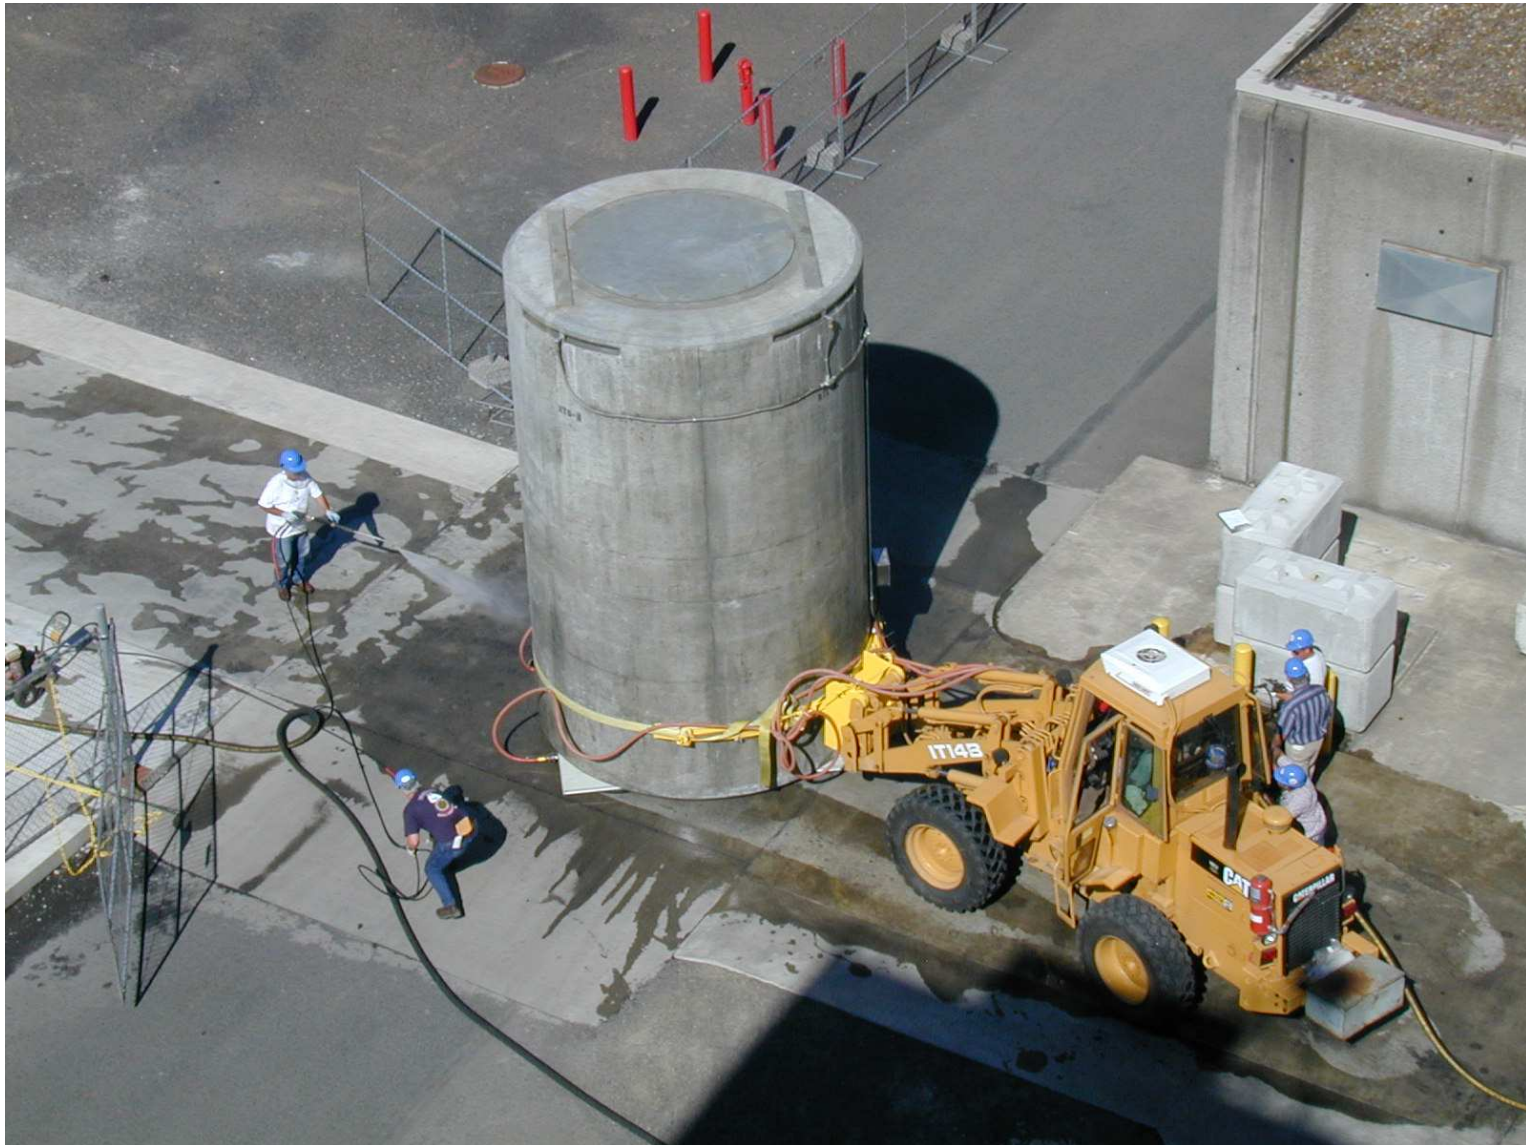
Concrete Cask AMP

- Visual inspection per ACI 349.3R-02, including three tier acceptance criteria:
 - (1) acceptance without further evaluation
 - (2) acceptance after review
 - (3) acceptance requiring further evaluation
- Deficiencies meeting criteria (2) or (3) resolved in Trojan Corrective Action Program
- Technical justification may be provided to deviated from ACI 349.3R-02 acceptance criteria

- Concrete Cask interior consists of carbon steel liner coated with inorganic zinc-rich coating
- Minor surface rust blooms observed during previous inspections, evaluated as acceptable
- Future inspections on five year interval while inspecting accessible portions of MPC exterior

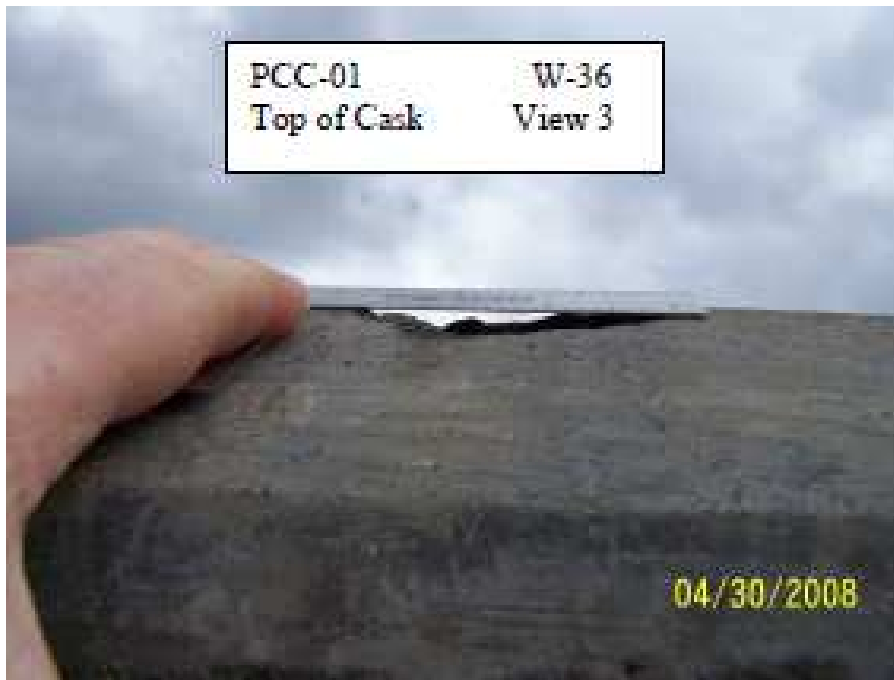
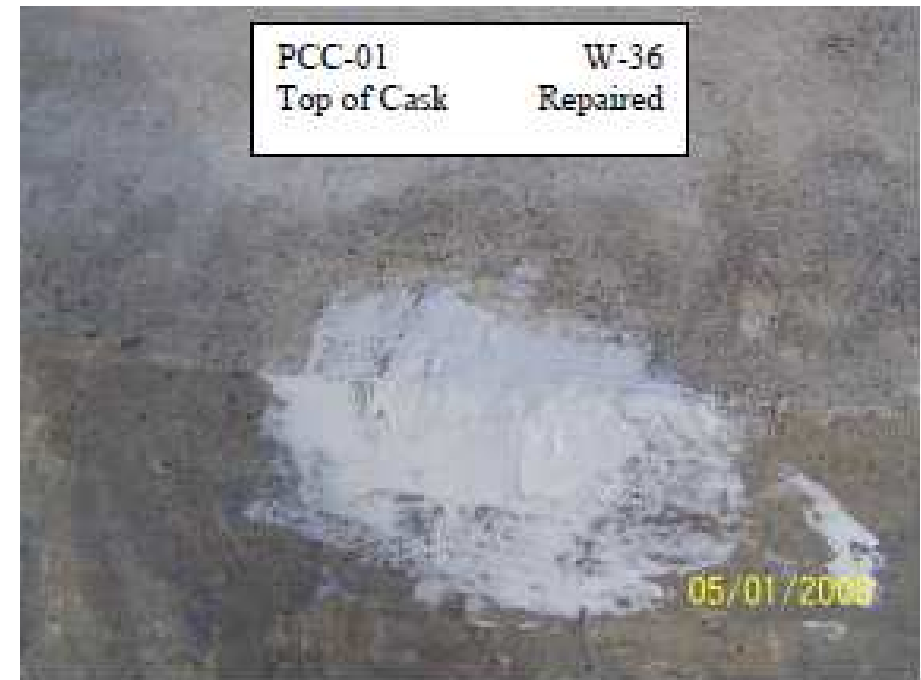
Concrete Cask AMP

- Visual inspection of one MPC using video scope through inlet and outlet vents
 - Accessible surfaces
 - VT-3 examination per ASME Section XI, Article IWA-2200
 - May be extended to VT-1 based on results
 - Five year interval
 - First cask placed in service (lowest heat load also)
 - Previously inspected in 2008 and 2013 during Concrete Cask interior inspection

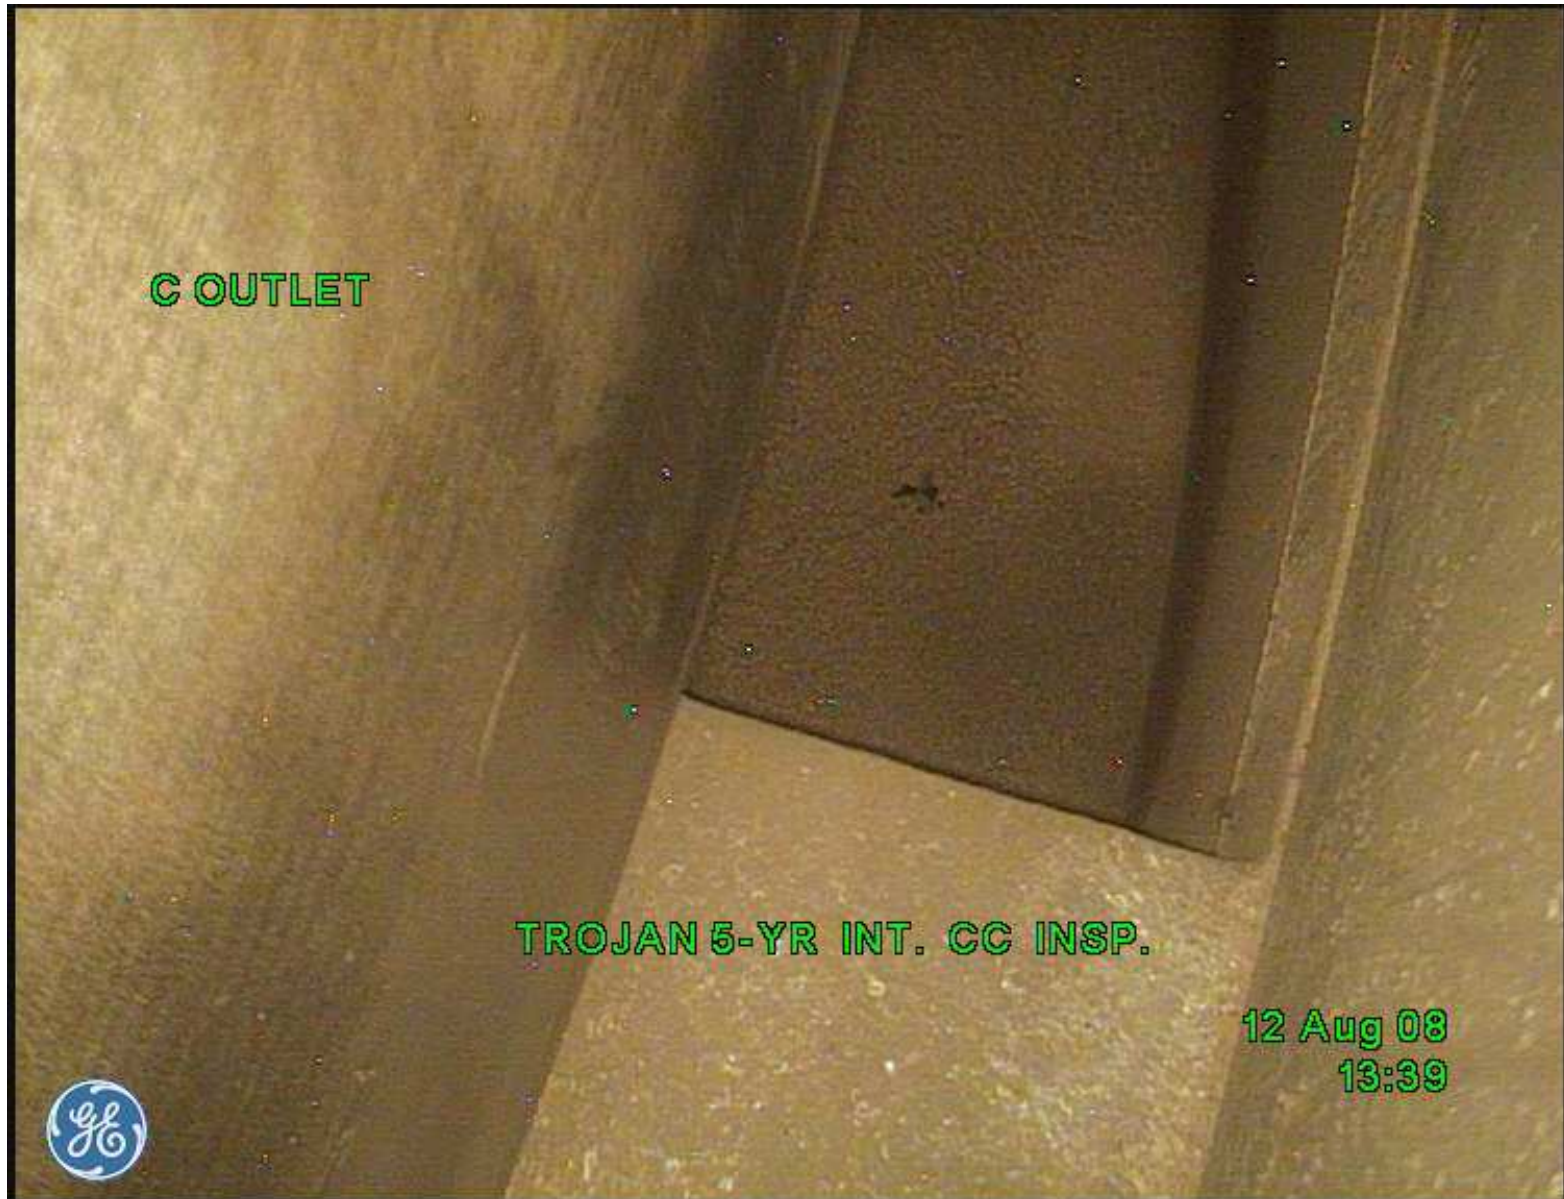
Previous MPC Inspections

- Completed inspection in one day
- All vent passages areas were clear other than minor dirt accumulation and some very small wasp nests
- Cask / MPC annulus completely clear
- Confirmed condition of insulating tiles underneath MPC
- A few small areas of surface rust (through a zinc-rich coating on the Concrete Cask inner liner) were present; no pitting or significant loss of material

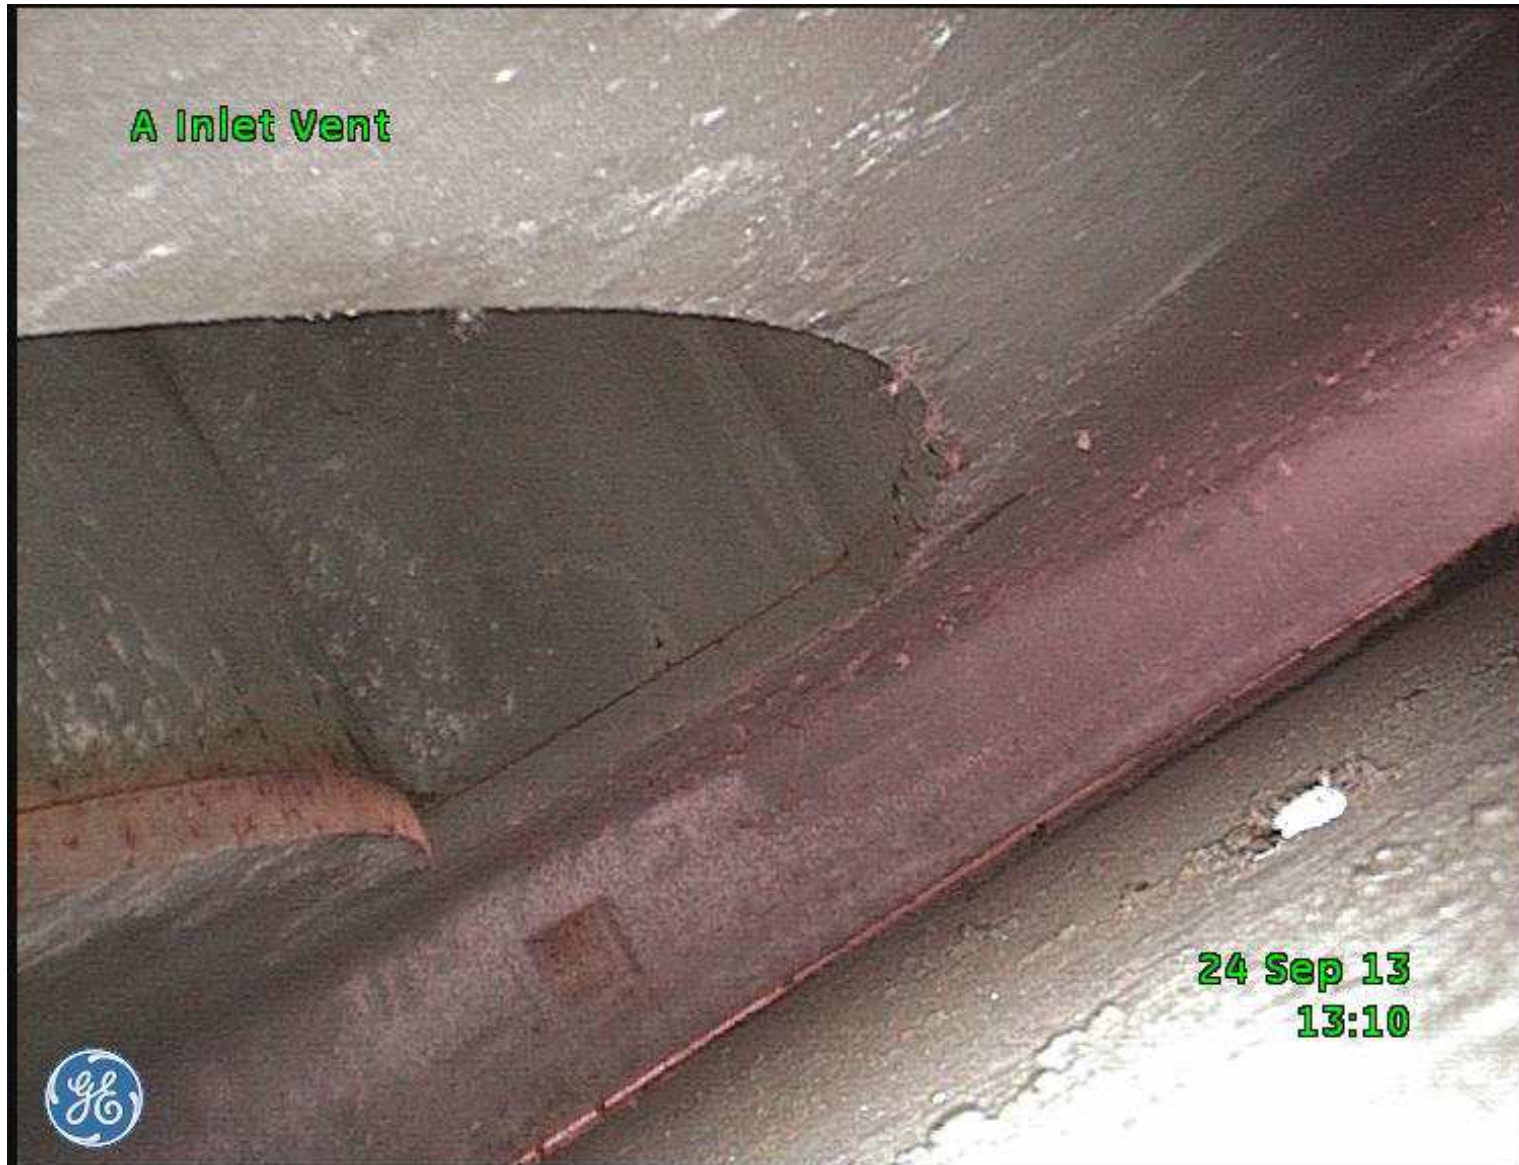
Previous MPC Inspections

- Patches of white surface residue present at junction between upper vent plenum and cask liner plate (not a welded joint)
- Could not sample white residue, but its appearance was similar to deposits on outside of cask (calcium carbonate)
- Deposits appear to have been present during cask construction; evaluated as having no effect on concrete strength or integrity
- No apparent changes in deposits between 2008 and 2013 inspections
