Historical Radiological Assessment – Supplemental Technical Memorandum

**Naval Station Treasure Island
San Francisco, California**

July 1, 2014

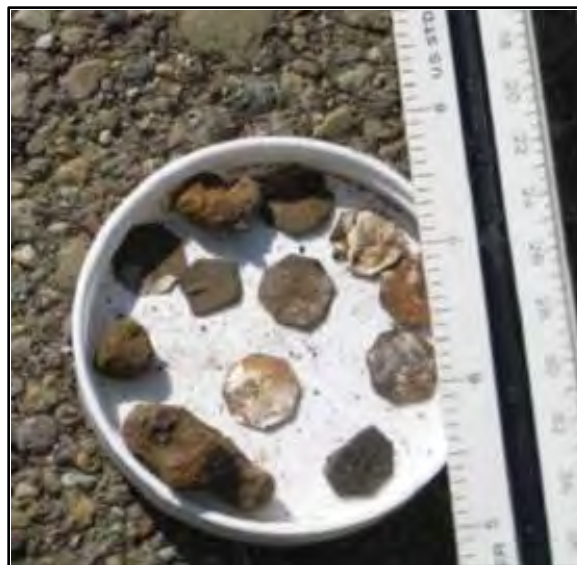
Photo 1 Radium Foils

One particular focus of research was to obtain additional detail regarding the purpose and use of the radium foils that have been found buried in the SWDAs. About 75 radium foils have been found to date, as detailed in [Table 1](#). The foils typically read about 1 roentgen (rem) on contact with the LLRO and range between 12 to 15 millirem 1 foot away from the LLRO. The foils are about the size of a dime and are octagonal or hexagonal in shape, as can be seen in [Photo 1](#) below. The evidence suggests that they would have been buried in the SWDAs sometime between 1942 and 1955, when evidence of the SWDAs can no longer be found in photographs. The Society for the History of Navy Medicine and the curators of both the National Atomic Testing Museum in Las Vegas, Nevada, and the Museum of Science and Energy in Oakridge, Tennessee, were contacted to try to obtain additional information regarding the purpose and use of the radium foils found buried in the SWDAs at TI.

a check source of the approximate size and shape of the radium foils found buried in the SWDAs on TI can be seen. It is the conclusion of this HRASTM that the most likely use of the foils that have been found on NAVSTA TI would have been as calibration or check sources in association with a high-range radiac utilized in conjunction with the above schools. They were likely disposed of as excess in the early 1950s as radium use as check sources was phased out.

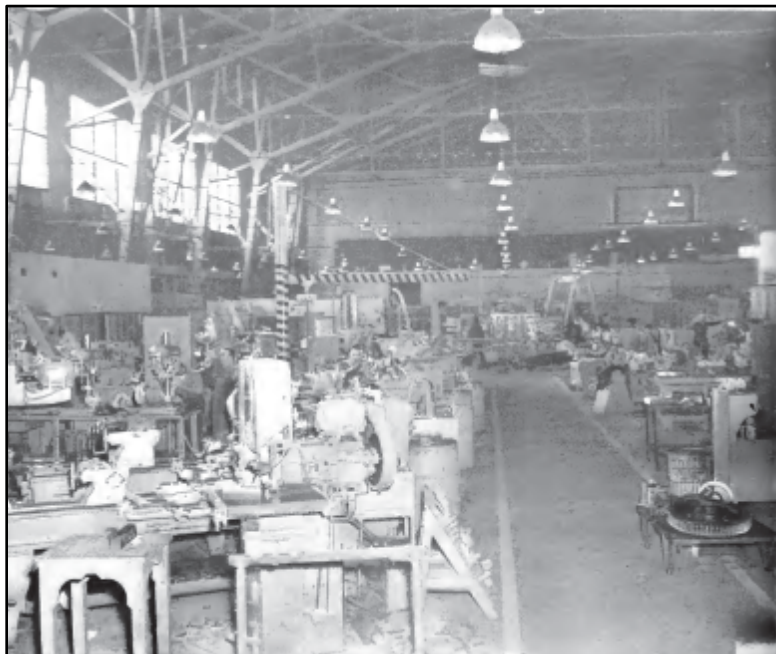
Photo 5 Interior of Hangar 3 during WWII repair shop for Frontier Base

Hangar 3 was the Palace of Fine and Decorative Arts during the GGIE. It is evident from the records reviews and [Photo 5](#) that Building 3 was configured to conduct inside shop work associated with the repair activities associated with the “Section/Frontier Base” operations. Building 3 has been designated as radiologically impacted in this HRASTM because of the potential for those historical ship repair activities to have involved radioactive deck markers and gauges painted with radioluminescent paint. Evidence was found regarding the potential for an optical shop associated with the “Section/Frontier Base” on NAVSTA TI (Navy Undated). Former Navy optical shops at other bases have been found to contain residual radium contamination. The optical shop was on the roof of Building 3 as shown on [Photo 6](#). The plan elevation and details show the presence of sinks and drains in the optical shop and these drains are considered impacted from the point of origin in the shop downstream to the sewer outfall. It is apparent that the 6-inch sanitary sewer line shown on [Photo 7](#) was added sometime after 1943 as it is not shown in earlier drawings. It is therefore likely added in association with the construction of the optical shop (Navy 1944a). As noted in the handwritten note on the plan elevation and details, the optic shop was demolished in 1969. Part of the drain line serving the shop was removed along with the shop, but the majority of the line leading to the pump station remains. There were a number of ship repair piers and two floating dry-docks by the war’s end that were dedicated to this activity (see [Figure 3](#), 20 February 1945 aerial photograph). Ship repair activities appear to have ceased sometime in the 1950s; however, it is not clear exactly when these activities ceased.

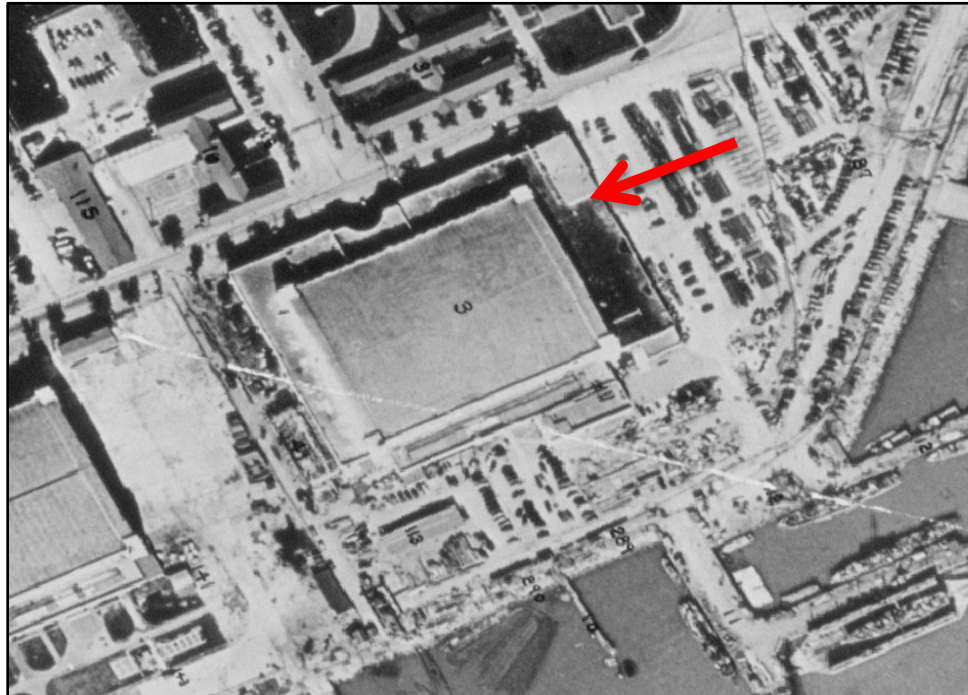
**Photo 6 1945 photo showing the presence of the optical shop
on the north corner of the Building 3 roof**

- Research identified the presence of an optical shop on the roof of Building 3. The optical shop had sinks that drained to the sanitary sewer system. The presence of such a shop is notable, as these shops have historically been found on other bases to have radium and thorium contamination associated with their operations. Radium and thorium were used for their radioluminescent properties in optical sighting devices and rangefinders during the WWII period.

At the start of WWII, NAVSTA TI was designated a “Section Base” with limited repair capability. The designation and the repair capability were upgraded later in the war to a “Frontier Base,” and TI became one of the largest Frontier Bases by supplementing similar repair facilities around the bay area that were overloaded. The Frontier Base took on the important job of completely servicing inshore and offshore operations and voyage and transient repairs for all crafts up to and including 2,200-ton destroyers (Navy 1946a). Further evidence of the magnitude of repair work is provided by Masthead articles that refer to the amount of scrap metal from repair activities at 200,000 pounds per month (Navy 1945a) and the complete replacement of an engine room on LCS 119 (Landing Craft Ship) that was struck by a Japanese Kamikaze (Navy 1945b). Wartime recycling activities, particularly related to ship repair, have historically included radiological impacts to the locations, thus their evaluation in this HRASTM. In addition to ship repair work, evidence was found regarding an optical shop in association with the “Section/Frontier Base” (Navy 1944a, 1945c, 1951b, Undated). Former Navy optical shops at other bases have been found to contain residual radium and thorium contamination. The optical shop on NAVSTA TI was located on the roof of Building 3.

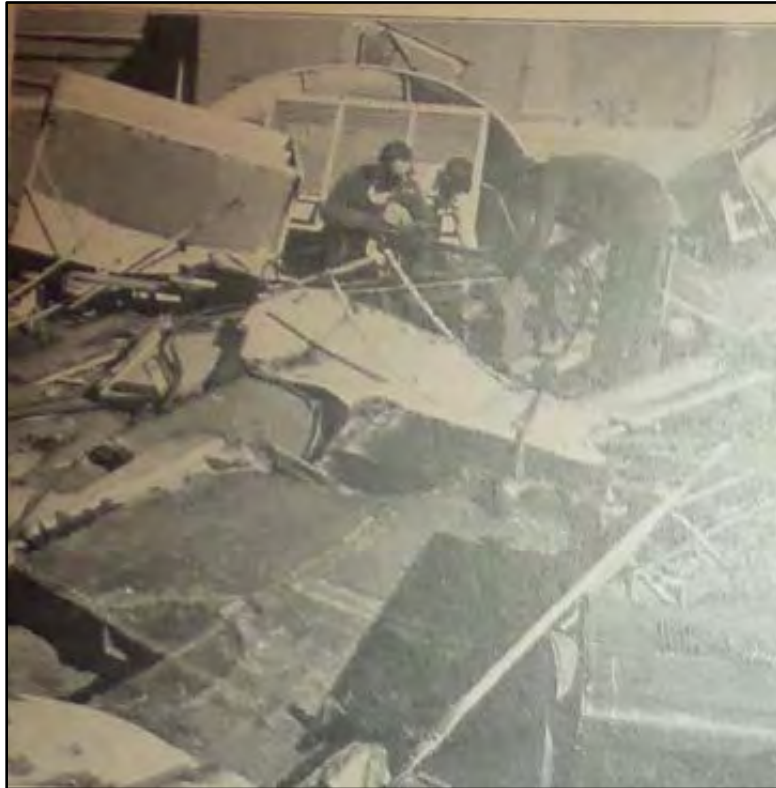
Photo 18 *Masthead* photo showing welders cutting up scrap metal for salvage

As noted in [Section 2.2](#), ship repair was ongoing throughout WWII. Those activities generated significant amounts of scrap metal, as evidenced by a *Masthead* article that referred to the amount of scrap metal from repair as 200,000 pounds per month (Navy 1945a). This same article contained a photograph ([Photo 18](#)) showing in-progress salvage operations for scrap metal. Salvage yards are typically a concern at ship repair facilities, as there is a potential for impacted sites from processing waste that contains unregulated radioisotopes such as Ra-226. While it is not clear exactly where the salvage area was, it is likely that the area would have been in the open area just south of Building 327 that was identified as a "Salvage Building" in the HRA. [Photo 19](#) is a 1945 aerial photograph of this area and suggests that the area south of Building 327 is likely the pictured salvage yard based on the presence of the buildings in the background of [Photo 18](#). Therefore, this area has been designated as impacted in this HRASTM. As shown on [Figure 8](#), Building 327 was demolished in the 1960s and the impacted salvage yard area is now in the footprint of the sewage treatment plant that was constructed in 1961.

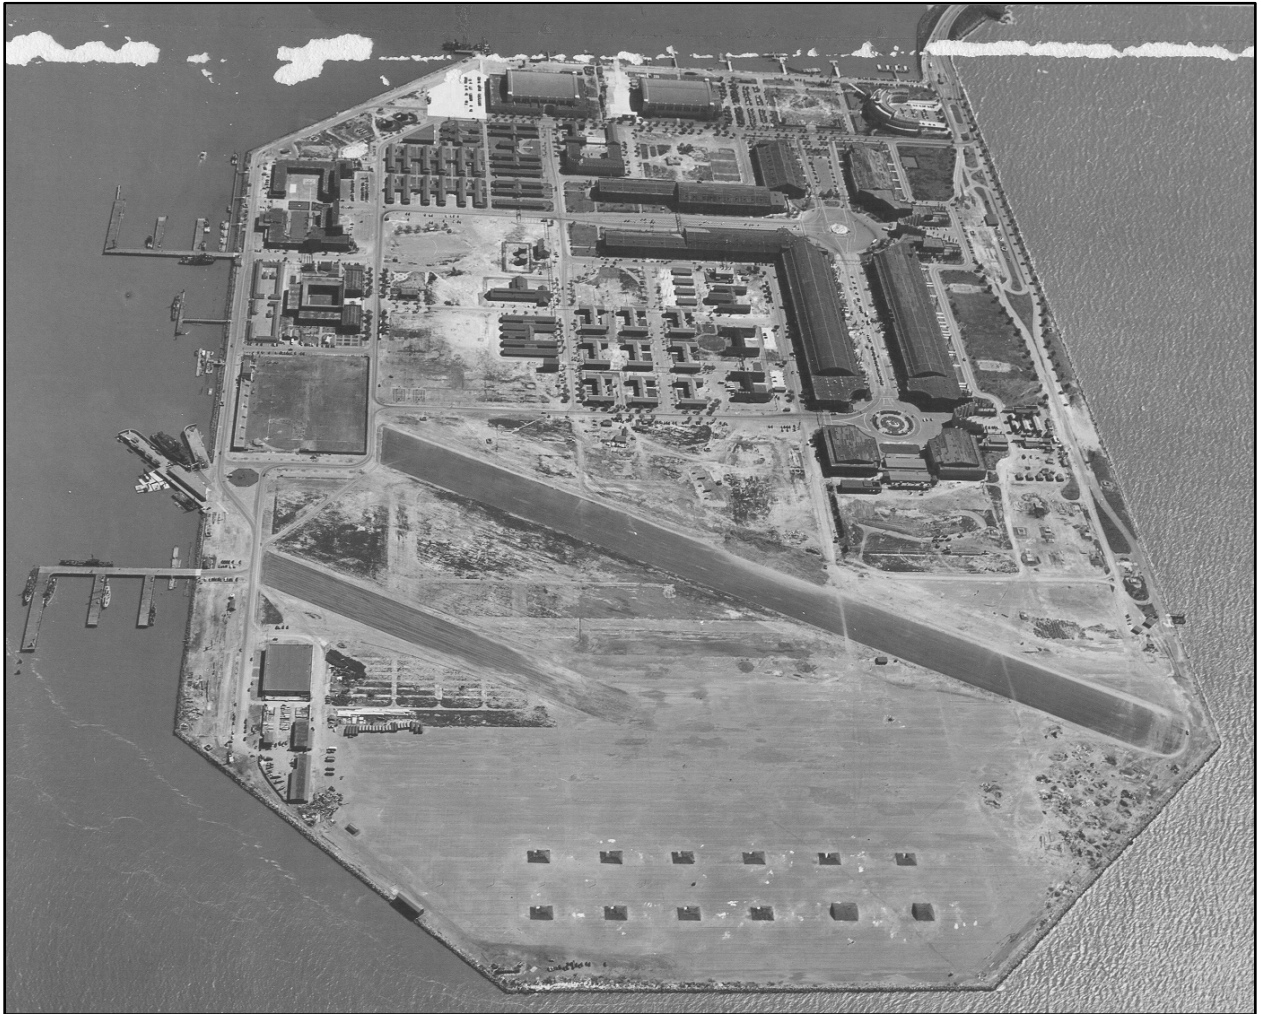
**Photo 24 1942 Aerial photograph showing smaller ammunition storage bunkers
on the north end of the Island**

- Areas covered by existing structures:** This category refers to the ammunition bunkers formerly located in AOI 7. There were two sets of bunkers on the property: small bunkers built immediately after the Navy acquired the property in early 1942 (Photo 24), and larger pile-supported bunkers built in 1944 (Photo 25). The concrete portion of the bunkers was to be either removed from the site, broken into pieces not exceeding a 1 foot maximum dimension, and placed in reworked fills at a depth not less than 2 feet below the base of foundations; or broken into pieces smaller than a cubic yard and deposited along the seawall adjacent to the 1200 series housing (Navy 1968). Earth materials obtained from bunker demolition were allowed to be placed in fills (Navy 1965). Because the larger bunkers were supported by piles, the plans called for digging down at least 6 feet around the bunkers and breaking or cutting off the pilings. These excavations within the rubbish disposal areas had the potential to bring rubbish to the surface.

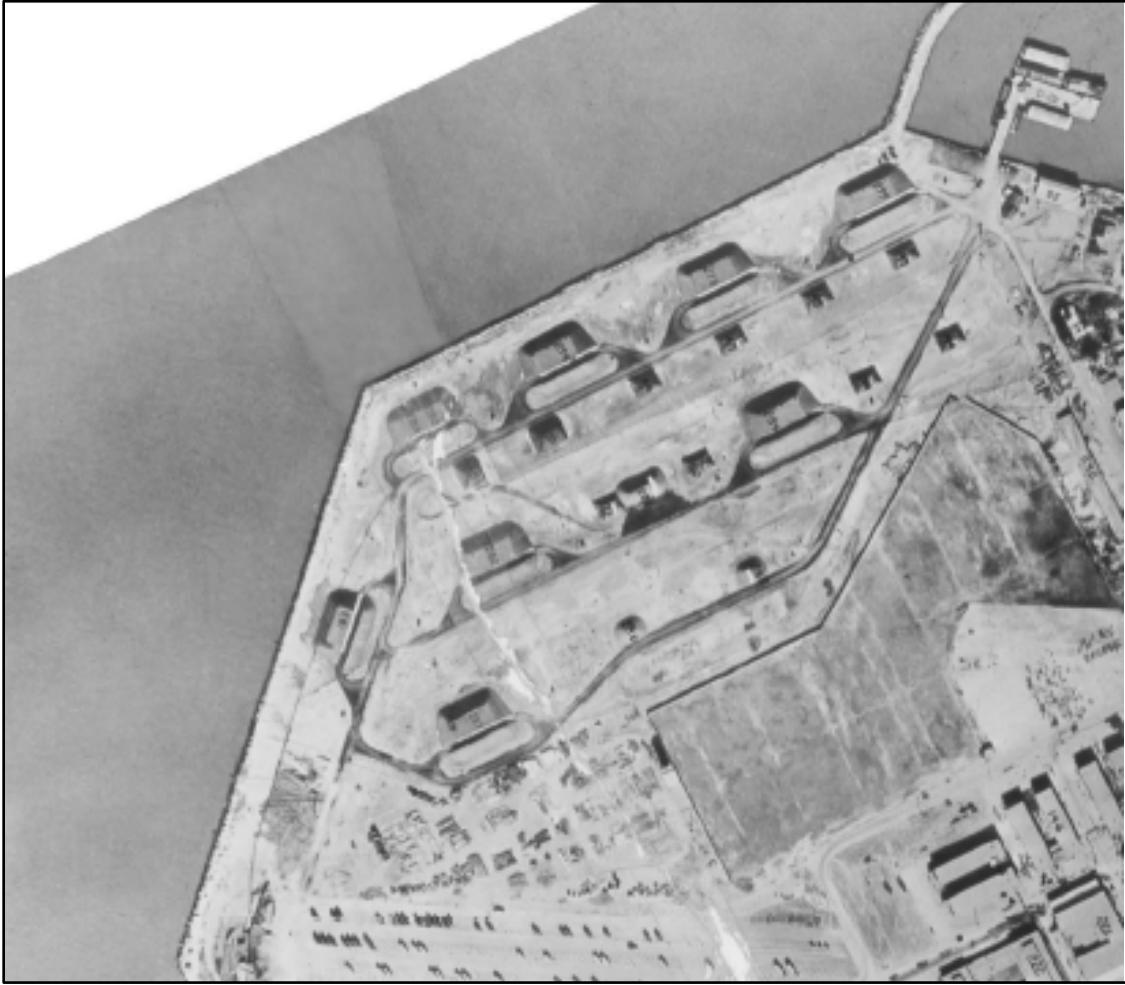
Photo 25 1942 Aerial photograph showing larger ammunition storage bunkers on the north end of the island

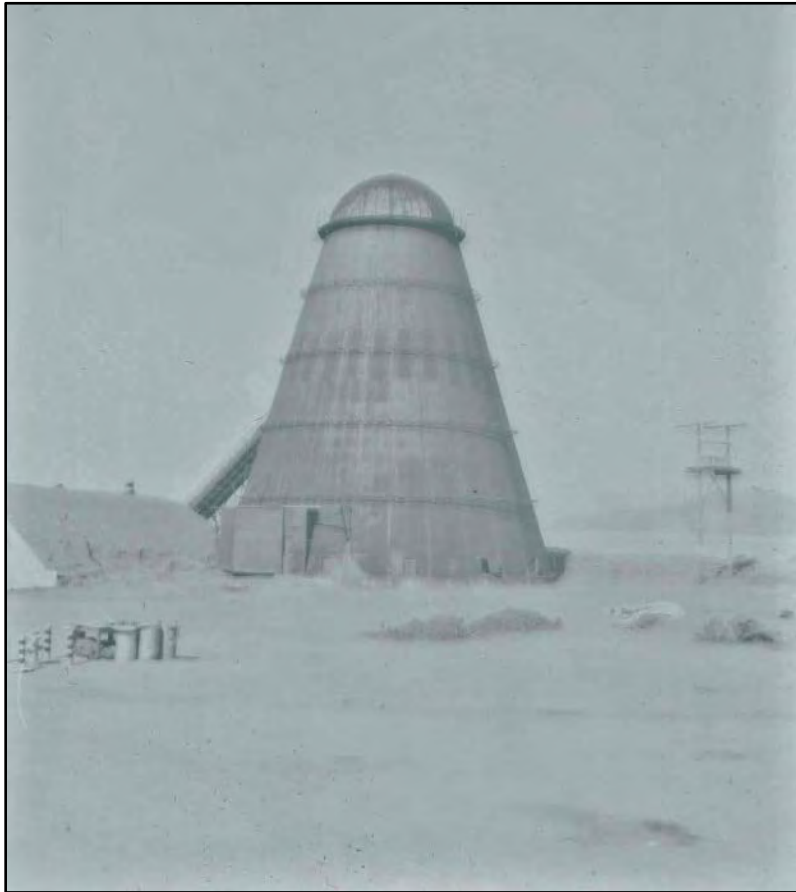
Photo 26 Photograph of incinerator

A large incinerator, identified as Building 345 and shown in [Photo 26](#), was present from approximately 1951 to 1952 (Navy 1952) until October 28, 1959, when it was demolished, according to Navy property records (Navy 1959). The incinerator was located in the same footprint as SWDA North Point (formerly named 1231/1233) and, more specifically, close to the foundation of housing unit 1231. There is no evidence that LLROs may have been disposed of in the incinerator, but disposal of such LLROs in incinerators has been noted at other military sites from the same era. For this reason, research associated with this HRASTM focused on obtaining more information regarding disposal of incinerator ash. No information could be found regarding disposal of the ash, and no evidence was found regarding disposal of the ash on TI. This HRASTM concludes it is likely the incinerator ash was disposed of offsite and it is unlikely that LLROs were disposed of in the incinerator. This conclusion is based on the fact that the quantity of ash created by an incinerator the size of Building 345 and operated for 9 years would have been significant; however, no evidence of significant ash disposal has been found on TI. In addition, if LLROs were disposed of in the incinerator, then the ash would contain radioactivity, and it is reasonable to expect that incidental ash containing radioactive contamination from incinerator operations would have been spilled in the immediate area of the incinerator. That ash would be visible in excavations, would result in an increase in area radiation levels, and LLROs found in the area would show evidence of being charred or burned. However, the opposite was found, supporting the conclusion that radioactive material was unlikely to have been disposed of in the incinerator. Ash has not been found in excavations associated with exploratory trenching conducted in 2003 (with the exception of one notation of burned wood and ash in the excavated spoils from 0 to 2 feet from trench 1229F-1) (Shaw 2004) or during NTCRA trenching conducted in 2007 (Shaw 2012b). In addition, no general increase in background radiation readings was noted in the 2007 NTCRA. Furthermore, the LLROs that were found in the general area of Building 1231 (two LLROs found at a depth of 6 inches to 1 foot below ground surface) showed no evidence of charring, as can be seen in [Photo 27](#) from the post-construction summary report for SWDAs Bayside (formerly named 1207/1209) and North Point (Shaw 2012b).

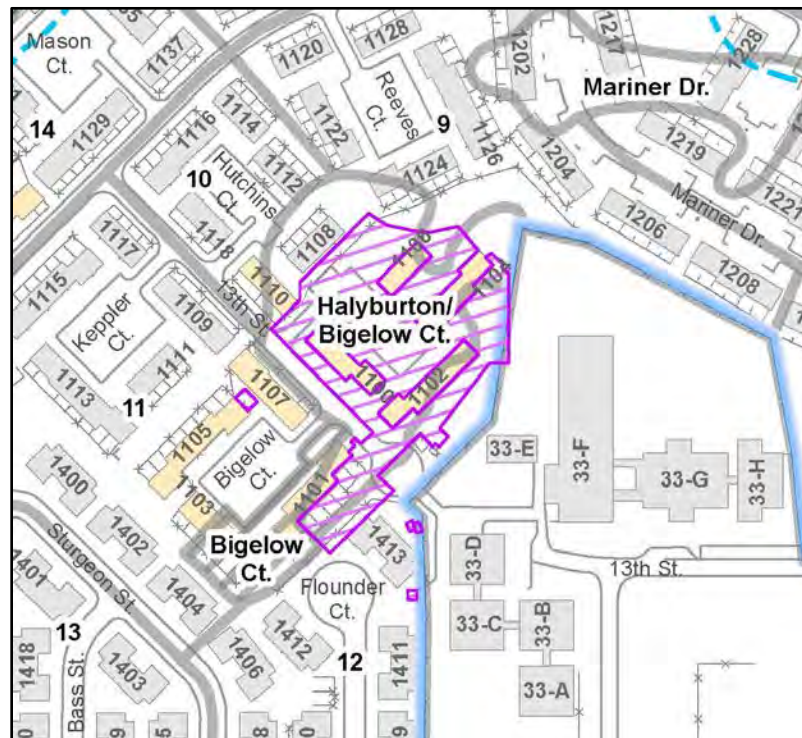
Photo 29 Showing excavated areas at Halyburton and SWDA Bigelow Courts

- Based on a 1945 aerial photograph, Site 12 also contains portions of an approximately 175,000-square-foot former storage yard overlapping Halyburton Court and SWDA Bigelow Court (TriEco-Tt 2012) (portions of SWDA Bigelow Court are also found in AOI 8). The identity of specific materials stored at the former storage yard prior to the construction of housing is not known. SWDA Bigelow Court is a debris disposal area planned for a remedial action in 2014. However, the former storage yard differs from the SWDAs because waste was not intentionally disposed of in this area. Results from sampling in 2000 indicated soils in the former storage yard area contained PCBs and polycyclic aromatic hydrocarbons (PAH) at concentrations in excess of the action levels protective of human health. Based on these results, the Navy performed a removal action in the former storage yard area. Excavations were from 2.5 to 4 feet deep in the footprint shown in [Photo 29](#) (purple cross-hatched area). While no screening for radiological material was done, the excavated soil was replaced with clean soil from an off-base source. The excavation was not backfilled completely to the final grade because additional removal is necessary in the area near Building 1100. There will be additional excavation in the SWDA Bigelow Court area, as shown in [Photo 30](#) (green area), because in previous investigations between 1995 and 2003, concentrations of dioxins, lead, and PAHs exceeded their action levels and these chemicals of concern may pose a threat to current and future residents and utility workers. There will be screening for radiological materials during the removal action.

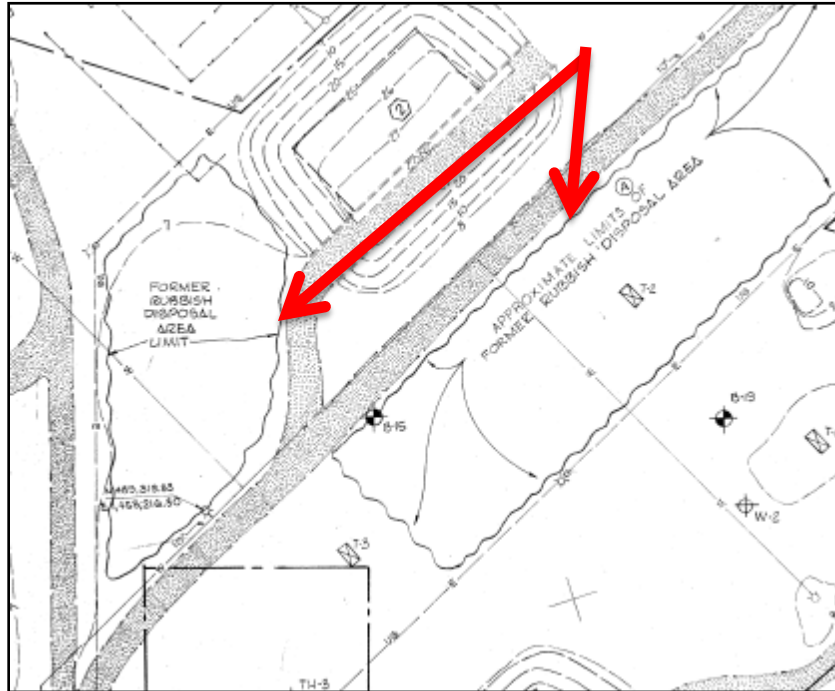
Photo 32 Two rubbish disposal areas
(Note: The lower rubbish disposal area is only partially shown)

Two new non-contiguous “Rubbish Disposal Areas” were identified during research associated with this HRASTM ([Photo 32](#)). Review of historic exploratory trenches exposed loose rubbish buried approximately 4 feet below grade (McCreary, Koretsky Engineers 1965; Navy 1965). The recommendation of the geotechnical report was to remove the rubbish to an elevation of not higher than ± 2 feet, project datum, mix the rubbish with clean sand, and compact the mixture by tamping with heavy equipment. Rubbish disposal areas are considered radiologically impacted based on the correlation between rubbish disposal and LLROs found at other such sites on TI.

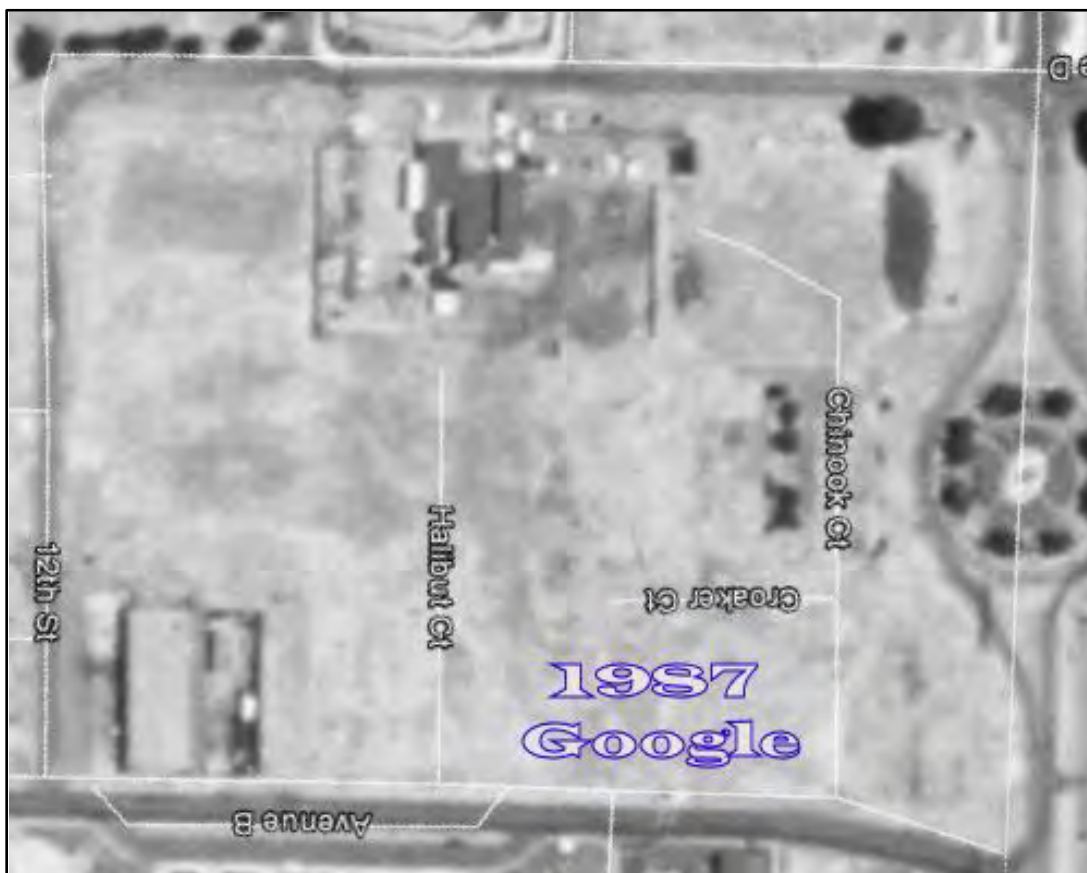
Photo 35 Fenced Compound surrounding Fire Station, Building 157

- The Building 157 area that occupies a rectangular footprint in the south eastern portion of the housing in AOI 8 was built during WWII and is currently fenced. That same fence line can be seen in Photo 35 just prior to the construction of the 1400 series housing. The fact that the fence line was in place prior to the construction of the housing and that it remains in place today makes it unlikely that grading activities associated with the construction of housing would have impacted the fire station.

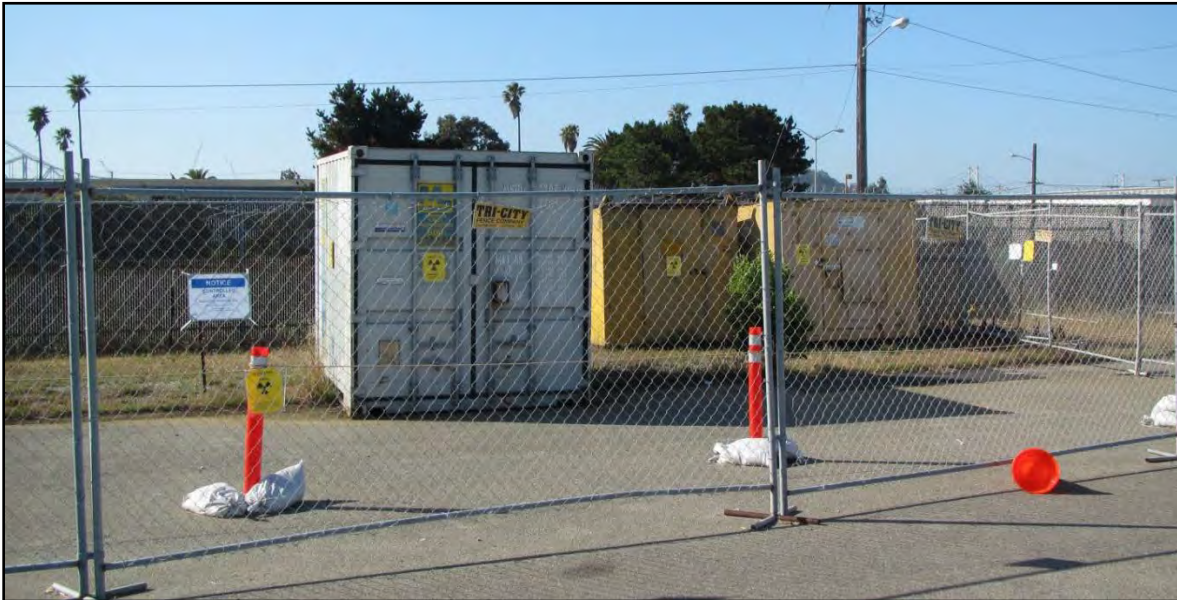
**Photo 36 Conex boxes used for storage of LLROs
in the Building 570 compound**

Building 570 was not identified in the HRA as a radiologically impacted or non-impacted site. Building 570 has been used as an office trailer and laydown area by Navy contractors (Shaw Environmental Inc., Tetra Tech, Environmental Management Services, New World Technology, and Gilbane) in association with remedial activities on NAVSTA TI, including those at Site 12. Building 570 and the surrounding storage yard is now designated as radiologically impacted as discussed in [Sections 2.2.5 and 5.2.3](#) because removal actions in the Site 12 S WDAs that occurred after the HRA involved LLROs and radiologically contaminated soil. Soil samples were stored and counted in the Building 570 area and LLROs were stored in conex boxes in the smaller fenced yard of Building 570 ([Photo 36](#)).

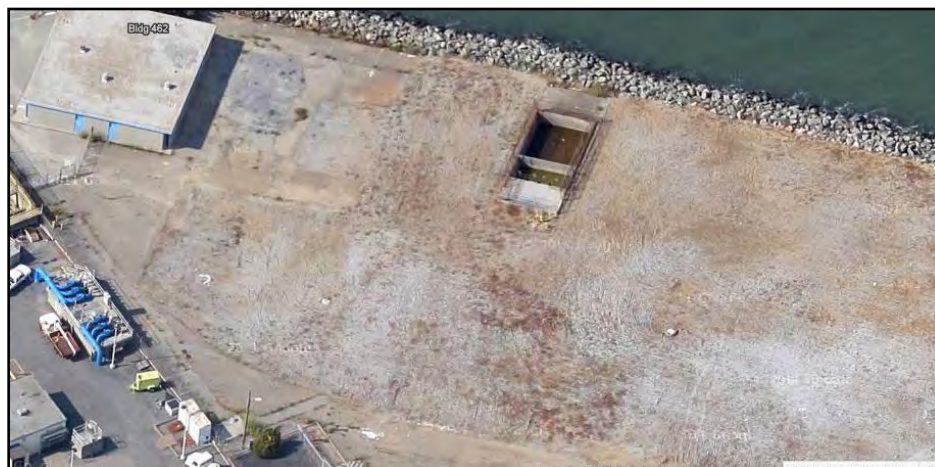
Photo 38 USS *Pandemonium* Site II holding tanks after interim removal action in 2011

The former USS *Pandemonium* (NE) holding tanks and discharge piping are all that remains of the former ship mock-up and associated infrastructure ([Photo 38](#)). This site is currently being characterized with a scoping survey consisting of a gamma walkover survey and solid samples from the holding tanks. The preliminary results of the Site 32 asphalt areas and holding tanks found no surface radiological contamination pending the results of holding tank wall samples (concrete) that were collected in areas of elevated alpha counts (report in preparation).

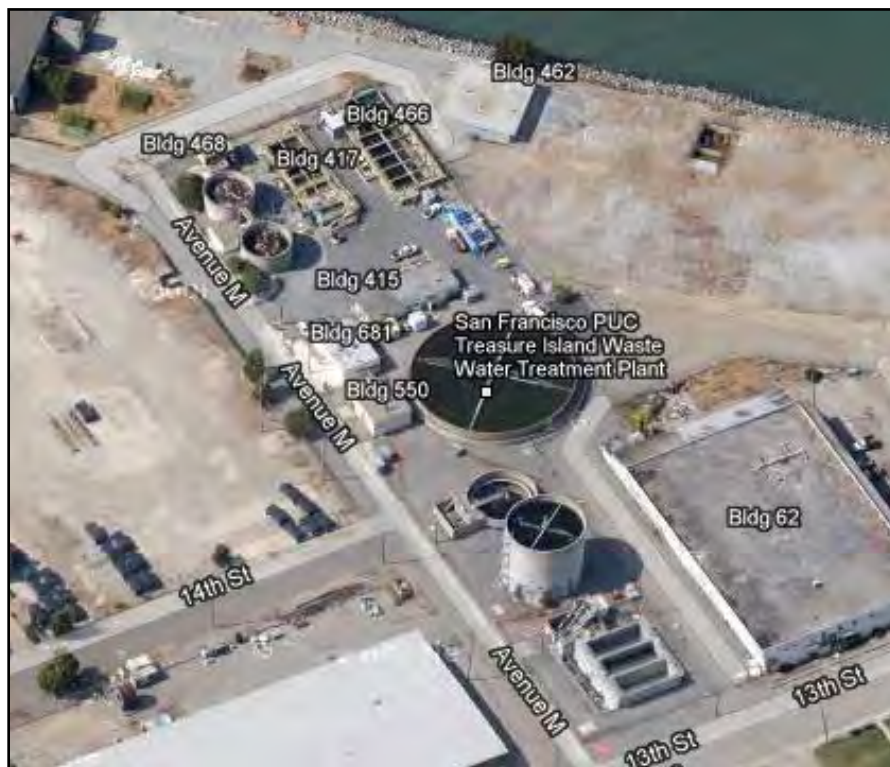
Photo 39 Current photo of TI waste water treatment plant

The Former Salvage Yard was not identified in the HRA as a radiologically impacted or non-impacted site. No radiological related or other IRP work has been conducted at the Former Salvage Yard site (Figure 8) since the HRA. The site is considered radiologically impacted based on the historical propensity for former salvage yards that handled industrial debris to be radiologically contaminated. The former WWII era salvage yard is in the footprint of the current wastewater treatment plant, as shown in Photo 39 and overlaps the open area directly north of the plant (Site 6).

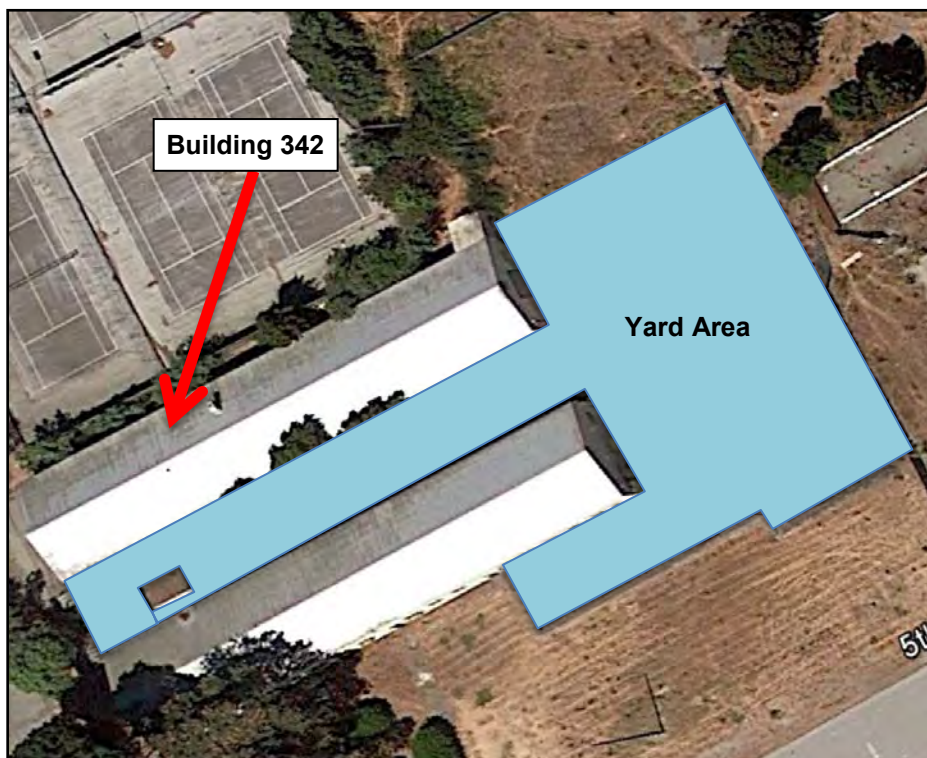
Photo 41 Building 342 and associated yard area

Building 342 was identified in the HRA as a non-impacted site. It is a metal, one-story building built on a concrete foundation, completed in 1951. As originally configured, this building of approximately 8,000 square feet contained three laboratories of equal size. The building was used for instrument calibration and instruction. Laboratories were used to conduct training exercises and calibrate instruments with sources in fixed locations. The radiation beams from the sealed sources were controlled in specific directions. As stated in the HRA, periodic leak tests of all sealed sources were required by operational procedures. The use of the building was gradually reduced, and the last use of radioactive sources was in 1972. No leakage was reported; however, this HRASTM recommends the building and the fenced yard area outside of the building be considered impacted based on the possibility that prior use may have resulted in contamination ([Photo 41](#)). No intrusive work has been done at the site of Building 342 since the HRA, but radiological surveys are planned for 2014/2015.

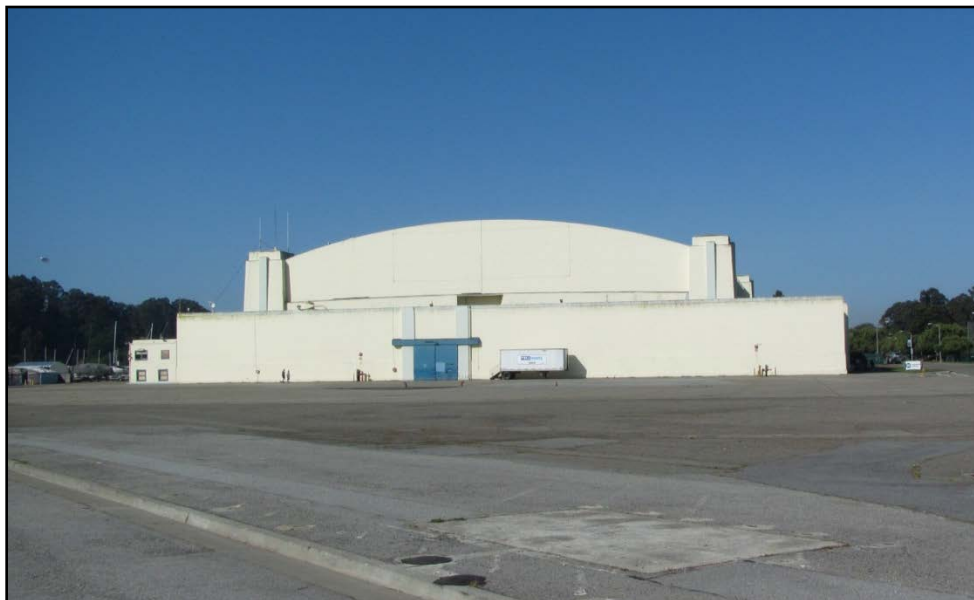
Photo 44 Northeast side of Building 3

Site Description – Building 3 is one of the original buildings constructed on TI for the 1939 GGIE. It is a large general warehouse building with both arched and flat roofs. The building covers approximately 145,000 square feet. This building was designated as non-impacted in the HRA. An optical repair shop was located on the roof of the northern corner of the building. The CSM that applies to this building is discussed in [Section 5.2.1](#). The boundaries for the impacted site have been established to be contiguous with the perimeter of the building based on the fact that if contamination exists, it would most likely have been deposited during shop activities within the building. The sanitary sewer leading from the former optical repair shop has also been radiologically impacted to account for the potential that non-regulated radiological substances could have been disposed of in the drains.

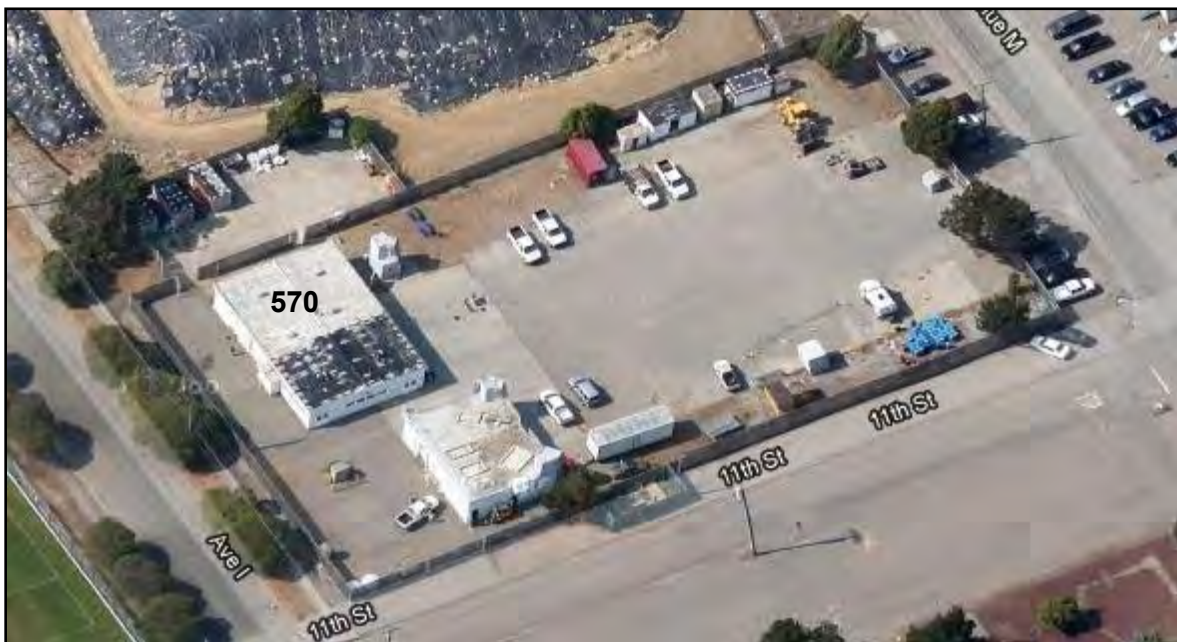
Photo 46 Building 570 area and location

Site Description – Building 570 was constructed in 1988. It is a single story slab-on-grade metal building. The building covers approximately 3,000 square feet. This area was not identified as radiologically impacted in the HRA, but is now identified as radiologically impacted to account for the potential that it has been operationally impacted in association with other remedial activities. The CSM that applies to this site is discussed in [Section 5.2.3](#). The boundaries of the site are based on the existing fenced perimeter shown in [Photo 46](#).

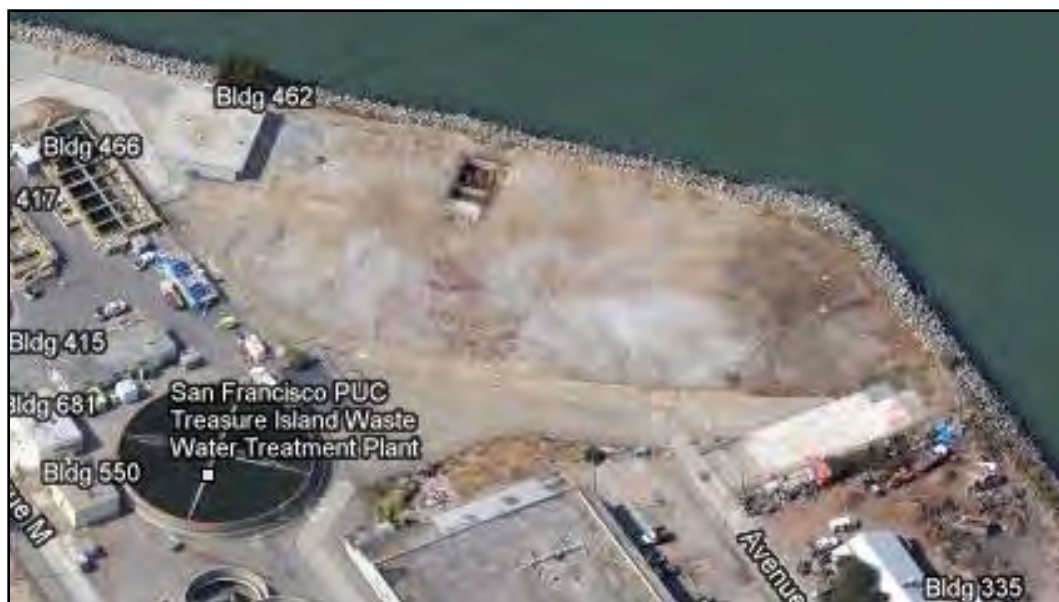
Photo 47 *USS Pandemonium Site II (NE)*

Site Description – The *USS Pandemonium* training ship was moved to the northeast corner of NAVSTA TI in 1969, where it remained until it was demolished in 1996. The training ship was part of the new Damage Control School complex that included Buildings 461, 462, and 463. Access to the area was by the tear-gas decontamination building (462). An 8-foot-high fence separated the training area from the rest of the island. The CSM for this site is discussed in [Section 5.2.2](#). Use of the mock-up ship ended in 1992, though the mock-up remained until 1996. The training ship was used to simulate radioactive fallout using short-lived isotopes, as discussed in [Section 2.2.6](#), and Cs-137 sources for fixed locations. (A short-lived isotope is one with such a short half-life that it decays to a negligible quantity in a matter of hours or perhaps days.) Two below-grade concrete holding tanks collected the wash-down water when short-lived isotopes were decontaminated in the *USS Pandemonium*. The wash-down water was released to the bay through a 6-inch pipe after sufficient time transpired for the isotopes to have decayed away. Ra-226-containing gauges were used as check sources during training, as discussed in [Section 2.2.6](#). The *USS Pandemonium* Site II (NE) was designated as non-impacted in the HRA. As discussed in [Section 2.2.6](#), this site was part of a removal action completed in 2009 at Site 32. The removal was done to address contaminants of concern that included PCB, dioxins, pesticides, total petroleum hydrocarbons, and metals. The boundaries for this site include the interior of Building 461 and are otherwise contiguous with Site 32, except on the southeastern end where the boundary is established by the presence of a former building. The area west and north is also impacted, as discussed below, and the area to the east is the San Francisco Bay.

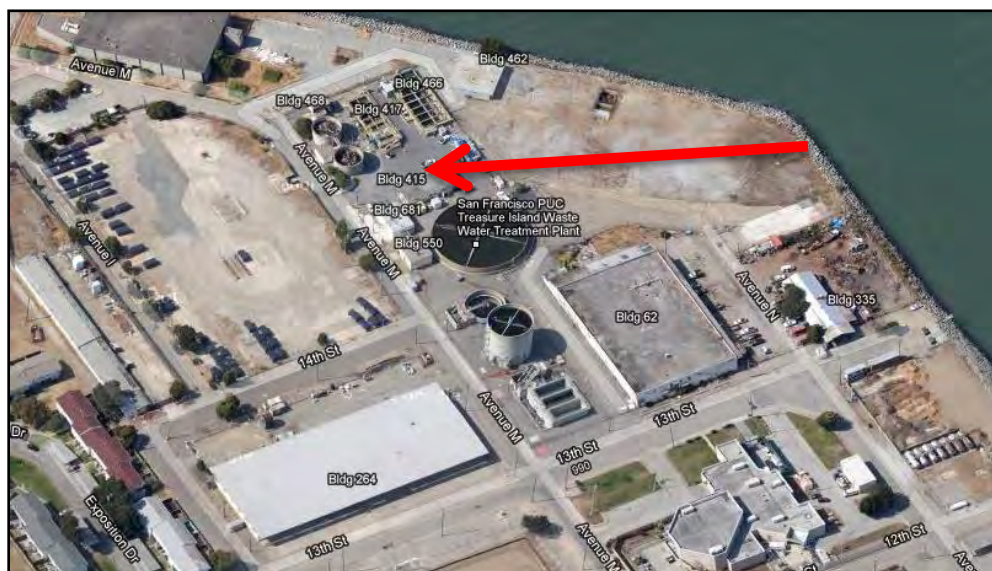
Photo 49 Location of Former Salvage Yard

Site Description – As noted in [Section 2.2](#), ship repair was ongoing throughout WWII. Those activities generated significant amounts of scrap metal, which was potentially processed in the open area and south of Building 327 that was identified as a Salvage Building in the HRA. The CSM for this salvage yard is discussed in [Section 5.2.1](#). Building 327 was demolished in the 1960s, and the radiologically impacted area is now beneath the footprint of the sewage treatment plant that was constructed in 1984. This area was not identified as radiologically impacted in the HRA. The boundaries for the area have been established to be contiguous with the outline of the sewage treatment plant, which overlays the former Building 327 area. The southern portion of the sewage

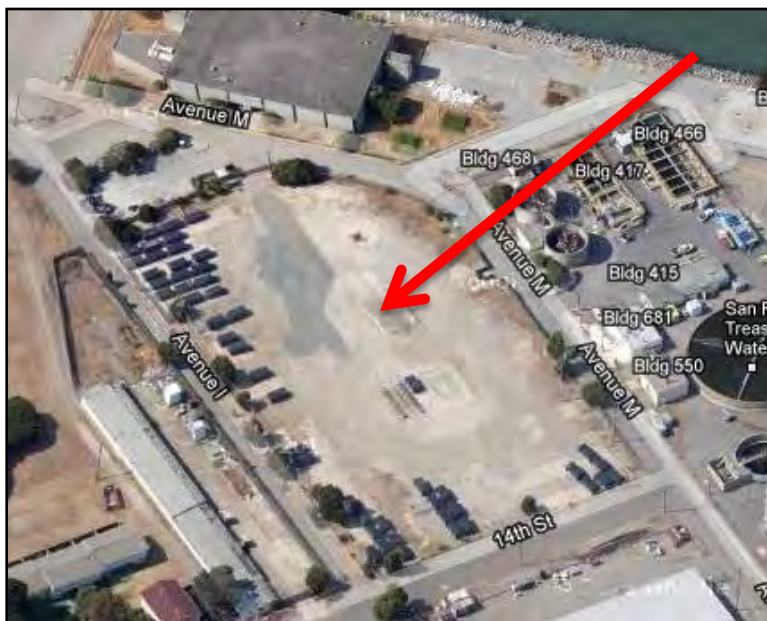
Photo 50 Waste and Clean Soil Stockpile/Loading and Decontamination Site

Site Description – The Waste and Clean Soil Stockpile/Loading and Decontamination Site is an open area in AOI 6 (Figure 8) and shown in Photo 50. This area was not identified as radiologically impacted in the HRA. The CSM for the area is discussed in Section 5.2.3, and the boundaries of the impacted area have been established to include the open areas between Site 12 and the sewage treatment plant, except for the fenced area between Site 6 and 12 to the south. This entire area is deemed as potentially operationally impacted in association with remedial activities.

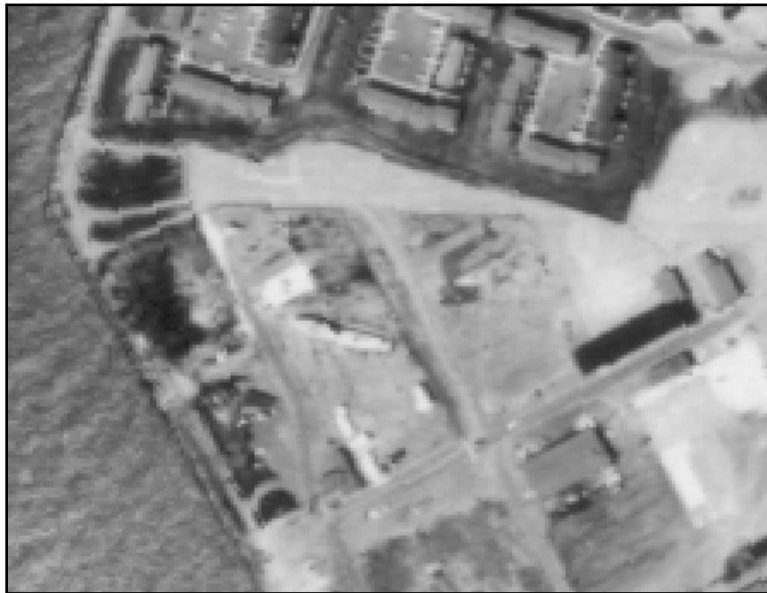
Photo 51 USS Pandemonium Site I (NW)

Site Description – This radiologically impacted site is wholly contained within Site 12, which has been separately impacted as discussed above; however, it also warrants and is further discussed in this section. The USS *Pandemonium* training ship was constructed in 1956. The CSM for this area is discussed in [Section 5.2.2](#). The training ship was commissioned for use in February 1957 and remained in service in the northwest corner until July 1969. The fenced-off, gravel-surfaced training area was approximately 400 by 600 feet. The area enclosed eight buildings, two old aircraft, the USS *Pandemonium*

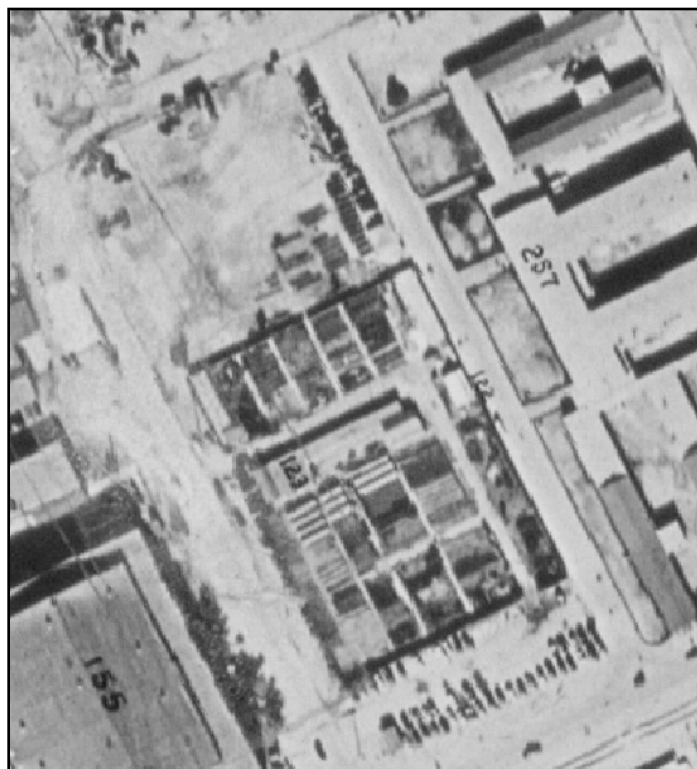
Photo 53 Storage yard area circa 1945

Site Description – The Former Storage Area that includes Sites 30 and 31 is a former open area in AOI 10 ([Figure 10](#)) and shown in [Photo 53](#). The area is composed of two former storage areas north and south of Sites 30 and 31 and the IRP sites that are discussed further below. This area was not identified as radiologically impacted in the HRA. The CSM that applies to this area is discussed in [Section 5.2.1](#). The boundaries for the area are based on the historical extent of storage area according to a review of aerial photographs.

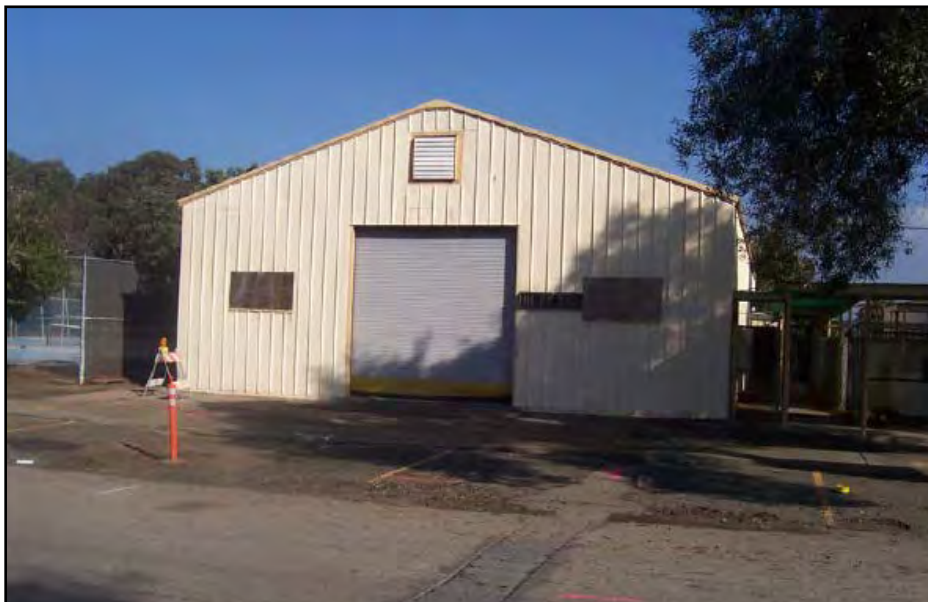
Photo 55 Building 342 area

Site Description – Building 342 was constructed in 1951. It is a single story, slab-on-grade approximately 8,000-square-foot metal building and a fenced yard area alongside of and to the rear (east) of the building ([Photo 55](#)). This area was not identified as radiologically impacted in the HRA. The 1972 license description states that “Building 342 houses two labs belonging to RADIAC Maintenance School and one lab

Recommended Actions – Do a scoping and an FSS of the structure, and a scoping survey of the sanitary sewer line that services the building out to the nearest sump.

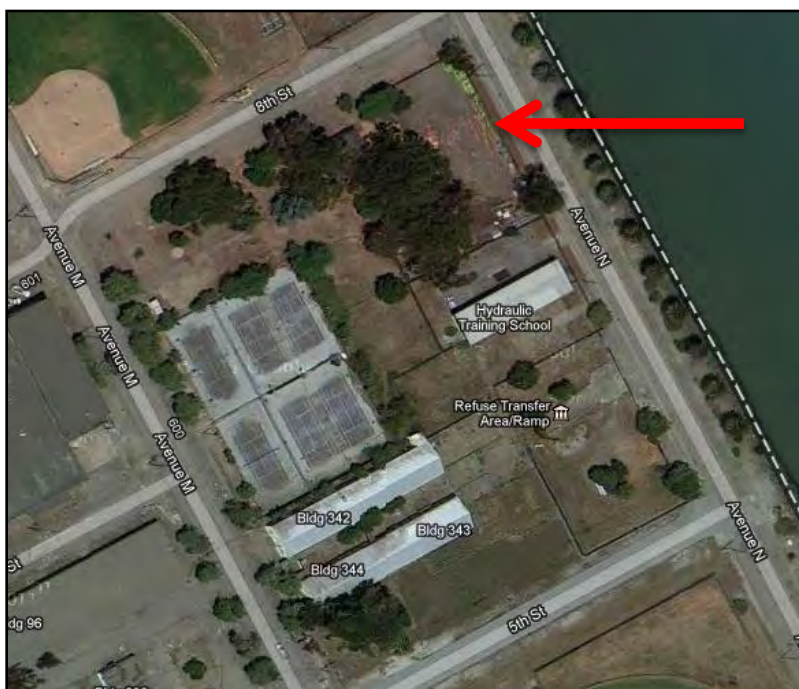
Photo 56 Location of Former Salvage Yard (Lot 69)

Site Description – As noted in [Section 2.2](#), sometime between 1962 and 1968, a Supply Department Salvage Yard was established east of the tennis courts (see above [Photo 56](#) and [Figure 6](#)). By 1996, this salvage yard area was referred to as Lot 69 and was listed as a Hazardous Waste Accumulation Area in the Spill Prevention Control and Countermeasures Plan. The northern, larger part of Lot 69 was the nonhazardous storage or staging area for furniture and nonhazardous tools waiting to be disposed of by the DRMO. South of the lot is a transfer station for solid waste. A general inventory of waste stored in the hazardous waste accumulation area consisted of waste oils, flammables, corrosives, and other regulated materials such as rags, latex paints, and empty paint and flammable containers. this HRASTM identifies this salvage yard (Lot 69) as impacted because salvage yards are often linked with the potential for disposal of unregulated LLROs; this conclusion is reached because this area was used as a salvage yard and based on the lack of any other radiological information associated with this site. The CSM for this yard is discussed in [Section 5.2.1](#). The boundaries of the site are based on the existing fence line.

Recommended Actions – Perform a scoping survey of the ground surface in the salvage yard area.
