Historical Radiological Assessment – Supplemental Technical Memorandum

**Naval Station Treasure Island
San Francisco, California**

July 1, 2014

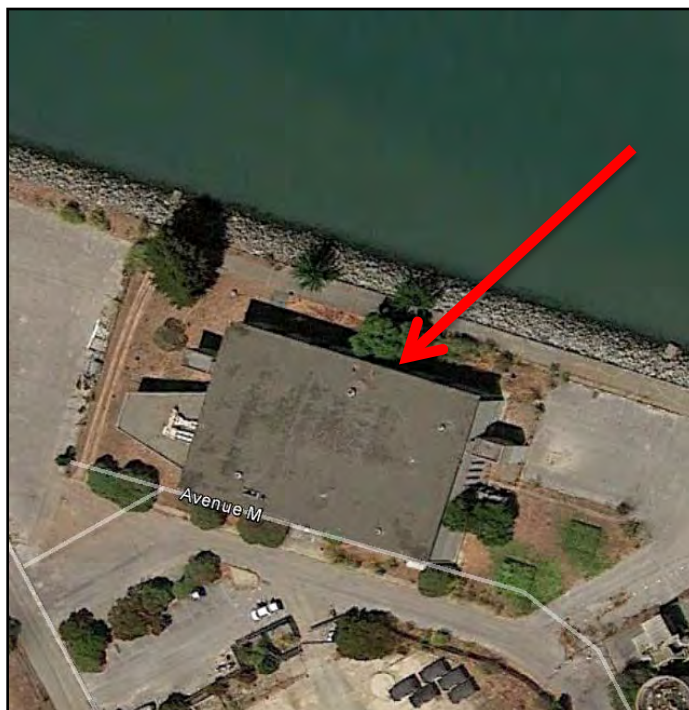
Photo 57 Location of Building 461

Site Description – Building 461 and the area around it was identified in the HRA as a non-impacted site. Building 461 was constructed in 1970 and is part of the Damage Control School complex that included Buildings 462 and 463 and the training ship mockup, USS *Pandemonium*, after it was moved from the northwest corner of NAVSTA TI. The building was used for Damage Control School classrooms, office space, fire training, and storage of RADIAC instruments with attached check sources that were maintained in the building for use during decontamination exercises on the USS *Pandemonium* (Weston Solutions, Inc. 2006). There were no reports of leaking check sources. However, this HRASTM recommends the building and associated area be considered impacted based on the possibility that unlicensed Ra-226 check sources may have been used or stored on site. No intrusive work has been done at the site of Building 461 since the HRA. The CSM for this site is discussed in [Section 5.2.2](#), and the boundaries for site consist of exterior walls for Building 461.

Recommended Actions – Perform an FSS of Building 461 and the surrounding ground surface.

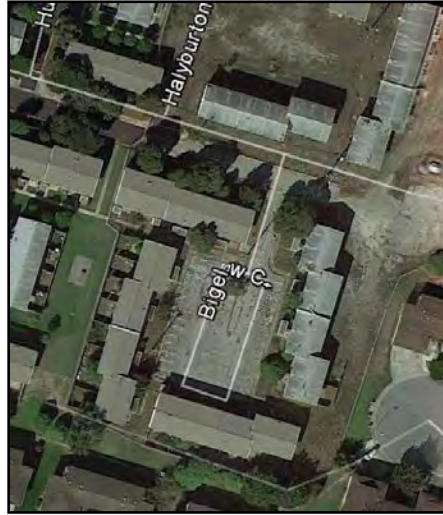
Photo 59 SWDA Bigelow Court Area

Site Description – SWDA Bigelow Court was identified in the HRA as a non-impacted site. The site is a former storage yard that overlapped both the Halyburton Court and SWDA Bigelow Court area; see [Section 4.1.2.10.2](#). Halyburton Court was the subject of a previous removal action for non-radiological contaminants of concern, and the SWDA Bigelow Court area is the site of a planned future removal action to address concentrations of dioxins, lead, and PAHs that exceed action levels. Because the SWDA Bigelow Court area has been designated as a debris disposal area, it is identified as radiologically impacted in this HRA. The CSM for this site is the same as the surrounding housing area and is discussed in [Section 5.2.1](#). Buildings 1101 and 1103 have been demolished and the Navy has begun excavating areas planned for removal based on non-radiological contamination. The boundaries of the SWDA Bigelow Court Area are based on the prior excavations for chemical contamination conducted in this area.

Recommended Actions – Do radiological monitoring of future removal action and a FSS of the ground surface of the excavation.

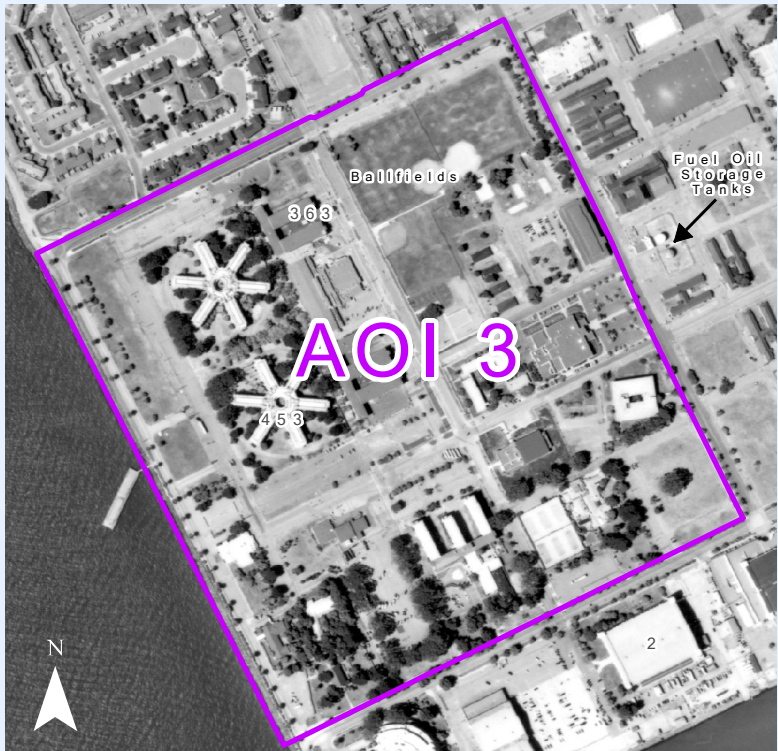
Island Core Area of Interest
15 August 2000 (not to scale)

NOTES:
Area of Interest 3 has no radiologically impacted areas:
1) No evidence of radiological work has been found in this area;
2) Buildings in the area primarily served as barracks and support facilities and there is no evidence of industrial activities in this area;
3) There is no evidence of industrial lay down areas having been present in this area from review of available documents.

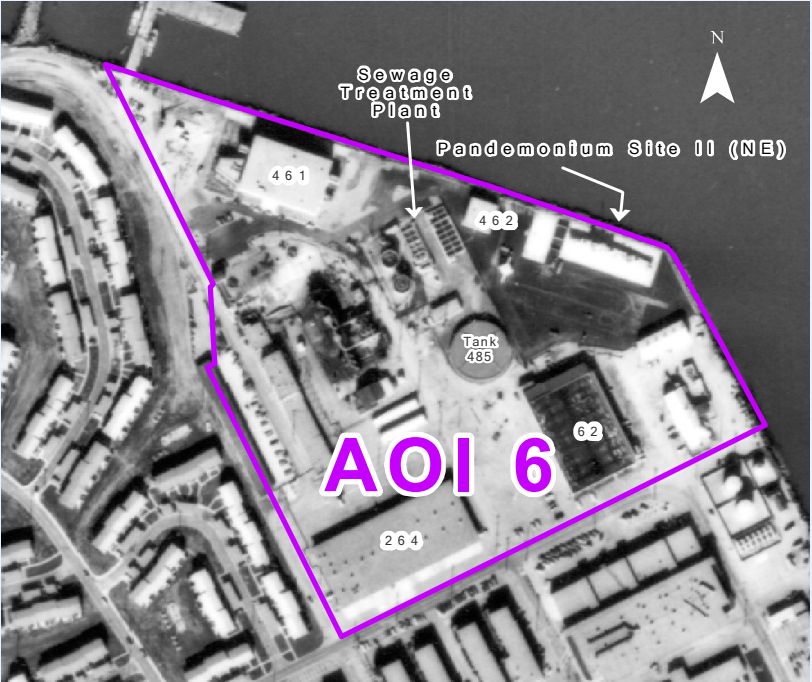
Sewage Treatment Area of Interest
30 December 1969 (not to scale)

NOTES:
-There is evidence of lay down areas being utilized during the war in the area that is now the sewage treatment plant, suggesting this activity was associated with the Supply Department or a salvage yard. The waste treatment facility was constructed in the early 1960s.
-In 1970, the Navy's damage control school, which included radioactive decontamination training, was relocated to the northern portion of the site. Facilities included Buildings 461 and 462 and the USS Pandemonium Site II (NE), a full scale mockup training ship. The relocation was completed in September 1970. The use of these facilities ended by 20 February 1994.
