From: Adams, Thomas C. <Thomas.Adams@pseg.com>
Sent: Tuesday, January 03, 2017 1:20 PM
To: EndangeredSpecies Resource
Subject: [External_Sender] PSEG Nuclear Atlantic Sturgeon Report 12/30/16
Attachments: Sturgeon Collection Report 12302016.pdf

Appendix C, Part 2A (Sturgeon)

Site of Collection: PSEG Salem Generating Station, SGS Unit 2; CWI 21B

STURGEON DATA COLLECTION FORM

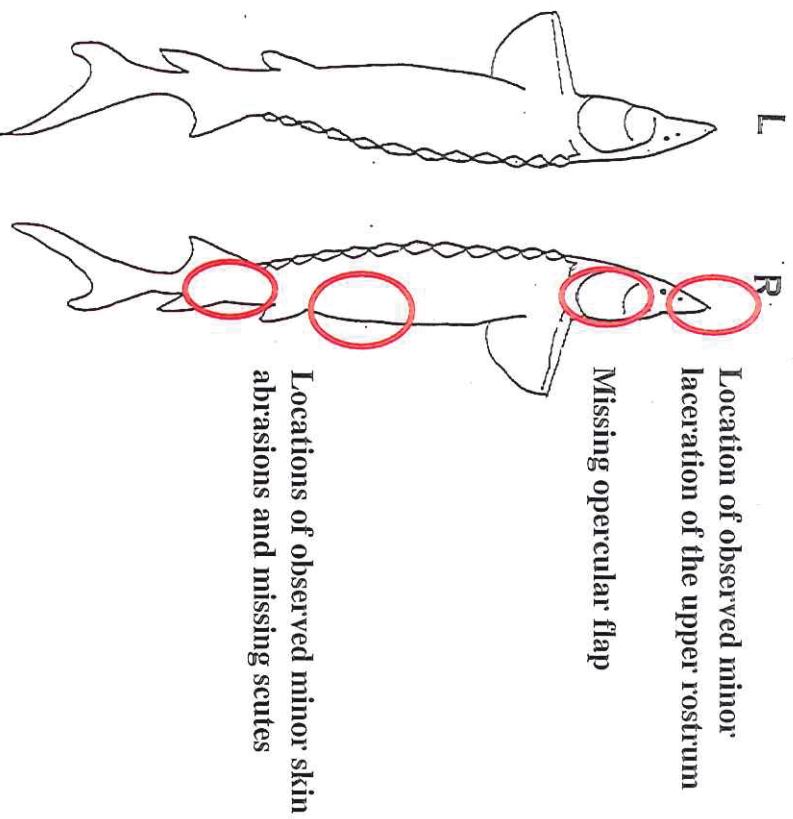
Draw wounds, abnormalities, tag locations on diagram and briefly describe below

Describe any wounds / abnormalities (note tar or oil, gear or debris entanglement, propeller damage, etc.). Please note if no wounds / abnormalities are found. Specimen was alive but revealed evidence of recent damage in the form of minor skin abrasions and missing scutes along its right side, both posterior and anterior to the pelvic fin, as well as a minor laceration to the dorsal region of the rostrum. Additionally, it was observed that the specimen was missing the opercular flap on its right side, leaving the gills exposed. The injury appears to be old, as there was evidence of scar tissue. No evidence of existing tags or prior fin clips were observed. The specimen was returned to the Delaware River immediately after processing.

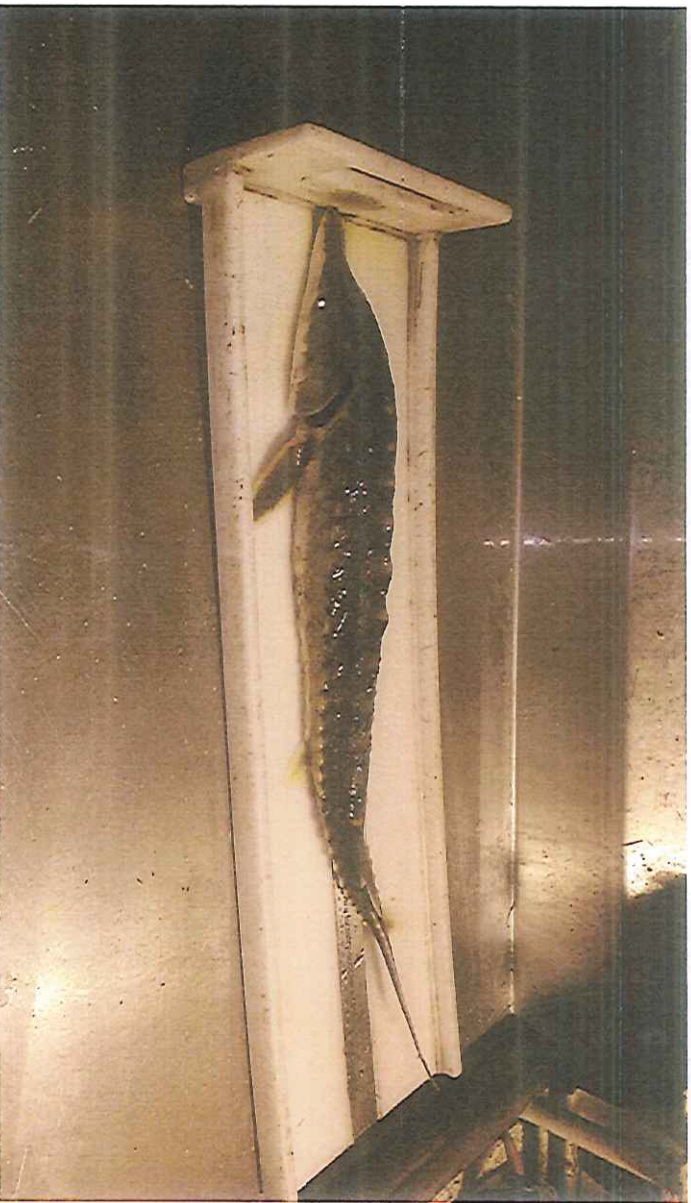
View showing the size of the live, but damaged Atlantic Sturgeon (*Acipenser oxyrinchus*) retrieved at 09:45am on 12/30/16 by Salem Yard Crew personnel during routine trash rack cleaning at the PSEG Salem CWIB. Damage to the specimen, in the form of minor skin abrasions and missing scutes was observed and is clearly shown in the following photograph (12/30/2016).

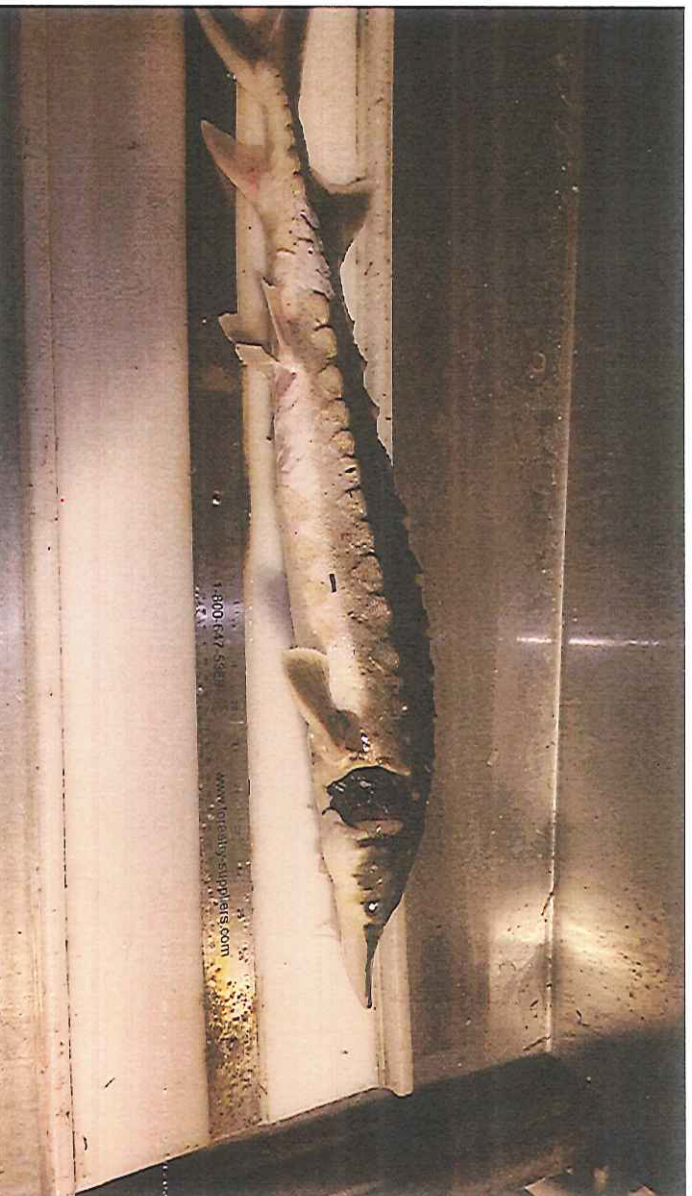
This right lateral view shows the minor skin abrasions and missing scales located below the dorsal fin and both anterior and posterior to the right pelvic fin (12/30/2016).

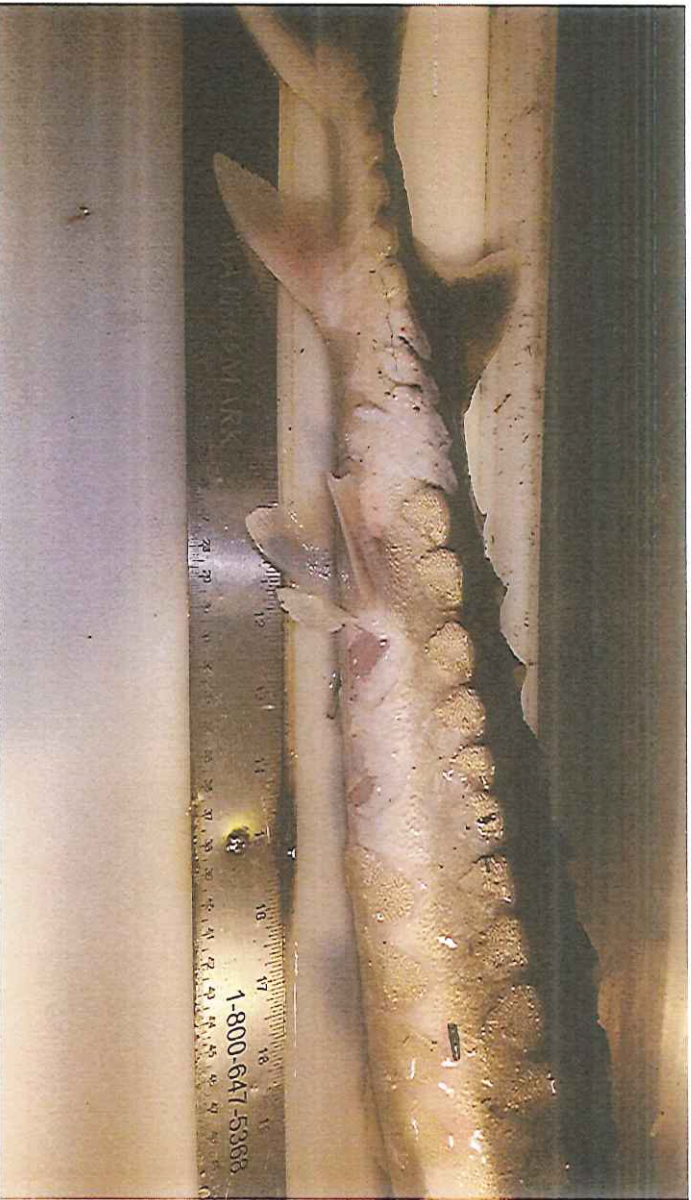
This photo provides a closer view of the damaged area as shown in the previous photo (12/30/2016).

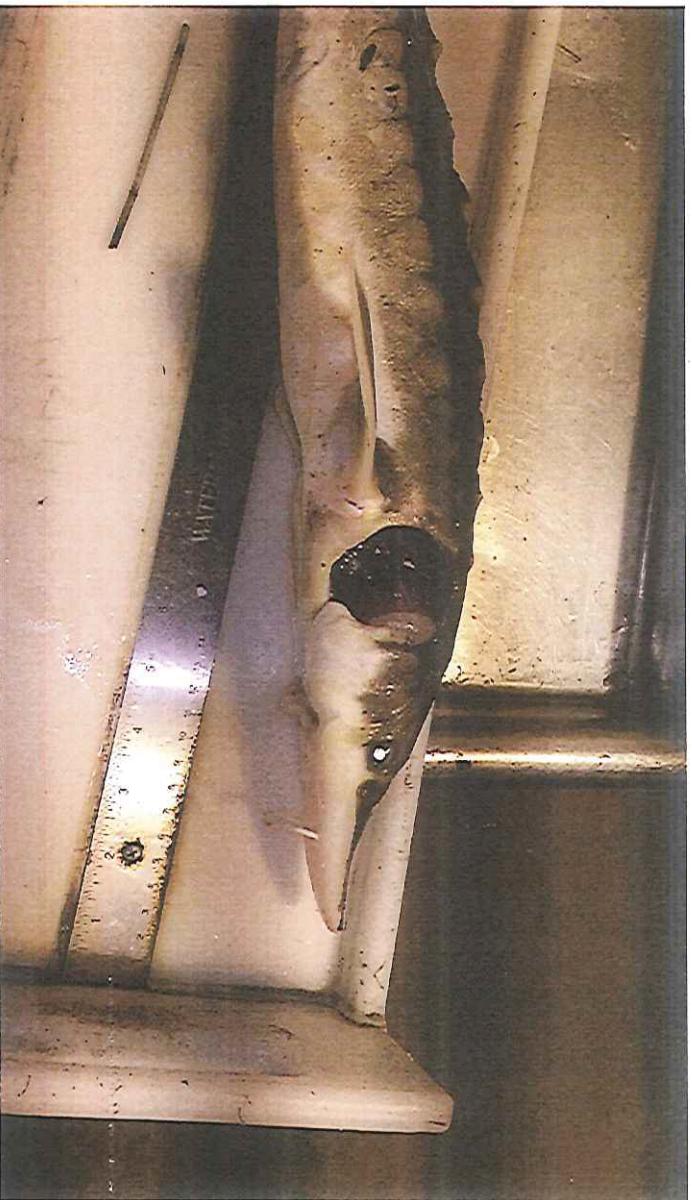
This photo shows evidence of a missing opercular flap on the specimen's right side, which appears to be an older injury that has successfully healed (12/30/2016).

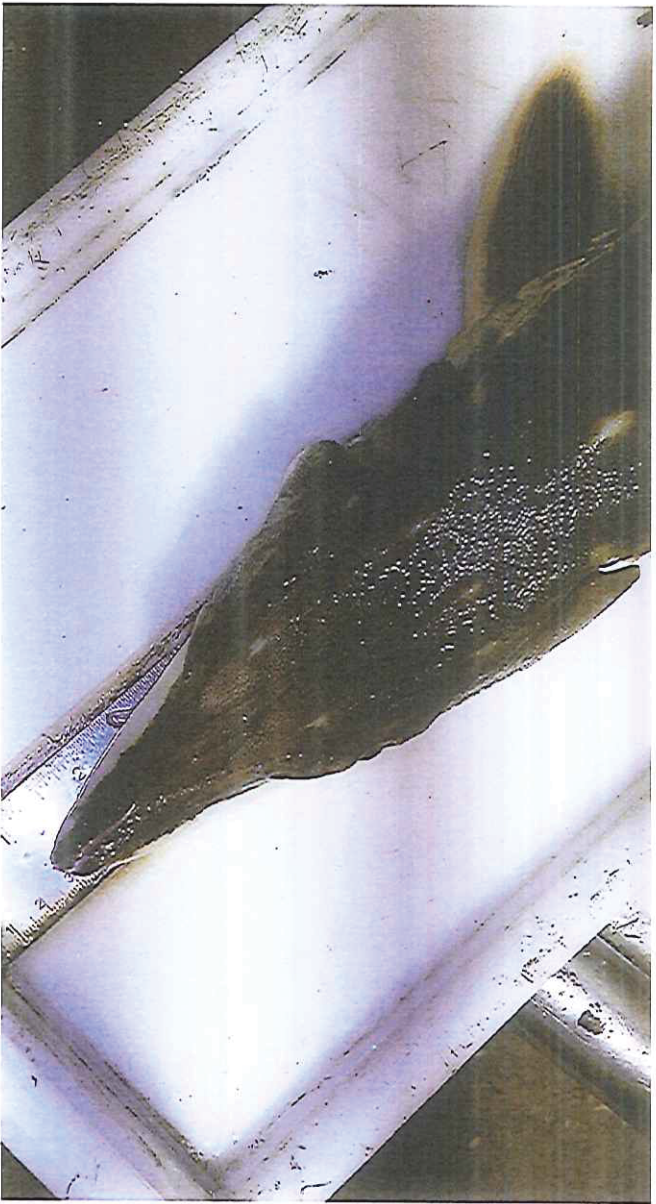
Dorsal view of the specimen showing the location of a minor laceration to the tip of the rostrum (12/30/2016).

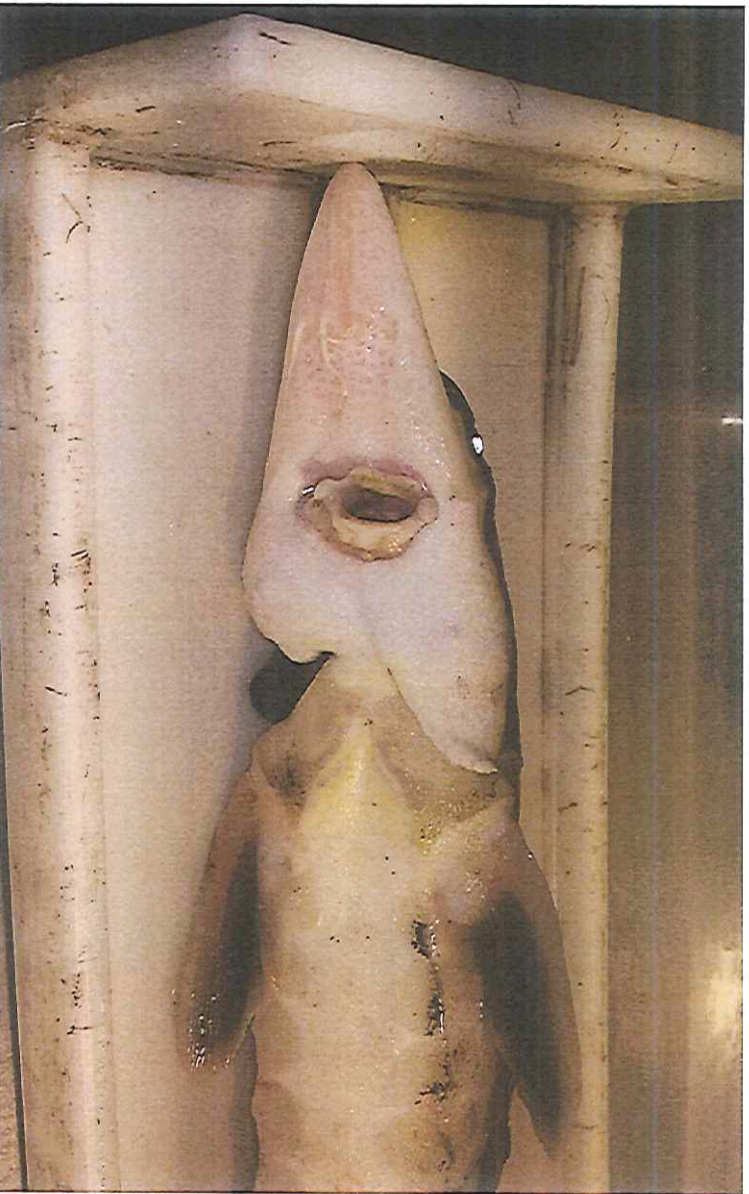
A ventral view of the specimen, showing the small mouth and elongated rostrum, each a characteristic feature of the species. No tags were indicated during processing, so PIT tagging procedures were implemented. Specimen has been identified with Tag #96500000360178. A pelvic fin clip was collected and has been preserved in non-denatured ethanol. The sample has been placed in refrigeration at the ECSI office, waiting further instruction on disposition (12/30/16).
