# Evaluation of Ultrasonic Phased-Array for Detection of Planar Flaws in High-Density Polyethylene Butt-Fusion Joints

NRC-Industry Technical Information Exchange  
(TIE) Public Meeting  
Rockville, MD  
January 17-19, 2017

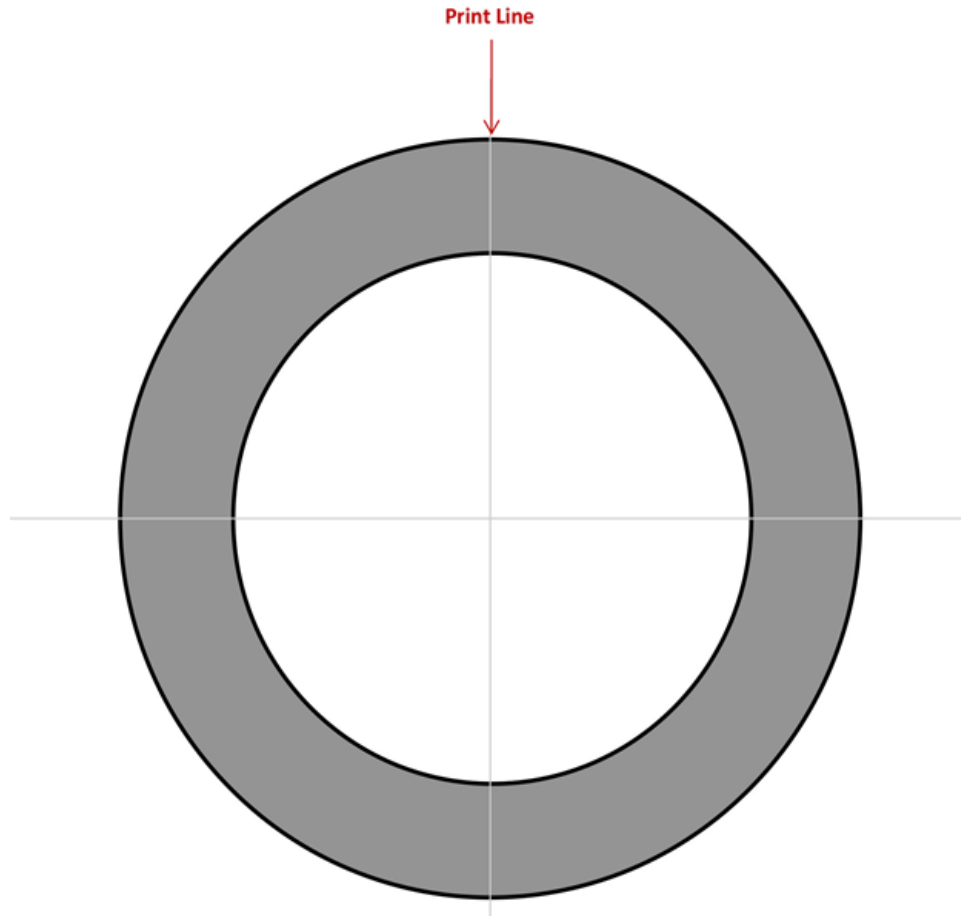
Specimen J-28 (baseline; no implanted flaws)  
Fabrication: TR-33

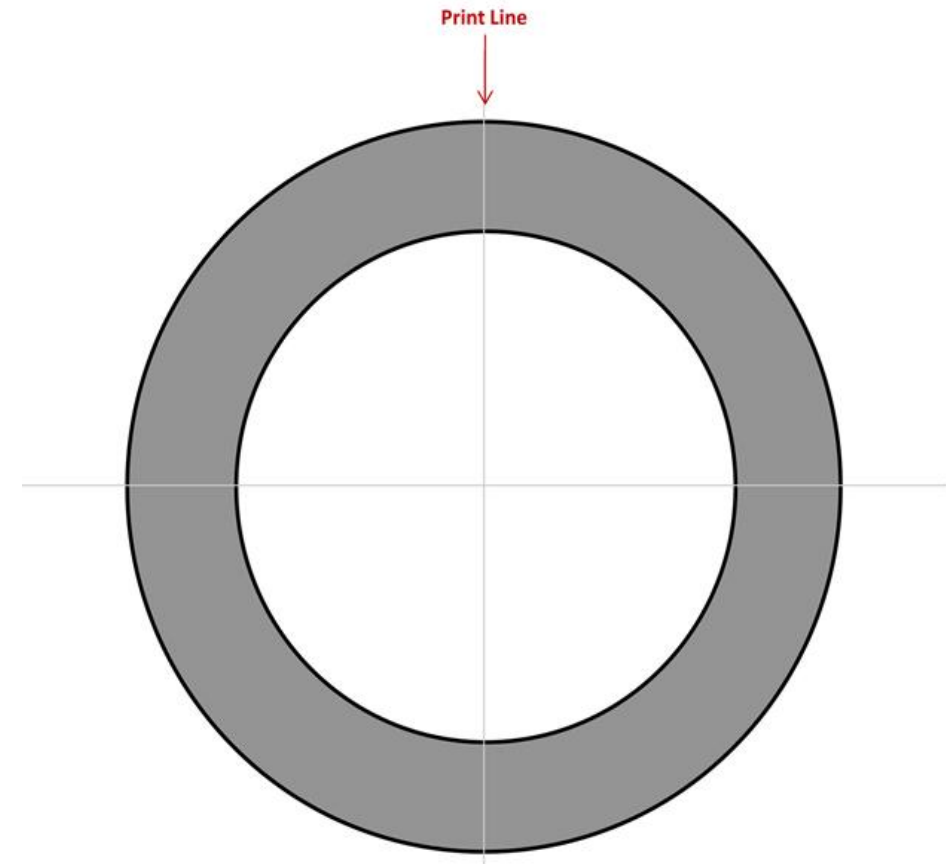
Specimen J-31 (cold fusion attempt; no planar flaws)  
Fabrication: TR-33 **violation** with 75 psi ( $5.2\text{E}+2$  kPa) interfacial pressure during heat soak

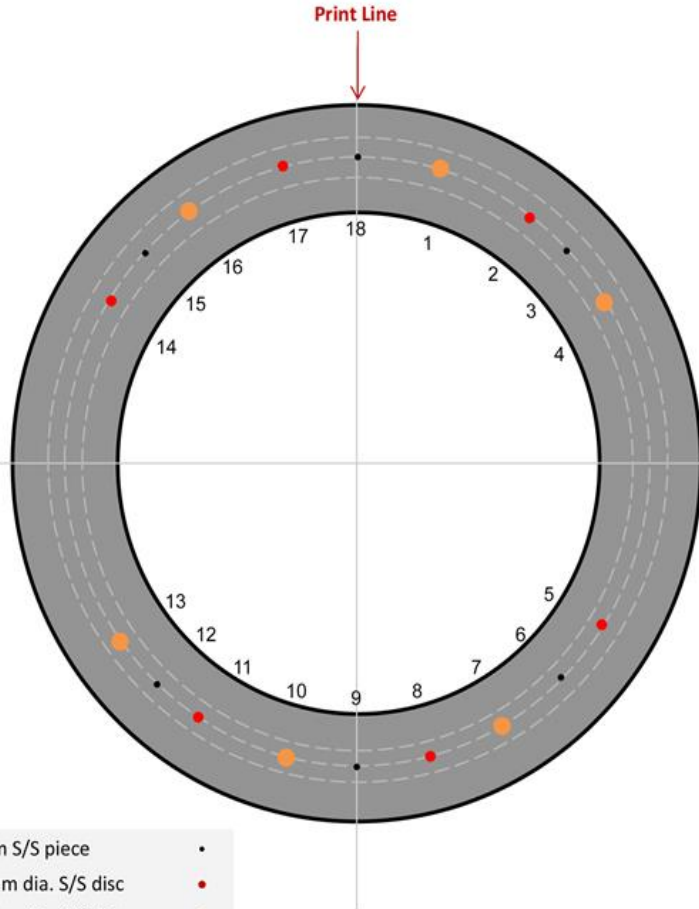
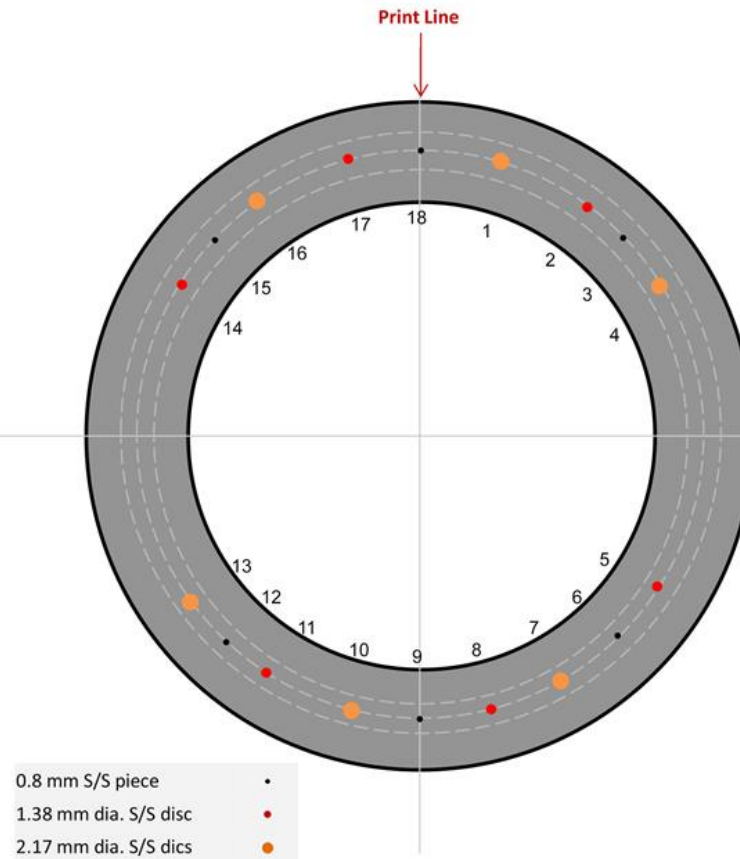
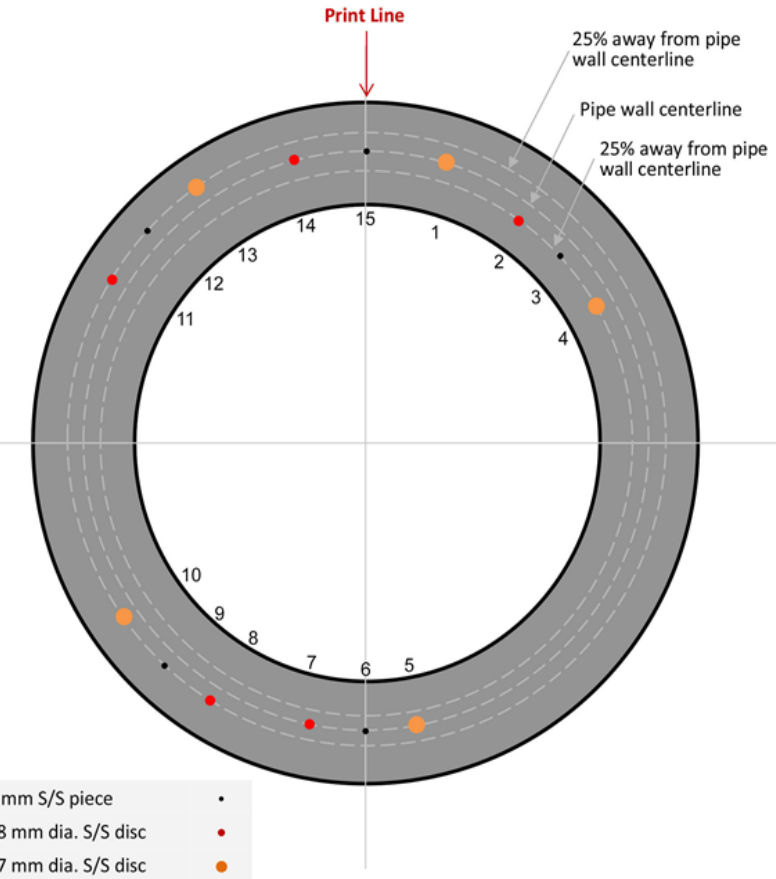
Specimen RJ4/RJ6-2 (planar flaws)  
Fabrication: TR-33

Specimen RJ-8 (cold fusion attempt with planar flaws)  
Fusion Procedure: TR-33 **violation** with 2-minute heat soak

Specimen RJ4/RJ6 (planar flaws)  
Fabrication: TR-33

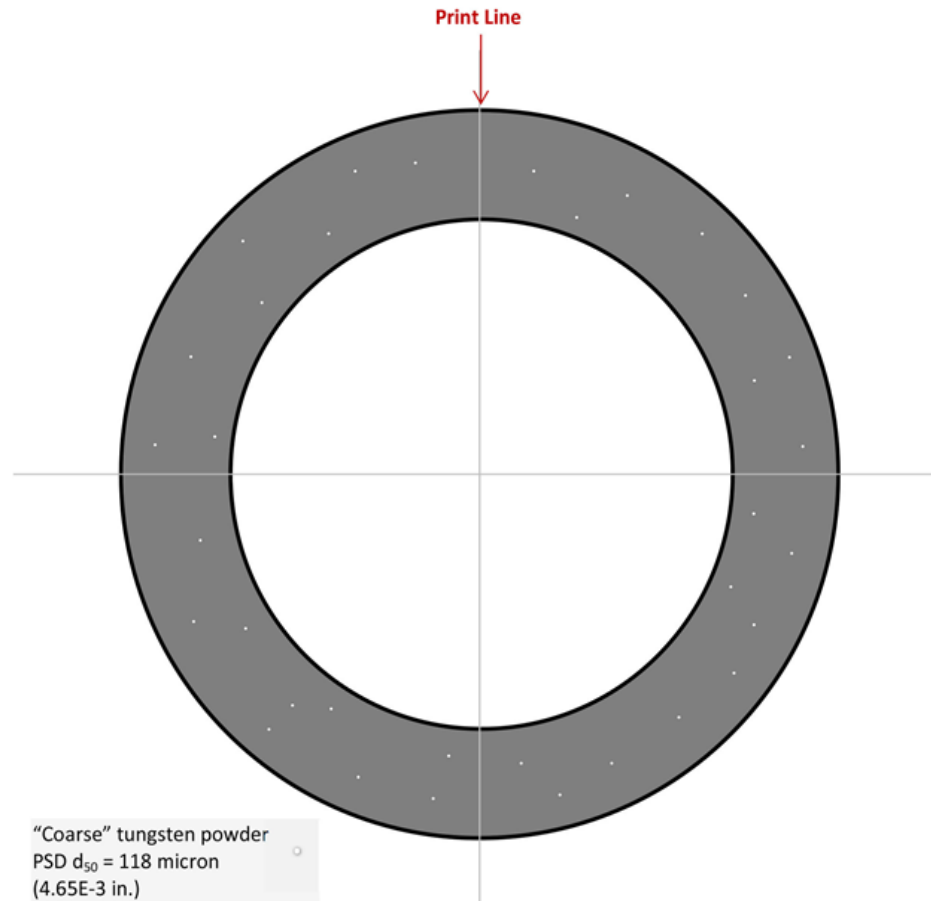
Specimen J-29 ("coarse" particulate contamination)  
Fabrication: TR-33

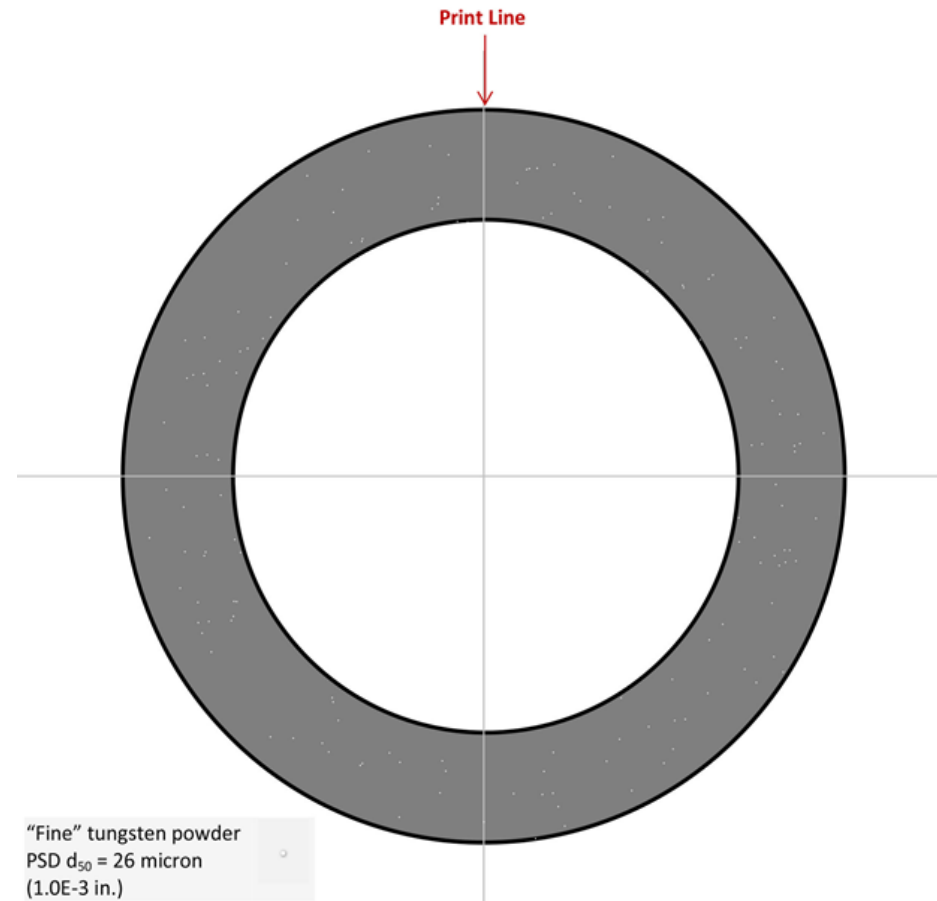
Specimen J-30 ("fine" particulate contamination)  
Fabrication: TR-33

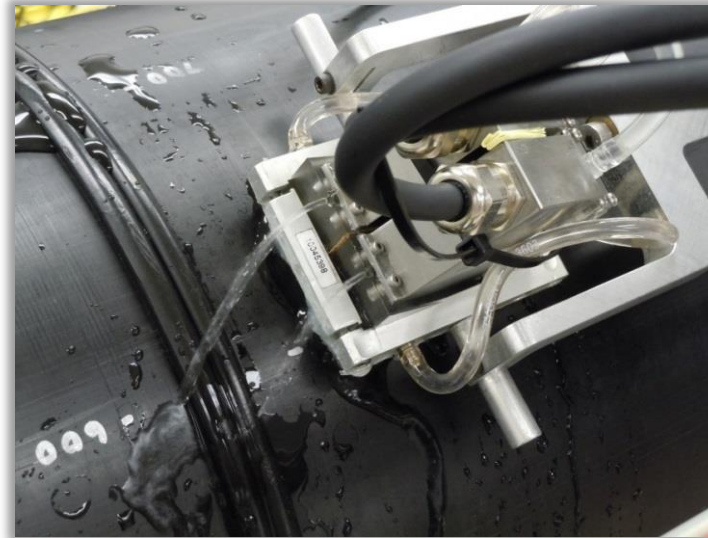
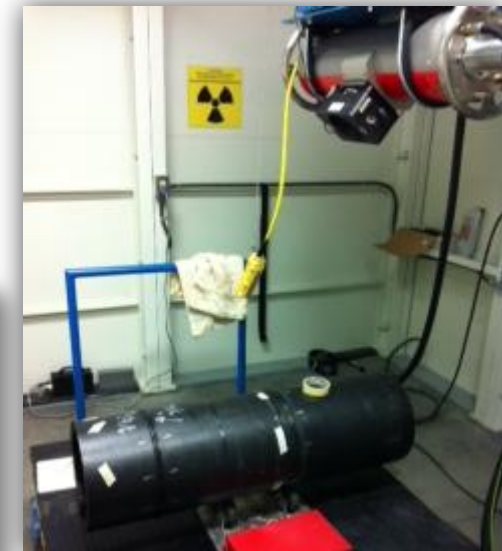
- ▶ True state of post-fabrication planar flaw size, position verified with RT (see supplemental slides)
  - 51 discs implanted before fabrication
  - 38 remained in the weld after fabrication
- ▶ Butt-fusion joints examined by PAUT-TRL
  - Examined with weld beads intact
  - Three different apertures:
    - 128E – represented best possible
    - 64E – represented reasonable mid-point
    - 32E – minimum specified in ASME Code

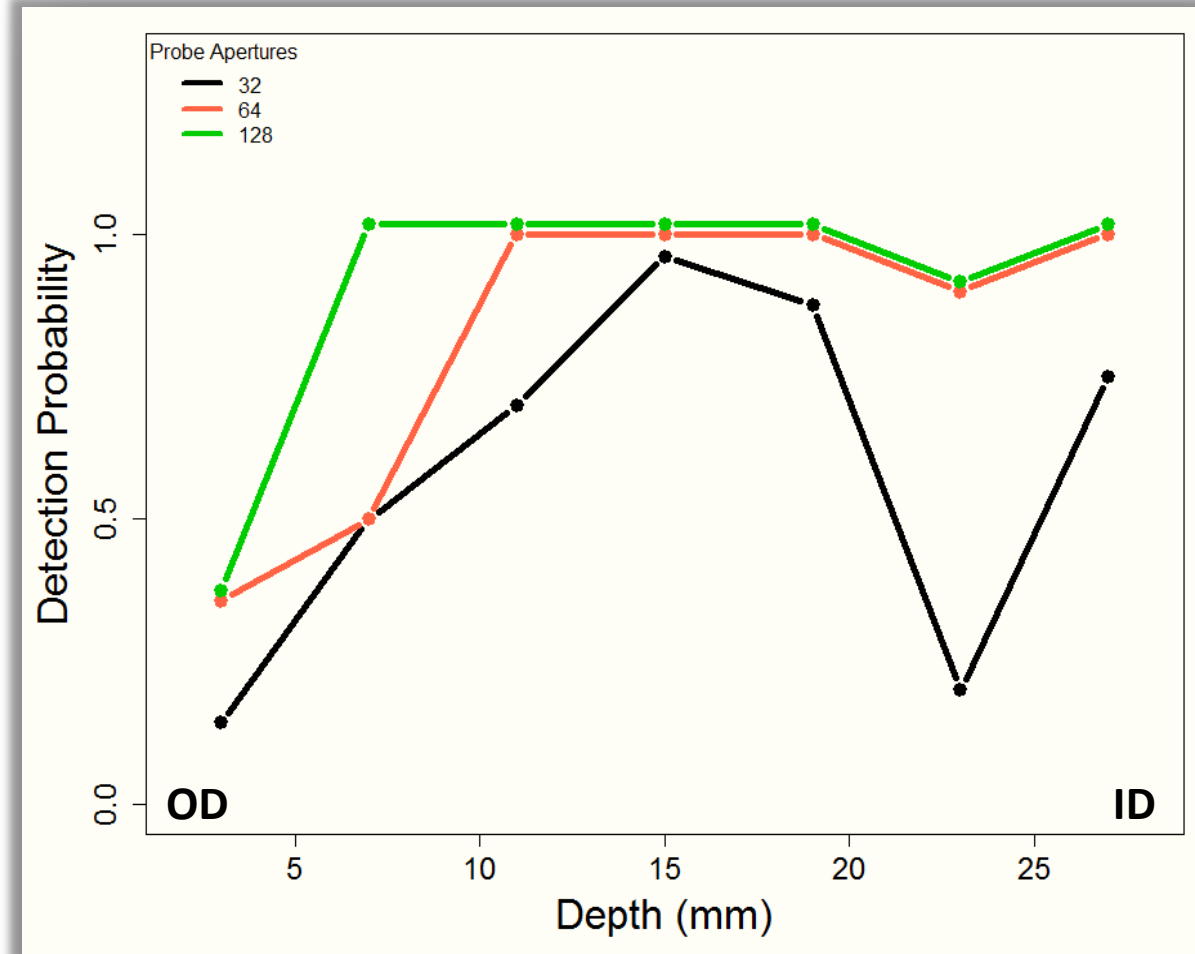
- ▶ Completed evaluation of PAUT-TRL for HDPE weld joints containing planar flaws, with weld beads intact
- ▶ Detection depends primarily on through-wall (radial) position of discs
  - Discs near OD difficult to detect by all apertures
  - 128E and 64E similar in detection performance
  - 32E had lowest detection rate overall
  - Sharp changes in plot are exaggerated – due to a limited number of data points at that through-wall depth
- ▶ Work illustrates volumetric coverage using PAUT-TRL

POD for Each Probe Aperture as a Function of Radial Disc Position. POD based on 38 discs.

- ▶ Overall detection of the discs using the 128E and 64E were comparable
  - Above 75% for these two apertures on all discs
  - Undetected discs were located near the OD of the specimen (~2 mm deep “blind spot”)
- ▶ Detection using a 32E aperture was significantly lower
  - Only the 2.17 mm discs were detected with a certainty above 75%

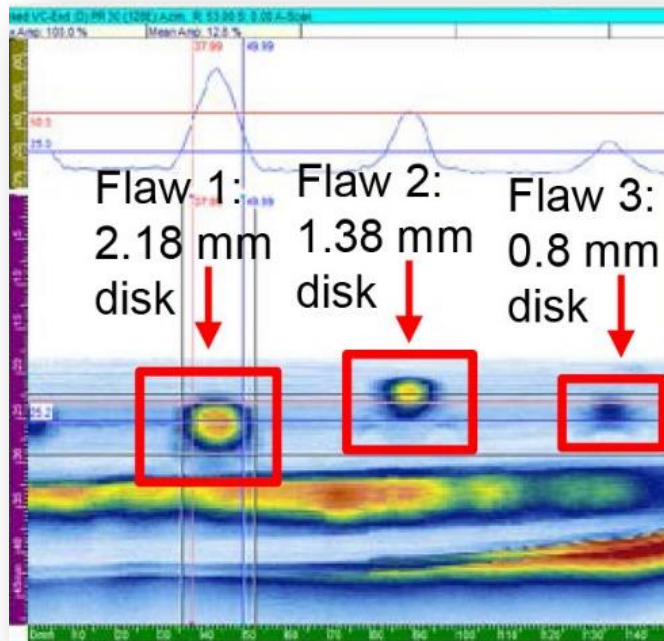
## 128E Aperture

Same specimen, same flaws: RJ4/RJ6-2, Flaws 1, 2, and 3 (skew 180°)

- 2.17 mm → 20.6 dB SNR
- 1.38 mm → 18.1 dB SNR
- 0.80 mm → 11.6 dB SNR

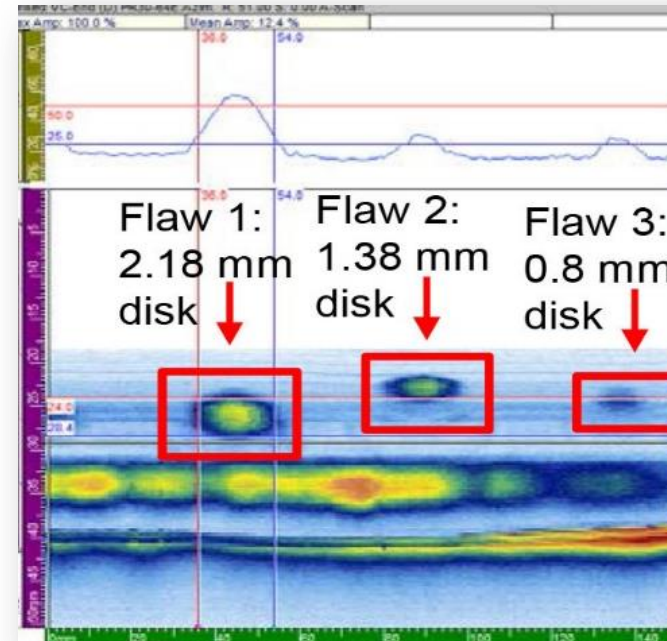
## 64E Aperture

- 2.17 mm → 15.3 dB SNR
- 1.38 mm → 15.3 dB SNR
- 0.80 mm → 11.2 dB SNR

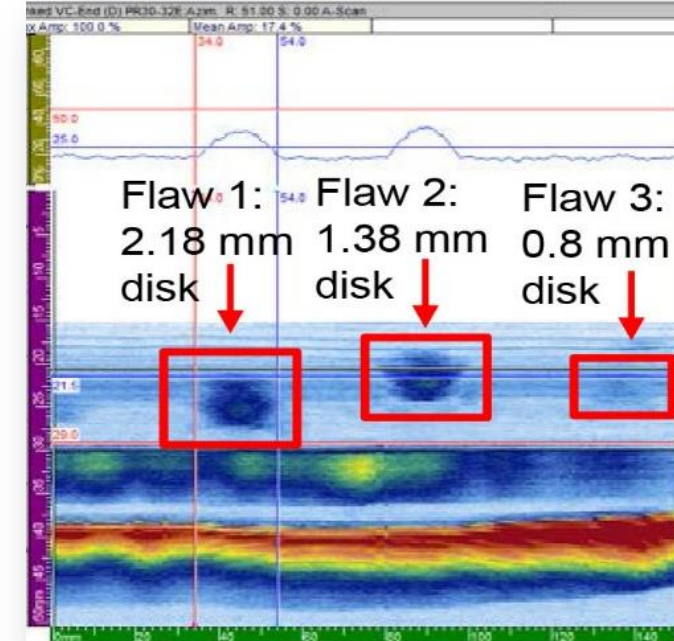
## 32E Aperture

- 2.17 mm → 11.3 dB SNR
- 1.38 mm → 10.8 dB SNR
- 0.80 mm → < 9.5 dB (marginal detection)

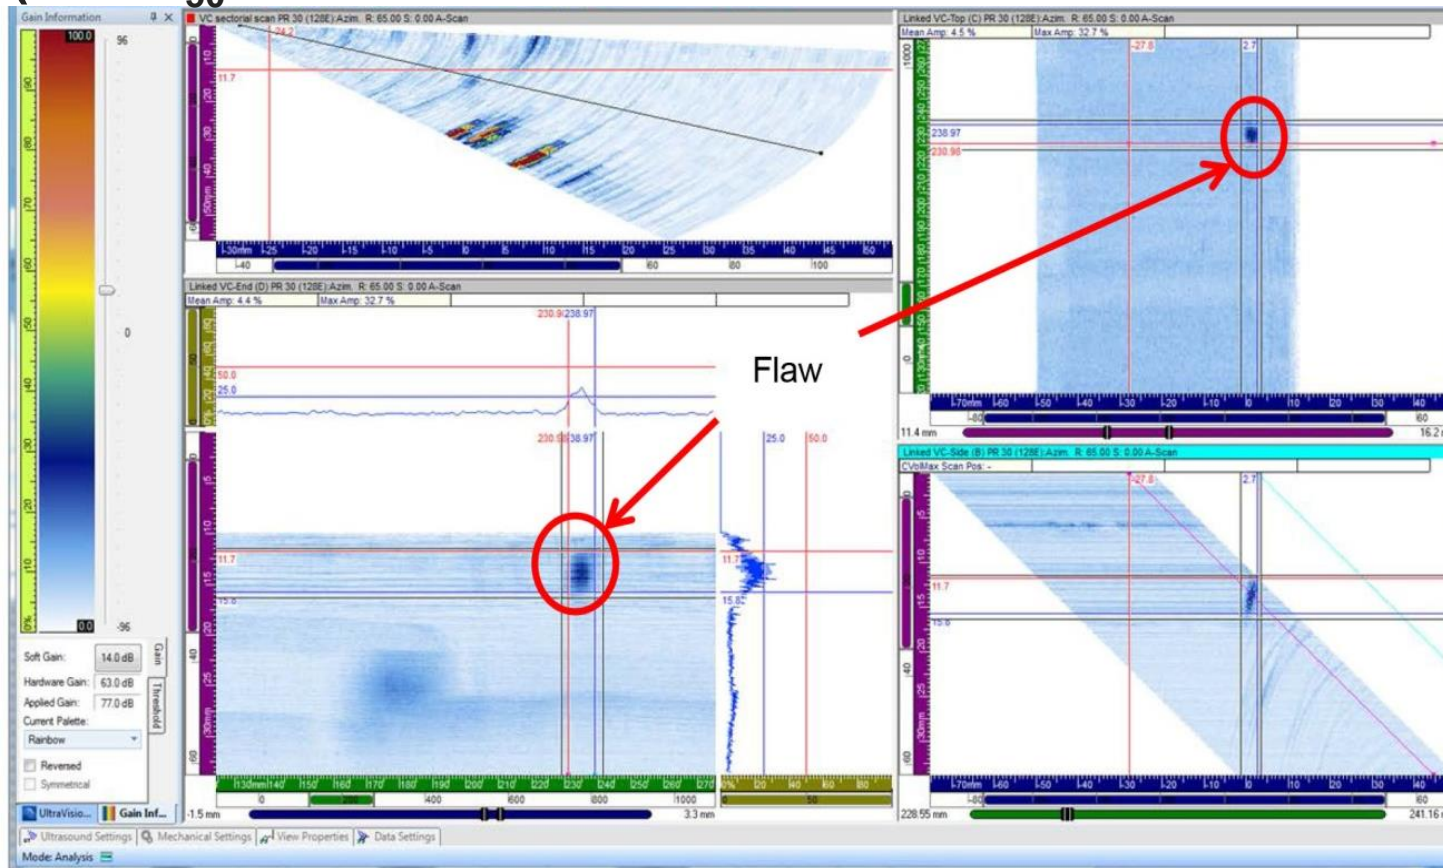
- Results are preliminary. The distribution of tungsten powder has yet to be confirmed.

Specimen J-29 with coarse tungsten powder  
(PSD  $d_{50}$  = 118 micron)

Example from Specimen J-29, 128E, Skew 0 (Flaw 4, 231–239 mm)

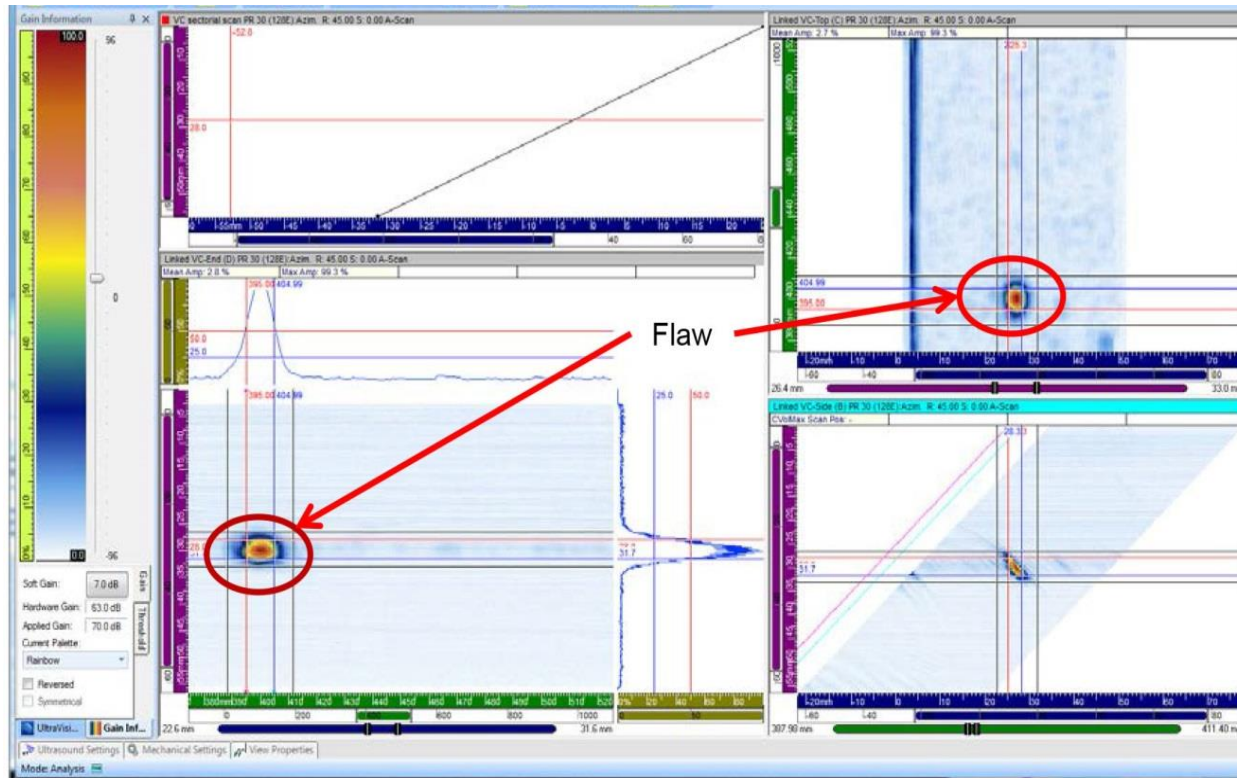
Parent material indications with signal-to-noise ratios (SNRs) greater than those for the discs

Example from Specimen J-31, 128E, Skew 180  
“Flaw” PM21 (395–405 mm) with **SNR 30.4**

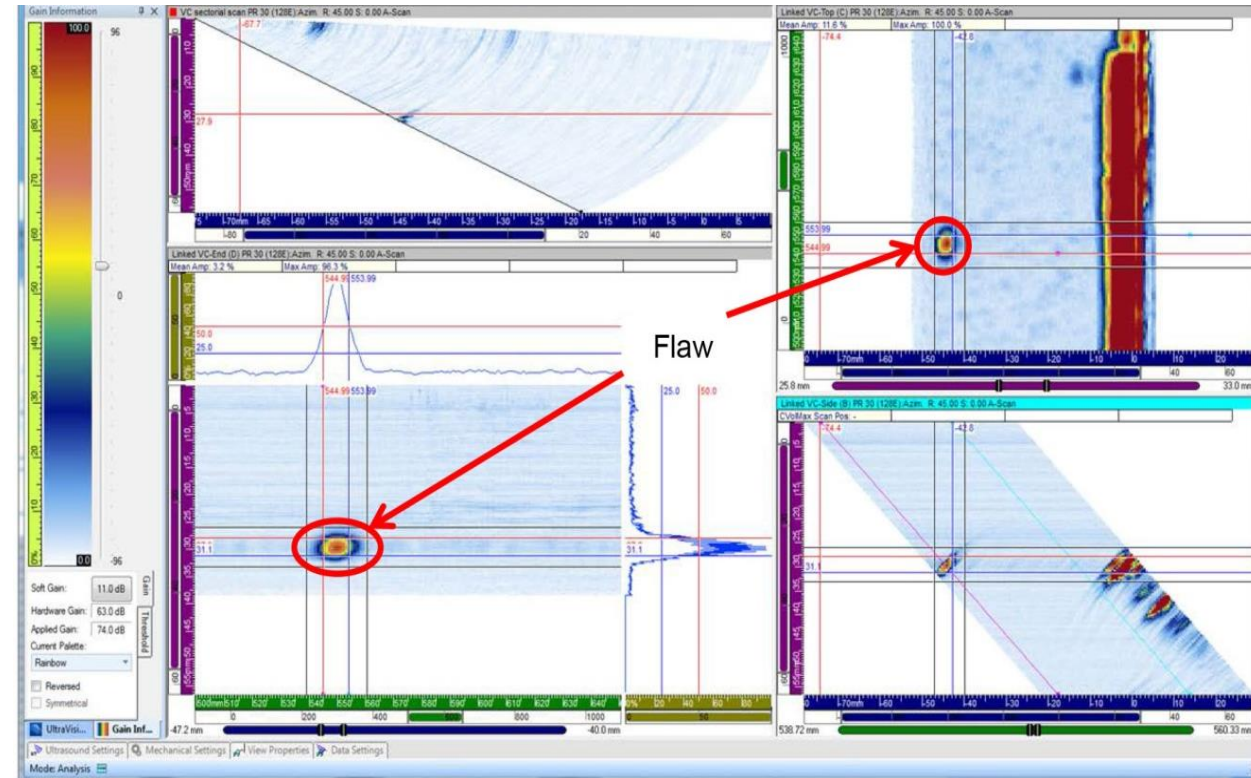
Example from Specimen J-29, 128E, Skew 0  
“Flaw” PM7 (545–554 mm) with **SNR 27.9**

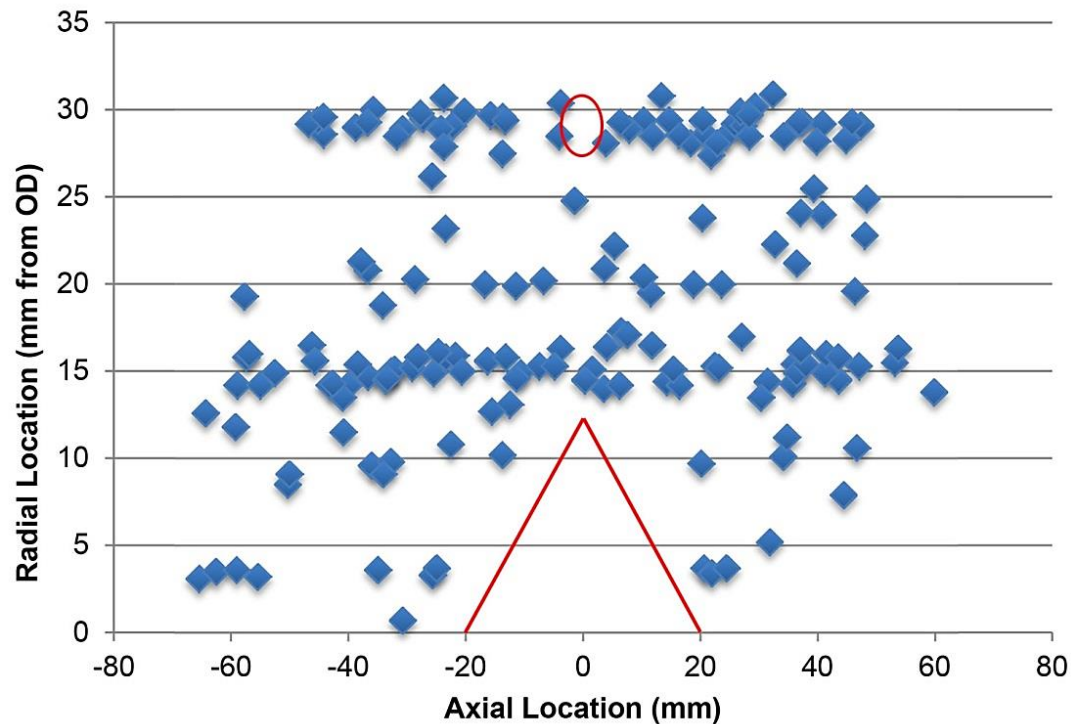
- ▶ Parent material inhomogeneities detected from OD to ID, except in blind spots identified by red outlines (shown for 128E)

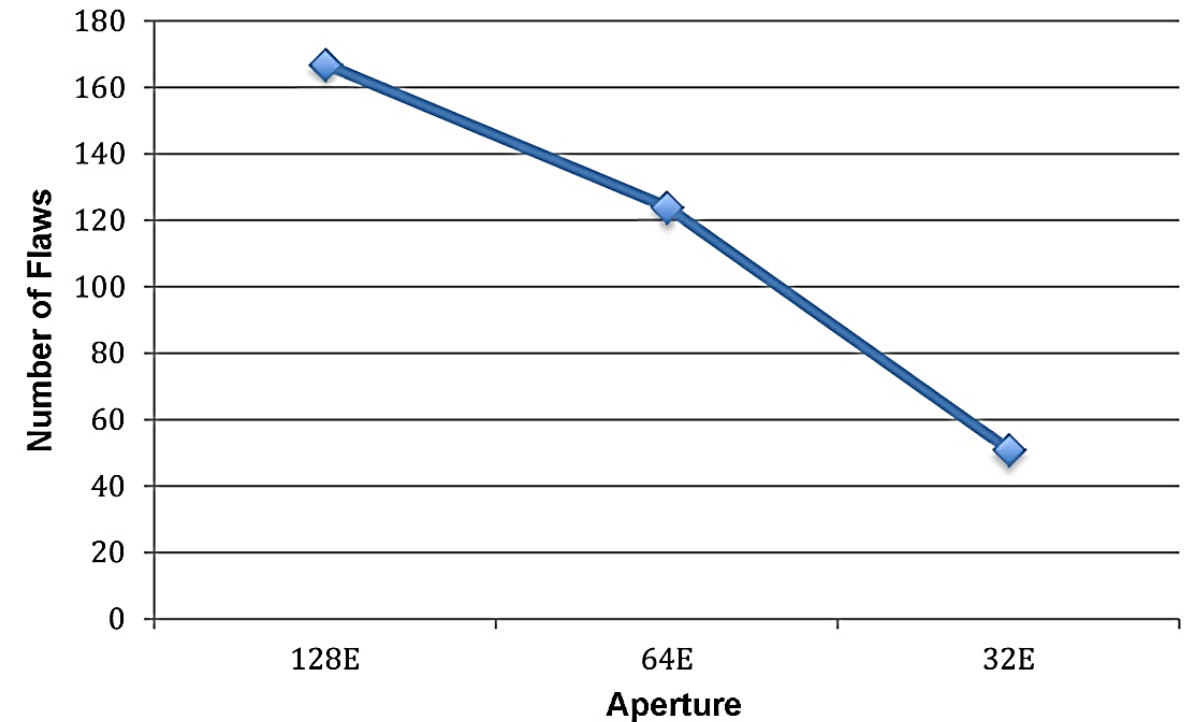
- ▶ Quantity of parent material inhomogeneities detected as a function of aperture

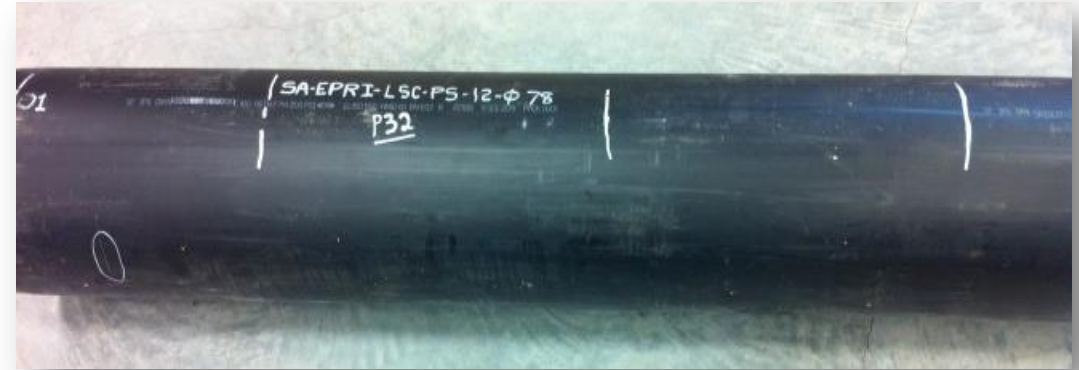
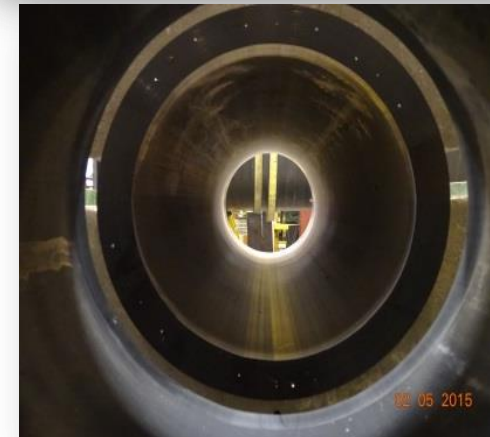
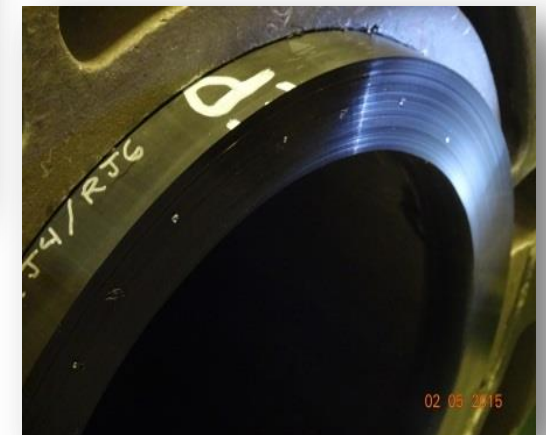
- ▶ Surrogate planar flaws (SS discs)
  - 0.8 mm, 1.38 mm, 2.17 mm diameters
- ▶ 0.05 mm thickness
- ▶ Attached to the side designated skew 180°

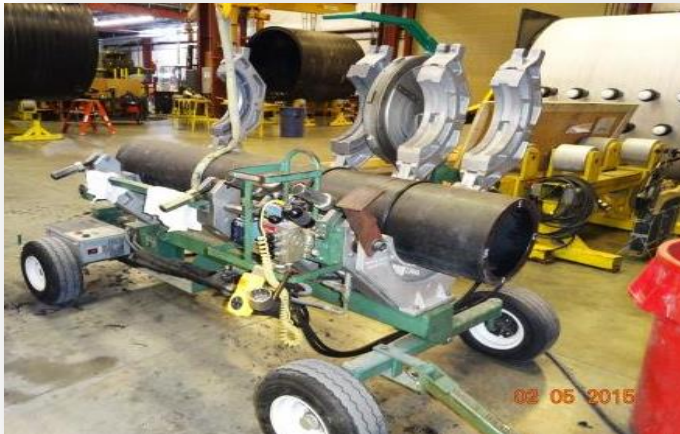
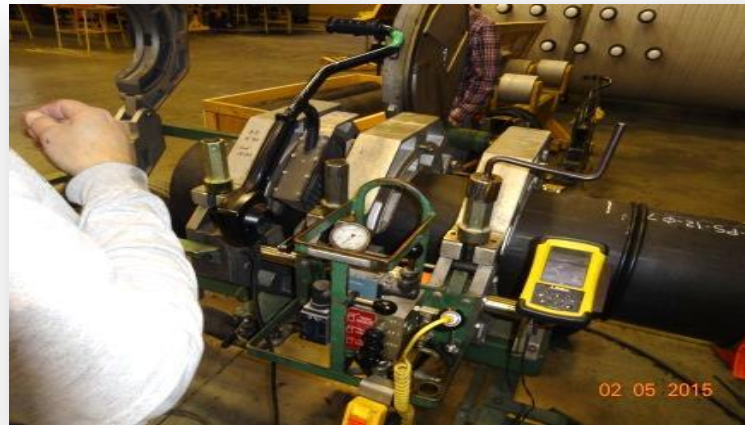
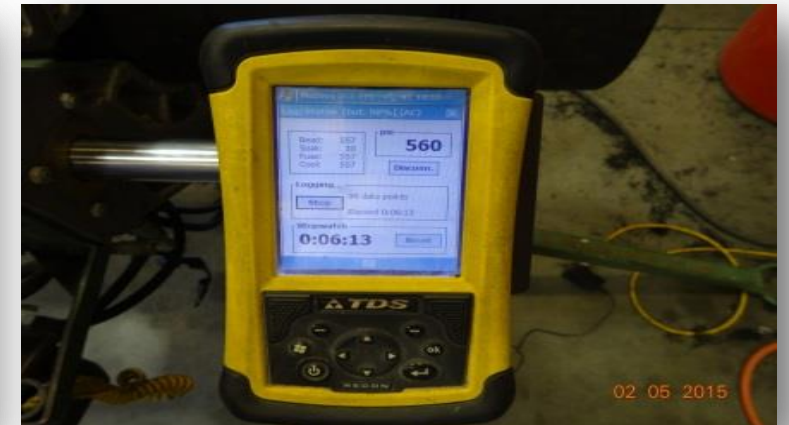
- Thermally butt-fused per and intentionally outside ASME Code standard fusing procedure (ASTM F2620, PPI TR-33)
- 12-in., DR11: Minimum 5.25-minute heat soak; minimum 13-minute cooling period
- Fusion performed by technician with >20 years experience
- Calibrated equipment with data logger

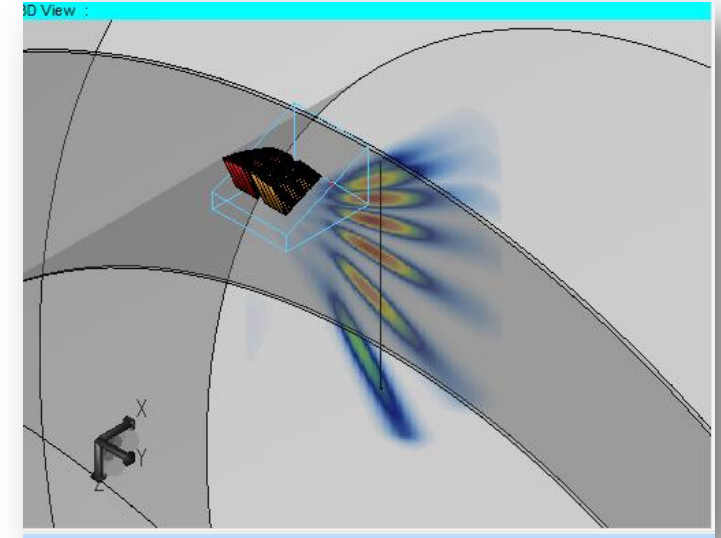
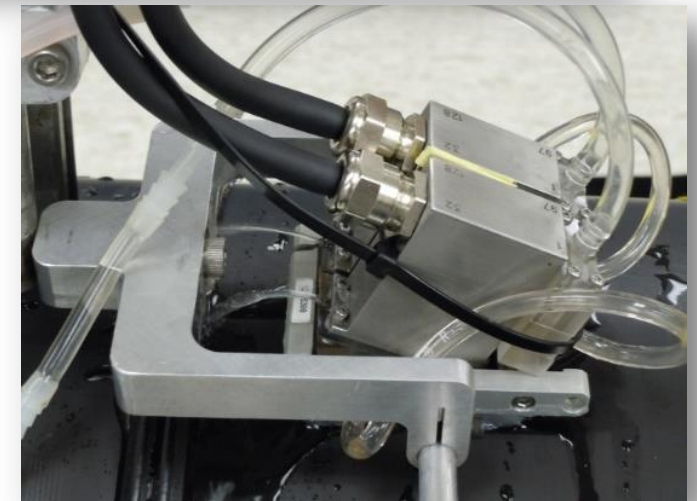
- ▶ Inspection performed with two 2.0-MHz PAUT probes
  - Probe was modeled/designed to function in 1"-4" HDPE wall thickness
  - 128-elements available in each probe
  - Operated in a TLR configuration
- ▶ Effect of aperture size on flaw detection was evaluated
  - 128E (2x[32x4]-element)
  - 64E (2x[32x2]-element)
  - 32E (2x[16x2]-element)
- ▶ Beam was focused on a vertical-plane 30 mm in front of the wedge
  - Probes were models and beams simulated to validate the ability of the probe to focus energy into the weld plane

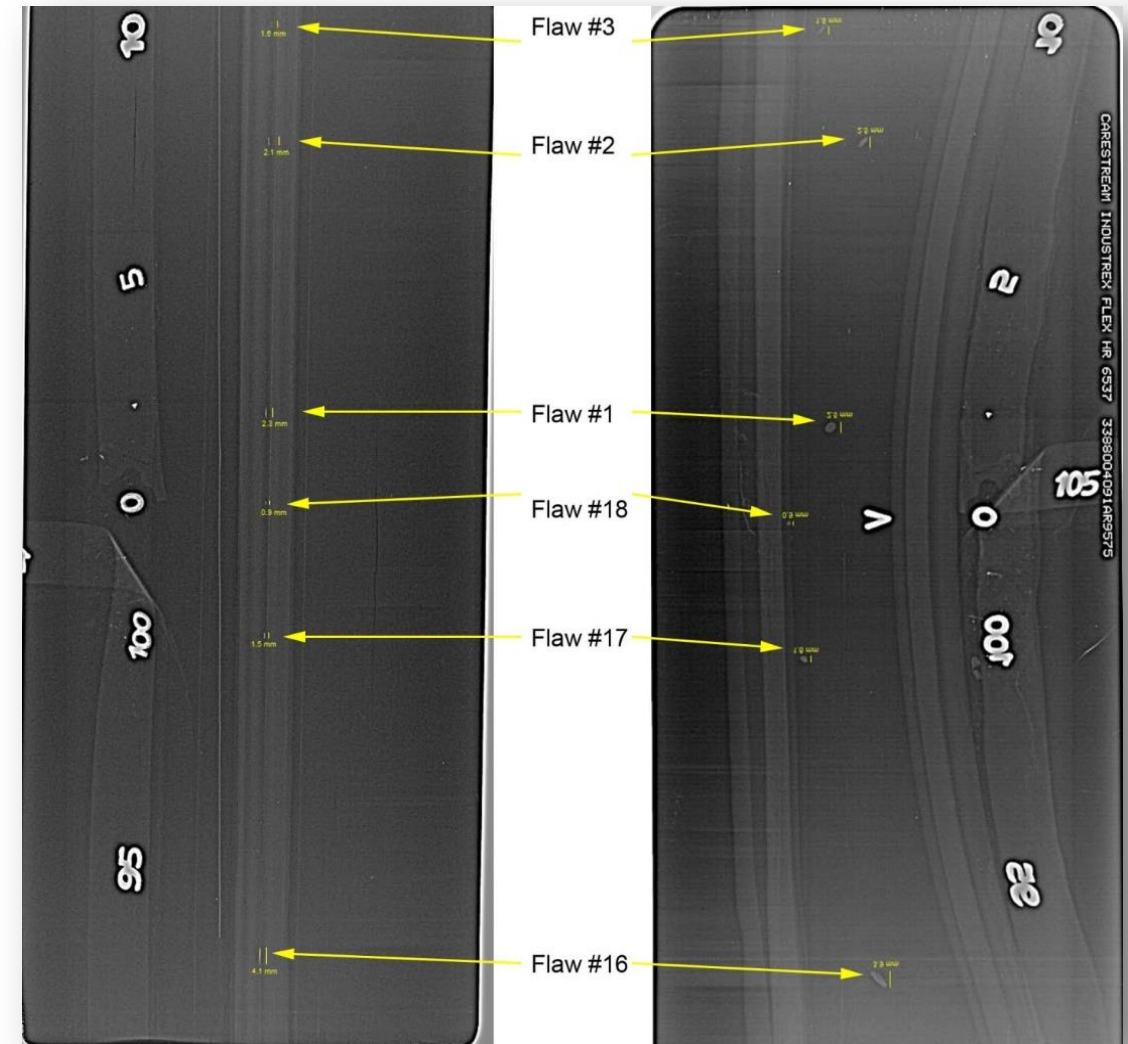
- ▶ X-ray radiography can illuminate SS discs within the weld joint
  - 8:1 density difference between steel and HDPE
- ▶ RT was performed at normal and angled-incidence to obtain disc locations within the weld
  - Discs moved with melt during fusion
  - Less motion in RJ8 due to less melt/flow
- ▶ Through-wall location difficult to determine with weld beads intact

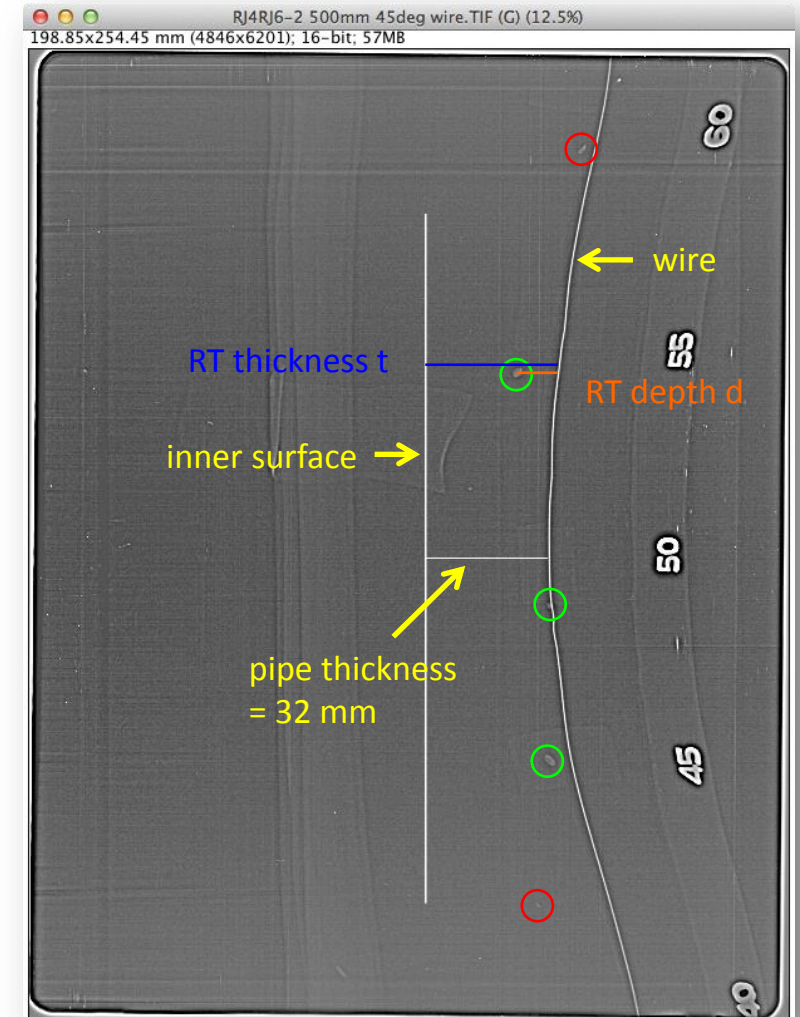
- ▶ ID and OD beads were removed on both RJ4/RJ6 and RJ4/RJ6-2
  - RT images were generated of both the weld and removed beads
  - All implanted discs were accounted for prior to bead removal
  - 2 discs were lost during bead removal, and were determined to be in the transition material and thus outside the weld
- ▶ A small section of the OD weld bead was removed on RJ8
  - Radial position of most discs could be determined with the weld beads intact
- ▶ Radial positions were measured using 45° angled-incidence RT images

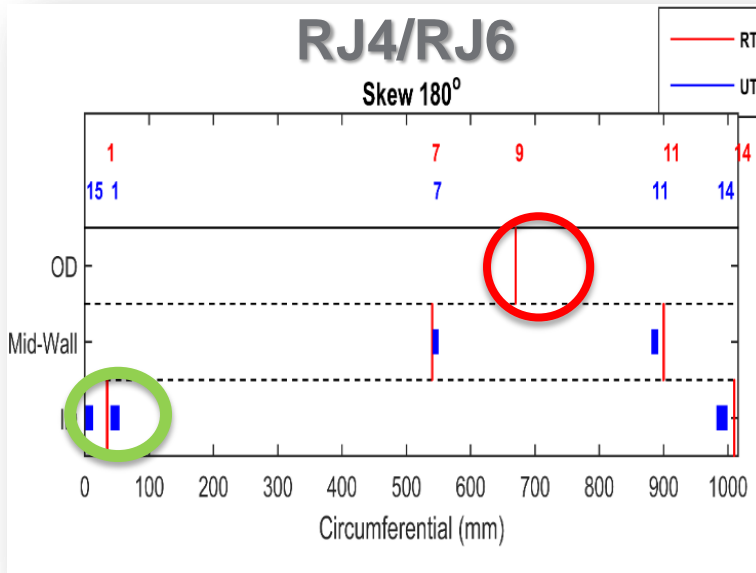
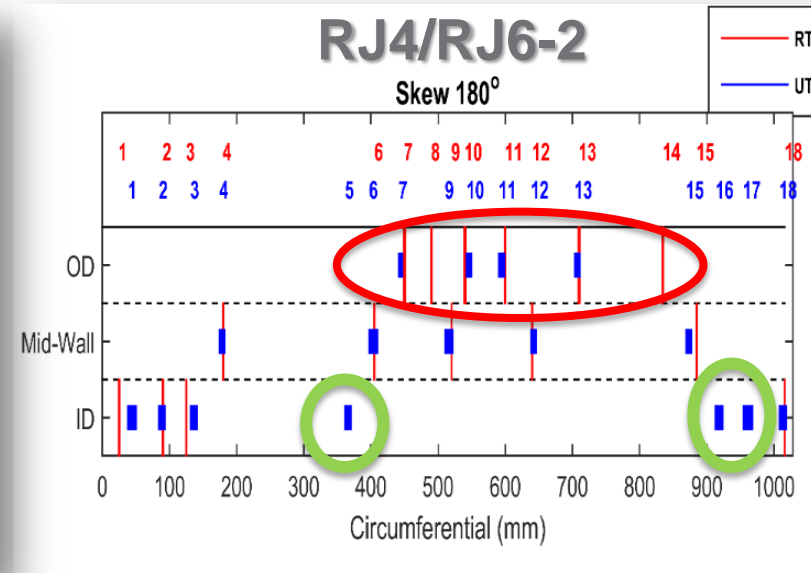
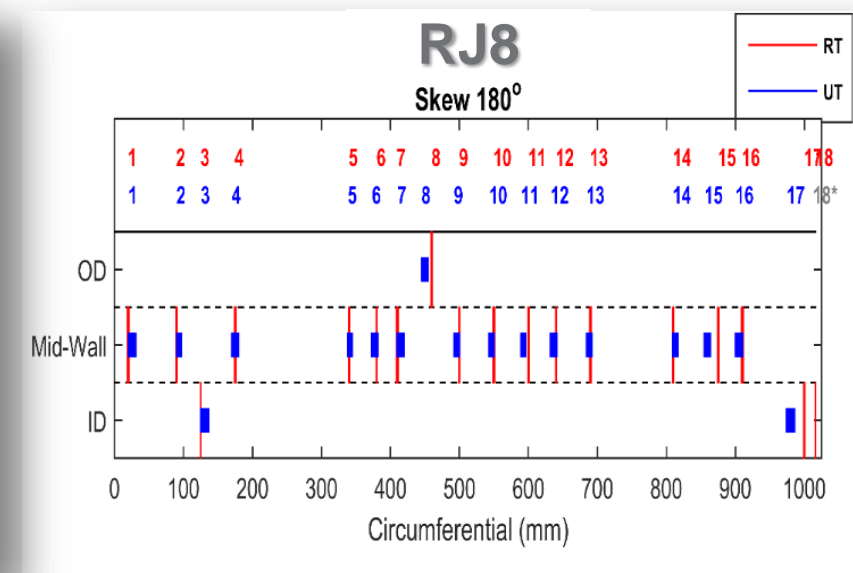
- ▶ Majority of discs verified within the weld joints were detected by PAUT
  - Most missed were near the OD
- ▶ Some discs within the ID transition-region or ID-bead were detected before bead removal
  - Example: Disc in transition region of RJ4/RJ6 detected by 128E and 64E apertures

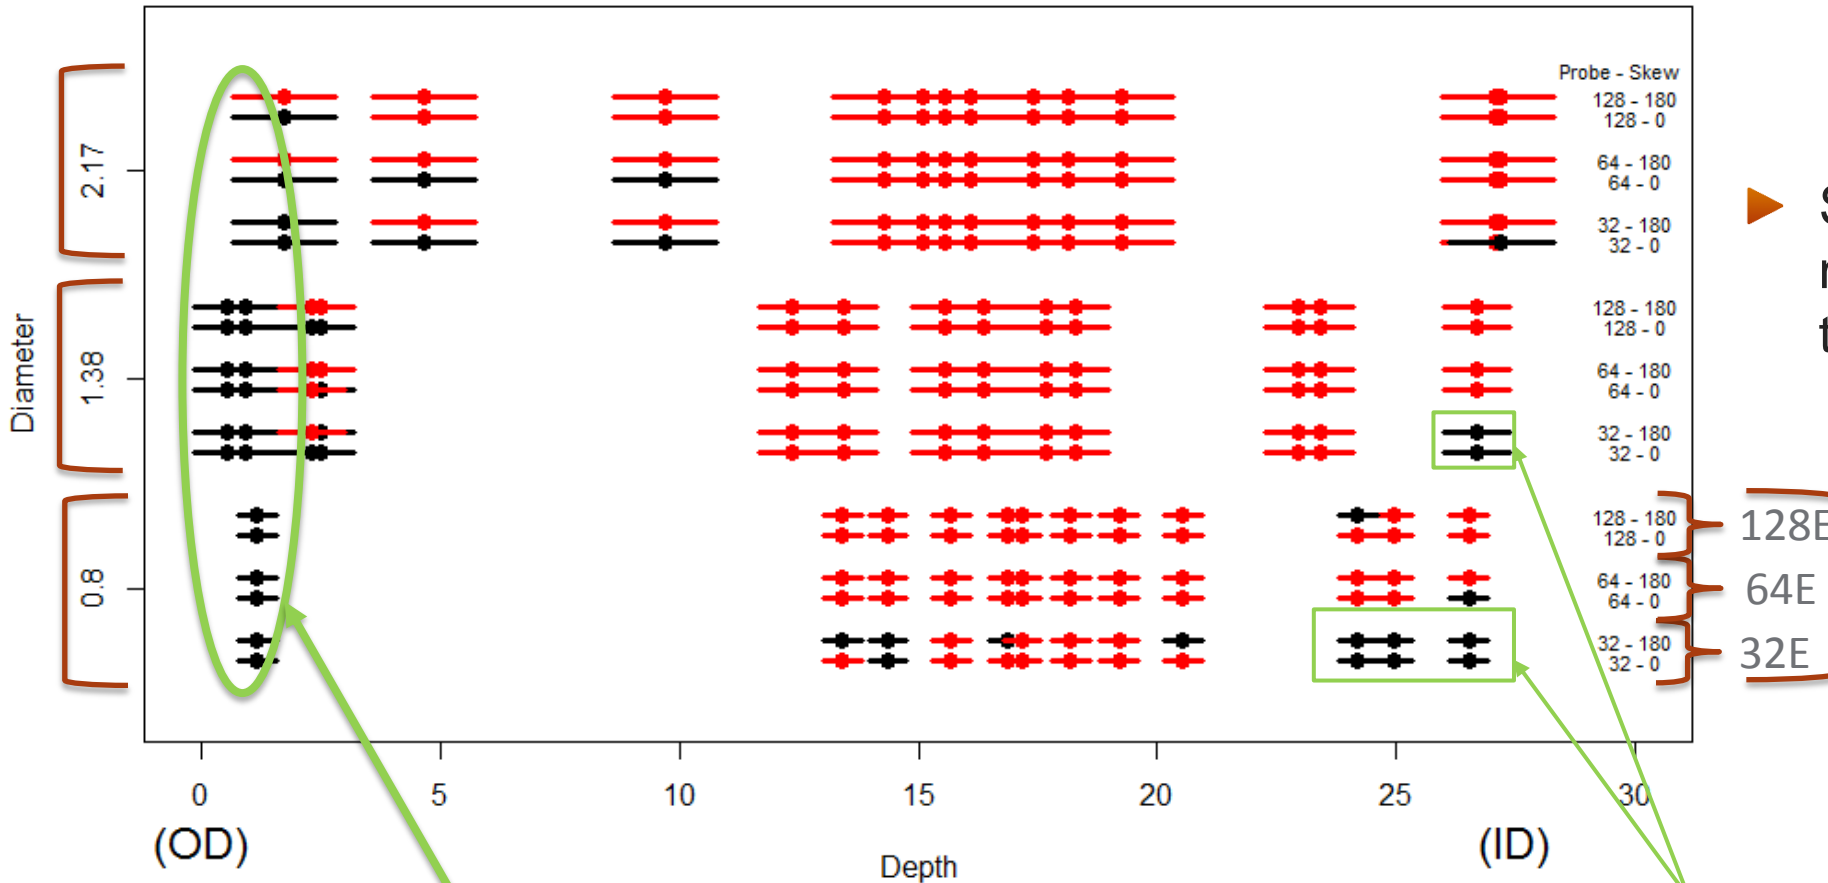
● = Detected    ● = NOT Detected

- ▶ Sorted by disc diameter
  - Detection was divided based on aperture and inspection direction
- ▶ Some regions contained no discs between the three joints
  - Movement of the disc during fusion

Discs located near the OD were consistently missed (blind-spot due to presence of bead)

32E aperture had difficulty distinguishing discs from the ID bead
