# Evaluation of Ultrasonic Phased-Array for Detection of Planar Flaws in High-Density Polyethylene Butt-Fusion Joints

NRC-Industry Technical Information Exchange  
(TIE) Public Meeting  
Rockville, MD  
January 17-19, 2017

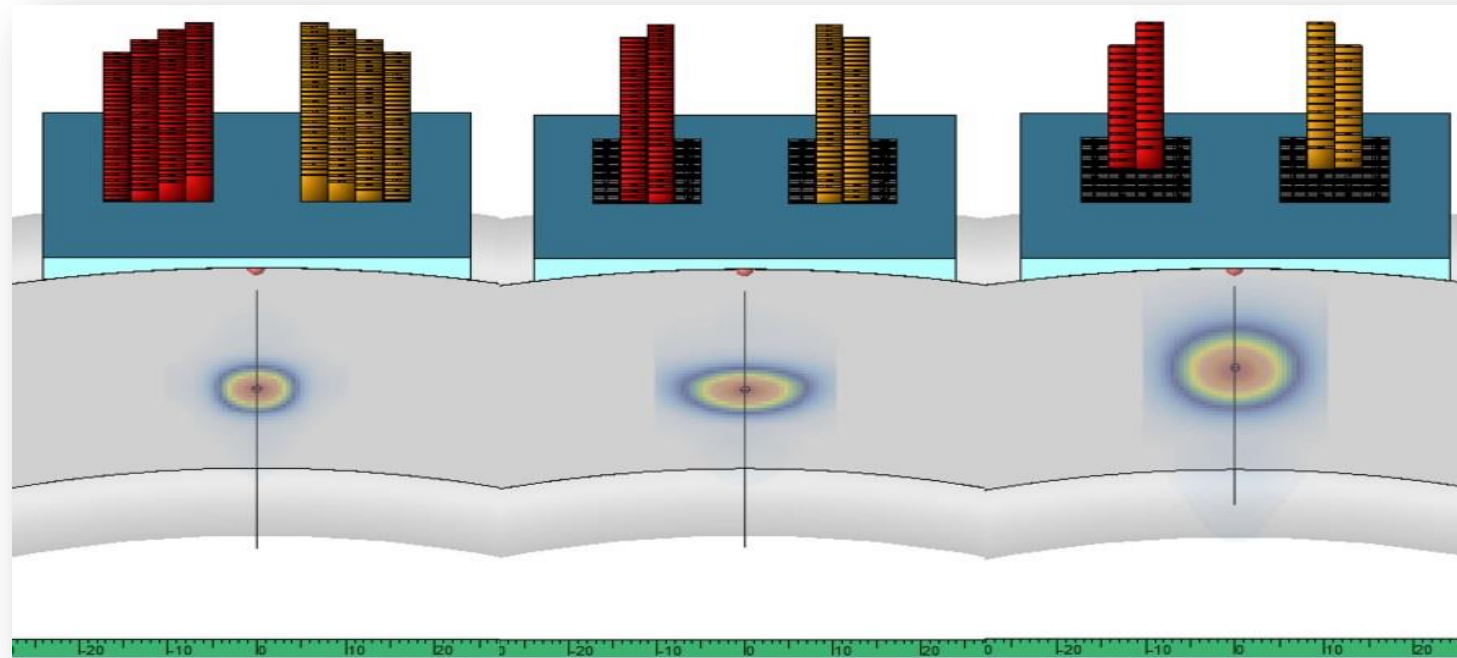
## Modeling results of beam spot-size on the focal plane

128E (32x4)

64E (32x2)

32E (16x2)
