Main Title REPAIR OF TENDON V-75 FOR  
R.E. GINNA NUCLEAR POWER PLANT

Sub-Title REPAIR REPORT

This report presents the results of repair work conducted on tendon V-75 of the Ginna Power Plant. This tendon had been damaged during the 3rd Year Surveillance and Inryco was called upon to provide a repair procedure and technical assistance.

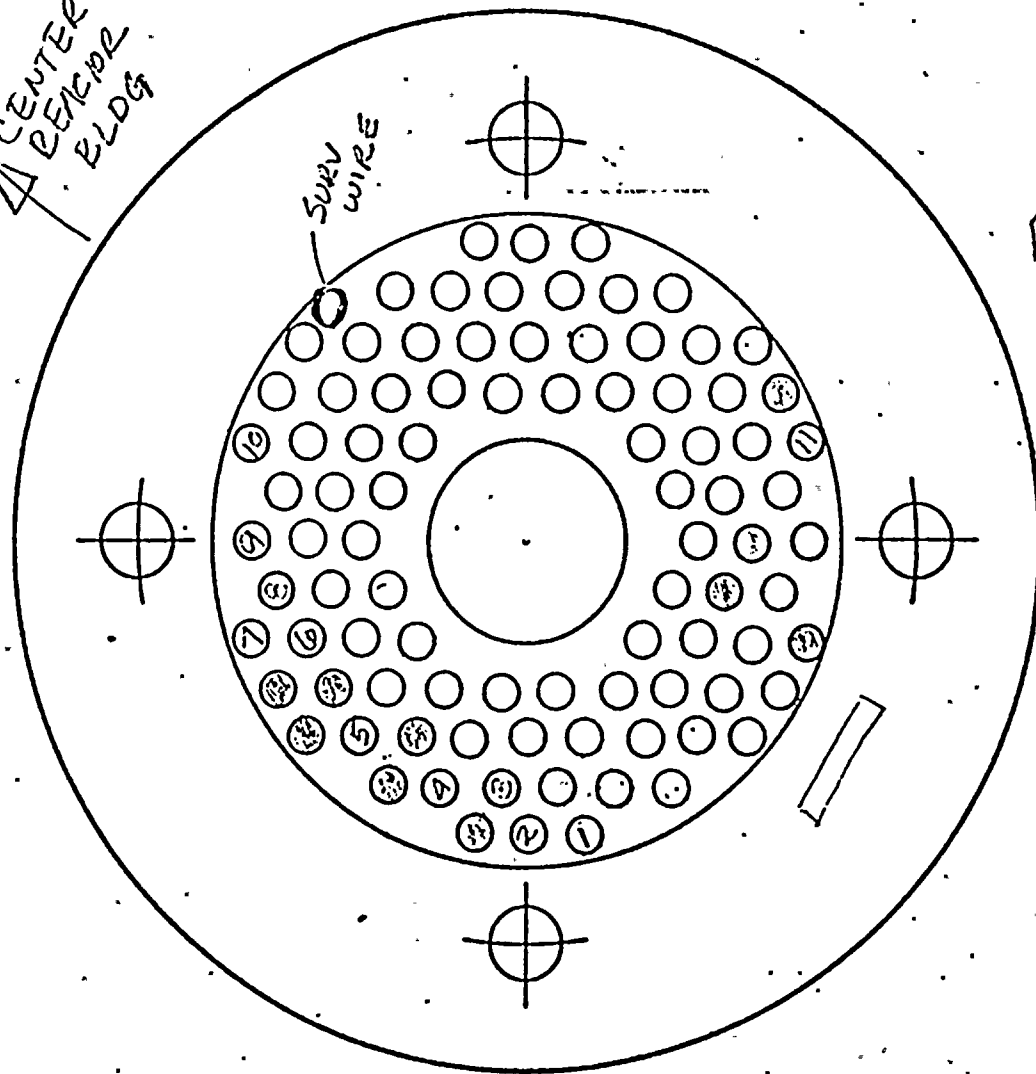
FIGURE 2.0

a. Comments: Pulled the 11 <sup>protruding</sup> wires previously identified and marked - Found 1 additional wire which was broken + pulled it. See data sheet. Total of 22 broken wires removed as of 11:30 am. Photos taken: 11:45 AM; found 2 more broken (\* on Data Sheet). - TOTAL 24 BROKEN AS OF 11:45 AMb. Complete Figure 2.0: ✓ △

Broken Wires  
(C.A.F. 10/24/73)

+ 10-19  
broken & pulled
