**NEQ REPORT**  
(Nuclear Environmental Qualification)

REPORT NO. 17490-2  
WYLE JOB NO. 17490  
YOUR P.O. NO. N-BU-17089  
DATE January 15, 1982

ANALYSIS OF THE DECOMPOSITION EFFECTS OF  
VINYLCEL INSULATION ON 304 SST FACINGS  
IN A DESIGN BASIS ACCIDENT

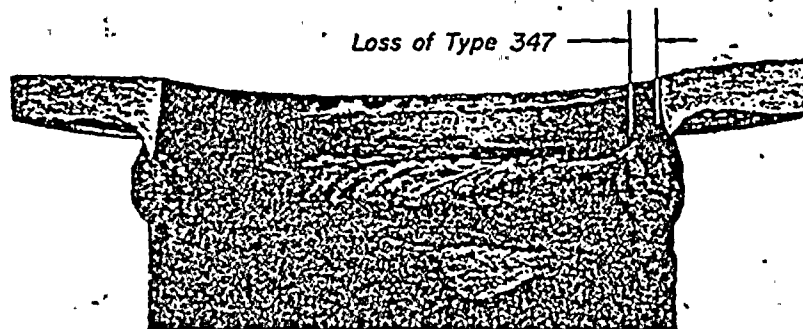
Fig. 6. Weld metal and pipe of type 316 and flange of type 347 corroded by fatty acid at 400 F

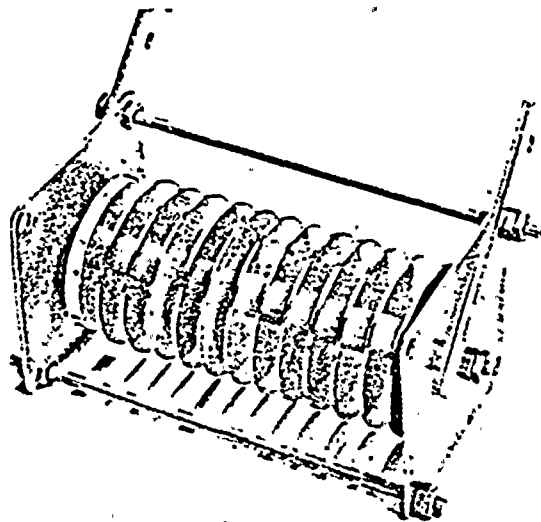
FIGURE 1 — Corrosion test spool.

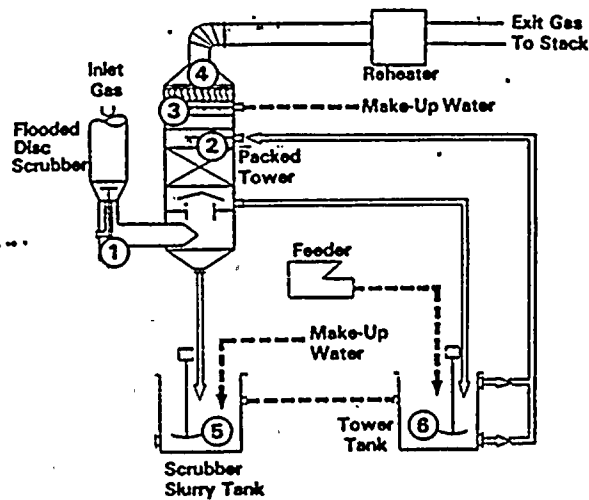
FIGURE 2 — Limestone FGD system.

shown in Figure 2. This design confines the recirculating chloride containing scrubbing solution to the first loop, i.e., the flooded disc scrubber and the absorber area below the packed tower. Corrosion data for AISI 1010 steel and three alloys are given in Table 2.

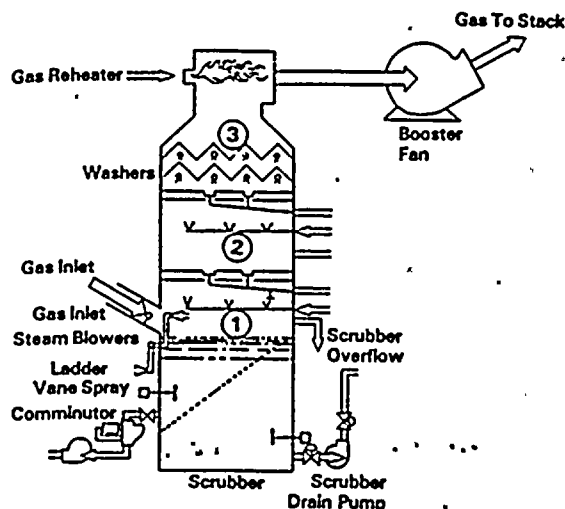
FIGURE 3 — Lime FGD scrubber.

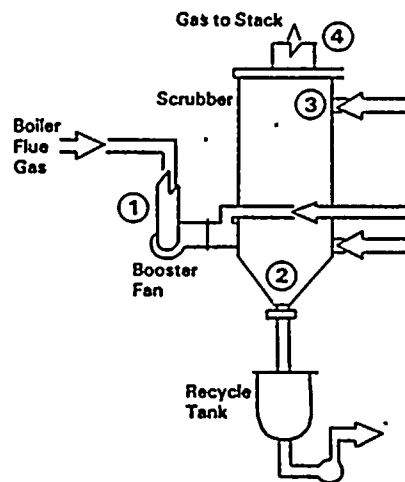
FIGURE 4 — Double alkali FGD system, dilute mode.

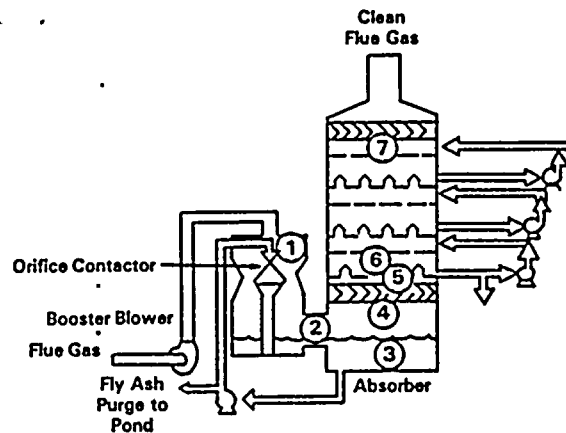
FIGURE 6 — Sodium sulfite SO<sub>2</sub> recovery process.

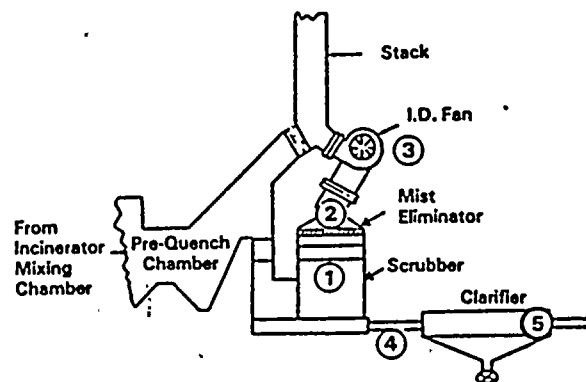
FIGURE 7 — Refuse incinerator scrubber.

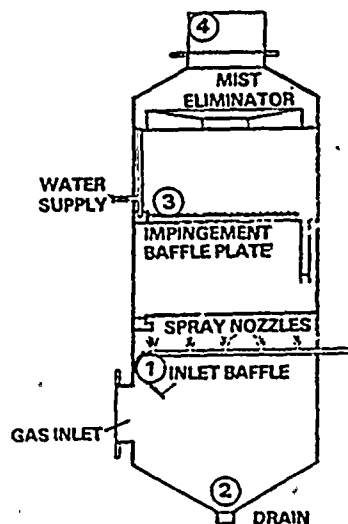
FIGURE 8 — Sewage Incinerator scrubber.

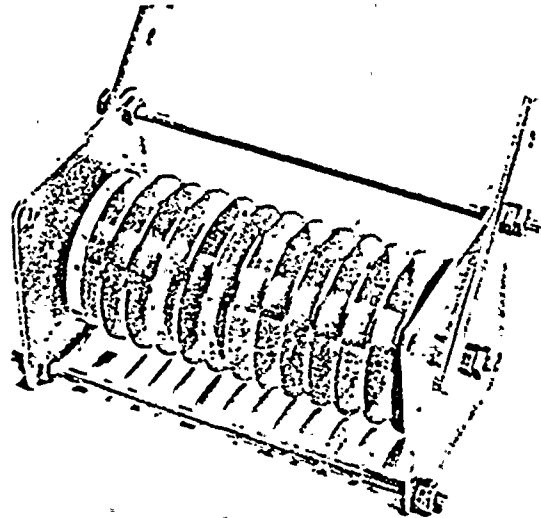
FIGURE 1 — Corrosion test spool.

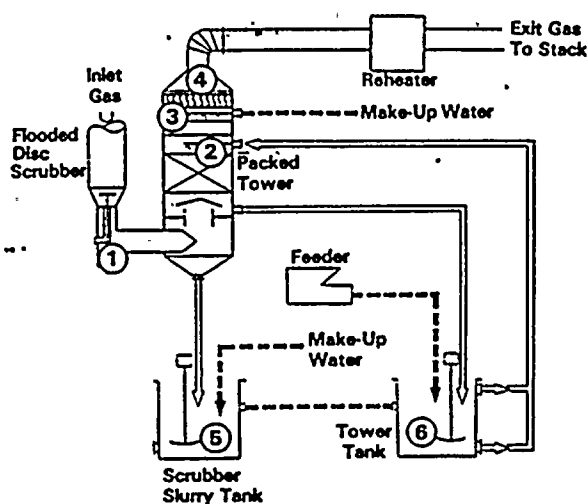
FIGURE 2 — Limestone FGD system.

shown in Figure 2. This design confines the recirculating chloride containing scrubbing solution to the first loop, i.e., the flooded disc scrubber and the absorber area below the packed tower. Corrosion data for AISI 1010 steel and three alloys are given in Table 2.

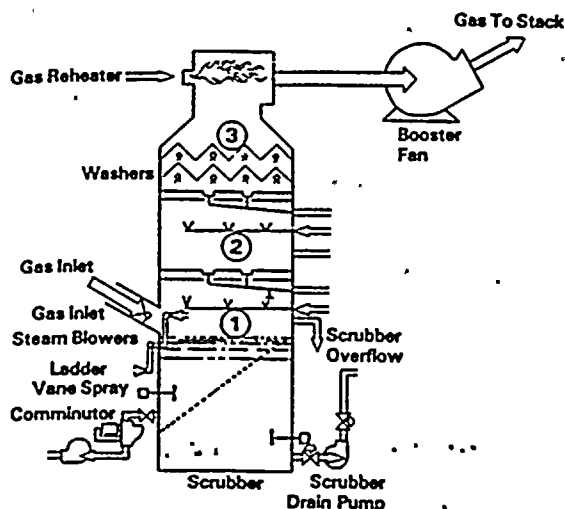
FIGURE 3 — Lime FGD scrubber.

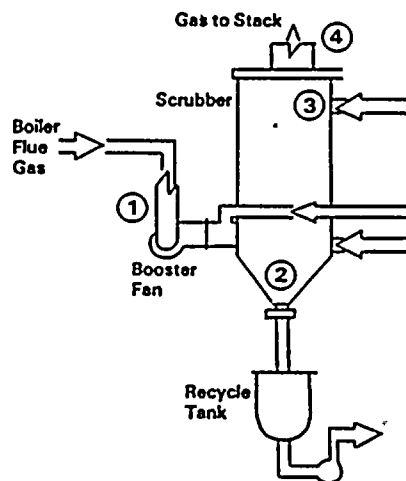
FIGURE 4 — Double alkali FGD system, dilute mode.

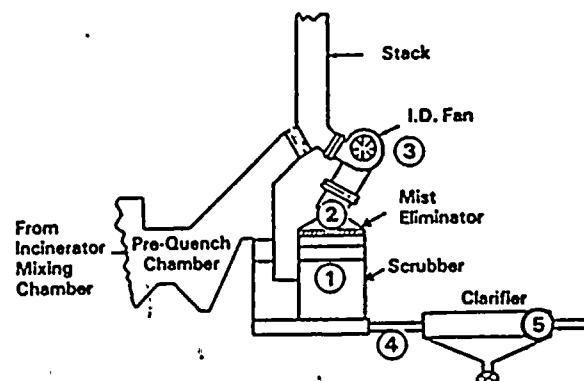
FIGURE 7 — Refuse Incinerator scrubber.

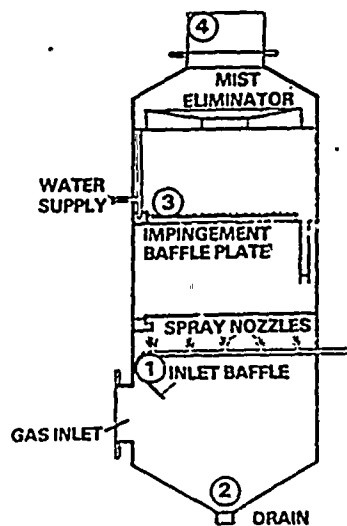
FIGURE 8 — Sewage Incinerator scrubber.

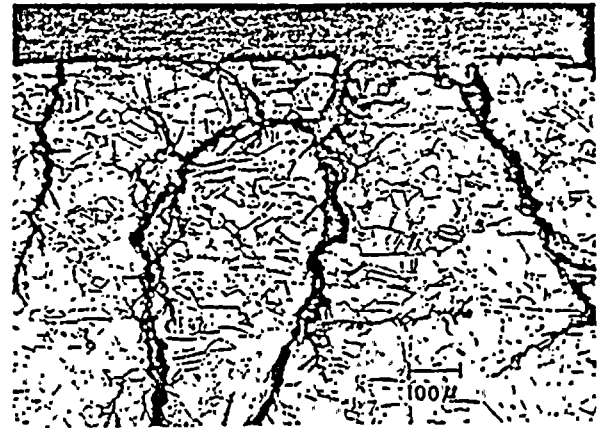
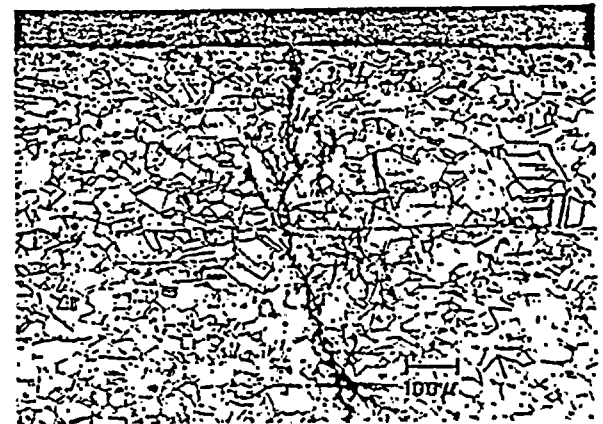
FIGURE 1 — Stress corrosion cracks; 4% NaCl + 1%  $H_3PO_4$  at 141 C (285 F). (a) AISI 304 stainless steel; 50X, and (b) AISI 316L stainless steel; 50X.

It should be noted that SCC of the stainless steels was observed at 141 C (285 F) only in the chloride solution containing the phosphoric acid. No SCC occurred in the sodium chloride solution (without  $H_3PO_4$ ) nor in the boiling phosphoric acid (without NaCl), as indicated by the data summarized in Tables 3 and 4. It is appreciated that the test reported in Table 2 was in 4% NaCl + 1%  $H_3PO_4$  at 141 C, while in Table 3, the medium was 2% (not 4%) NaCl at 141 C, and in Table 4 it was 2% (not 1%)  $H_3PO_4$  at 102 C (not 141 C). These variations were dictated by a customer problem being worked on. However, I believe the conclusions are valid since

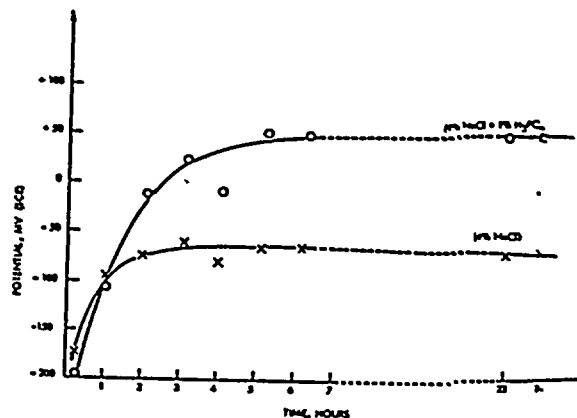
FIGURE 5 — Corrosion potential of AISI 316 stainless steel as a function of time; T ≈ 82 C (180 F).
