**OAK RIDGE ASSOCIATED UNIVERSITIES:
SITE STATUS REPORT FOR HARVEY-HUBBELL AT
1575 STATE STREET, BRIDGEPORT, CONNECTICUT**

FEBRUARY 2, 2018

SITE STATUS REPORT

Property: Former Harvey-Hubbell facility
1575 State Street
Bridgeport, CT 06605

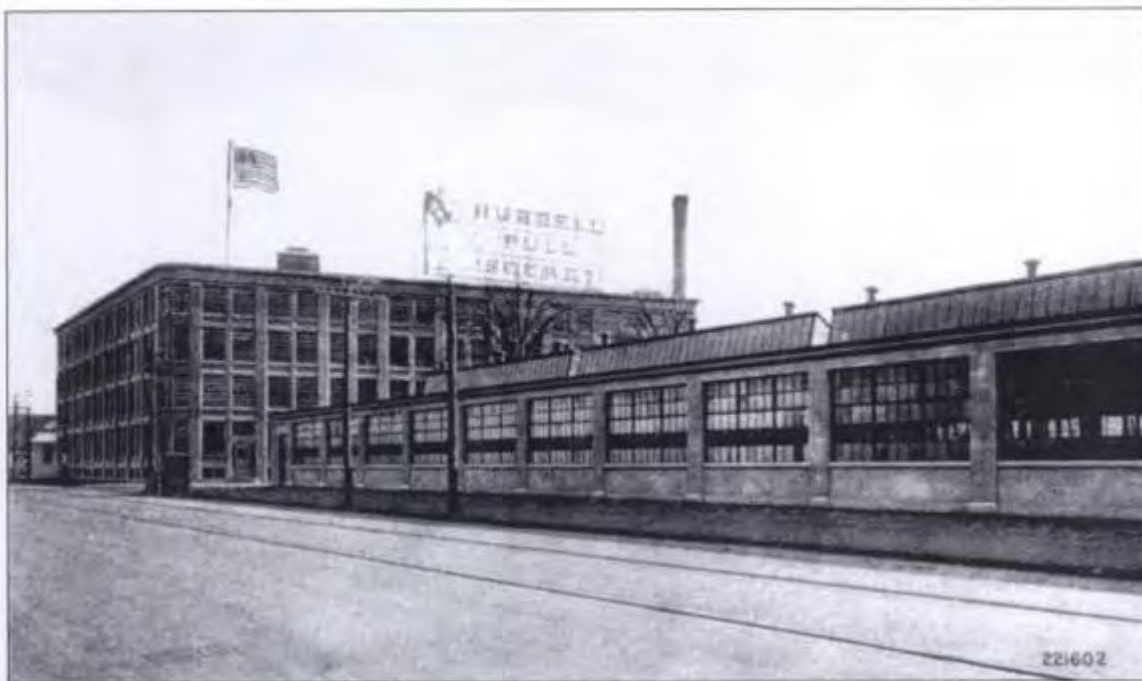
Figure 1. Harvey-Hubbell (Pehanick 2005)

Harvey-Hubbell II opened a small manufacturing facility in 1888 in a small loft in Bridgeport, Connecticut. The factory, pictured in Figure 1 on the corner of State Street and Bostwick Avenue, was built in 1909 to increase manufacturing efficiency and was best known for producing pull-socket light switches. The large electric sign on the roof displayed a lightbulb turning on and off when the chain was pulled (Pehanick 2005). In addition to being a recognized producer of pull-socket light switches, an advertisement from 1922 listed this facility as manufacturing luminous flush-type switches and pull-chain pendants (McGraw-Hill 1922).

Manufacturing ceased at this plant in 1990. The lower building on the right in Figure 1 had already been demolished by then, and the large building on the left was razed in early 2005 (Pehanick 2005), though the Bridgeport History Center states that the Bostwick Avenue plant was demolished in 2008 (Witkowski 2011).

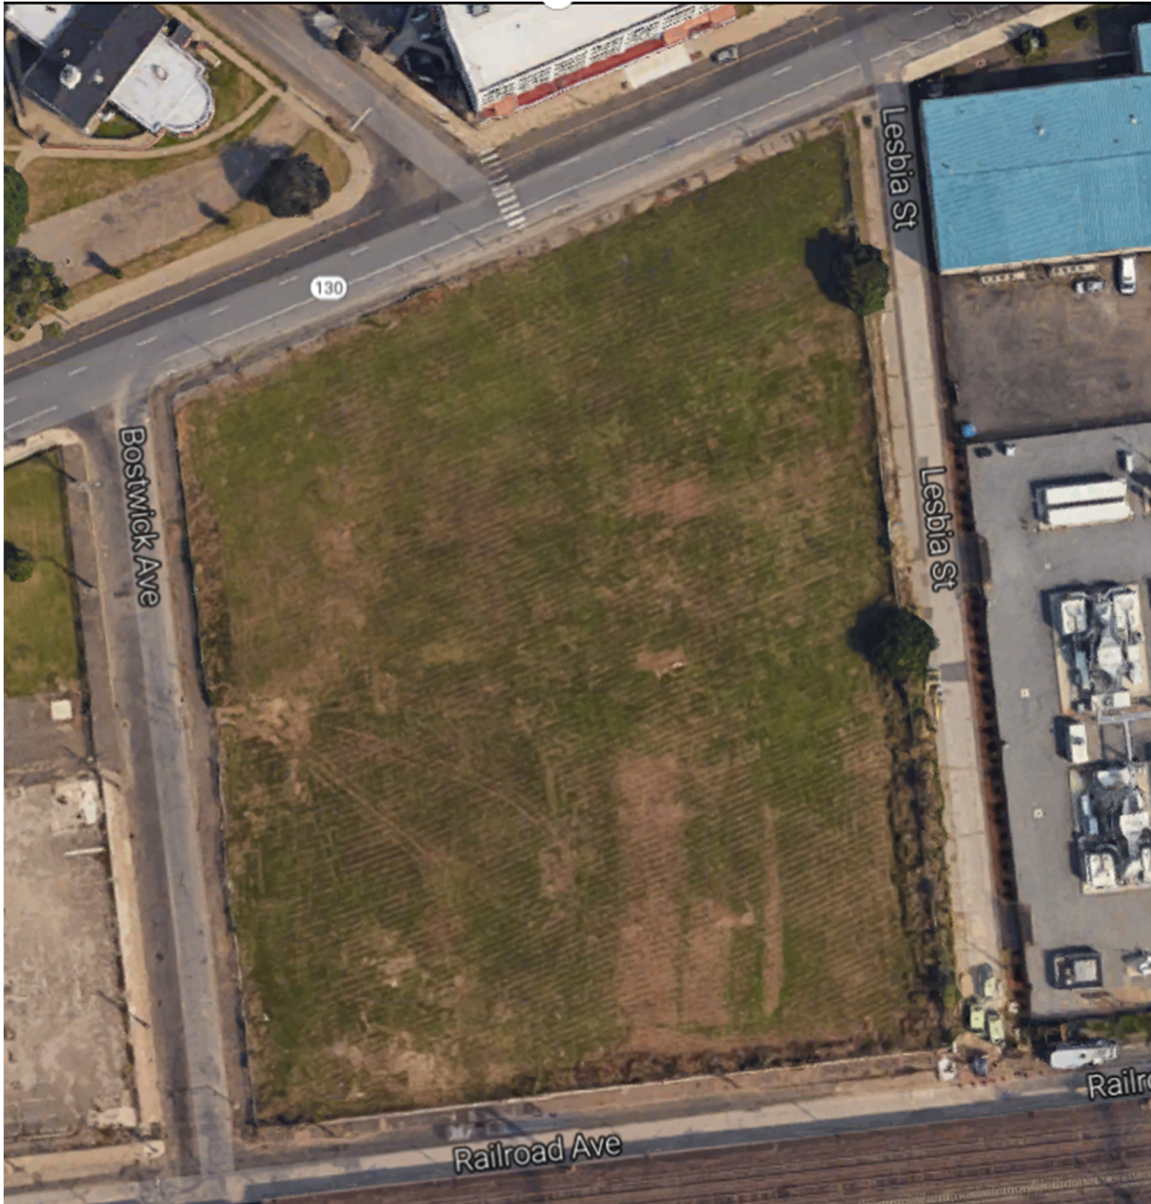
Figure 2. Aerial View of Former Harvey-Hubbell Property (Google Maps, June 2017)

As shown in the aerial view of the property in Figure 2, the 3.7-acre property is now an empty, mostly grass-covered field, with some areas of asphalt and rocks. Hubbell personnel informed the survey team that the original building formed a U-shape along the north, east, and south sides of the now vacant lot. An extensive internet search of public records did not reveal any information about radium cleanup of the facility (ORNL 2015). Therefore, it is possible that soil from the site may be contaminated with radium.
