EQUIPMENT ROOT CAUSE OF FAILURE ANALYSIS

CLASS 1E 125 VDC POWER SYSTEM BATTERIES

2EPKAF11, 2EPKBF12, 2EPKCF13, 2EPKDF14

May 9, 1997

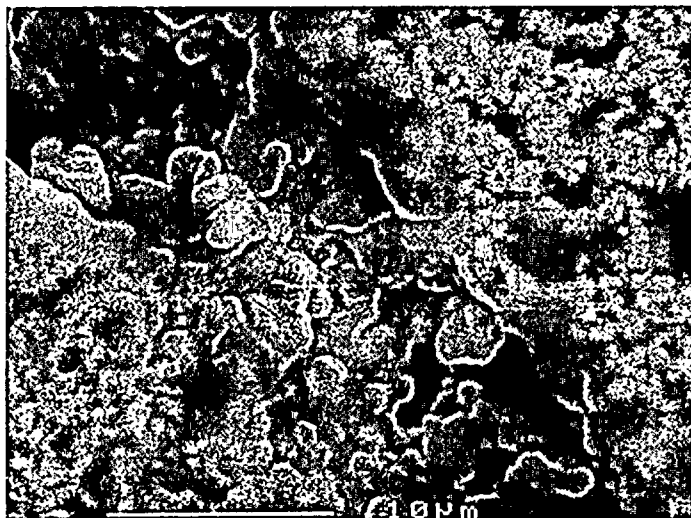
Further examination of these scale separations revealed that PbSO_4 crystals had formed within them. On occasion, these crystals could be discerned by looking down into scale separations. They could be seen much more clearly after sections of the outer scale were removed. The removal process was relatively easy because in the affected cells, the scale would preferentially cleave along the existing lateral separations rather than at the grid interface. All of these crystals were relatively flat ($1\text{ }\mu\text{m}$ to $3\text{ }\mu\text{m}$) because of the geometric constraints imposed by the narrow gaps. In the plane of the separation, however, some crystals reached $30\text{ }\mu\text{m}$ in major dimension. The planar growth was variable and resulted in crystals with distinct shapes. Most often, simpler and much thinner disc-shaped crystals formed (Figure 7). On occasion, these crystals developed in pairs (Figure 8). In other instances, both

Figure 7. Cell 59941 - Small, Disk-Shaped PbSO₄ Crystals

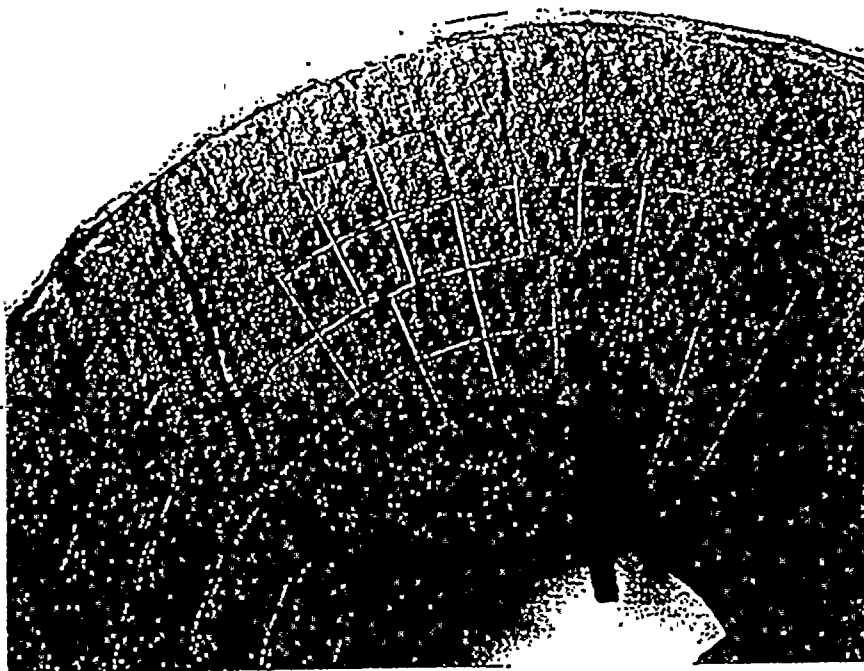
Fig. 9. Inadvertently Bonded Drops of Negative-Electrode Paste (upper, cell 59936; lower, cell 77773)

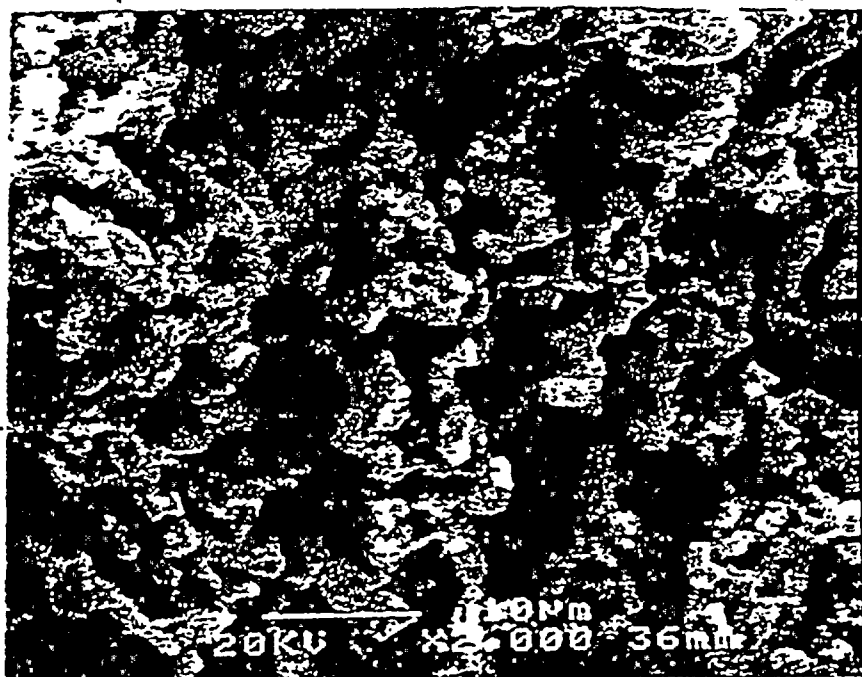
Fig. 13. Comparison of Interior (upper) and Surface (lower) Microstructures for Negative Electrodes from Cell 74975

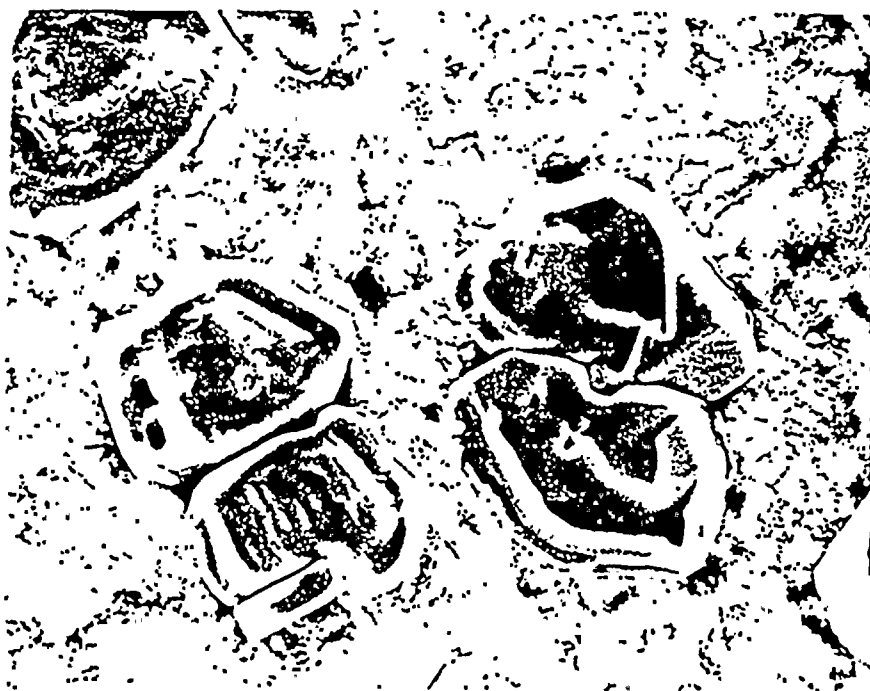
" 24. Exterior Surface of Scale (upper) with the Outer Scale Section Removal to Reveal PbSO_4 Crystals (lower) Embedded in Scale Separation of Cell 77773
