## Erosion Testing of Zoned Rockfill Embankments

**Tony L. Wahl**

*Hydraulics Laboratory, Denver, Colorado*

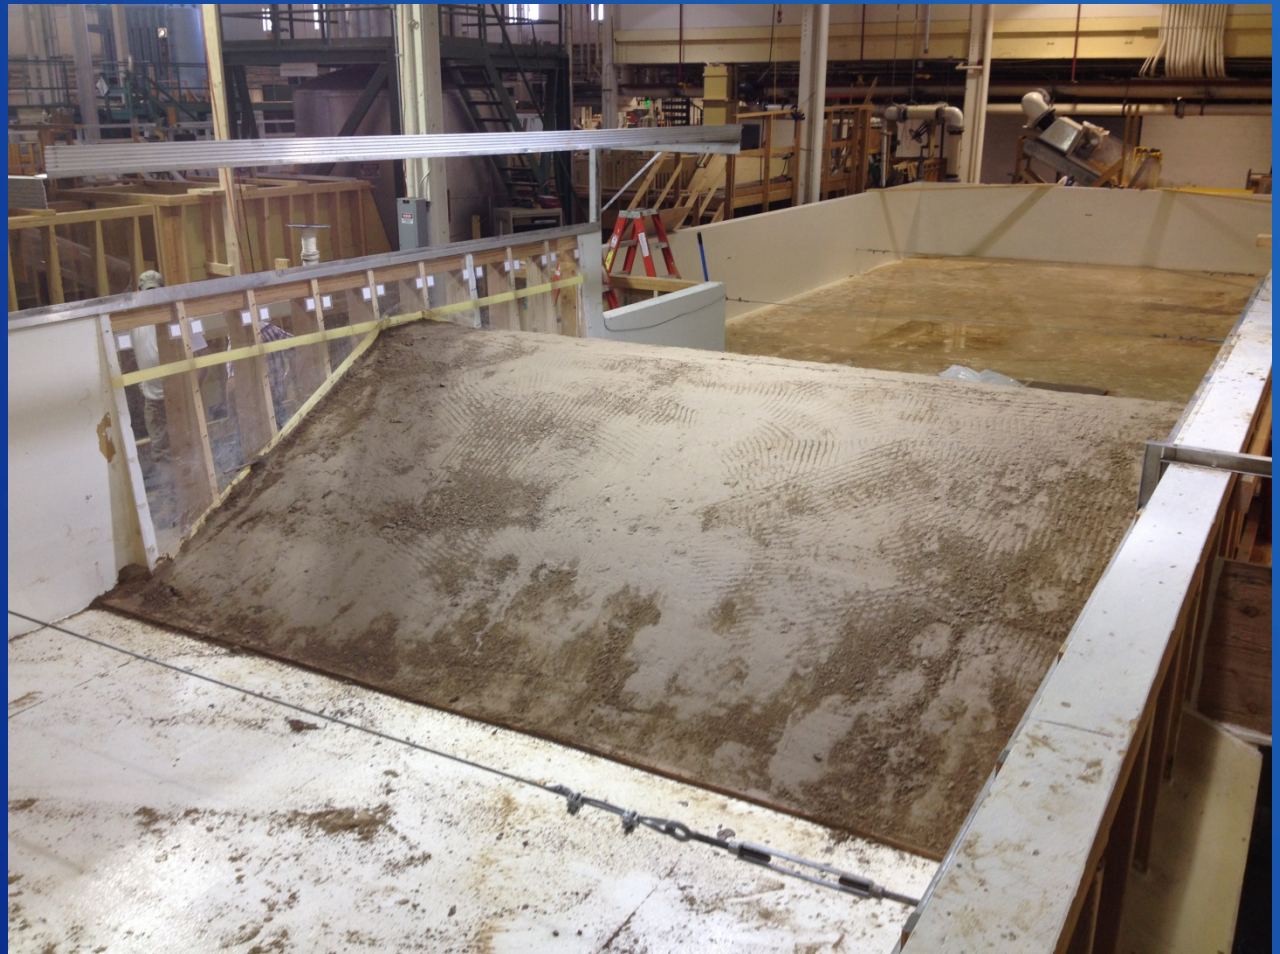
- 13-ft wide, 3-ft high embankment
- Inclined abutment (1:10), acrylic for viewing
- Large tailbox to contain breach outflow
- Headbox spillway with adjustable crest to maintain steady reservoir level

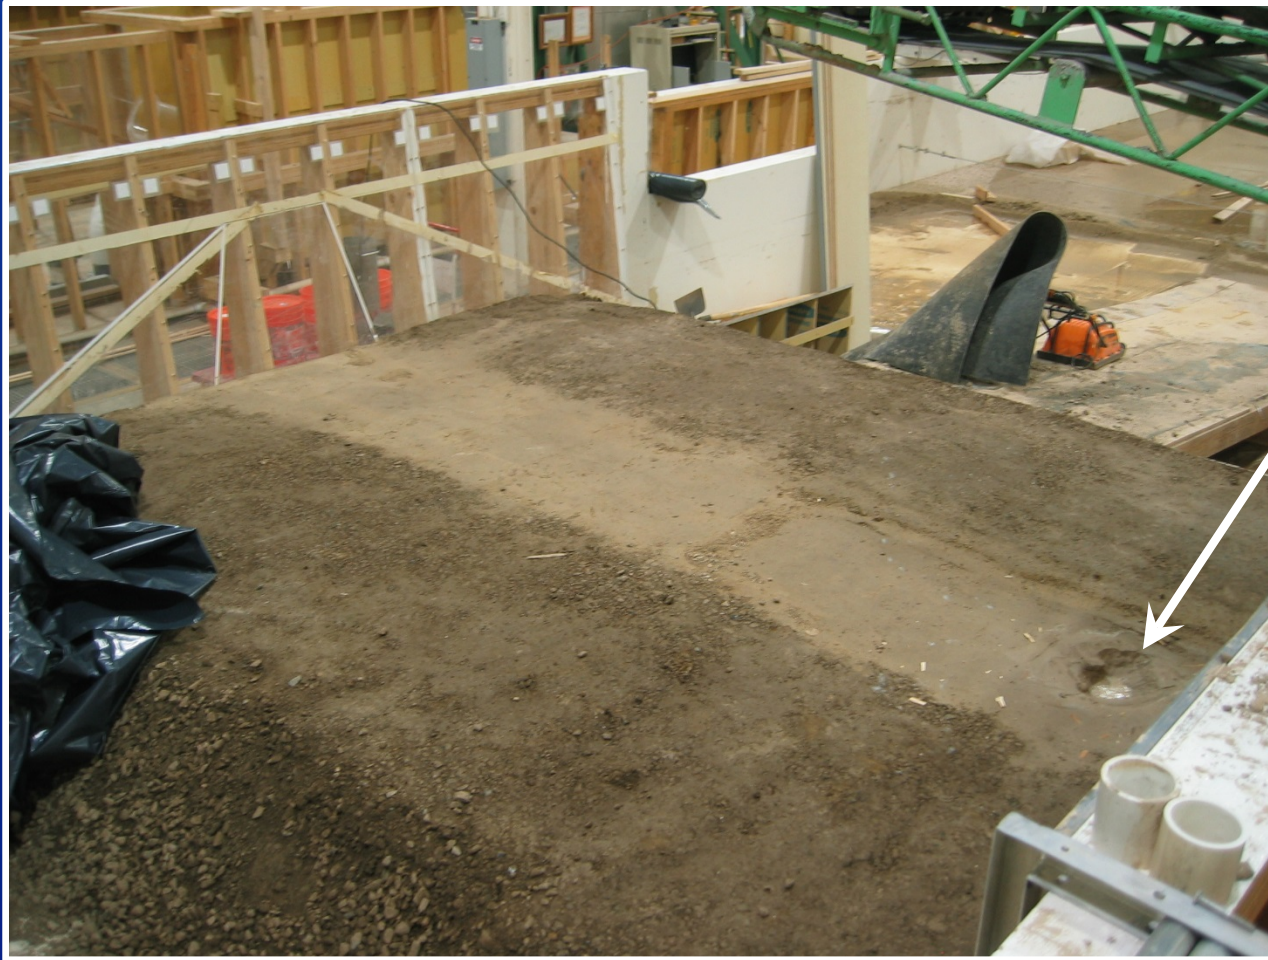
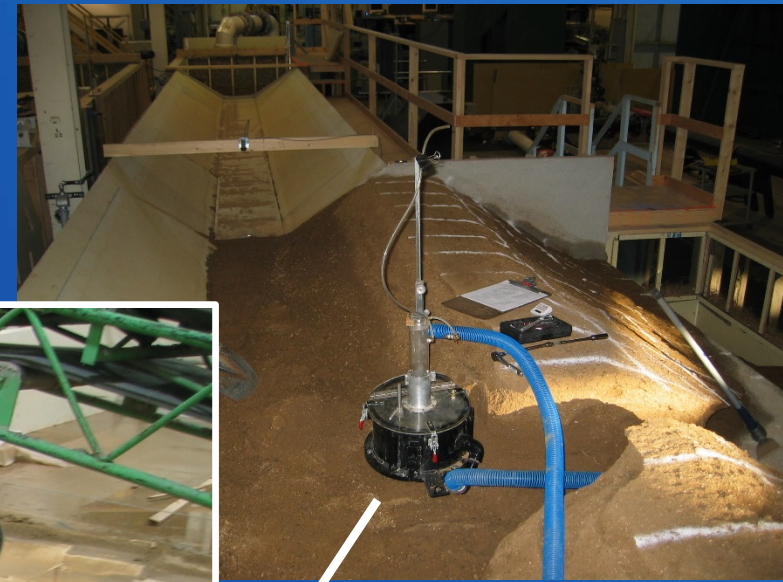
# JET test of core

Sand cone tests  
also performed to  
measure density  
of core and  
gravel zones

Approx. 100% of  
standard Proctor  
for all zones

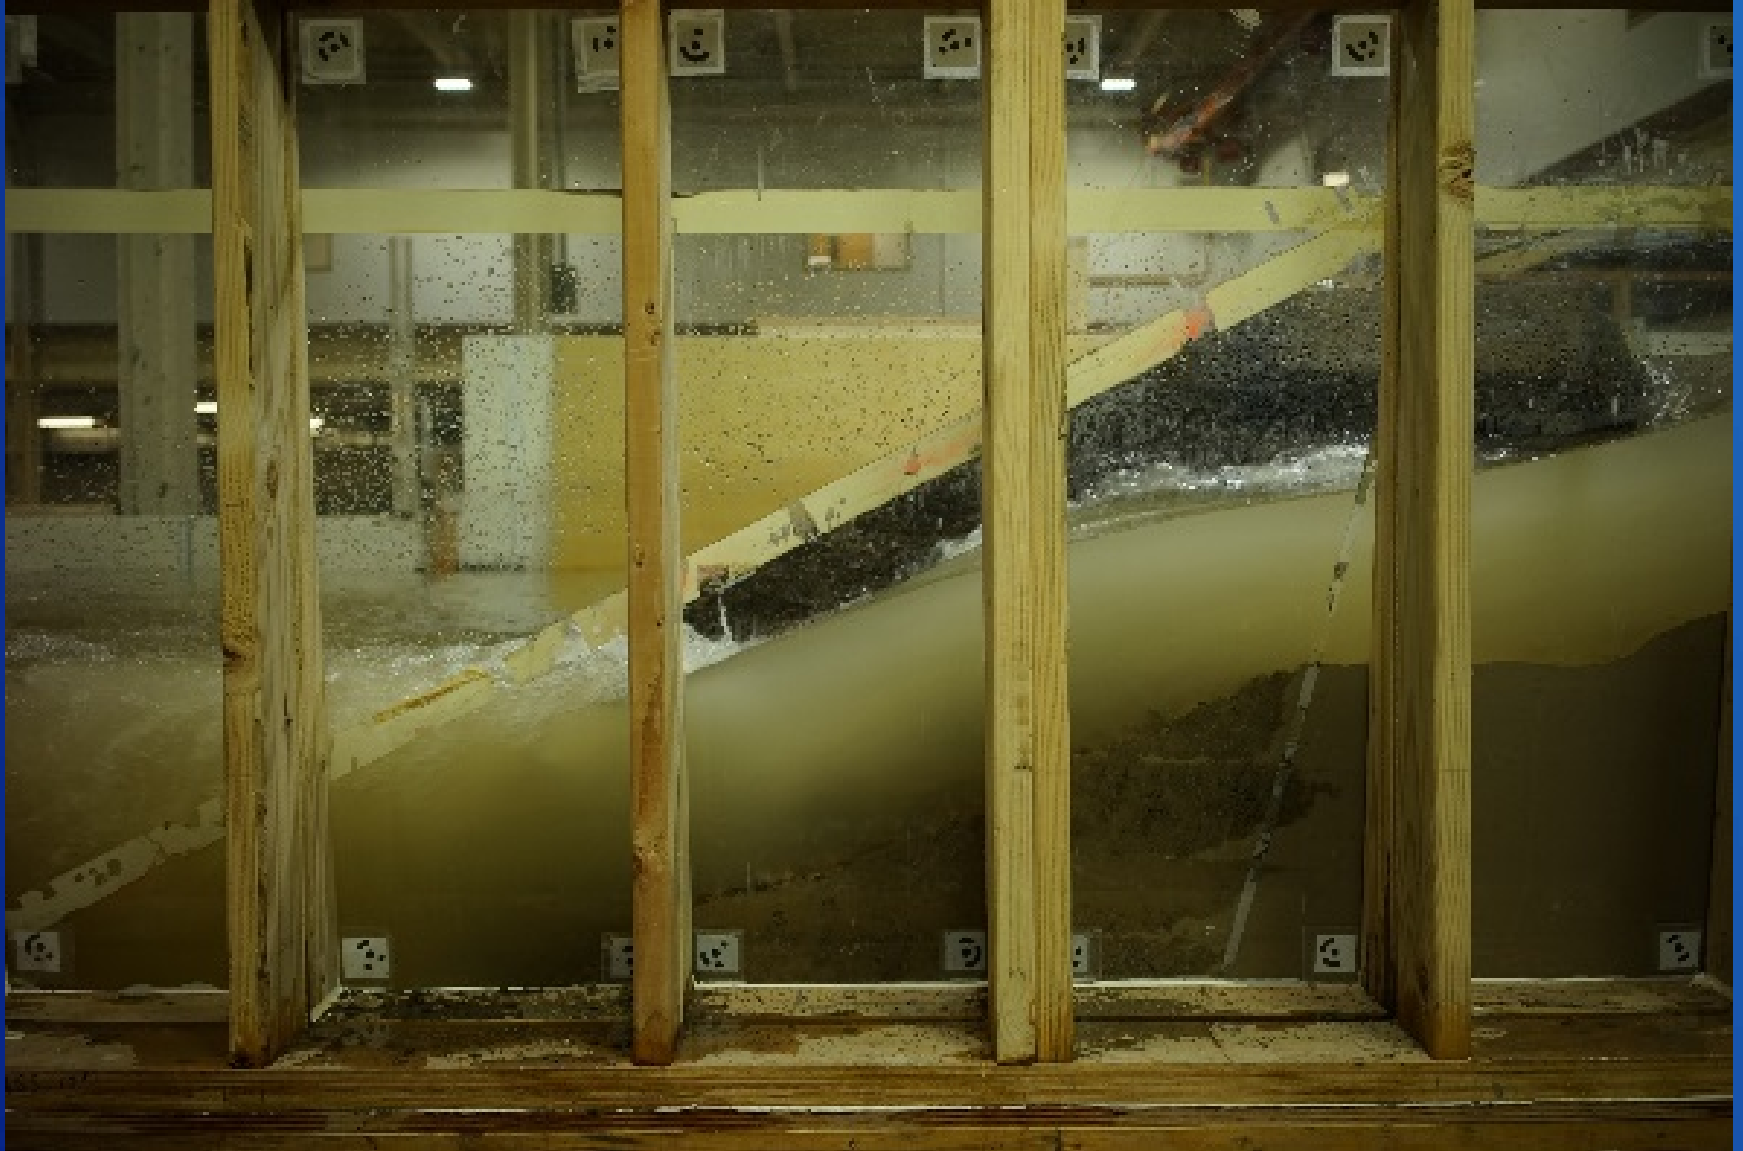
# Overtopping Test – 180 minutes

**End of Test**

1:17:00	2.16	0.38	2.5	3.02	0.49	0.148	0.204	0.82	1.21
2:00:00	2.25	0.61	3.63	2.66	0.45	0.201	0.141	0.88	0.73
3:00:00	2.38	0.64	4.55	3.00	0.32	0.157	0.177	0.95	0.41

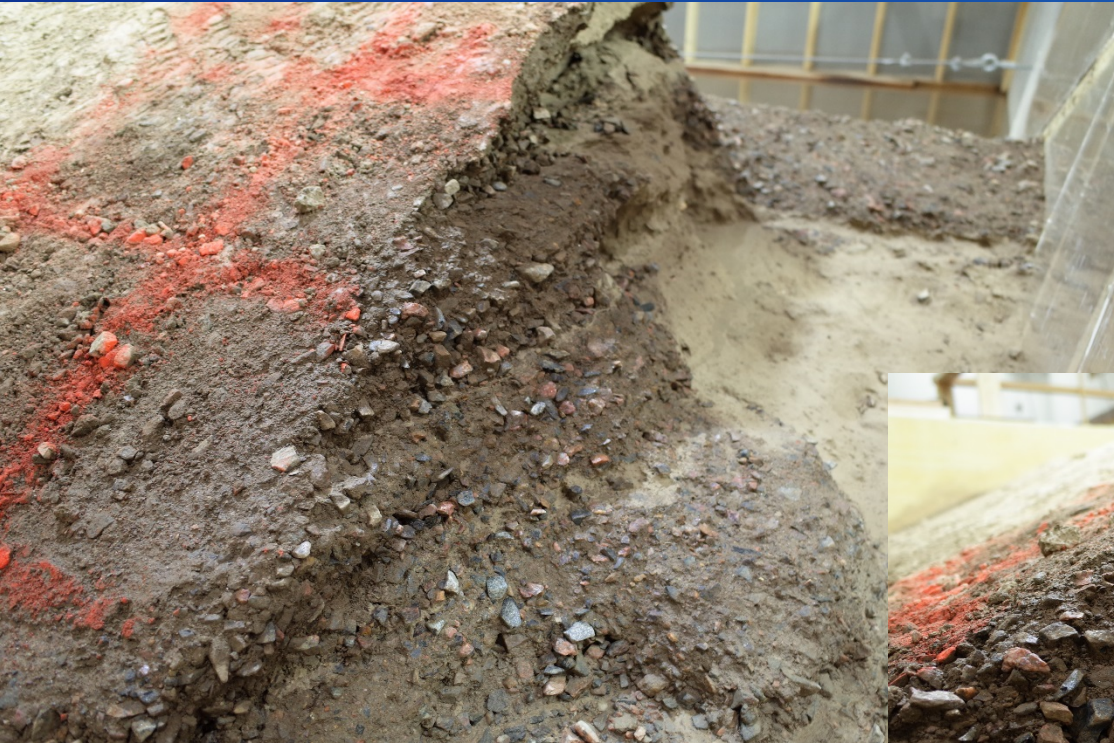
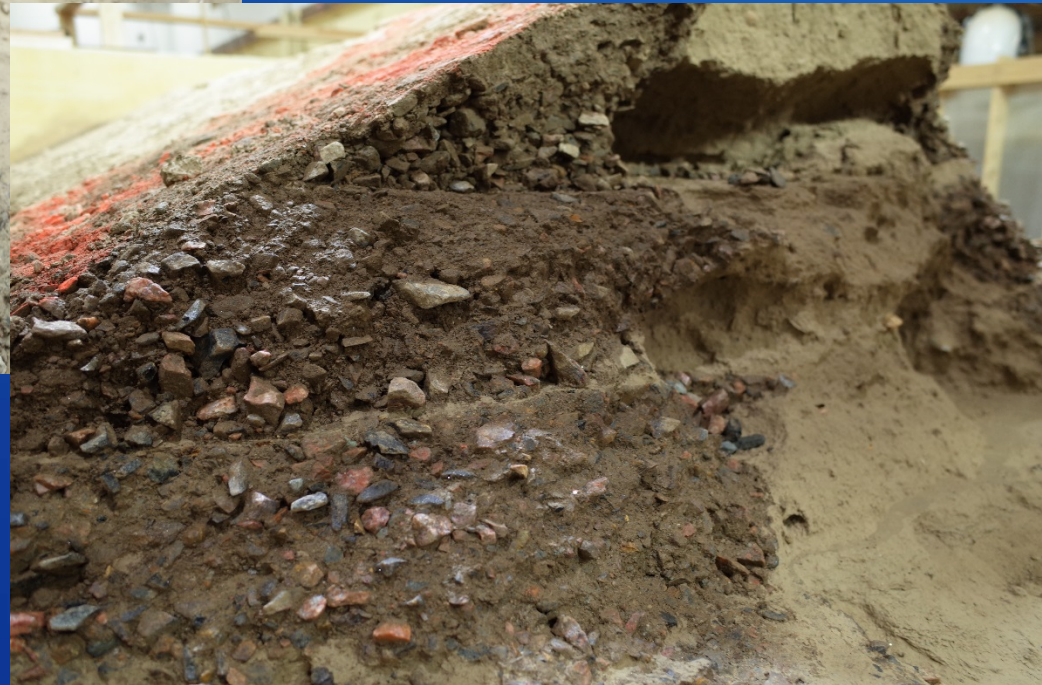
# Material Behavior - cohesive

- Although core and gravel zones both showed cohesive behavior (near-vertical sidewalls), erosion did not adopt a headcut pattern
- Surface erosion was dominant
  - Lack of tailwater pool to provide recirculation and accelerate erosion at toe

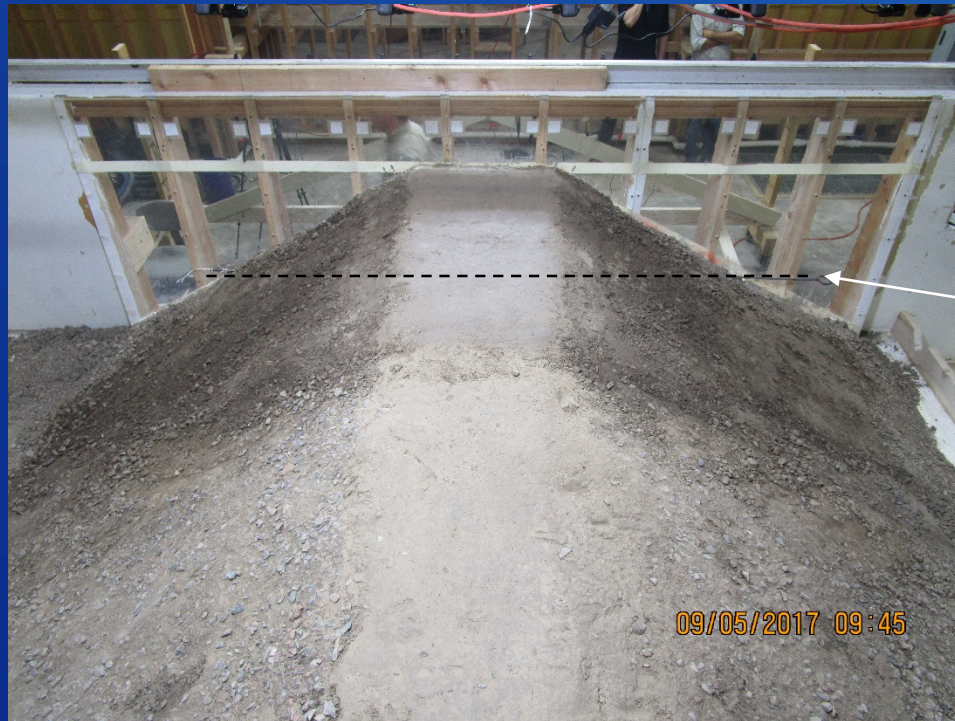
- Embankment was reconstructed only in the area affected by first test (near abutment)

1/2" rebar  
18 inches below crest

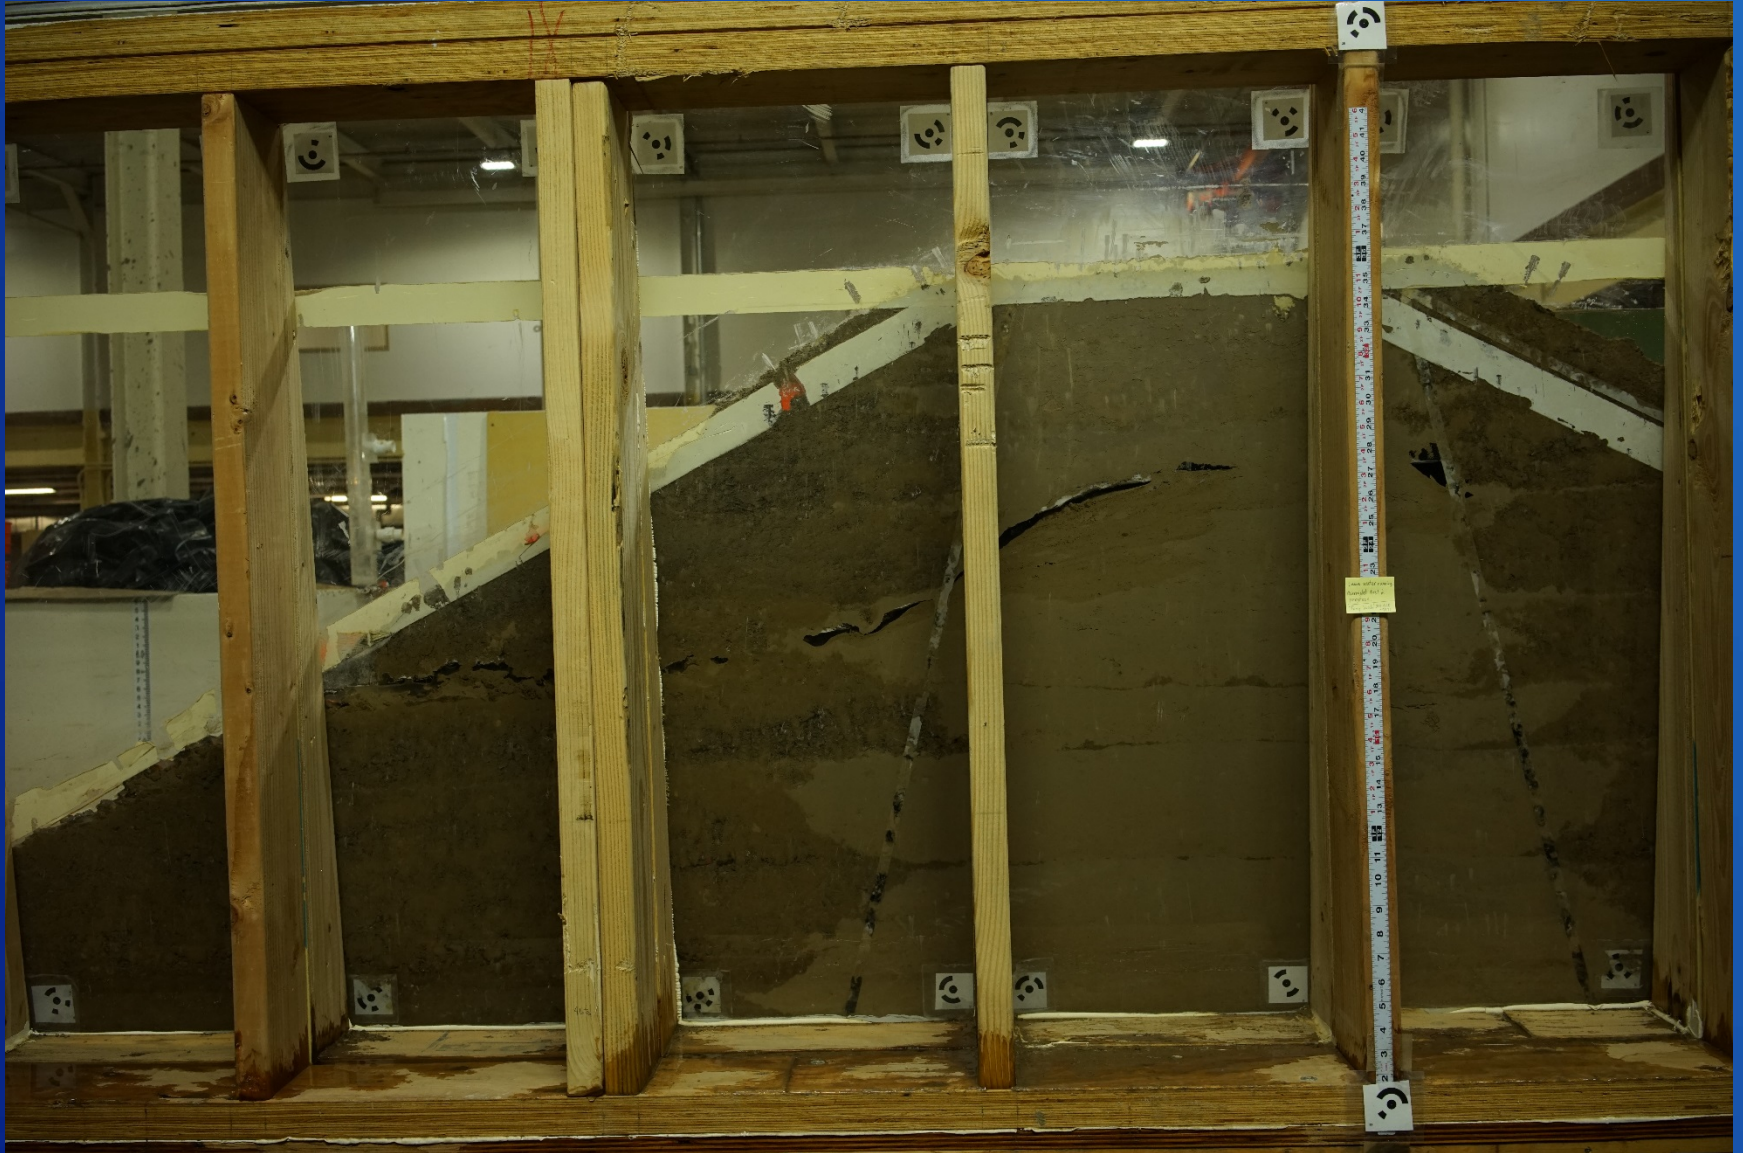
# Internal Erosion – 15 hours

- Erosion process is leading to a slow “stoping” failure
  - Upward migration of erosion channel as roof slowly collapses and void increases in size
  - As stope rises, this could eventually cause a collapse of the crest that could produce...
    - Overtopping
    - Shortened seepage path -- increased hydraulic gradient
- Downstream and upstream gravel zones limiting flow, keeping process slow
