| Project Name: | Clinch River Project |
| Project Location: | Oak Ridge, TN |

Joint Roughness Profiles by ASTM D5607

Sliding Friction Test of Rock by ASTM D5607-08 ⁽¹⁾

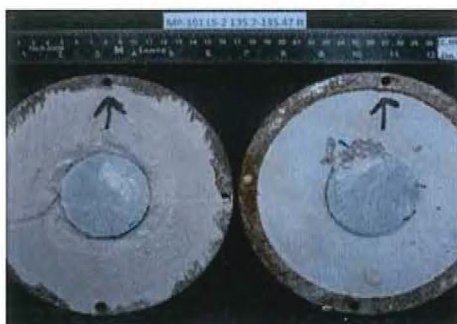
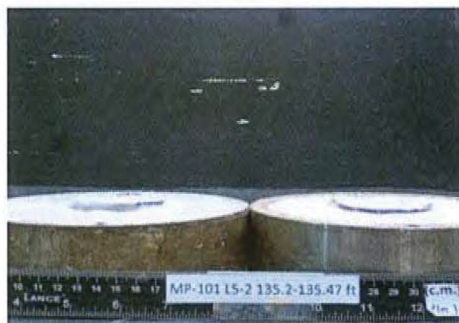
| Sample Description: | NA After test |

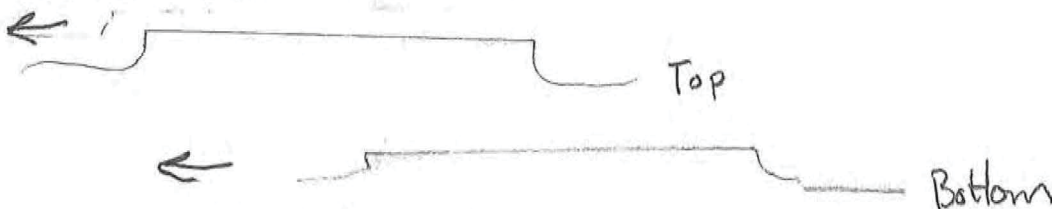
Sliding Friction Failure Shear Surface

Normal Load: 150 psi

Joint Roughness Coefficient: 0-2

Note: Surface Roughness measured in the direction of shear displacement. Joint Roughness Coefficient based on ASTM D5607 Figure 4.

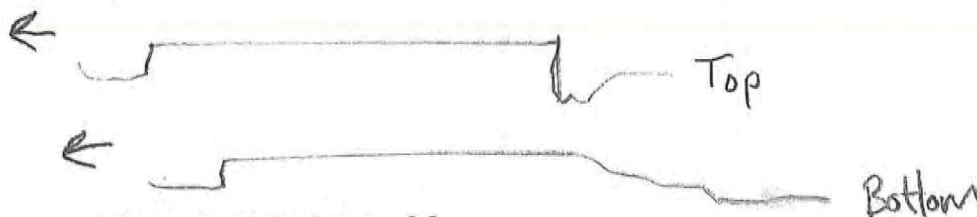
Sliding Friction Failure Shear Surface

Normal Load: 200 psi

Joint Roughness Coefficient: 0-2

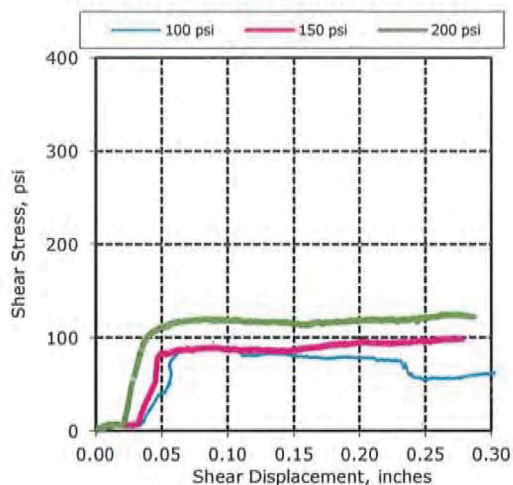
Shear Stress vs. Shear Displacement

| Parameter | Point 1 | Point 2 | Point 3 | Point 4 | Point 5 |
|---|---|---|---|---|---|
| Peak Shear Stress, psi | 90 | 100 | 125 | --- | --- |
| Post-Peak Shear Stress, psi | 61 | 92 | 121 | --- | --- |

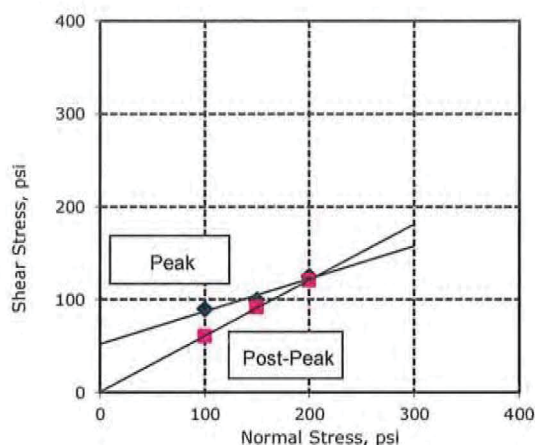
Shear Stress vs. Normal Stress

| Peak Friction Angle: | 19.3 | degrees |
| Peak Cohesion: | 52.4 | psi |
| Post Peak Friction Angle: | 31.0 | degrees |
| Post Peak Cohesion: | 1.3 | psi |

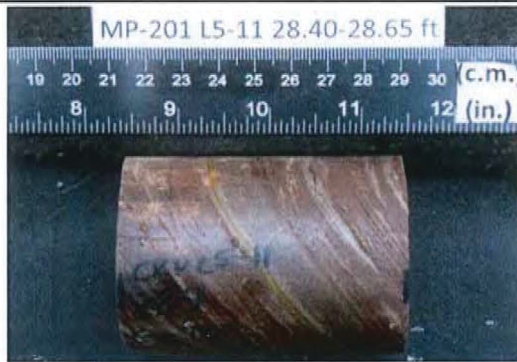
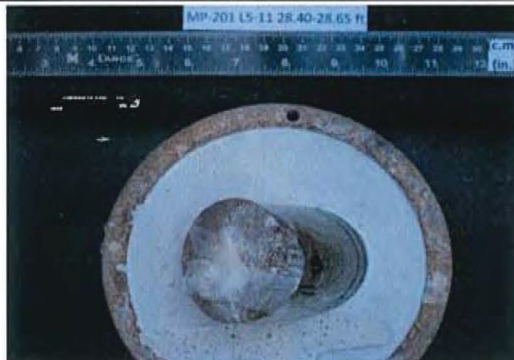
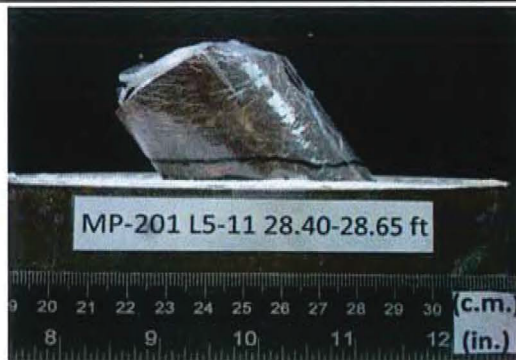
| Sample Description: | NA Before test |

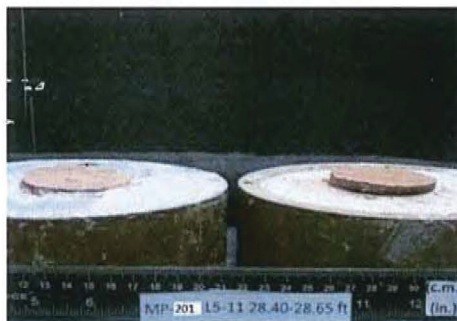
| Sample Description: | NA After test |

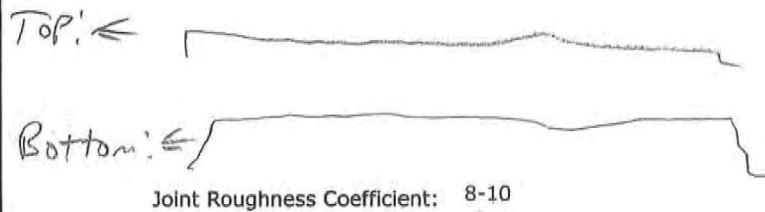
Sliding Friction Initial Shear Surface

Initial JRC: 8-10

Note: Surface Roughness measured in the direction of shear displacement. Joint Roughness Coefficient based on ASTM D5607 Figure 4.

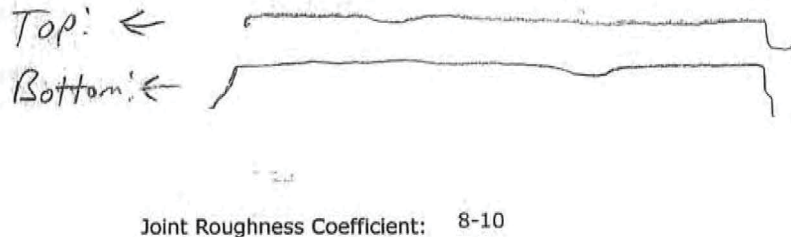
After Point 1 JRC: 8-10

Sliding Friction Failure Shear Surface

Normal Load:

100 psi

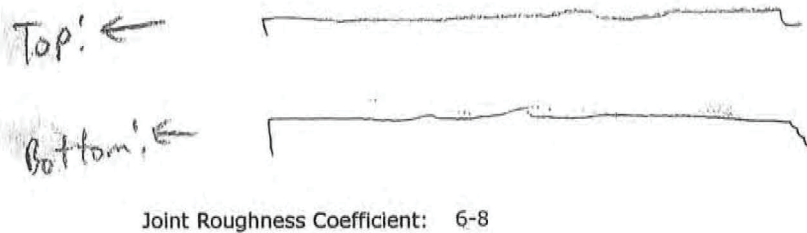
After Point 2 JRC: 6-8

Sliding Friction Failure Shear Surface

Normal Load:

150 psi

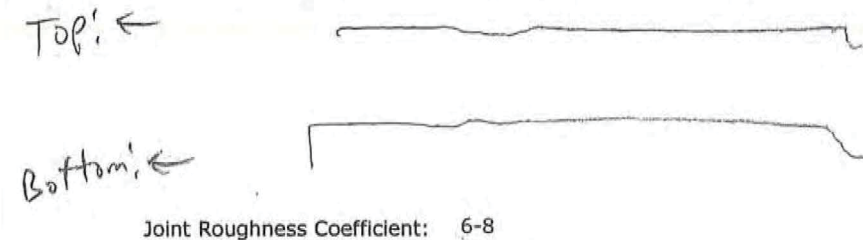
Final JRC: 6-8

Sliding Friction Failure Shear Surface

Normal Load:

200 psi

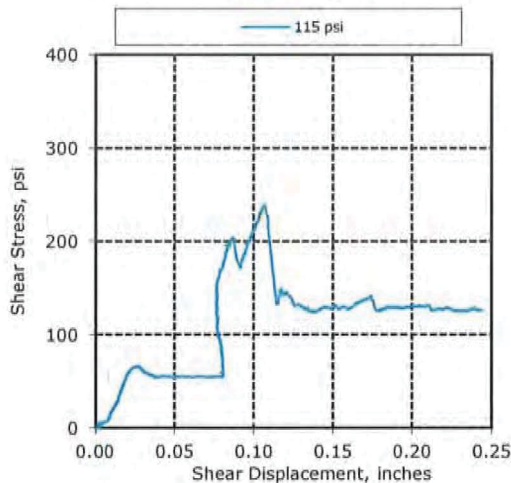
Shear Stress vs. Shear Displacement

| Parameter | Point 1 | Point 2 | Point 3 | Point 4 | Point 5 |
|---|---|---|---|---|---|
| Peak Shear Stress, psi | 239 | NA | NA | NA | NA |
| Post-Peak Shear Stress, psi | 126 | NA | NA | NA | NA |

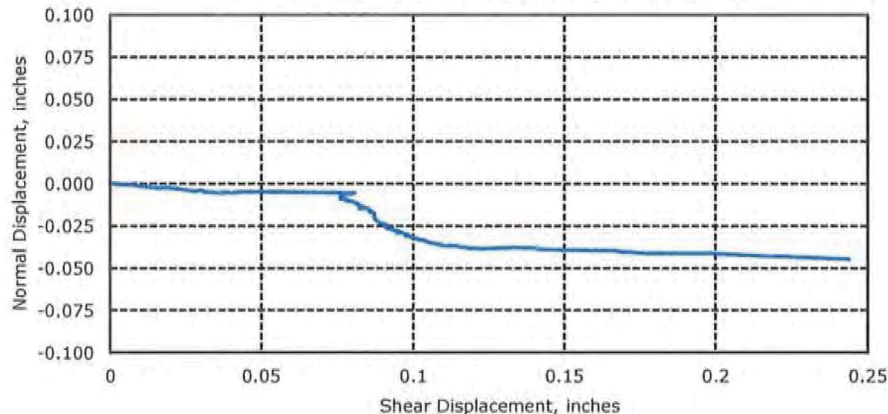
Normal Displacement vs. Shear Displacement

- (1) Deviation approved by Bechtel: Test specimens coated with polyurethane spray
- (2) Specimen volume is determined with three digital caliper measurements of length and diameter. Due to the irregular shape of the specimen, the calculated volume and bulk density values may not represent actual values for the specimen. Vertical LVDT 3, located behind the specimen, did not record data during the test.

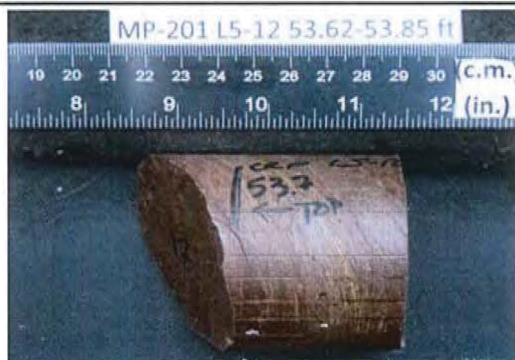
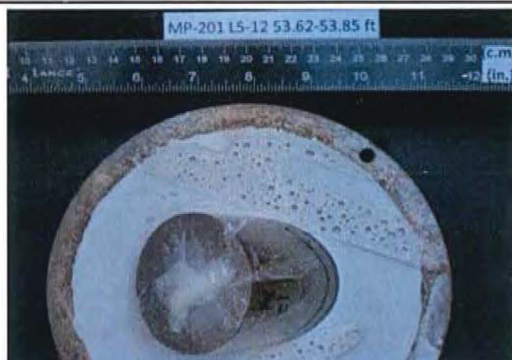
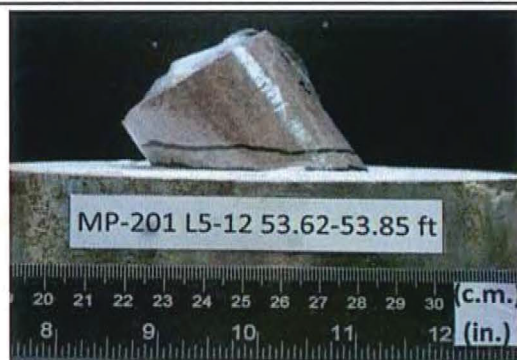
| Sample Description: | NA Before test |
