Primary Water Stress Corrosion Cracking of High-Chromium, Nickel- Base Welds Near Dissimilar Metal Weld Interfaces

The report summarizes the results of a testing program to evaluate the stress corrosion cracking (SCC) susceptibility at or near the interface between Alloy 52 and 152 weld metals and other weld or base metals. Alloys 52 and 152 are high-chromium weld metals used in reactor pressure vessel head penetration nozzles and as overlays, inlays, or onlays for dissimilar metal piping welds. Alloys 52 and 152 typically show very low SCC growth rates in laboratory testing and are not known to have cracked in service. Nevertheless questions remain as to whether the localized dilution of chromium content or the presence of microstructural features near the interface with the low-chromium weld metals Alloy 82 and 182, as in the case of a weld overlay (WOL), or with steel, as in the case of a head penetration nozzle, could affect the SCC response. For this study, SCC growth rates were measured on a WOL mockup with Alloy 52M (a compositional variant of Alloy 52) on Alloy 182 and on a butt weld mockup with Alloy 152 joined to low-alloy steel (LAS). For the WOL mockup, tests were perf

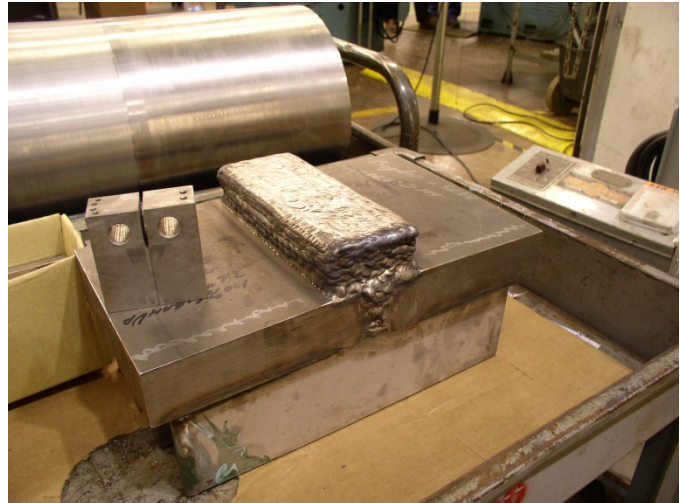
Figure 2-1 (a) Conceptual schematic (units in inch), and (b) photograph of the resulting Alloy 52M-182 weld overlay. The continuous welded restraints used during the Alloy 52M WOL deposition are visible in the photograph.

The Alloy 52M (Heat NX75W1TK) WOL (Figure 2-1) was deposited on top of an existing Alloy 182 weld [5]. The chemical compositions of the two welds provided in Table 2-1 shows that the Cr concentrations for the two alloys were 29.98% and 14.35%, respectively. The Alloy 182 weld had been tested previously (without the overlay), and a set of both cyclic and SCC CGR data existed for this weld [6].

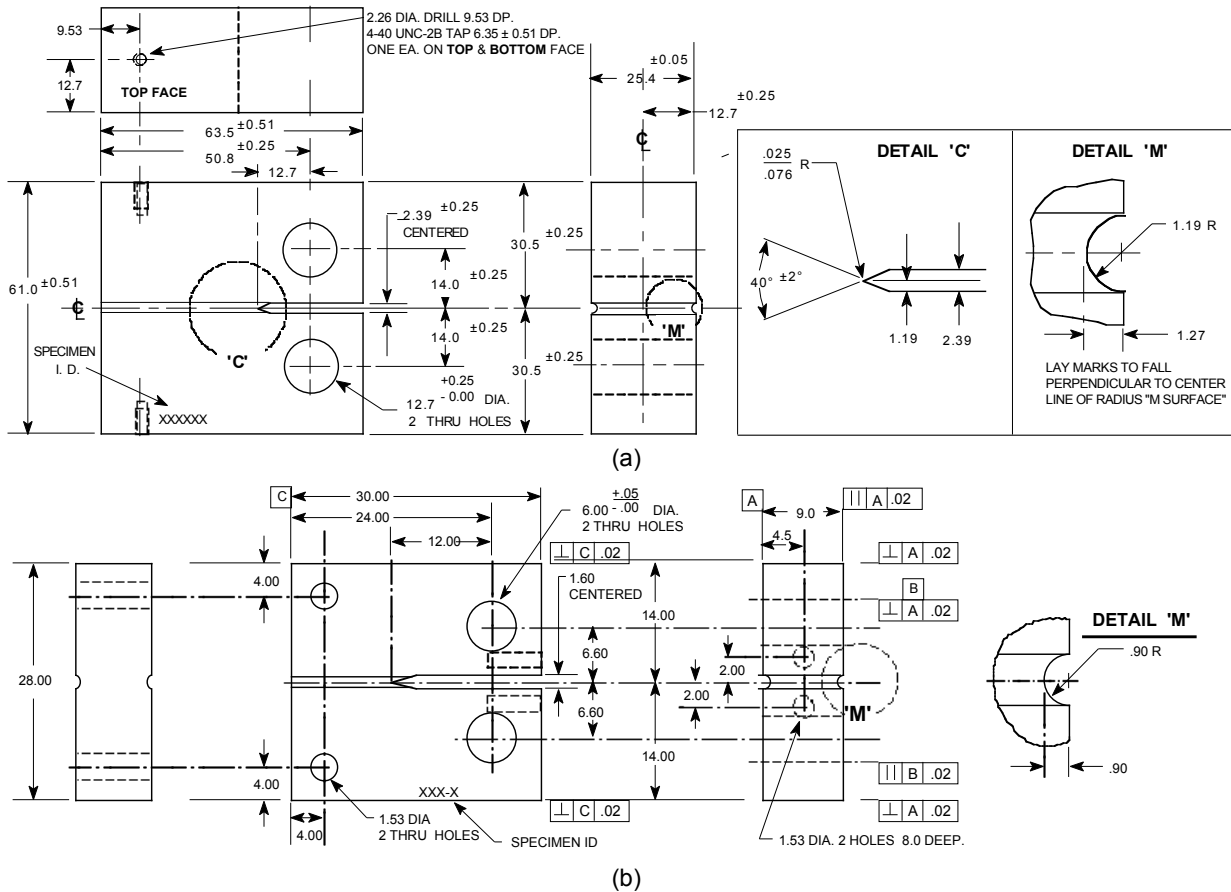
Figure 2-3 Configuration of the (a) 1-T and (b) 1/2-T CT specimens used for this study. Dimensions are in mm.

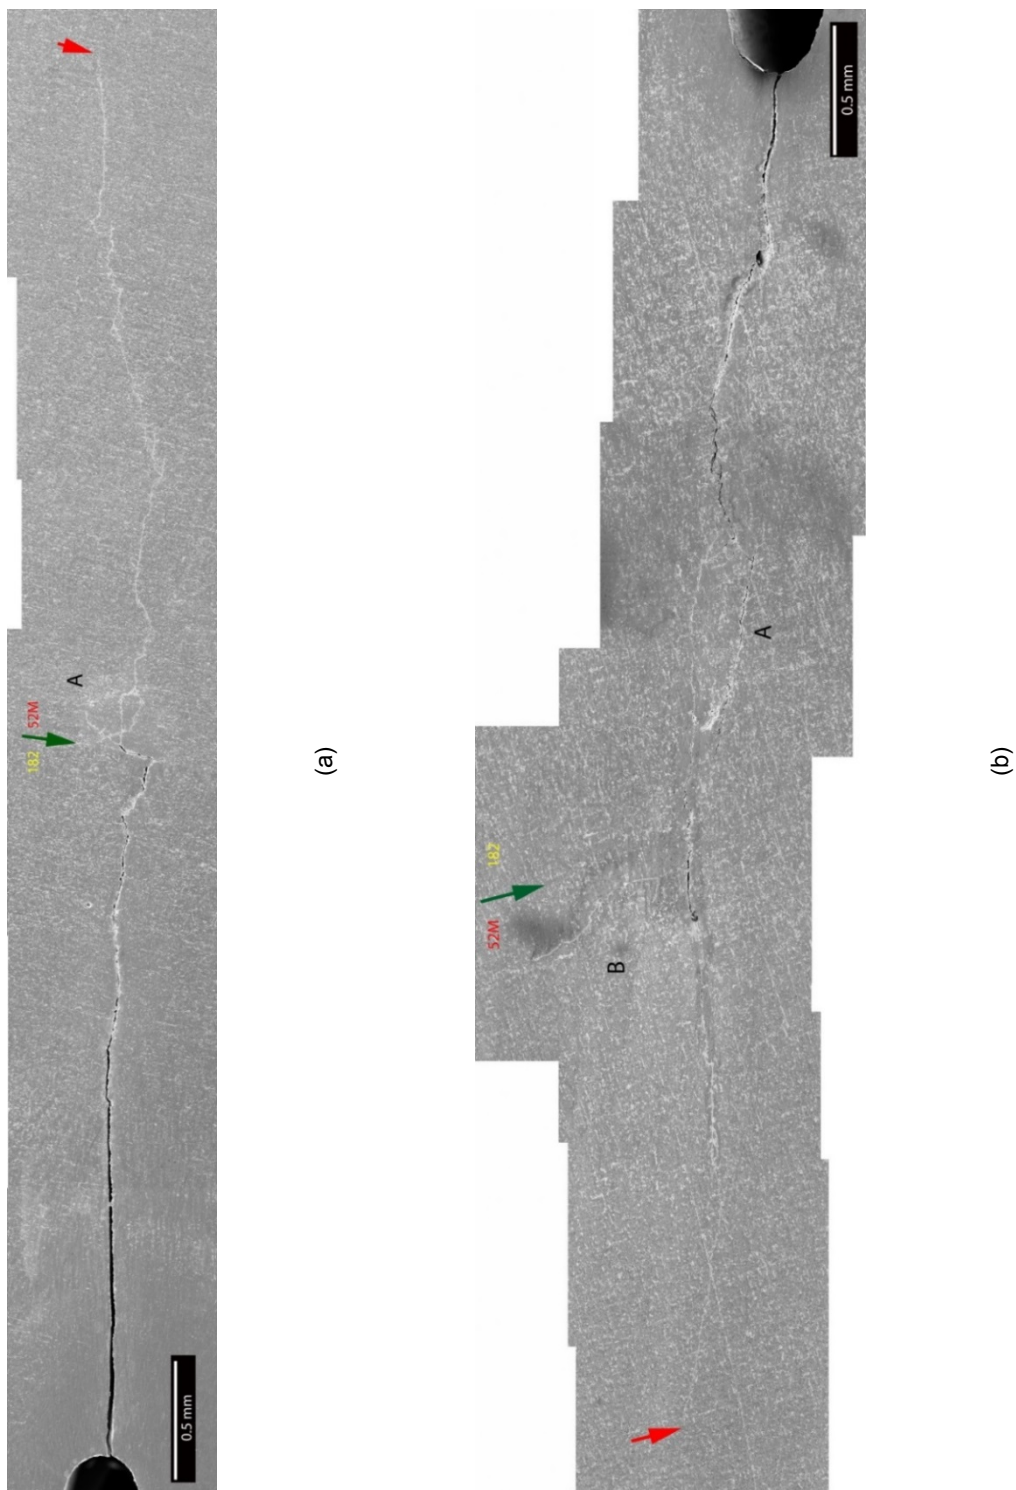
Figure 3-4 The two side surfaces of Specimen A52M-182-TS-3. Crack advance is from left to right (a), and right to left (b). The green arrows show the interface between the two welds and the red arrows indicate the end of the test.

The first step in the post-test examination of this specimen involved the two side surfaces. For this purpose, the sides of the specimen were ground to remove the side grooves, then polished, and etched. The SEM images of the two cross sections are shown in Fig. 3-4. As expected, the crack initiated in the Alloy 182 weld and propagated into the Alloy 52M interface. In each figure, several locations of interest are marked, however, the region of highest interest was the interaction of the crack with the Alloy 52M WOL interface.

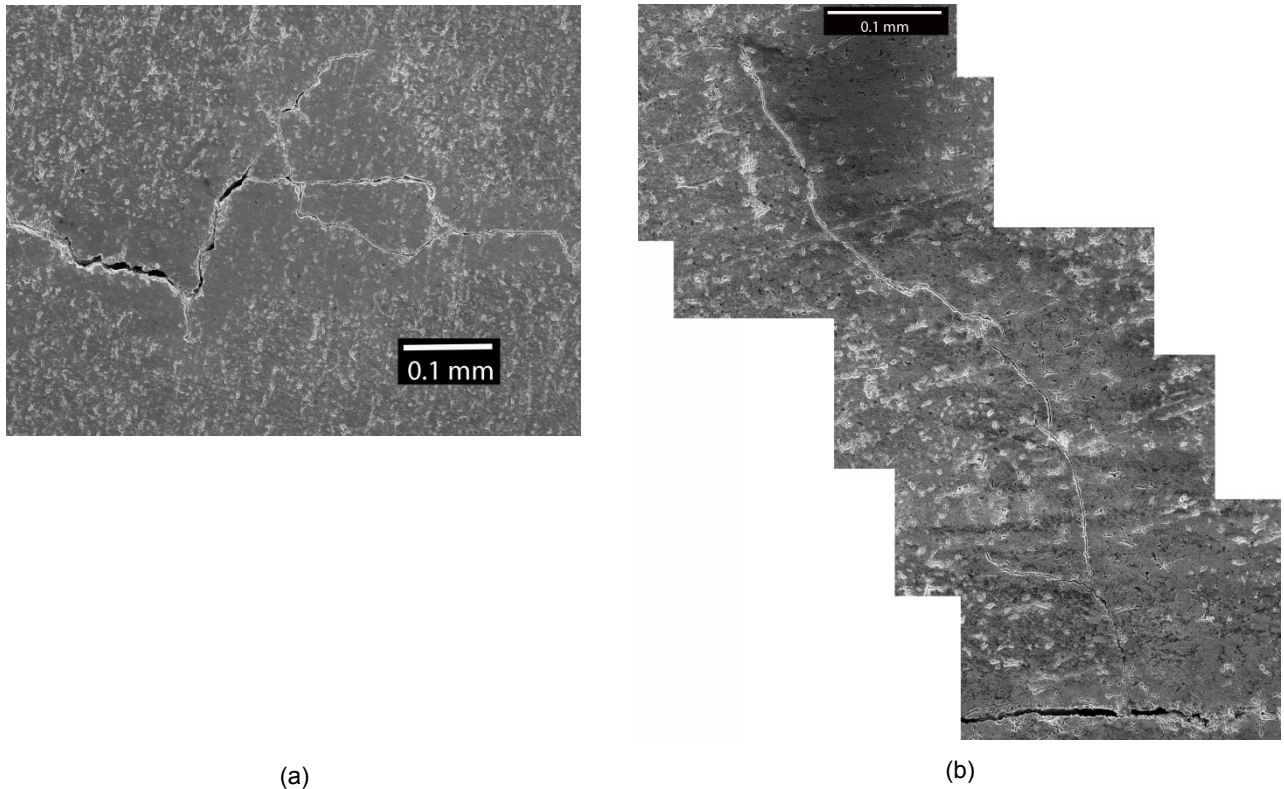
Figure 3-5 Interaction with the Alloy 52M interface (a) location A in Fig. 3-4a, crack propagation is from left to right, and (b) location B in Fig. 3-4b, crack propagation is from right to left.

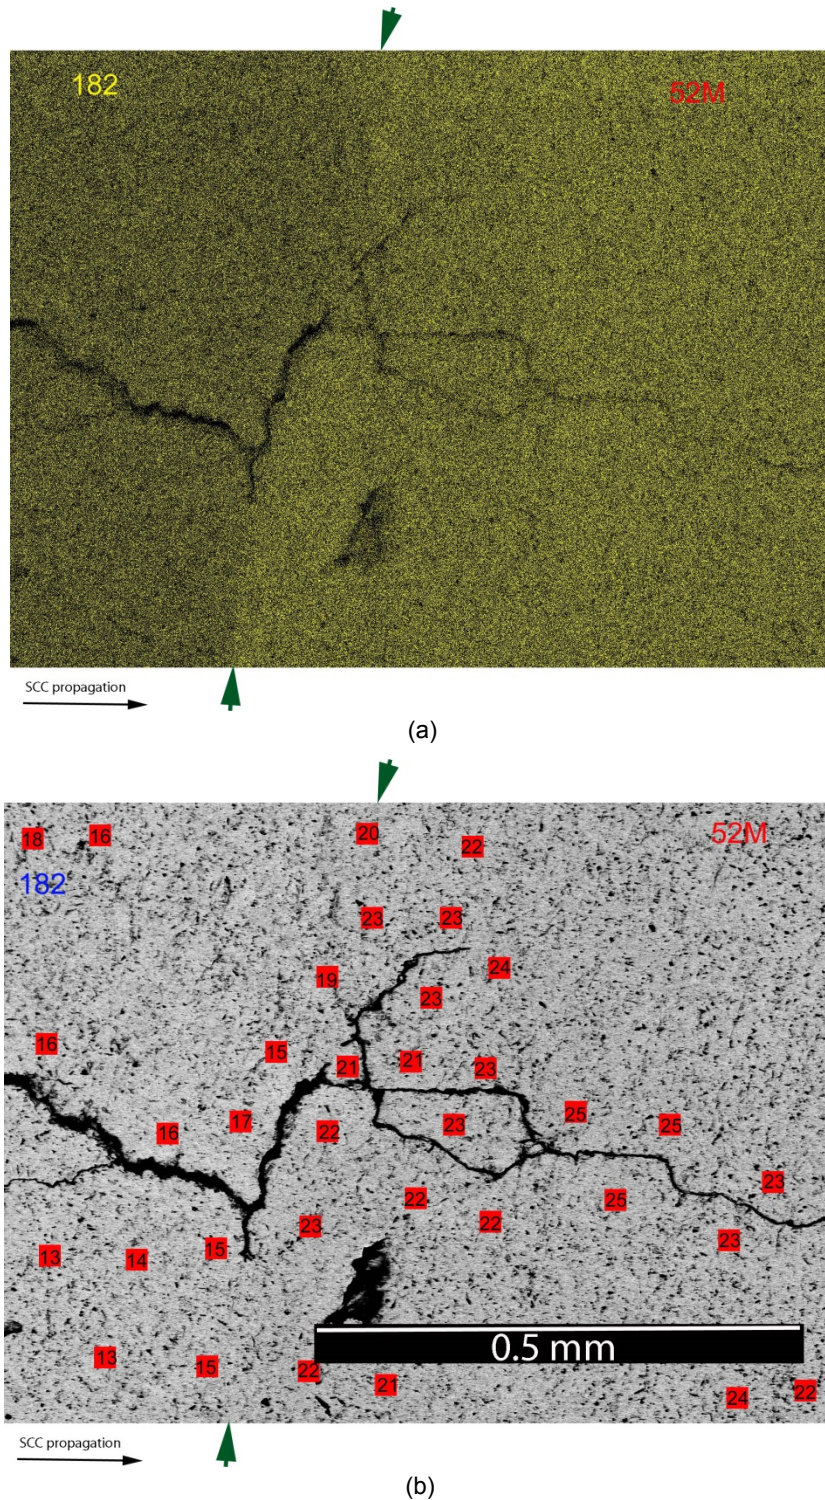
Figure 3-6 SCC interaction with the Alloy 52M WOL interface (location A in Fig. 3-4a): (a) overlap of SEM image and elemental map, and (b) Cr concentration (wt. %) at each location. Crack propagation is from left to right. Green arrows indicate the Alloy 52M-182 interface.

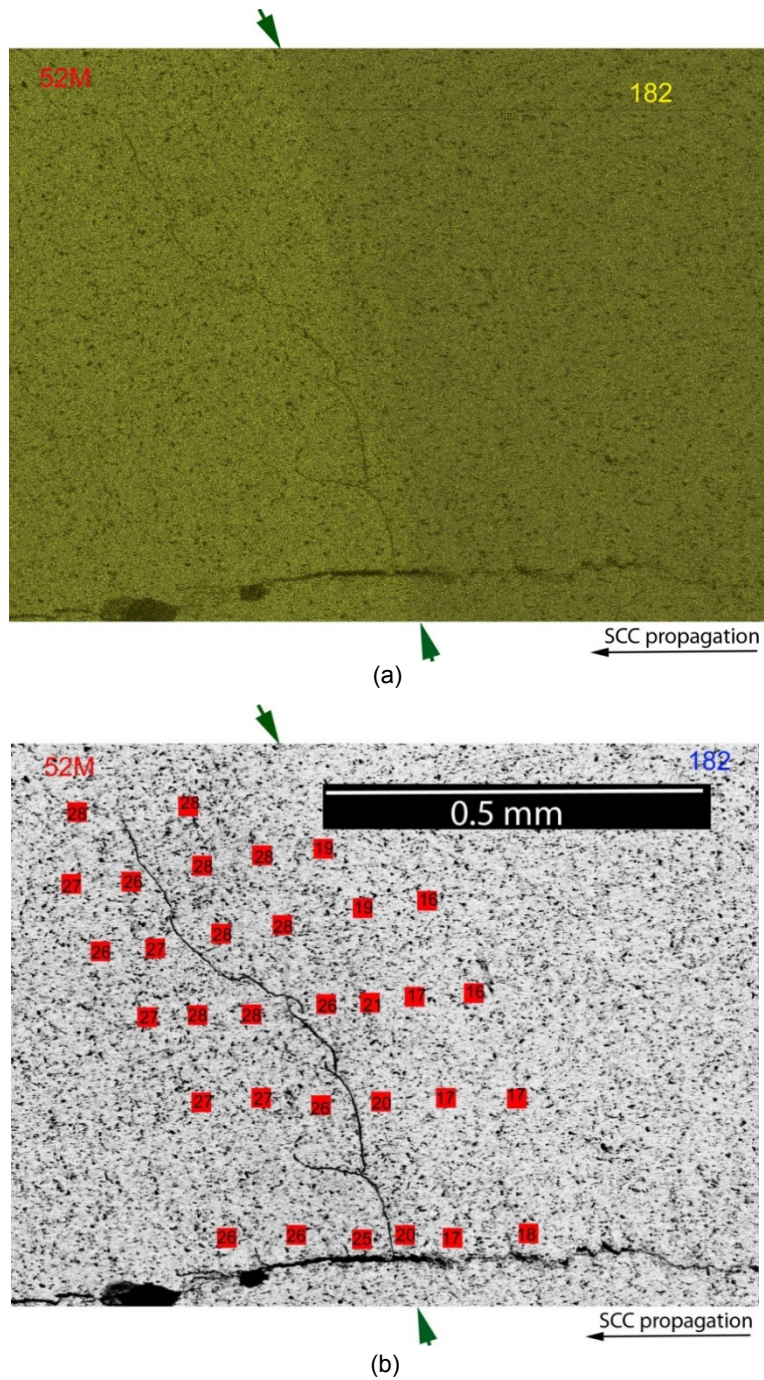
Figure 3-7 SCC interaction with the Alloy 52M WOL interface (location B in Fig. 3-4b): (a) overlap of SEM image and Cr map, and (b) Cr concentration (wt. %) at each location. Crack propagation is from right to left. Green arrows indicate the Alloy 52M-182 interface.

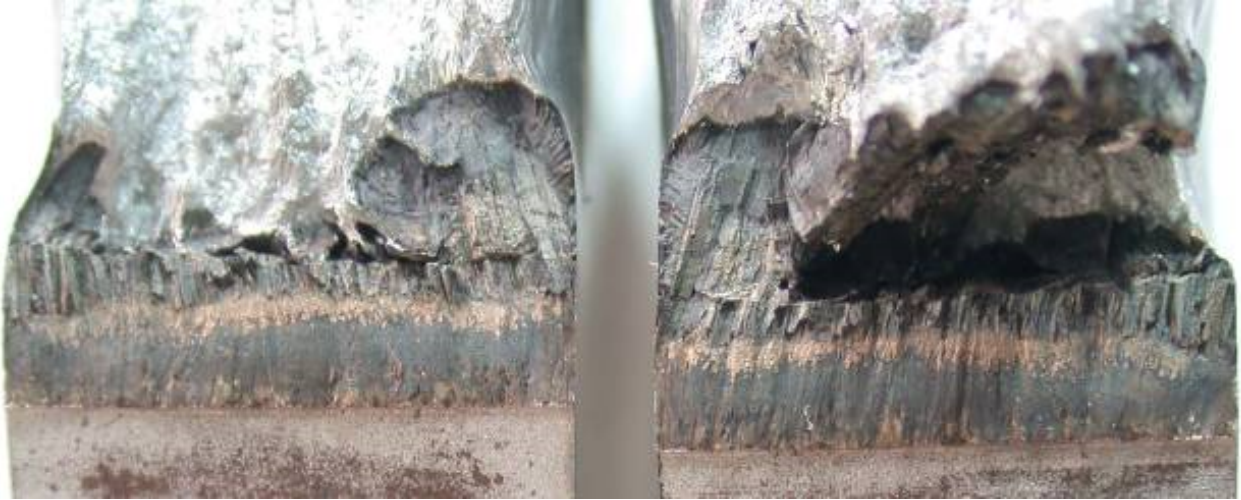
Figure 3-8 Fracture surfaces of Specimen A52M-182-TS-3.

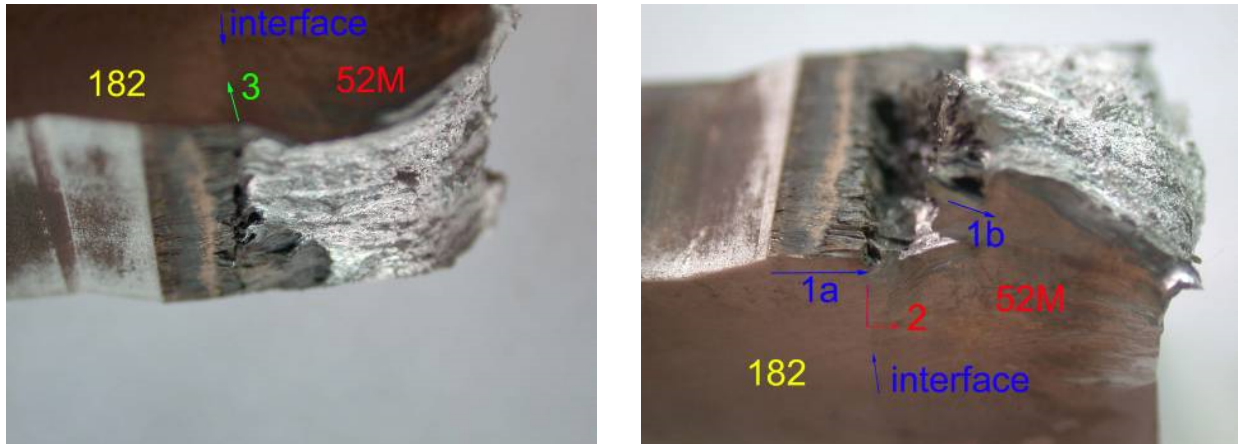
Figure 3-10 The two halves of fractured specimen A52M-182-TS-3.

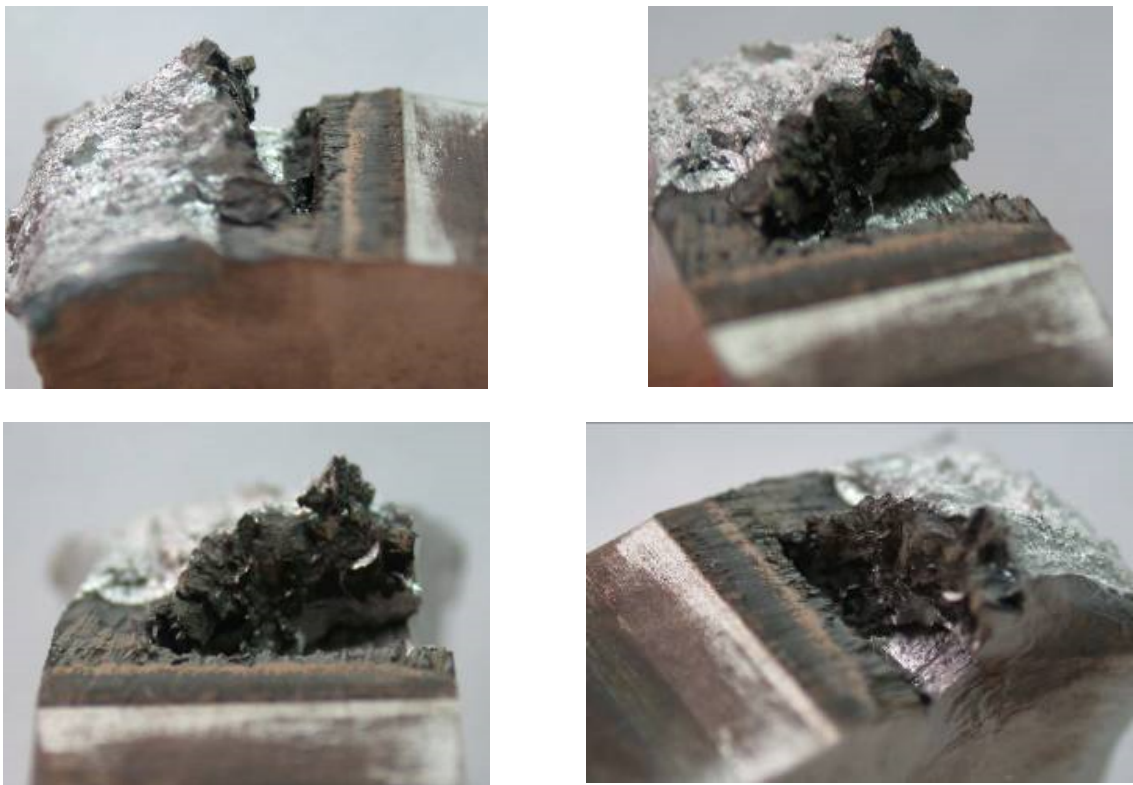
Figure 3-11 Fractured specimen A52M-182-TS-3.

Figure 3-11 shows additional pictures taken at various angles to better illustrate the severity of the cracking.

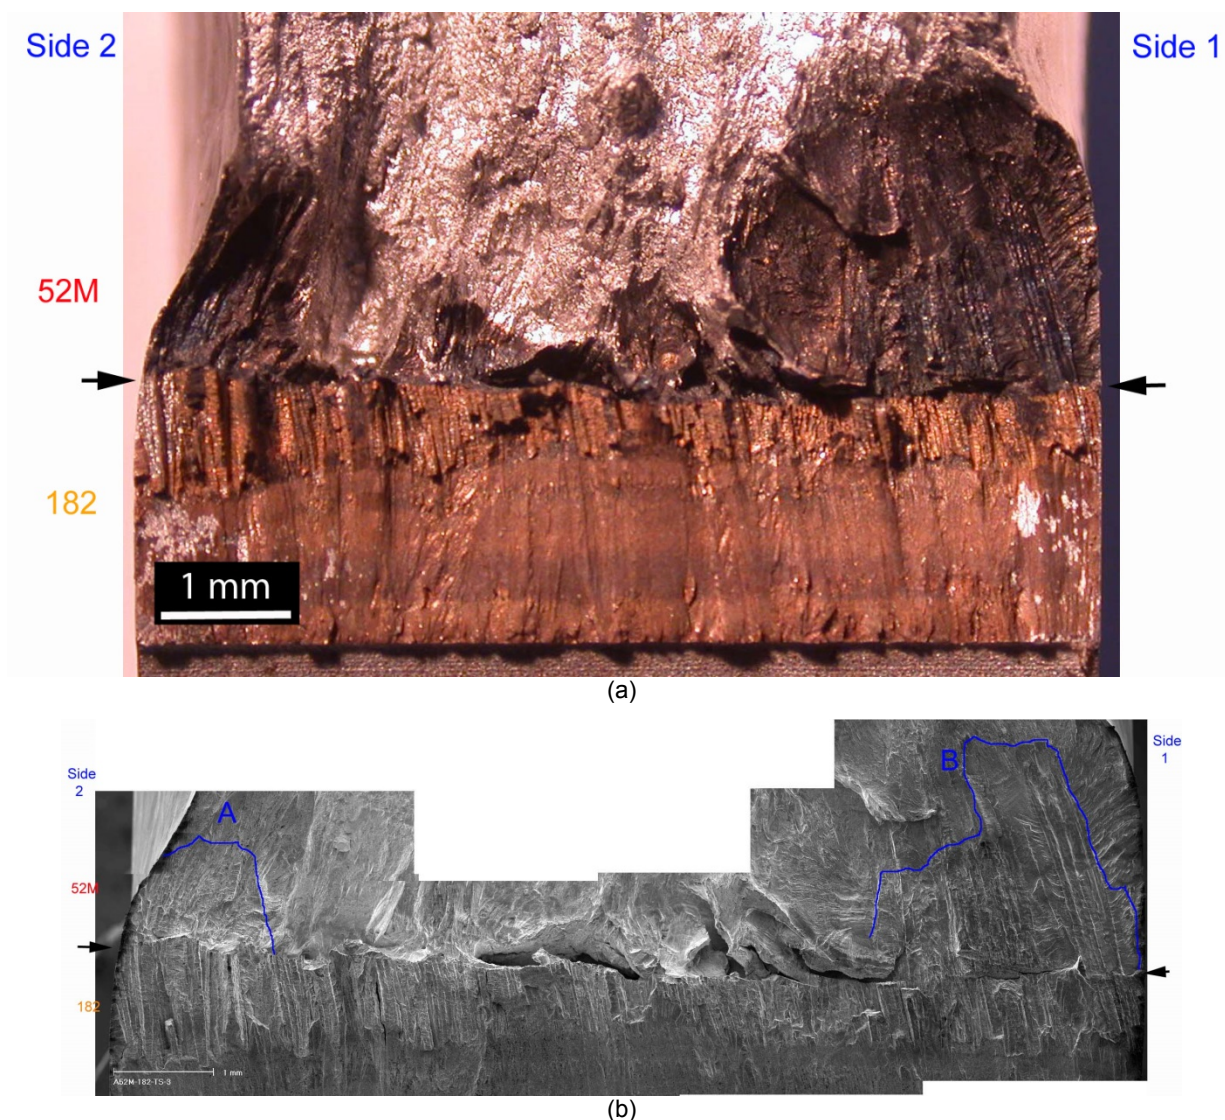
Figure 3-12 Fracture surface of Specimen A52M-182-TS-3 (a) photograph, and (b) SEM micrograph. Regions marked “A” and “B” represent the two most prominent regions of IG SCC propagation into the Alloy 52M WOL. Crack propagation is from bottom to top.

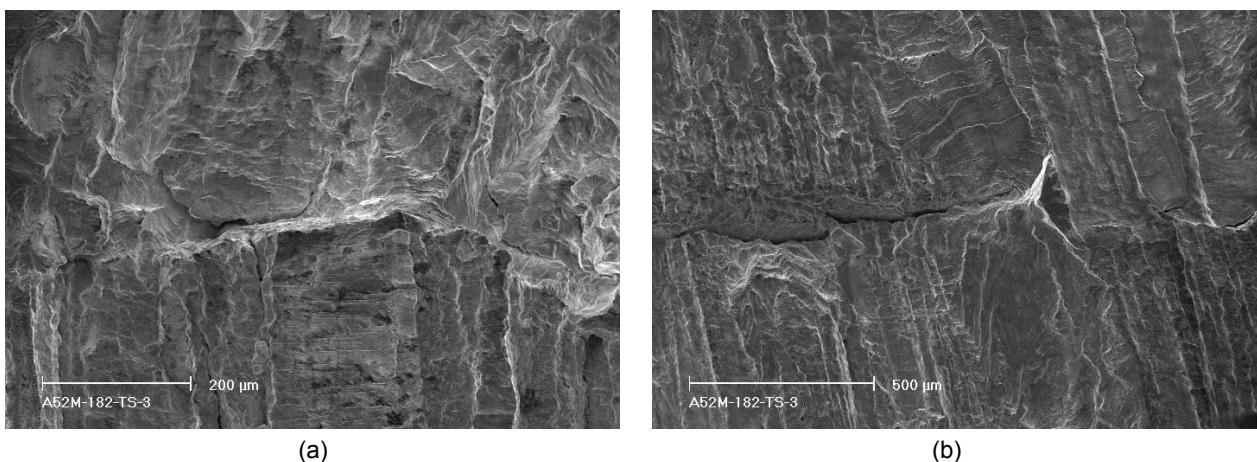
Figure 3-13 Crack transition across the Alloy 52M-182 interface at locations (a) A, and (b) in Fig. 3-12b. Crack advance is from bottom to top.

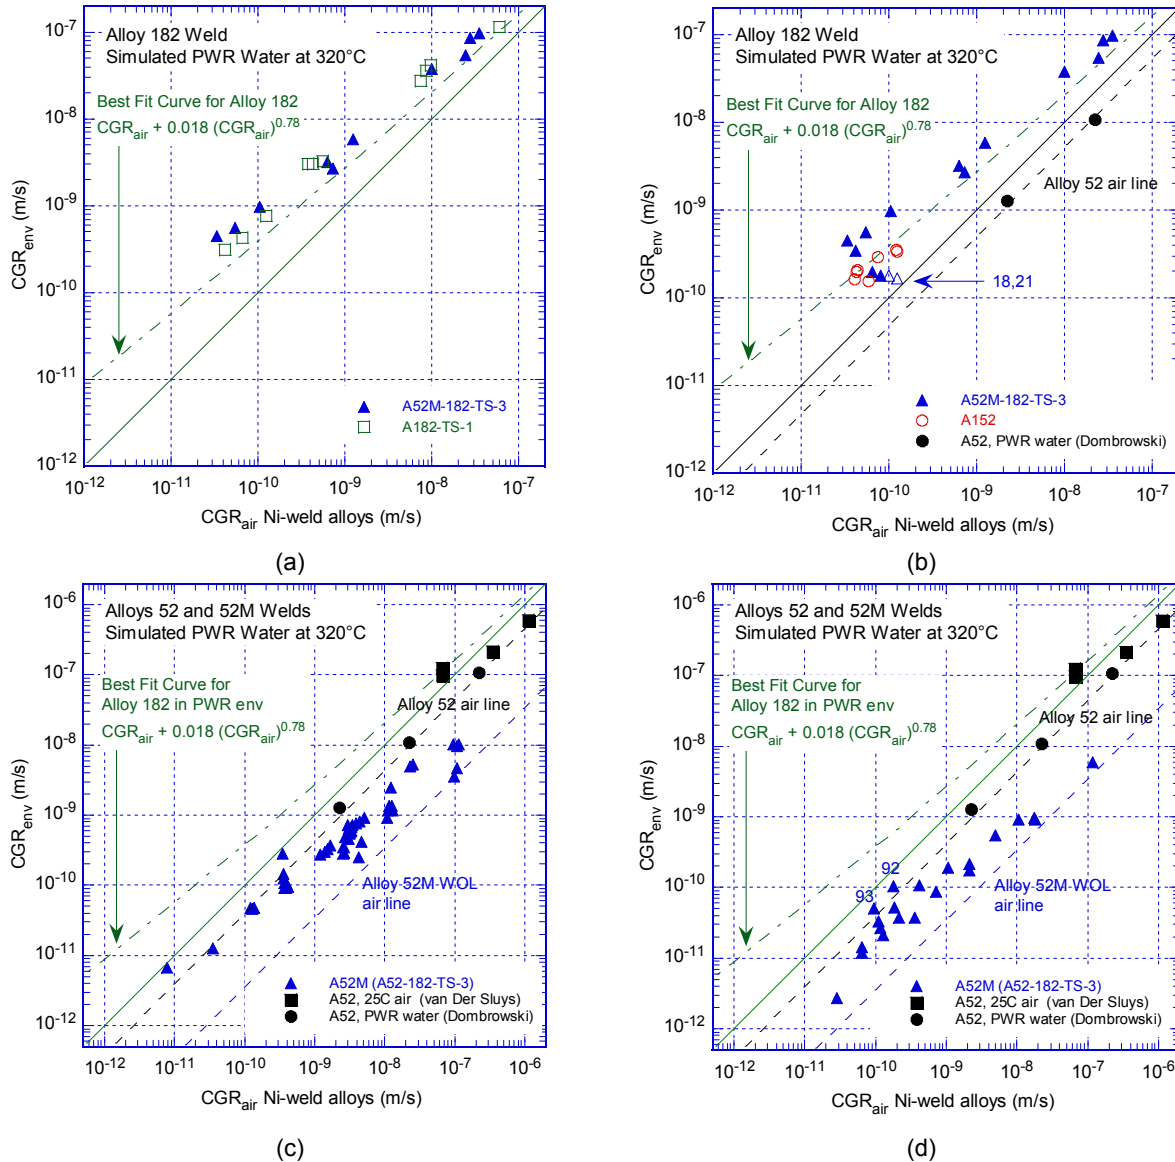
Figure 3-15 Cyclic CGR data in PWR environment for (a) specimen A52M-182-TS-3 and specimen A182-TS-1 of the same alloy tested previously (without WOL), (b) specimen A52M-182-TS-3 and Alloy 152 specimen A152-TS-4 under similar loading, and Alloy 52 data from the literature [24, 25], (c) Comparison between Alloy 52M data obtained in the current test and Alloy 52 data from the literature [24, 25], (d) Transitioning in Alloy 52M, periods 78-93.

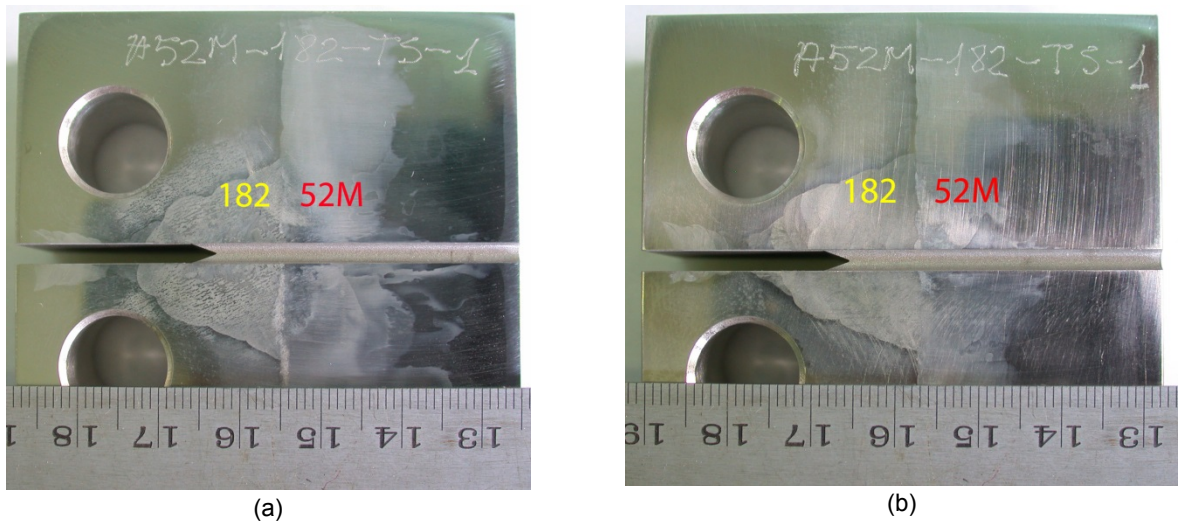
Figure 3-17 Photographs of the two sides of the 52M/182 weld overlay specimen A52M-182-TS-1.

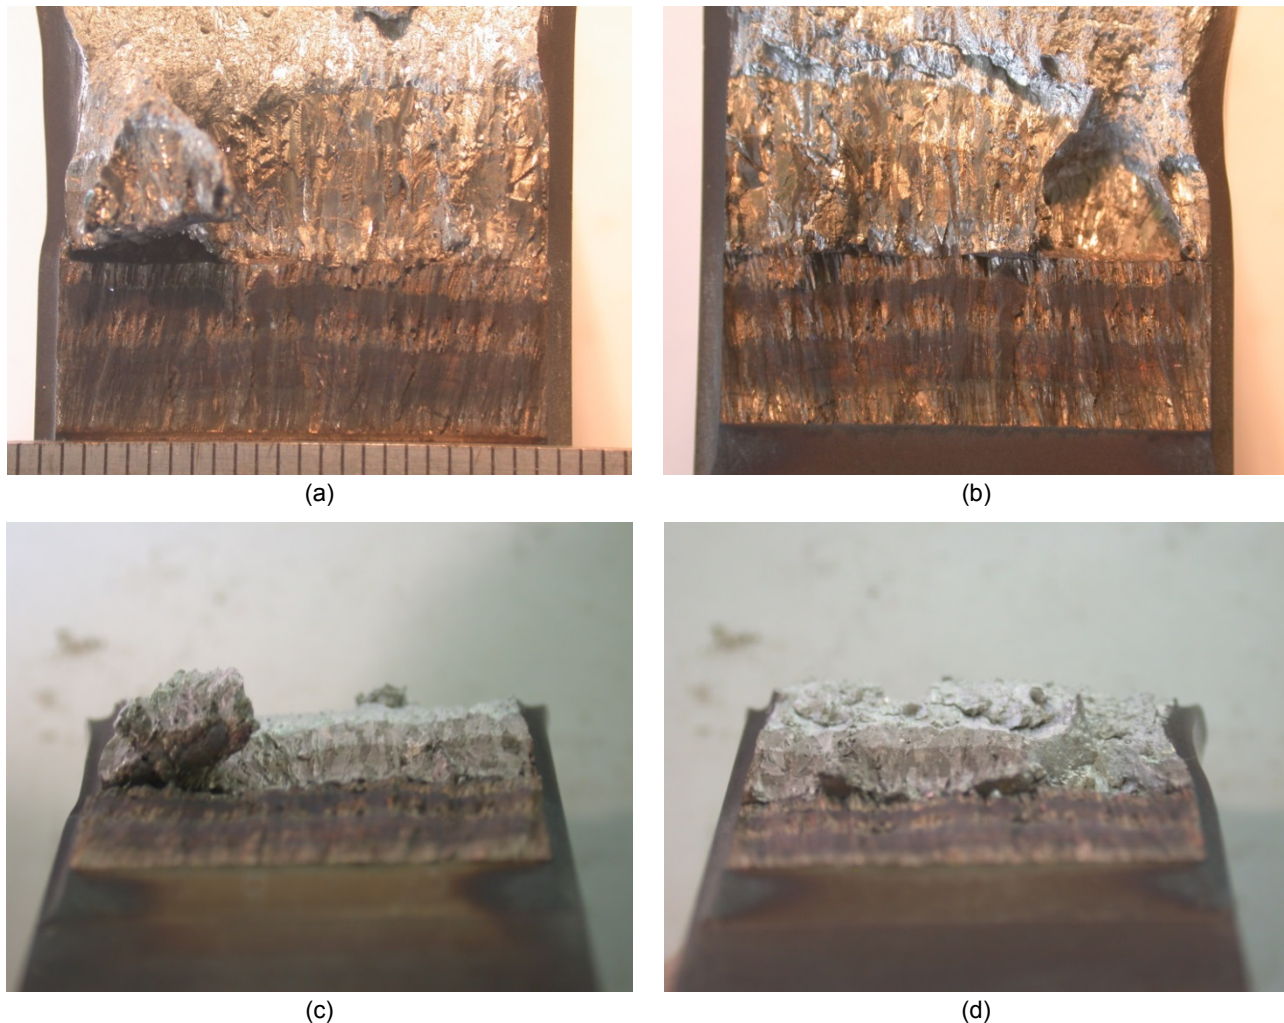
Figure 3-19 (a, b) The two halves of fractured specimen A52M-182-TS-1. Crack advance is from bottom to top. (c, d) Same fracture surfaces photographed at an angle to show the cracking pattern at the interface.

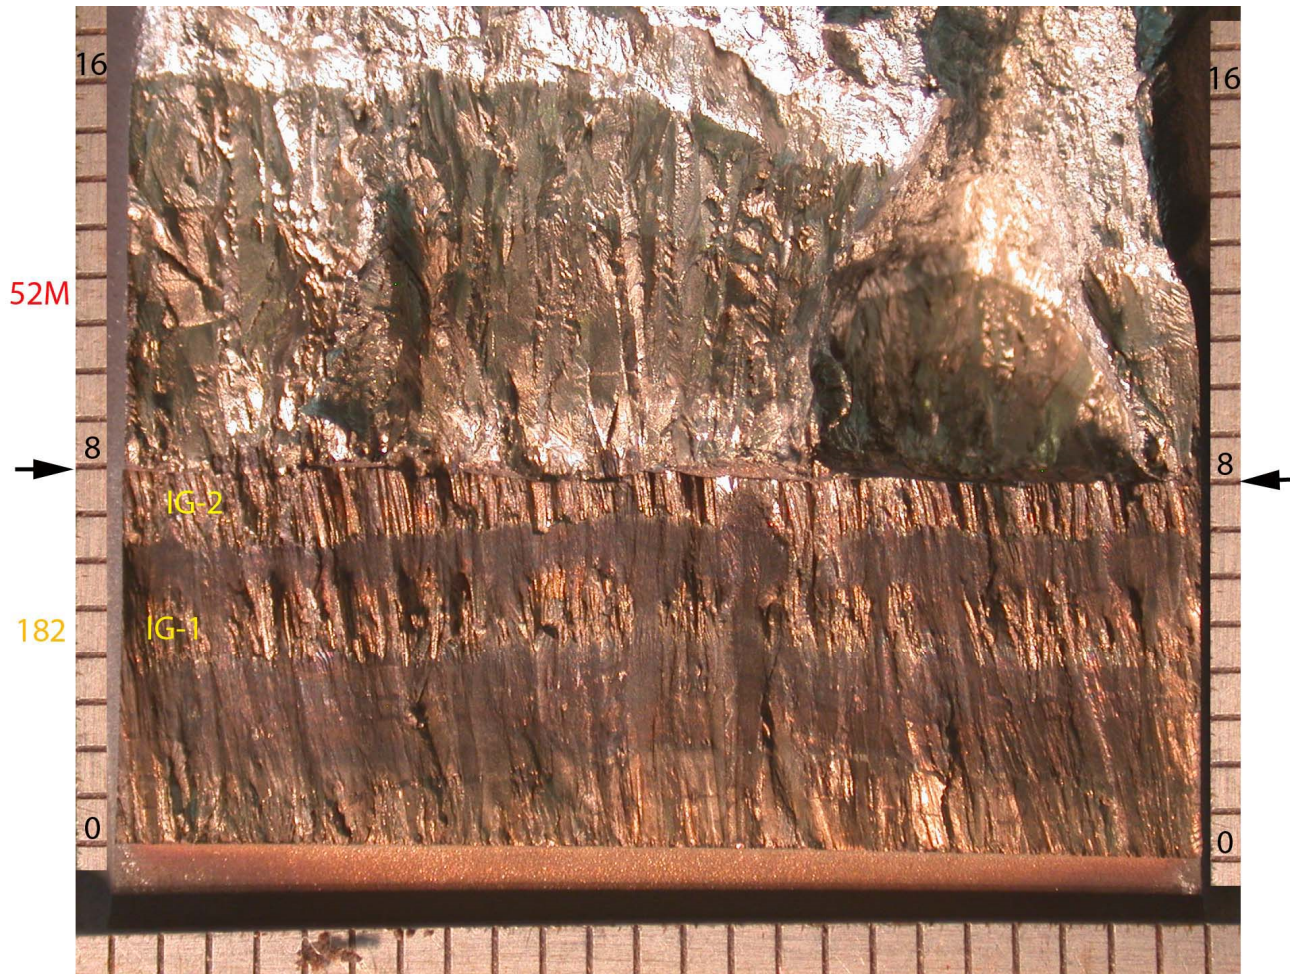
Figure 3-20 Fracture surface of specimen A52M-182-TS-1. The interface is indicated by black arrows. Crack advance is from bottom to top. The units of the bottom and side rulers are mm.

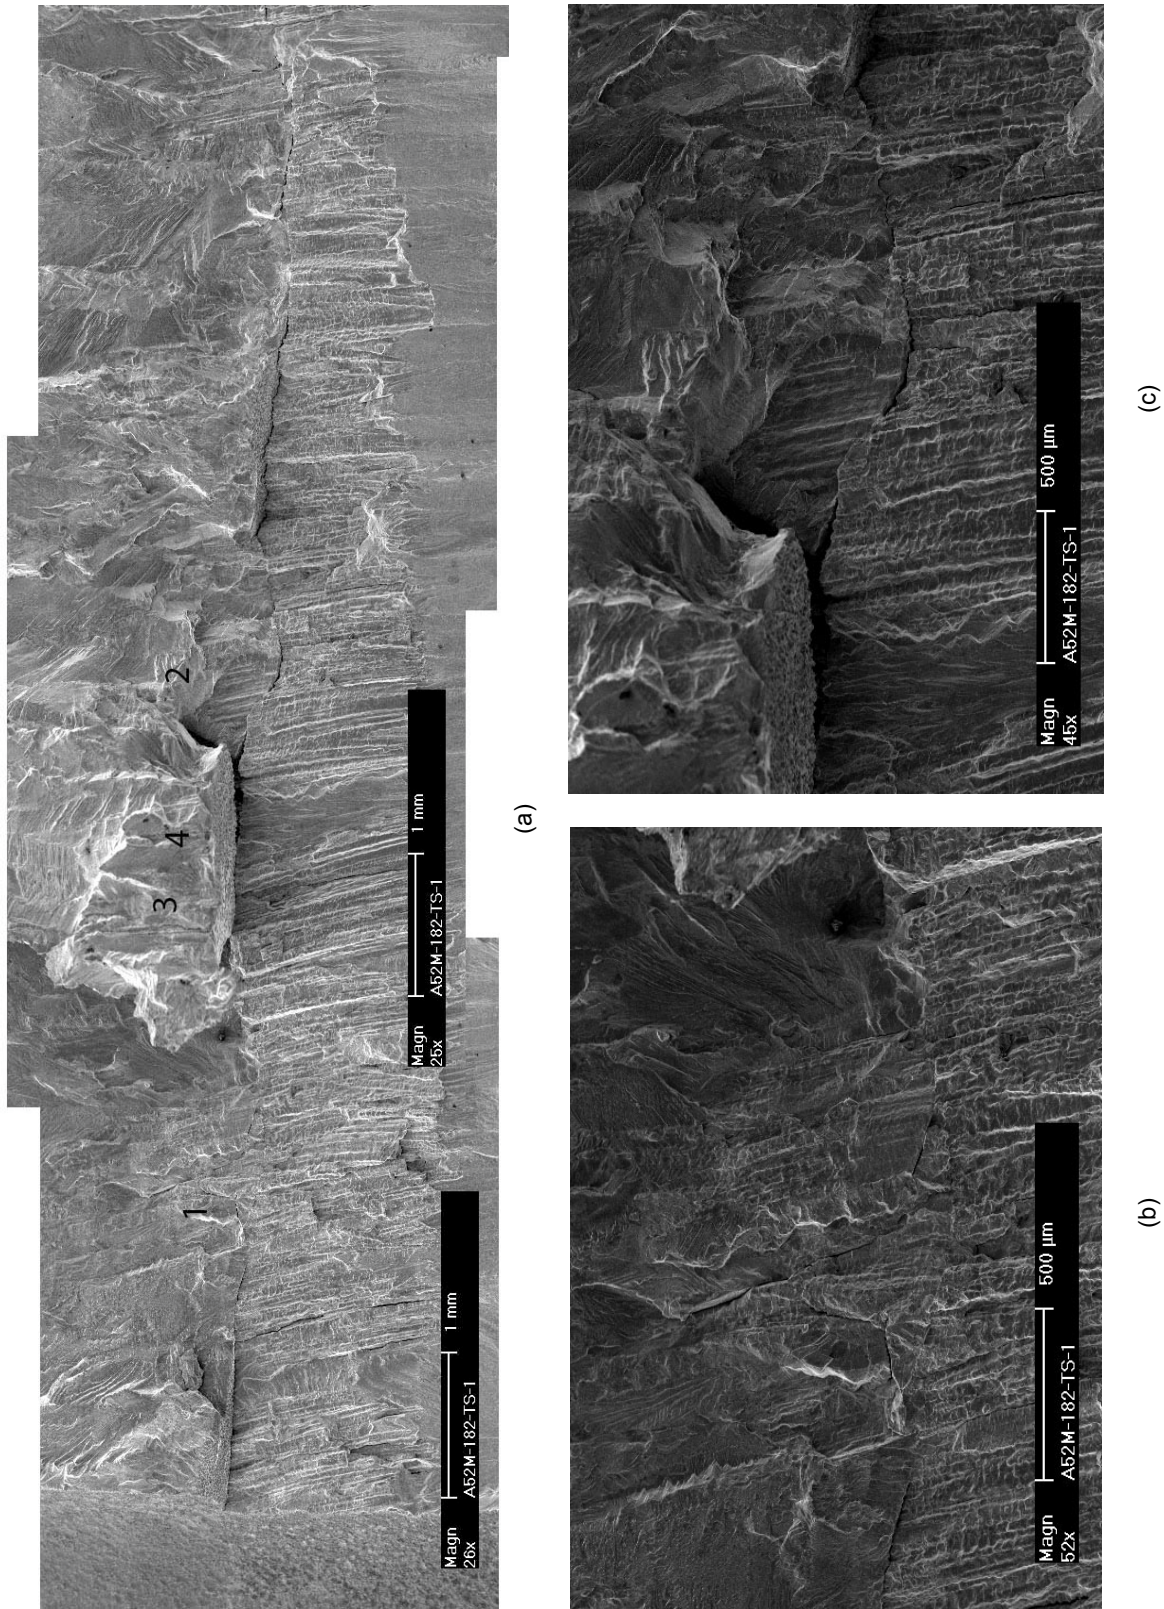
Figure 3-21 Specimen A52M-182-TS-1: (a) first half of fracture surface, (b) detail at location 1, and (c) detail at location 2. Crack advance is from bottom to top.

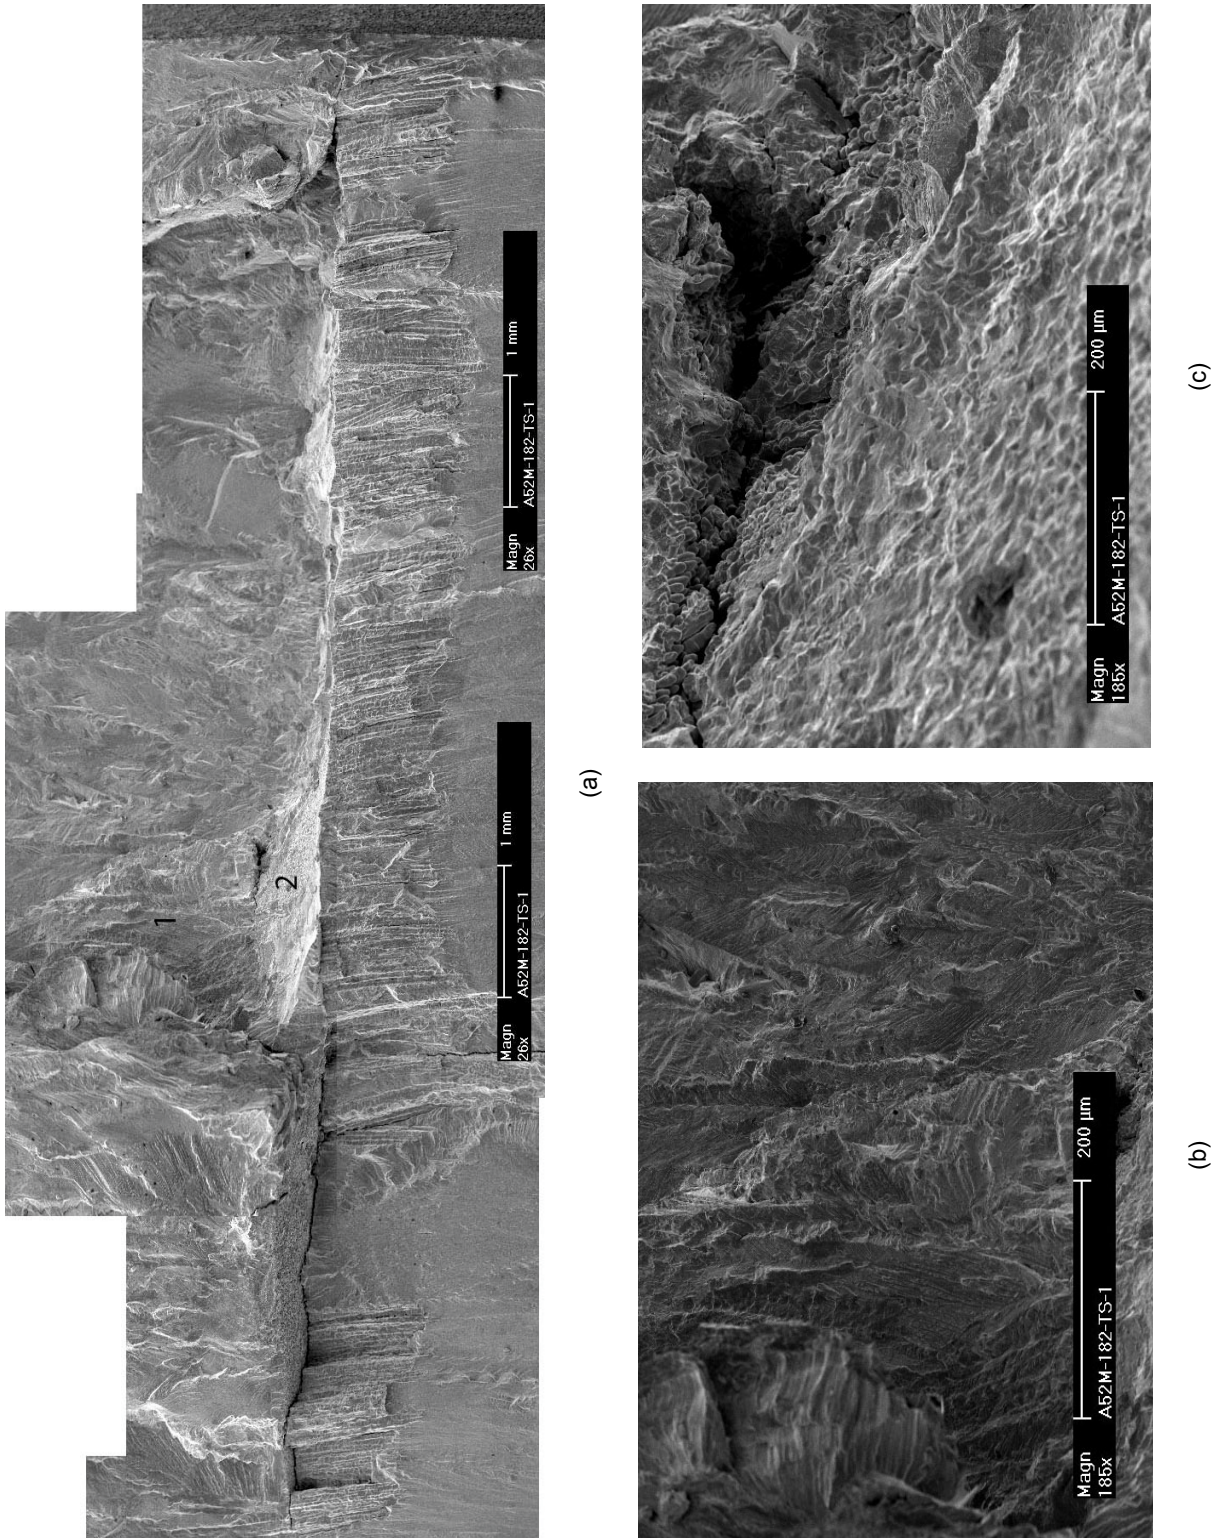
Figure 3-23 Specimen A52M-182-TS-1: (a) second half of fracture surface, (b) detail at location 1, and (c) detail at location 2. Crack advance is from bottom to top.

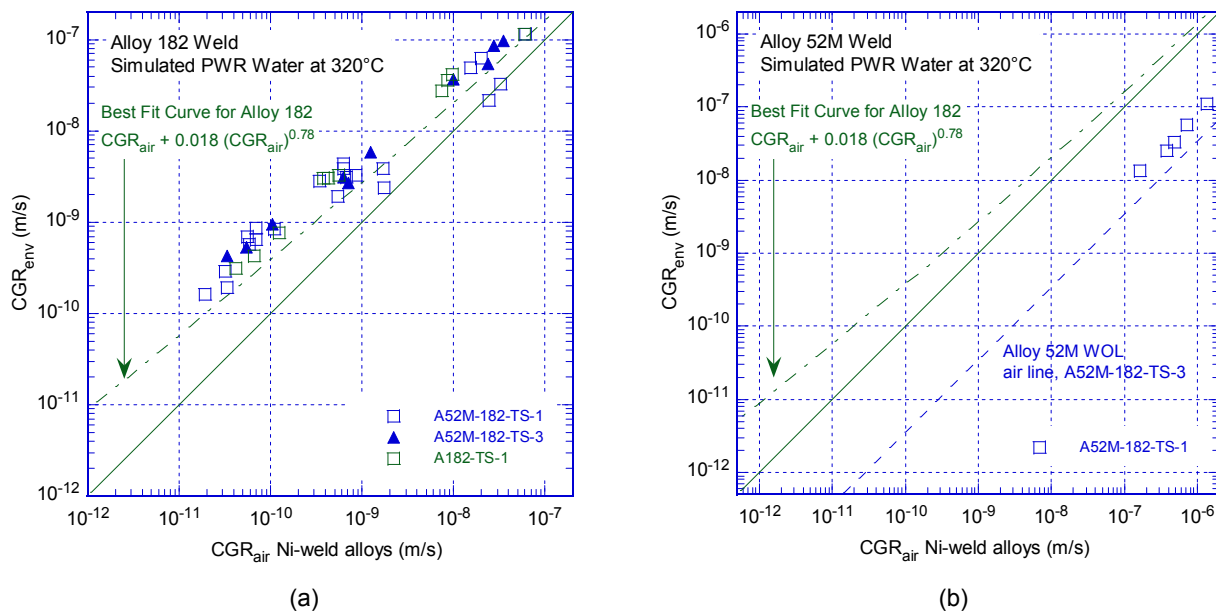
Figure 3-24 Cyclic CGR data for Alloy 52M WOL specimen A52M-182-TS-1 in simulated PWR environment during (a) precracking and transitioning in Alloy 182, and (b) at the end of the test in Alloy 52M. The dotted blue line shows the “air line” for Alloy 52M obtained in the prior test.

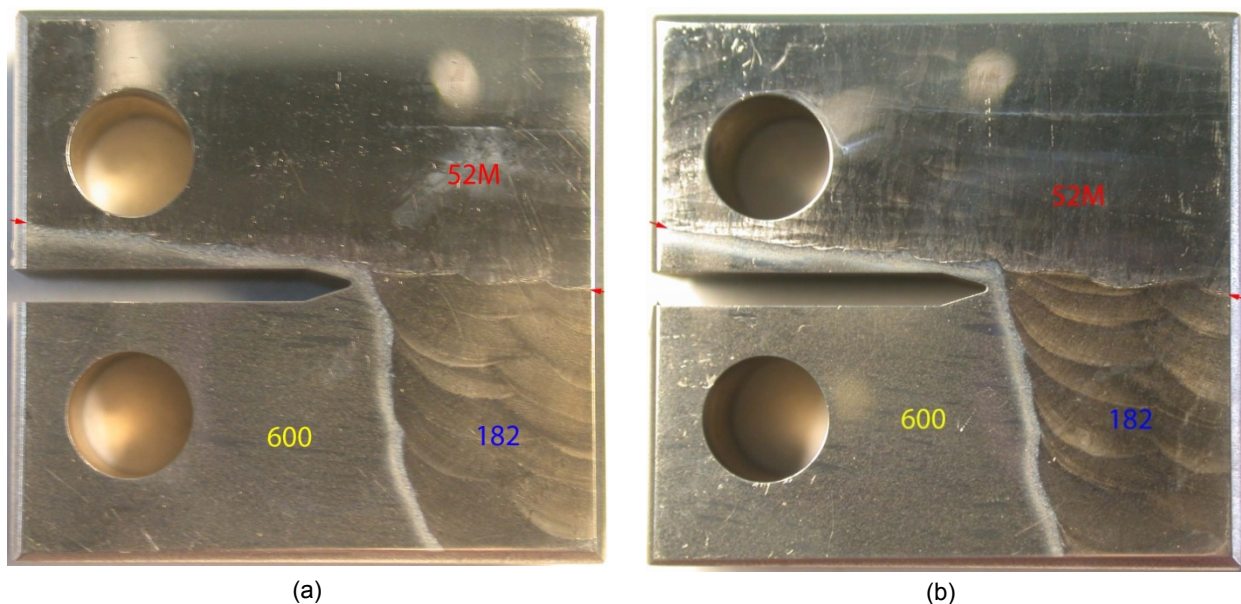
Figure 3-31 Post-test specimen WOL-ST-1 seen from both sides: (a) side 1, and (b) side 2. The red arrows indicate the Alloy 52M WOL interface. Crack advance is from left to right.
