Primary Water Stress Corrosion Cracking of High-Chromium, Nickel- Base Welds Near Dissimilar Metal Weld Interfaces

The report summarizes the results of a testing program to evaluate the stress corrosion cracking (SCC) susceptibility at or near the interface between Alloy 52 and 152 weld metals and other weld or base metals. Alloys 52 and 152 are high-chromium weld metals used in reactor pressure vessel head penetration nozzles and as overlays, inlays, or onlays for dissimilar metal piping welds. Alloys 52 and 152 typically show very low SCC growth rates in laboratory testing and are not known to have cracked in service. Nevertheless questions remain as to whether the localized dilution of chromium content or the presence of microstructural features near the interface with the low-chromium weld metals Alloy 82 and 182, as in the case of a weld overlay (WOL), or with steel, as in the case of a head penetration nozzle, could affect the SCC response. For this study, SCC growth rates were measured on a WOL mockup with Alloy 52M (a compositional variant of Alloy 52) on Alloy 182 and on a butt weld mockup with Alloy 152 joined to low-alloy steel (LAS). For the WOL mockup, tests were perf

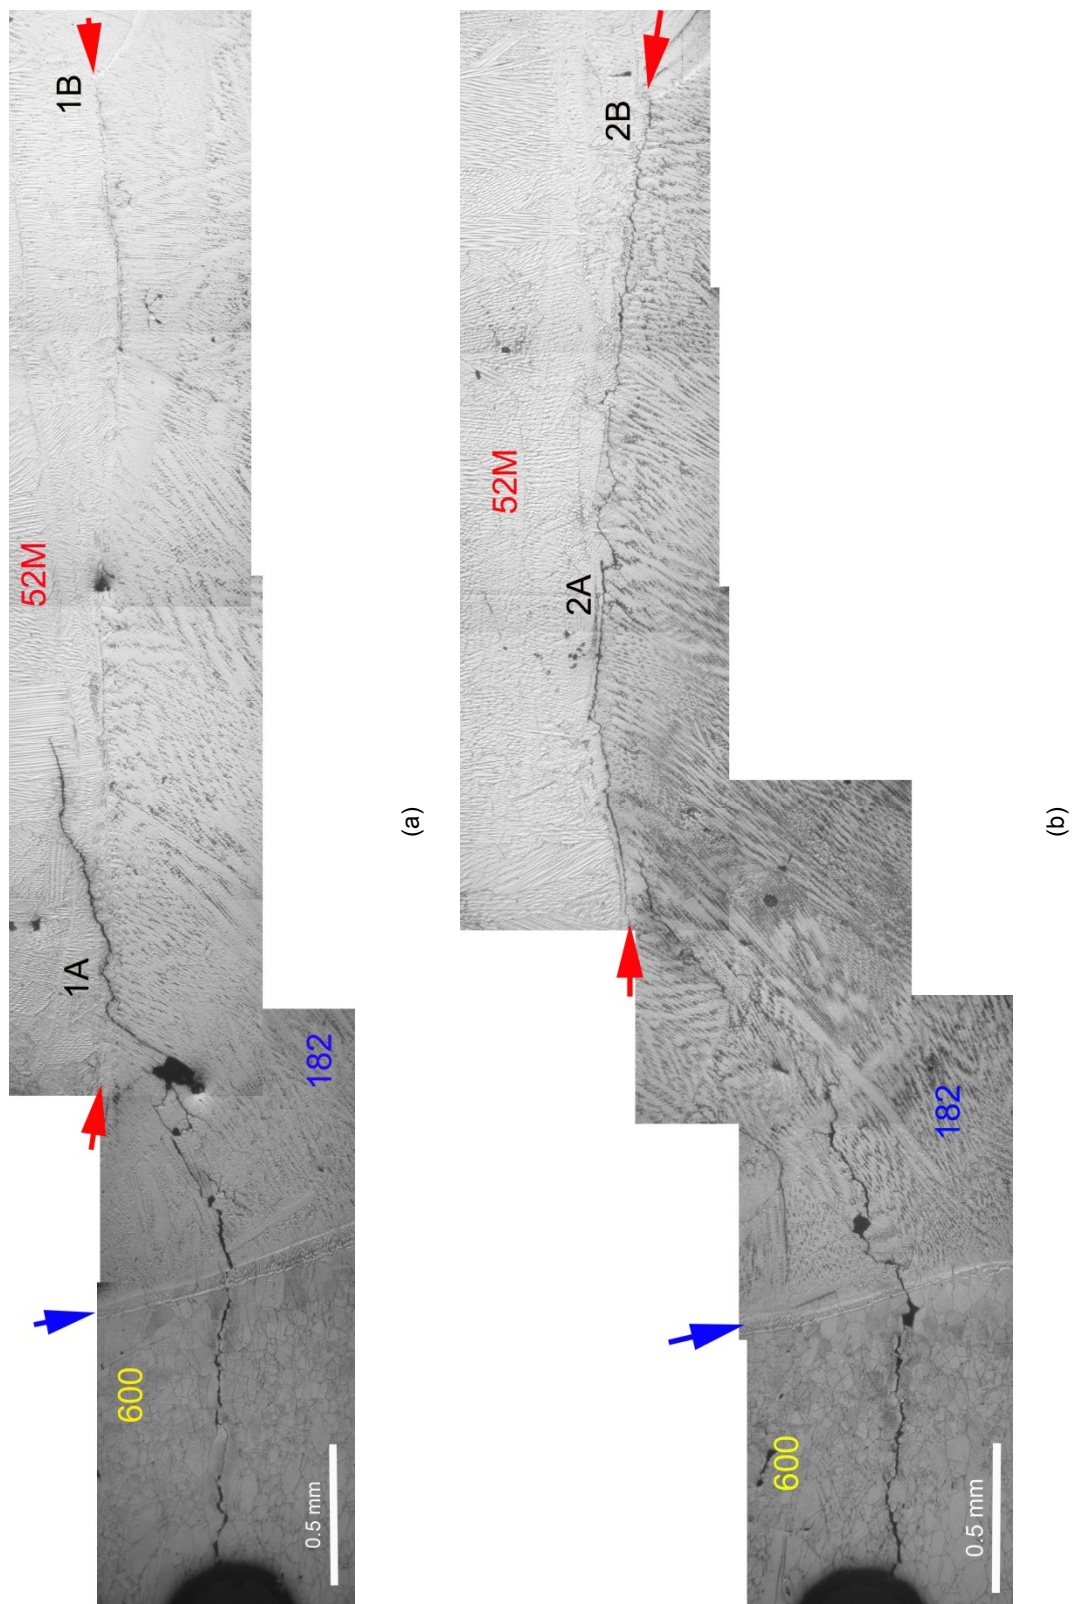
Figure 3-32 Cross sections of specimen WOL-ST-1: (a) side 1, and (b) side 2. Blue arrows indicate the Alloy 600/182 interface and the red arrows indicate the Alloy 182-52M interface. Crack advance is from left.

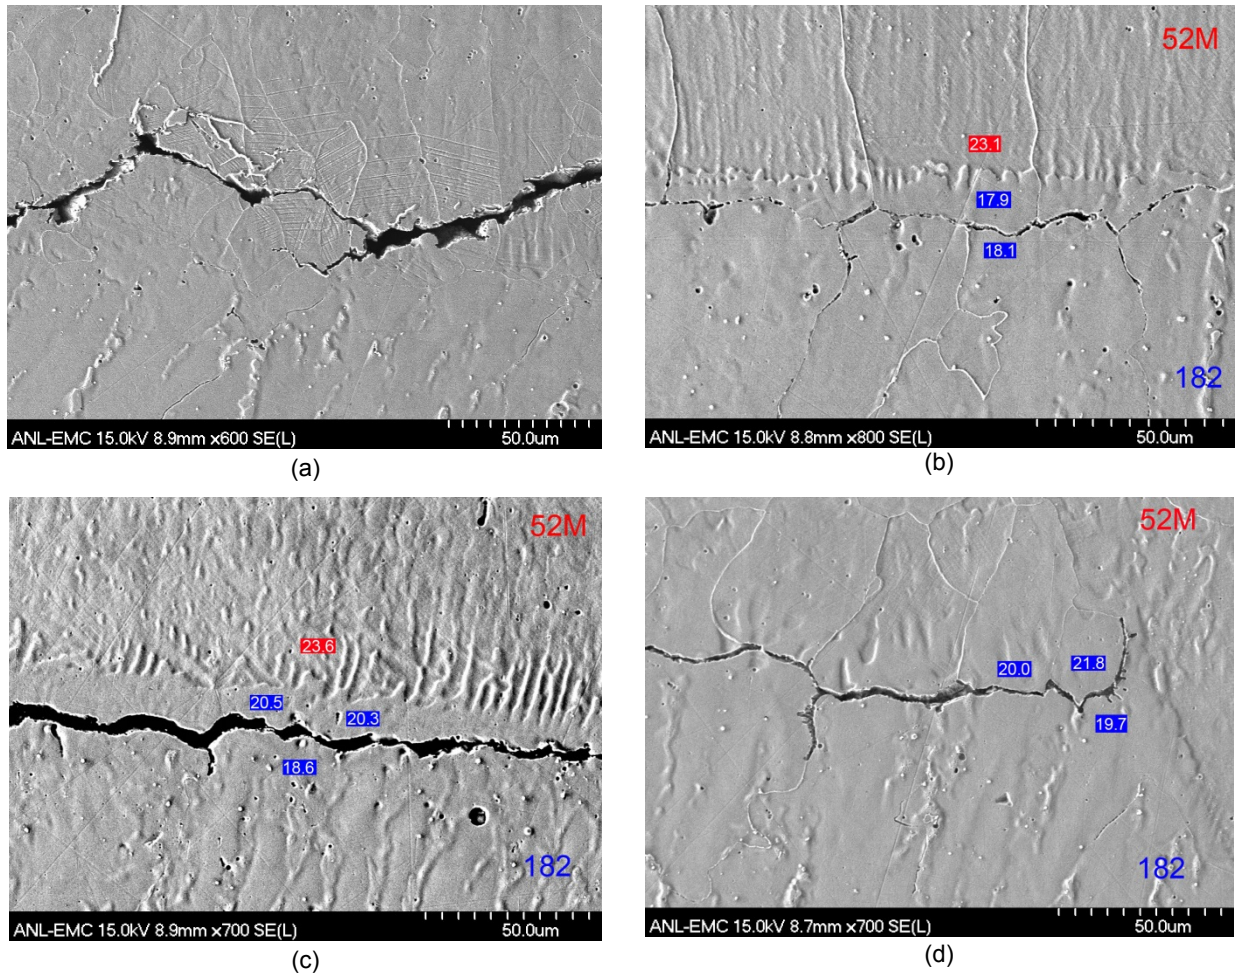
Figure 3-33 Micrographs on the cross section of specimen WOL-ST-1 on: side 1 taken at location (a) 1A, and (b) 1B in Fig. 3-32a, and side 2 taken at location (c) 2A and (d) 2B in Fig. 3-32b. Inserts show the local Cr concentrations (wt. %). Crack advance is from left to right.

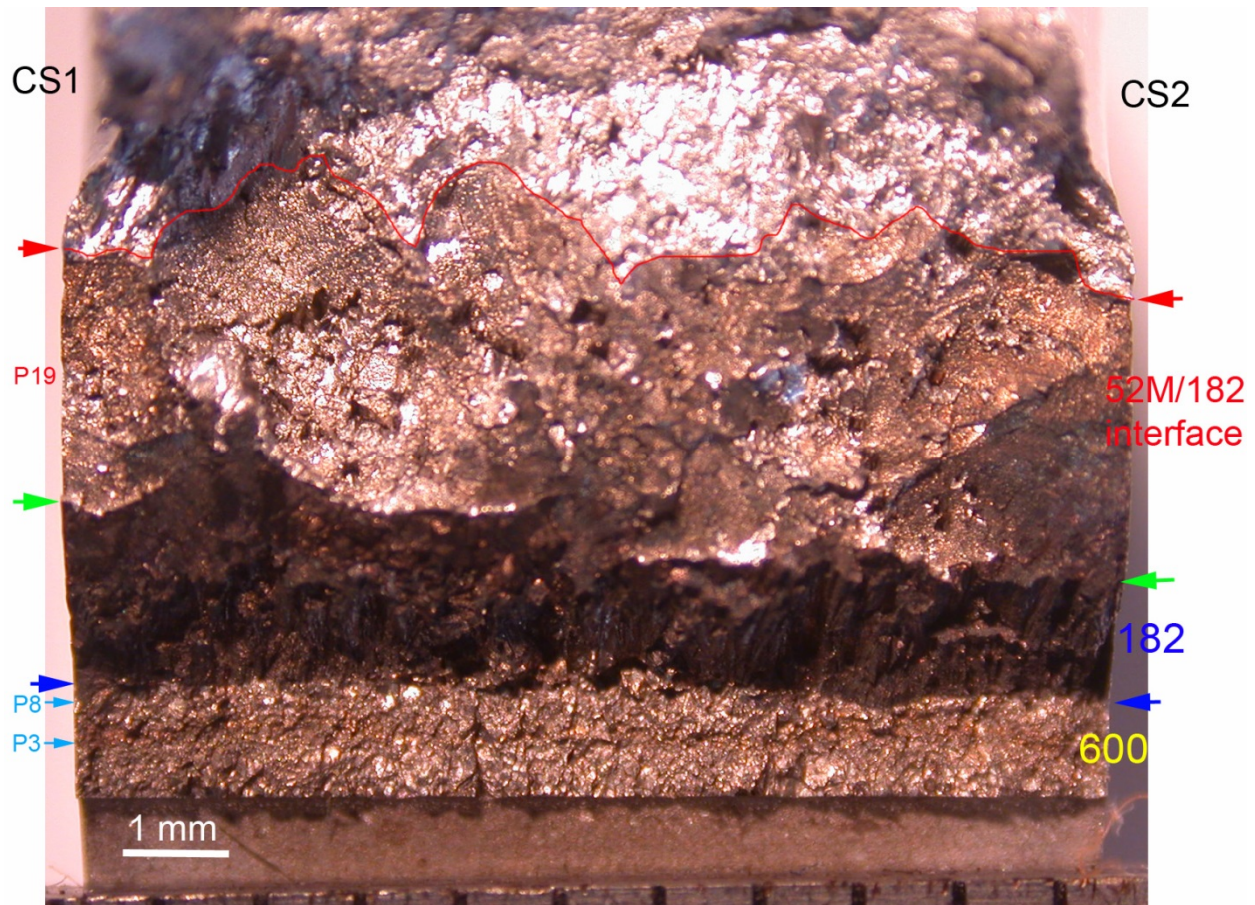
Figure 3-34 Fracture surface of specimen WOL-ST-1. Blue arrows indicate the Alloy 600-Alloy 182 interface, green arrows indicate the Alloy 182-Alloy 52M interface, and the red arrows and line mark the end of the test. The locations of the two test periods in Alloy 600 (P3 and P8) and along the Alloy 52M-182 interface (P19) are indicated in the figure. Crack advance is from bottom to top.

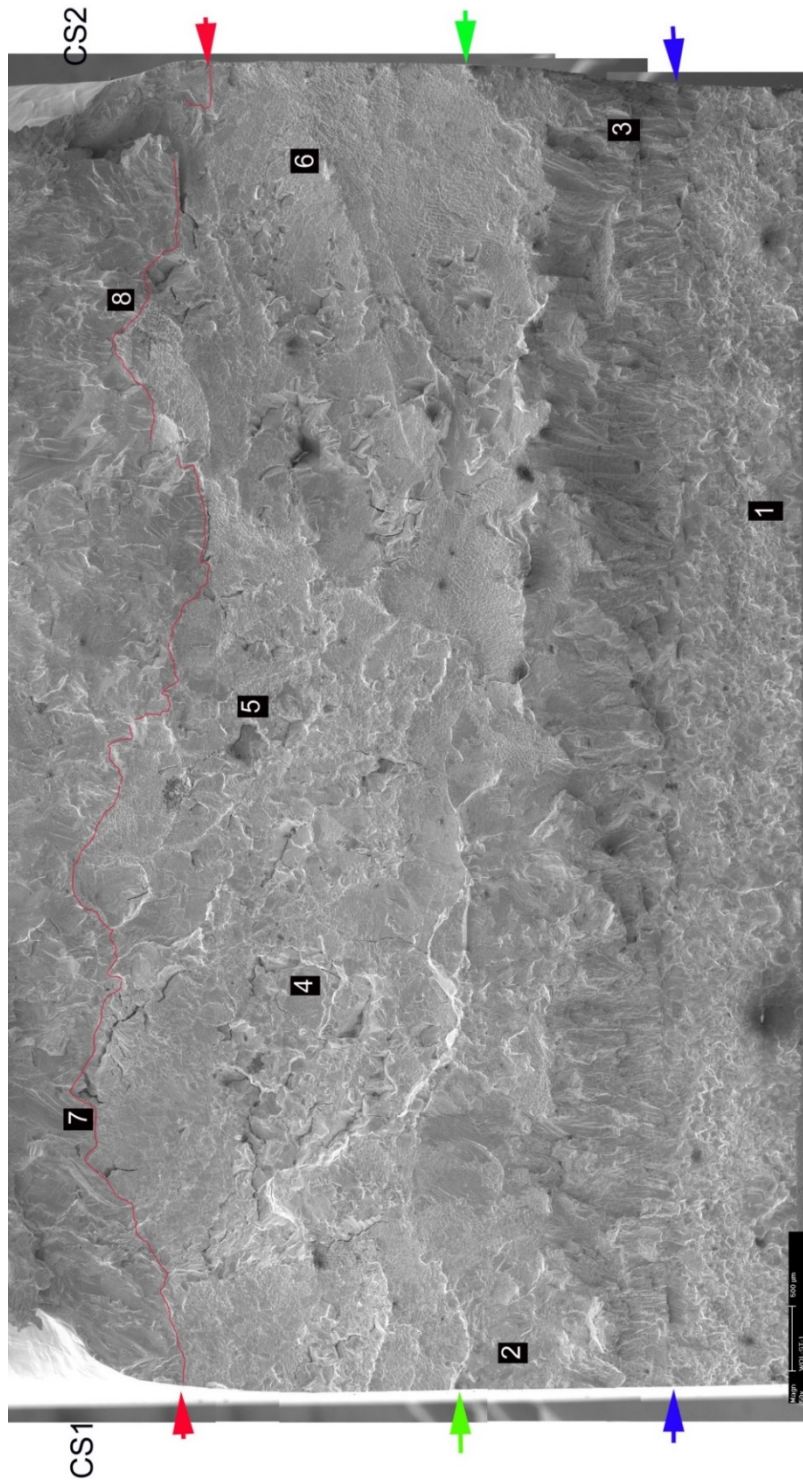
Figure 3-35 Fracture surface of specimen WOL-ST-1. Blue arrows indicate the Alloy 600-Alloy 182 interface, green arrows indicate the Alloy 182-Alloy 52M interface, and the red arrows and line mark the end of the test. Crack advance is from bottom to top.

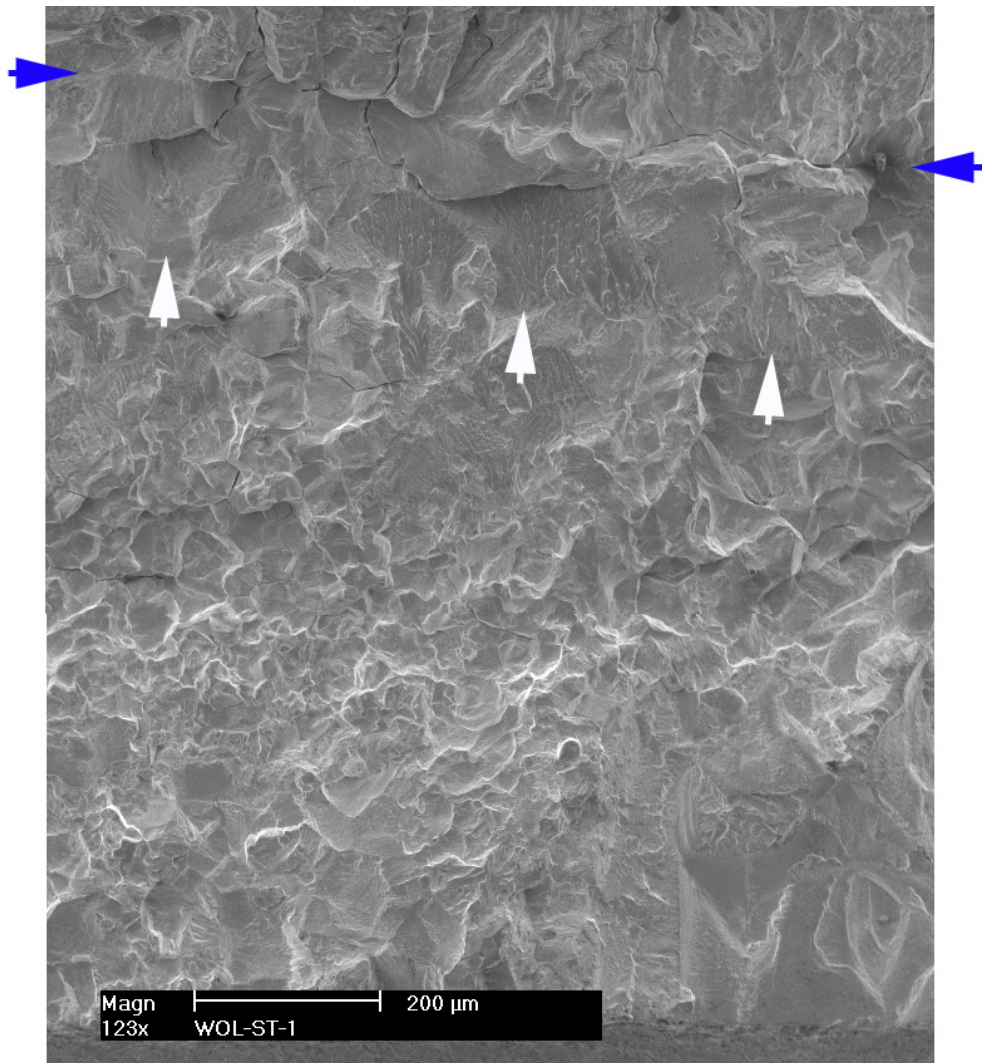
Figure 3-36 Fracture surface of specimen WOL-ST-1 at location 1 in Fig. 3-35. The blue arrows designate the intersection with the Alloy 182 weld, and the white arrows show areas of TG obtained most likely during fast cycling in at the beginning of test period 9, Table 3-4. Crack advance is from bottom to top.

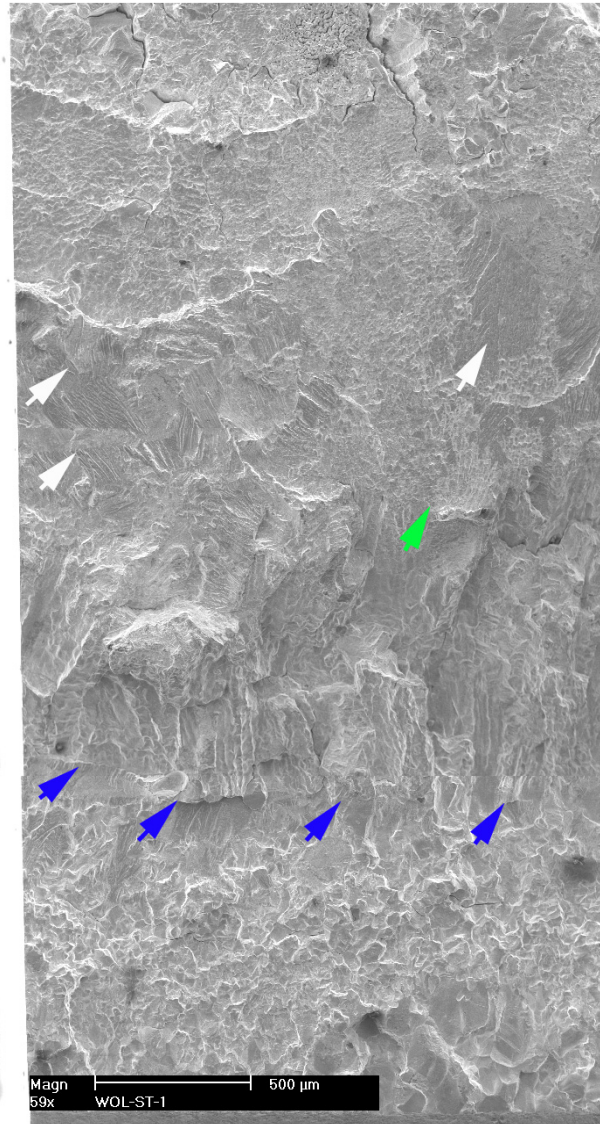
Figure 3-37 Fracture surface of specimen WOL-ST-1 at location 2 in Fig. 3-35. The blue arrows indicate the onset of cracking in Alloy 182, and white arrows indicate the occasional TG fracture that occurred prior to transitioning into Alloy 52M. An early occurrence of IG is indicated with a green arrow. Crack advance is from bottom to top.

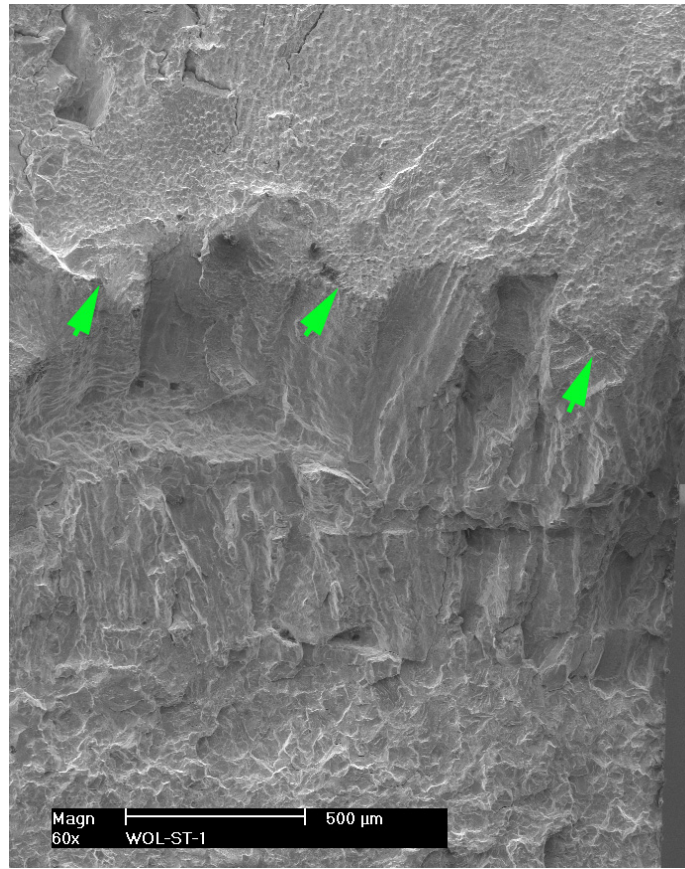
Figure 3-38 Fracture surface of specimen WOL-ST-1 at location 3 in Fig. 3-35. The green arrows indicate the onset of IG along the interface. Crack advance is from bottom to top.

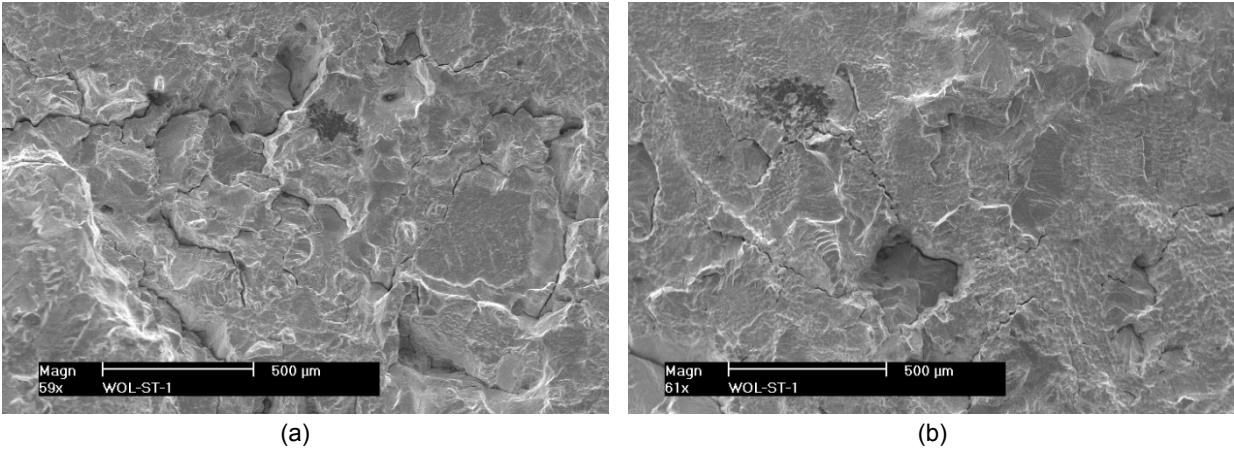
Figure 3-39 Fracture surface of specimen WOL-ST-1 at (a) location 4, and (b) location 5 in Fig. 3-35. Crack advance is from bottom to top.

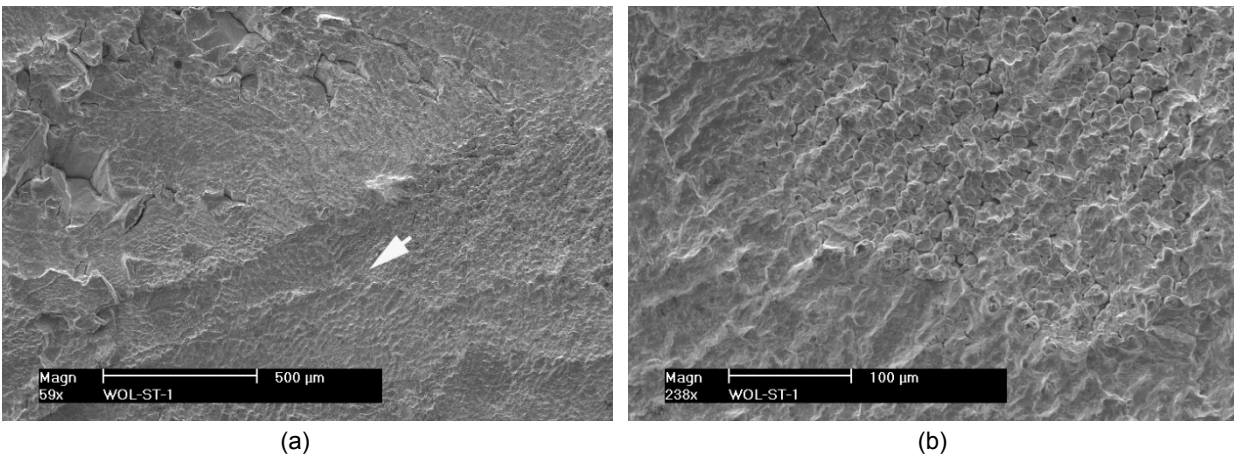
Figure 3-40 Fracture surface of specimen WOL-ST-1 at (a) locations 6 in Fig. 3-35, and (b) detail at the white arrow in (a). Crack advance is from bottom to top.

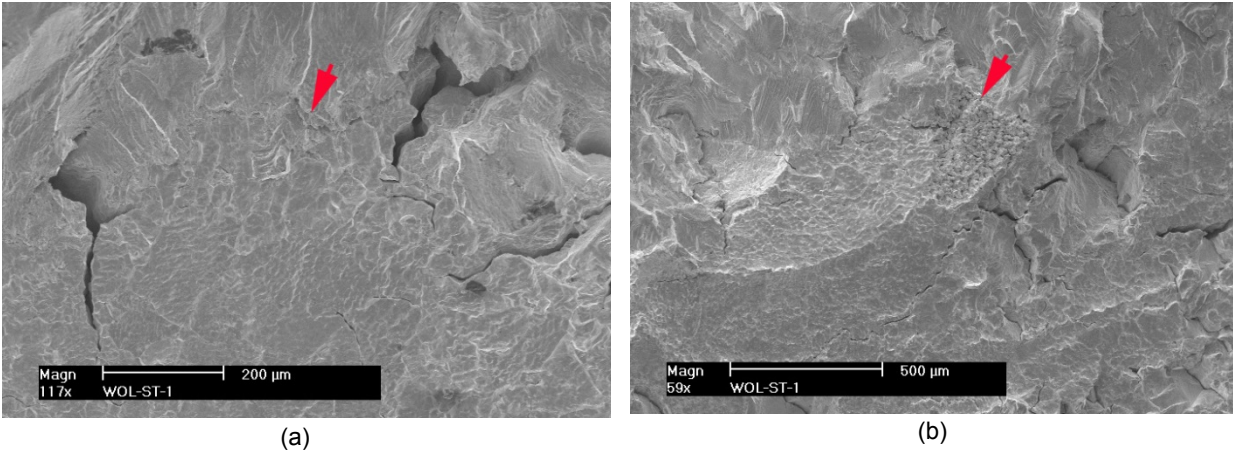
Figure 3-41 Fracture surface of specimen WOL-ST-1 at (a) location 7, and (b) location 8 in Fig. 3-35. The red arrows indicate IG fracture mode at the end of the test. Crack advance is from bottom to top.

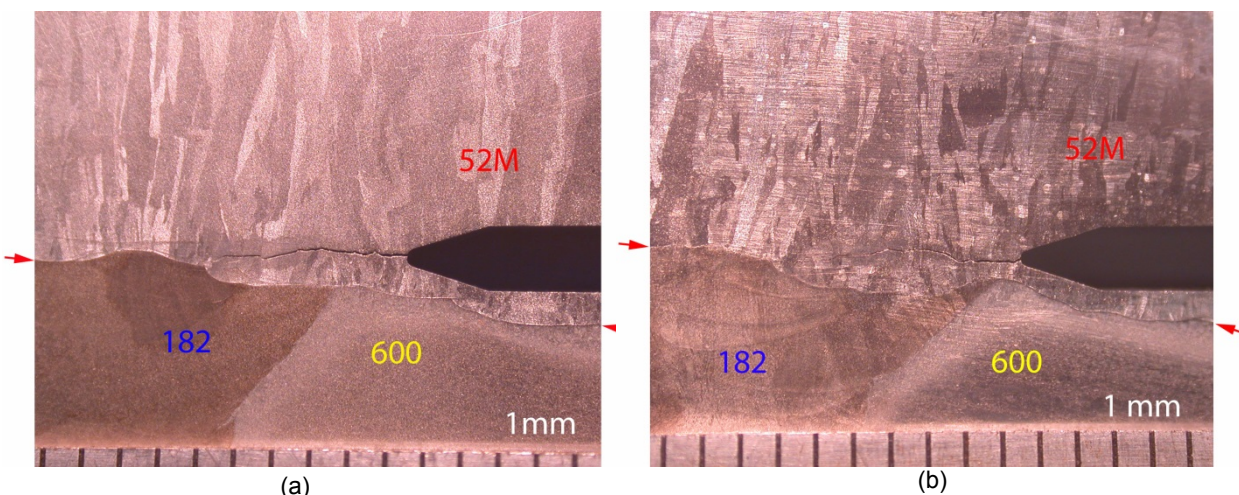
Figure 3-46 Notch area post-test in specimen WOL-ST-2 seen from both sides: (a) side 1, and (b) side 2. The red arrows indicate the WOL interface. Crack advance is from right to left.

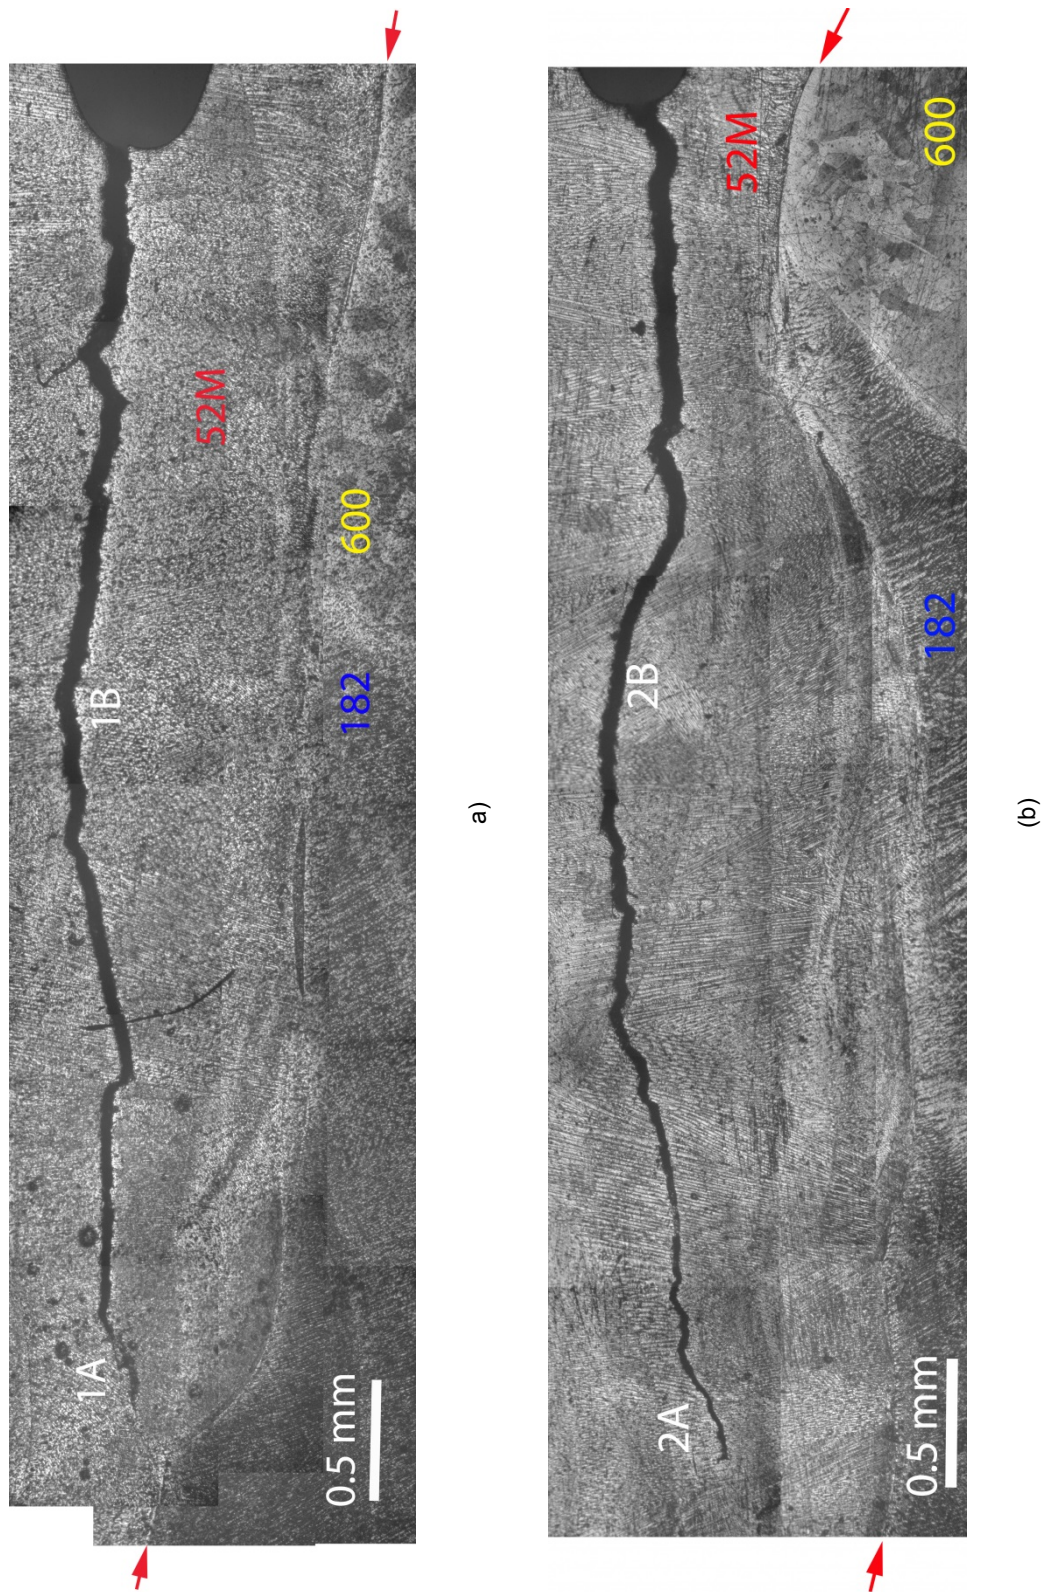
Figure 3-47 Cross section of specimen WOL-ST-2: (a) side 1, and (b) side 2. Crack advance is from right to left. The red arrows indicate the WOL interface.

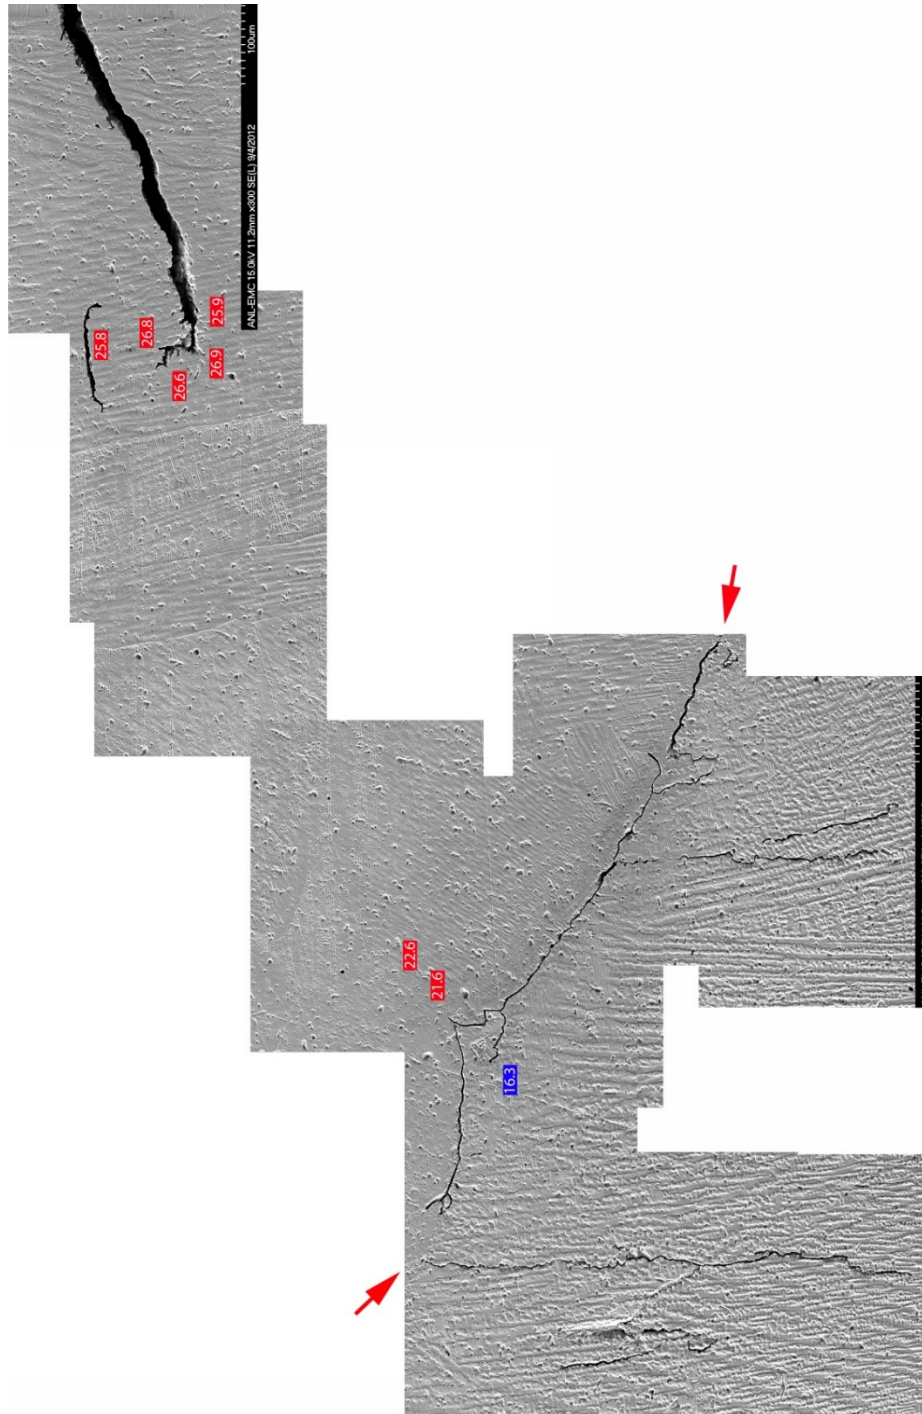
Figure 3-49 Crack tip regions on the second side surface of specimen WOL-ST-2 (side 2, location 2A in Fig. 3-47b). Crack advance is from right to left. Cr concentration at select locations is indicated in the figure. The red arrow indicates the WOL interface.

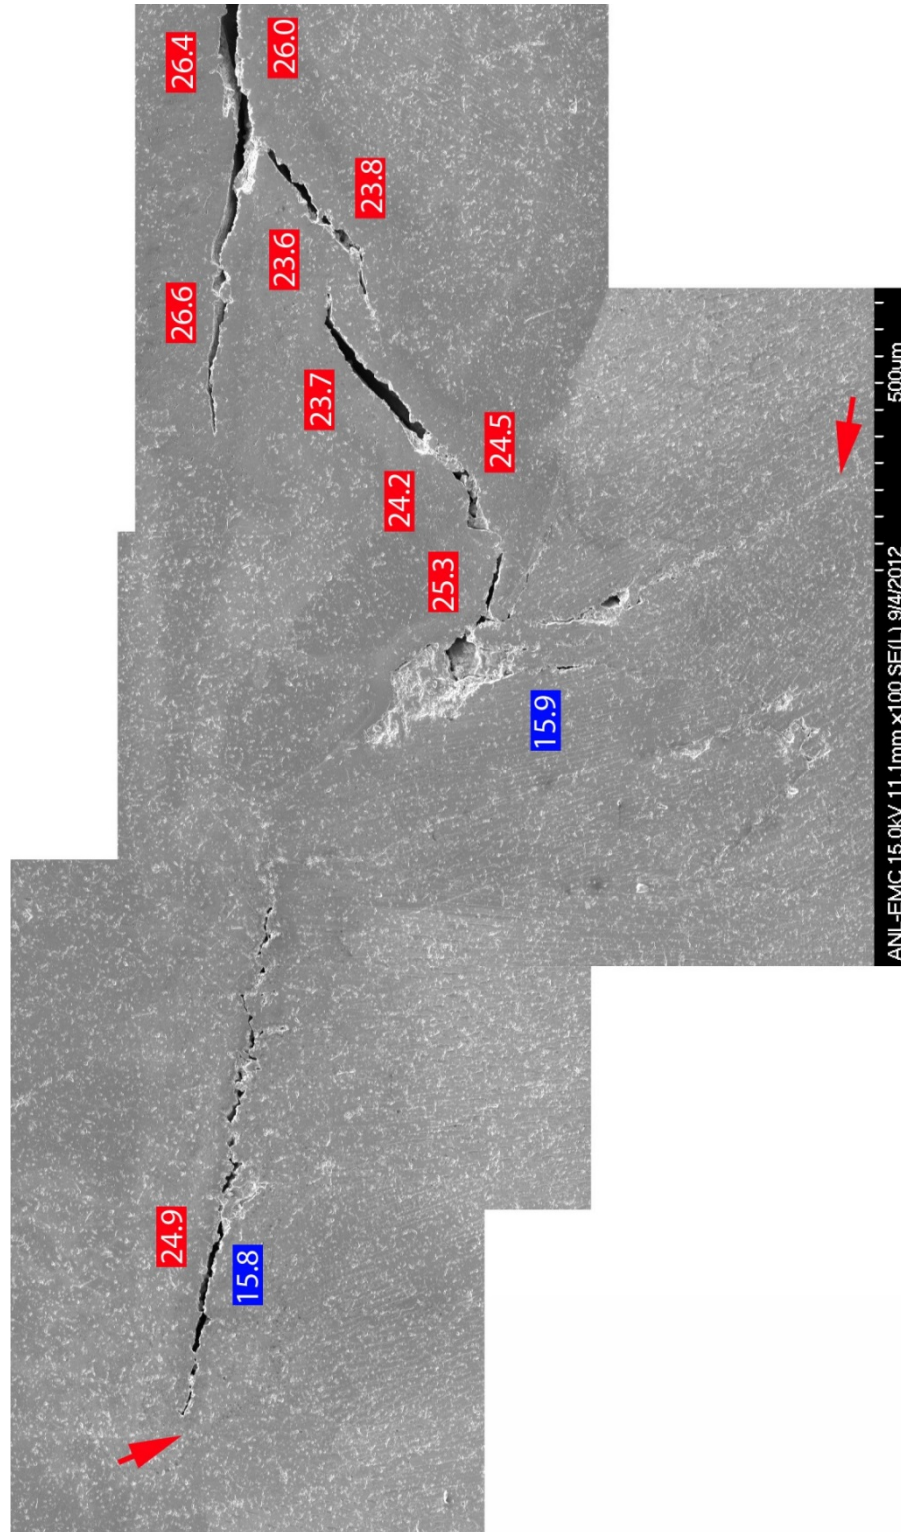
Figure 3-51 Crack tip regions on the second side surface of specimen WOL-ST-2 (side M, location A in Fig. 3-50). Crack advance is from right to left. Cr concentration at select locations is indicated in the figure. The red arrow indicates the WOL interface.

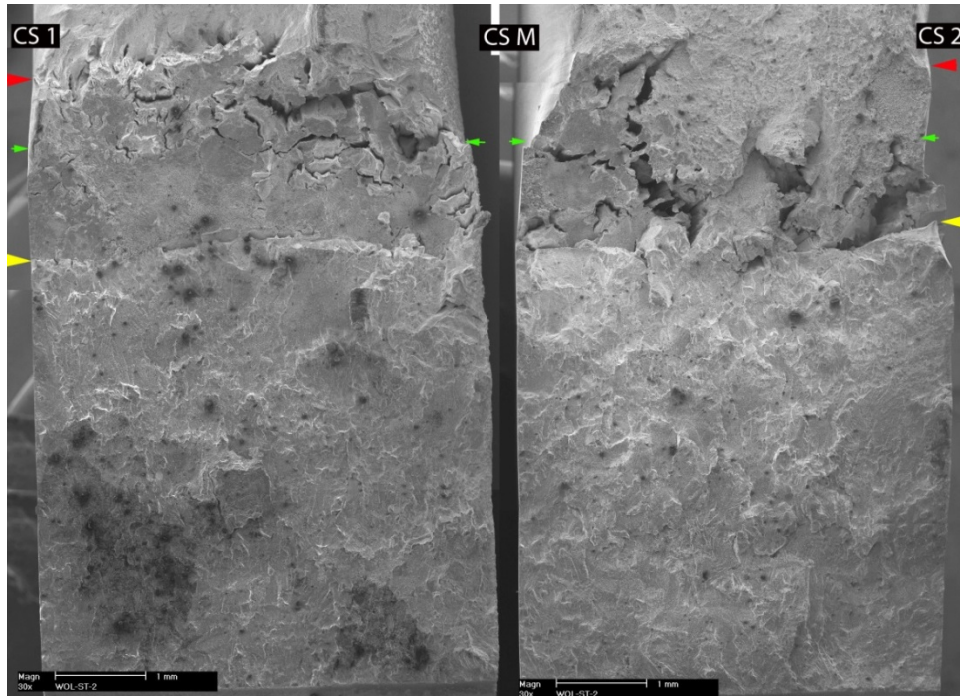
Figure 3-52 Fracture surface of specimen WOL-ST-2. The yellow arrows indicate the beginning of SCC growth, the red arrows show the end of the test, and the green arrows indicate the region where the crack would have intersected the interface. Crack advance is from bottom to top.

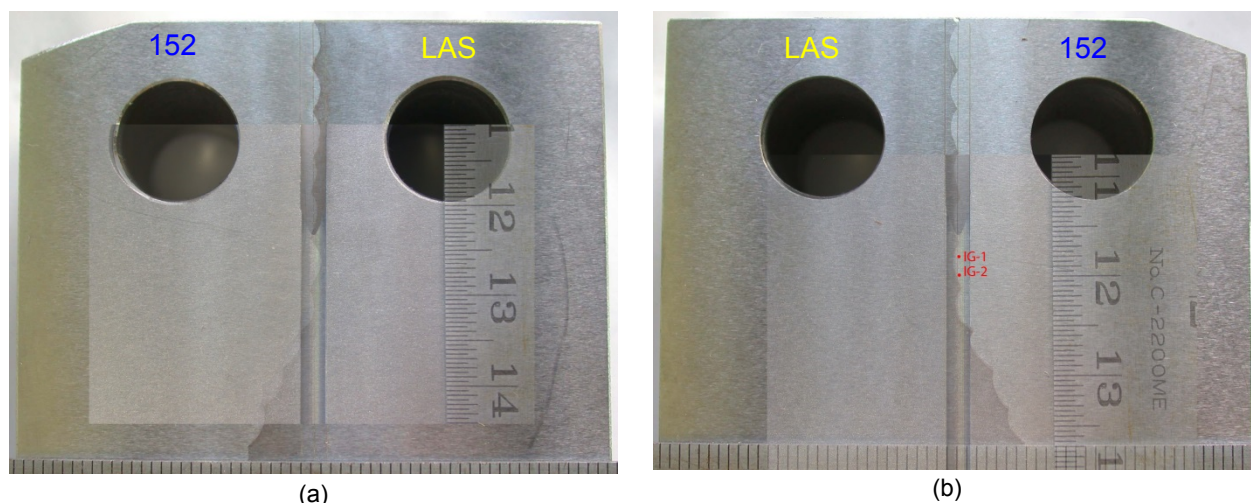
Figure 3-58 Specimen N152-LAS-1, overlapped images before and after the specimen notch was machined: (a) side 1, and (b) side 2. Units of the rulers are mm.

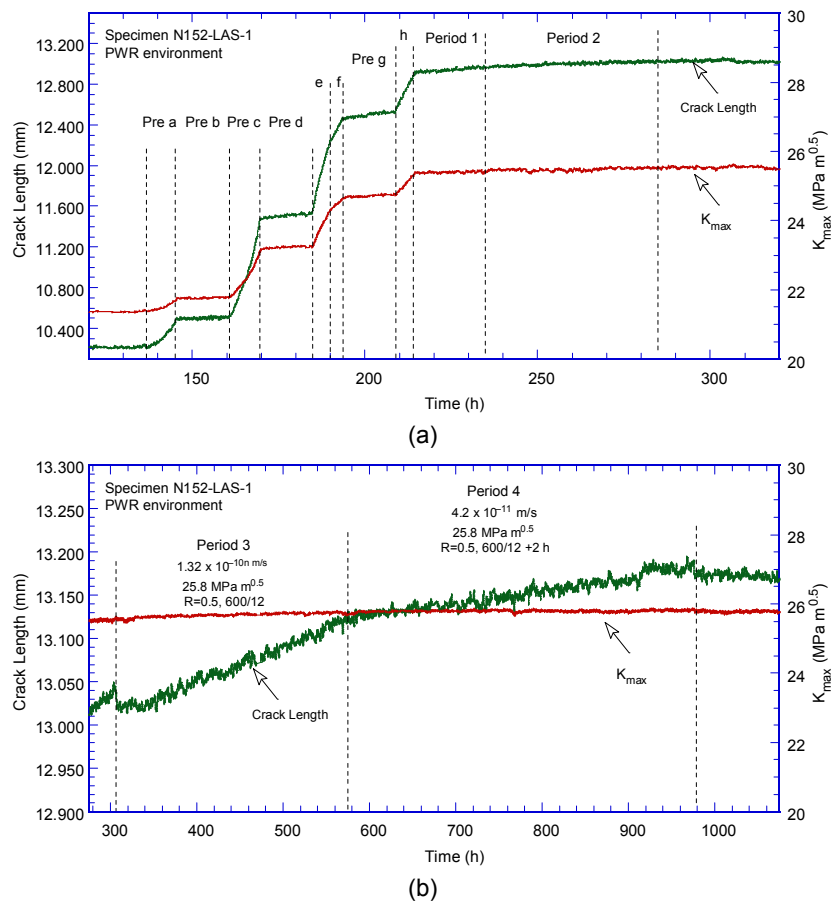
Figure 3-60 Crack-length-vs.-time for dilution specimen N152-LAS-1 in simulated PWR environment during test periods (a) precracking-2, (b) 3-4, (c) 5, (d) 6, (e) 7-10, (f) 11-17, (g) 18, (h) 19-20, (i) 21, (j) 22-23, and (k) 24.

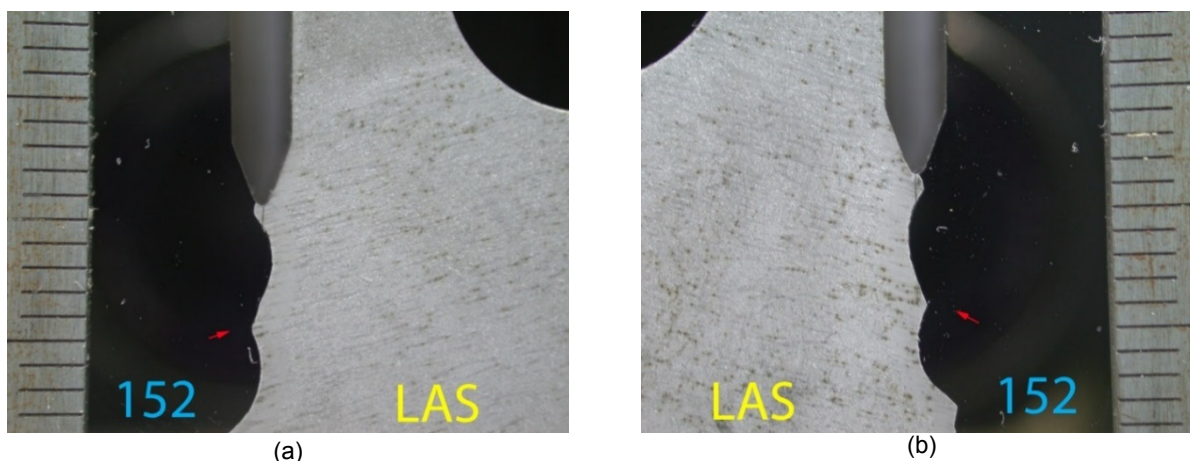
Figure 3-61 The two sides of the dilution specimen N152-LAS-1 after testing in primary water: (a) side 1, and (b) side 2. The red arrows indicate the approximate location of the end of the test as determined on the fracture surface. Units of the side rulers are mm.

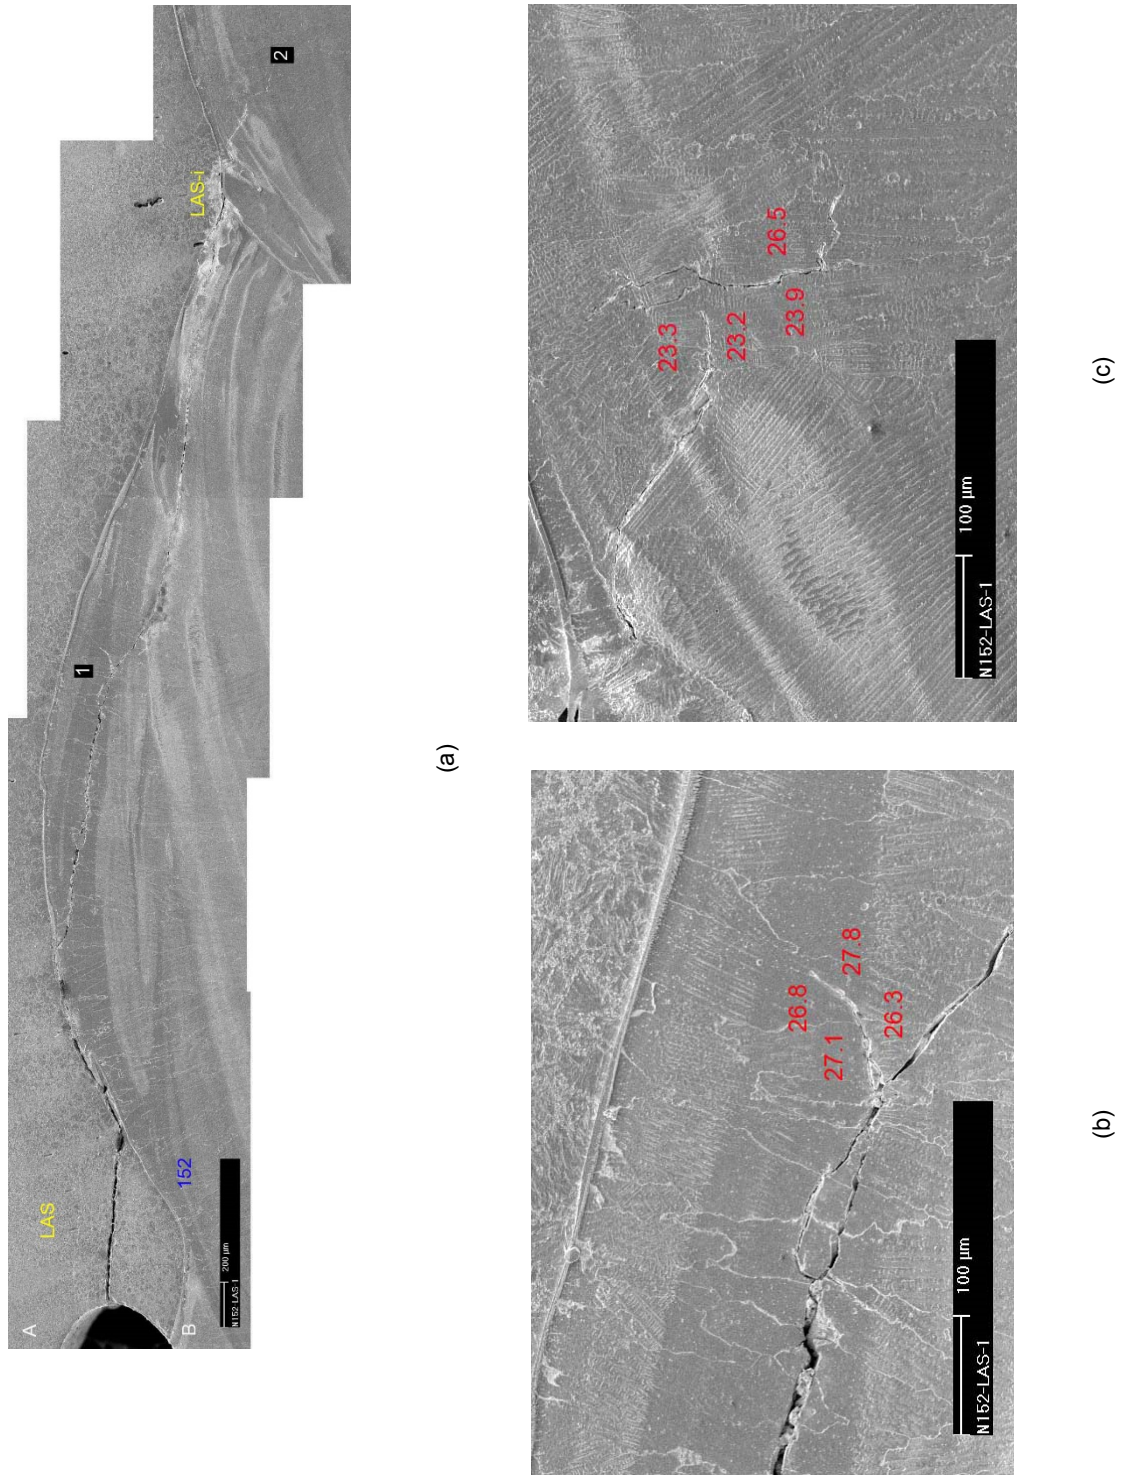
Figure 3-62 (a) Cross section 1 of Specimen N152-LAS-1, (b) detail at location 1 in (a), and (c) detail at location 2 in (a). The local Cr concentration is shown in red. Crack advance is from left to right.

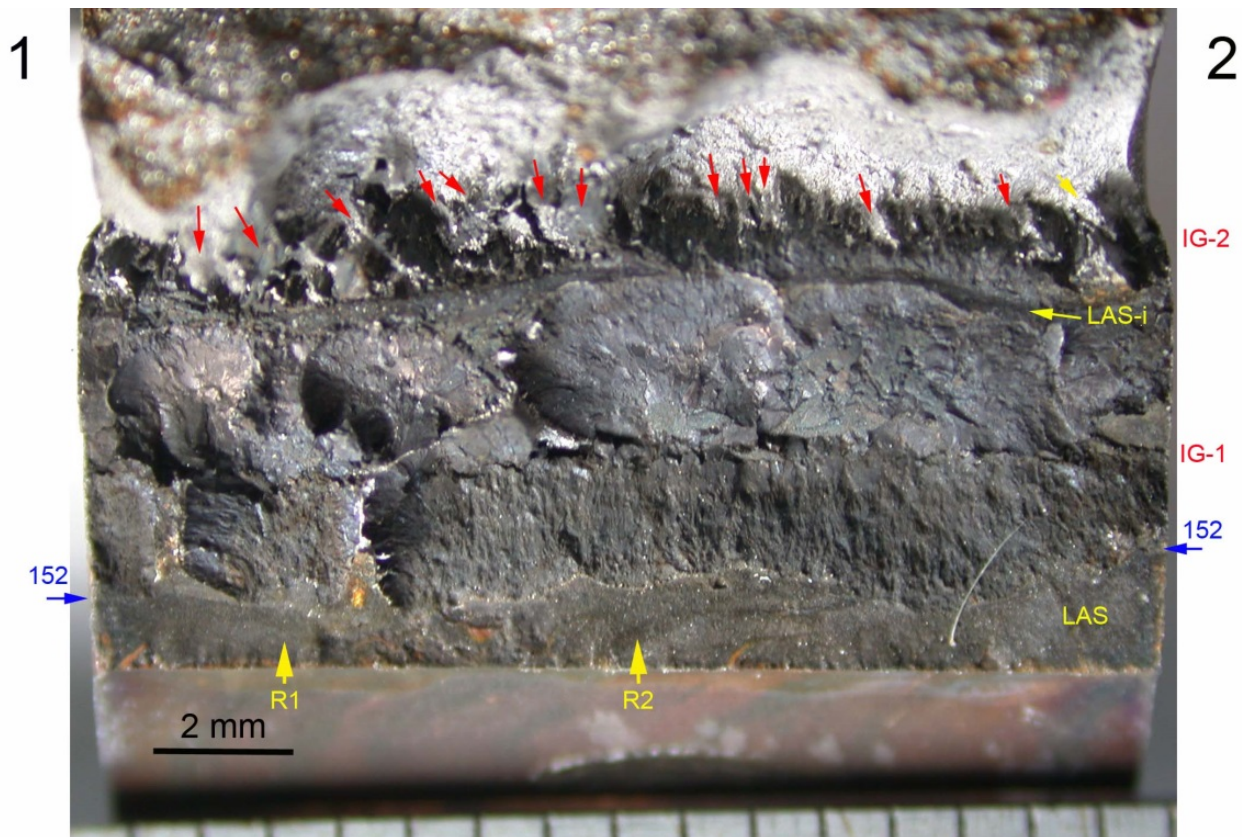
Figure 3-64 Fracture surface (A, Fig. 3-63) of specimen N152-LAS-1 tilted to show the final IG region. Two regions of interest, R1 and R2 are marked in the figure. Crack advance is from bottom to top.

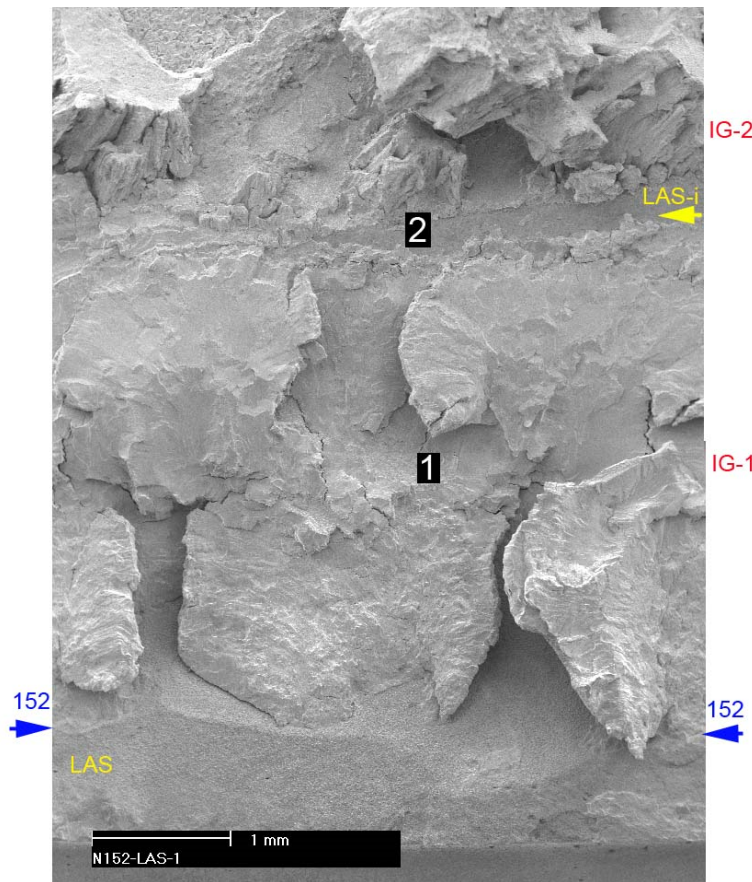
Figure 3-65 Region R1 on the fracture surface A of specimen N152-LAS-1 (Fig. 3-64). Blue arrows indicate the transition from LAS to Alloy 152, and two additional locations of interest: IG-1 (location 1) and the second intersection of the crack with the LAS interface (location 2), labelled LAS-i. Crack advance is from bottom to top.

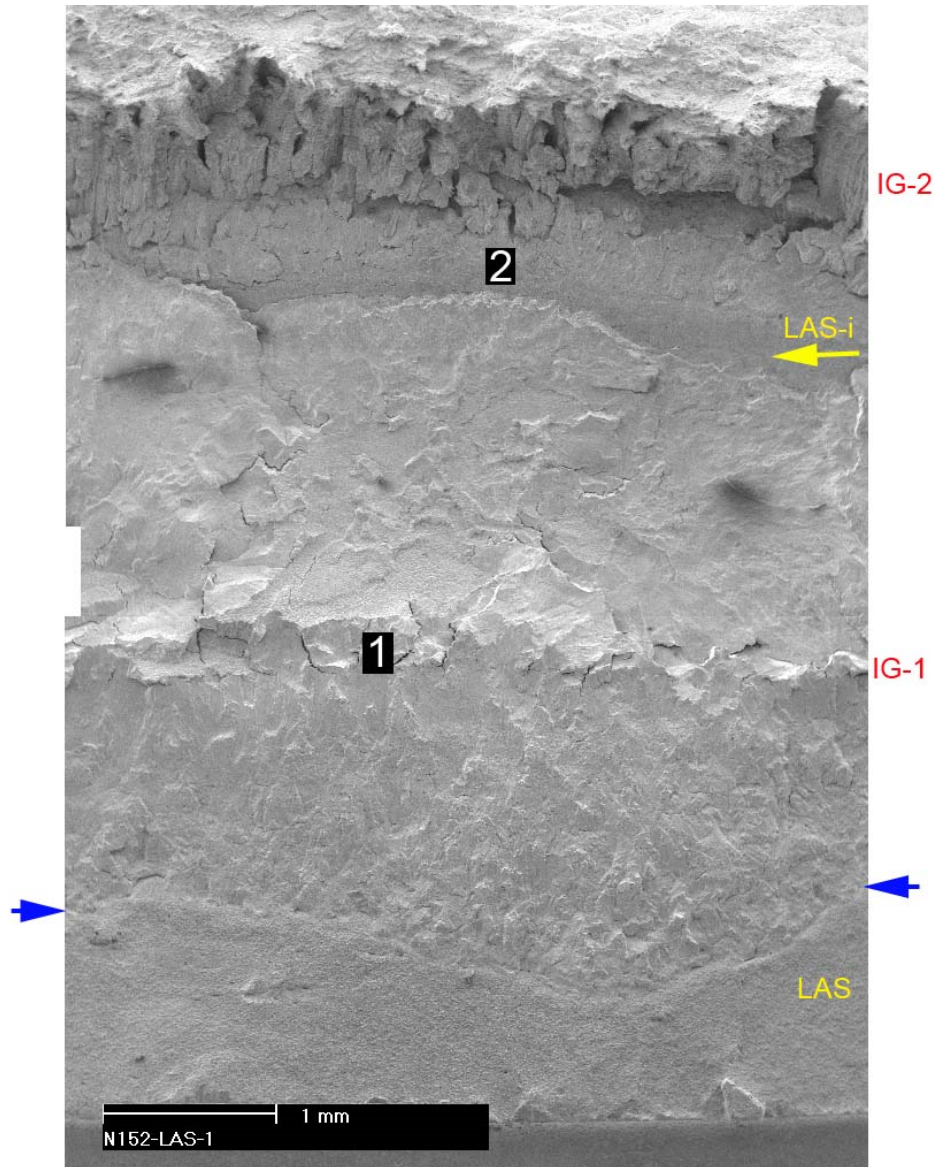
Figure 3-67 Region R2 on the fracture surface A of specimen N152-LAS-1 (Fig. 3-64). Blue arrows indicate the transition from LAS to Alloy 152, and two additional locations of interest: IG-1 (location 1) and the second intersection of the crack with the LAS interface (location 2), labelled LAS-i. Crack advance is from bottom to top.
