Primary Water Stress Corrosion Cracking of High-Chromium, Nickel- Base Welds Near Dissimilar Metal Weld Interfaces

The report summarizes the results of a testing program to evaluate the stress corrosion cracking (SCC) susceptibility at or near the interface between Alloy 52 and 152 weld metals and other weld or base metals. Alloys 52 and 152 are high-chromium weld metals used in reactor pressure vessel head penetration nozzles and as overlays, inlays, or onlays for dissimilar metal piping welds. Alloys 52 and 152 typically show very low SCC growth rates in laboratory testing and are not known to have cracked in service. Nevertheless questions remain as to whether the localized dilution of chromium content or the presence of microstructural features near the interface with the low-chromium weld metals Alloy 82 and 182, as in the case of a weld overlay (WOL), or with steel, as in the case of a head penetration nozzle, could affect the SCC response. For this study, SCC growth rates were measured on a WOL mockup with Alloy 52M (a compositional variant of Alloy 52) on Alloy 182 and on a butt weld mockup with Alloy 152 joined to low-alloy steel (LAS). For the WOL mockup, tests were perf

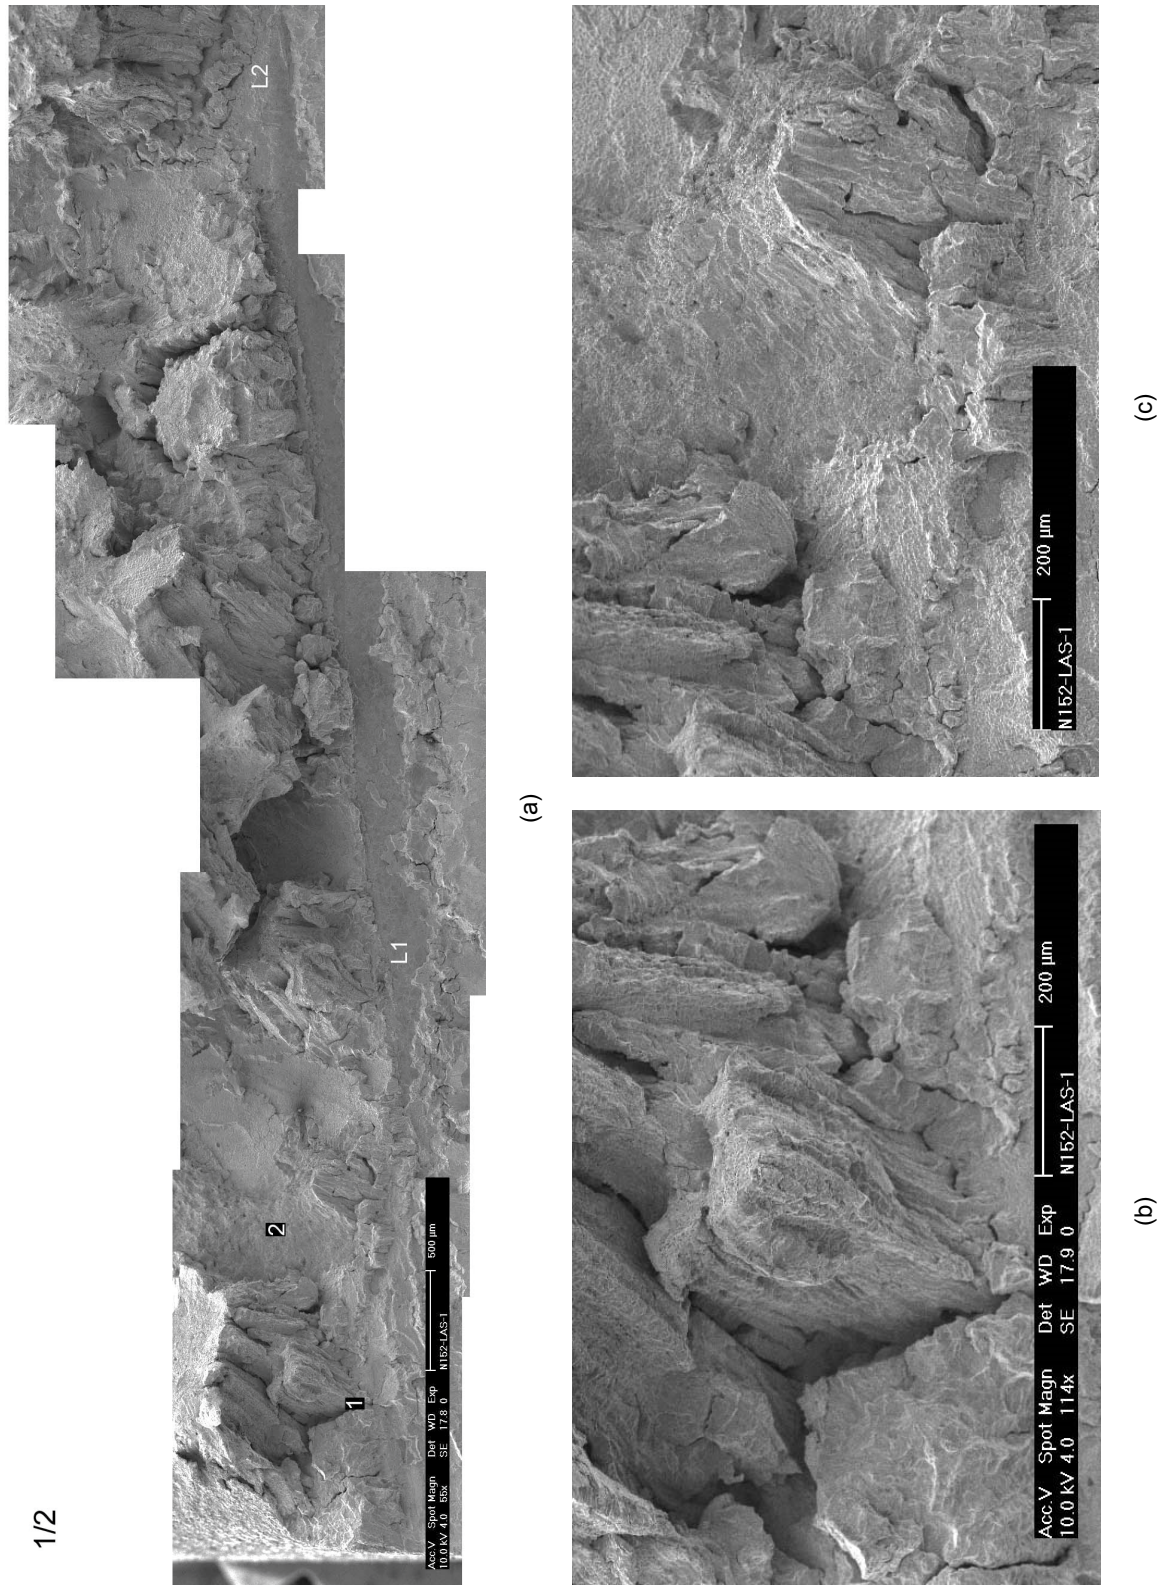
Figure 3-69 Fracture surface of N152-LAS-1, region IG-2 (Fig. 3-64): (a) first half of the fracture surface, (b) detail at location 1, and (c) detail at location 2. Crack advance is from bottom to top.

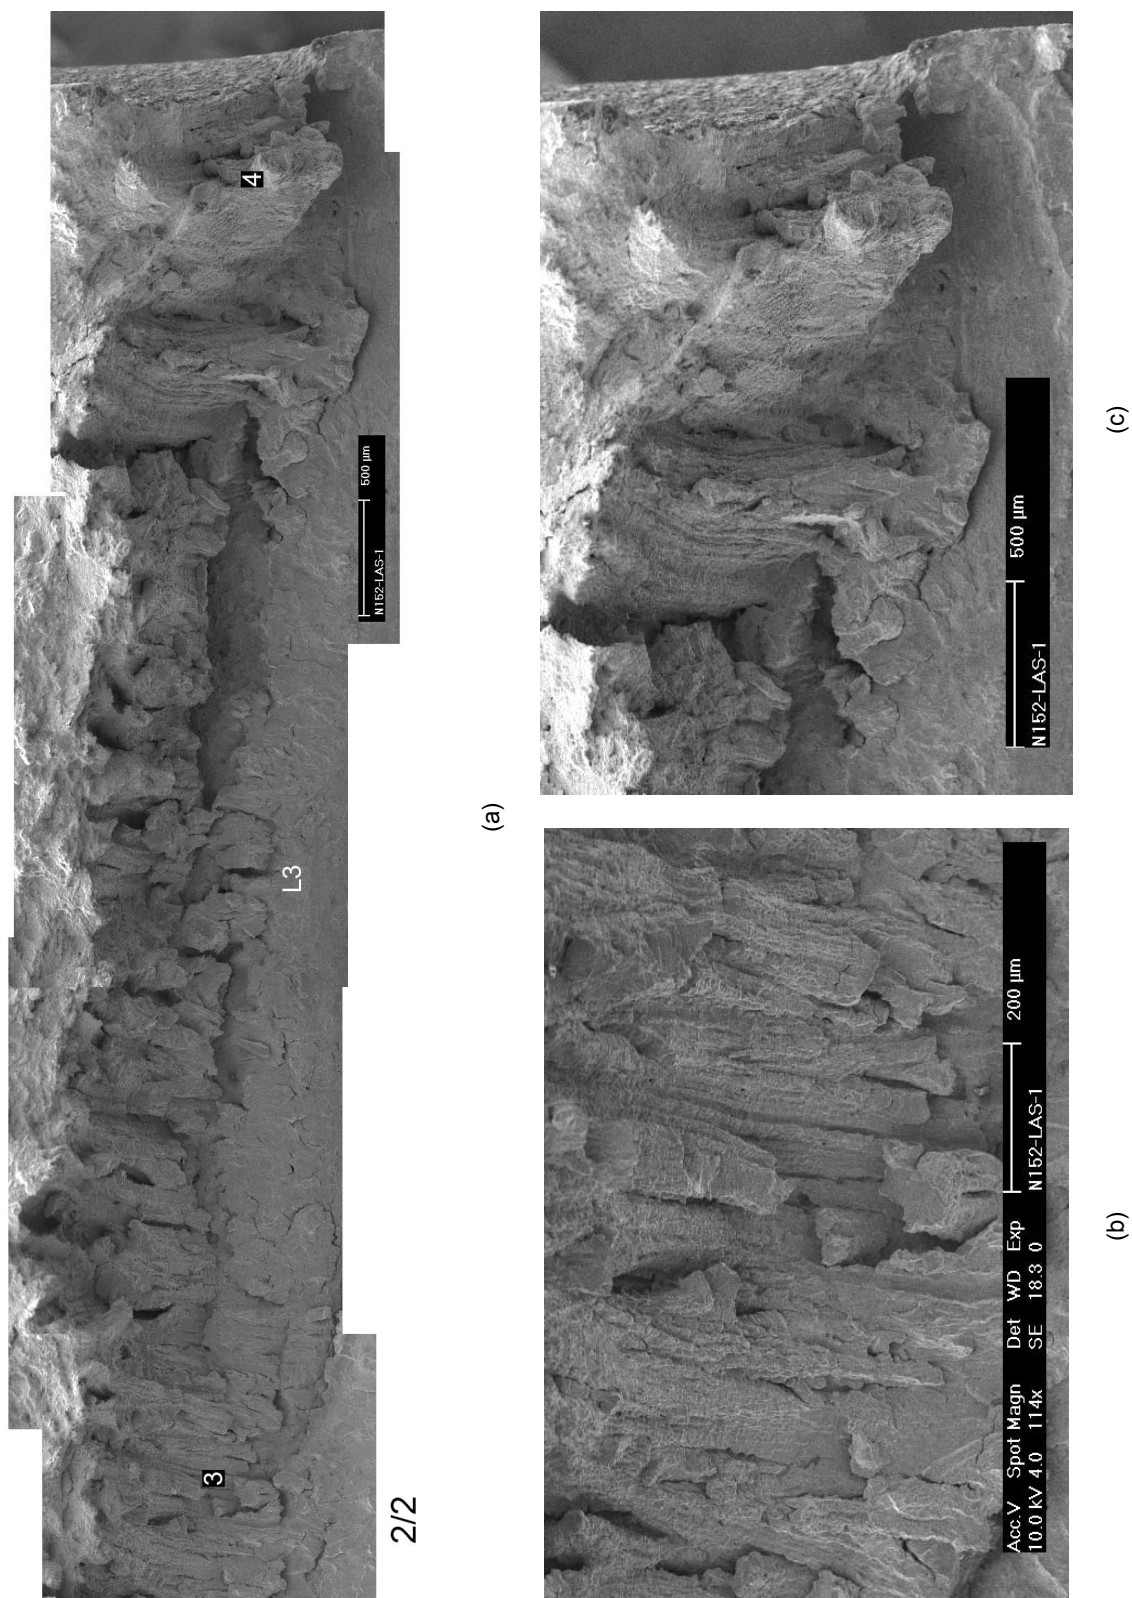
Figure 3-70 Fracture surface of N152-LAS-1, region IG-2 (Fig. 3-64): (a) second half of the fracture surface, (b) detail at location 3, and (c) detail at location 4. Crack advance is from bottom to top.

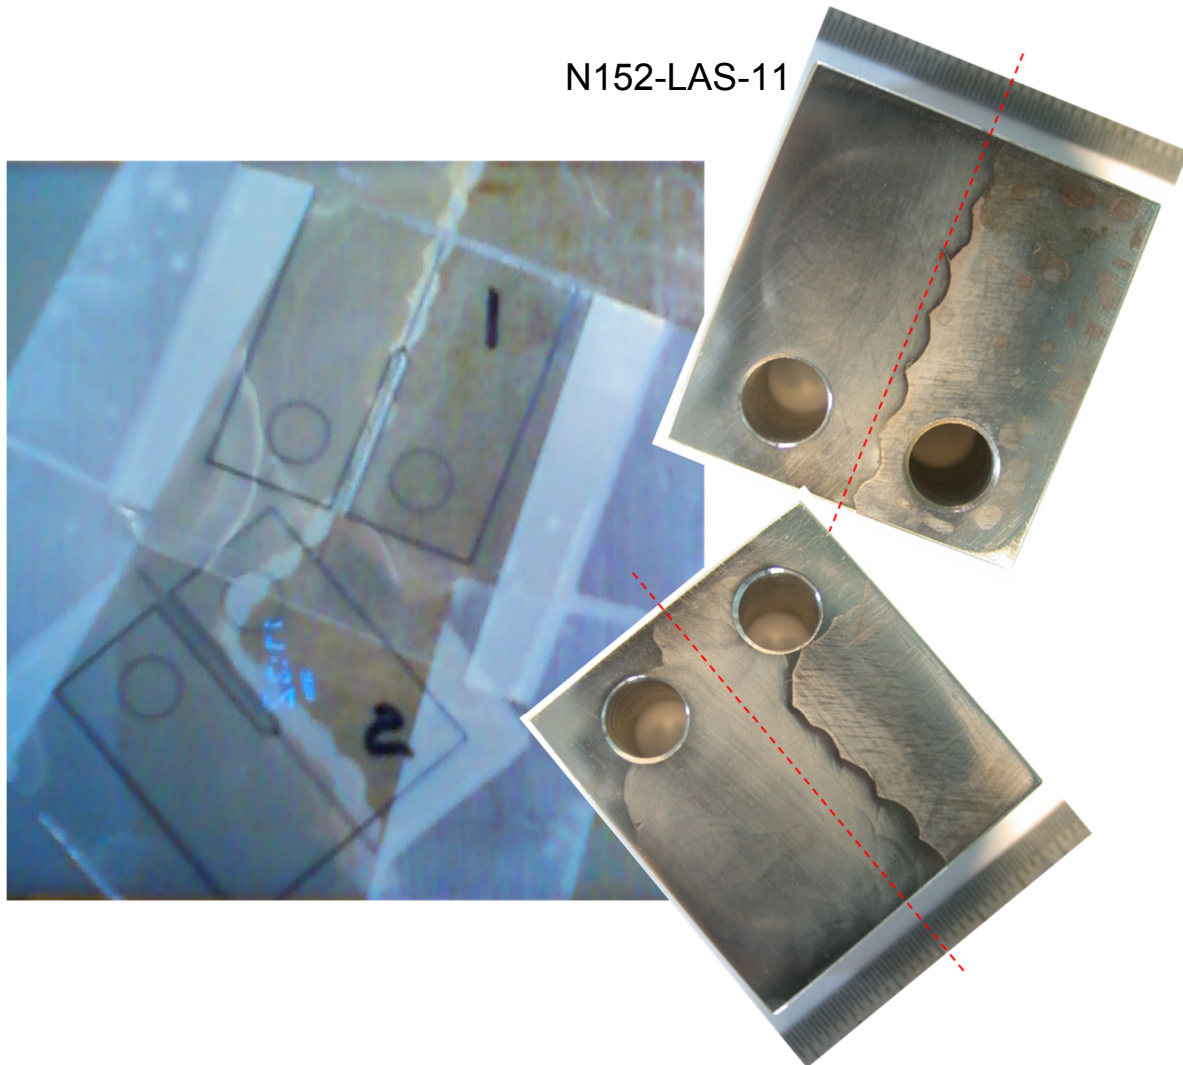
Figure 3-71 Approximate locations of the CT specimen blanks for first layer and second layer weld butter SCC CGR testing. The specimen blank that will later become CT test specimen N152-LAS-11 is indicated in the figure.

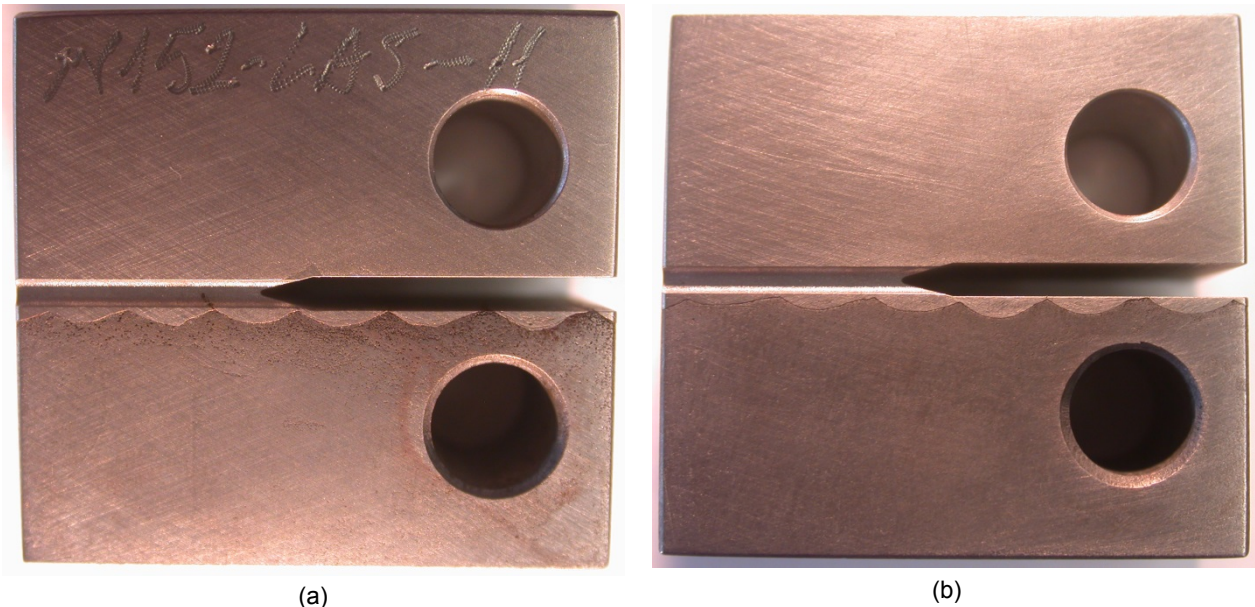
Figure 3-72 The two sides of specimen N152-LAS-11 prior to the SSC test: (a) side 1, and (b) side 2. Alloy 152 is in the top half, and the LAS is in the bottom half of both pictures.

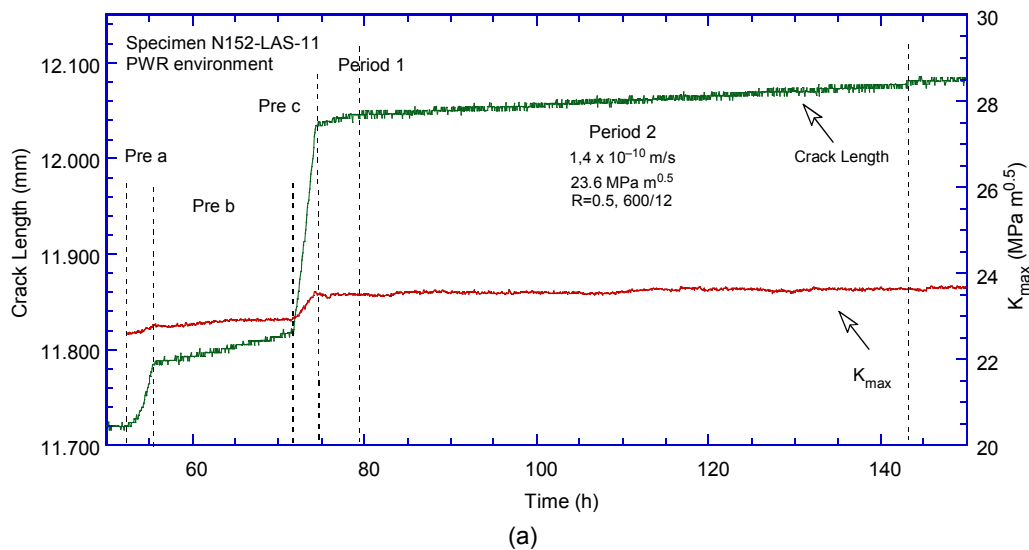
Figure 3-74 Crack-length-vs.-time for dilution specimen N152-LAS-11 in simulated PWR environment during test periods (a) precracking-2, (b) 3-5, (c) 6, (d) 7 9, (e) 10, (f) 11-13, (g) 14-15, (h) 16-27, and (i) 28.

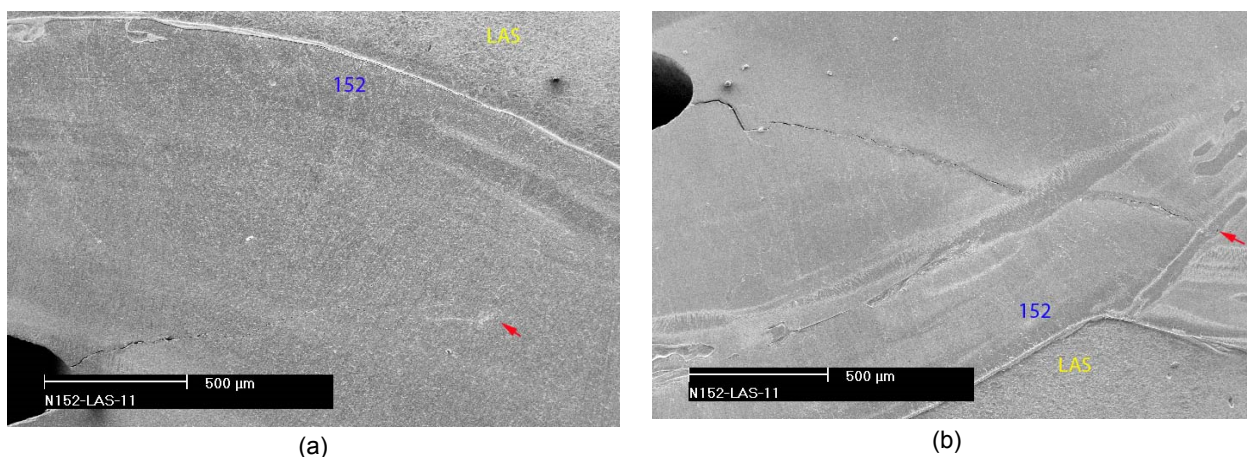
Figure 3-75 SEM images of the two sides of the dilution specimen N152-LAS-11 after the test: (a) side 1, and (b) side 2. Alloy 152 and the LAS are as marked in each picture. The red arrows mark the end of the test.

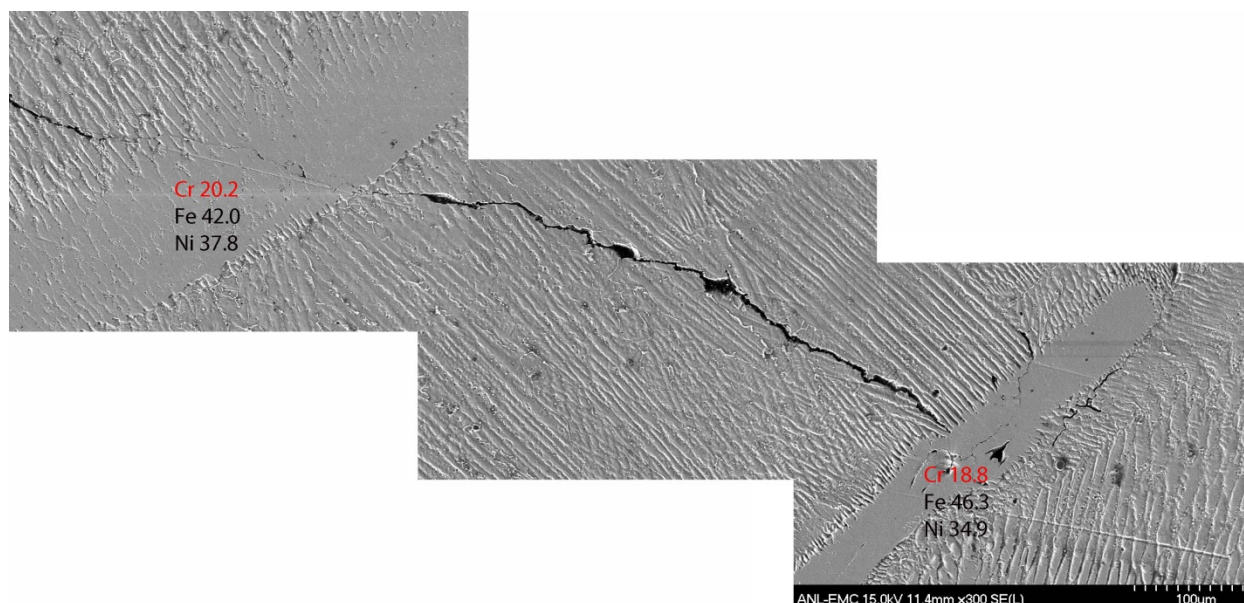
Figure 3-77 “Swirls” appearing to slow down/arrest crack propagation observed on the side surface 2 in specimen N152-LAS-11 (locations 2 and 3 in Fig. 2-9b). Measured Cr concentration (wt. %) for each “swirl” is indicated with red in the figure. Crack propagation is from left to right.

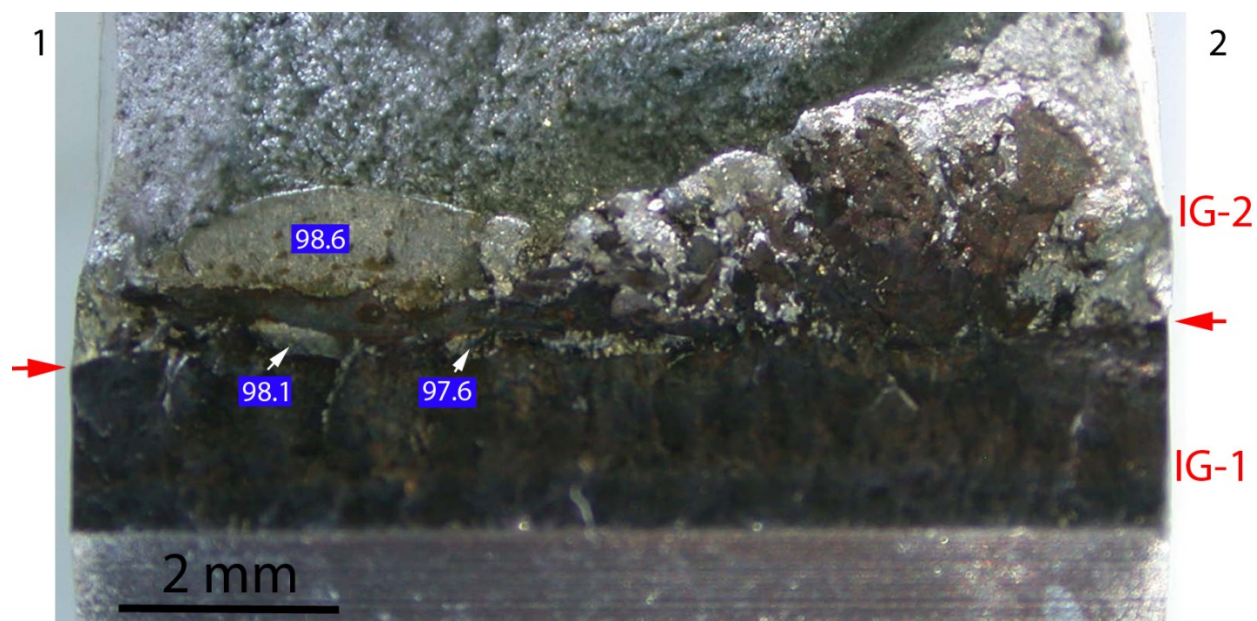
Figure 3-78 Fracture surface of specimen N152-LAS-11. The red lateral arrows indicate the end of cyclic loading and the beginning of the final constant load test period. Measured Fe concentration (wt. %) for at several locations is indicated on a blue background in the figure. Crack advance is from bottom to top.

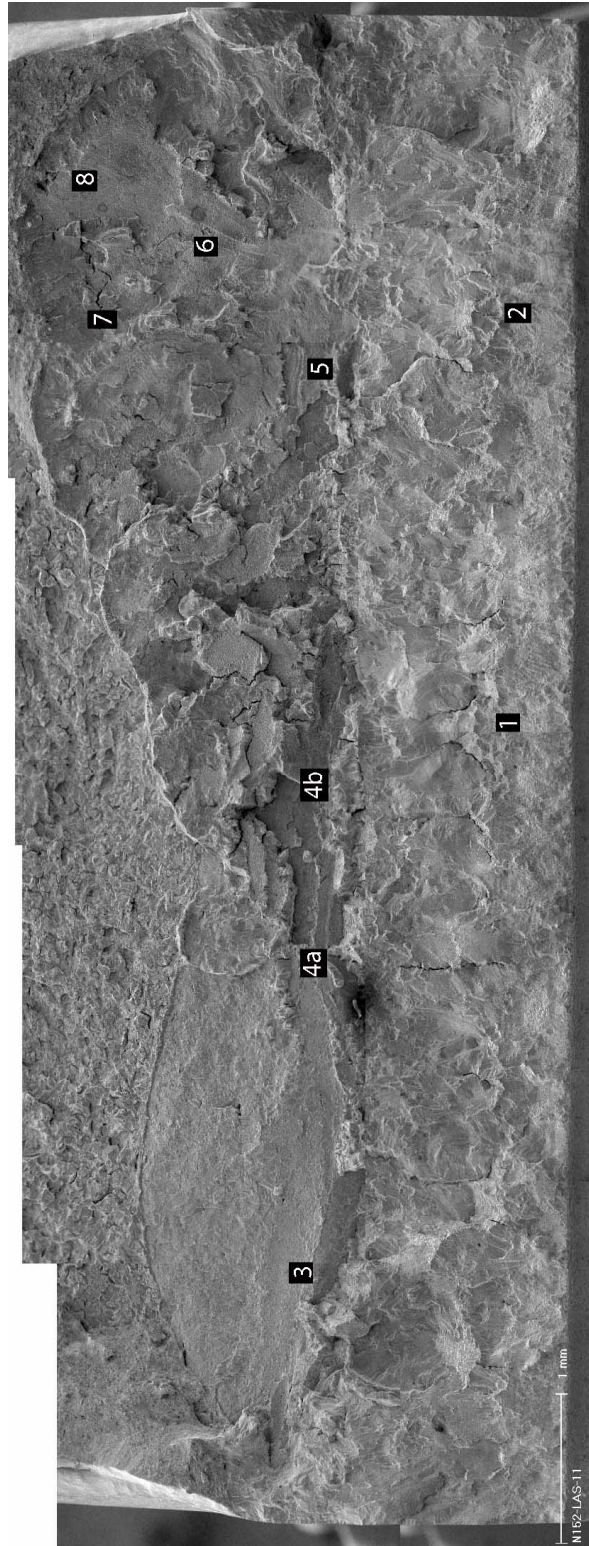
Figure 3-79 Fracture surface of specimen N152-LAS-11. Crack advance is from bottom to top.

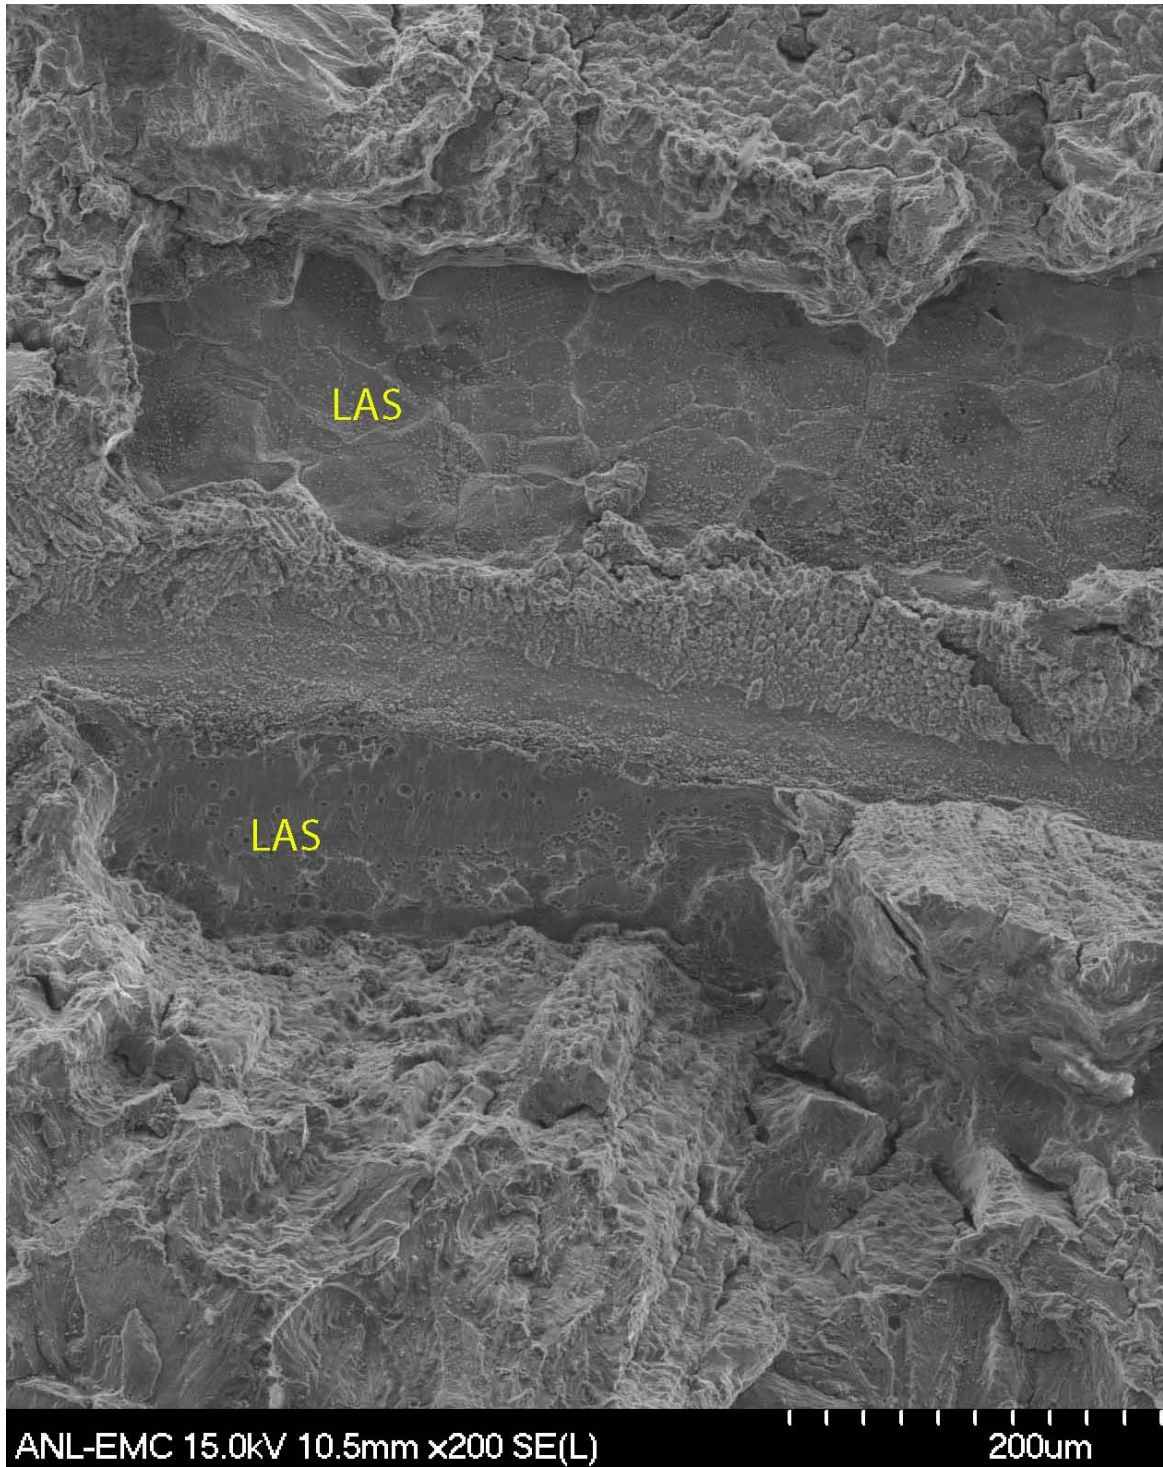
Figure 3-82 Fracture surface of specimen N152-LAS-11 at location 4a in Fig. 3-79. Crack advance is from bottom to top.

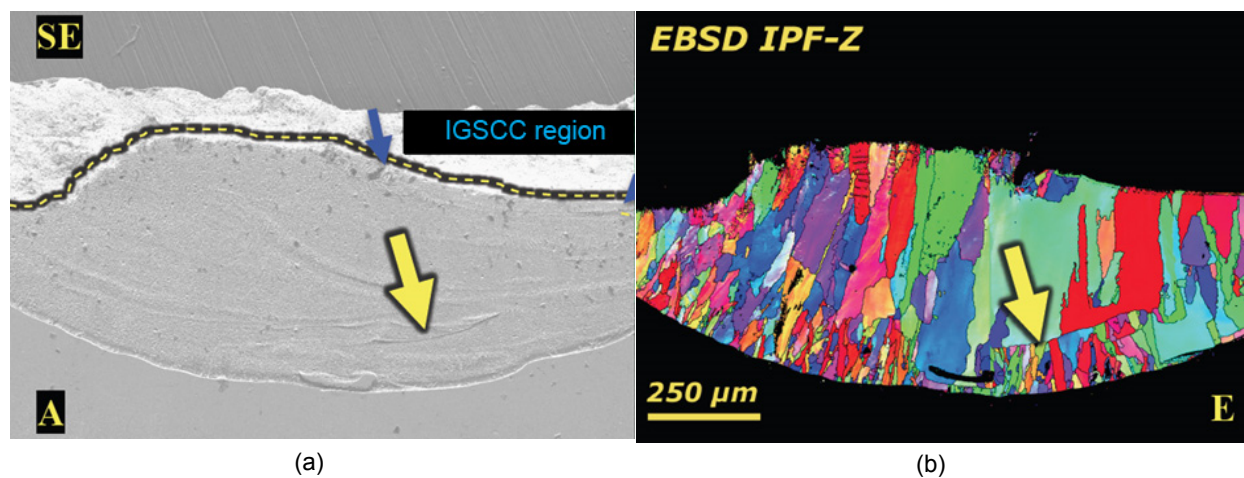
Figure 3-86 SEM (a) and EBSD (b) map obtained on cross section “22” (Fig. 3-85) of Specimen N152-LAS-11. The yellow arrow points to a set of aligned boundaries that could plausibly explain the crack path in this test [28]. Crack propagation is from right to left.

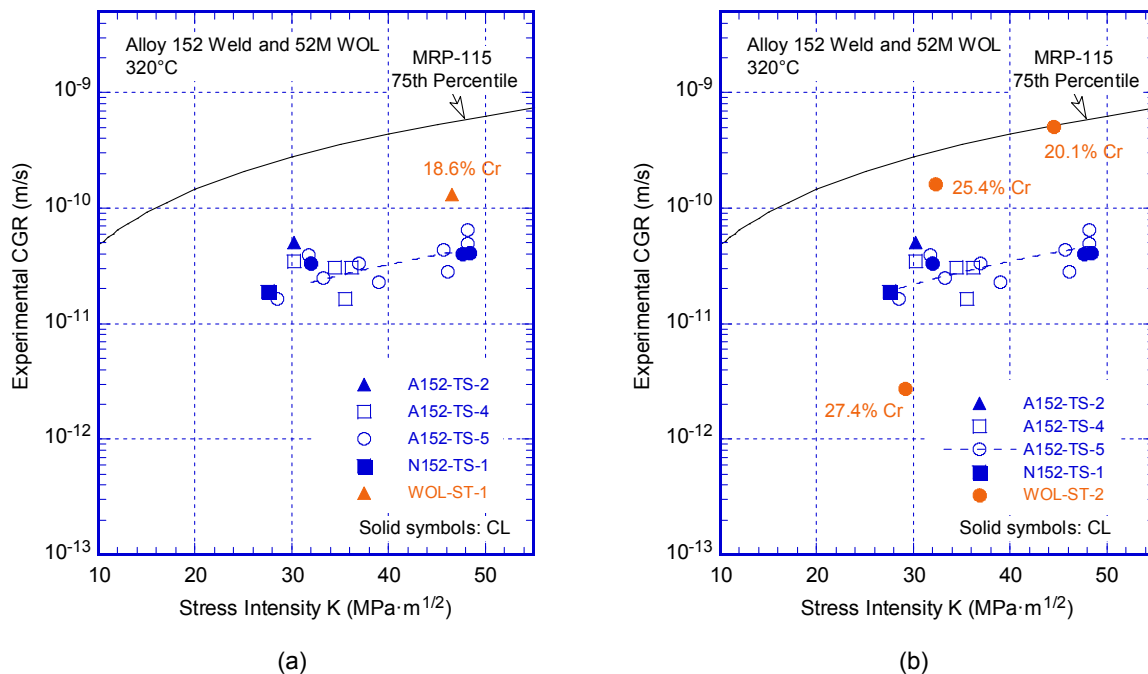
Figure 4-2 SCC CGRs in the Alloy 52M-182 overlay: (a) along the Alloy 52-182 interface in specimen WOL-ST-1, and (b) as a function of average Cr content in specimen WOL-ST-2. Also included are Alloy 152 data generated at ANL [22, 23] and the MRP-115 disposition curve for Alloys 82/182 [1].

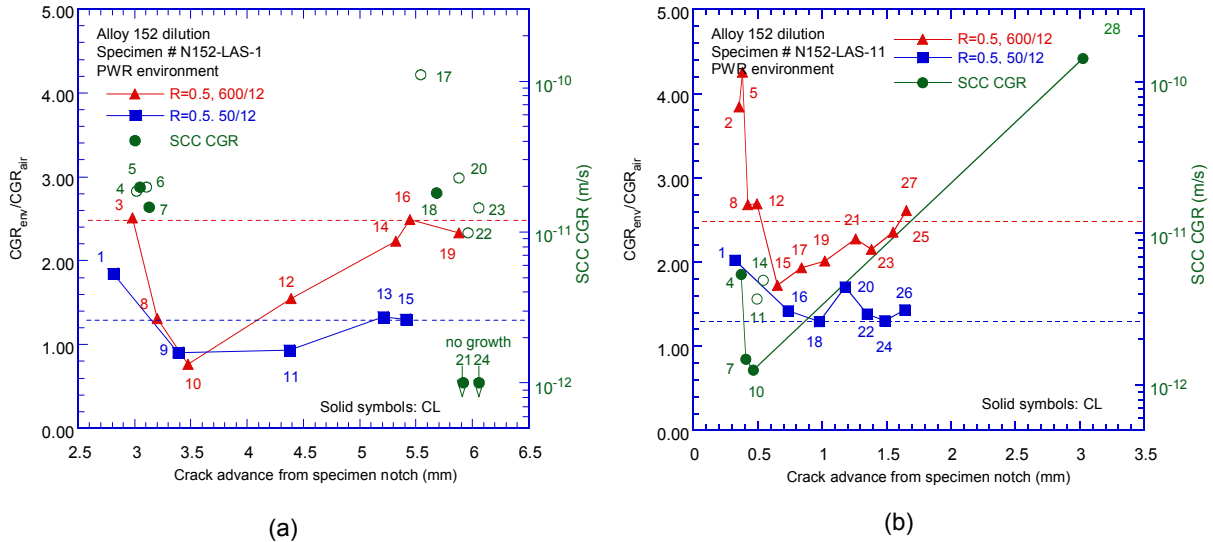
Figure 4-3 Environmental enhancement of two control test conditions and SCC CGRs vs. distance from the specimen notch for (a) N152-LAS-1, and (b) N152-LAS-11. Crack propagation is from left to right.

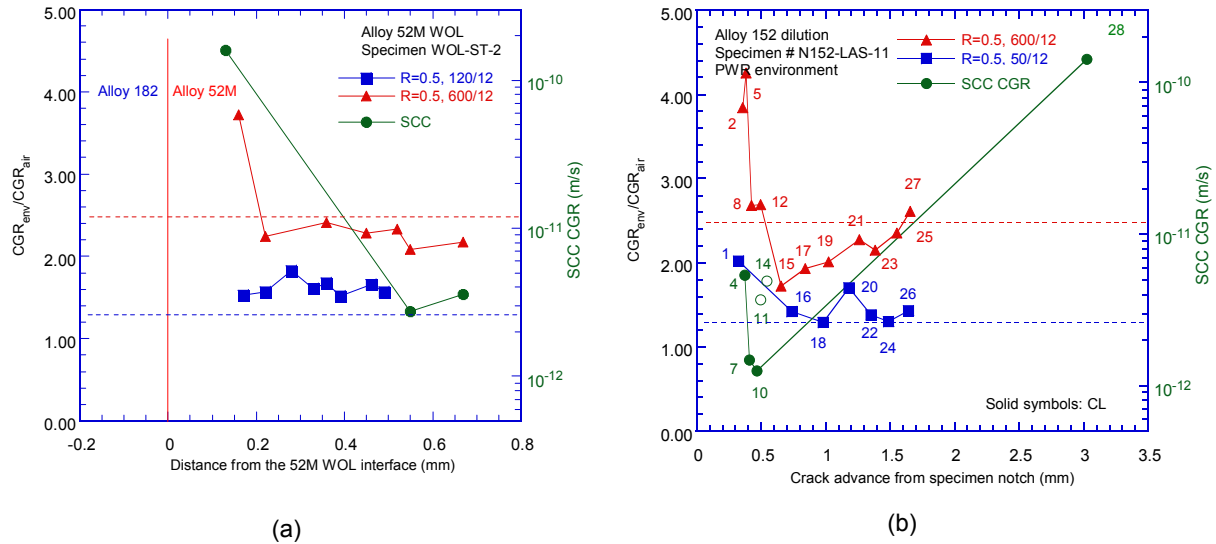
Figure 4-5 Environmental enhancement of two control test conditions and SCC CGRs vs. distance from the specimen notch for 1st layer (a) Alloy 52-182 specimen WOL-ST-2, and (b) Alloy 152-LAS specimen N152-LAS-11.
