WM-00048

Evaporation Pond Removal Excavation Control and Verification Report Durango, Colorado, Disposal Site

January 2018

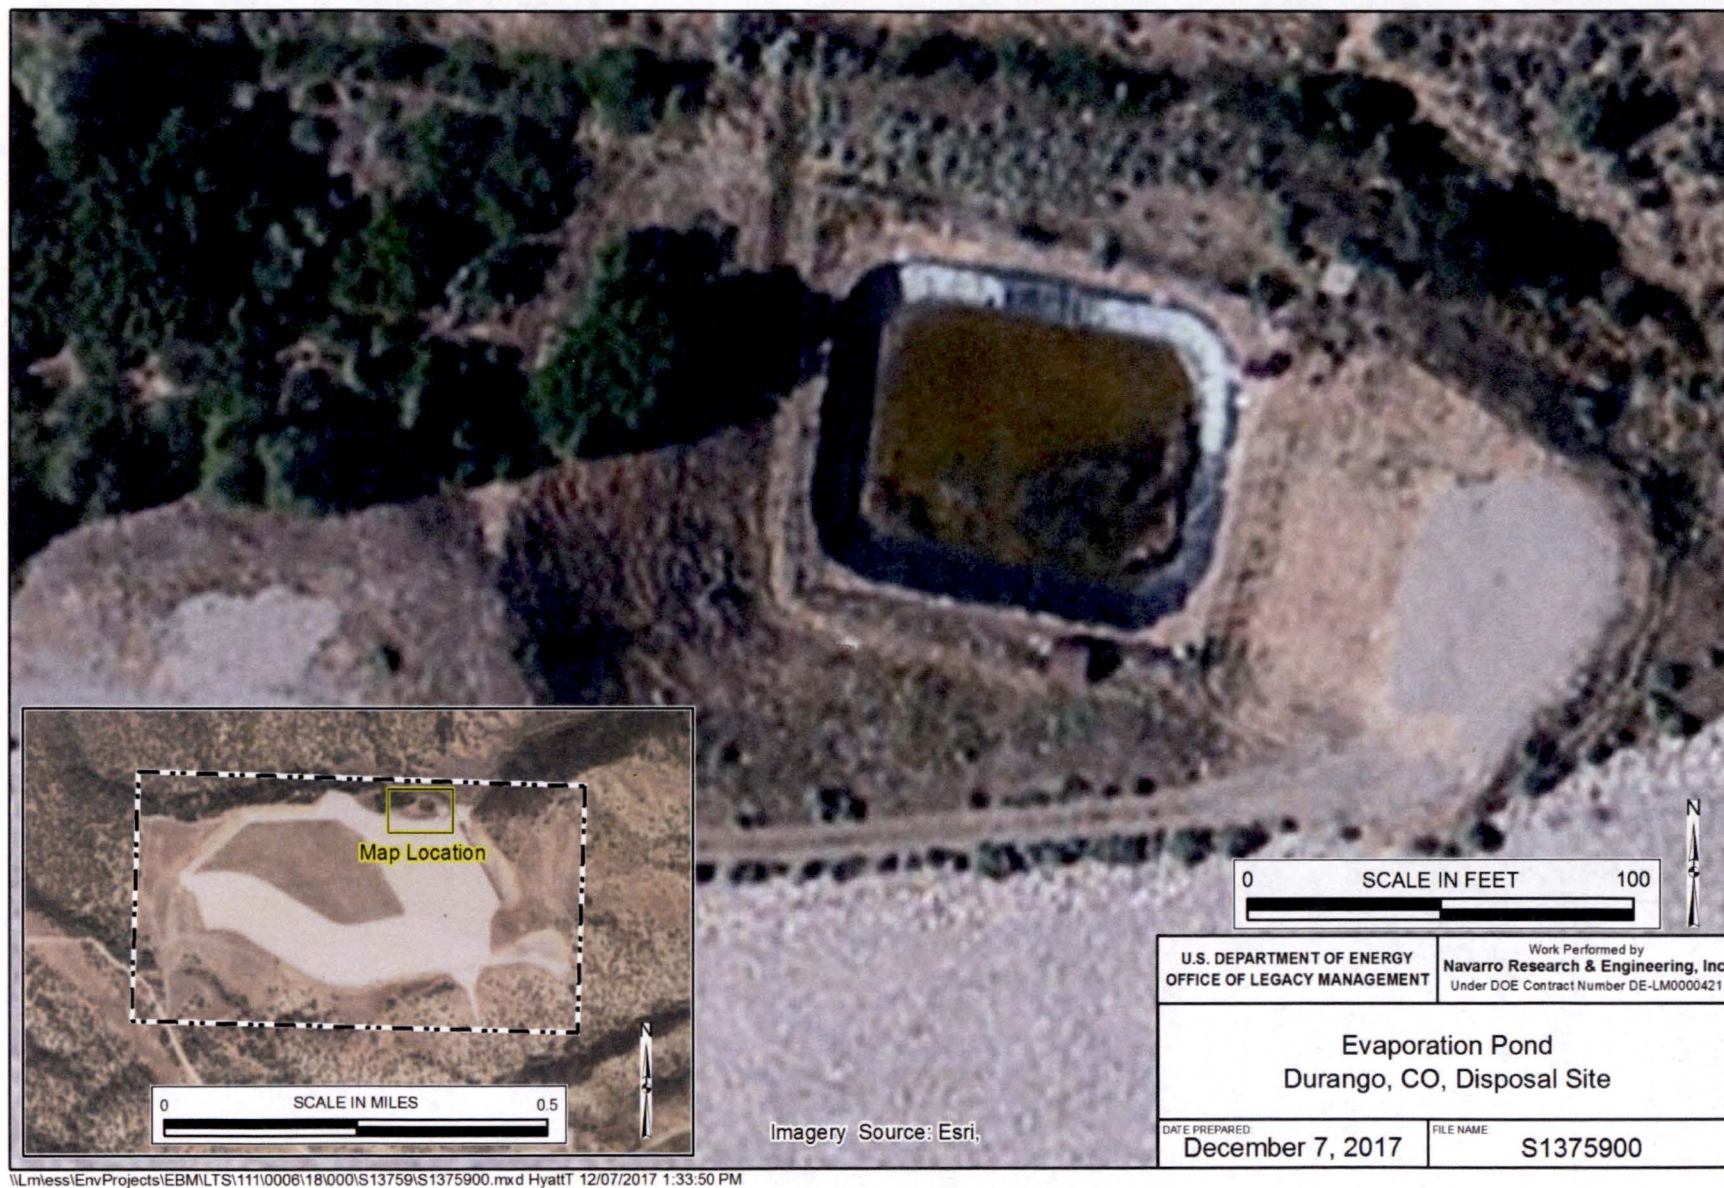
Figure 2. Evaporation Pond at the Durango, Colorado, Disposal Site

The evaporation pond measured 90×110 feet (ft) across the surface and could hold up to approximately 320,000 gallons. The evaporation pond was lined with a 2-foot-thick compacted clay liner and two 40-millimeter-thick high-density polyethylene (HDPE) liners, with drainage nets placed in between the liners.

Once the top liner was removed, the second liner was visually inspected, before the underlying clay layer was exposed. Radiological measurements and inspection of the clay beneath the liner did not identify any areas with elevated radiological readings or wetness, discoloration, or salt deposits associated with the pond contents.

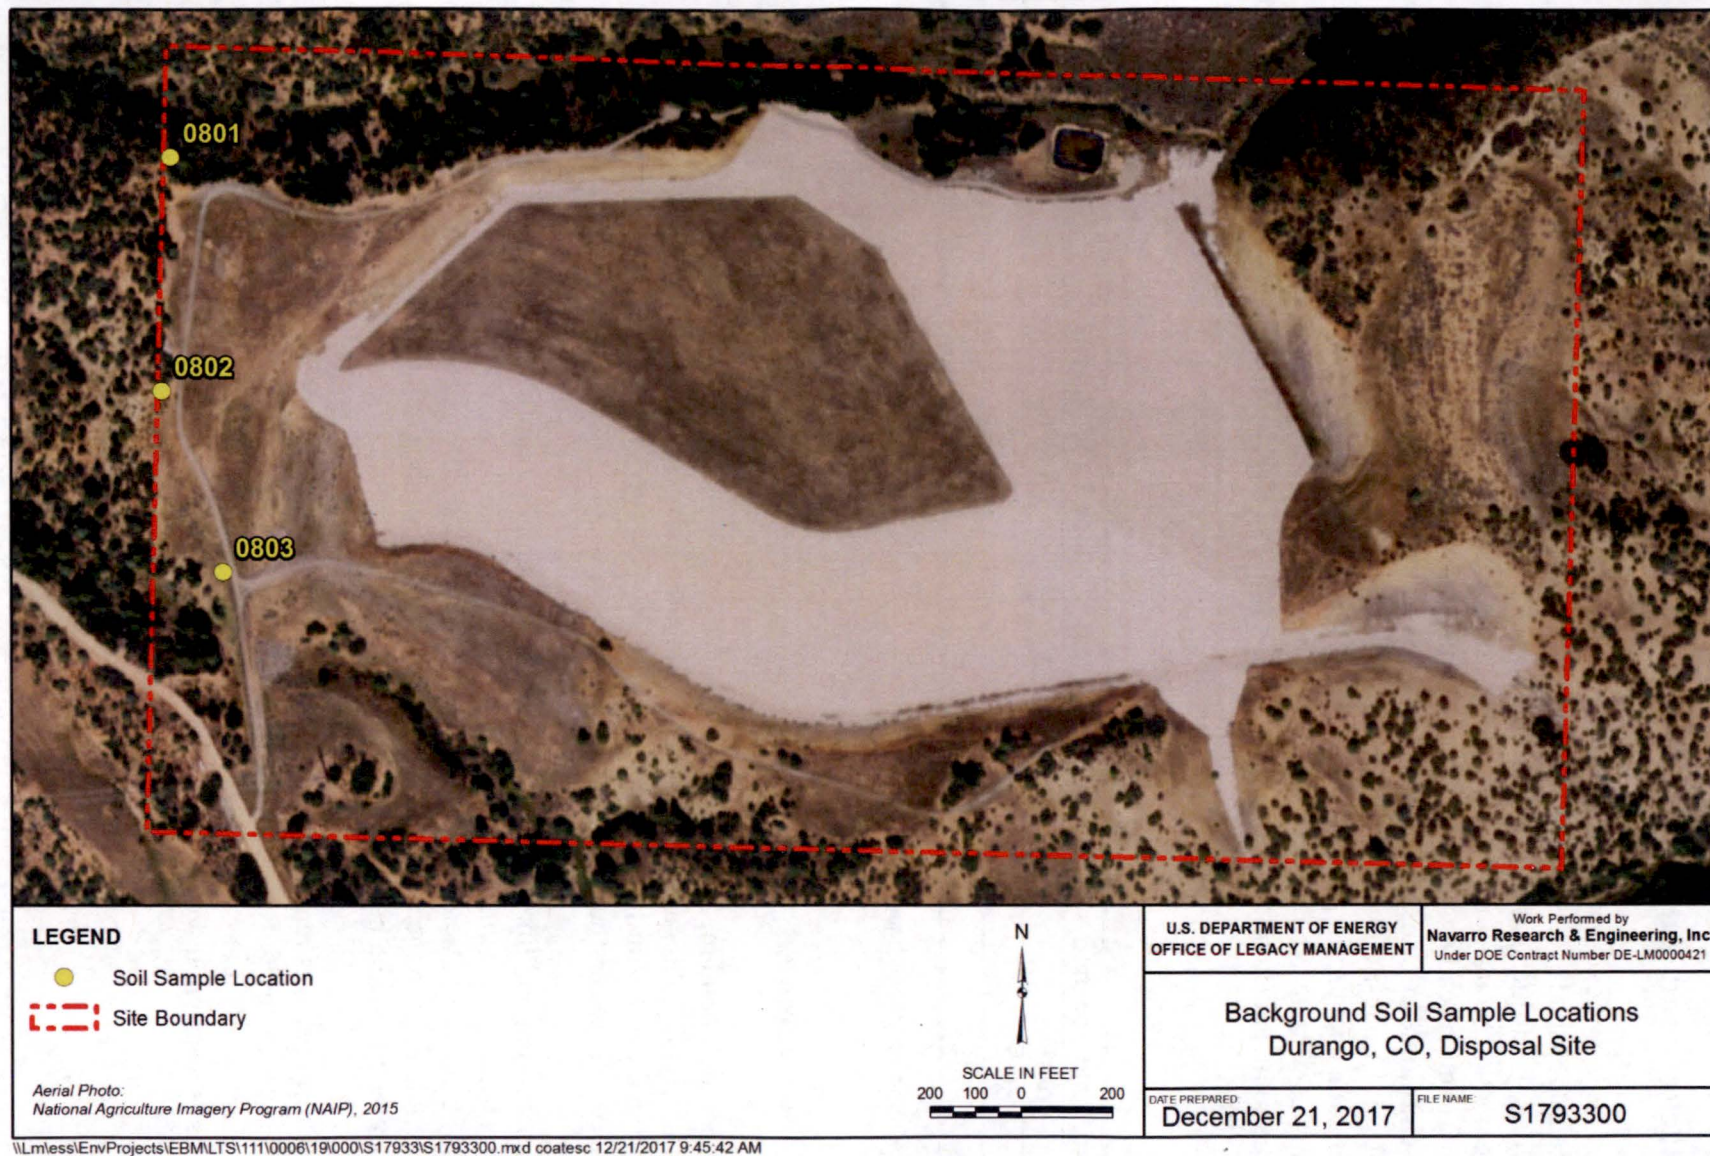
Figure 3. Background Soil Sample Locations at the Durango, Colorado, Disposal Site

Prior to the start of excavation activities, background values for the Durango, Colorado disposal site were established. Three upgradient locations, 0801, 0802, and 0803, within the site boundary and beyond the influence of the evaporation pond and disposal cell, were selected for the measurement of background values and were sampled on May 23, 2017 (Figure 3). At these locations, gamma readings in counts per second (cps) were collected using Mount Sopris SC-132 crutch scintillometers; dose rates were measured using a Thermo Scientific BICRON Micro Rem/Sievert Tissue-Equivalent Survey Meter; soil samples were collected for ^{226}Ra determination using an opposed crystal system (OCS). These results are presented in Table 1. Soil samples were also collected using a hand auger for analytical laboratory analysis of ^{226}Ra , ^{230}Th , uranium, and supplemental analyte concentrations. Results of this analysis are presented in Section 3.0.
