Department of Energy

Subject: Draft Long-Term Surveillance Plan for the Naturita, Colorado, Disposal Site

DRAFT
Long-Term Surveillance Plan
for the Naturita, Colorado,
Disposal Site

January 2018

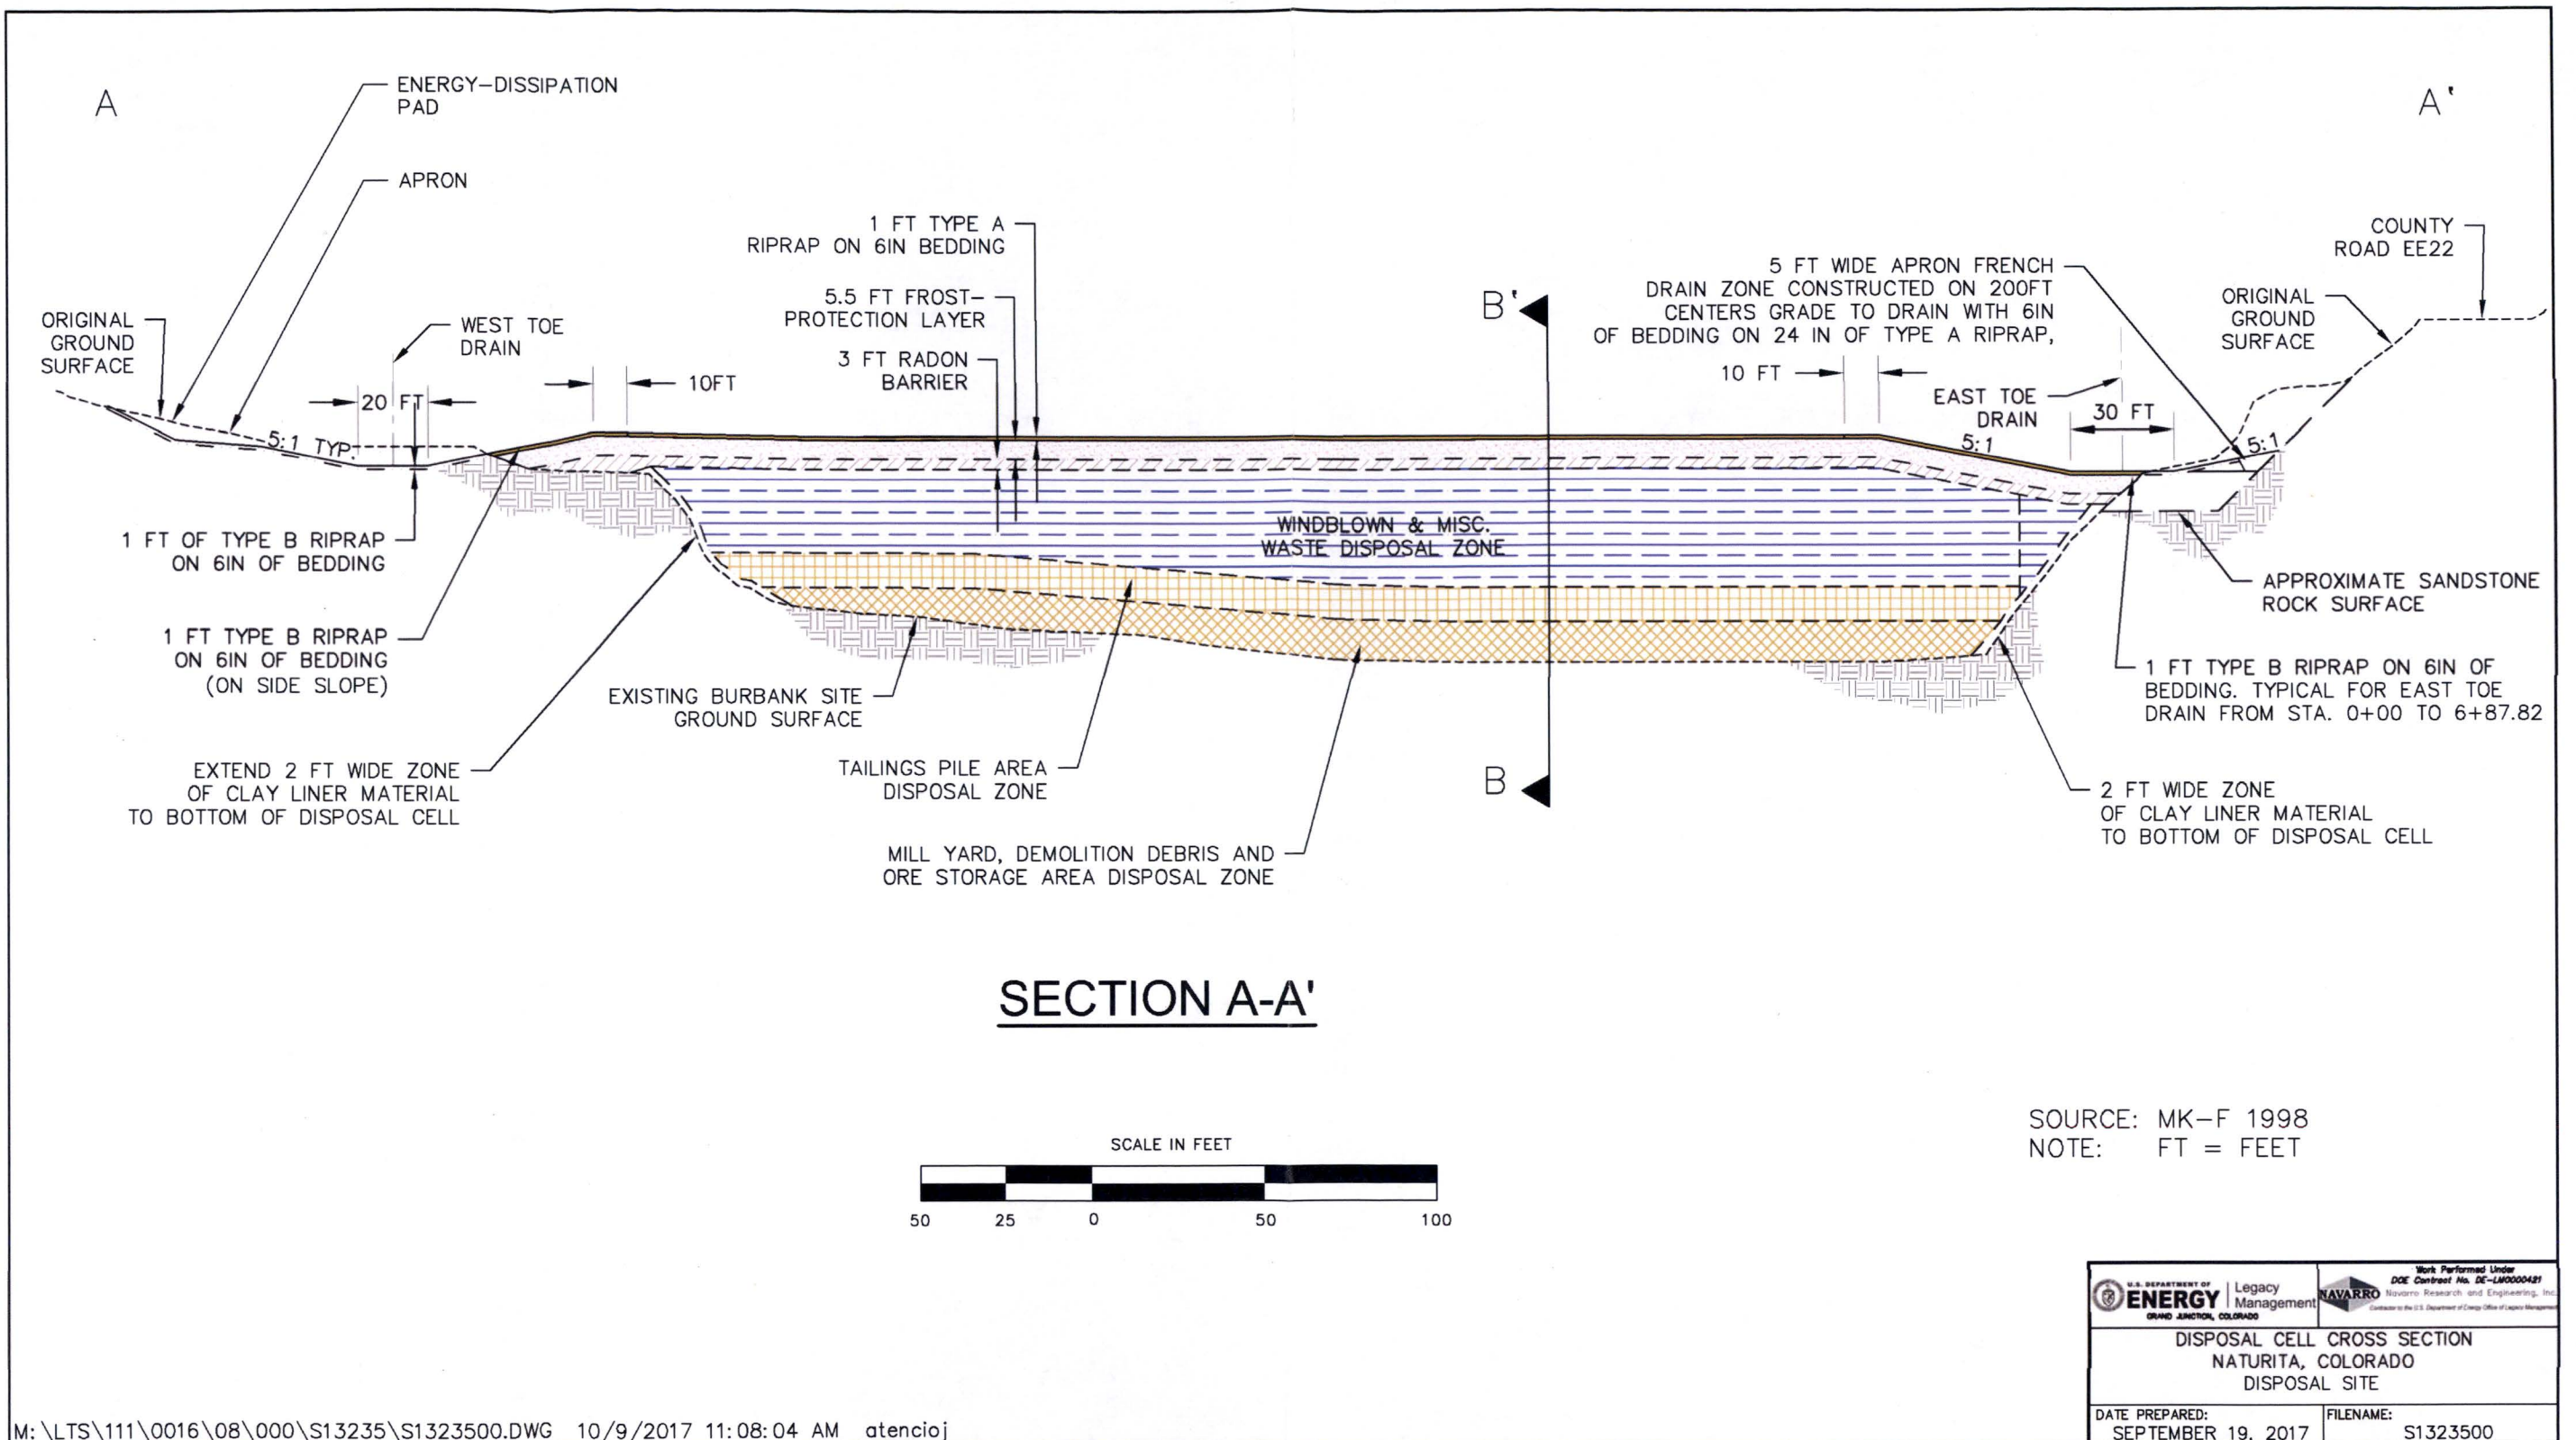
Figure 4. Disposal Cell Cross Section at the Naturita, Colorado, Disposal Site

The disposal cell cover consists of (1) a 3-foot radon barrier (the first layer placed over the material in the disposal cell), (2) a 5.5-foot frost-protection layer, (3) a 6-inch bedding layer, and (4) a 1-foot riprap layer (Figure 4 and Figure 5). The radon barrier is fine-grained clay and has low permeability, forming a capillary break to maintain moisture in the radon barrier layer. The design for the radon barrier assumes the moisture of the material will sustain the cohesiveness of the radon barrier and mitigate disposal cell cover cracking. The radon barrier is protected from seasonal temperature and moisture fluctuations by the 5.5-foot frost-protection layer of compacted soil. The riprap layer was designed to resist erosion forces resulting from a probable maximum precipitation (PMP) event. The PMP for the site was determined to be a 1-hour thunderstorm with 8.2 inches of rainfall. The calculated surface water runoff resulting from the

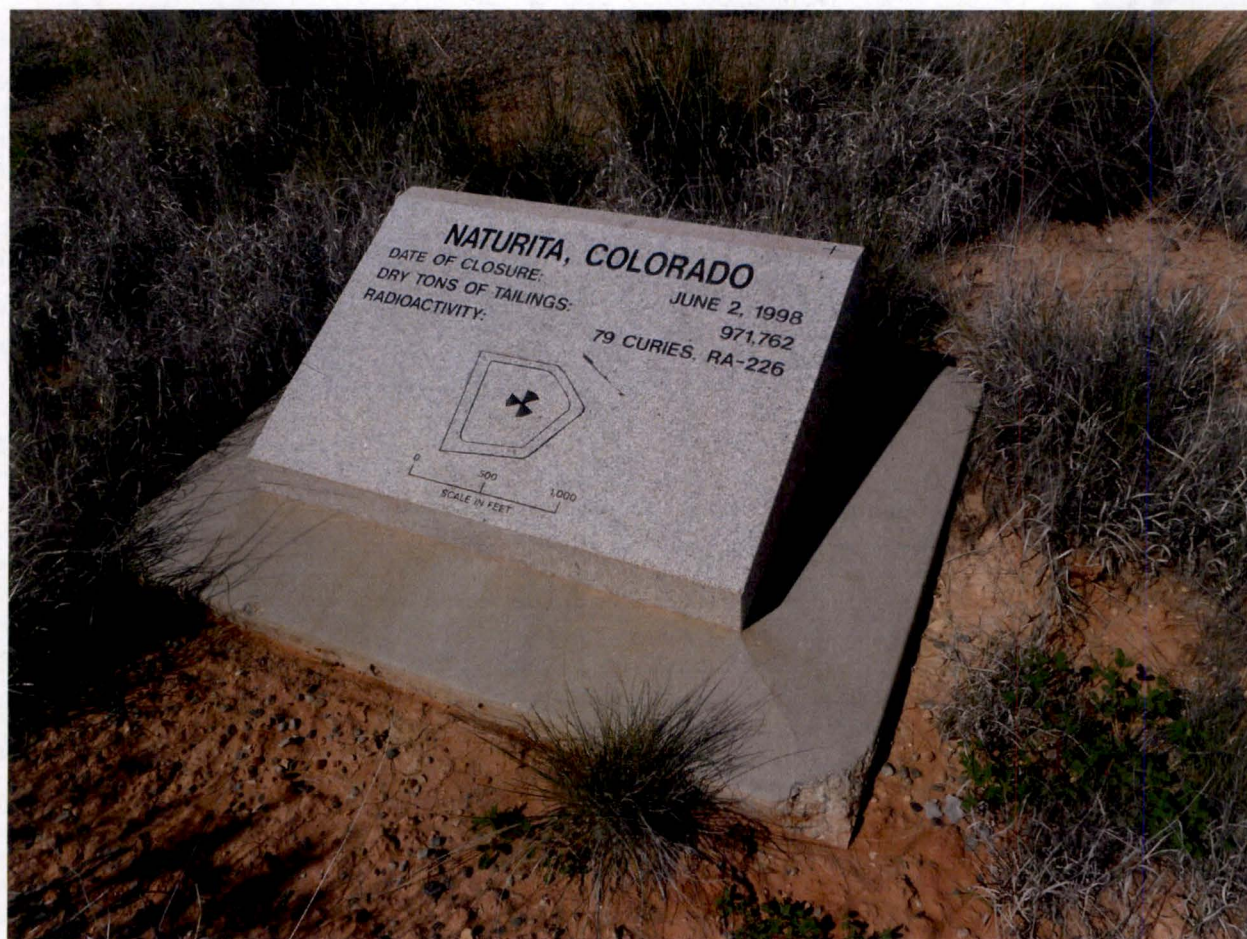
Figure 6. Site Marker SMK-1 by the Entrance Gate

Site Markers: There are two granite site markers (SMK-1 and SMK-2) at the site. SMK-1 is just inside the entrance gate and is set in reinforced concrete that extends 3 feet below the ground surface. SMK-2 is on top of the disposal cell and is set in reinforced concrete that extends to the top of the frost-protection layer. The markers identify the site, the general location of the disposal cell, the date of closure (June 2, 1998), the mass of residual radioactive materials (971,762 dry tons), and the radioactivity (79 curies ^{226}Ra). A photo of one of the markers is shown in Figure 6.

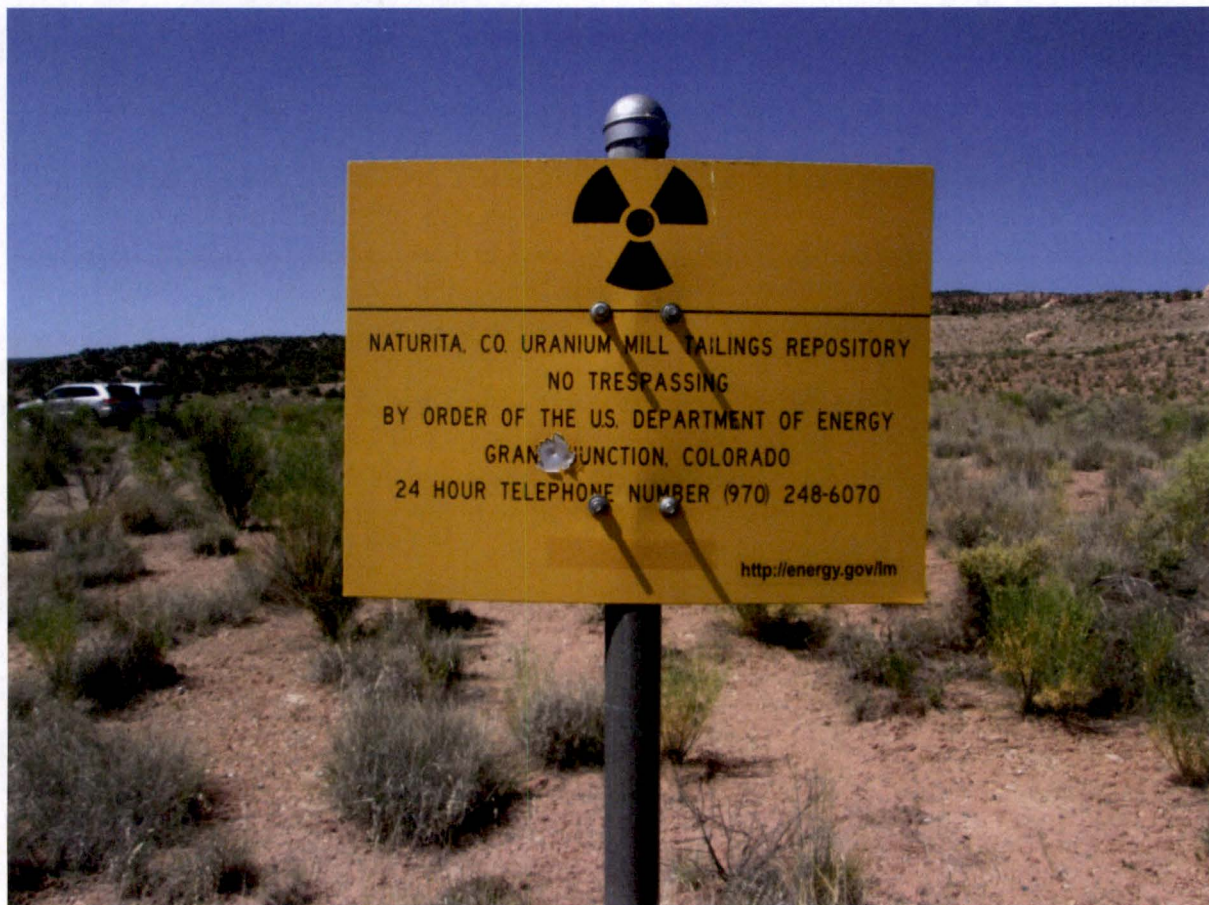
Figure 7. Entrance Sign

Entrance and Perimeter Signs: LM-posted warning signs (18 × 24 inches) indicate property use around the site boundary. The entrance sign is near the entrance gate and site marker SMK-1. In addition to the entrance sign, 25 perimeter signs (P1–P25) are located at approximately 200-foot intervals along the site boundary, offset 5 feet inside the perimeter fence. These signs display the international trefoil symbol indicating the presence of radioactive materials and state that trespassing is forbidden. The entrance sign (Figure 7) has the same information as the perimeter signs, plus the name of the site (Naturita Colorado Uranium Mill Tailings Repository), the 24-hour telephone number for LM in Grand Junction, Colorado ([970] 248-6070), and the LM website address. All sign posts are embedded in concrete to a depth of approximately 3 feet below ground surface.

- A condition is identified during the annual inspection (or other site visit) that requires personnel, perhaps with specific expertise, to return to the site to evaluate the condition.
- DOE is notified by a citizen or outside agency that conditions at the site are substantially changed. A 24-hour DOE contact telephone number is posted on the entrance sign and is intended for public use to request information or to report a problem at the site (Figure 7).
