Subject: Concerns about Anomalies at the Mexican Hat Uranium Mill Tailings Radiation Control Act Site

MEXICAN HAT, UT
UMTRCA Title I Site
Trip Report
July 11, 2011

Subject: Results of Screening Level Radiological Survey of Two Areas West of the Title I Disposal Cell, Mexican Hat, Utah, and Review of Completion Reports Data

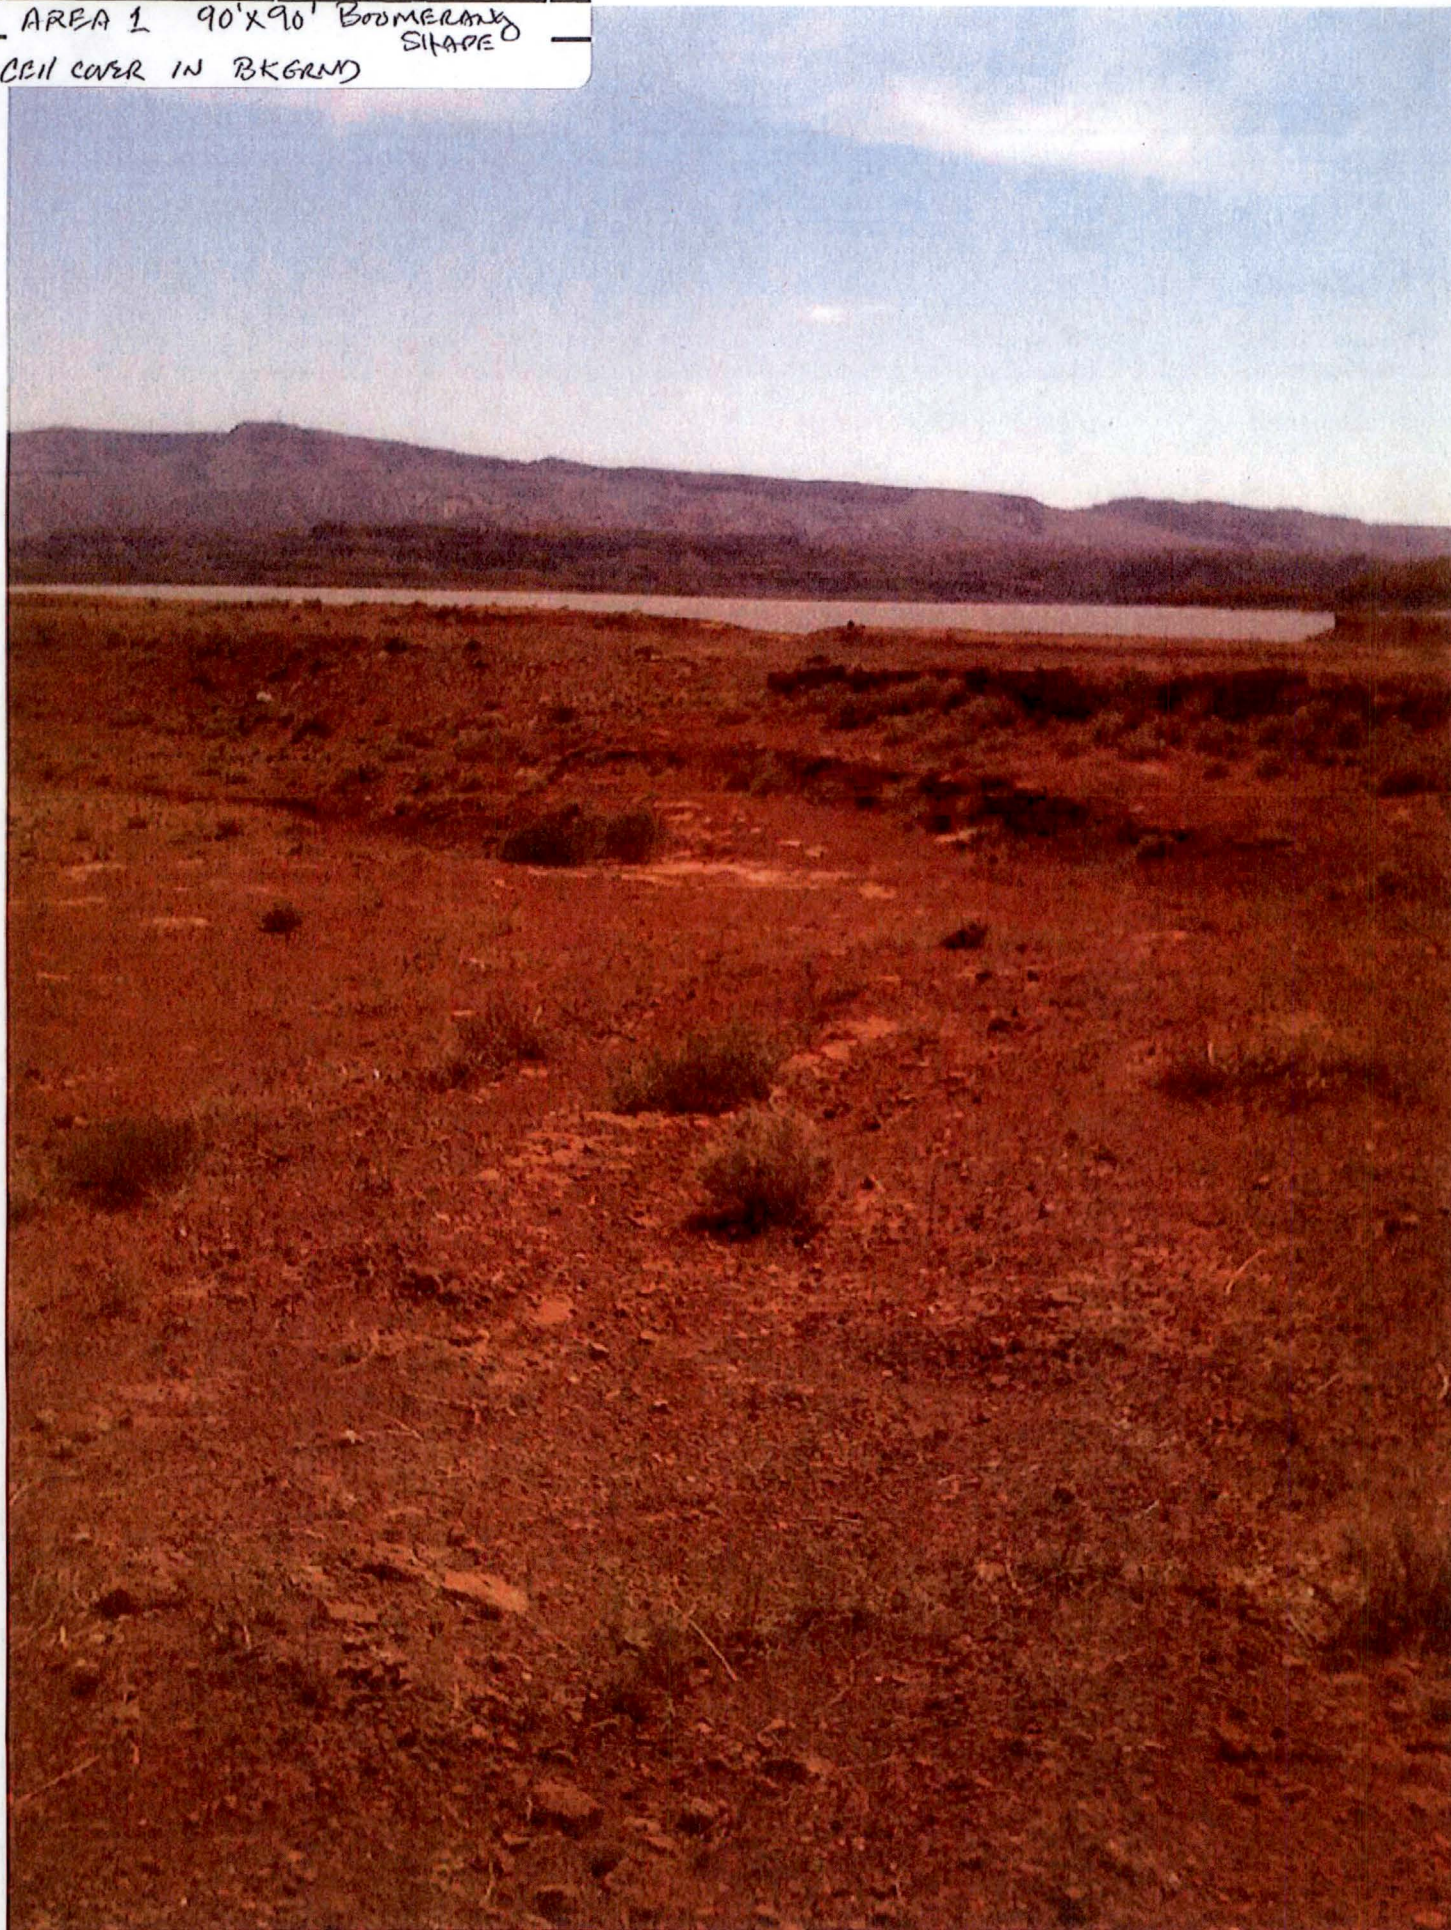
Everyone, This is the first area we were taken to. We Identified it as Area 1. The area was shaped like a boomerang and about 90' X 90' Most of the area had elevated reading 2-3 time background using the scintilometer. In the picture you can see 3 tiers. The middle tier was the area with elevated levels. The picture was taken standing on the middle tier At the point that your looking at were two hot spots (subsurface) with readings as high as from 800-100- CPS on the scintilometer. No construction debris was seen in this area.

Background = 100 CPS on Scintilometer

AREA 1 90'x90' BOOMERANG
CEIL COVER IN BKGND SHAPE

The first area (Area 1) was shaped like a boomerang with dimensions of about 90' x 90'; most of the area had elevated reading 2-3 times background (100 counts per second) using the scintilometer. The area was constructed of rock ledges or tiers. Photos were taken and sent out in an earlier email (attached), with the middle tier of Area 1 which contained the elevated readings. Two hot spots that we flagged which were (subsurface) had reading from 800 - 1000cps on the scintilometer. No construction debris was observed in the area of the hotspots; this was the area where the steel balls were found and picked up. Cassandra Bloedel insisted that there were more balls from the ball mill in the area; however, after a search of the area no additional balls were located. .

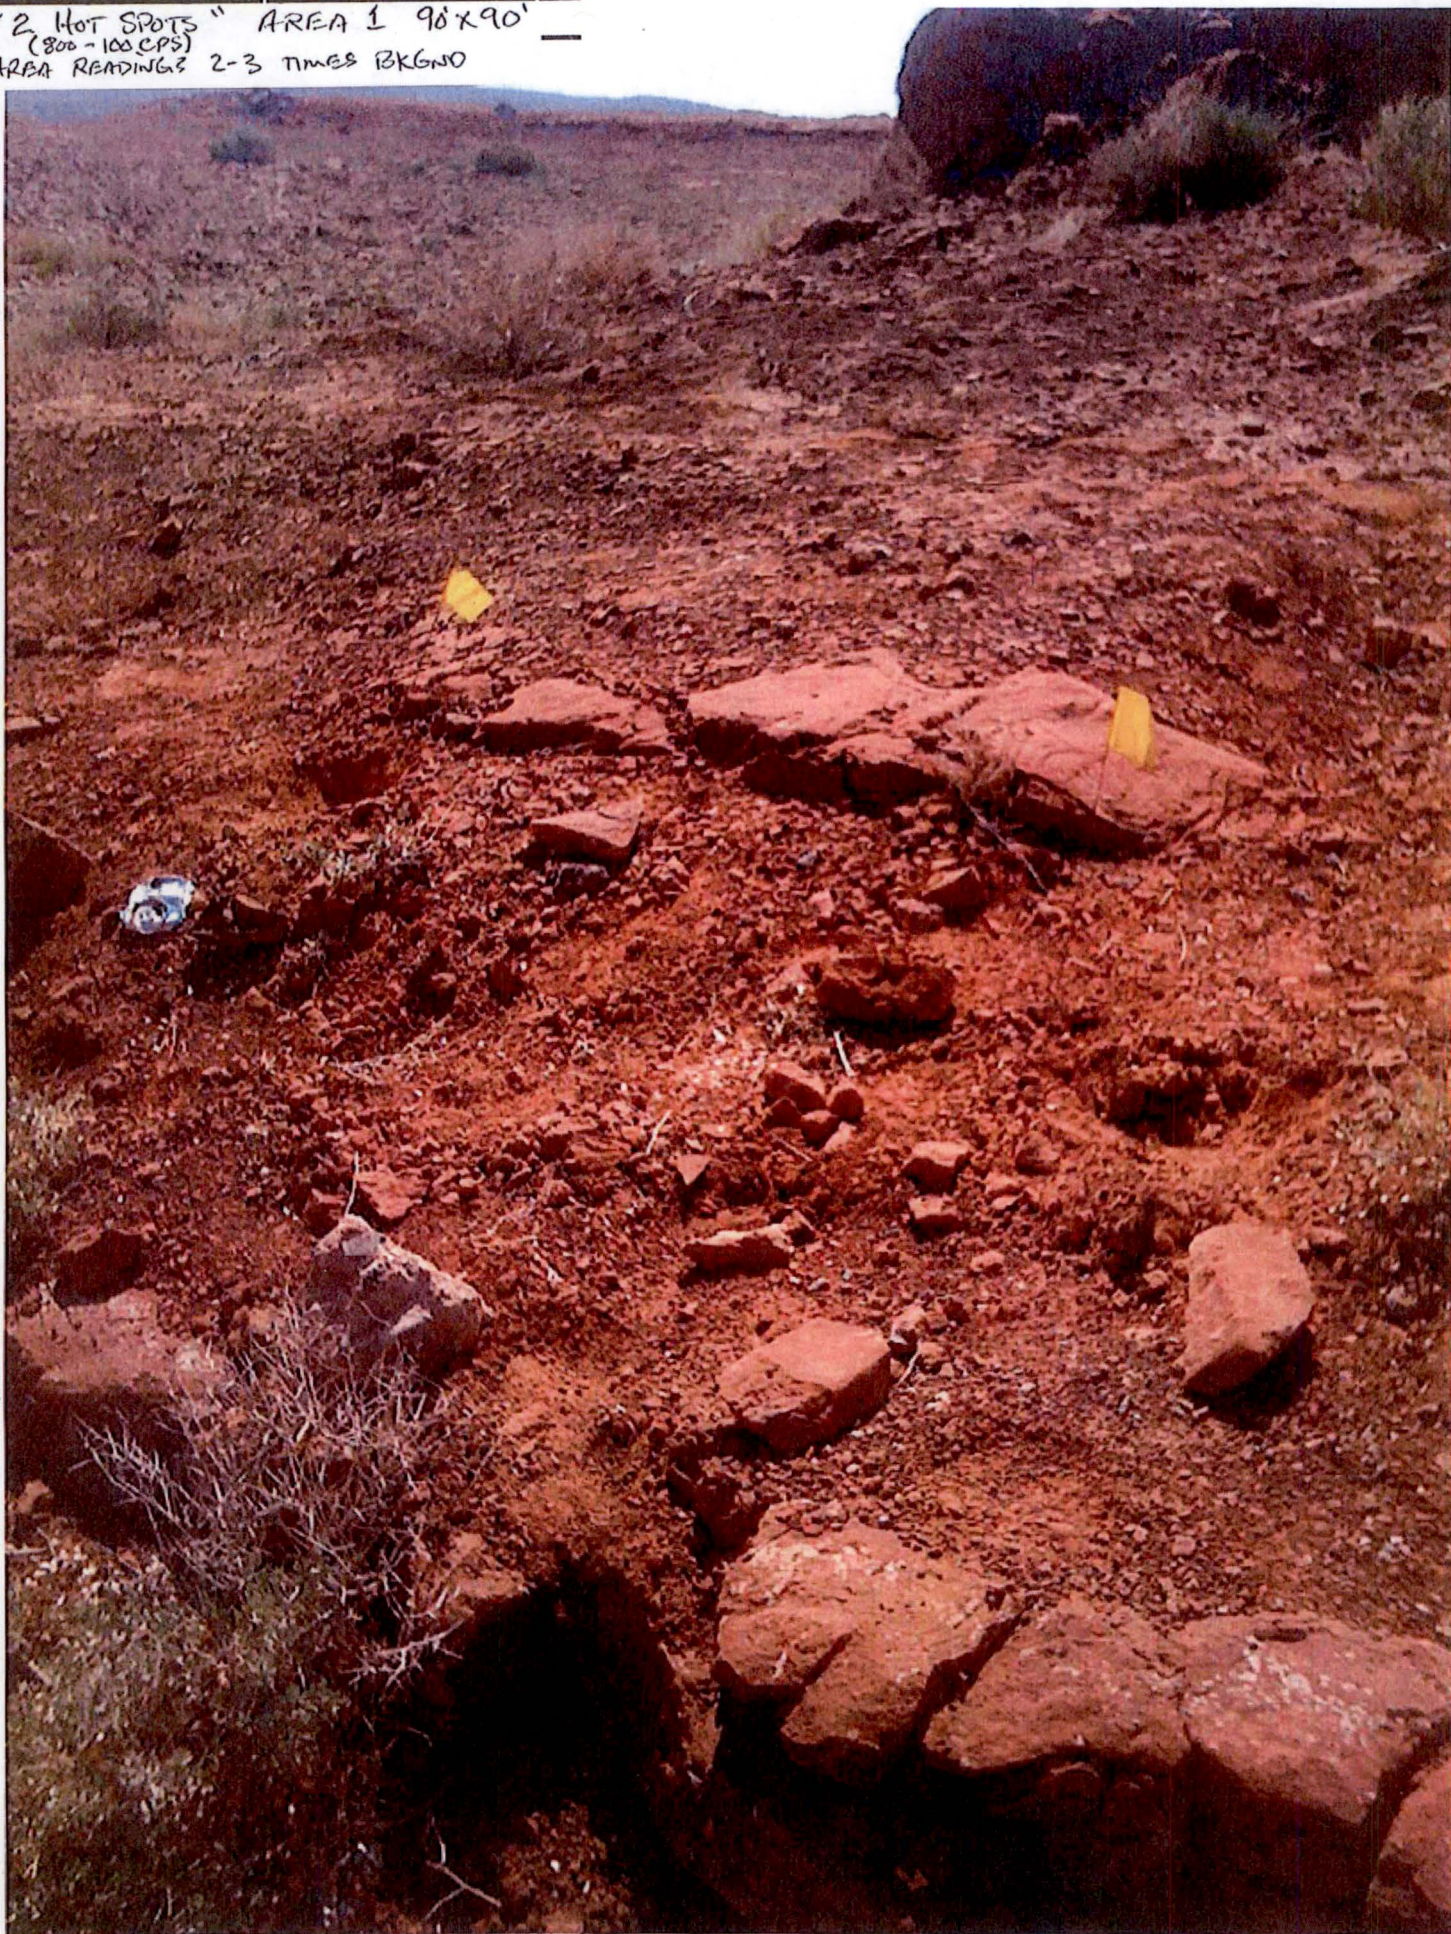
AREA 1 Hot SPOTS

This photo is take of the two Hot Spots mentioned in the previous e-mail and photo. Again subsurface, and no construction debris

"2 HOT SPOTS" AREA 1 90'x90'
(800-100 CPS)
AREA READINGS 2-3 TIMES BKGND

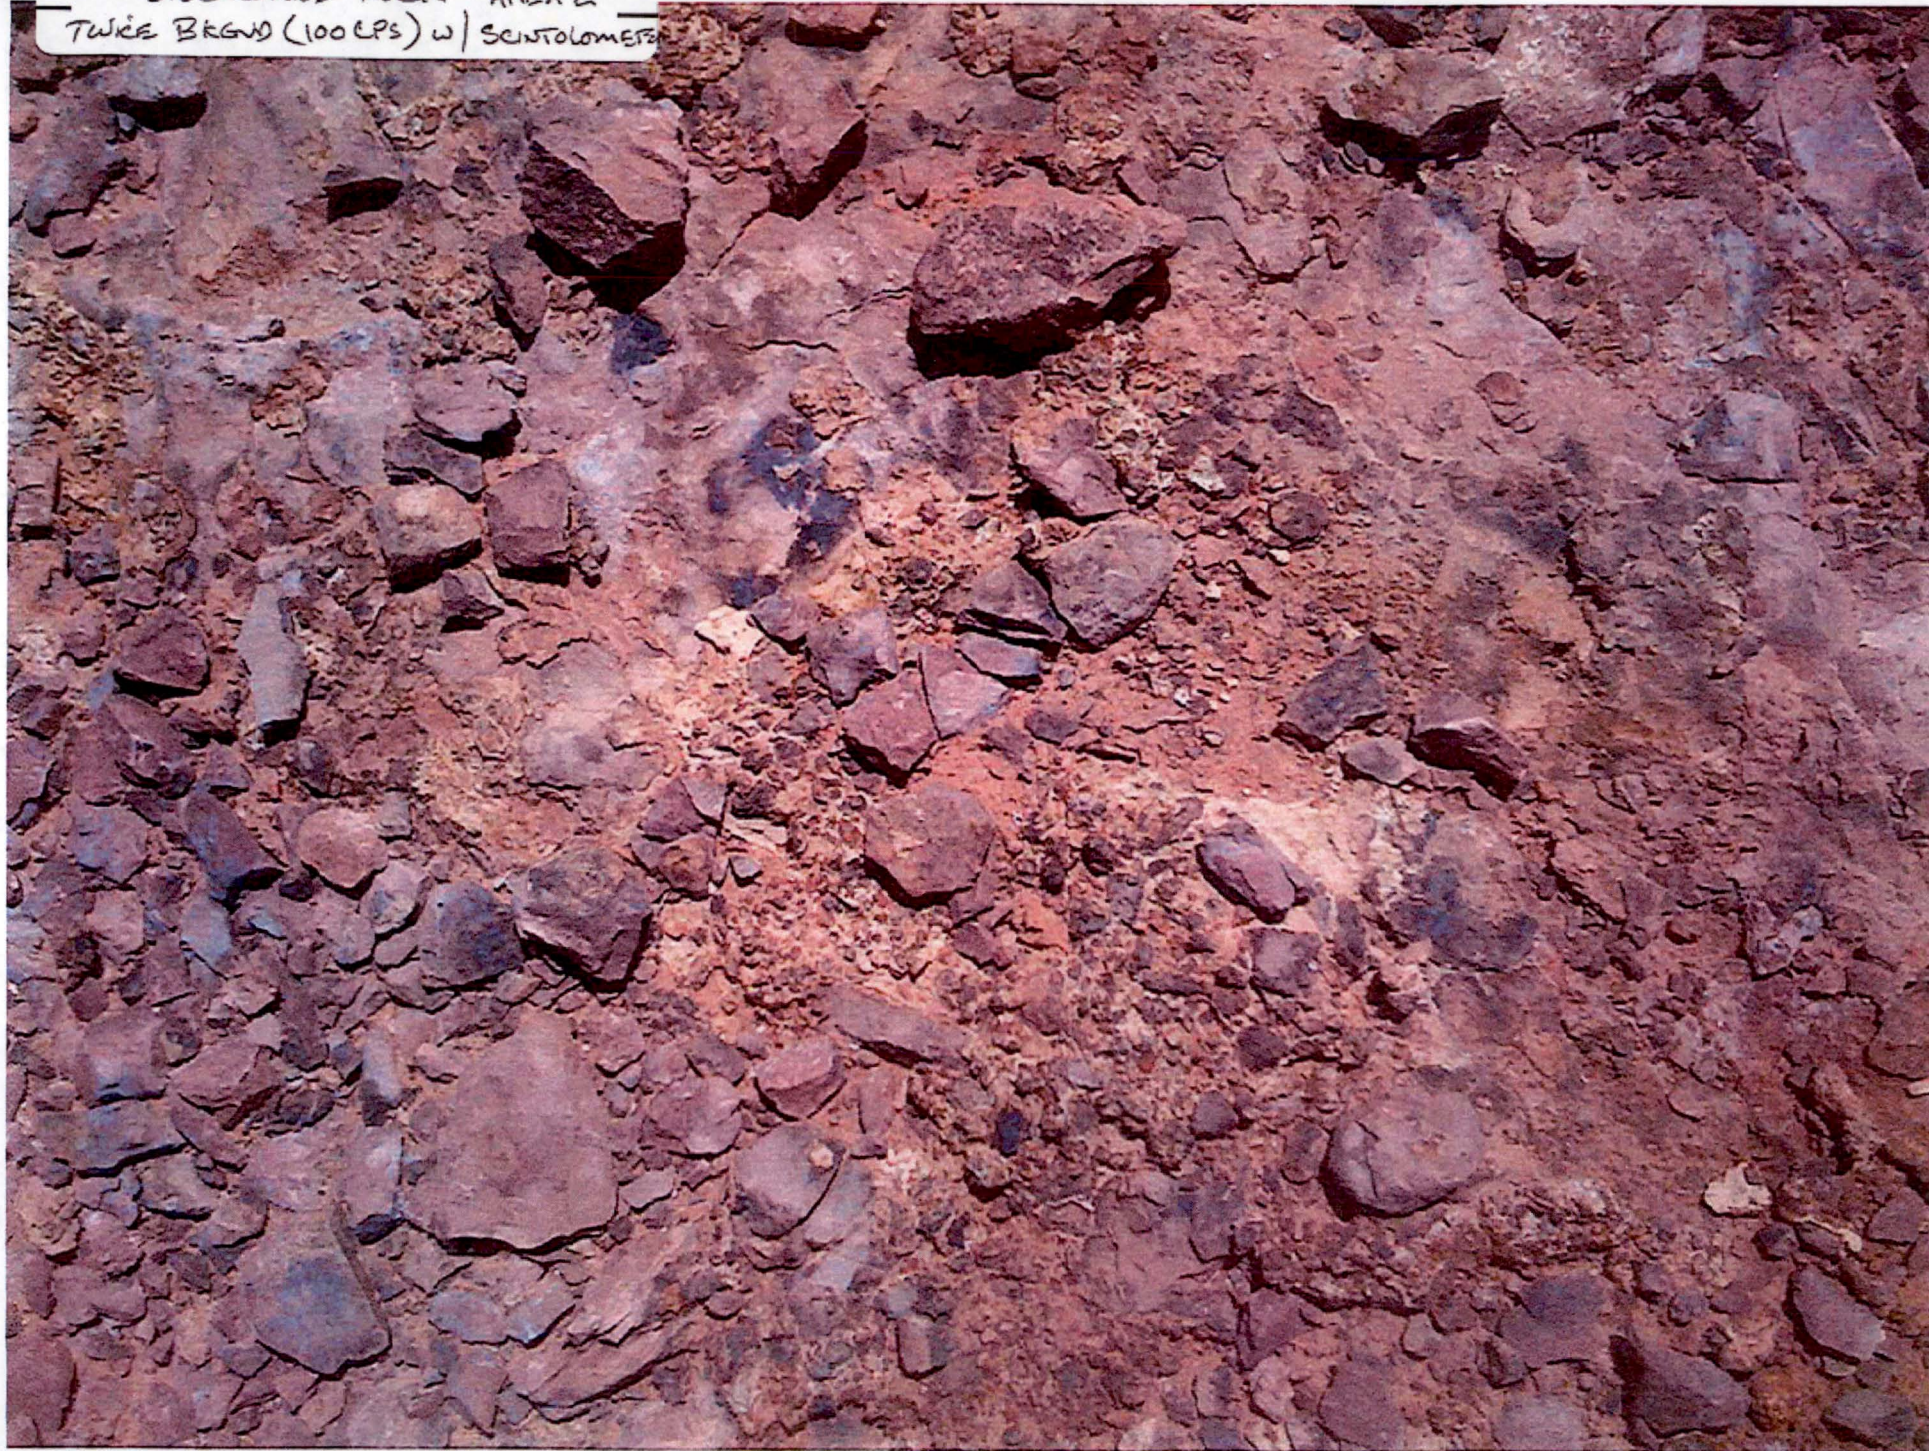
"Discolored Rock"

This photo is of the discolored rock in area 2 along the north edge. Center of photo is some light yellow, upper right is Greenish discoloring. Twice background with Scintilometer. The material was fixed to the hard sandstone layer and not on any of the loose rock. You had to work at it to get some to come off. John do you remember we also ran into this at Monticello at the bottom of the carbonite pile. We actually high pressure washed off that area to get it completely clean. This looks like a similar situation.

"DISCOLORED ROCK" AREA 2
TWICE BKGND (100 CPS) w/ SCINTLOMETER

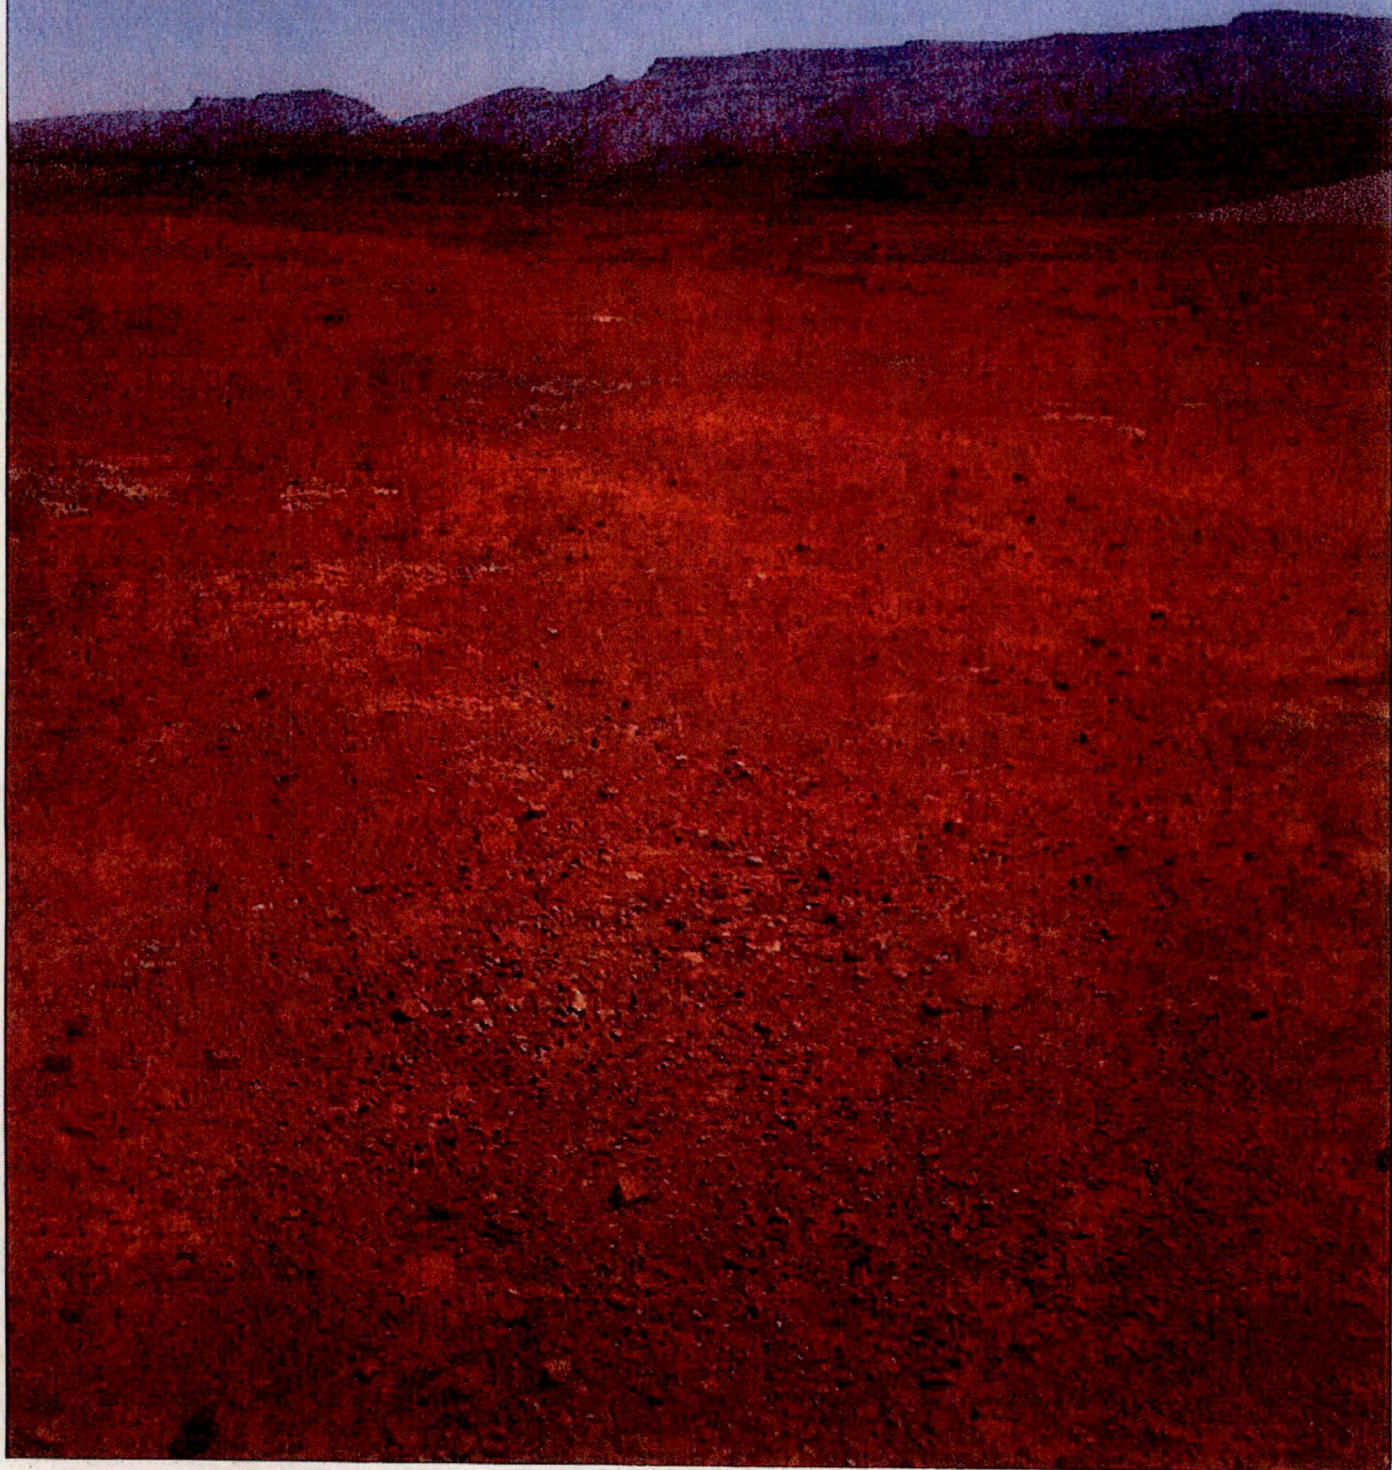
The second area (Area 2 photo) was shaped like a bullet, about 100 yards long and 30 yards wide on a shelf/mesa. The elevated readings were mainly on the north and east side. The area appeared to have been scraped down to the resistant sandstone layer by the remedial action. Some areas, mainly to the east, showed some black staining on the hard and loose rock, which appeared scorched. Material resembling slag was found along the far, east end of the rock shelf. This material registered twice background with the scintilometer. On the north end of Area 2, some discolored staining of green and yellow was found, which registered twice background (one location registering approximately 400 cps).

AREA 2 100yds X 30yds W
NORTH END. HOT SPOT (400 CPS)

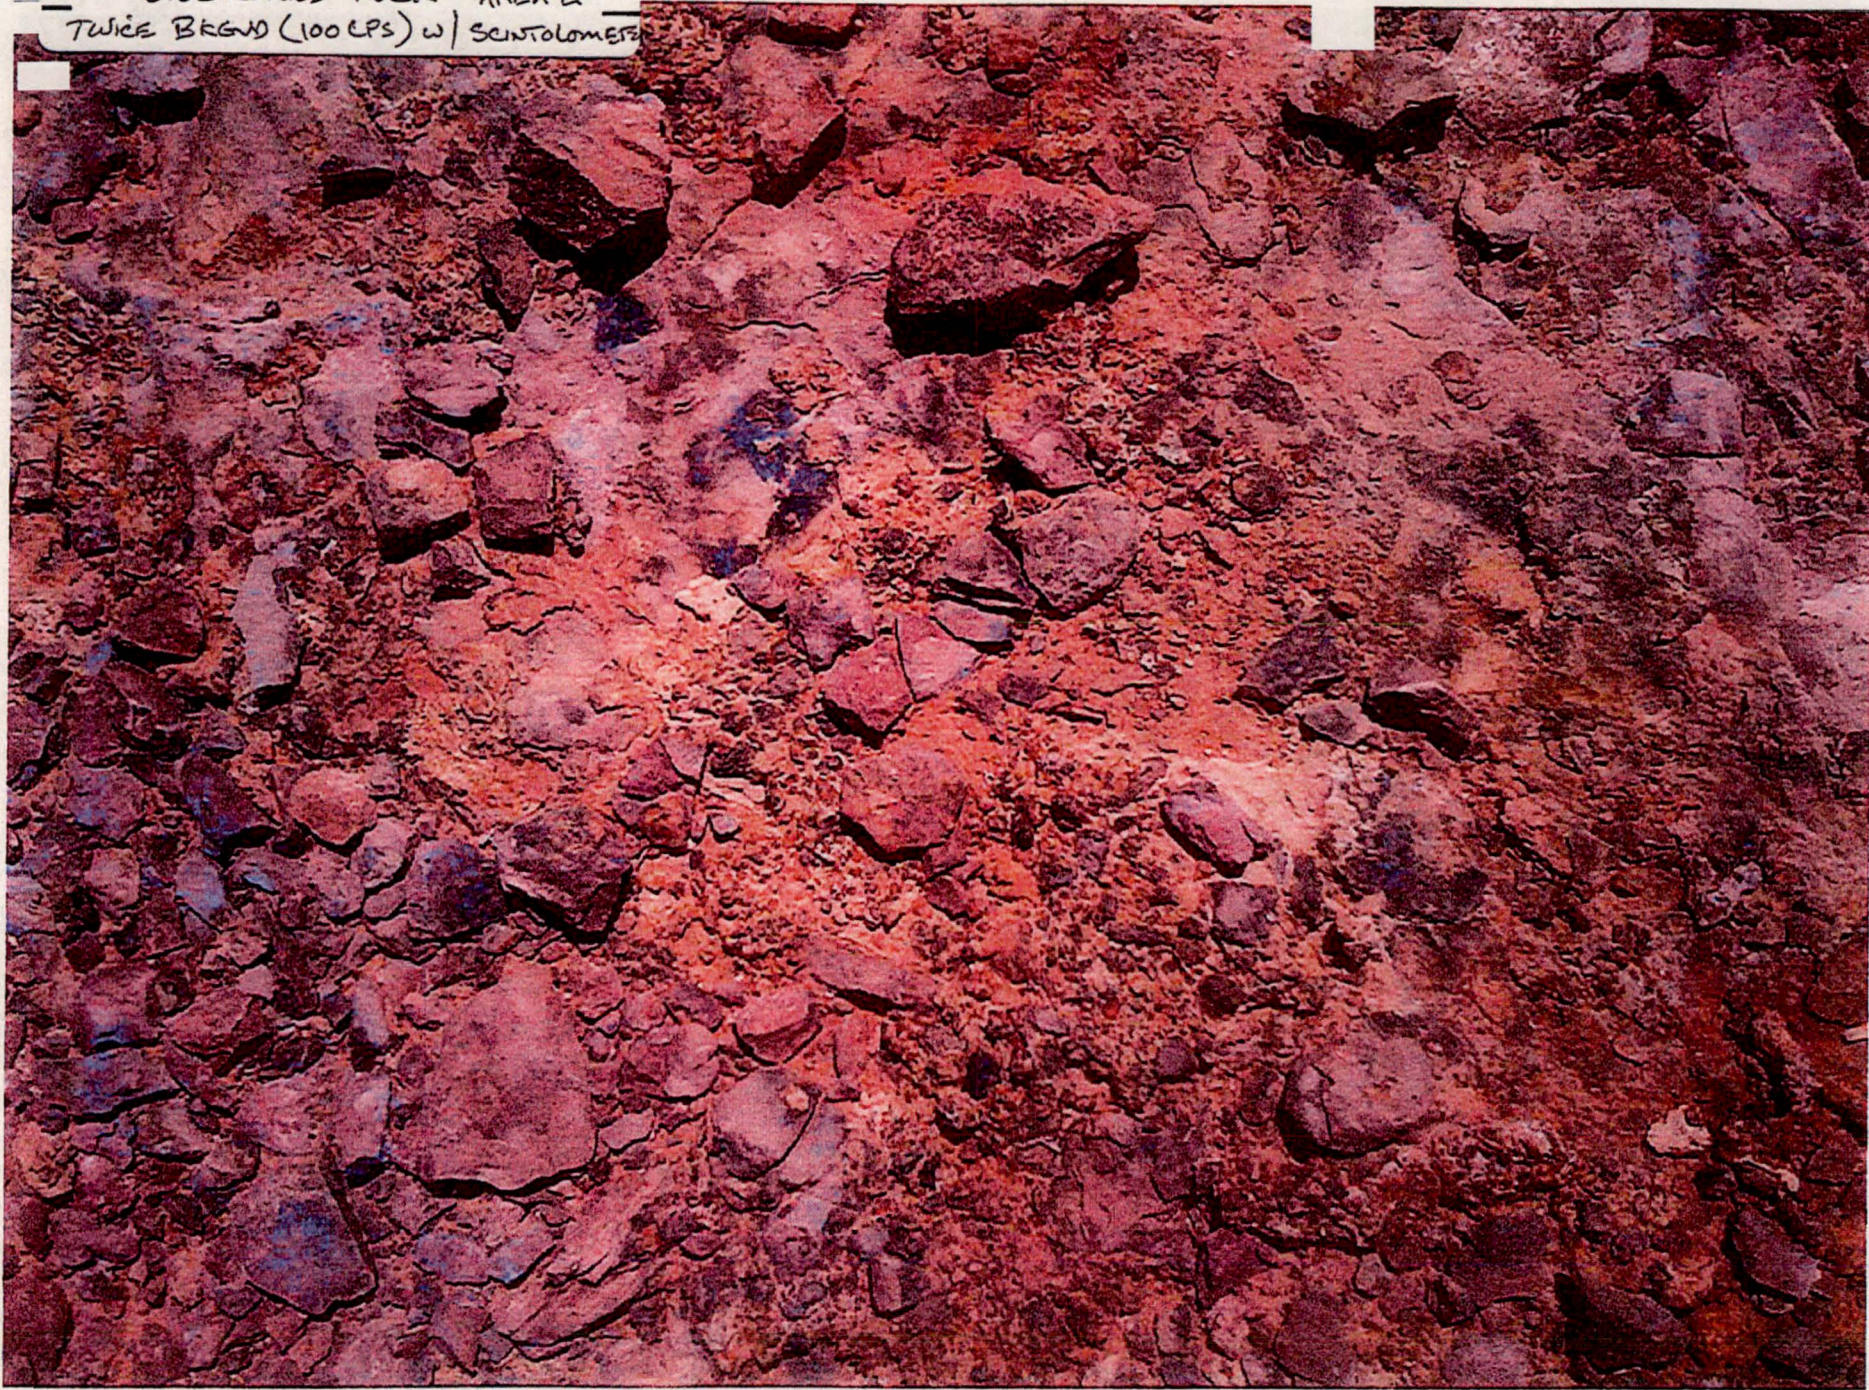
"DISCOLORED ROCK" AREA 2
TWICE BKGND (100 CPS) w/ SCINTLOMETER
