**Tank 12 Final Configuration Report for  
H-Tank Farm at the Savannah River Site**

**December 2016**

Prepared by: Savannah River Remediation LLC  
Waste Disposal Authority  
Aiken, SC 29808

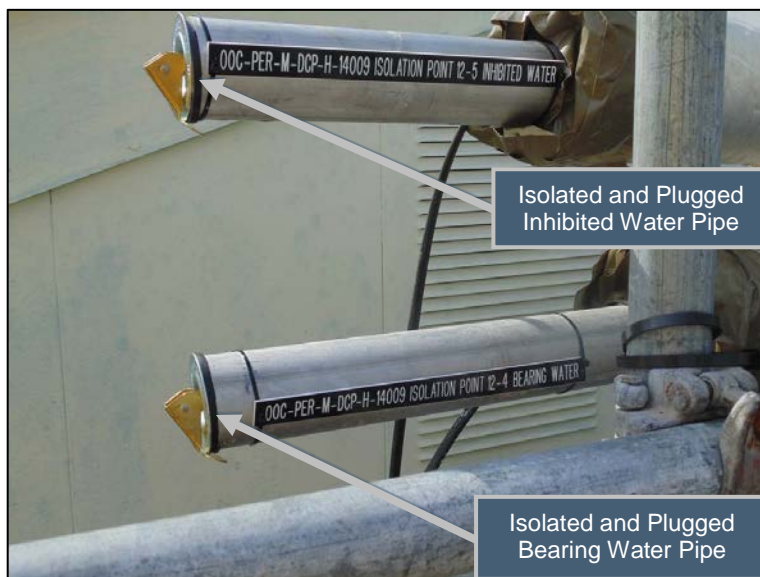
**Figure 3.1-1: Tank 12 Bearing Water and Inhibited Water Pipes Isolated**

Tank 12 was isolated in accordance with the Tank 12 CM Section 7.1 and the waste tank isolation plan. [M-CTP-H-00003] There are no exceptions to the Tank 12 field isolation configuration versus the Tank 12 CM and isolation plan. [SRR-LWE-2016-00036] Mechanical and electrical isolation consisted of demolishing and removing piping and components, plugging lines, removing equipment, identifying components as “Out Of Commission,” and removing obstructions from and around the risers. Tank 12 was isolated from the HTF WTS and the HTF support systems. The isolation plan consisted of identification and isolation of transfer lines, drain lines, water, air, and steam supply lines, ventilation lines, power and instrumentation lines, and all other penetrations into or out of the waste tank. Isolation of these systems was performed at the electrical control rooms or field locations for electrical and instrumentation and at the system supply headers located off the tank top for mechanical systems. For example, Figure 3.1-1 shows an inhibited water pipe and a bearing water pipe that has been cut and plugged to isolate the systems to Tank 12. Figure 3.1-2 shows an example of electrical isolation of slurry pump instrumentation on Tank 12.

Descriptions of mechanical isolation in Tank 12 and associated design documents are found in *Tank 12 Mechanical Isolation Matrix*. [M-TRT-H-00090] The descriptions of electrical isolation and associated design documents are found in *Tank 12 Electrical Equipment Isolation Matrix*. [E-TRT-H-00012] These design documents (e.g., design changes, work instructions, and radiological control checklists) can be retrieved from SRS Records Management to provide details of the isolation modifications, upon request. The waste tank was closed to waste processing activities by isolating transfer lines or plugging/capping the piping, thereby creating a physical break from the rest of the waste tank system.

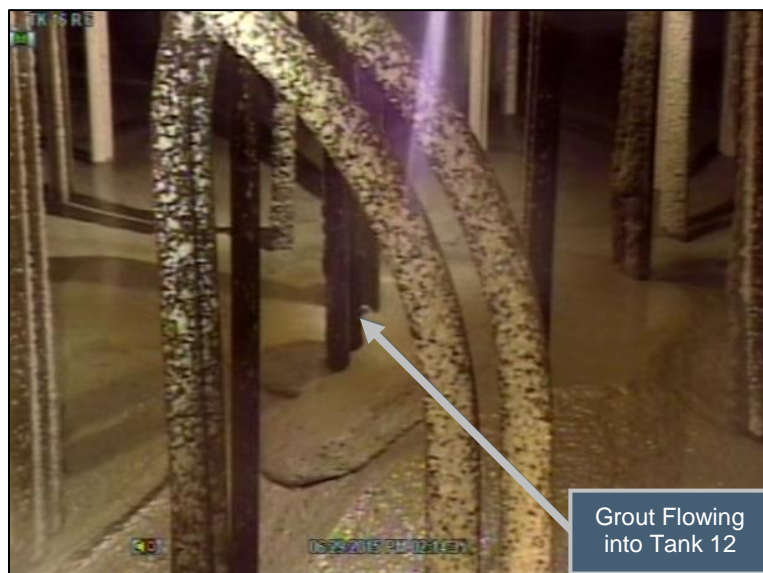
**Figure 3.2-2: Bulk Fill Grout under Riser 5 during the Filling Process (Lift 6)**

the residual material to stabilize and immobilize it at the bottom of the waste tank. The grout adequately flowed from the risers around internal obstructions (support columns and cooling coils) to other areas of the waste tank without significant mounding (Figures 3.2-2 and 3.2-3).

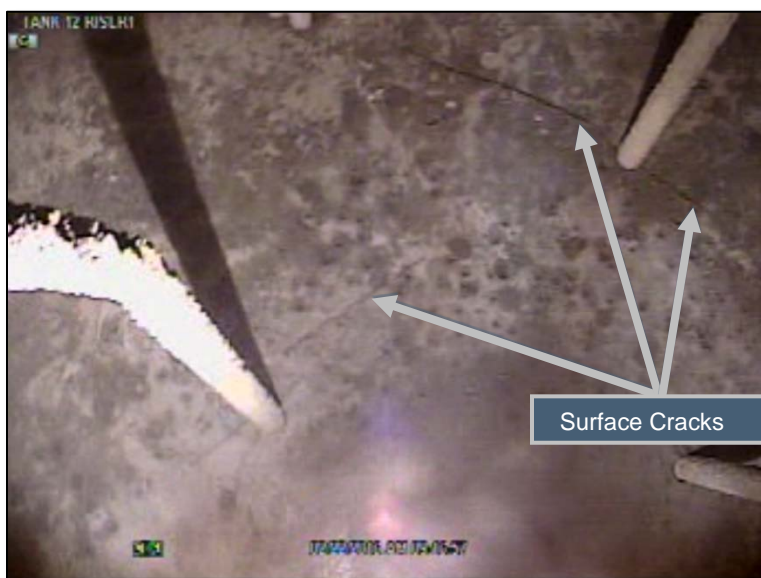
**Figure 3.2-4: Surface Cracks in Grout under Tank 12, Riser 1**

During lift 6, several small cracks were observed under Tank 12, Riser 1 during the morning inspection on February 22, 2016 (Figure 3.2-4). The longest crack was estimated to be less than three feet long. Grout had been poured in this riser during the previous pour which occurred five days earlier. The cracks were only observed in this location. These cracks appear to be shallow and would not be deeper than the previous daily pour which was less than 2 feet thick. These localized surface cracks were

determined to have minimal impact on the HTF PA because these cracks would not significantly increase the amount of groundwater traveling through the grout monolith to the residual waste at the bottom of the tank. They would not appreciably impact grout performance with respect to waste tank stability, flow through the tank, or the reducing capacity of the grout. . [SRR-LWE-2016-00036, SRR-CWDA-2010-00128, SRR-CWDA-2015-00074, SRR-CWDA-2012-00051]

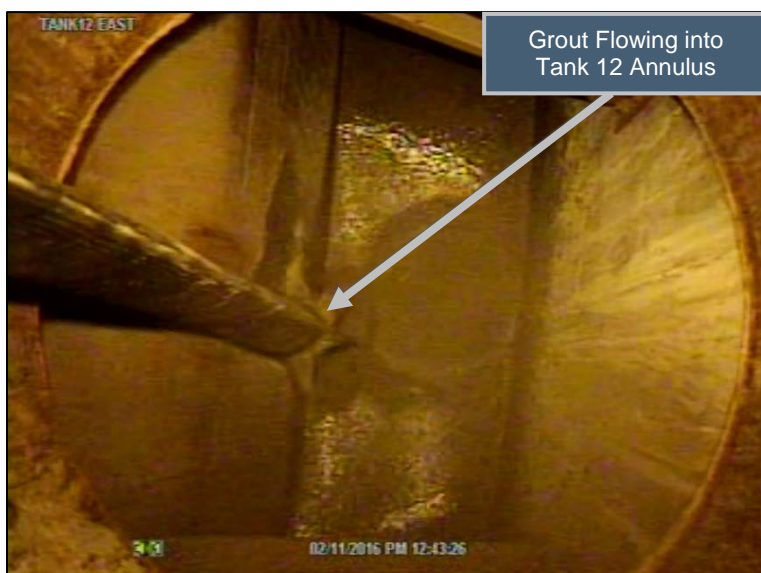
**Figure 3.2-6: Annulus Bulk Fill Grout during the Filling Process (Lift 5)**

It was estimated that 583 cubic yards of grout would be required to fill the Tank 12 annulus. Approximately 613 cubic yards of grout were poured in the annulus. The grout formulation used for the primary fill was also used for the annulus and the entire annulus duct (Figure 3.2-6). [SRR-LWE-2016-00036] The actual volume of grout used to fill the annulus aligned well with the estimated volume and provides evidence of the absence of significant voids. As with waste tank interior bulk fill, the actual volume of grout poured in the annulus is estimated based on the number of grout trucks and a nominal volume of eight cubic yards per truck of bulk fill grout.

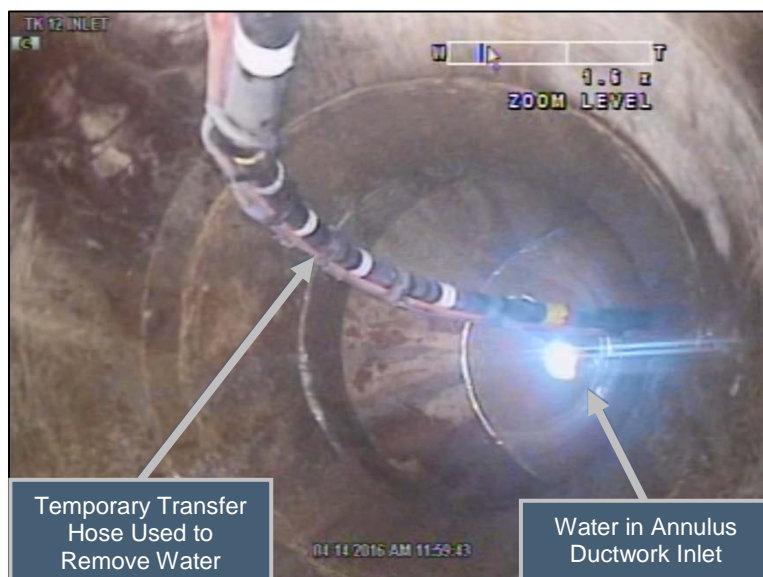
**Figure 3.2-7: Water in Annulus Ductwork Inlet Being Removed Prior to Filling with Grout**

Water was observed flowing into the duct through a crack in the duct wall prior to final grouting of the dehumidification ductwork. It was speculated that the source of the water

was groundwater in-leakage because this ductwork location is under the water table. Approximately 500 gallons of water was pumped out down to an estimated 2-inch remaining liquid level prior to adding the final amount of grout to fill the ductwork inlet (Figure 3.2-7). The rate of water in-leakage was estimated to be approximately 6 gallons per hour, and grout was poured into the ductwork approximately 1.5 hours after the liquid was pumped out.

Performance Assessment assumptions revolve around the final cured grout properties. The cured grout meets the HTF PA assumptions. The HTF PA contains assumptions regarding both mechanical and chemical properties of the tank fill grout. These assumptions pertain to the waste tank grout's performance with respect to 1) grout chemical properties, 2) waste tank stability, and 3) tank flow modeling. This small amount of water in the duct would not create grout property conditions different from those assumed in the HTF PA.

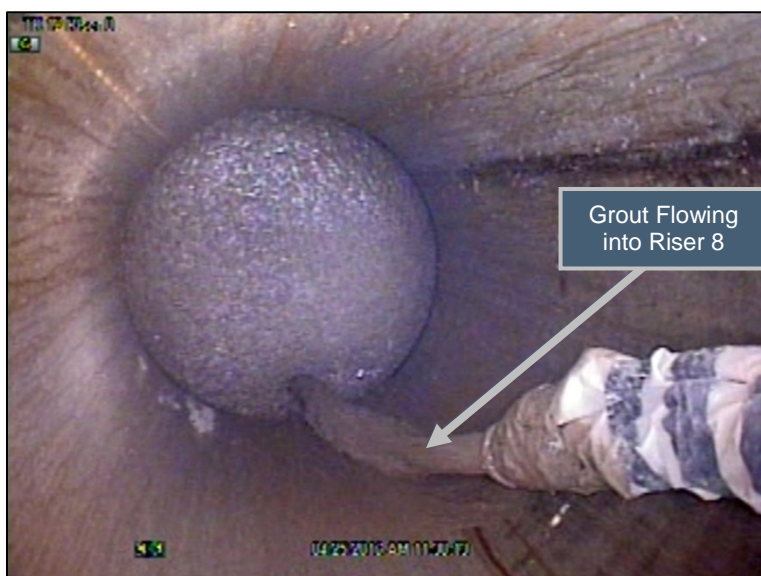
**Figure 3.2-8: Riser 8 Grout Fill**

Tank top modifications were made to accommodate waste tank riser grouting. Examples of pre-grout modifications included removing equipment components from risers and disconnecting and lowering miscellaneous hoses and cables into the waste tank. Final riser grout fill activities were completed on May 2, 2016. The estimated volume to fill the risers was 45 cubic yards (including four spray chambers). This estimated volume accounts for approximately five cubic yards of volume associated with riser plugs that remained in some risers. Approximately 26 cubic yards were actually used to fill the risers and spray chambers. The lower actual volume can be partially attributed to bulk fill grout from the primary present in the risers prior to riser fill. Visual inspection indicated the risers and spray chambers were filled with grout. Figure 3.2-8 shows Riser 8 being filled with grout.

The ground water in-leakage from the leaksite near the bottom of Riser 8 was informally estimated to be 5 gallons per hour. Grout was poured into Riser 8 in less than 1.5 hours after the liquid was pumped out. Performance Assessment assumptions revolve around the final cured grout properties. The cured grout meets the HTF PA assumptions. The HTF PA contains assumptions regarding both mechanical and chemical properties of the tank fill grout. These assumptions pertain to the waste tank grout's performance with respect to 1) grout chemical properties, 2) waste tank stability, and 3) tank flow modeling. This small amount of water in the riser would not create grout property conditions different from those assumed in the PA. Note that there is no free liquid present as Riser 8 is filled with grout (Figure 3.2-8).
