**GEOTECHNICAL EVALUATION
CHURCH ROCK MILL SITE JETTY**

Appendix A Boring Logs and Core Photos
April 24, 2017

Appendix B Field Photos
April 24, 2017

Appendix D Petrographic Analysis for rirpap sources
April 24, 2017

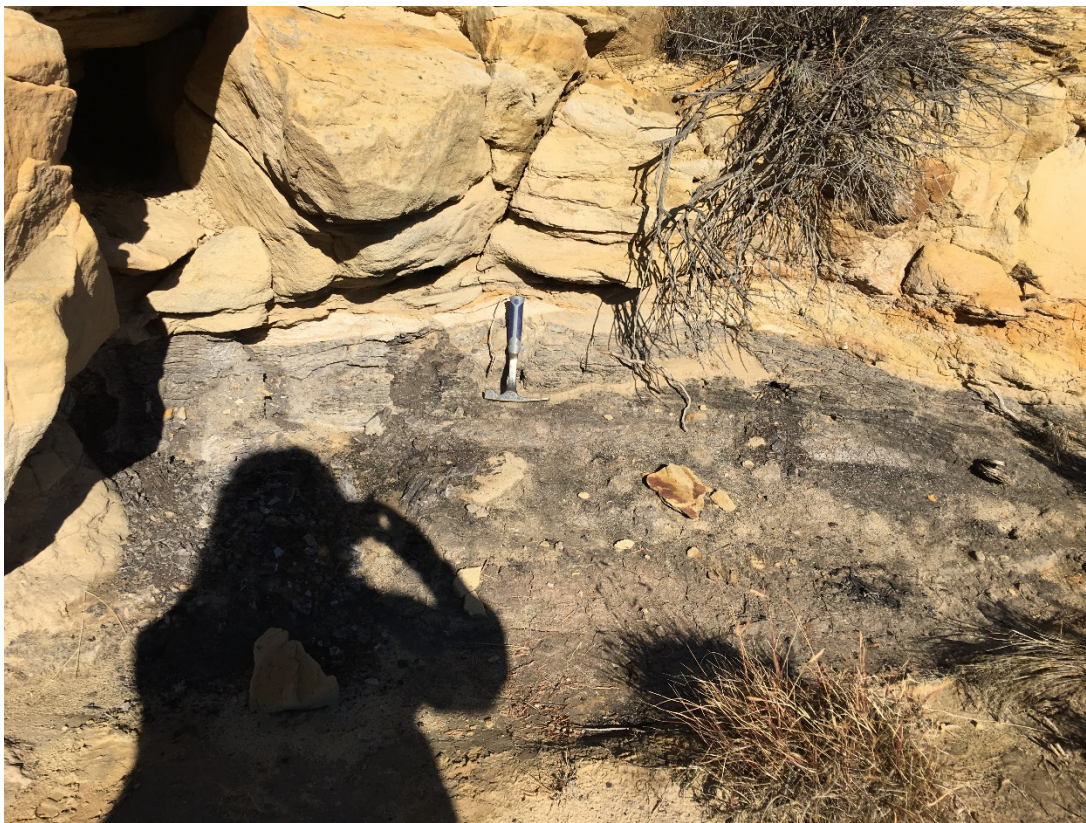
4. EXPOSED COAL LAYER BELOW BORING B1 LOCATION

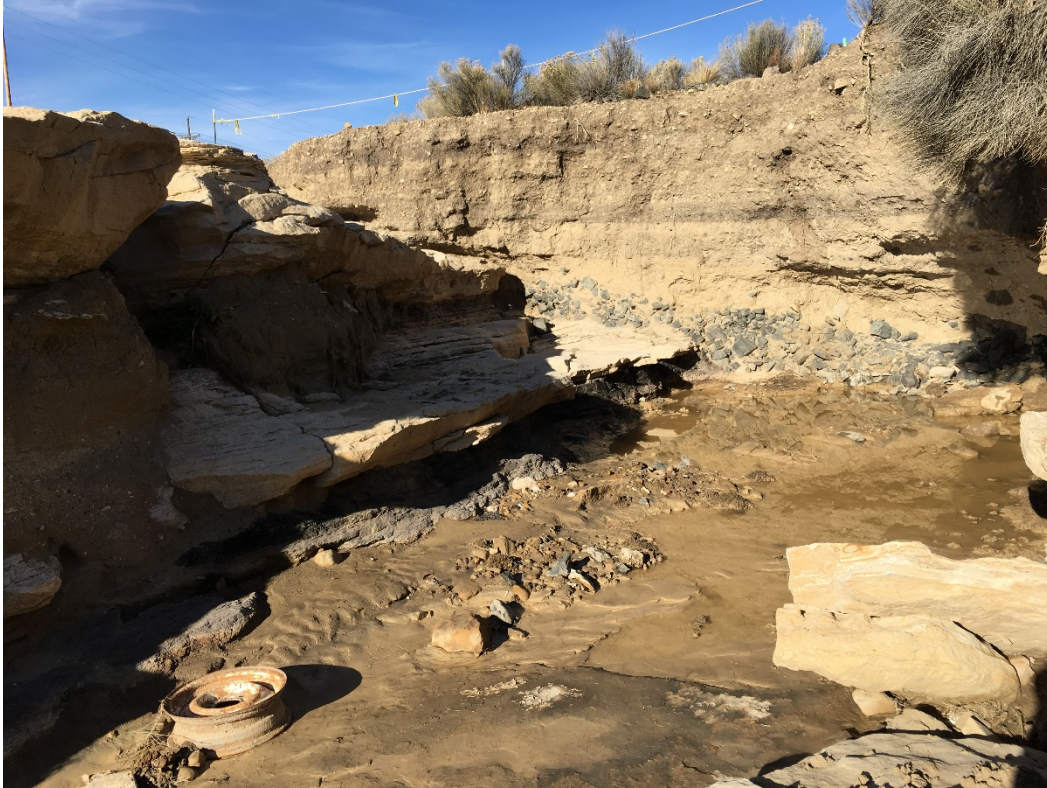
5. EXISTING JETTY EXPOSED IN THE EROSIONAL FLOW PATHWAY, PARALLEL TO JETTY

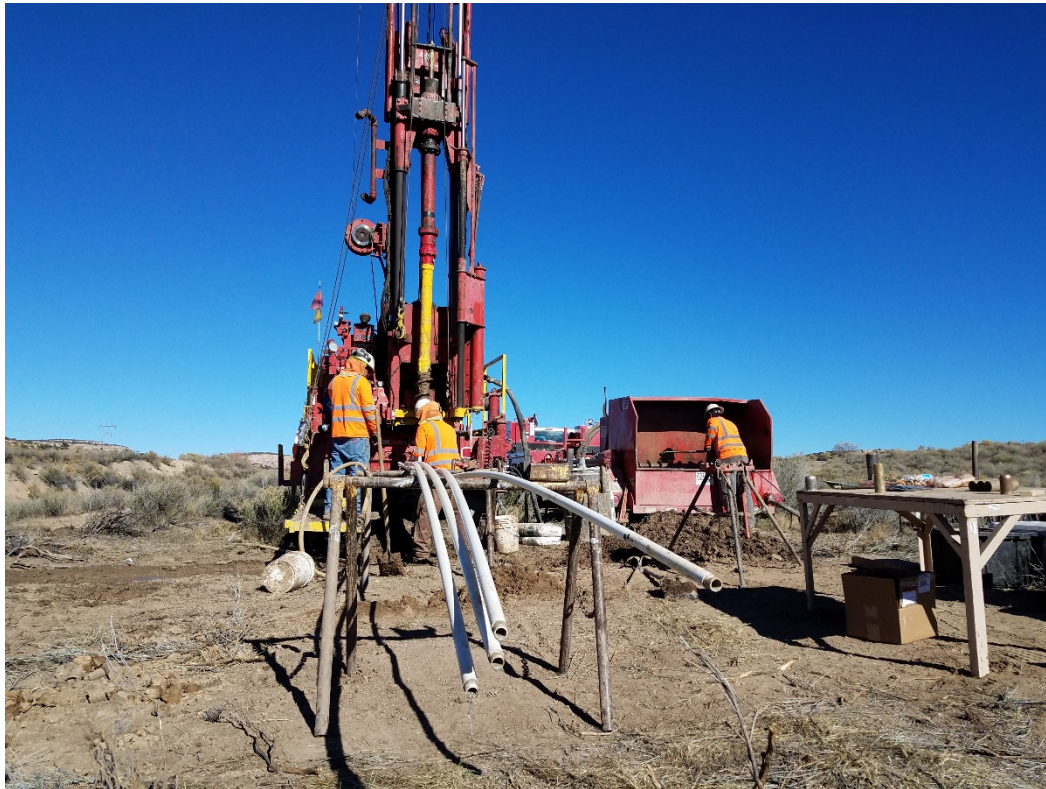
7. DRILLING OPERATIONS, GROUTING BOREHOLE B6
