FPG-TRT-C51-0101

NRW-FPGA-Based PRM System Qualification Project

Document Title Qualification Test Summary Report

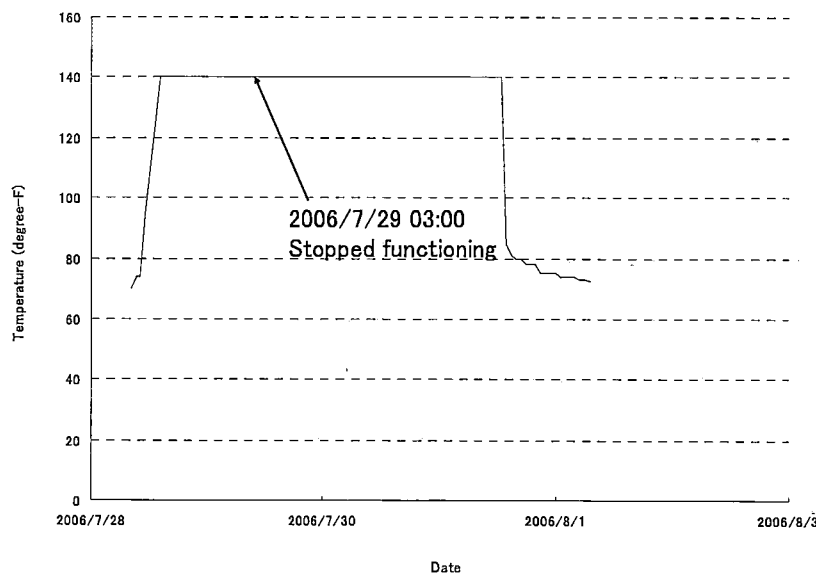
Figure 6.1.1 Temperature Profile in First Exposure Test

The Temperature and humidity profiles at the first exposure are shown in Figures 6.1.1 and 6.1.2.

The test started at 8:00 AM on Jul 28, 2006. The temperature and humidity were raised gradually, and at 2:00 PM on July 28, 2006, the temperature and humidity reached the expected values (140 degree-F and 95 %RH). The high-temperature and high-humidity conditions were kept for about 96 hours.

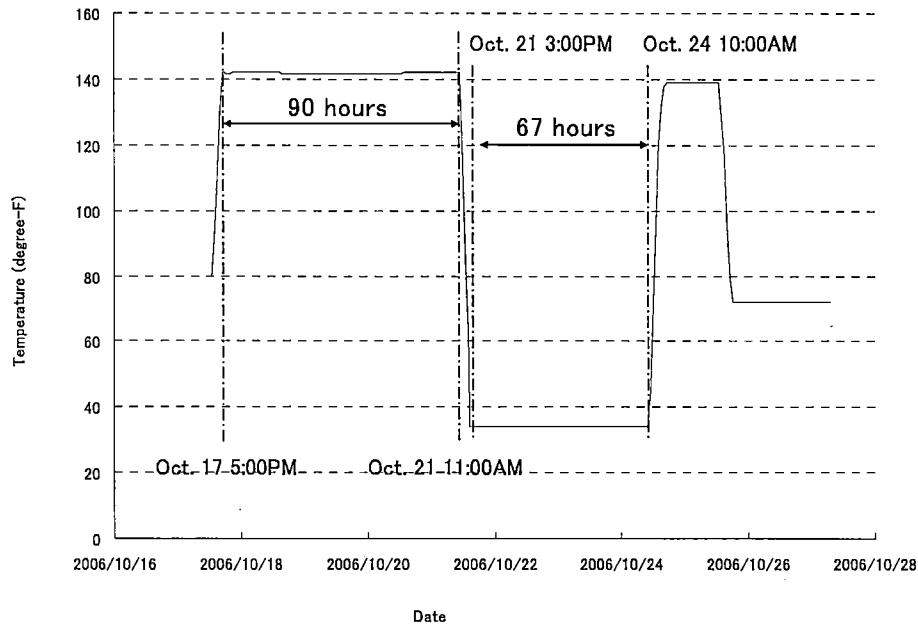
Figure 6.1.5 Temperature Profile in Second Exposure Test

- a. High Temperature and Humidity: 140 °F and 95% relative humidity, which meets EPRI TR-107330 Section 4.3.6 and Figure 4-4 requirements (Toshiba notes that adding 5% margin to the relative humidity would most likely induce condensation, which is not included in Toshiba's qualification envelope).

- b. Low Temperature and Humidity: 35 °F and 10% relative humidity, which meets EPRI TR-107330 Section 4.3.6 requirements (Figure 4-4 requirements for humidity could not be met in this chamber, even with relaxation for non-simultaneous temperature and humidity, and Toshiba notes that the OPRM is constructed of similar components and had no issues at 40 °F and 5% relative humidity which could be achieved in the environmental test chamber used for testing the OPRM).

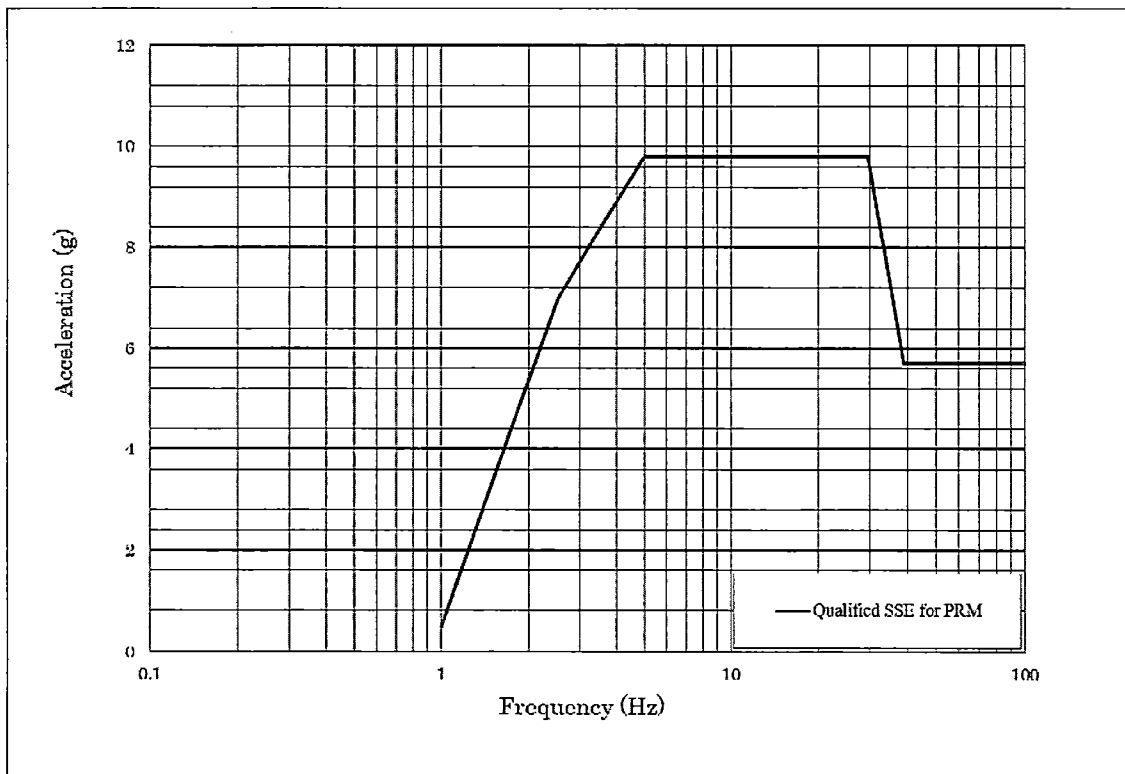
Figure 6.3.1 Qualified SSE for PRM

- Exceedances in the frequency lower than 3.5 Hz are acceptable based on Clause 8.6.3.1(j) of IEEE Std. 344-2004 since there are clearly no resonances below 5 Hz.
- An additional exception to the “broad” EPRI TR-107330 spectrum demand would have to be taken for the exceedance at the peak above 30 Hz.

Figure 6.3.1 shows the qualified SSE response of the PRM seismic test.

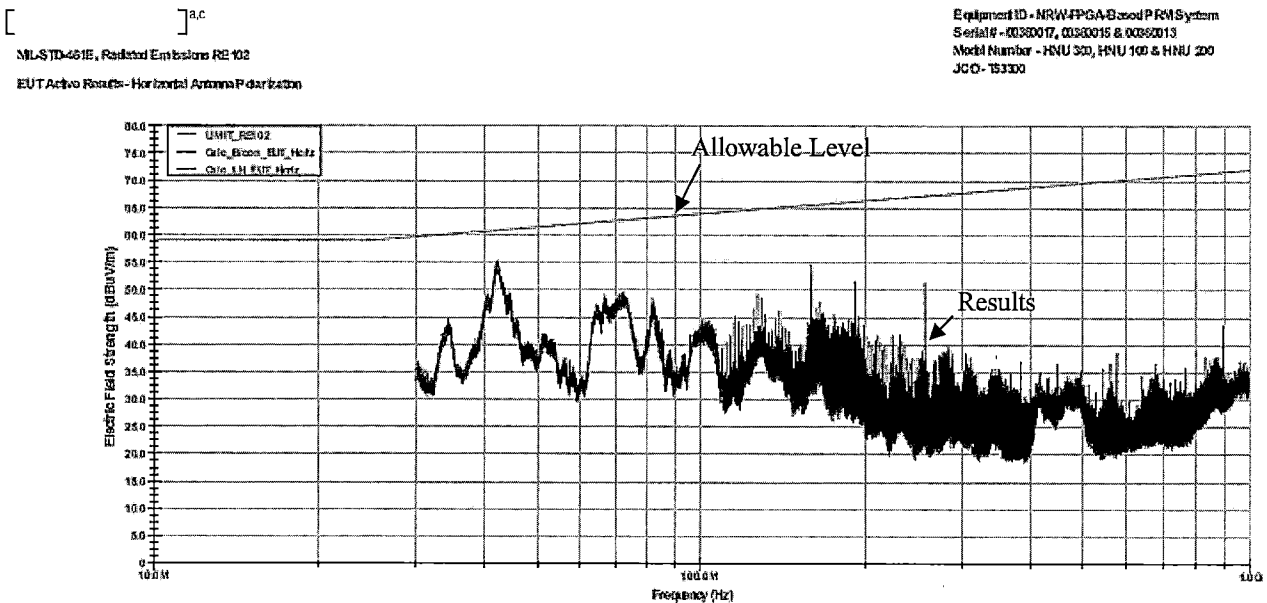
Figure B.2.1 Results of RE102 (Horizontal Antenna Position)

This test was performed according to MIL-STD-461E requirement RE102. The recommended emissions limits are shown in ERS Figure 5-10. The test frequency was set from 2 MHz to 1 GHz. This test was performed with both vertical and horizontal polarized waves.

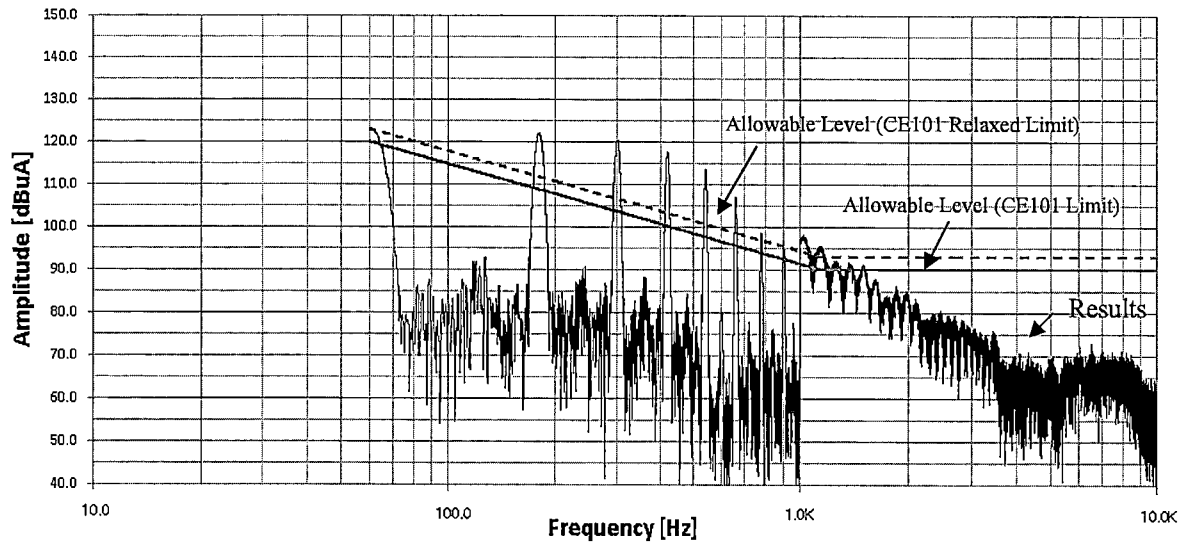
Figure B.3.1 Results of CE101 (Line, No coil)

CE101 Relaxed Limit = CE101 Limit + 20Log(Fundamental Current)

Margin = Peak Amplitude – CE101 Relaxed Limit

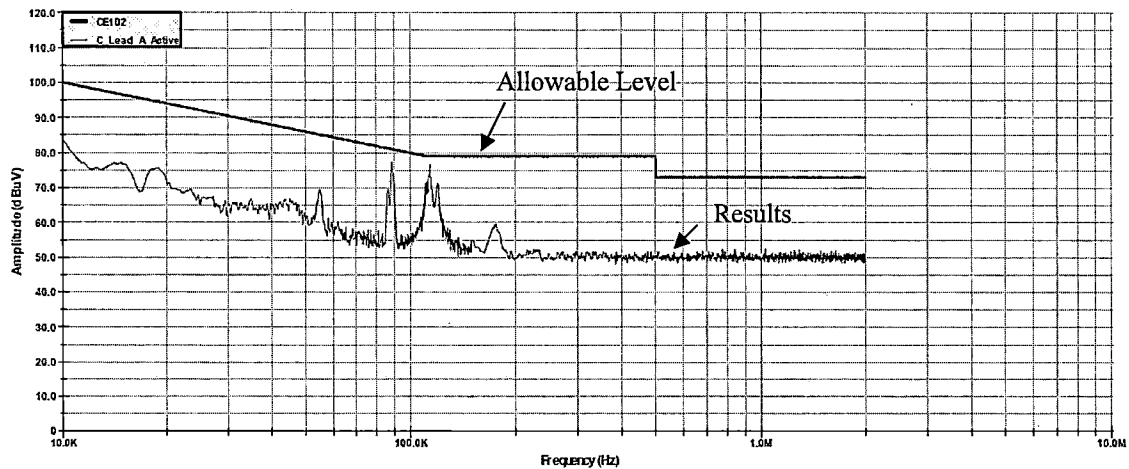
Figure B.4.1 Results of CE102 (Line)

This test was performed on the power input leads, according to MIL-STD-461E requirement CE102. The recommended emissions limits are shown in ERS Figure 5-8. The test frequency was set from 10 kHz to 2 MHz. Data was reported in dB μ V.

EUT Active Results for Line L1
