Vogtle Electric Generating Plant – Unit 1 and 2
Proposed ISI Alternative VEGP-ISI-ALT-19-01 for Tendon Inservice Inspection Extension

Enclosures: 1. Proposed Alternative VEGP-ISI-ALT-19-01
2. Containment Post-Tensioning System Inservice Inspection Technical Report

Proposed Alternative VEGP-ISI-ALT-19-01

Proposed Alternative VEGP-ISI-ALT-19-01 for Containment Unbonded Post-Tensioning System Inservice Inspection Requirements in Accordance with 10 CFR 50.55a(z)(1)

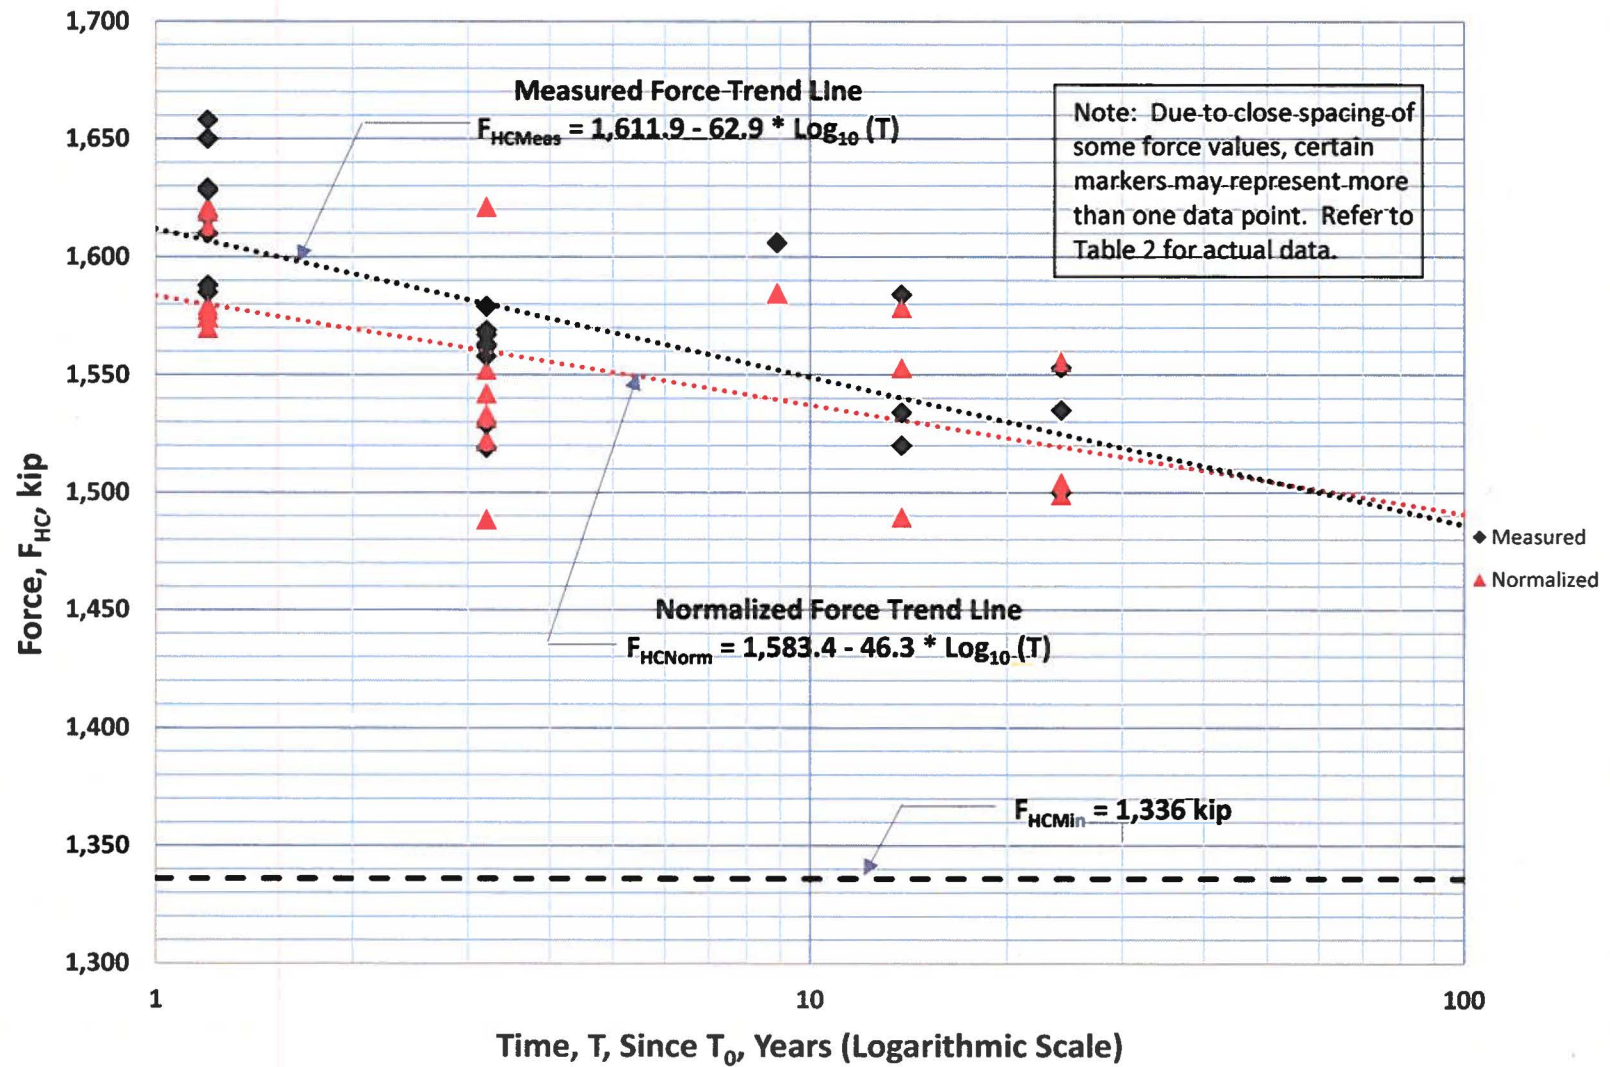
Figure 1 - Unit 1 Cylinder Hoop Tendon Measured & Normalized Force Trends

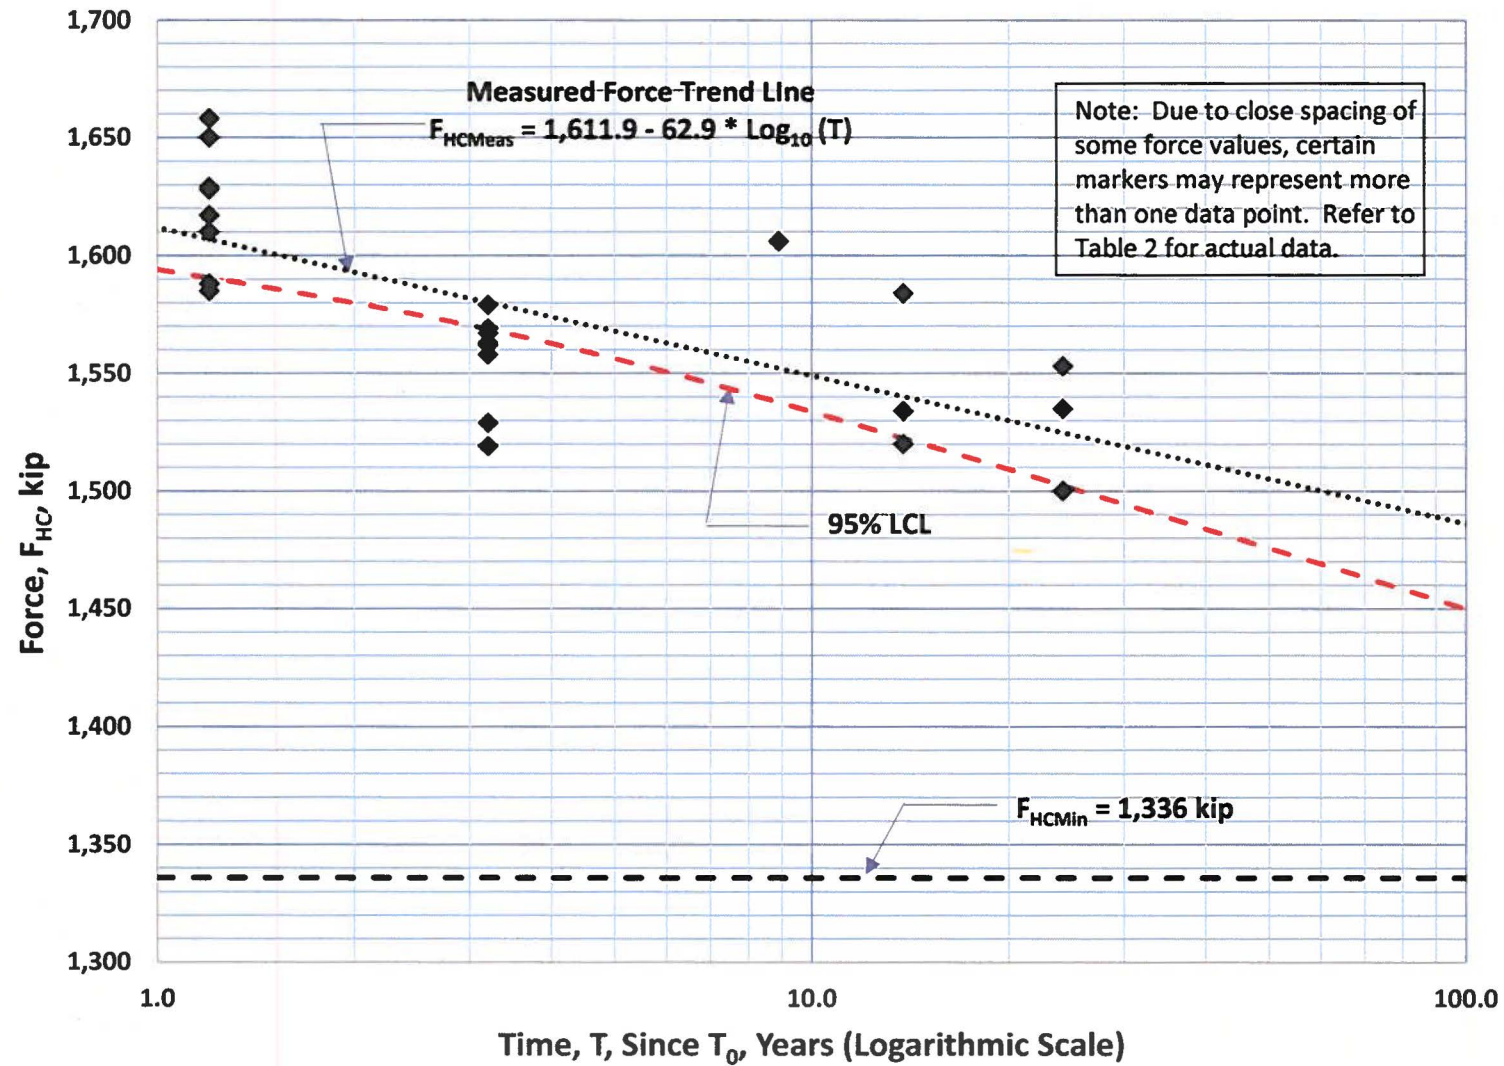
Figure 2 - Unit 1 Cylinder Hoop Tendon Measured Force Trend & LCL

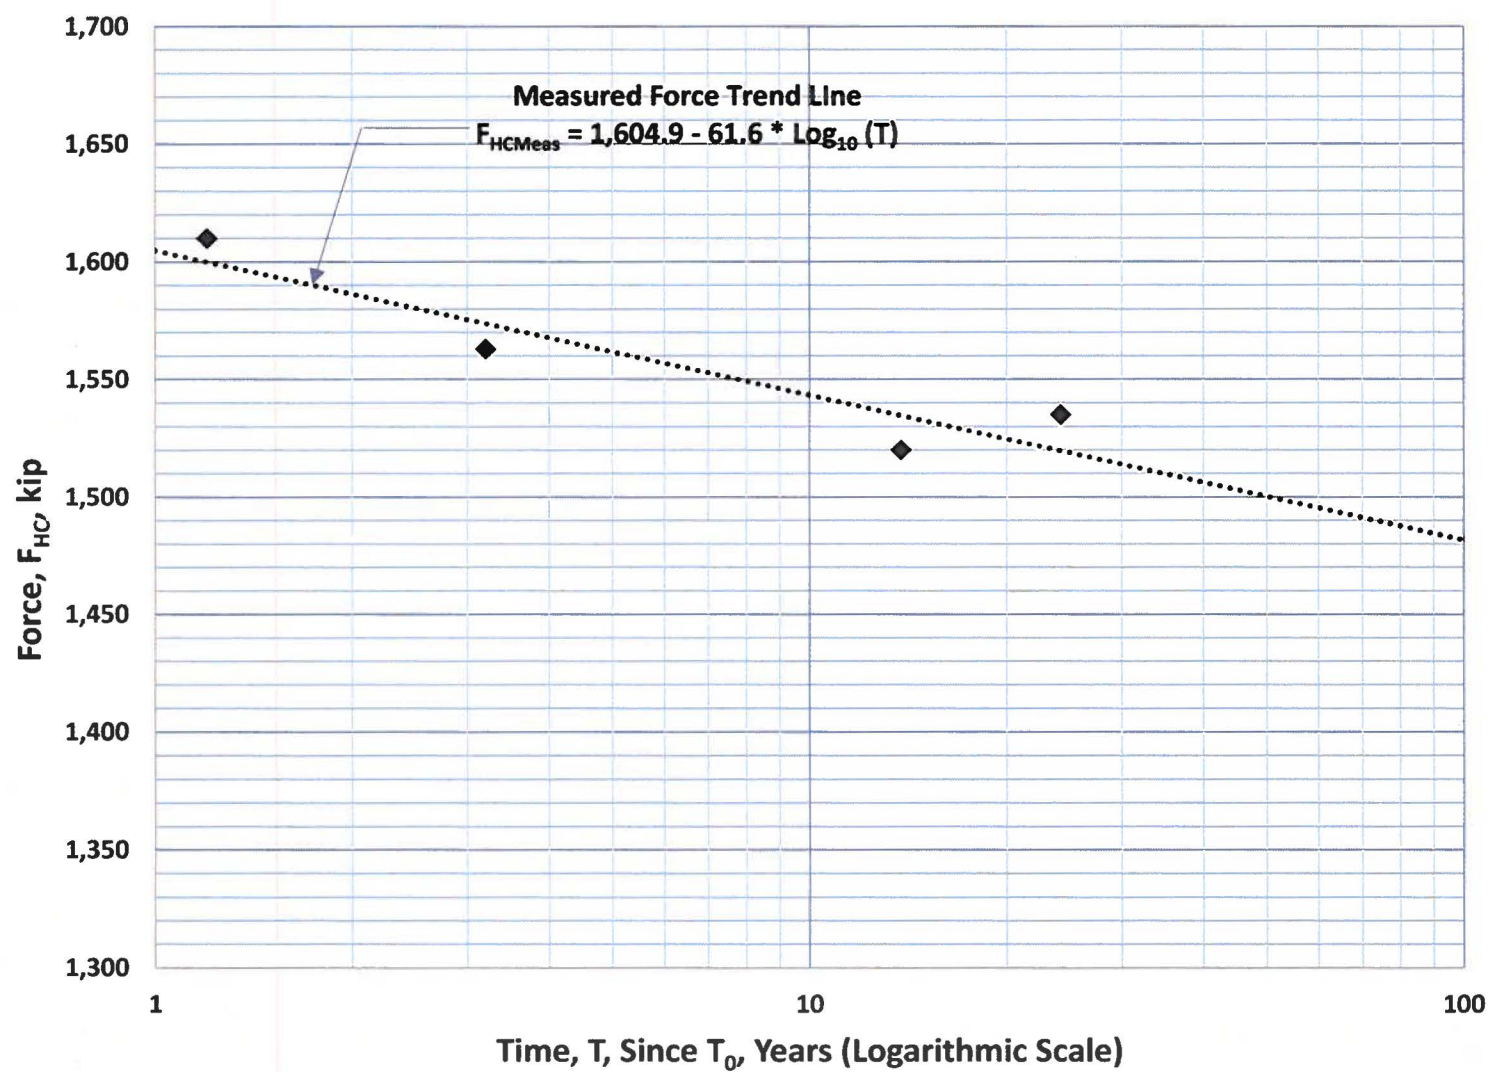
Figure 3 - Unit 1 Cylinder Hoop Common Tendon (1H-83) Force Trend

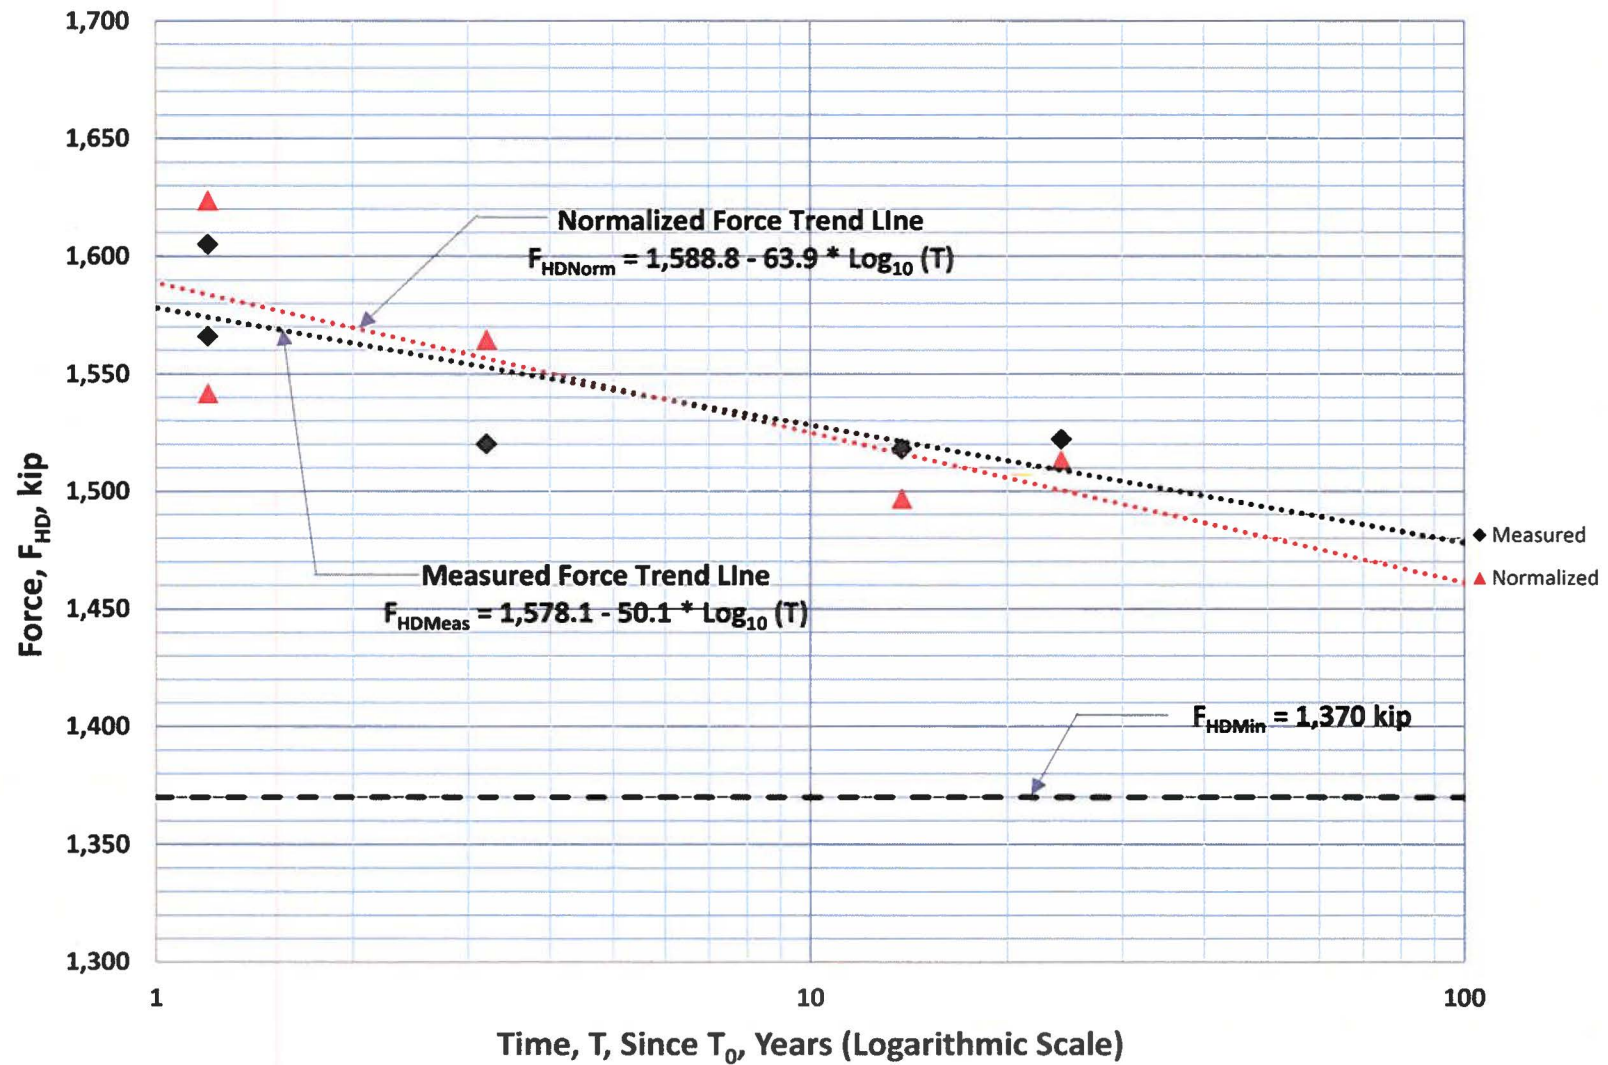
Figure 4 - Unit 1 Dome Hoop Tendon Measured & Normalized Force Trends

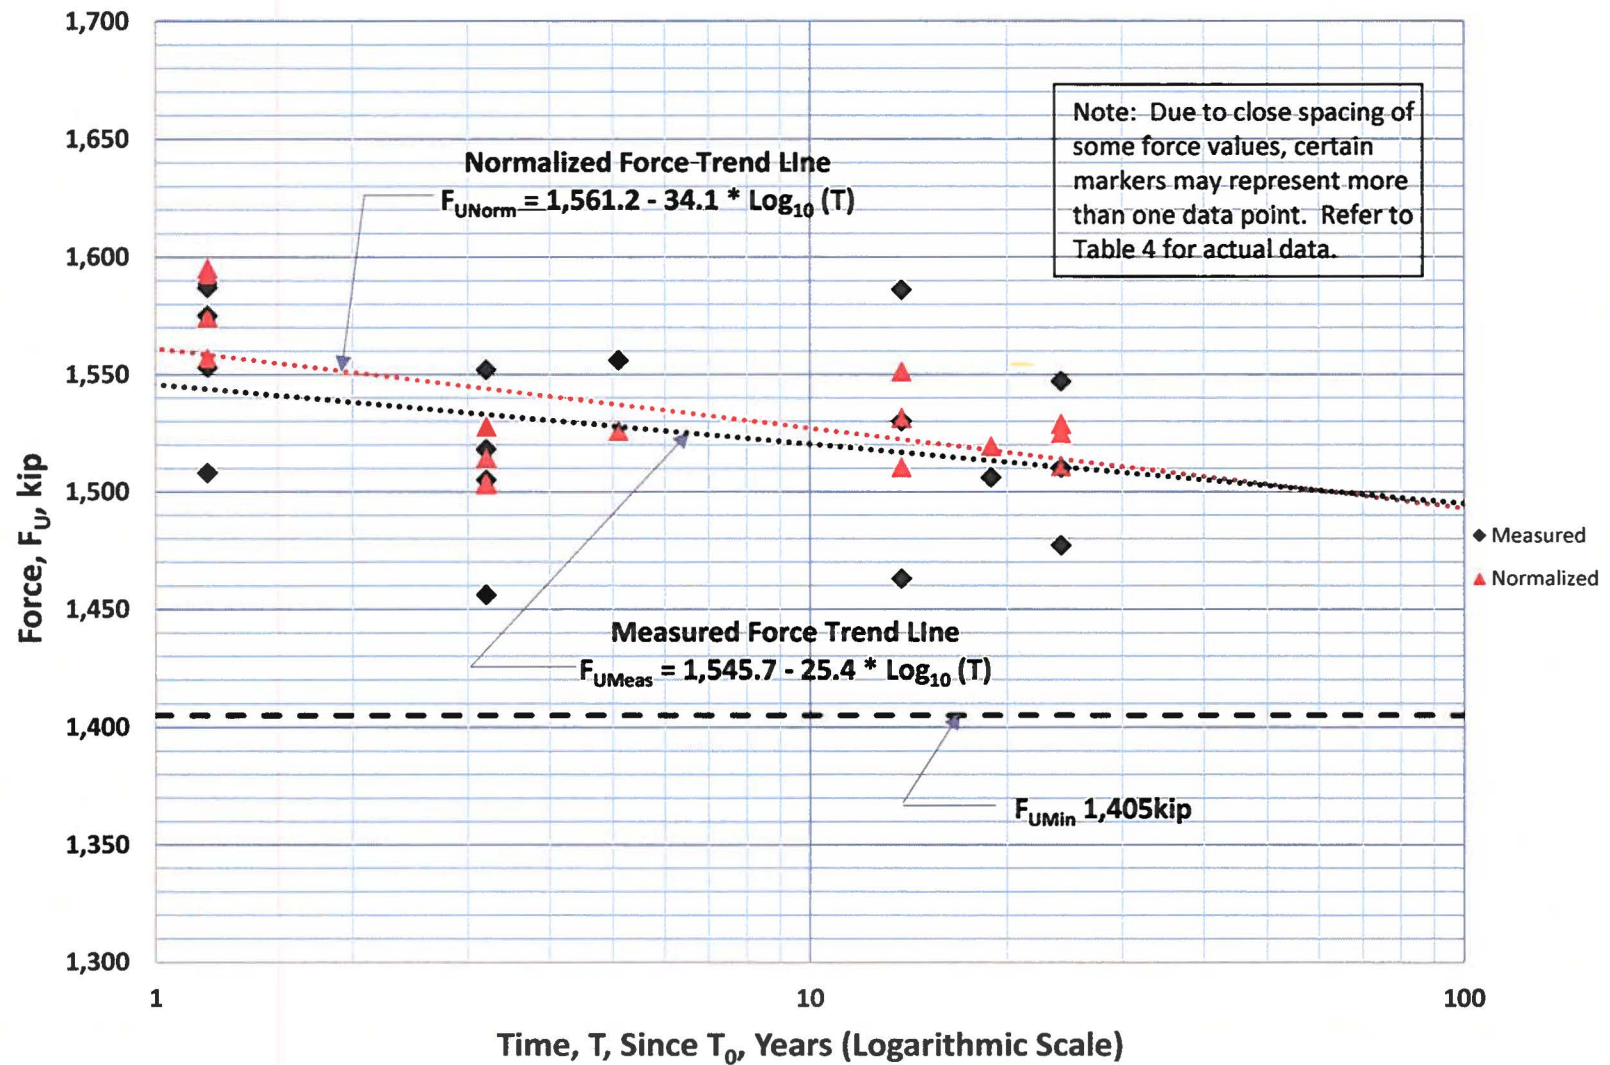
Figure 5 - Unit 1 Inverted U Tendon Measured & Normalized Force Trends

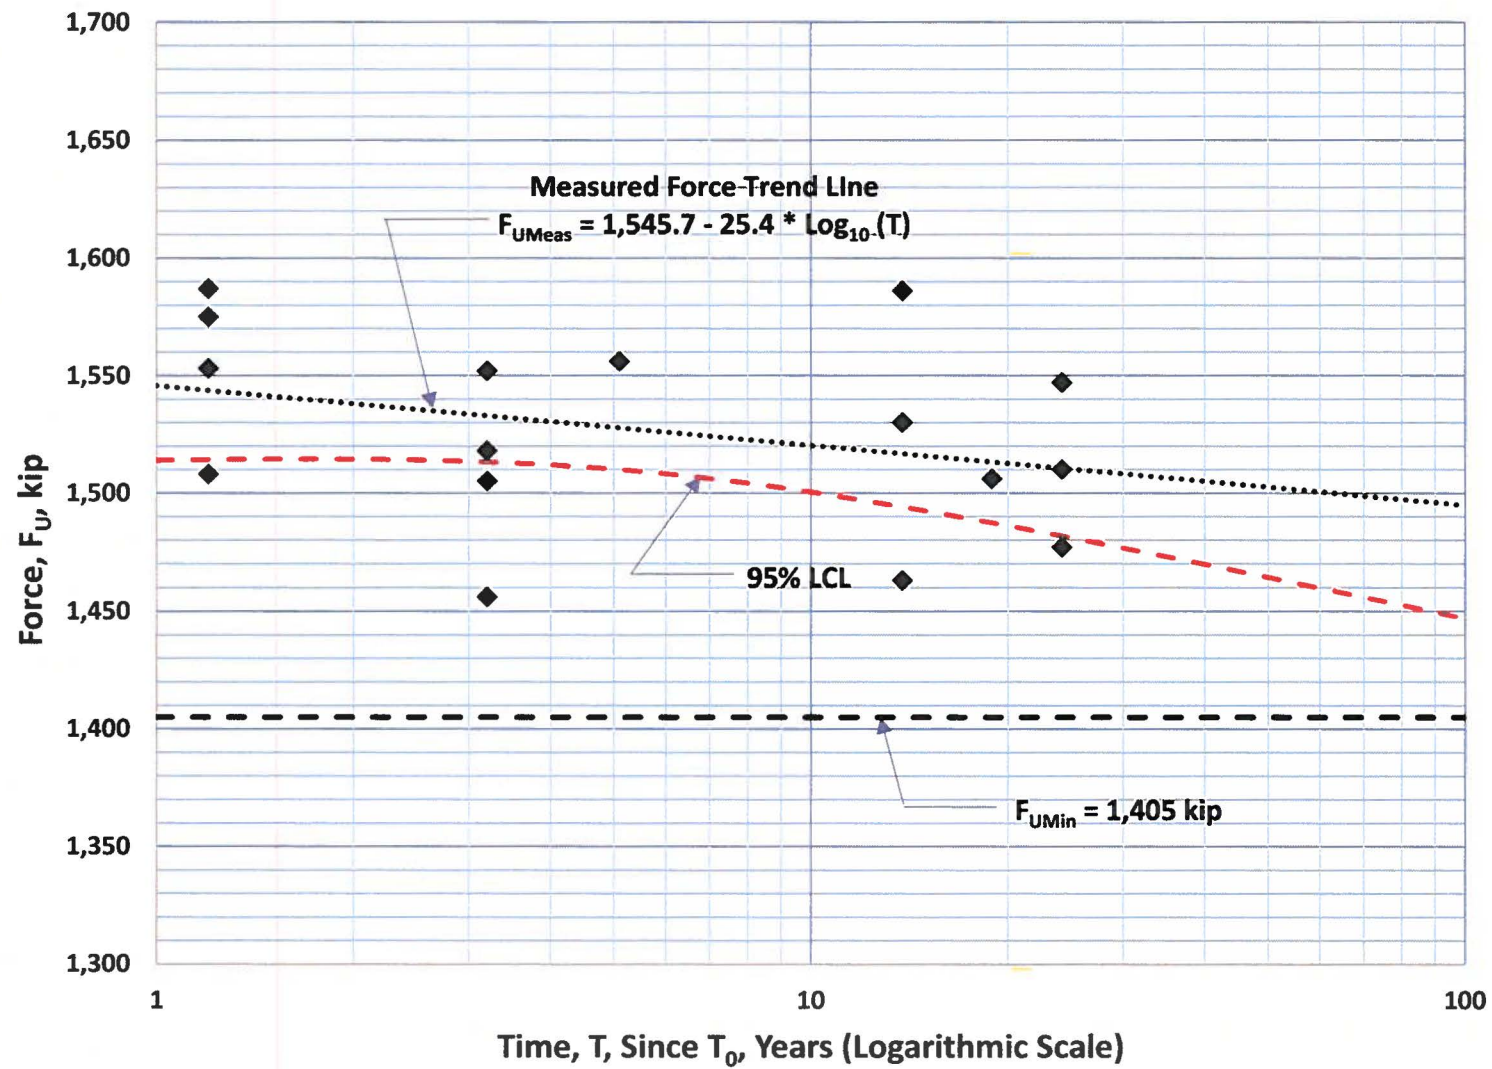
Figure 6 - Unit 1 Inverted U Tendon Measured Force Trend & LCL

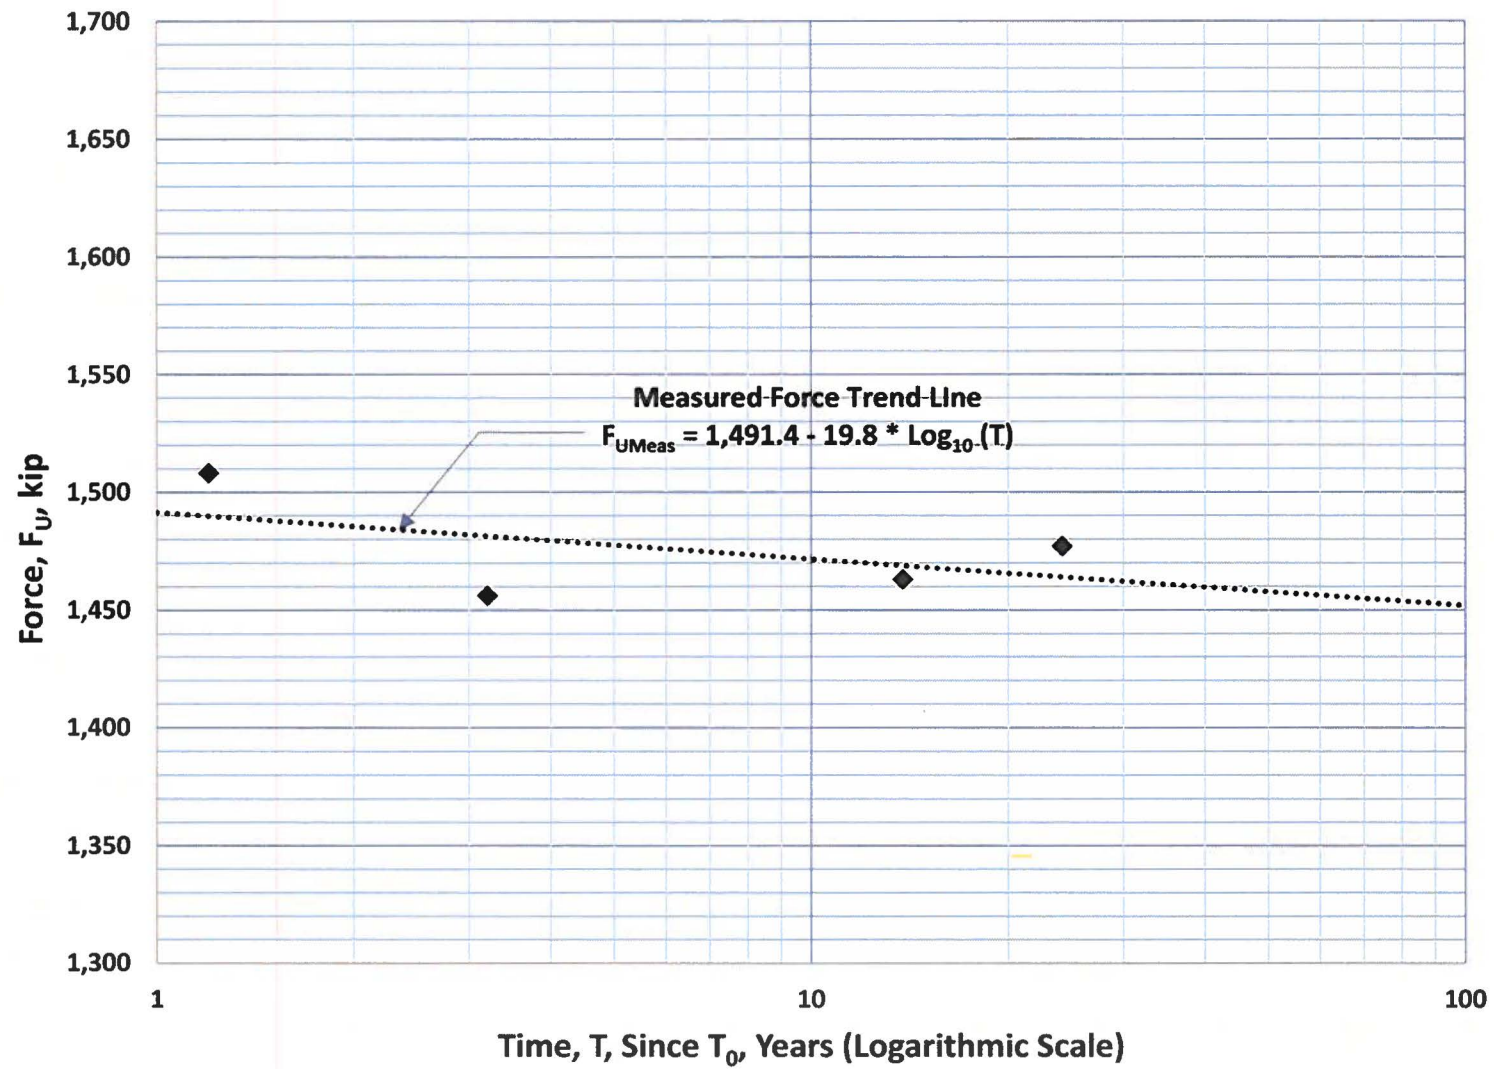
Figure 7 - Unit 1 Inverted U Common Tendon (1U18-94) Force Trend

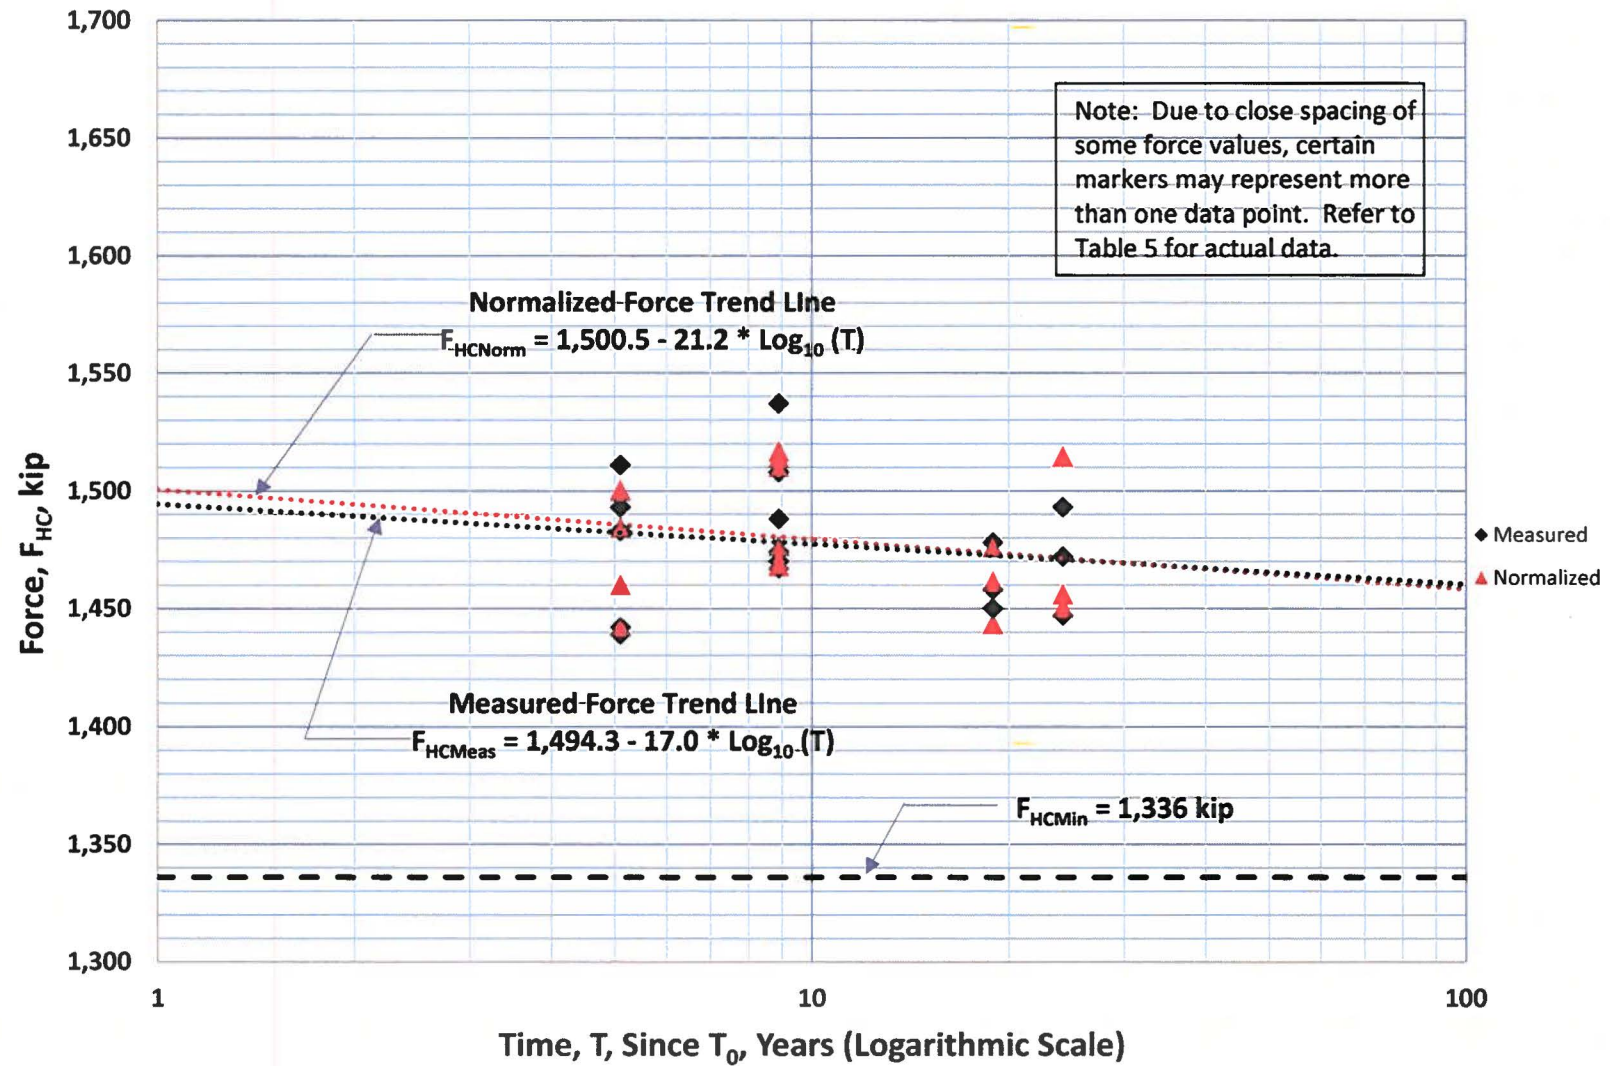
Figure 8 - Unit 2 Cylinder Hoop Tendon Measured & Normalized Force Trends

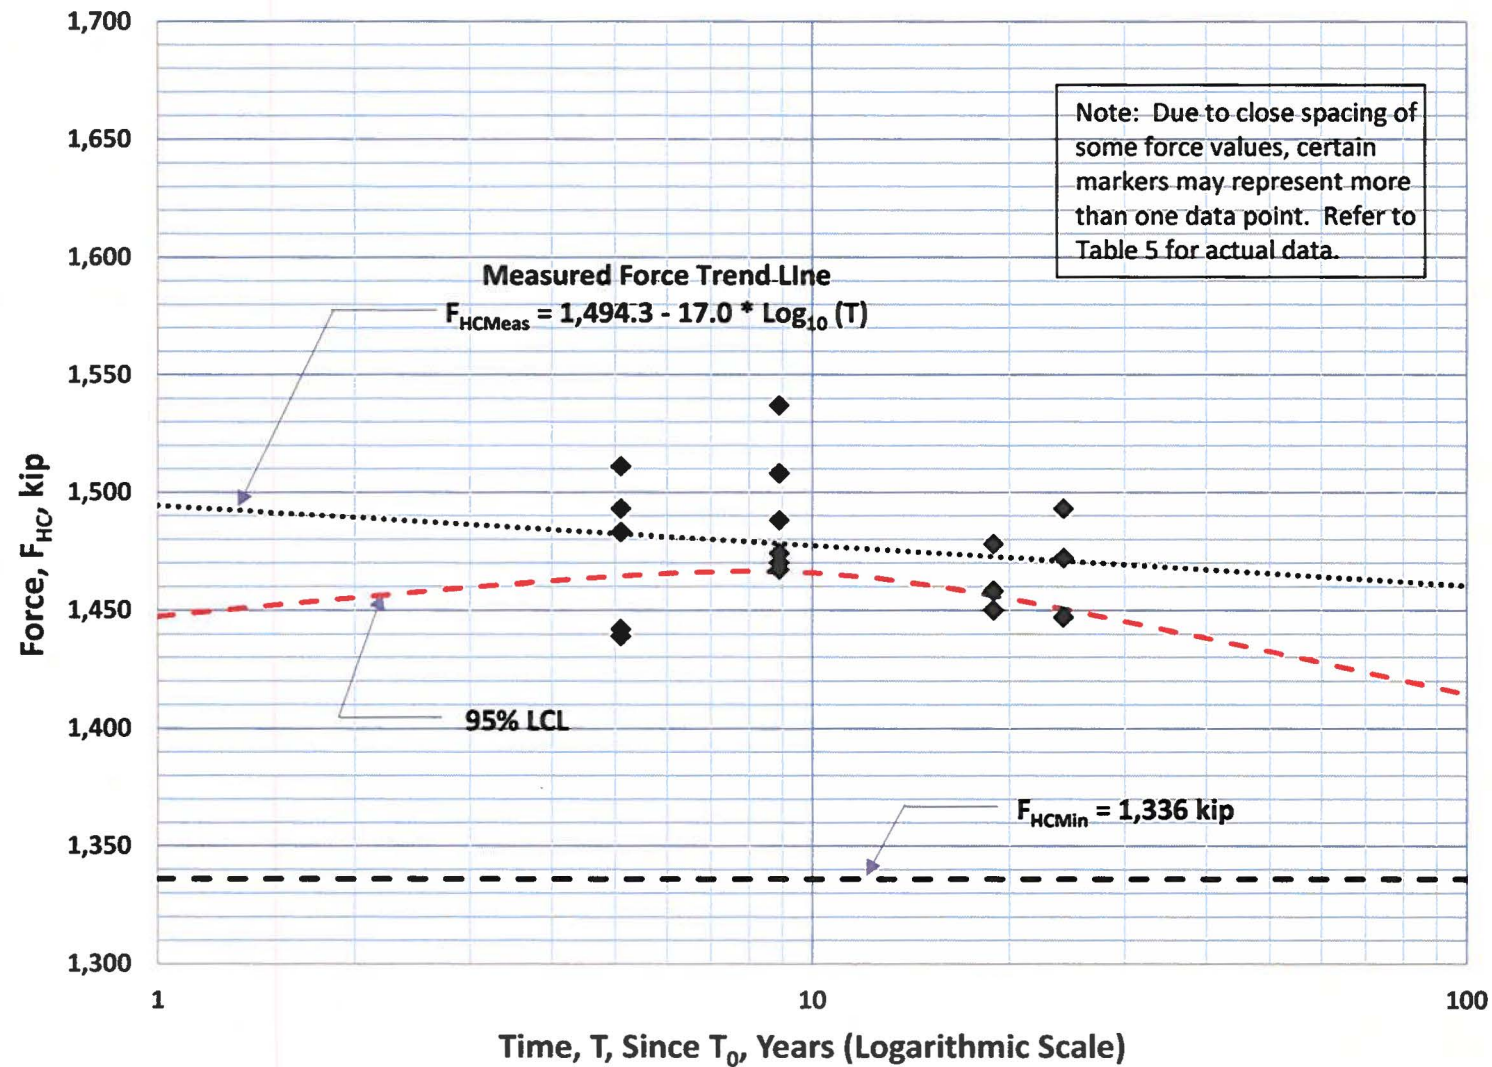
Figure 9 - Unit 2 Cylinder Hoop Tendon Measured Force Trend & LCL

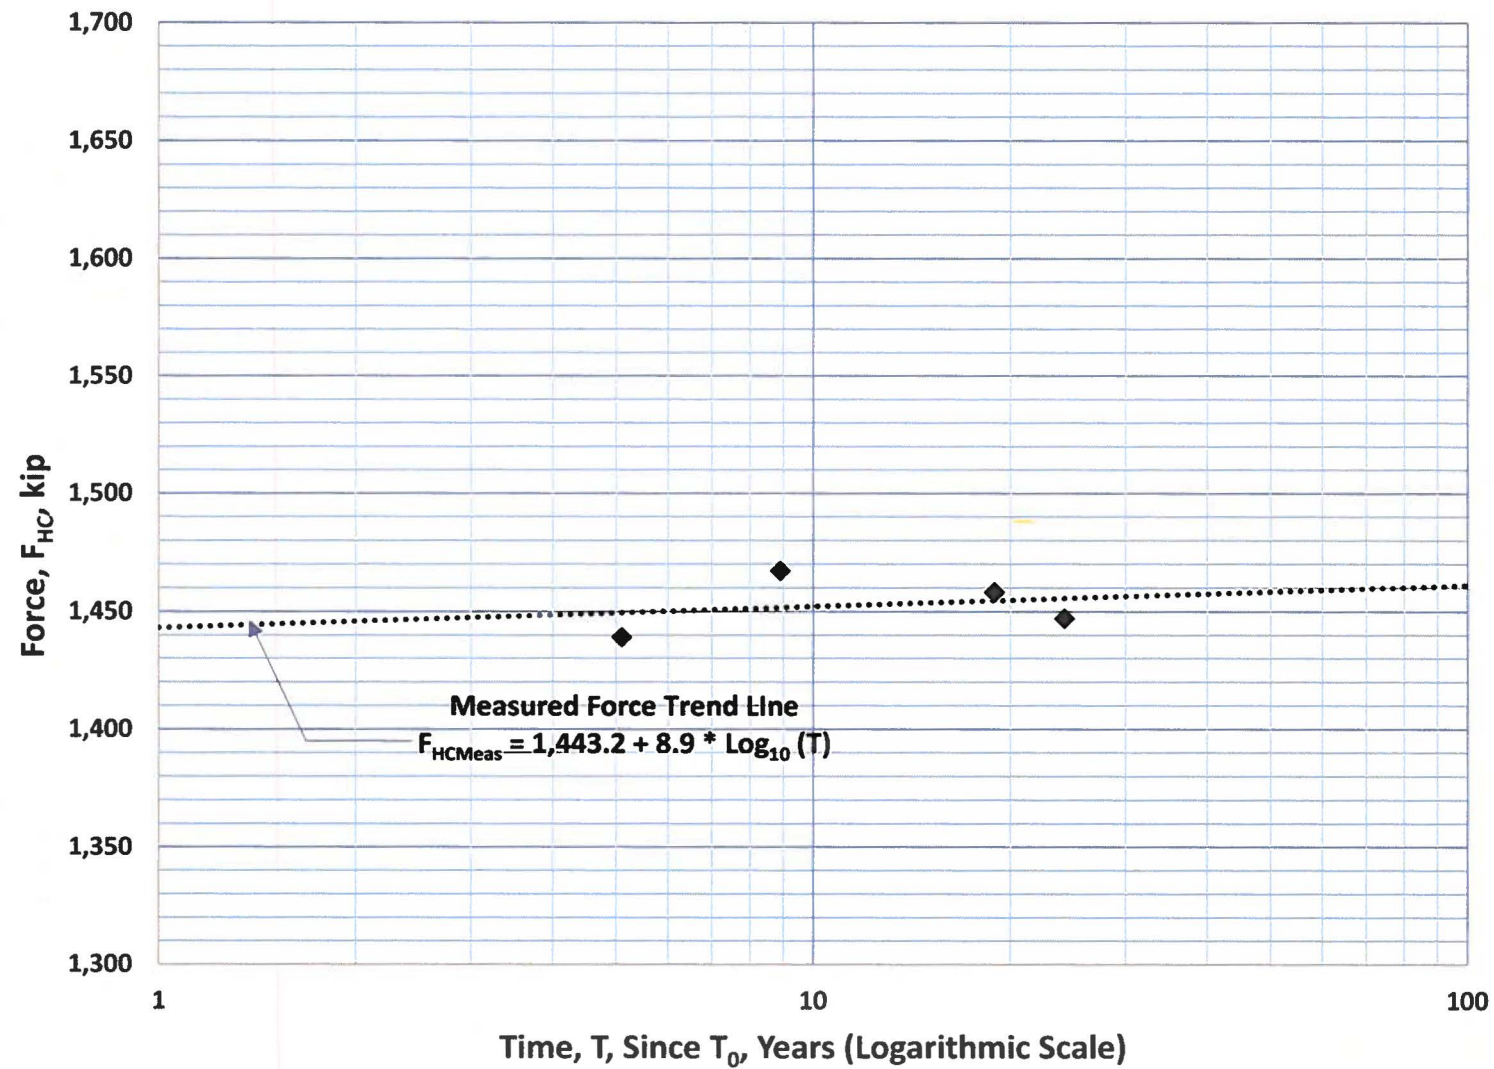
Figure 10 - Unit 2 Cylinder Hoop CommonTendon (2H99) Measured Force Trend

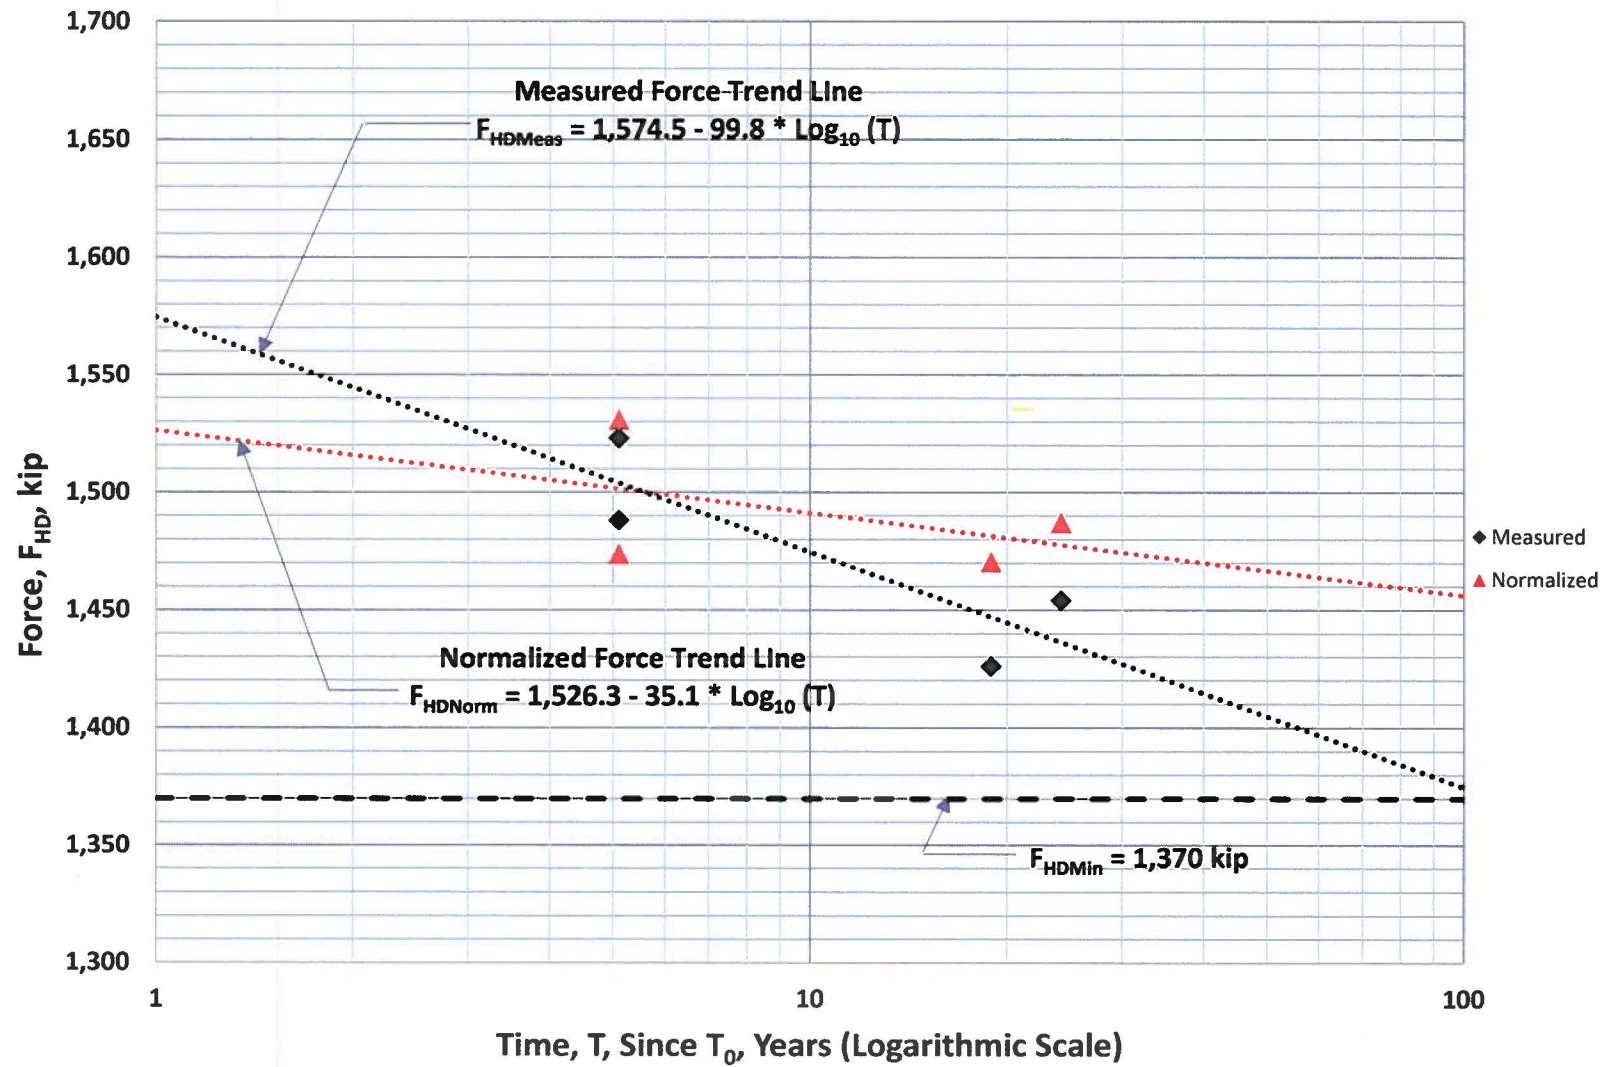
Figure 11 - Unit 2 Dome Hoop Tendon Measured & Normalized Force Trends

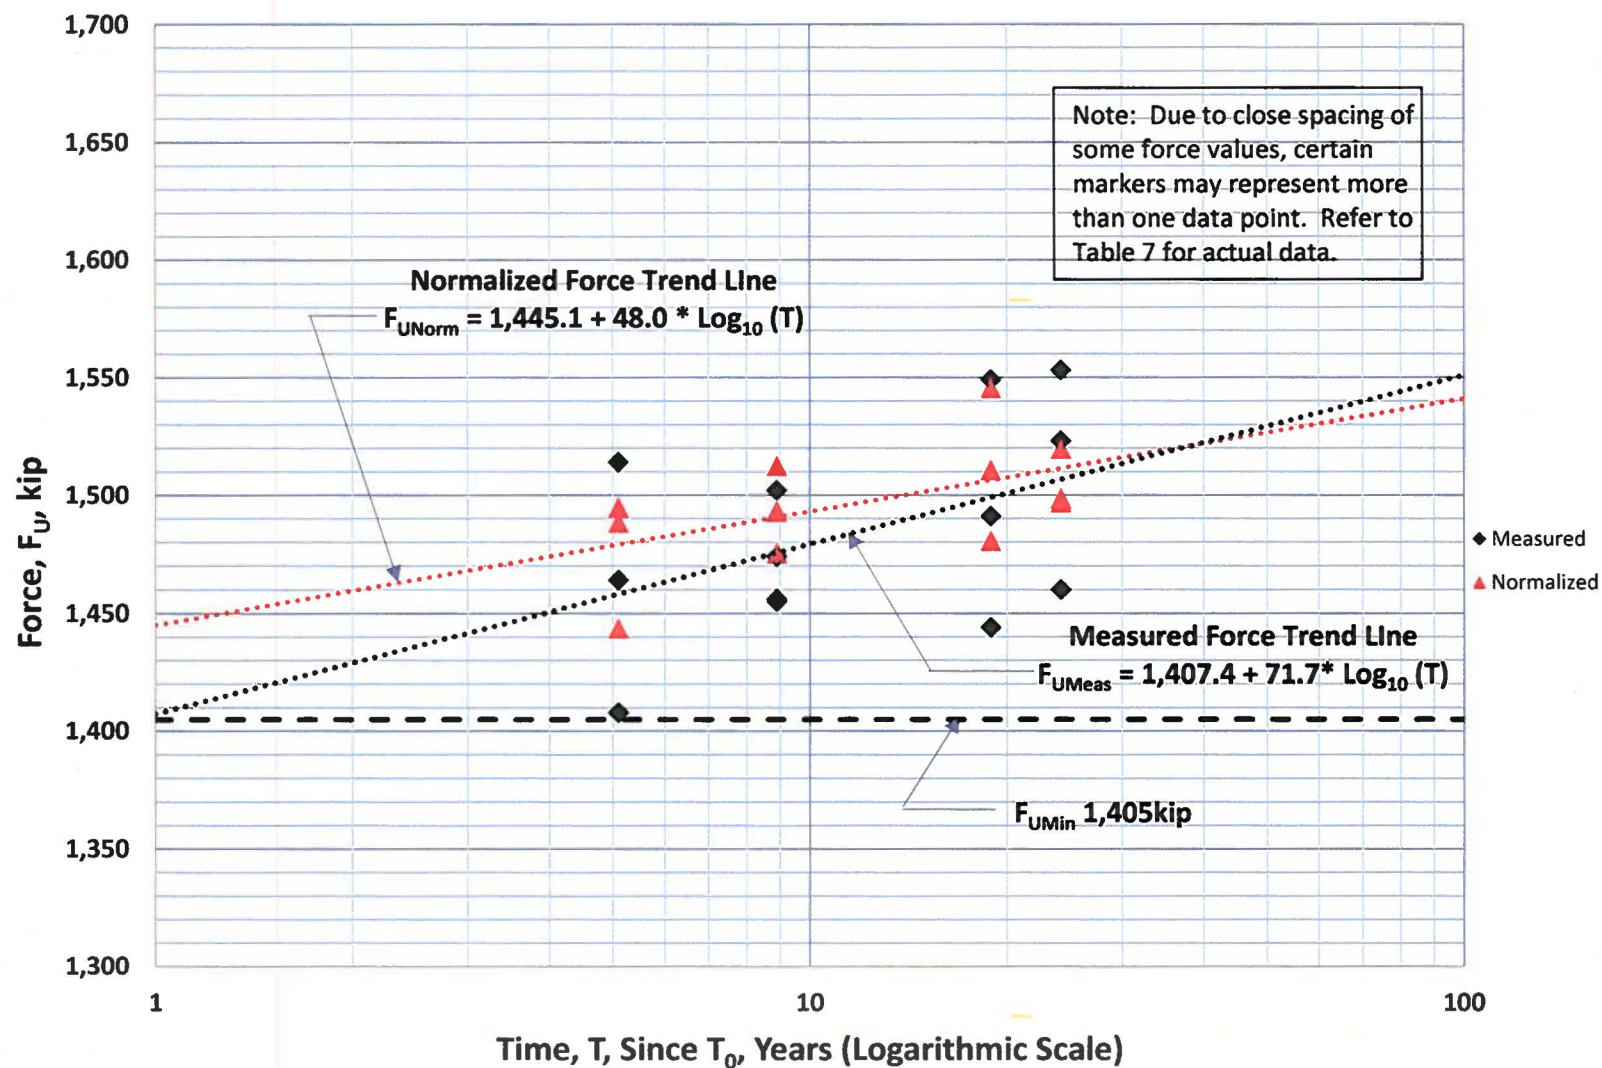
Figure 12 - Unit 2 Inverted U Tendon Measured & Normalized Force Trends

As discussed above, the Unit 2 inverted U tendon forces appear to be increasing over time. Since this cannot be explained by any reasonable scenario, it is concluded that the computed trends are a consequence of data scatter caused by the variations in tendon initial seating force as well as variable factors not otherwise accounted for. Again, the trends will be re-computed evaluated when the results of the next surveillance are available.

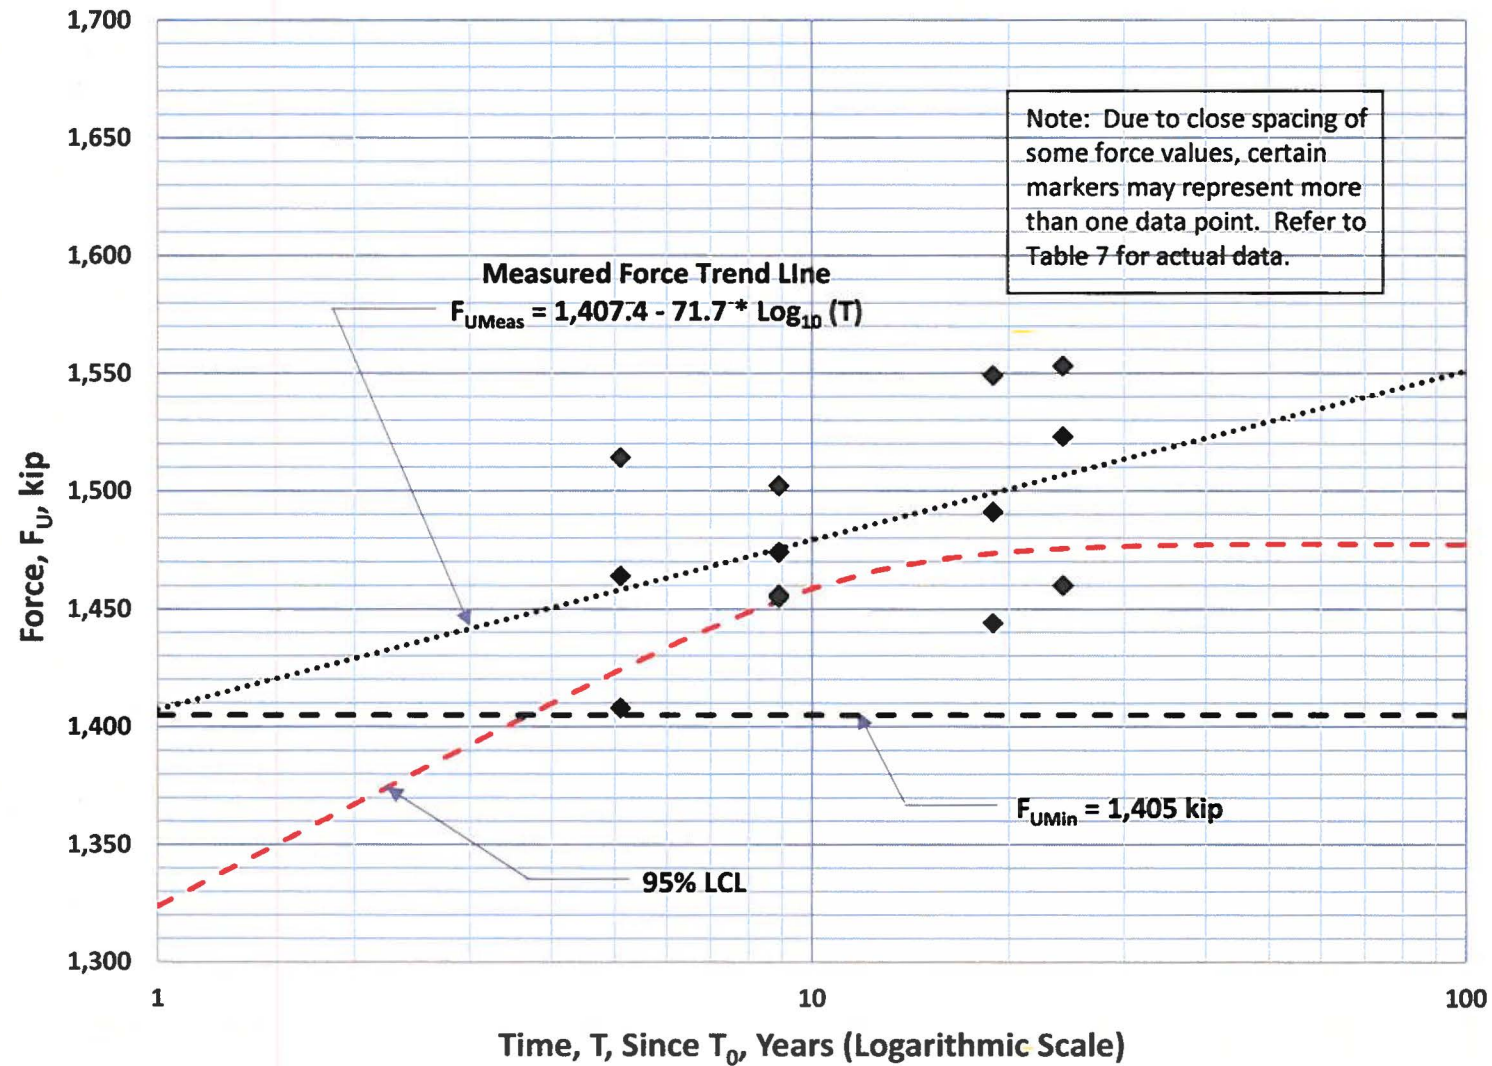
Figure 13 - Unit 2 Inverted U Tendon Measured Force Trend & LCL
