Vogtle Electric Generating Plant – Unit 1 and 2
Proposed ISI Alternative VEGP-ISI-ALT-19-01 for Tendon Inservice Inspection Extension

Enclosures: 1. Proposed Alternative VEGP-ISI-ALT-19-01
2. Containment Post-Tensioning System Inservice Inspection Technical Report

Proposed Alternative VEGP-ISI-ALT-19-01

Proposed Alternative VEGP-ISI-ALT-19-01 for Containment Unbonded Post-Tensioning System Inservice Inspection Requirements in Accordance with 10 CFR 50.55a(z)(1)

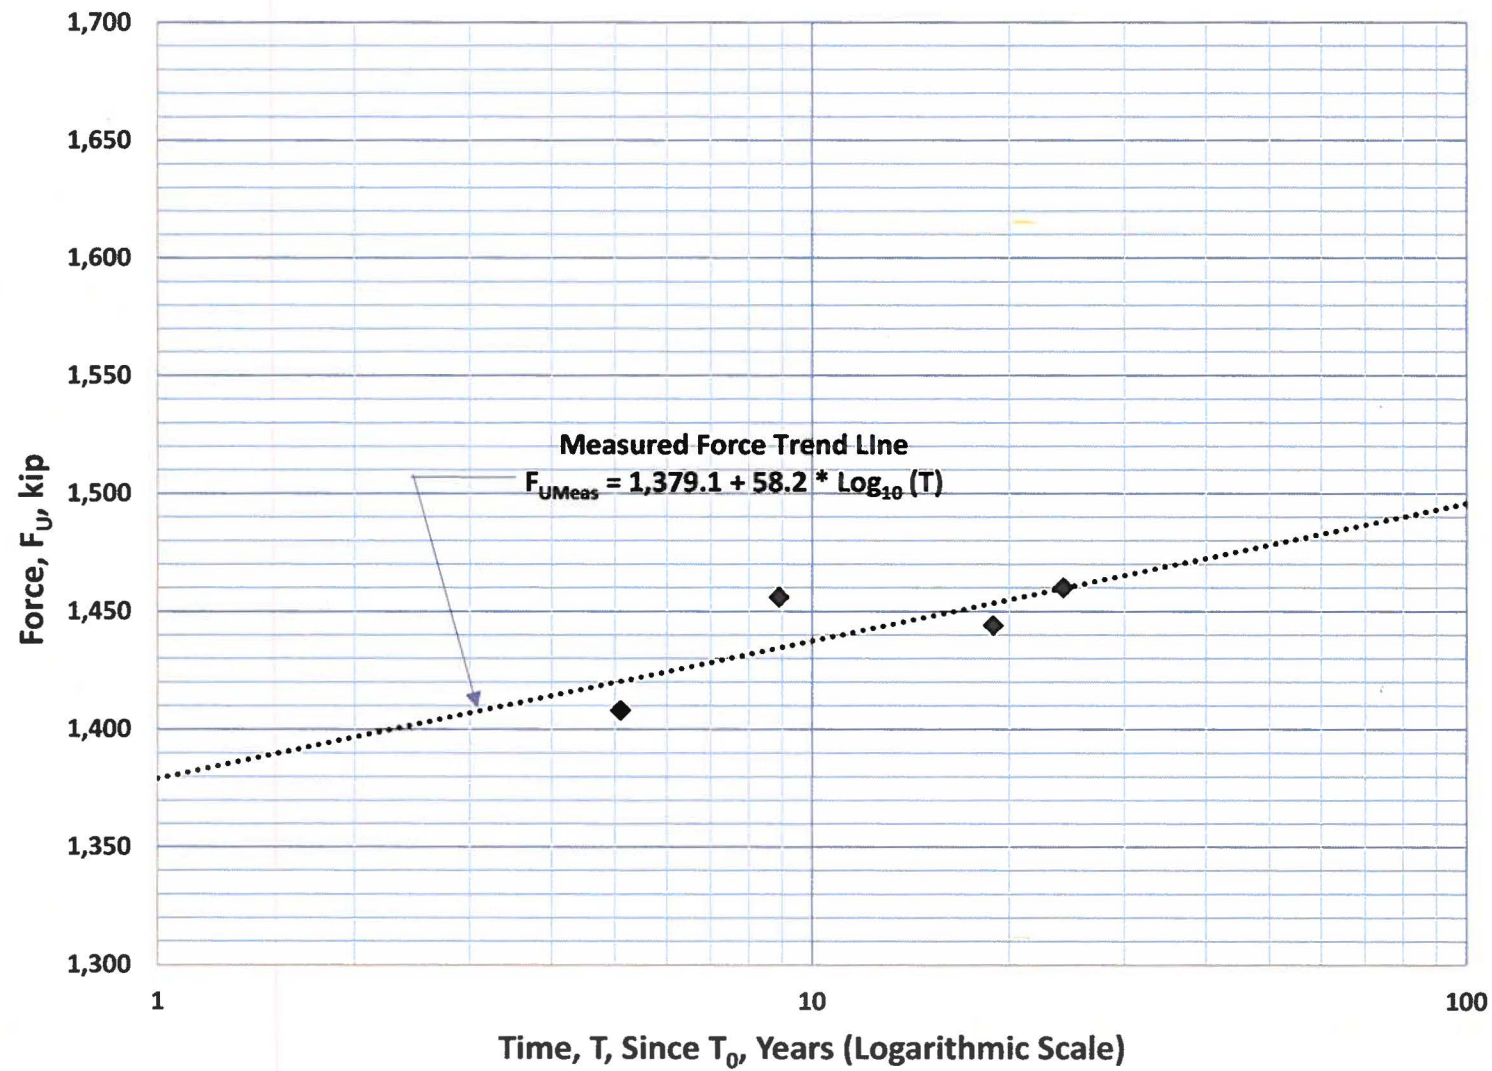
Figure 14 - Unit 2 Inverted U Common Tendon (2U20-92) Force Trend

Figure 14 is a plot of inverted U common tendon 2U20-92 measured forces and the log-linear trend. There is relatively little data scatter about the trend line, as would be expected for a common tendon. However, the computed slope of the trend is a positive (+)58.2 kips per unit logarithmic interval, a result that is, as previously noted, inconsistent with any reasonable scenario of structural behavior.

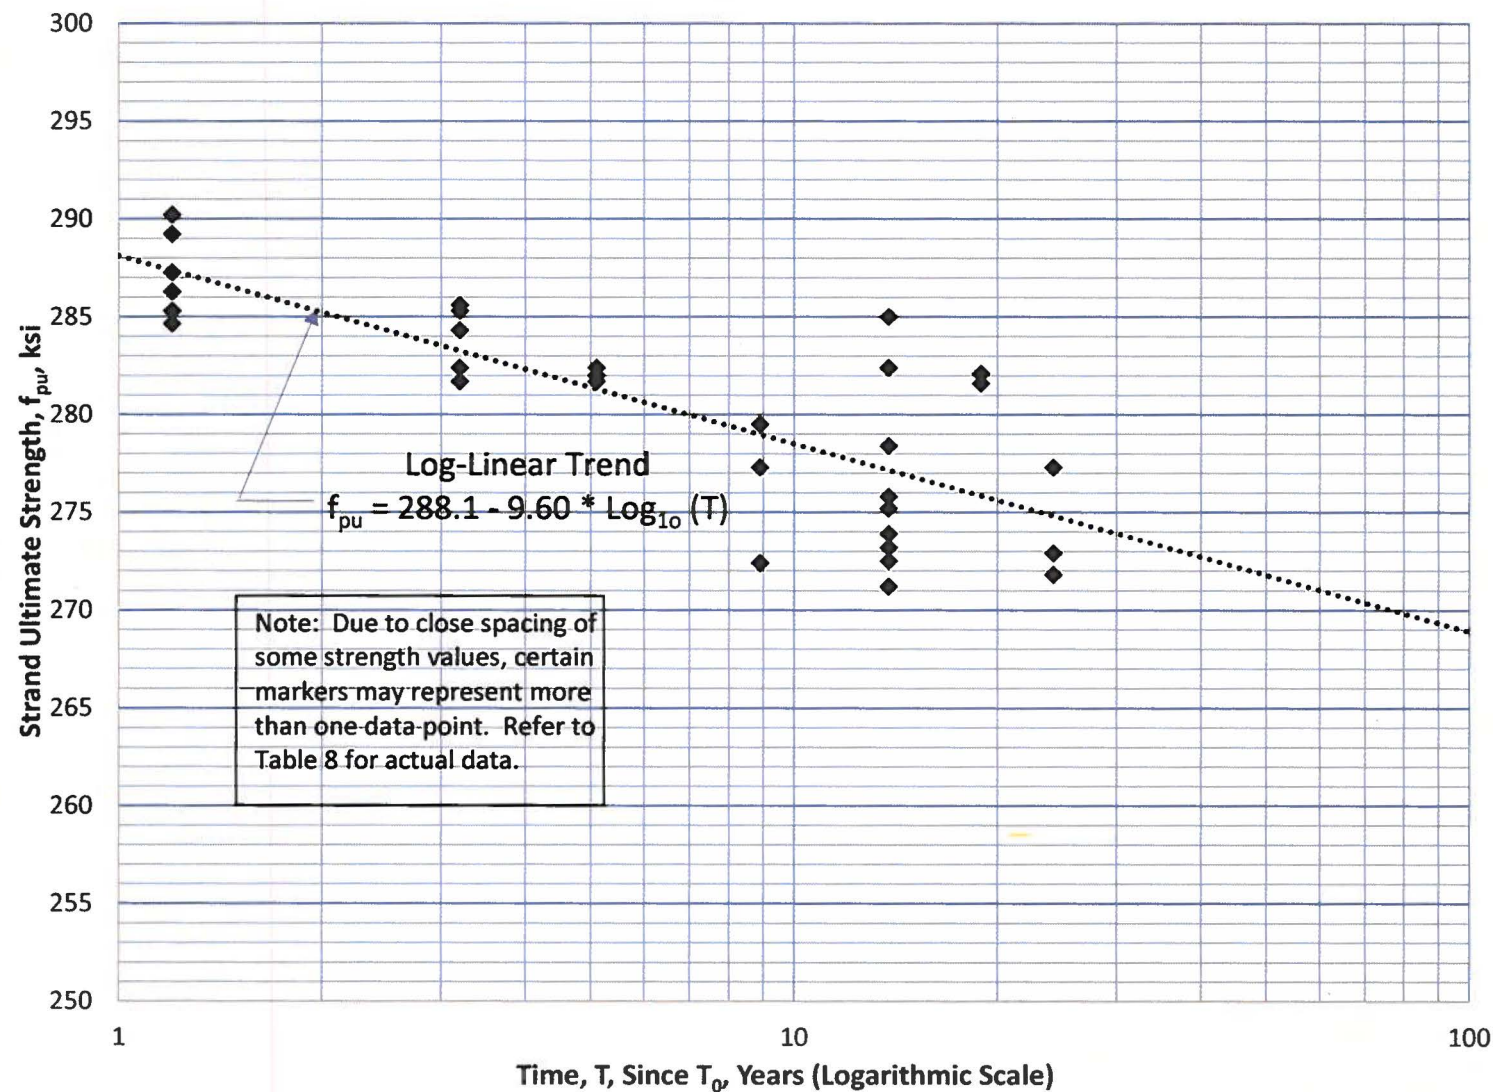
Figure 15 - Strand Mechanical Property Test Results / Ultimate Strength

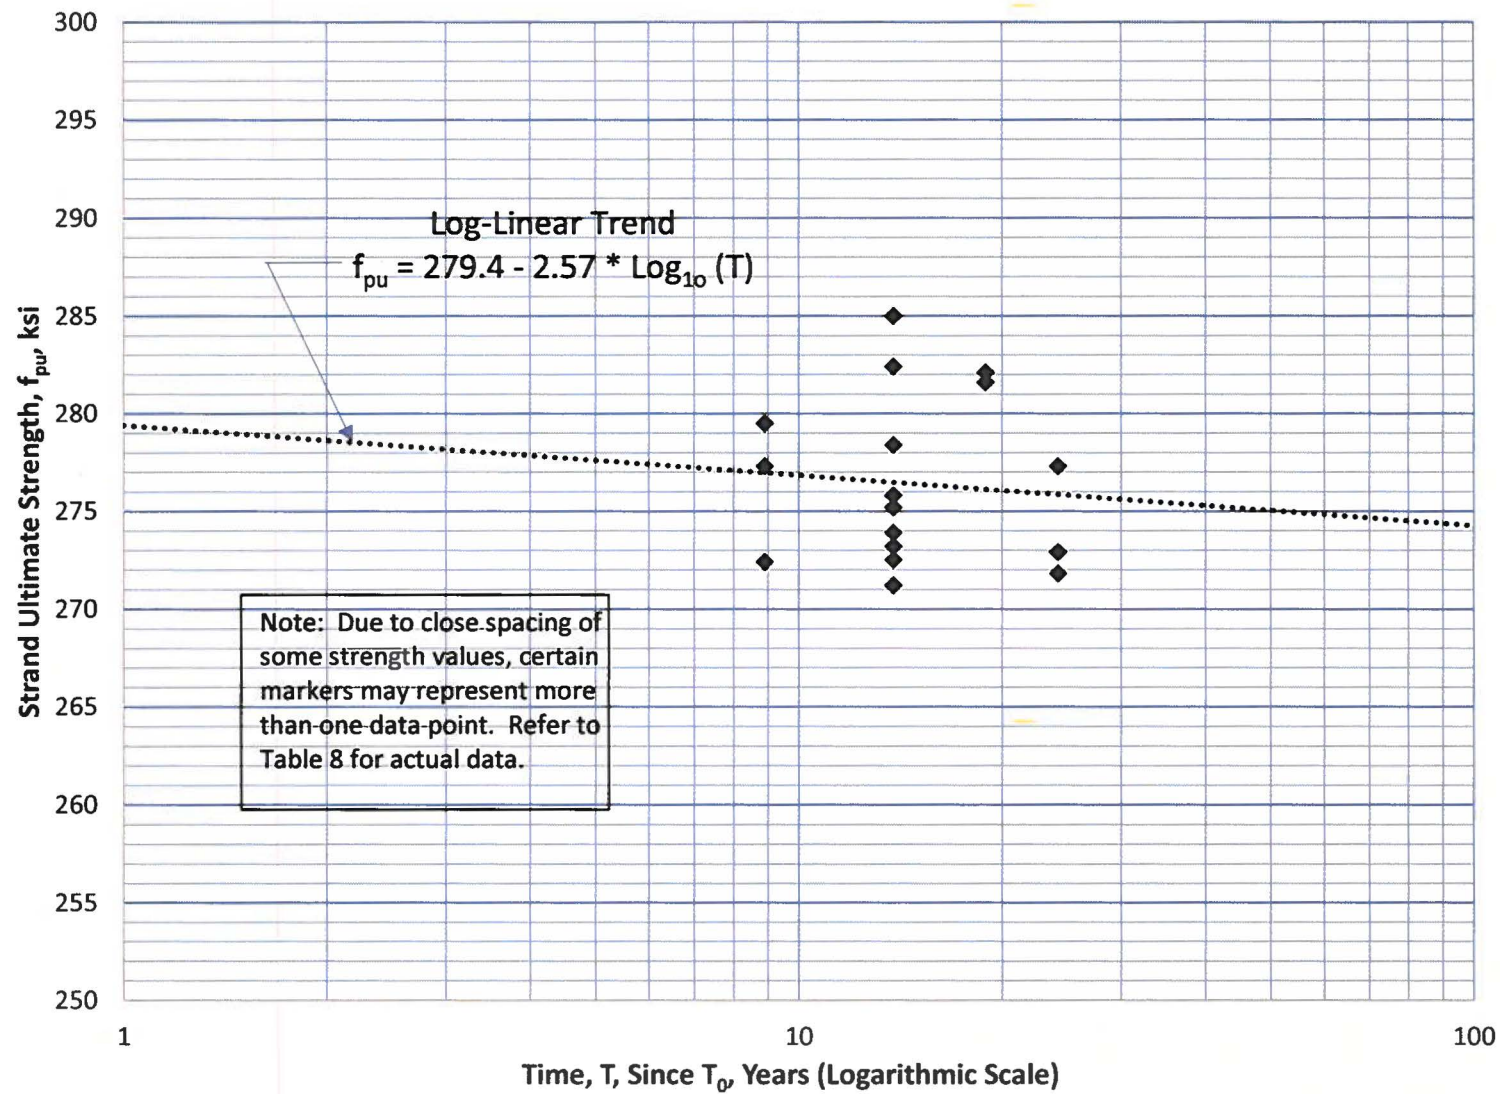
Figure 16 - Strand Mechanical Property Test Results (1995 - 2010) / Ultimate Strength

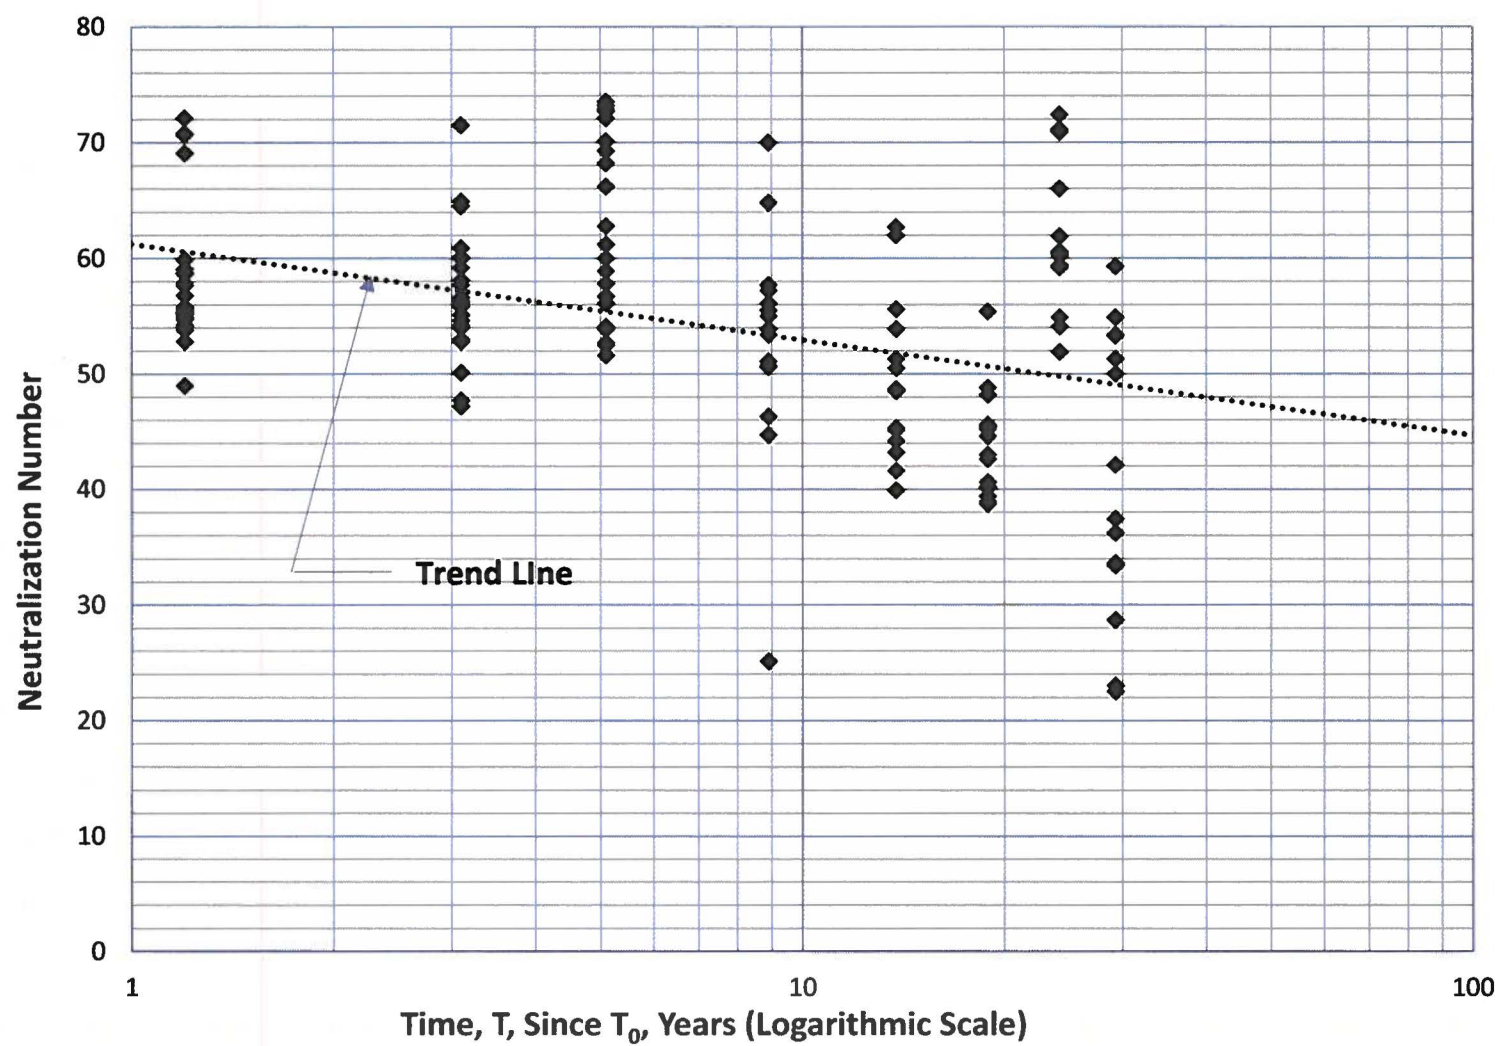
Figure 17 - Unit 1 CPM Neutralization Number Trend

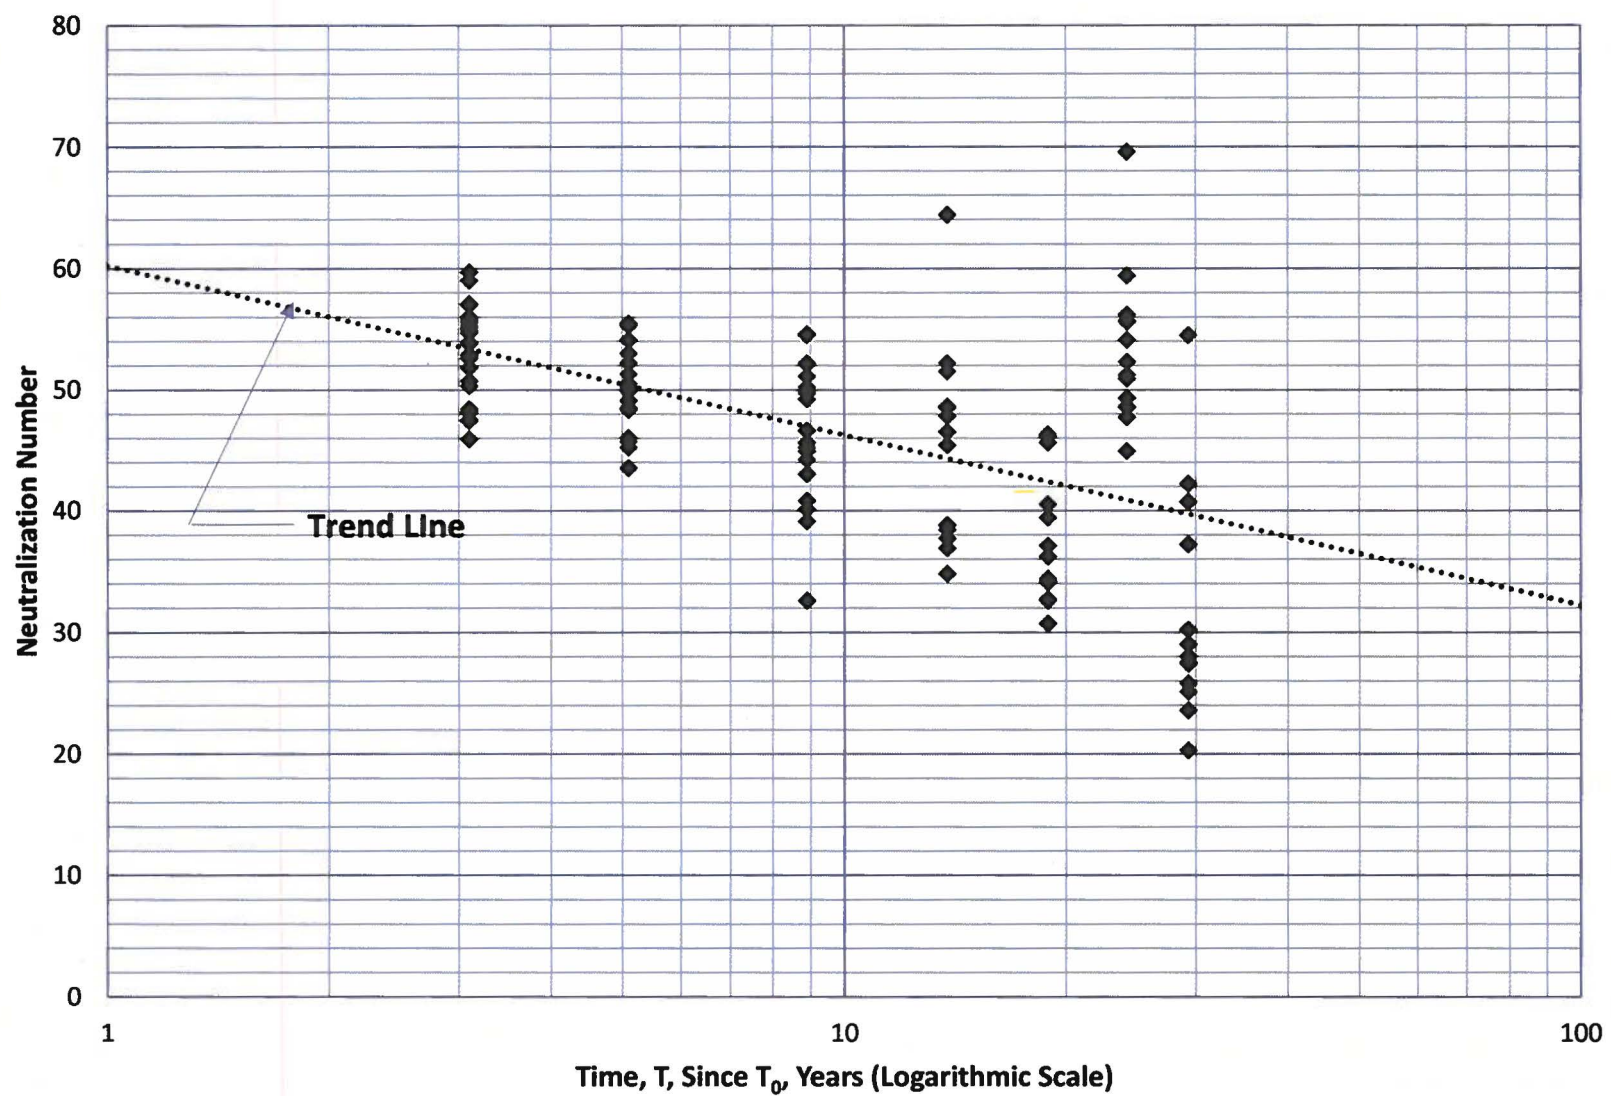
Figure 18 - Unit 2 CPM Neutralization Number Trend
