**From:** Strait, Kenneth A. <Kenneth.Strait@pseg.com>  
**Sent:** Tuesday, February 19, 2019 8:29 AM  
**To:** incidental.take@noaa.gov; EndangeredSpecies Resource  
**Cc:** jeanette.bowers@dep.nj.gov  
**Subject:** [External\_Sender] SALEM GENERATING STATION-INCIDENTAL TAKE OF ATLANTIC STURGEON  
**Attachments:** Atlantic Sturgeon Incidental Take Report 02-15-19.pdf

### Appendix C, Part 2A (Sturgeon)

# STURGEON DATA COLLECTION FORM

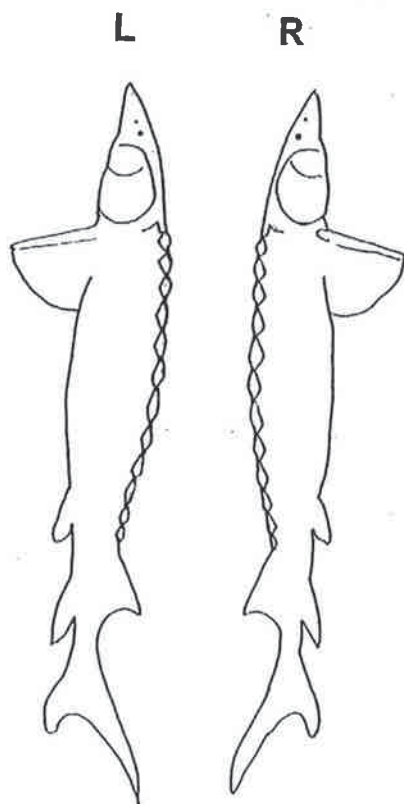
Draw wounds, abnormalities, tag locations on diagram and briefly describe below

Describe any wounds / abnormalities (note tar or oil, gear or debris entanglement, propeller damage, etc.). **Please note if no wounds / abnormalities are found. Specimen was deceased at the time of observation, and was found to be dried out. Despite this condition, the specimen was complete and revealed no evidence of external damage. During processing, no internal or external tags were indicated. After processing, the specimen was returned to the ECSI office and placed in refrigeration, awaiting direction on further disposition.**

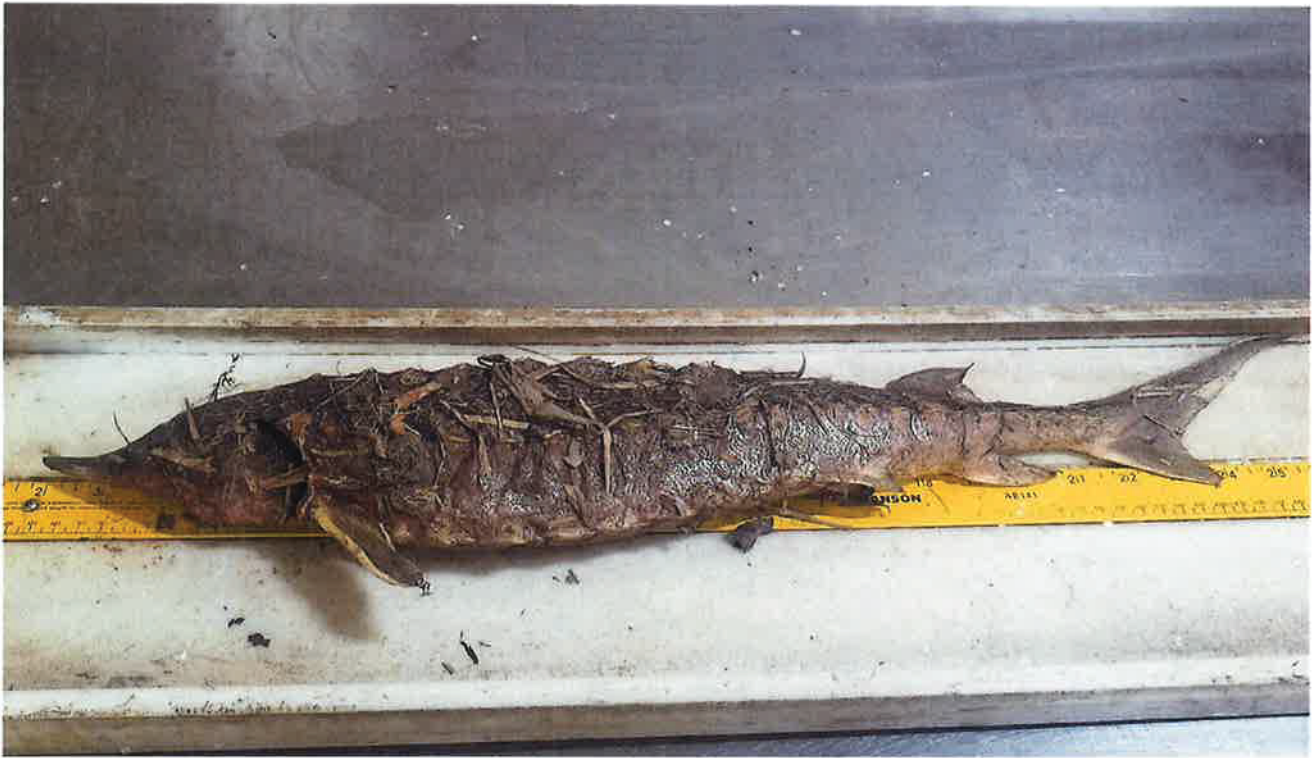
A dorsolateral view showing the size and condition of the deceased, Atlantic Sturgeon (*Acipenser oxyrinchus*), retrieved at 10:30am on 02/14/19 from the Unit 1 Circulating Water Intake trash basket by Operations personnel at Salem Nuclear Generating Station (02/15/2019).

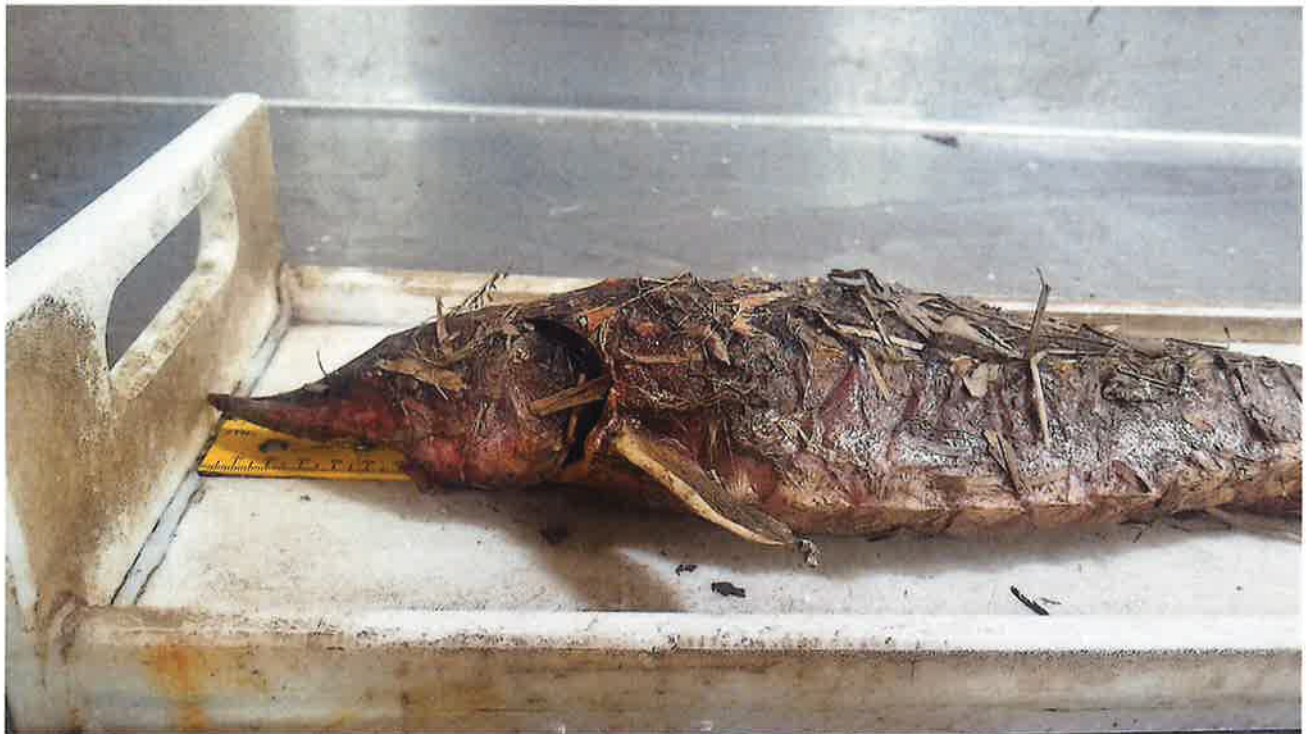
Another dorsolateral view of the specimen, showing a close up of the head and torso (02/15/2019).

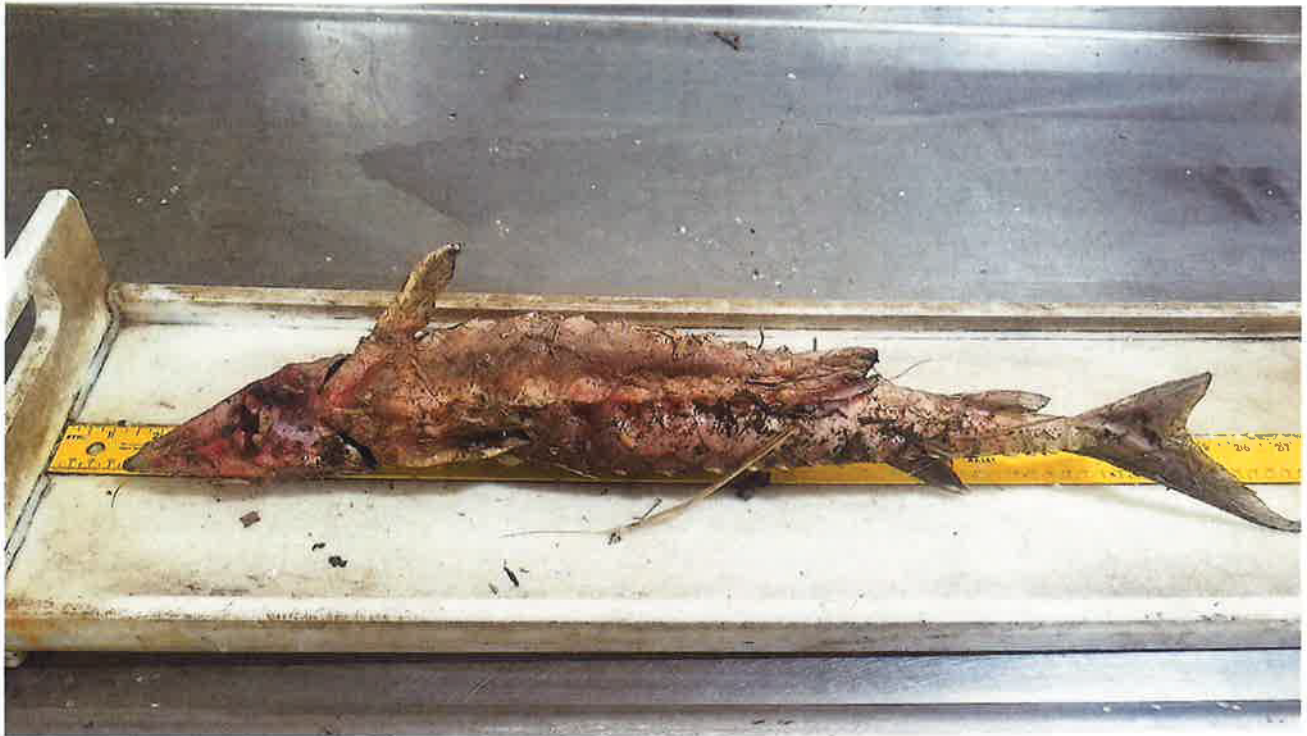
A ventral view of the carcass. The specimen was found to lack any evidence of external damage but was observed to be dried out (02/15/2019).

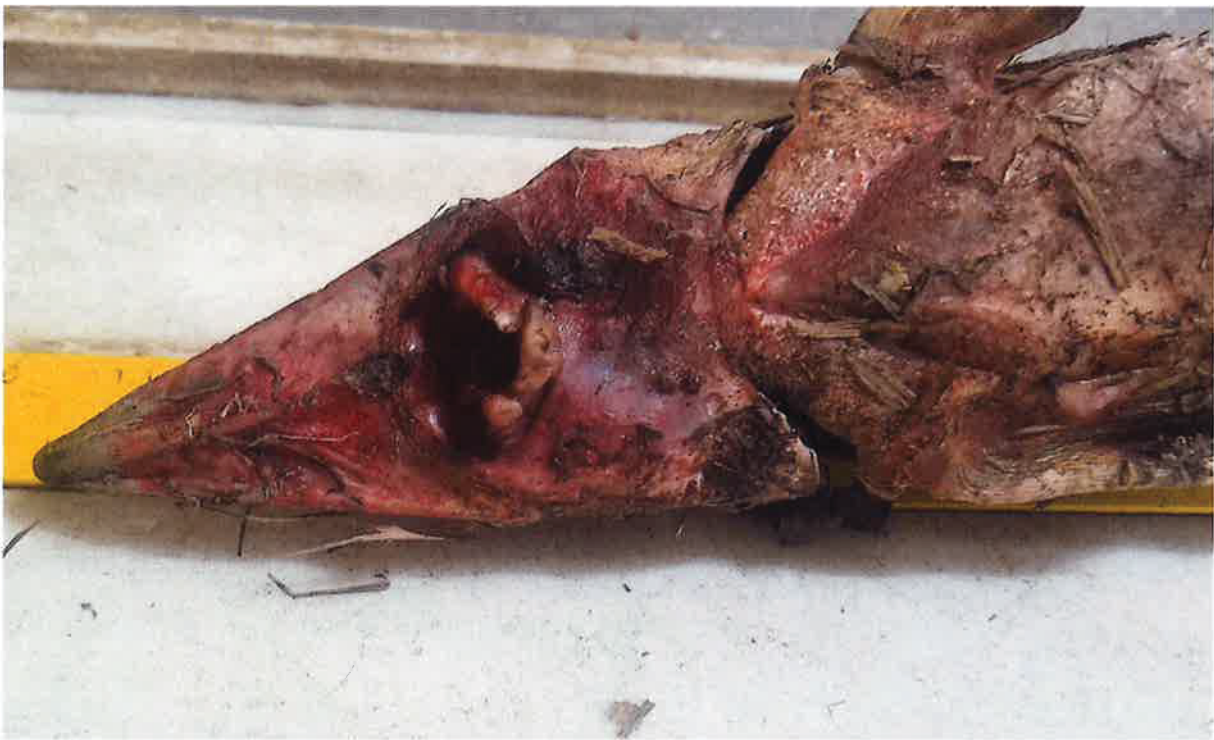
A ventral view of the head, showing the characteristic small mouth (02/15/2019).
