NRC REG CON MEETING

Dry Storage Canister Inspection, Mitigation, and Repair R&D Efforts

September 16-17, 2019

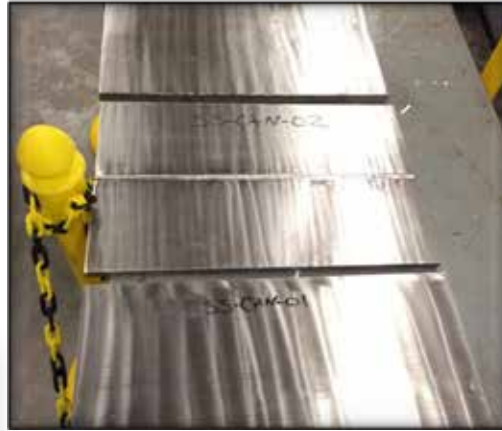
QA Flaw Mockups

8 flaw mockups with a range of flaw sizes, orientations, etc.

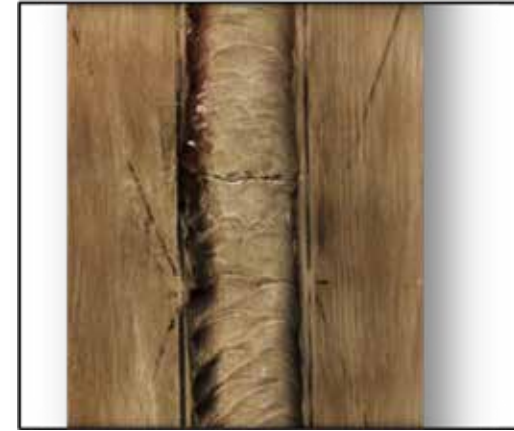
Non-QA Flaw Mockups

6 additional flawed and unflawed mockups are available

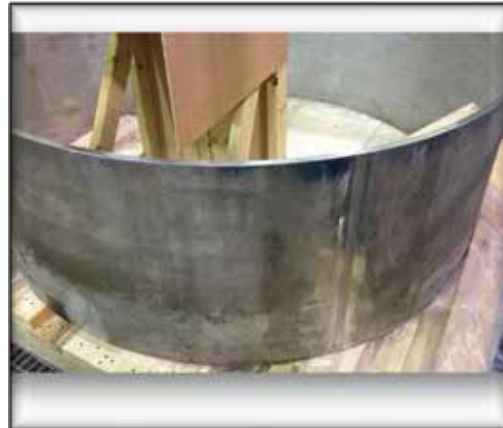
Sandia Mockup

SNL donated a full-diameter mockup and PNNL funded flaw implantation

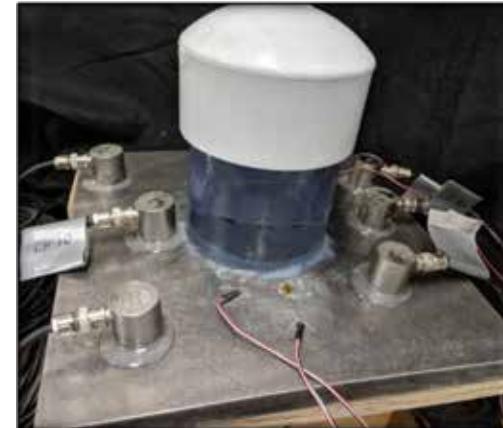
Acoustic Emission Mockups

EPRI is growing SCC in 5 flaw mockups

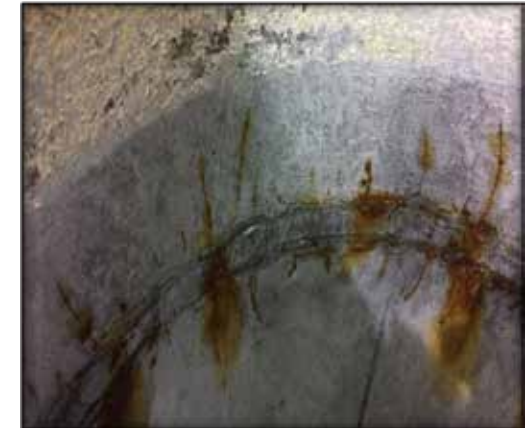
CISCC Mockups

EPRI has 3 mockups with laboratory-grown CISCC

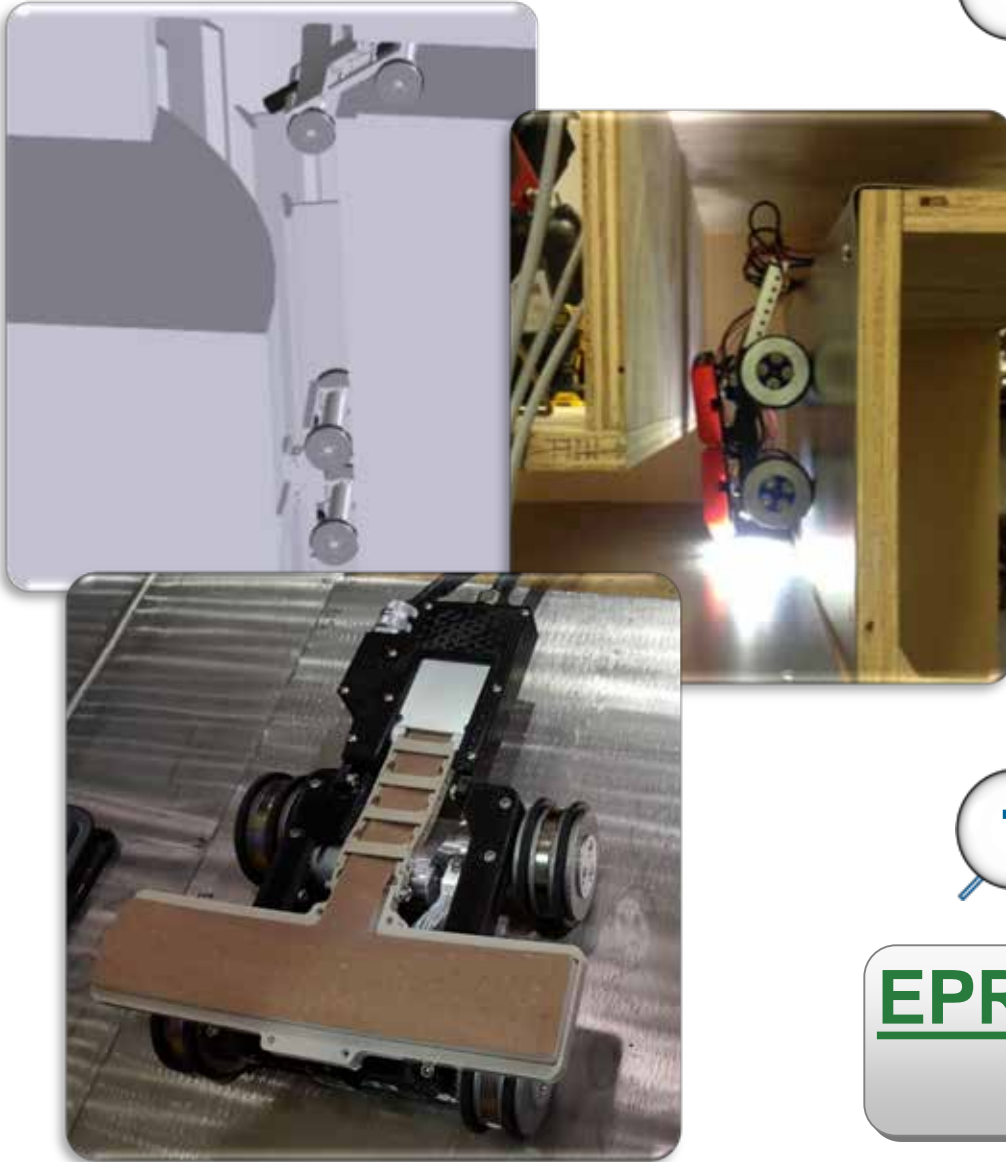
Field Trial Summary

- 1 AREVA's Aiken Facility
- 2 APS – 2nd Fuel-loaded canister – Trojan
- 3 Duke Energy – 4th/5th Loaded canisters – Vermont Yankee
- 4 9 – 6th-8th Loaded canisters – SONGS
- 5 Southern Co. – 9th-13th Loaded canisters – SONGS (2)
- 6 11 – Fuel-loaded canister – Trojan
- 7 PNNL Blind Inspection Demonstration

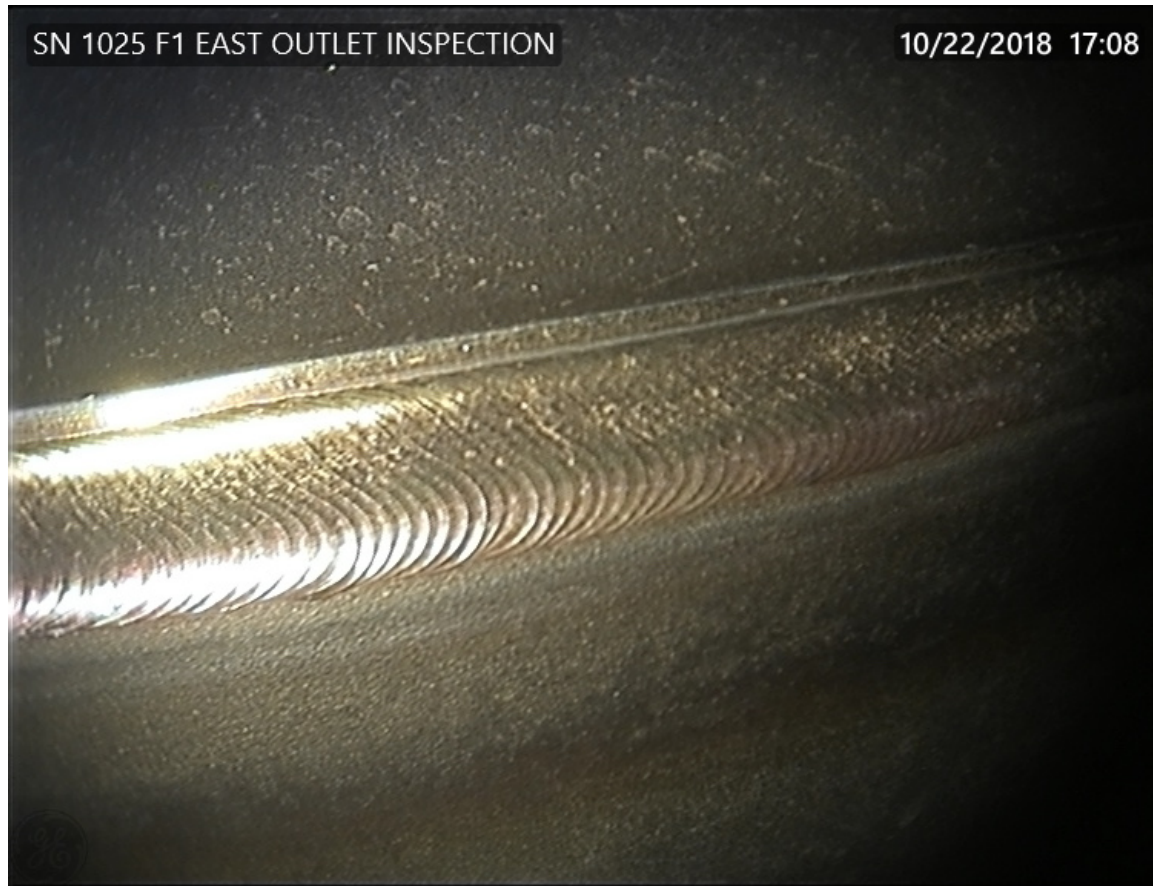
DCSS Visual Inspection – Lid Weld

Freshly-loaded canister

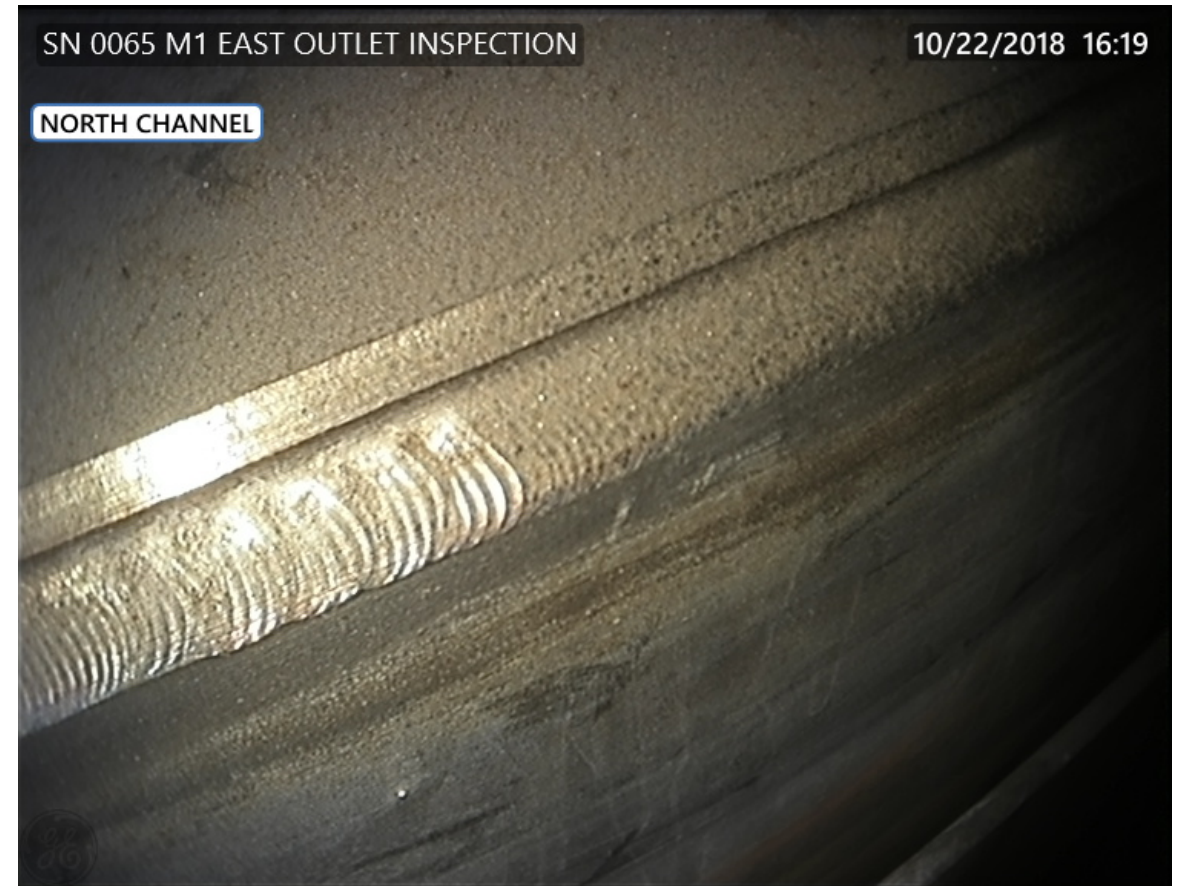
DCSS loaded in 2008

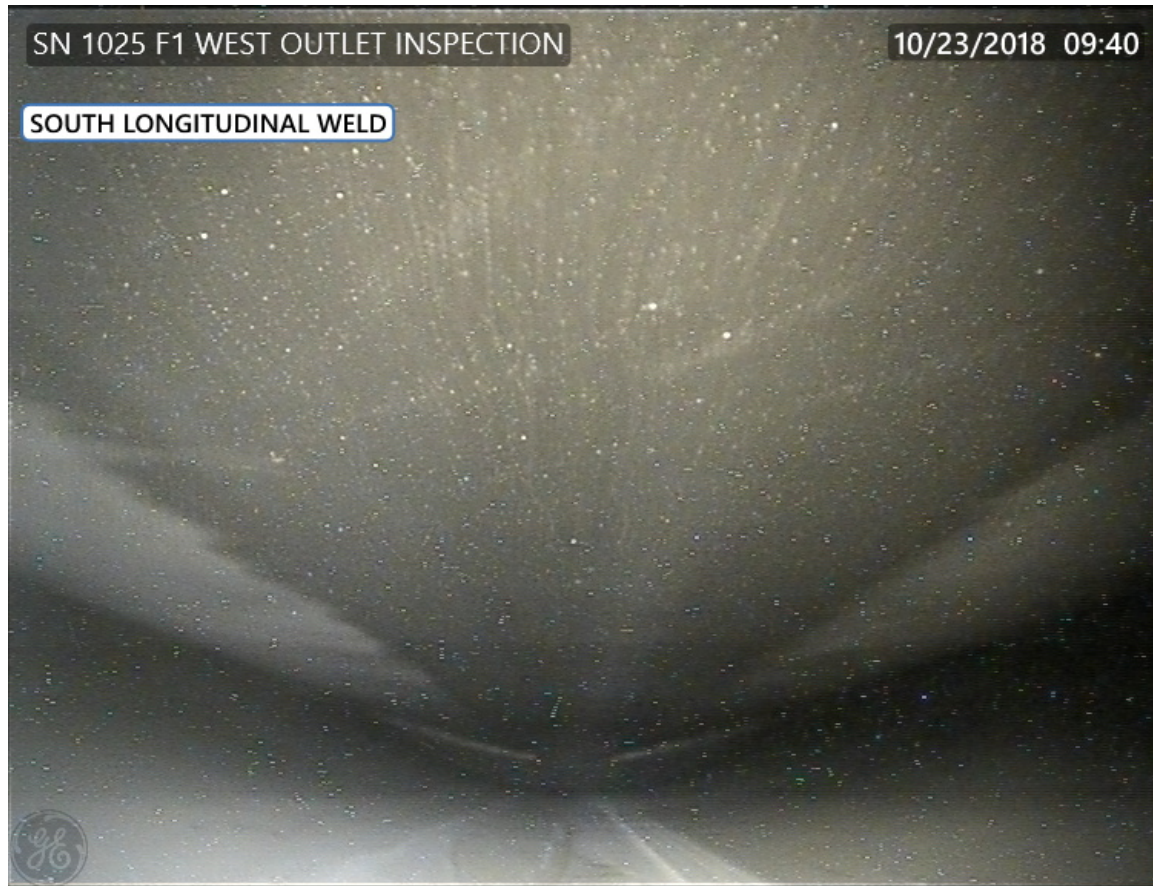
DCSS Visual Inspection – Shell Welds

Freshly-loaded canister

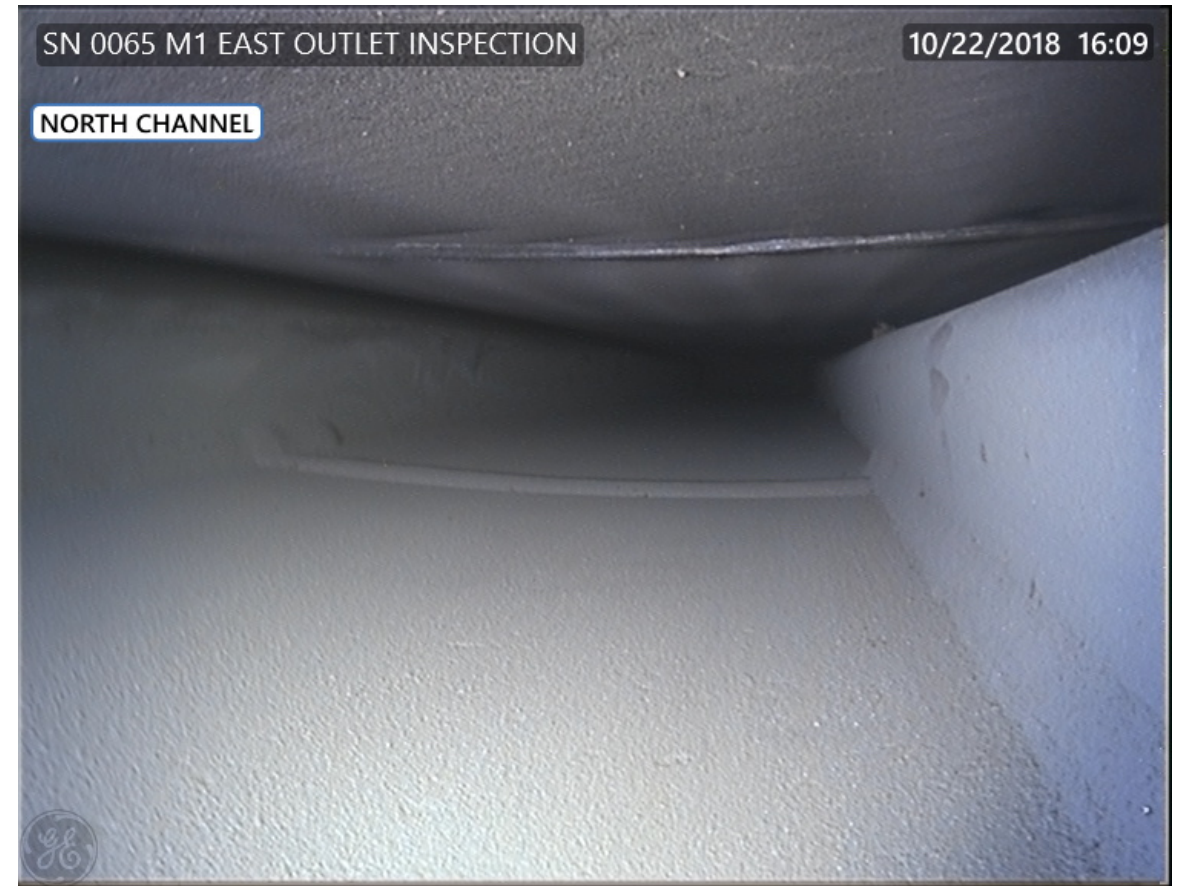
DCSS loaded in 2008

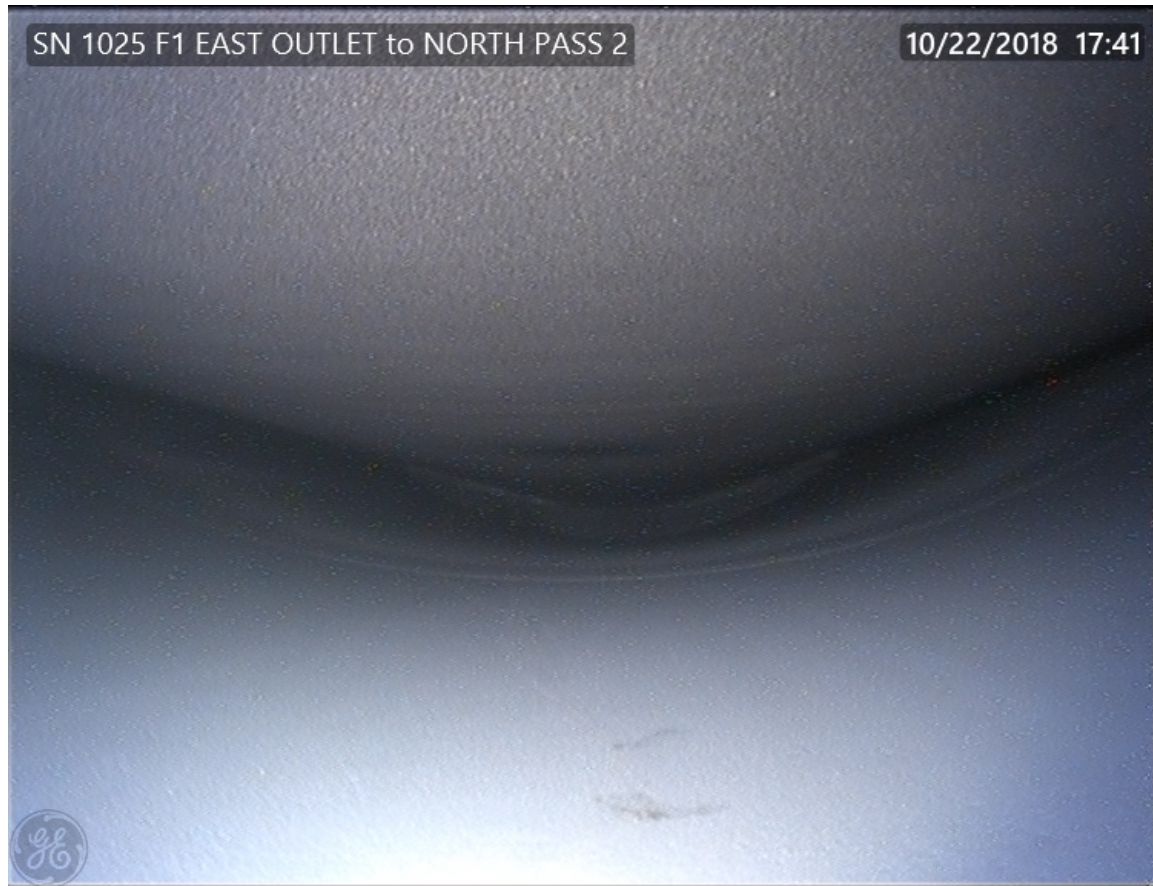
DCSS Visual Inspection – Base Metal

Freshly-loaded canister

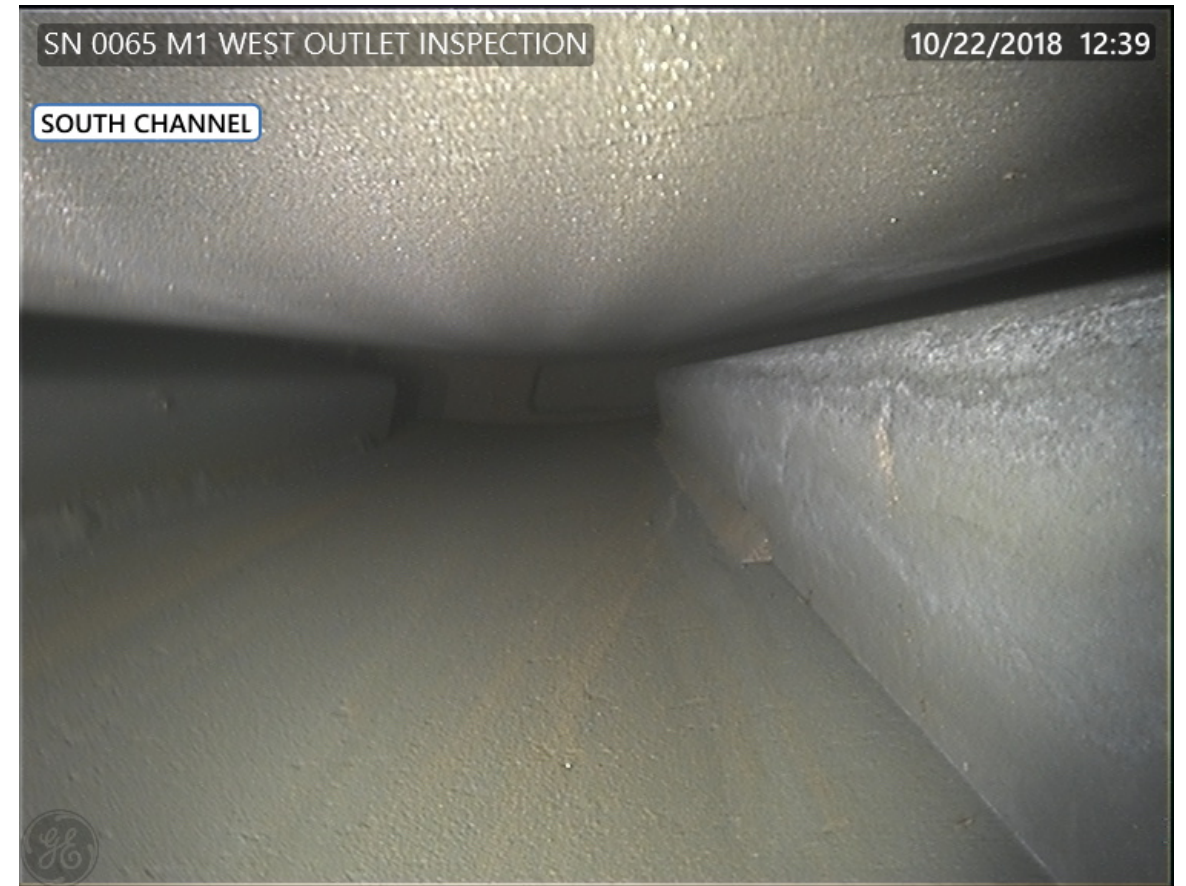
DCSS loaded in 2008

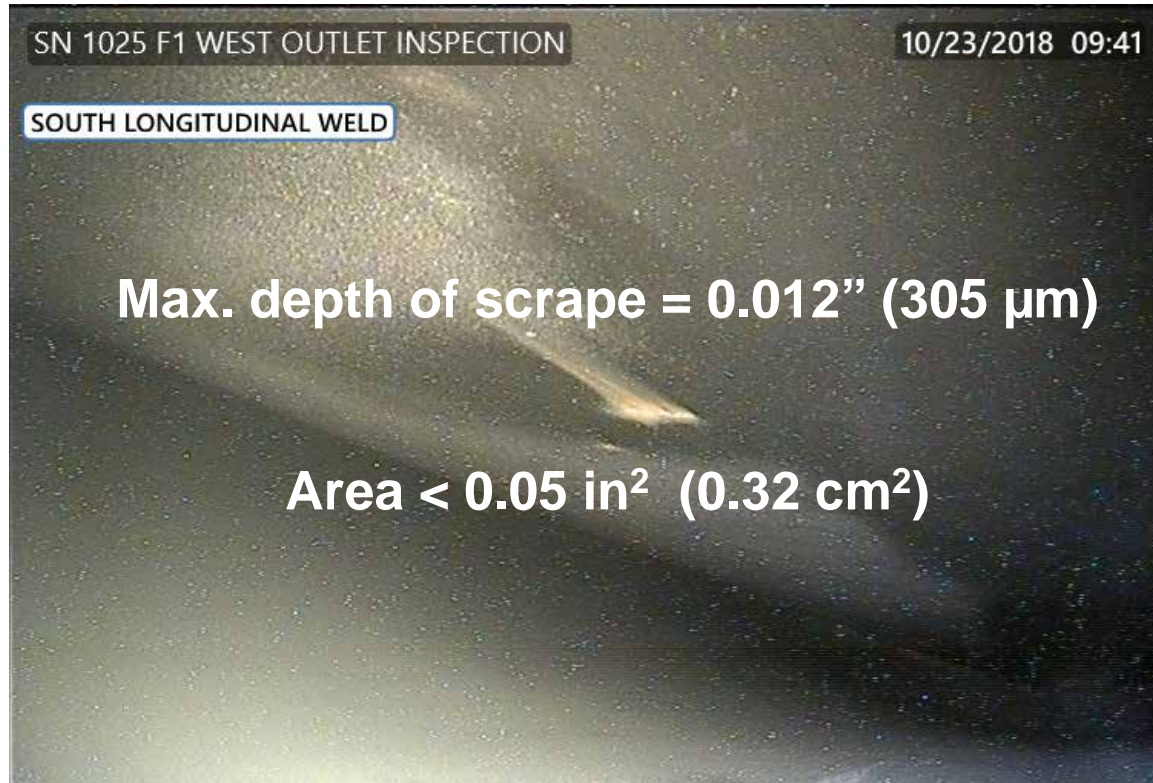
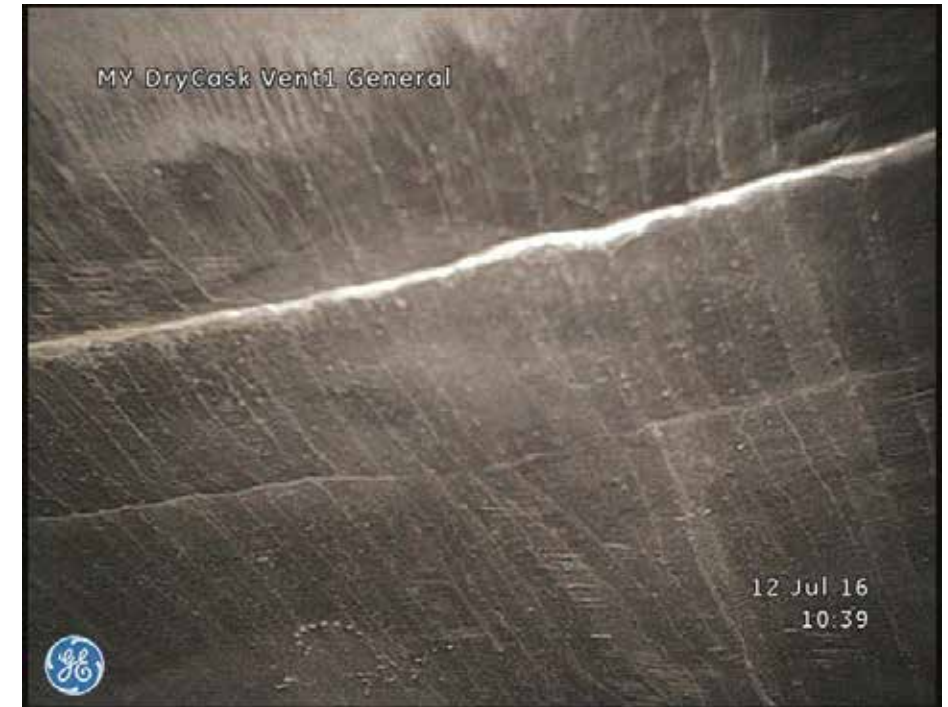
What Has Been Observed?

Overall, not much – bright, shiny metal surfaces similar to the top, right image

A small scrape mark was identified at one site and evaluated with a high-resolution probe tip

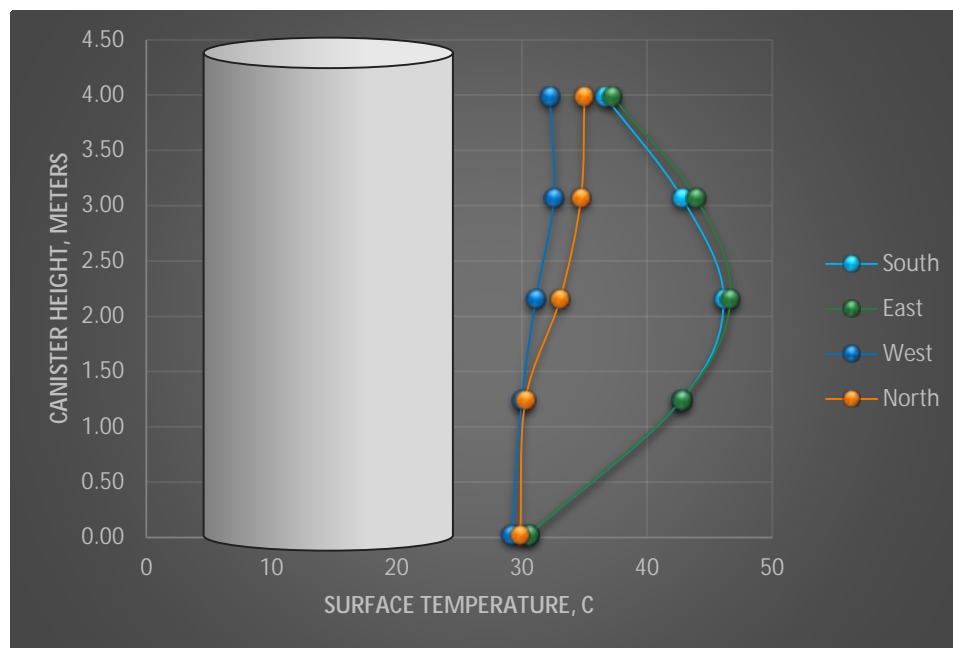
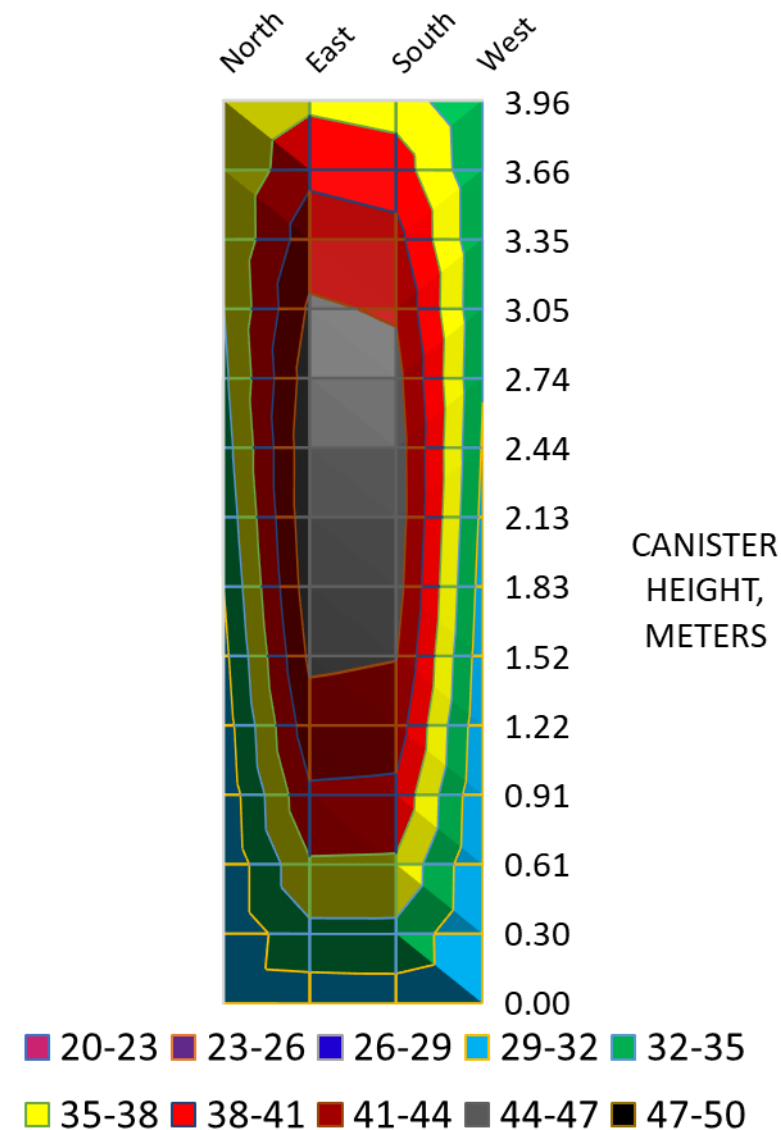
Temperature Data - Site 1, Canister 1

- § Adapted inspection tools to measure canister surface temperatures and dose rates
- § Data from a 16-year-old canister (4.27 kW) is shown here (temperatures in degrees Celsius)

- § Team received ~4 mrem of dose from this activity (inspecting 1 canister)

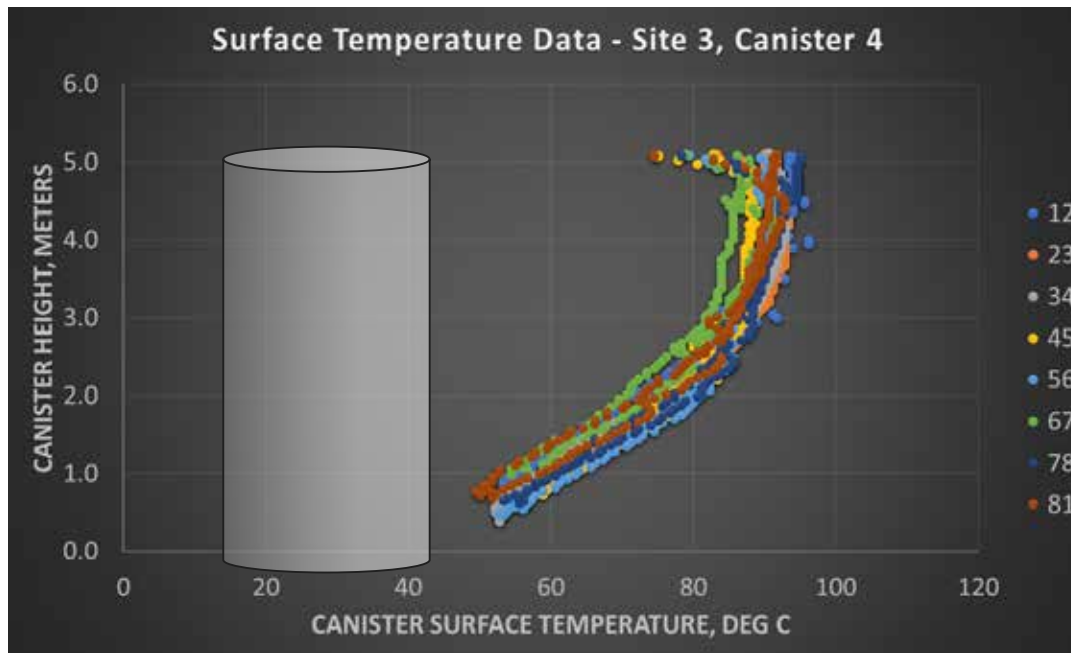
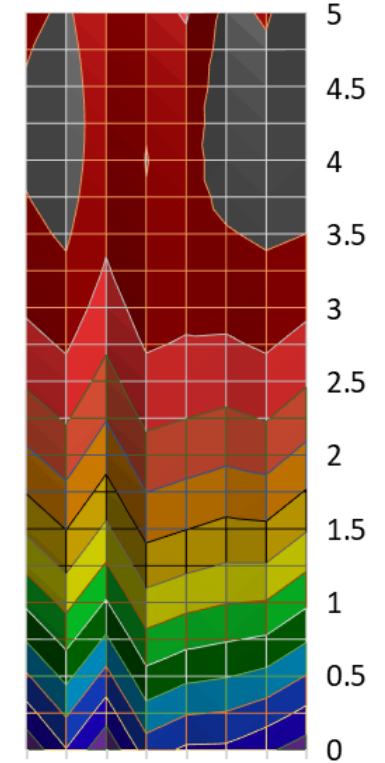
Surface Temperature - Site 3, Canister 4

- § Adapted inspection tools to measure canister surface temperatures and dose rates
- § Data from a 1.5-year-old canister (27.8 kW) is shown here (temperatures in degrees Celsius)

81 78 67 56 45 34 23 12

Team received
~176 mrem of
dose from this
activity (inspecting
8 canisters)

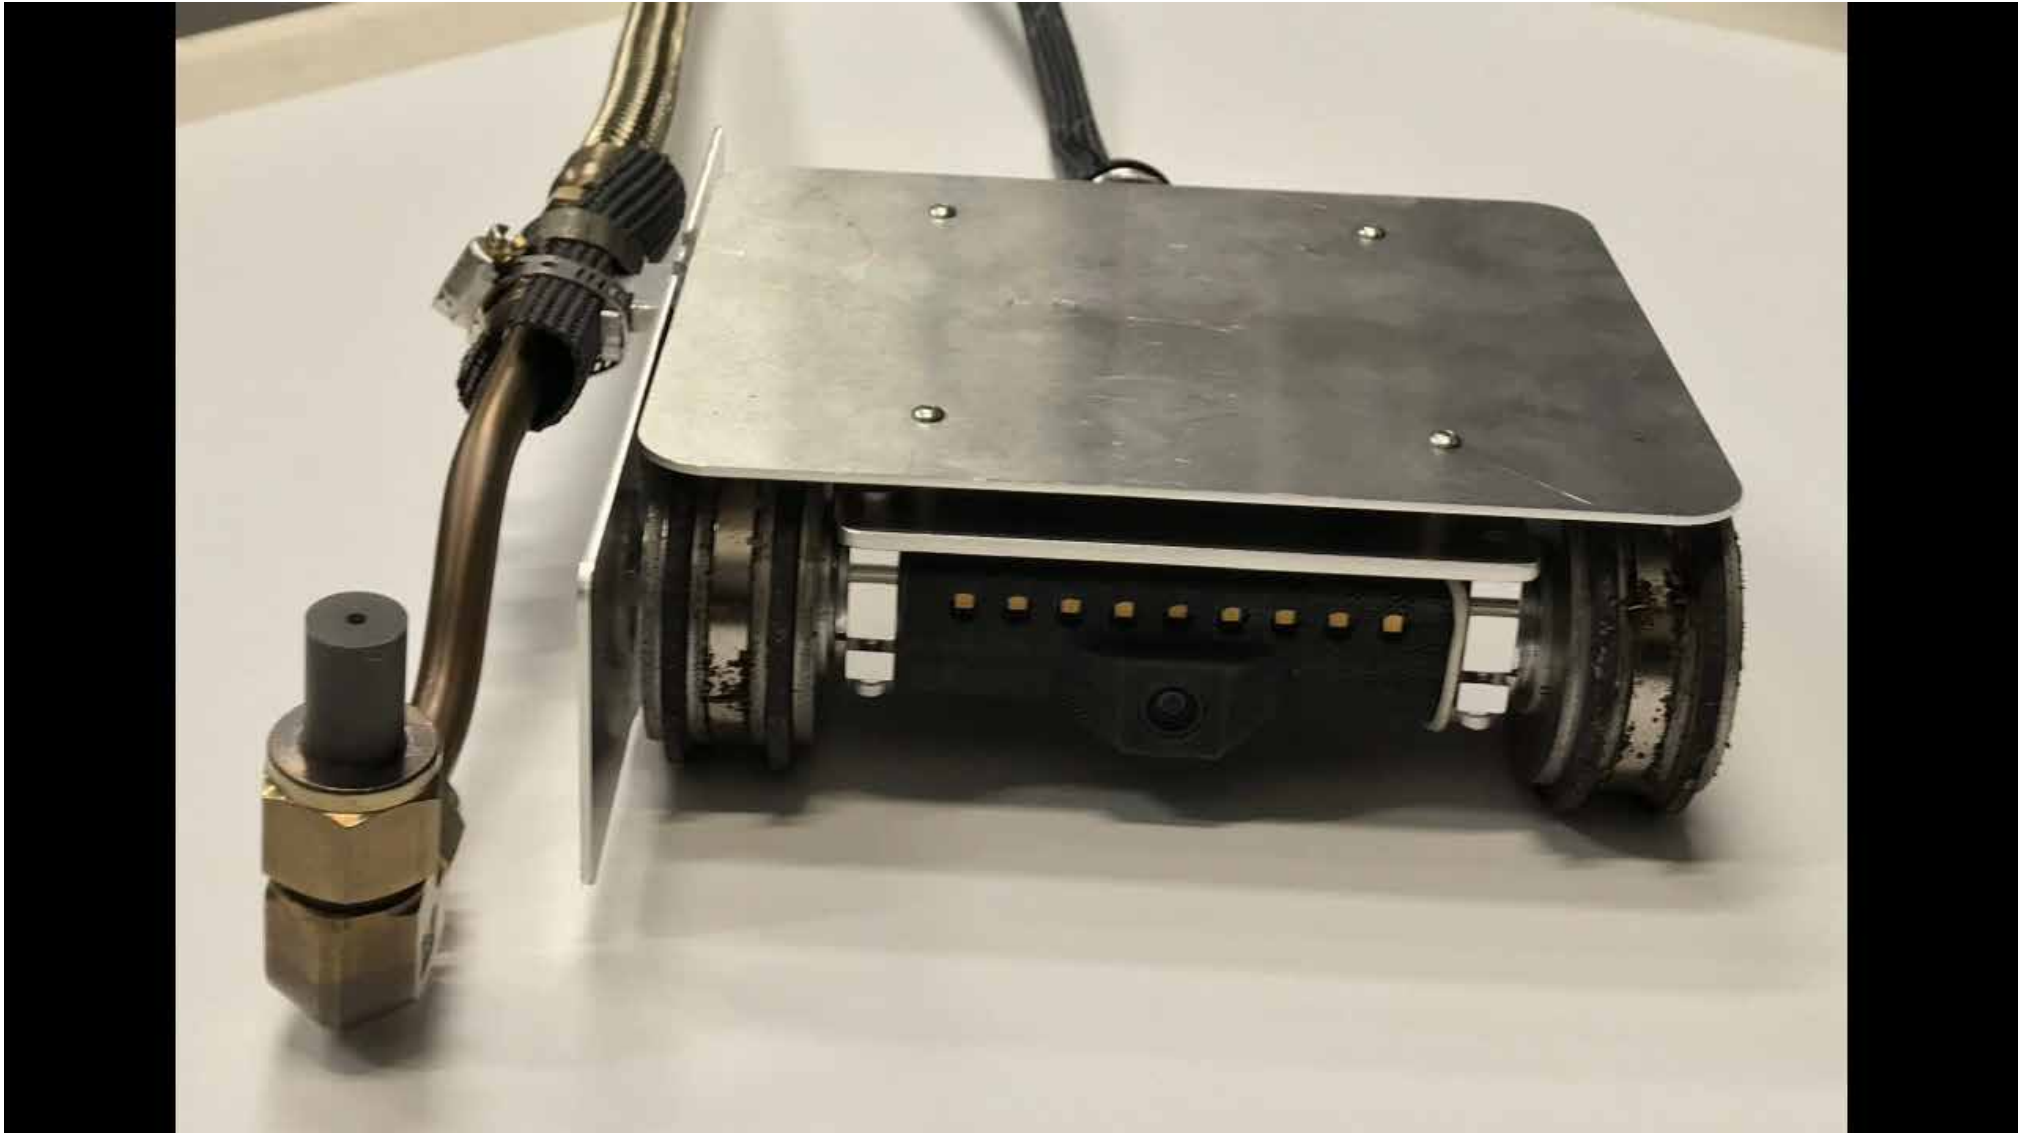
Laboratory Evaluation of Cold Spray Repair

- § EPRI is helping to organize industry efforts on mitigation and repair technologies via the Extended Storage Collaboration Program (ESCP)
- § Collaborations between organizations can accelerate development
- § Helps to avoid duplication of effort
- § Cold spray application to be demonstrated at EPRI by VRC Metal Systems as a part of the next ESCP Meeting on November 8, 2019

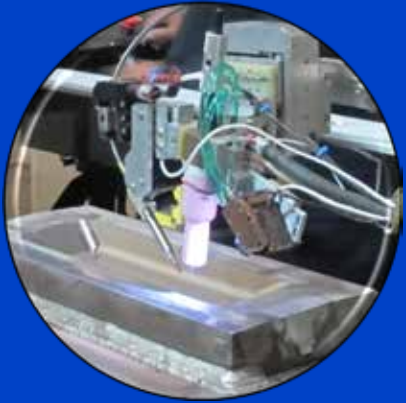
GTAW "TIG" Welding

- Standard industry technique
- Low-heat input techniques under development

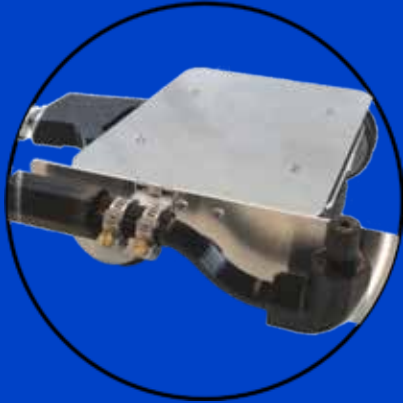
Cold Spray

- High-potential process for mitigation and repair
- Demonstrated on robotic delivery system in DSS environment

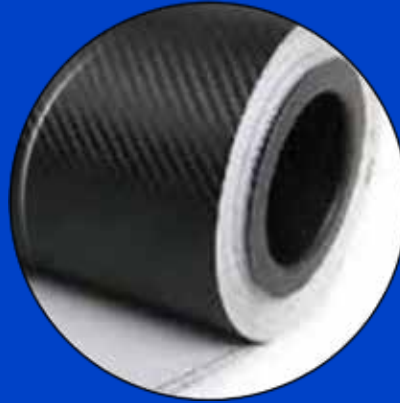
Non-metallics

- Potential for very long-term repair patch
- Potential to mitigate an active flaw

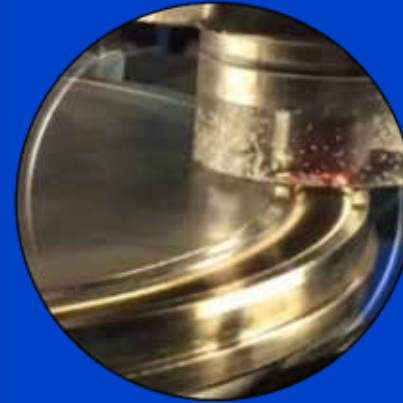
Friction-stir welding

- Low heat input, full structural repair
- Non-susceptible, repairs flaws

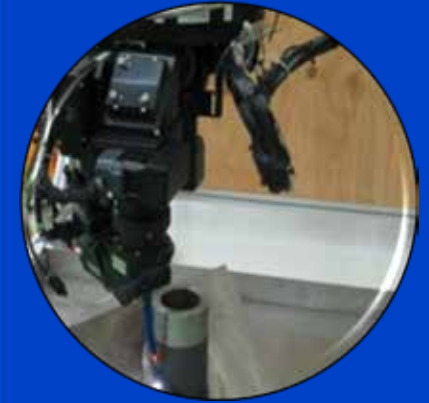
Surface Stress Improvement (i.e. peening)

- Reduces susceptibility to CISCC
- Can be performed pre-service or in-service
