# Decommissioning **San Onofre**

Nuclear Generating Station

## SONGS Recent Dry Storage Operating Experience

Randall Granaas  
*NRC RegCon*  
9/17/19

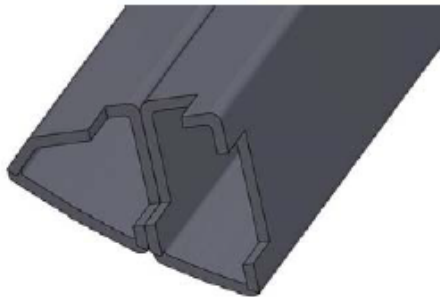
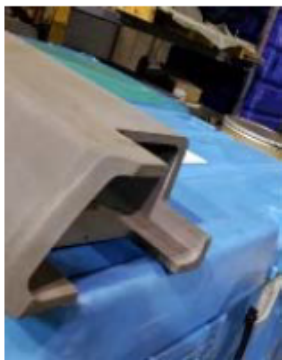
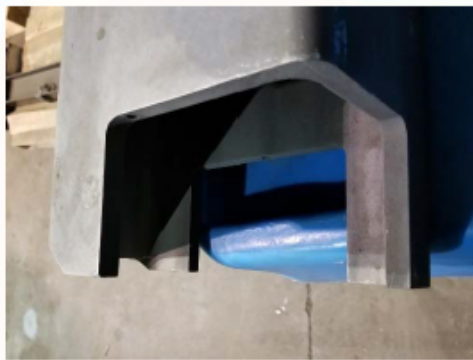
## Original Design

# Shim Designs

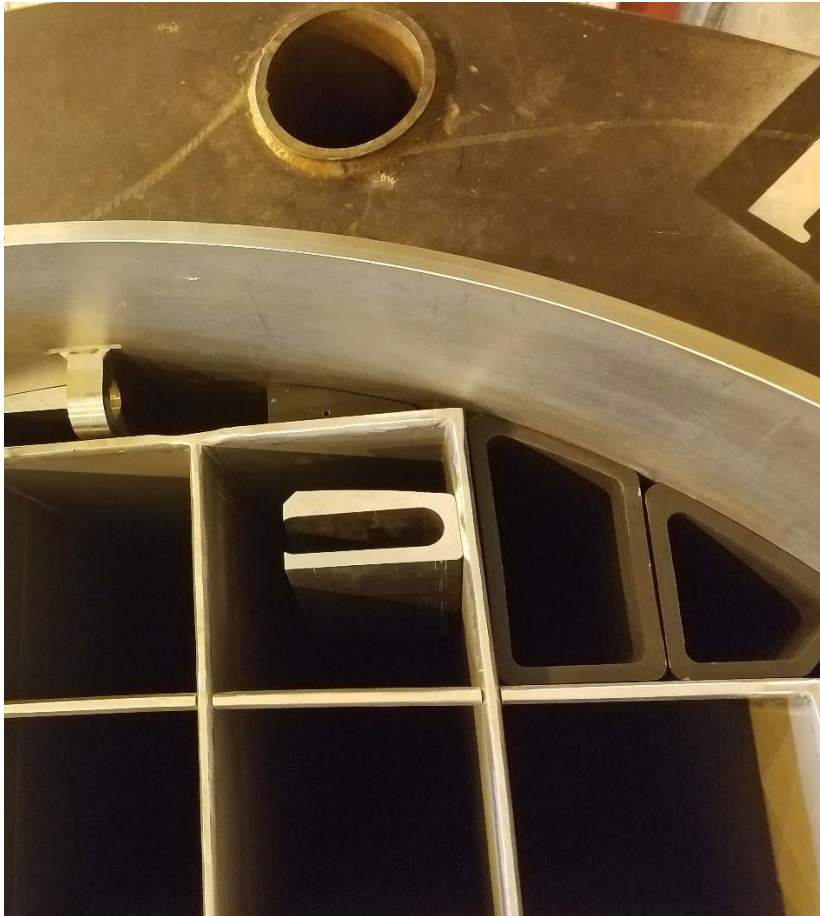
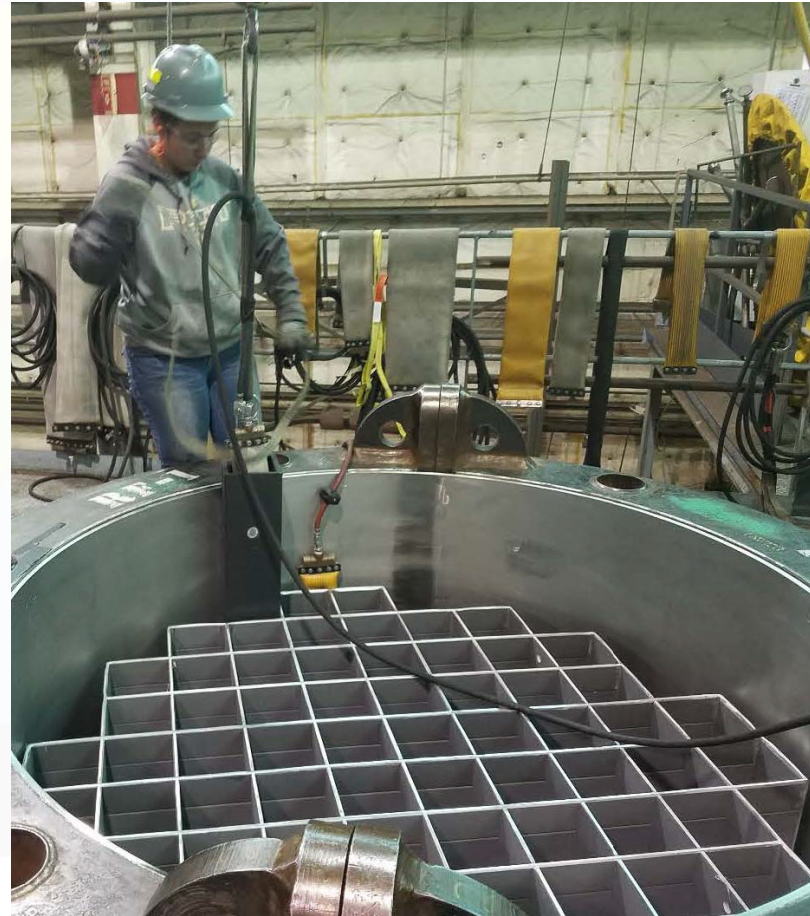
# Basket Shims

- First broken Shim Standoff (SSO) discovered 2/20/2018 during canister receipt inspection
- Four SONGS MPCs use SSO design
- Fuel stored safely within SSO design MPCs, even if all SSOs were to fail non-mechanistically (heat-loads much lower than design and licensed limits)

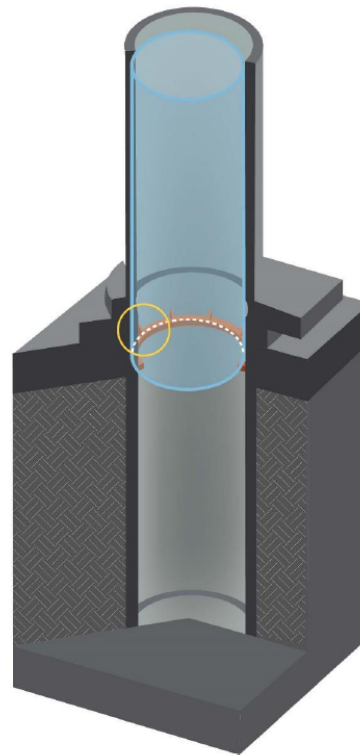
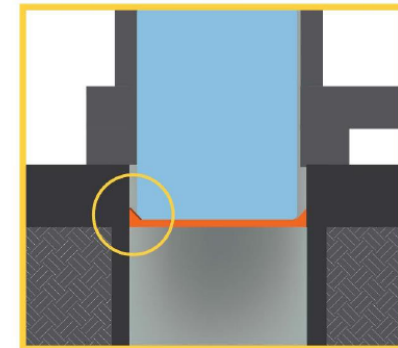
## What happened on Aug. 3

- On Aug. 3, 2018, as a loaded MPC was being downloaded into its storage vault, it became lodged on the shield ring
  - For less than an hour, the MPC remained lodged and was not suspended by the rigging

- MPC lodged on shield ring
- Shield ring is 2" thick; welded in place

■ MPC WEDGED IN CEC

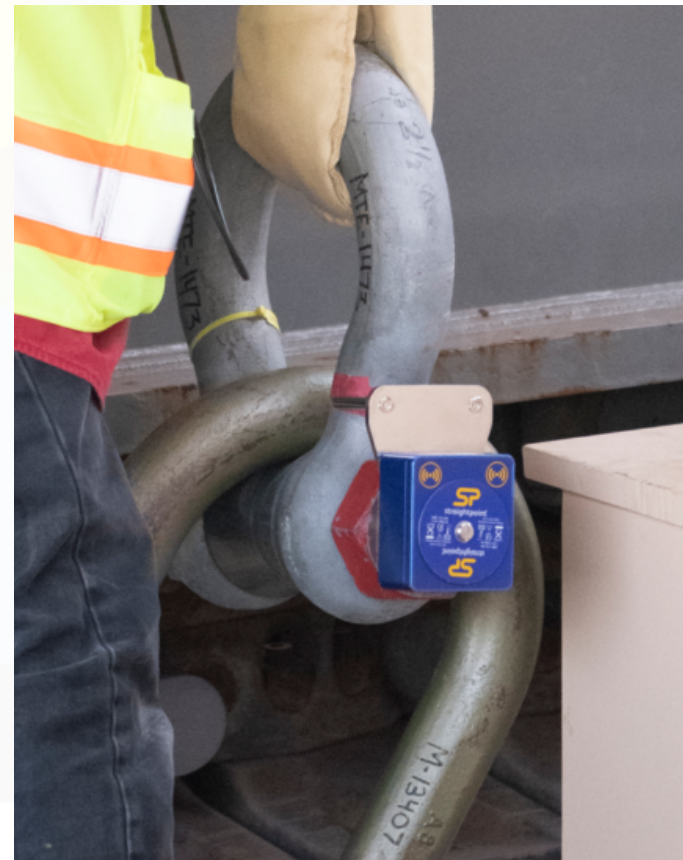
## Equipment

- Cameras and monitors to observe downloading remotely
- Load monitoring shackles with remote indication and alarms
- Rope on canister to verify physical status during downloading

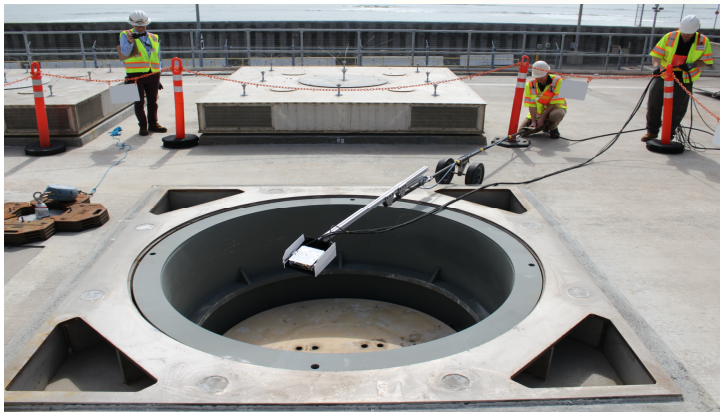
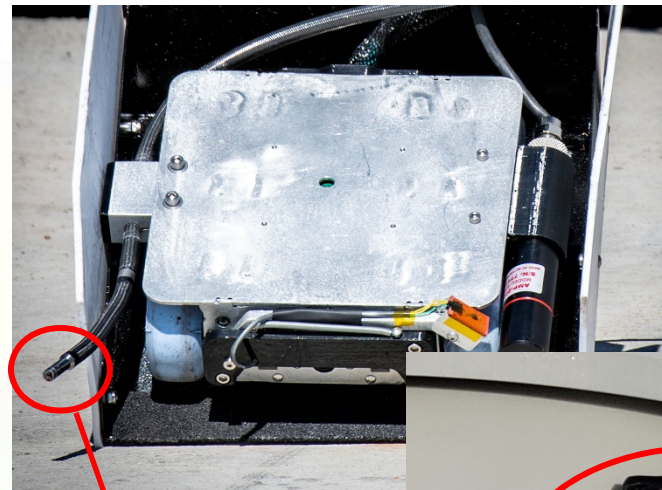
Borescope  
(camera)

- Precision digital borescope
- Capable of measuring depth and length of indications
- Remote-controlled robot
- Reached 92% of shell
  - Lower part of 3-inch-thick base plate not visible

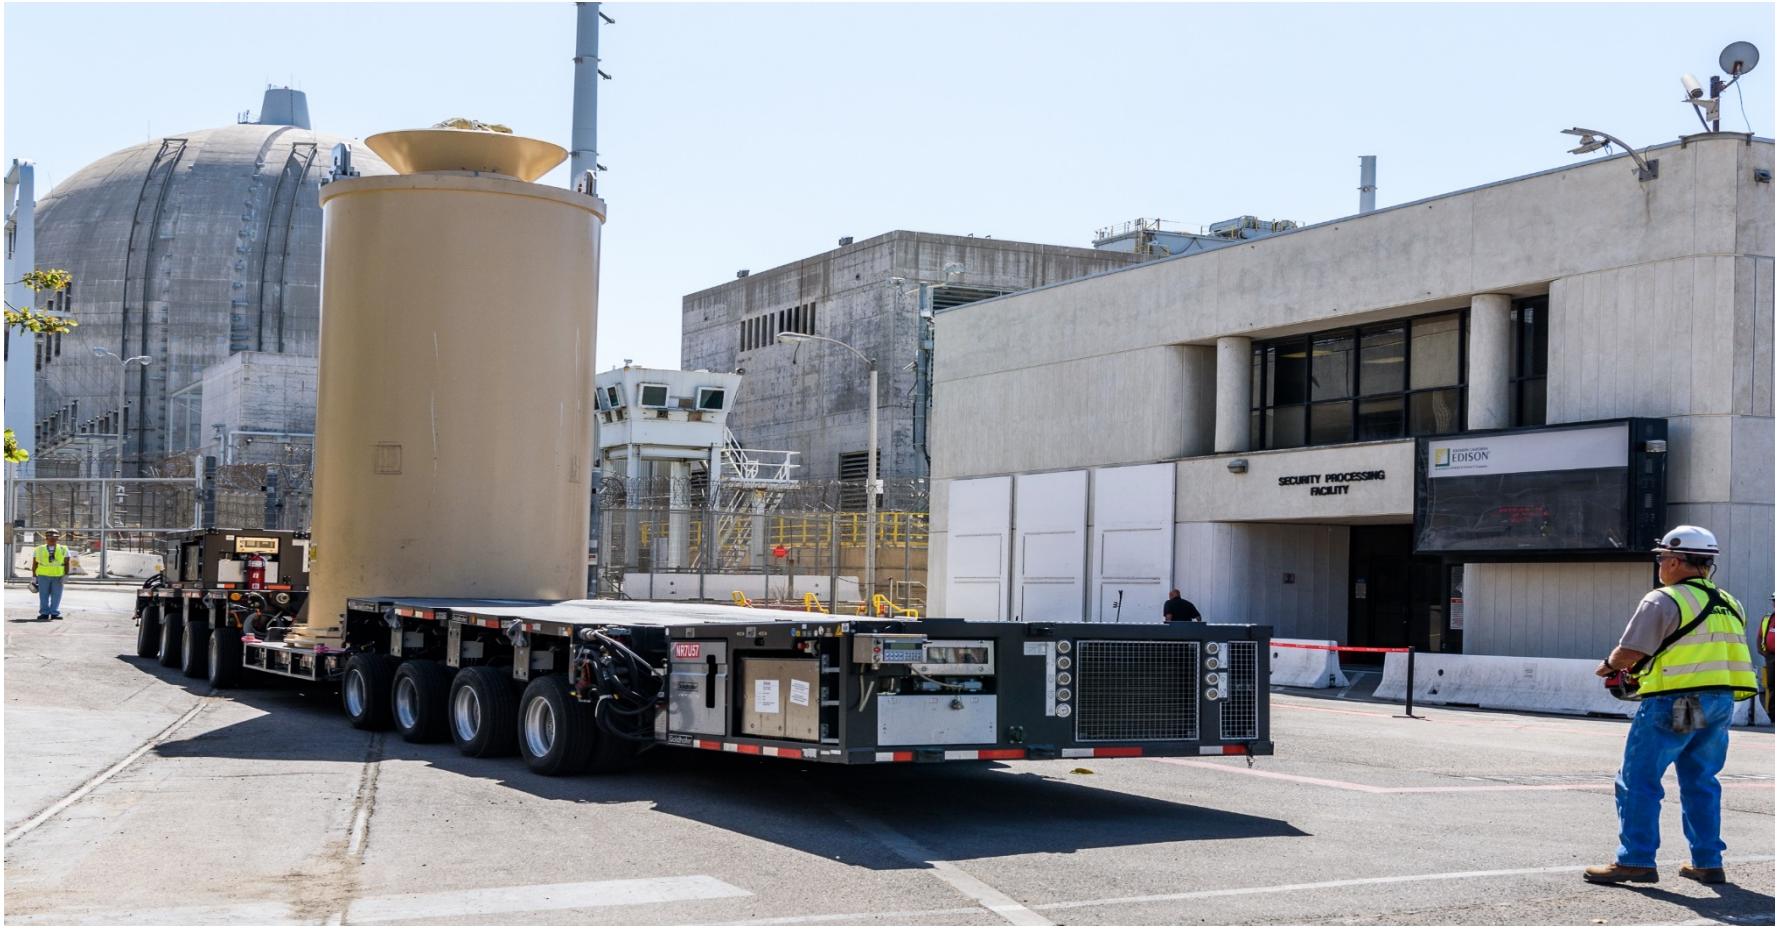
# “Crawler” Transporter Haul Path

- SCE identified issue with HI-PORT transporter haul route
  - Captured as part of broad review of operations after August incident
  - HI-PORT route too close to objects such as fence and light posts
- Notified the NRC on 12/19/18
- Analyzed obstructions and clearance
- Completed corrective actions to improve procedures and develop guidance for establishing the haul route
- Filed subsequent NRC report which included results of the causal analysis and corrective actions on 2/14/19
- NRC accepted corrective actions via Special Inspection

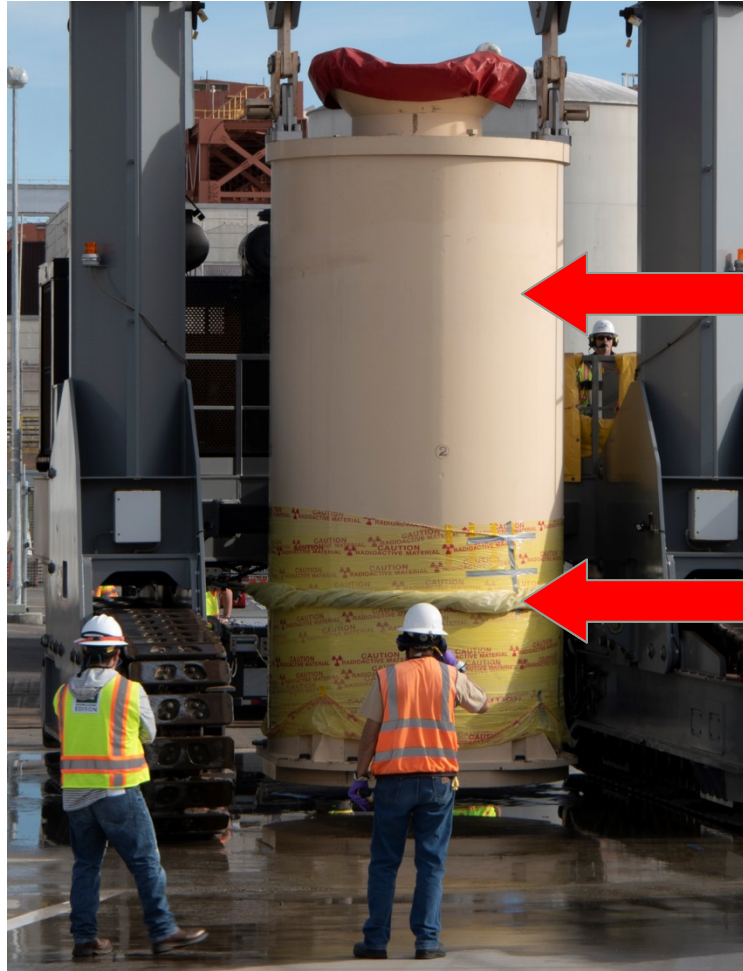
# Vertical Cask Transporter with Seismic Restraint

**HI-TRAC**  
(transfer cask  
and canister)

**Cask restraint  
strap**

- NRC identified seismic stability issue during inspection
- SCE formally reported issue to NRC on 2/2/19
- Analysis demonstrated VCT operation without strap has no adverse effect under design-basis earthquake
- Corrective actions implemented
  - Procedures revised for movement of VCT
  - SCE will maintain strap attached and tightened until HI-TRAC needs to be lifted, lowered or moved into position in approach to CEC
- SCE retracted NRC Event Notification based on the analysis
